OELWEIN MUNICIPAL AIRPORT
PAVEMENT MANAGEMENT REPORT

Prepared For:
Iowa Department of Transportation
Office of Aviation

Prepared By:
Applied Pavement Technology, Inc.

January 2010

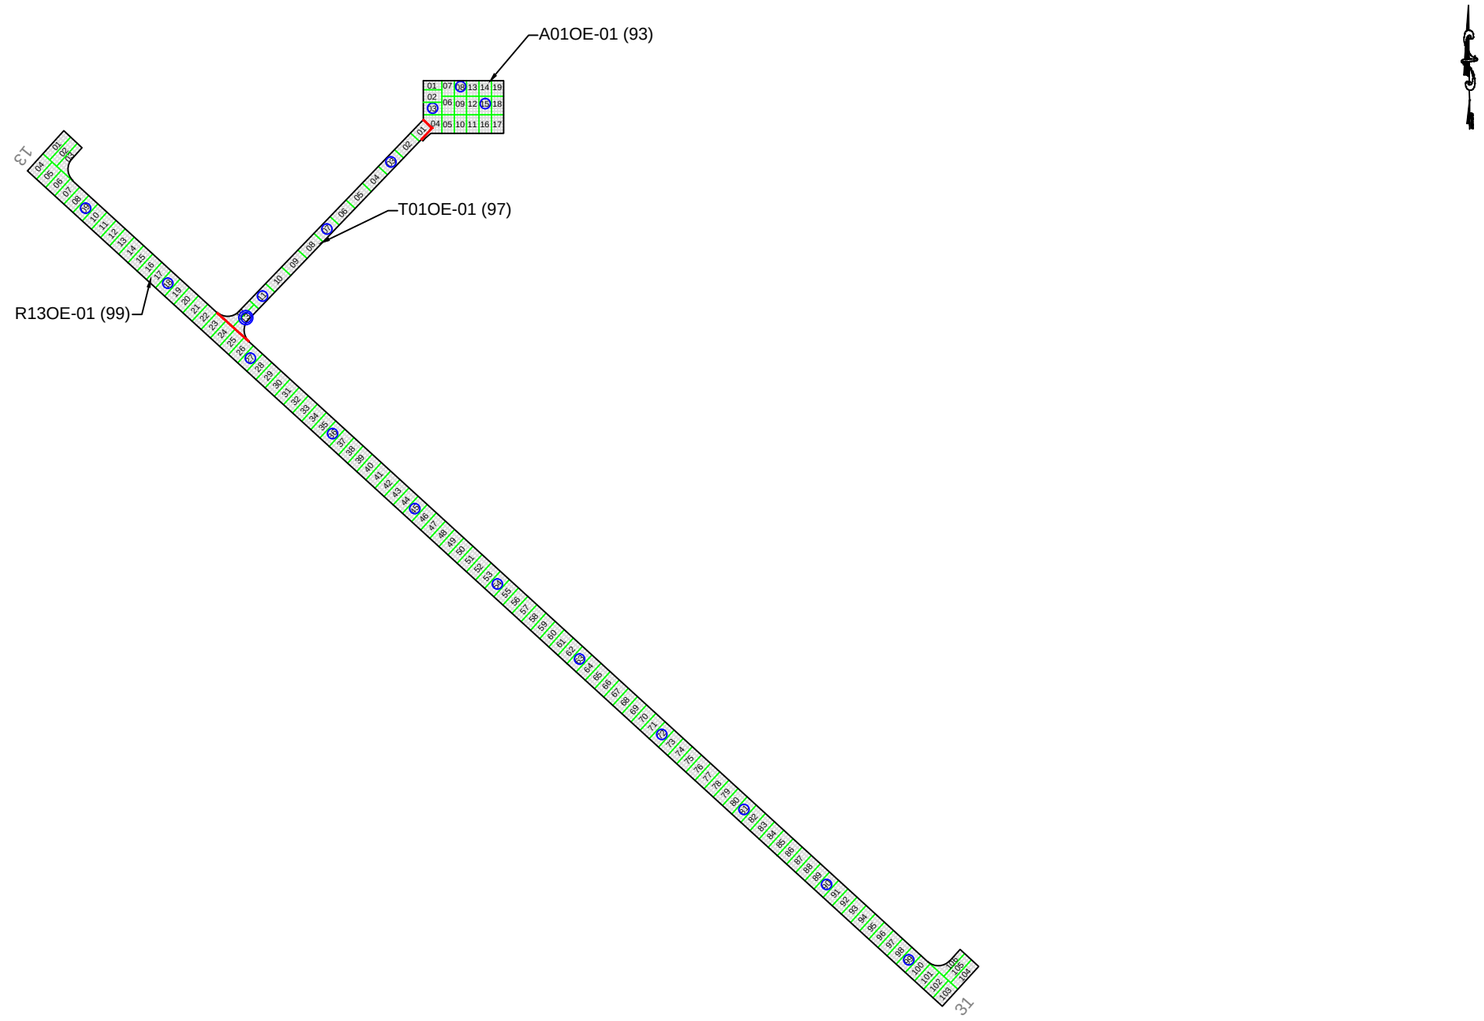
FIGURE 3. NETWORK DEFINITION MAP.

Runway 13-31 contains one section that is in excellent condition with isolated amounts of low-severity joint seal damage and patching and medium-severity corner spalling recorded.

Taxiway 01 is defined by one section in excellent condition with low-severity joint seal damage observed. Additionally, small quantities of low-severity patching along with isolated amounts of low-severity linear cracking, joint spalling, and corner spalling were identified.

The terminal apron consists of one section in good condition with low-severity joint seal damage recorded. In addition, small amounts of low-severity corner breaking, faulting, and corner spalling were observed.

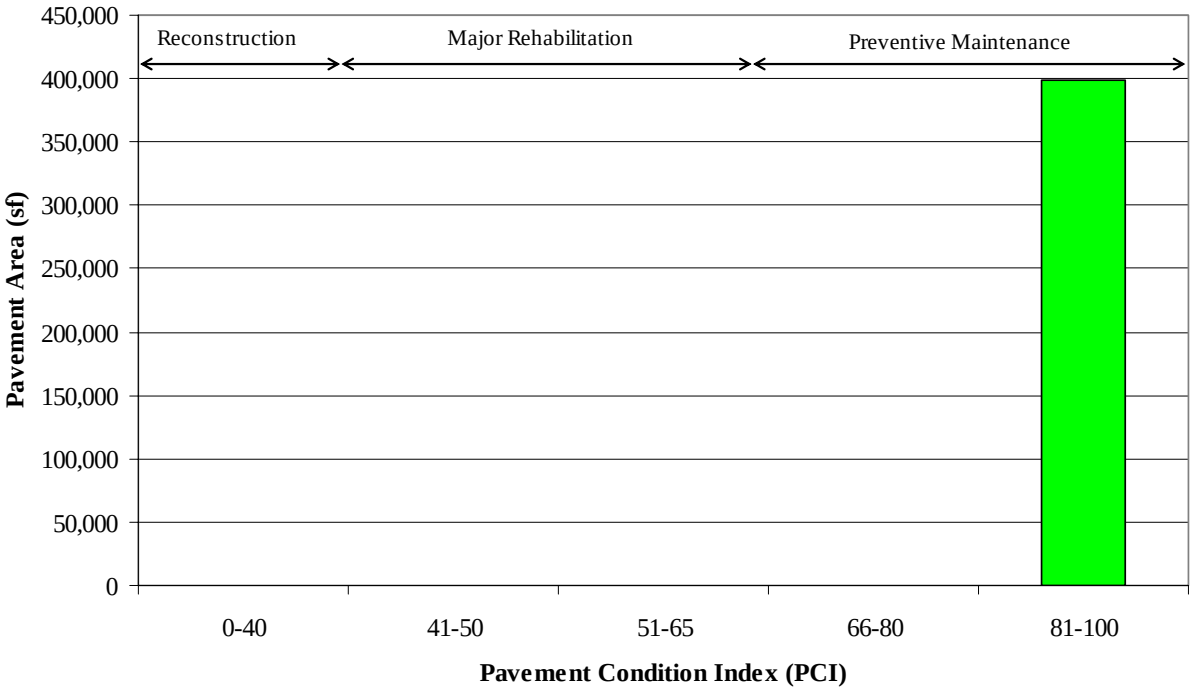
Figure 6. Overall condition.

The pavements at Oelwein Municipal Airport were inspected on September 22-23, 2009. The 2009 area-weighted condition of Oelwein Municipal Airport is 98, with conditions ranging from 93 to 99 (on a scale of 0 [failed] to 100 [excellent]). During the previous pavement inspection in 2005, the area-weighted PCI of the airport was 98.
