OSKALOOSA MUNICIPAL AIRPORT PAVEMENT MANAGEMENT REPORT

Prepared By:
Applied Pavement Technology, Inc.

December 2011

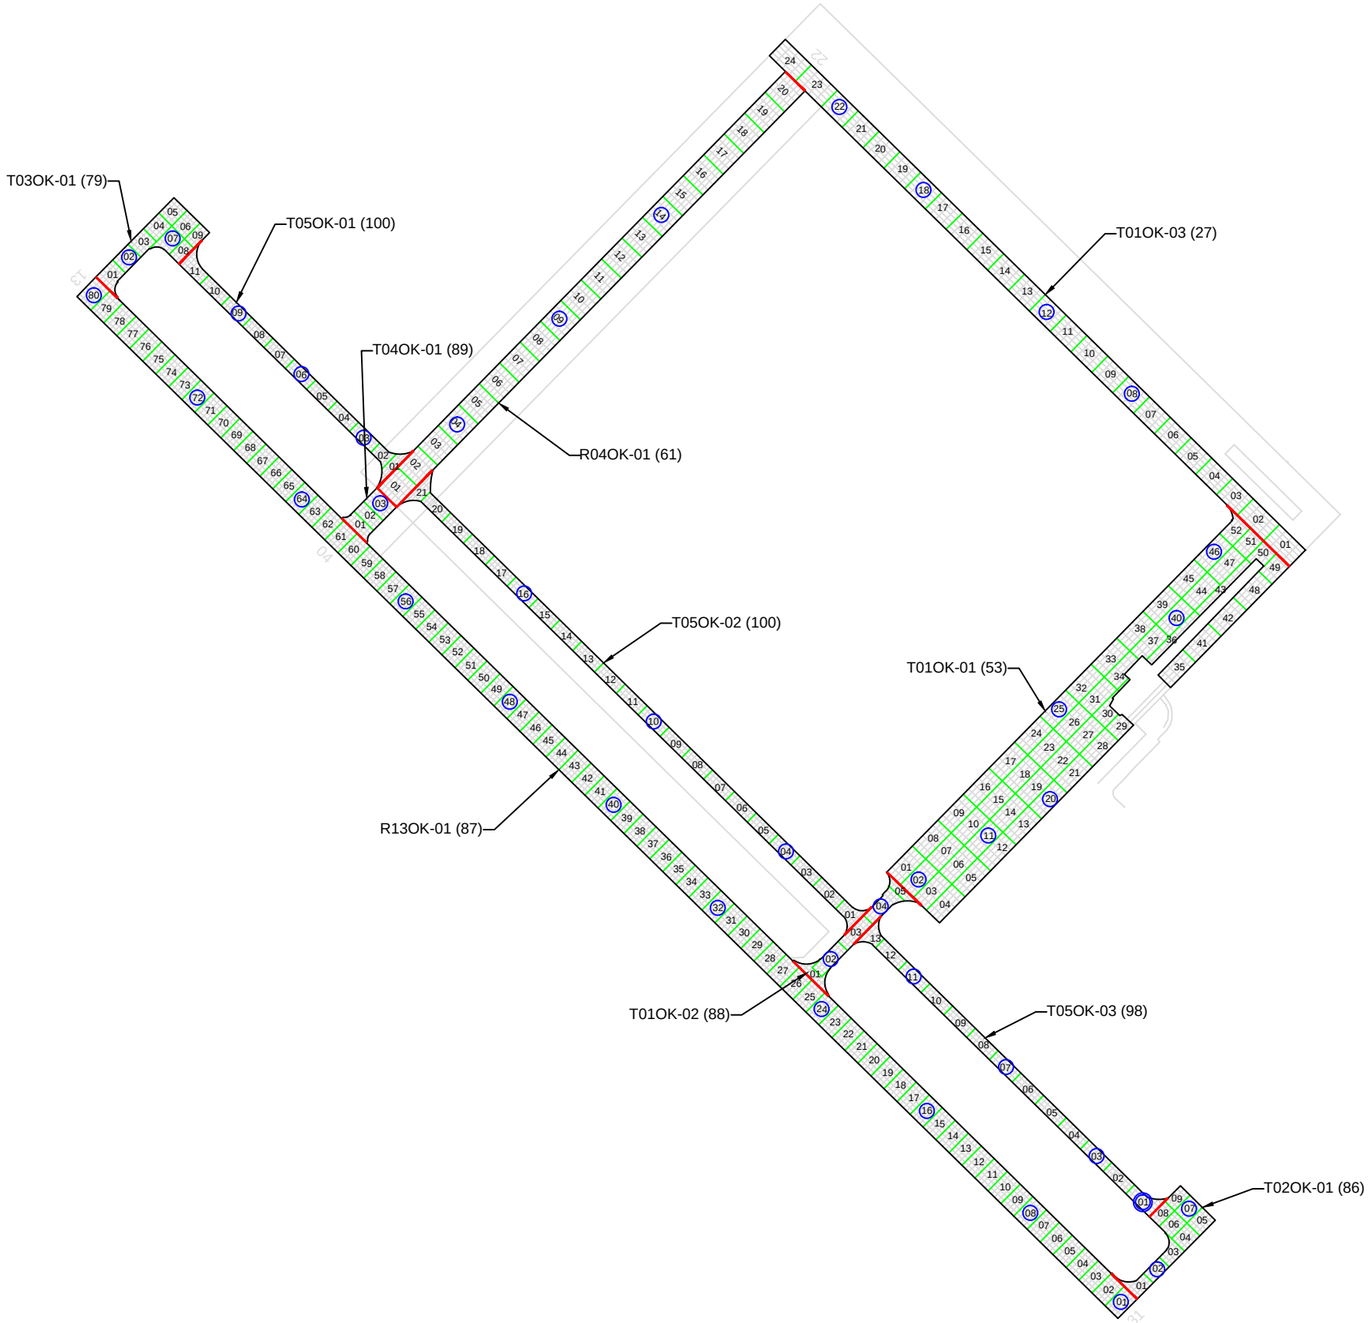
FIGURE 3. NETWORK DEFINITION MAP.

Runway 13-31 is defined by of one section in good condition with medium- and high-severity joint seal damage recorded. In addition, small amounts of low- and medium- severity joint spalling and corner spalling were observed along with low-severity scaling.

Runway 04-22 consists of one section in fair condition. High-severity joint seal damage was identified in Section 01. Additionally, extensive amounts of low-severity large patching and low- and medium-severity joint spalling, corner spalling, and longitudinal, transverse, and diagonal (LTD) cracking were recorded. Small amounts of high-severity corner spalling and low-severity corner breaking, faulting, and shattered slabs were also noted.

Taxiway 01 connects both runways and is comprised of three sections. Section 01, the majority of the pavement located in front of the terminal building, is in fair condition with high-severity joint seal damage observed. In addition, extensive amounts of all severities of corner spalling and low- and medium-severity small patching, joint spalling, and LTD cracking were also noted. Small amounts of shrinkage cracking, low- and medium-severity corner breaking, low-severity faulting and large patching, and medium-severity shattered slabs were also identified. Slab replacements and patching were recently completed on this section. Section 02 connects Runway 13-31 with the parallel taxiway and is in good condition. Only high-severity joint seal damage was recorded. Section 03, located between Runway 04-22 and the T-Hangars, is in poor condition with high-severity joint seal damage observed. Low- and medium-severity LTD cracking, all severities of joint spalling and corner spalling, low-severity large patching, high-severity durability cracking, and medium- and high-severity shattered slab were also noted.

Taxiway 02 is located adjacent to the Runway 31 approach and is defined by one section in good condition. High-severity joint seal damage and low-severity corner breaking were noted.

Taxiway 03, located adjacent to the Runway 13 approach, consists of one section. Section 01 is in satisfactory condition with high-severity joint seal damage observed. In addition, low- and high-severity corner spalling and medium- and high-severity joint spalling were recorded.

Taxiway 04 connects Runway 13-31 to the Runway 04 approach and is comprised of one section in good condition. Medium-severity joint seal damage, shrinkage cracking, and low-severity corner spalling were observed.

Taxiway 05, the parallel taxiway to Runway 13-31, consists of three sections. All three sections were recently constructed and are in excellent condition. No distresses were observed in Sections 01 and 02. Isolated amounts of medium-severity small patching noted to be caused by a lightning strike were recorded in Section 03 along with an additional sample unit recorded where medium-severity joint spalling and high-severity corner spalling were identified.

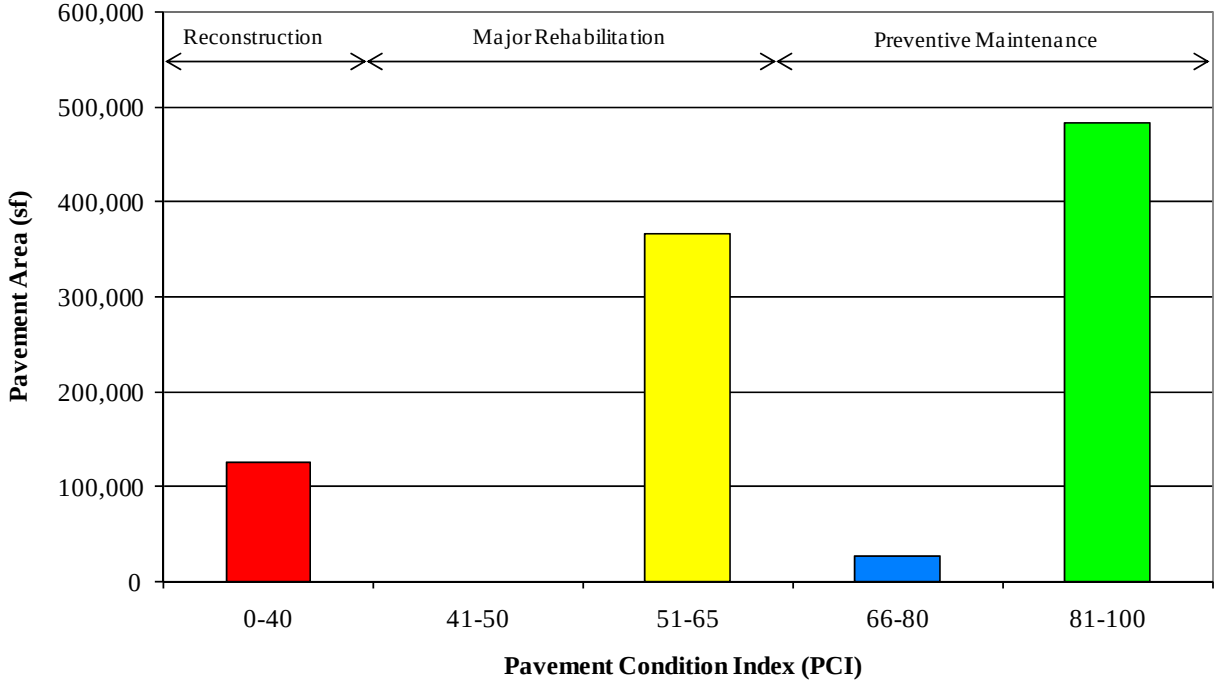
Figure 6. Overall condition.

The pavements at Oskaloosa Municipal Airport were inspected on September 10, 2011. The 2011 area-weighted condition of Oskaloosa Municipal Airport is 69, with conditions ranging from 27 to 100 (on a scale of 0 [failed] to 100 [excellent]). During the previous pavement inspection in 2008, the area-weighted PCI of the airport was 73.

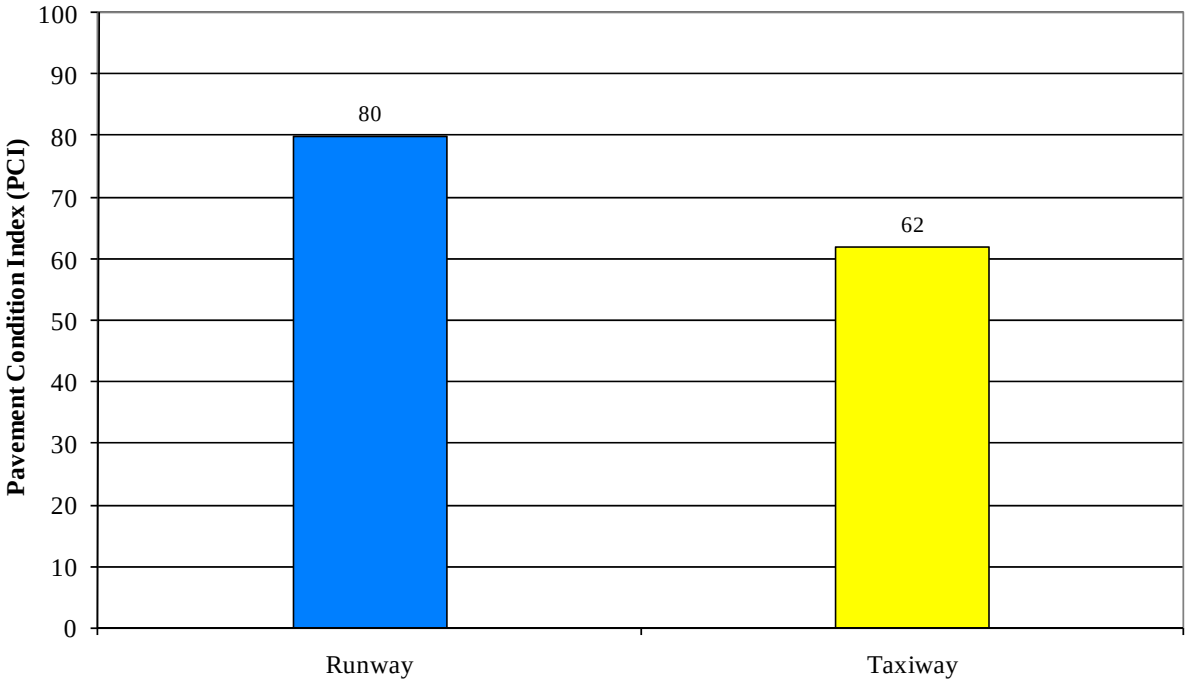
Figure 7. Condition by use.

Figures 6 and 7 provide graphs summarizing the overall condition of the pavements at Oskaloosa Municipal Airport. Figure 8 is a map that displays the condition of the pavements evaluated. Table 1 summarizes the results of the pavement evaluation. Appendix C presents photographs taken during the PCI inspection, and Appendix D contains detailed information on the distresses observed during the visual survey. Appendix E includes detailed work history information that
