MAQUOKETA MUNICIPAL AIRPORT PAVEMENT MANAGEMENT REPORT

Prepared By:
Applied Pavement Technology, Inc.

December 2010

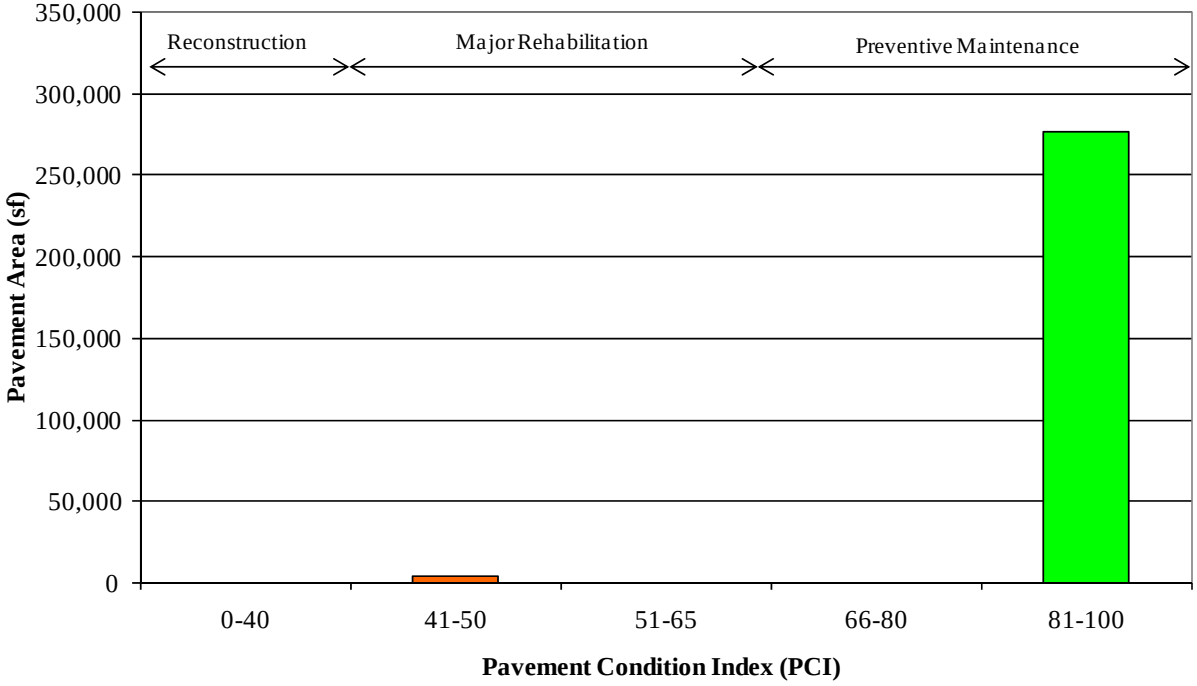
Figure 6. Overall condition.

Figures 6 and 7 provide graphs summarizing the overall condition of the pavements at the Maquoketa Municipal Airport. Figure 8 is a map that displays the condition of the pavements evaluated. Table 1 summarizes the results of the pavement evaluation. Appendix C presents photographs taken during the PCI inspection, and Appendix D contains detailed information on the distresses observed during the visual survey. Appendix E includes detailed work history

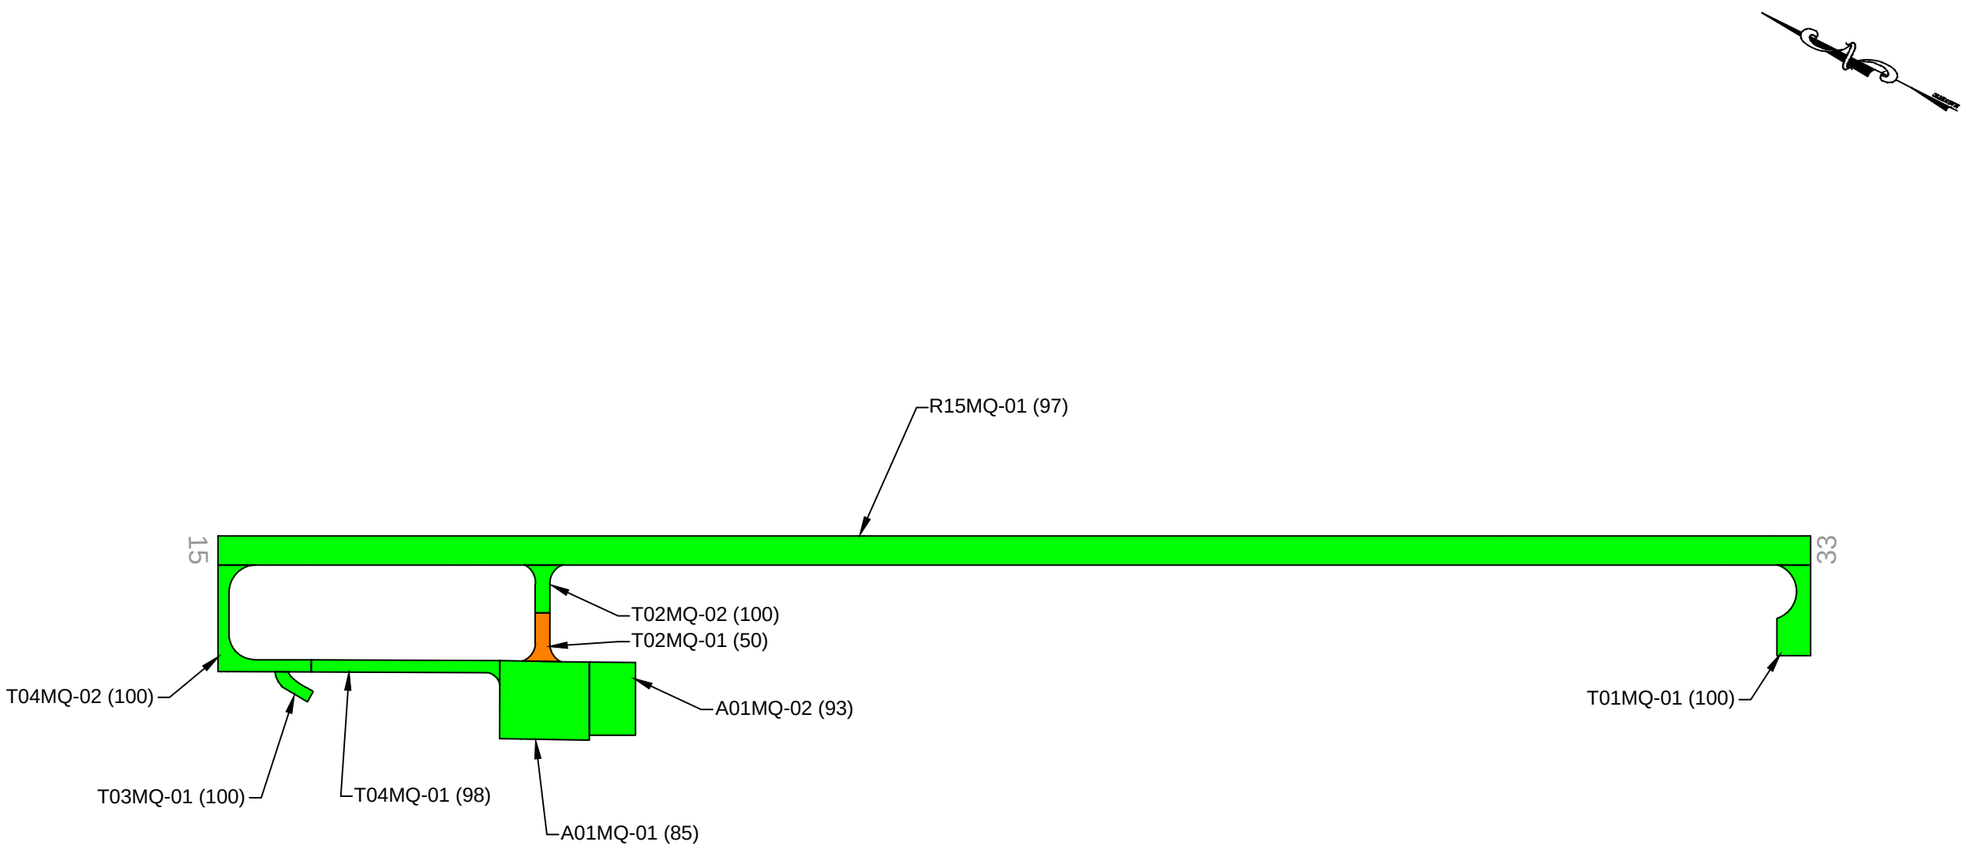
FIGURE 8. PCI MAP.

The pavements at Maquoketa Municipal Airport were inspected on September 21, 2010. The 2010 area-weighted condition of Maquoketa Municipal Airport is 95, with conditions ranging from 50 to 100 (on a scale of 0 [failed] to 100 [excellent]). During the previous pavement inspection in 2006, the area-weighted PCI of the airport was 96.

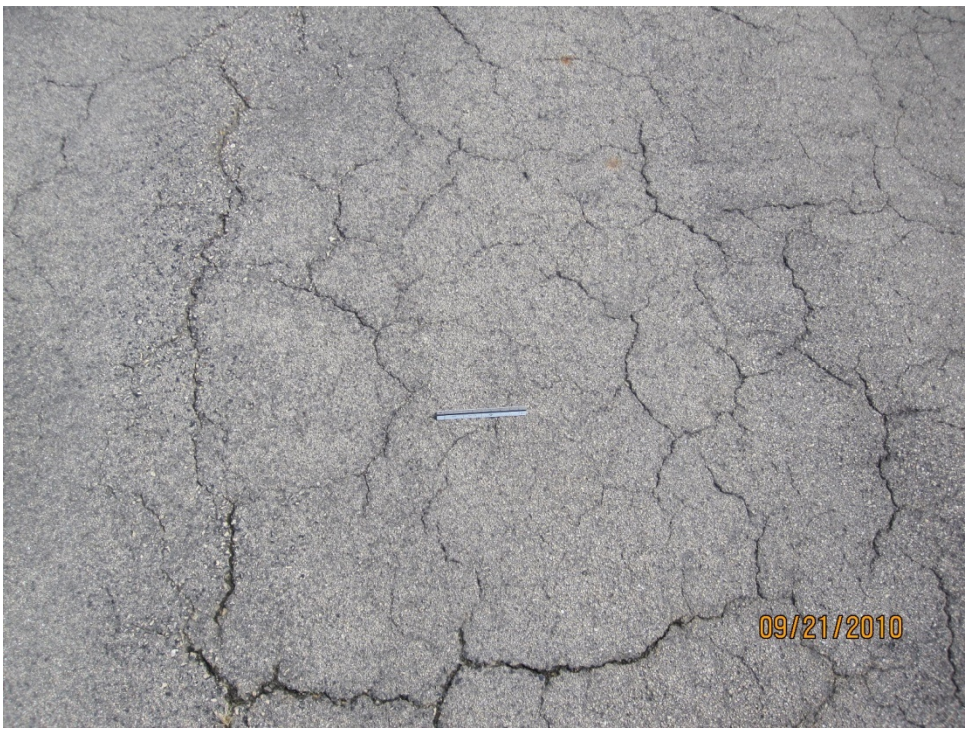
T02MQ-01. Raveling and Weathering (surface treatment).
