ORANGE CITY MUNICIPAL AIRPORT PAVEMENT MANAGEMENT REPORT

Prepared By:
Applied Pavement Technology, Inc.

January 2010

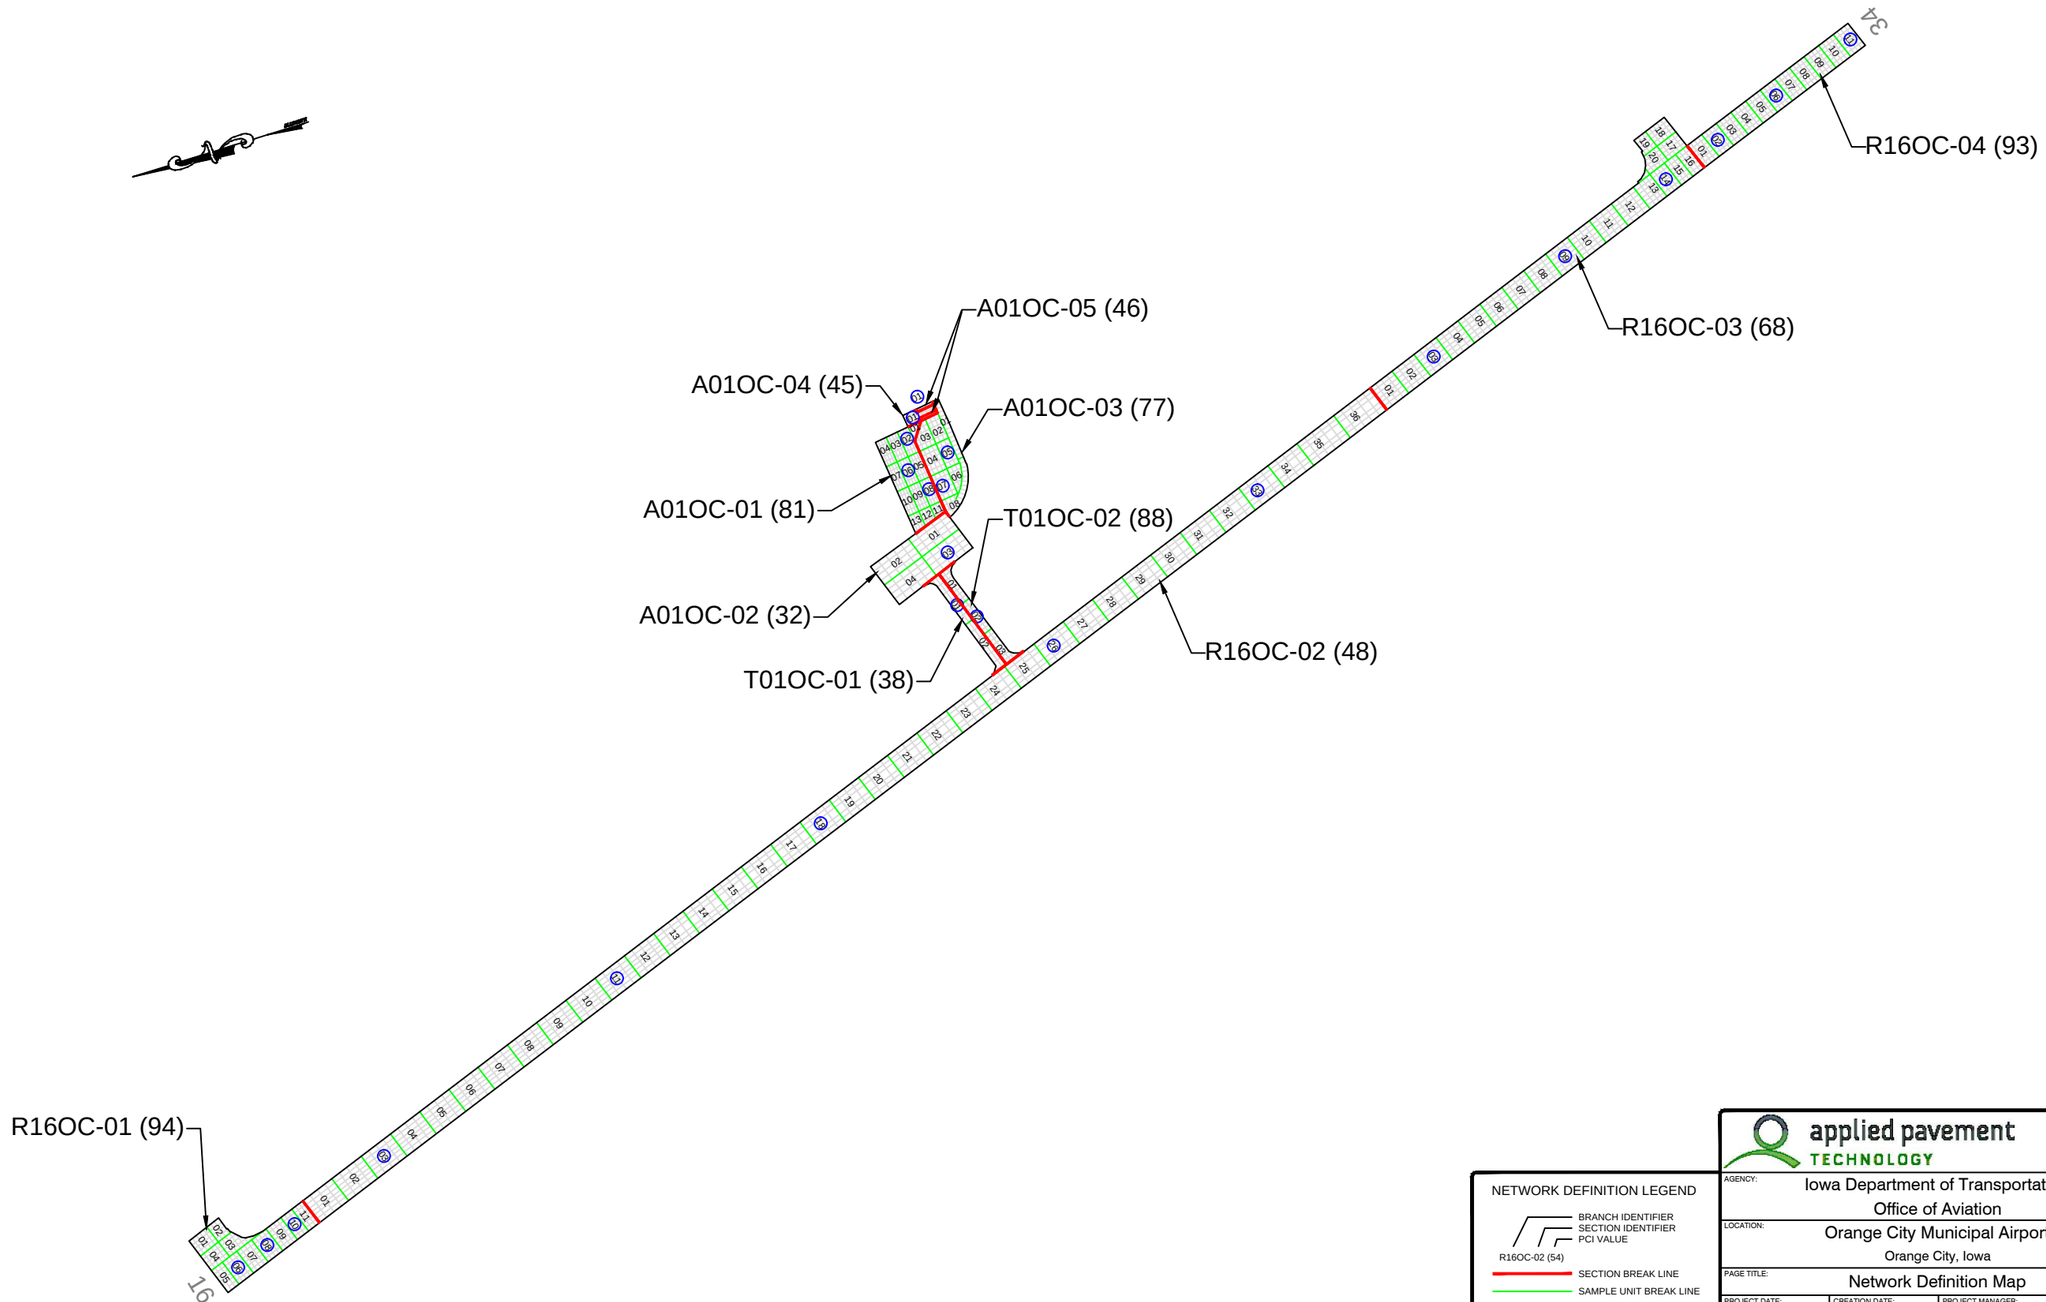
FIGURE 3. NETWORK DEFINITION MAP.

Runway 16-34 contains four sections. Sections 01 and 04, located at either runway end, are both in good condition with low- and medium-severity joint seal damage recorded along with isolated areas of low-severity corner spalling. Additionally, a small amount of low-severity joint spalling was noted in Section 04. The majority of the runway consists of Section 02, which is in poor condition with low-severity joint seal damage observed throughout. In addition, significant quantities of all severities of spalling and durability cracking, low- and medium-severity patching, low-severity linear cracking and corner breaking, and popouts were identified. Section 03, located near the Runway 34 approach, is in satisfactory condition with low-severity joint seal damage recorded throughout. Moderate amounts of low- and medium-severity joint spalling and all severities of corner spalling along with small quantities of low-severity durability cracking were also noted.

Taxiway 01 consists of two sections. Section 01 is in failed condition with extensive amounts of low-severity joint seal damage, low- and medium-severity spalling and durability cracking, and popouts observed. Small quantities of low-severity patching were also identified. Section 02 is in good condition with medium-severity joint seal damage and isolated areas of medium-severity joint spalling recorded.

Five sections are defined in the terminal apron area. Section 01, located adjacent to the terminal building, is in good condition with low- and medium-severity joint seal damage identified. Moderate amounts of all severities of joint spalling and low- and medium-severity corner spalling along with isolated areas of high-severity patching were also noted. Section 02, located adjacent to the taxiway, is in failed condition with extensive amounts of medium-severity joint seal damage and low-severity patching recorded. Additionally, moderate quantities of low- and medium-severity spalling, durability cracking, and linear cracking were noted. Section 03 is located south of the terminal building and is in satisfactory condition. Medium-severity joint seal damage was identified throughout. In addition, small quantities of low- and medium-severity linear cracking, low-severity corner breaking, and low-severity corner spalling were observed. Sections 04 and 05, located to the east of the terminal building, are both in poor condition with a moderate number of shattered slabs, linear cracking, and corner breaking recorded. Additionally, medium-severity joint seal damage in Section 05 and isolated areas of high-severity patching in Section 04 were noted.

Year	Branch[1]	Section	Type of Repair[2]	Estimated Cost[3]
2010	A01OC	02	Major Rehabilitation	$315,456
		04	Major Rehabilitation	$16,282
		05	Major Rehabilitation	$11,700
	R16OC	02	Major Rehabilitation	$1,676,699
	T01OC	01	Major Rehabilitation	$79,673
2012	R16OC	03	Major Rehabilitation	$475,376
			Total:	**$2,575,186**

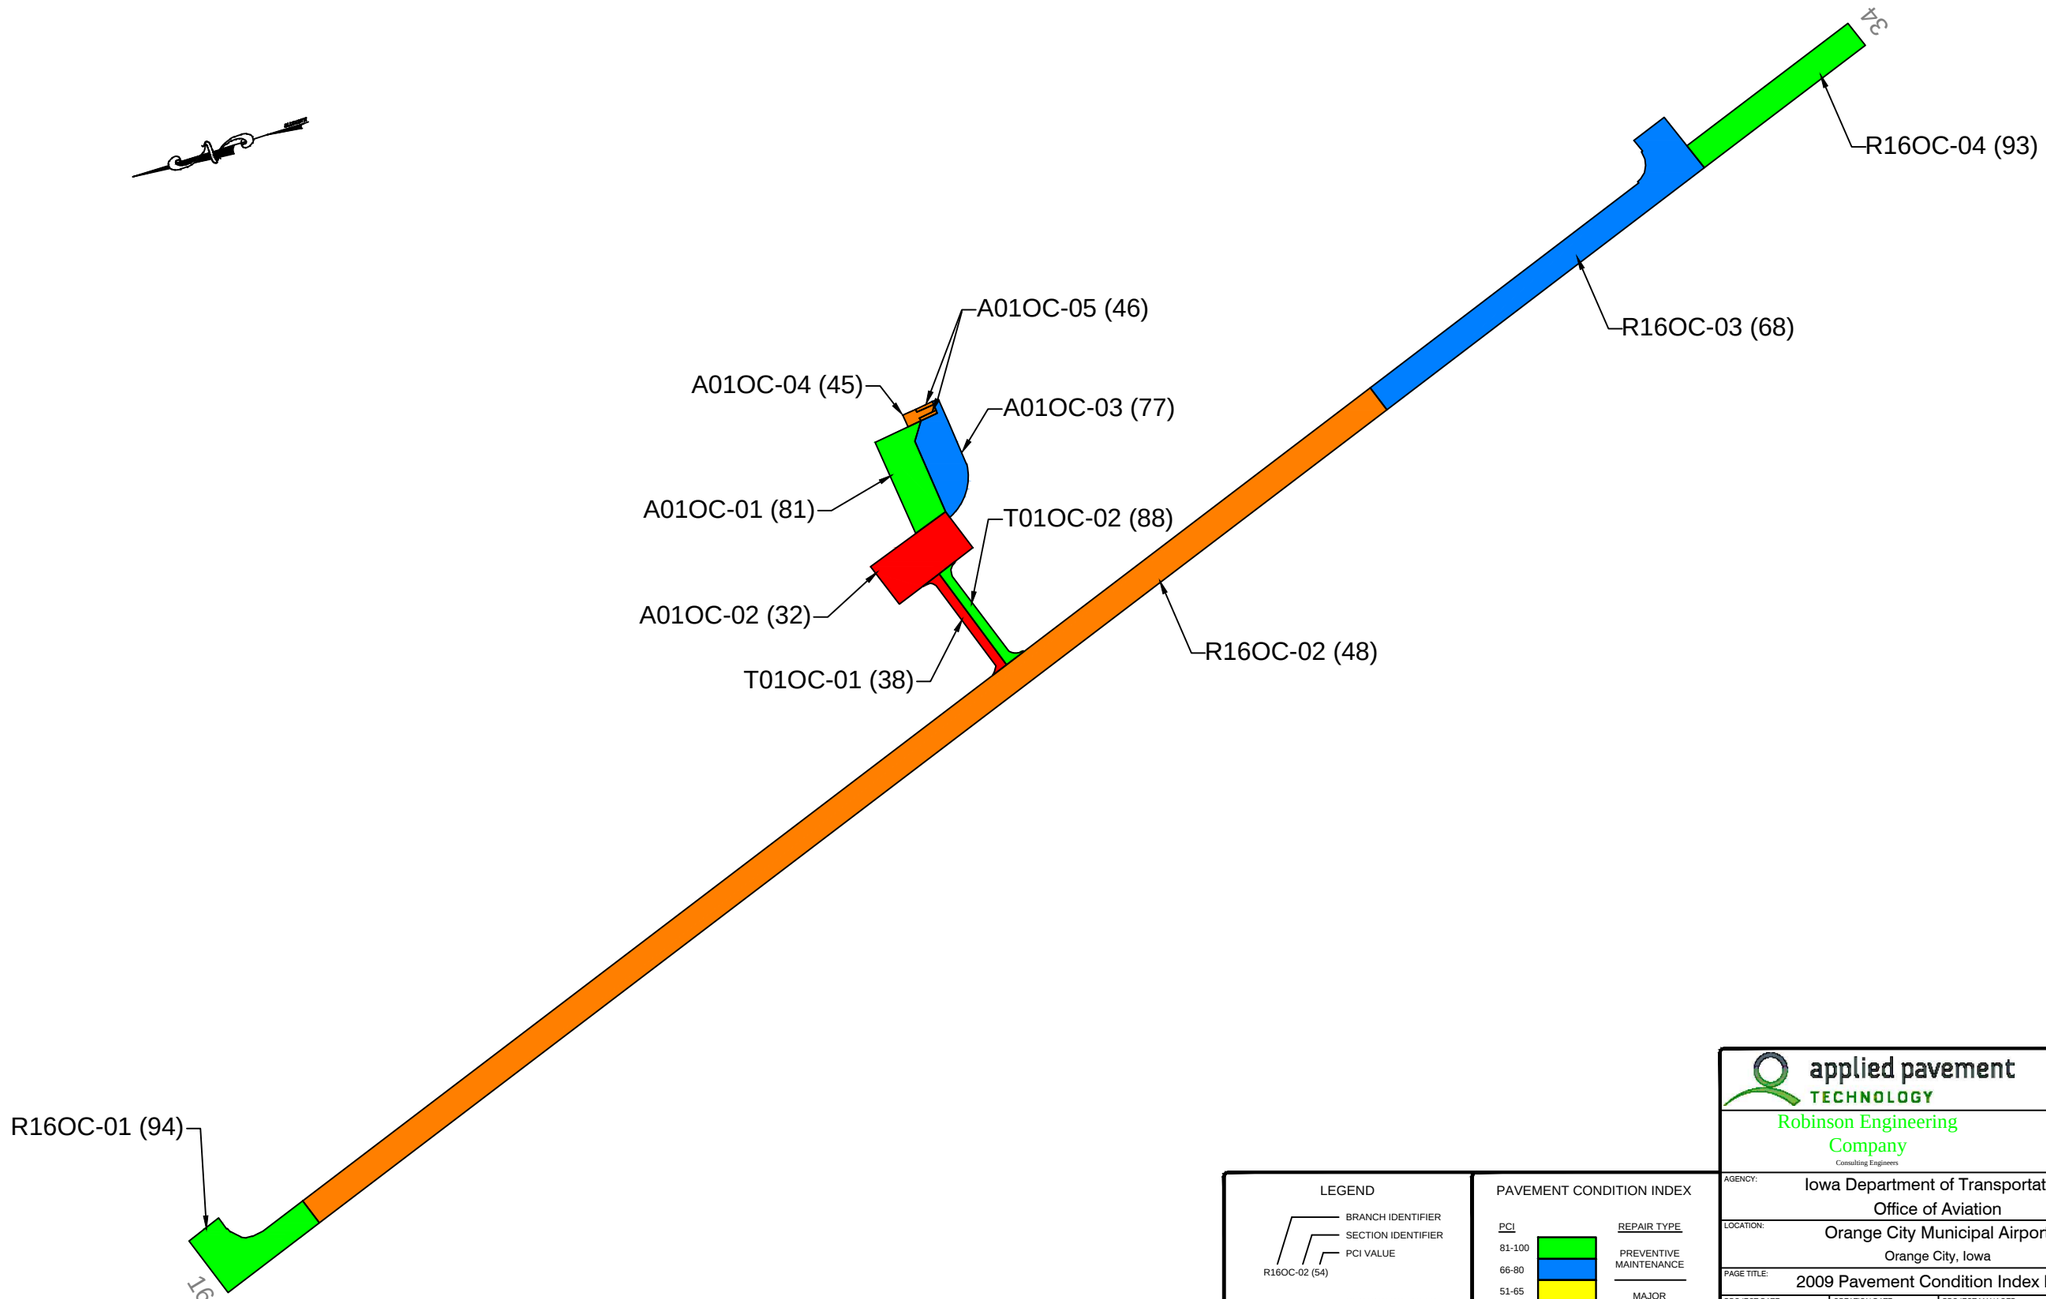
FIGURE 8. PCI MAP.

The pavements at Orange City Municipal Airport were inspected on September 16, 2009. The 2009 area-weighted condition of Orange City Municipal Airport is 60, with conditions ranging from 32 to 94 (on a scale of 0 [failed] to 100 [excellent]). During the previous pavement inspection in 2005, the area-weighted PCI of the airport was 66.
