OTTUMWA REGIONAL AIRPORT
PAVEMENT MANAGEMENT REPORT

Prepared For:
Iowa Department of Transportation
Office of Aviation

Prepared By:
Applied Pavement Technology, Inc.

January 2010

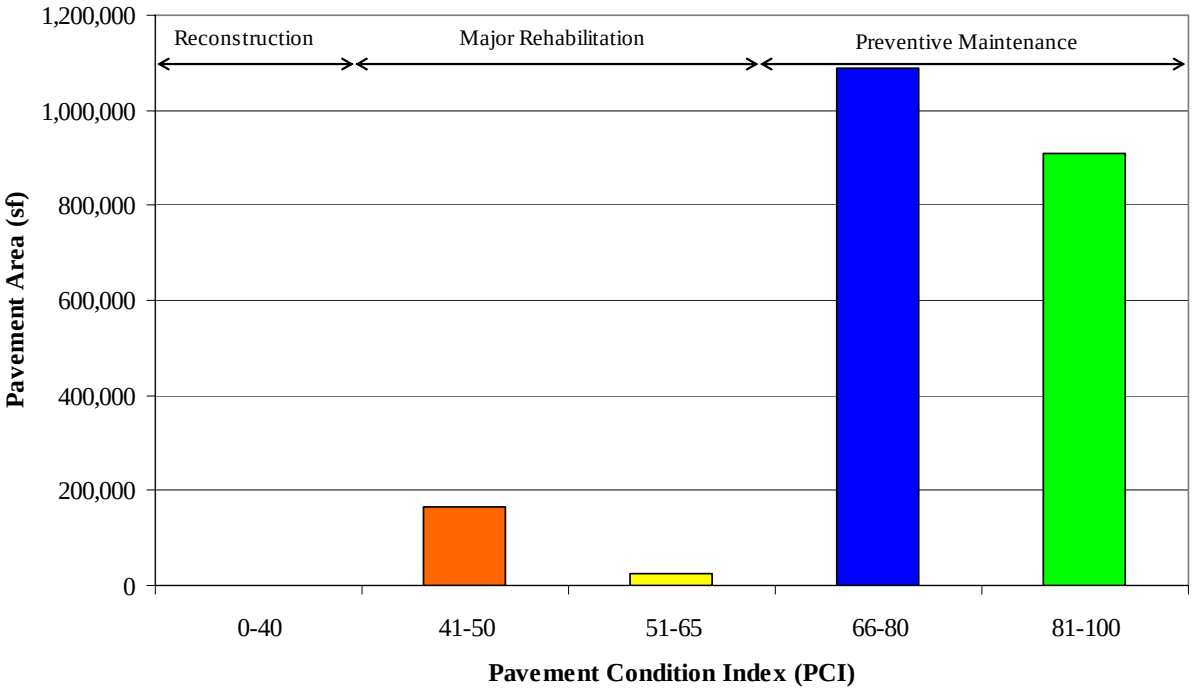
Figure 6. Overall condition.

The pavements at Ottumwa Regional Airport were inspected on September 21-22, 2009. The 2009 area-weighted condition of Ottumwa Regional Airport is 79, with conditions ranging from 46 to 100 (on a scale of 0 [failed] to 100 [excellent]). During the previous pavement inspection in 2005, the area-weighted PCI of the airport was 67.

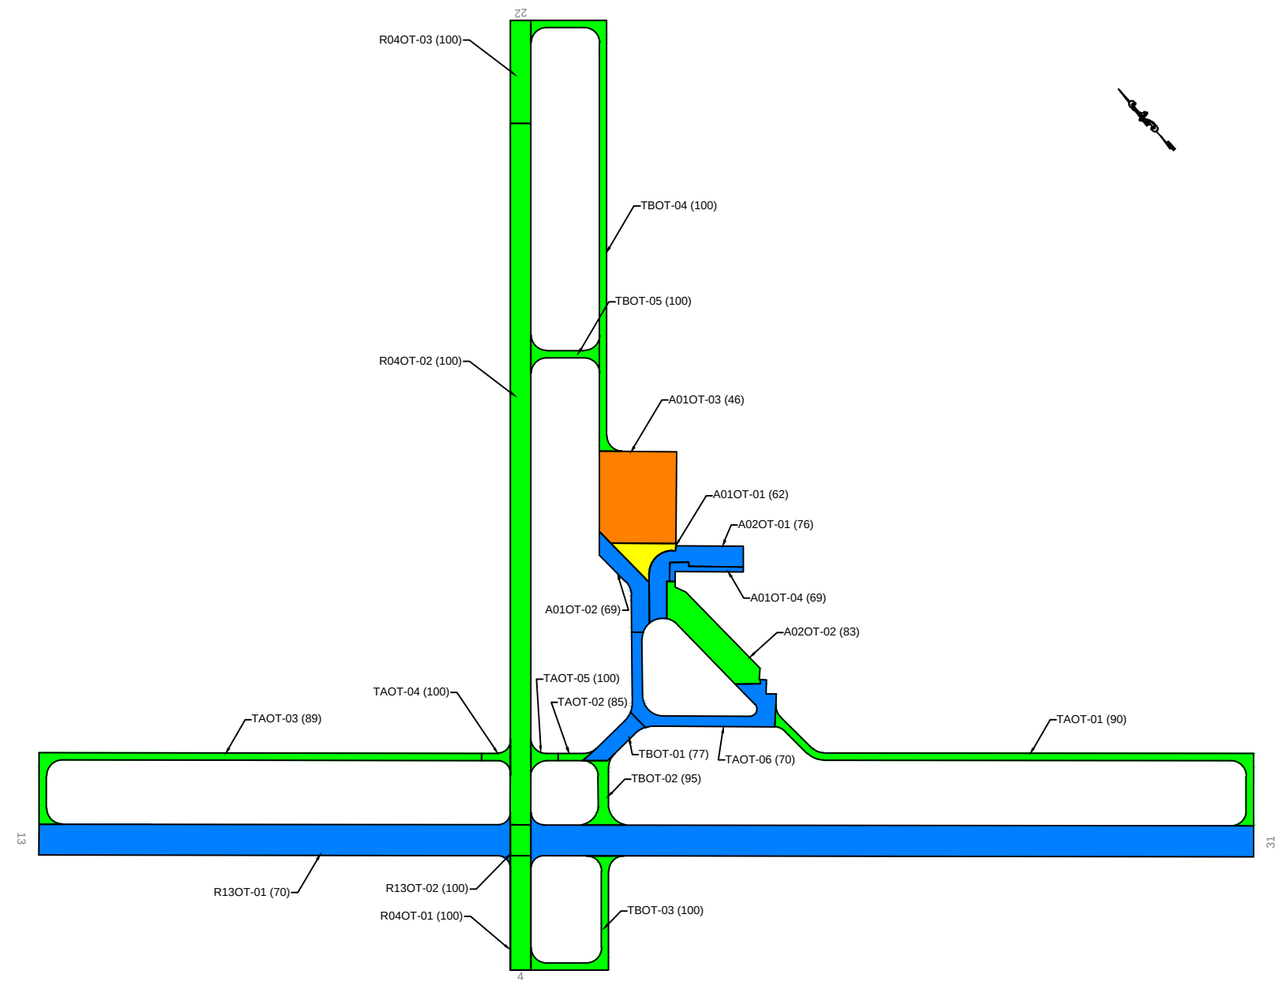
FIGURE 8. PCI MAP.

Runway 13-31 consists of two sections. Section 01, the majority of the runway, is in satisfactory condition with excessive amounts of low- and medium-severity longitudinal and transverse (L&T) cracking and joint reflective cracking recorded. In addition, small amounts of low-severity depression, swelling, and patching were noted. The majority of the low-severity cracking was sealed and the medium-severity cracking was mainly due to the development of the secondary cracking. Section 02 was recently rehabilitated and is in excellent condition with no distresses observed at the time of inspection.

Apron 01 consists of four sections. Section 01, located in the center of the apron, is in fair condition with excessive amounts of low- and medium-severity L&T cracking observed. In addition, small quantities of low-severity swelling and depression were noted. Section 02 is in satisfactory condition with moderate quantities of low- and medium-severity L&T cracking recorded along with isolated areas of low-severity depression. Section 03, located at eastern edge of the apron, is in poor condition with extensive amounts of medium-severity block

Year	Branch[1]	Section	Type of Repair[2]	Estimated Cost[3]
2010	A01OT	03	Major Rehabilitation	$1,057,966
2013	A01OT	01	Major Rehabilitation	$123,381
	R13OT	01	Major Rehabilitation	$4,363,236
2014	TAOT	06	Major Rehabilitation	$405,182
			Total:	**$5,949,765**
