PELLA MUNICIPAL AIRPORT
PAVEMENT MANAGEMENT REPORT

Prepared By:
Applied Pavement Technology, Inc.

December 2011

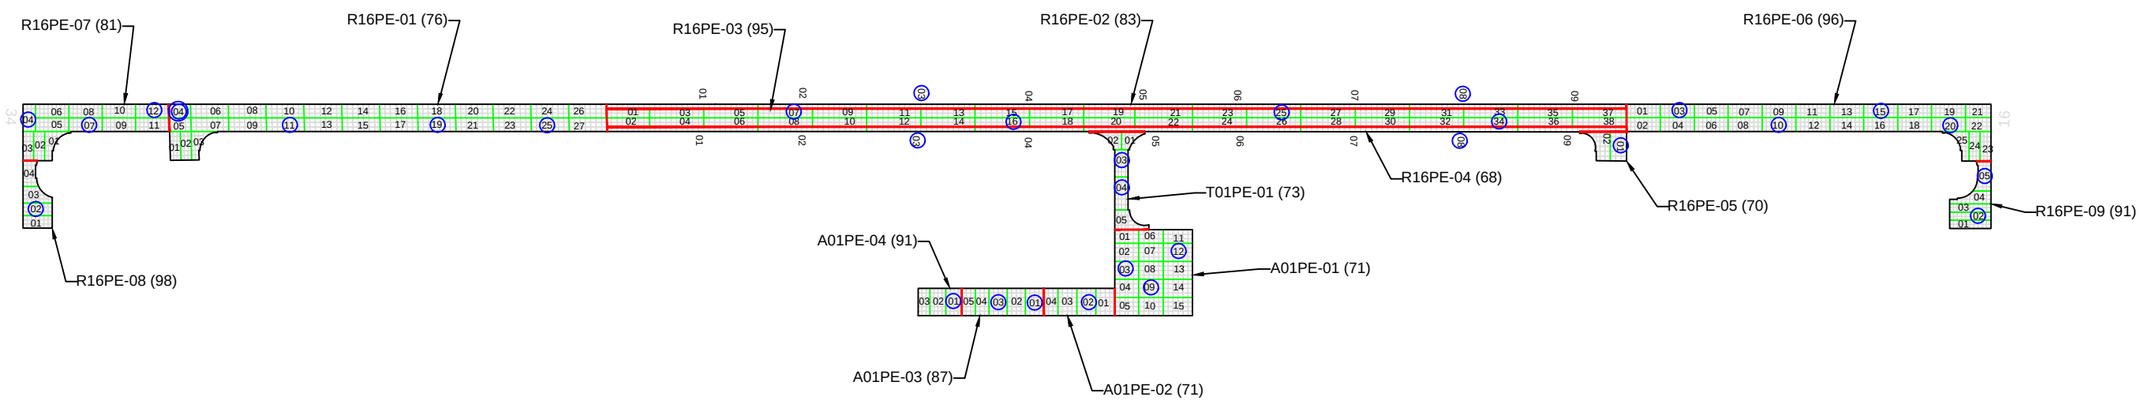
FIGURE 3. NETWORK DEFINITION MAP.

Figure 3 is a network definition map that identifies the pavements at Pella Municipal Airport that were evaluated during this project. This map shows how the pavement network was divided into branches, sections, and sample units for pavement management purposes. It also shows the nomenclature used in the MicroPAVER pavement management database to identify the different pavement areas.

Runway 16-34 is defined by nine sections. Section 01 is located near the southern end of the runway and is in satisfactory condition. Low- and medium-severity joint seal damage were recorded throughout along with moderate quantities of low- and medium-severity durability cracking and isolated amounts of low- and medium-severity faulting. An additional sample was noted where high-severity durability cracking and low-severity corner breaking were identified. This section was scheduled for slab replacements after the pavement inspection was completed. Section 02, the west edge of the runway, is in good condition with medium-severity joint seal damage and moderate amounts of low-severity durability cracking observed. Section 03, the central portion of the runway, is in excellent condition with low-severity joint seal damage and isolated quantities of shrinkage cracking, medium-severity corner spalling, and low-severity large patching recorded. Section 04, the east edge of the runway, is in satisfactory condition with medium-severity joint seal damage identified. Moderate amounts of low- and medium-severity durability cracking and longitudinal, transverse, and diagonal (LTD) cracking were noted along with small quantities of low-severity corner spalling, corner breaking, and large patching. Section 05, a small turnaround, is in satisfactory condition with moderate amounts of low- and medium-severity corner spalling, low-severity durability cracking, high-severity joint spalling, and shrinkage cracking recorded. Section 06, the runway extension at the north end, is in excellent condition. Low-severity joint seal damage was identified throughout along with low- and medium-severity corner spalling and low-severity joint spalling. Section 07, the runway extension at the south end, is in good condition with medium-severity joint seal damage and moderate amounts of low- and medium-severity corner spalling and all severities of joint spalling recorded. In addition, small quantities of low-severity small patching, large patching, and corner breaking were noted. Sections 08 and 09 are turnarounds at either end of the runway and are both in excellent condition. Low-severity joint seal damage was the only distress noted in Section 08 while medium-severity joint seal damage and low-severity joint spalling were identified in Section 09.

Taxiway 01 connects the apron area with the runway and consists of one section. Section 01 is in satisfactory condition with low-severity joint seal damage identified throughout. Moderate amounts of low- and medium-severity durability cracking, low-severity LTD cracking and large patching, and an isolated area of high-severity joint spalling were also observed.

The apron area (Apron 01) is comprised of four sections. Section 01, located in front of the terminal building, is in satisfactory condition with medium-severity joint seal damage recorded. Significant amounts of low- and medium-severity durability cracking, low-severity faulting, and medium- and high-severity joint spalling were also noted. This section was also scheduled for slab replacements after the pavement inspection was completed. Section 02 is also in satisfactory condition with high-severity joint seal damage, low- and medium-severity durability cracking, and low-severity corner breaking and corner spalling observed. Sections 03 and 04 are both in good condition. Low- and medium-severity joint seal damage were recorded throughout

Section 03 along with small quantities of low- and medium-severity corner spalling and low-severity large patching, LTD cracking, and joint spalling. Medium-severity joint seal damage was identified in Section 04 along with isolated amounts of low-severity corner spalling.

Year	Branch[1]	Section[1]	Type of Repair[2]	Estimated Cost[3]
2012	A01PE	02	Major Rehabilitation	$107,011
			Total:	**$107,011**

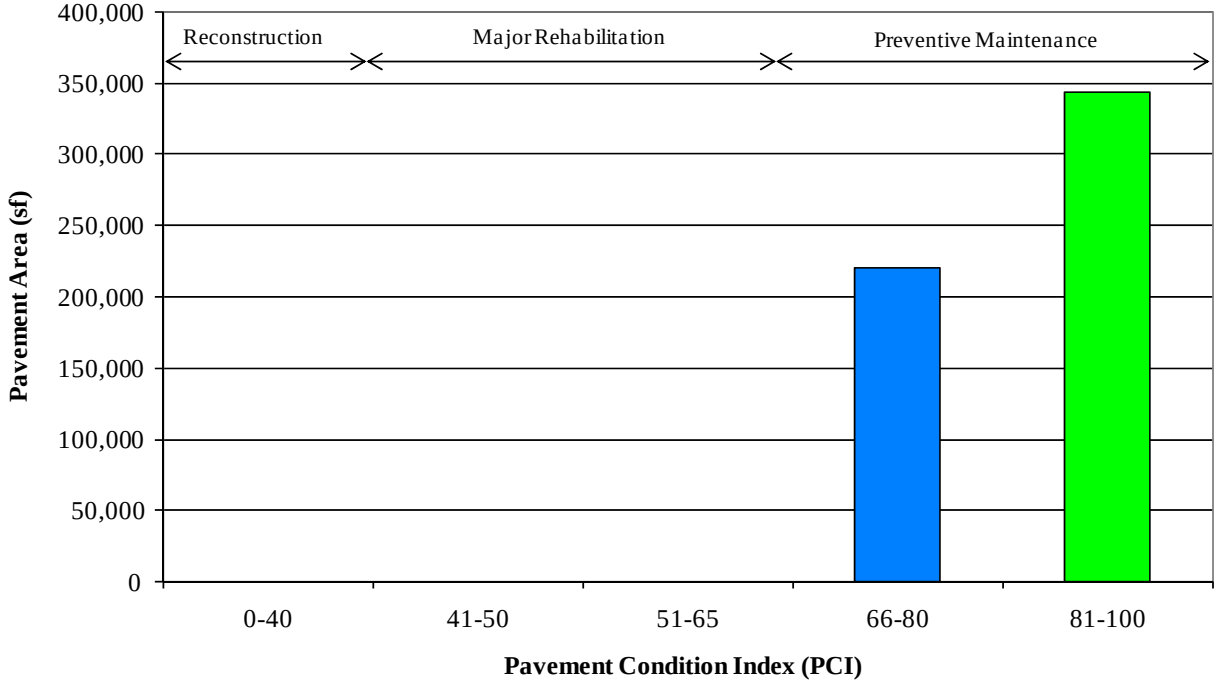
Figure 6. Overall condition.

The pavements at Pella Municipal Airport were inspected on September 10, 2011. The 2011 area-weighted condition of Pella Municipal Airport is 84, with conditions ranging from 68 to 98 (on a scale of 0 [failed] to 100 [excellent]). During the previous pavement inspection in 2008, the area-weighted PCI of the airport was 92.
