POCAHONTAS MUNICIPAL AIRPORT PAVEMENT MANAGEMENT REPORT

Prepared By:
Applied Pavement Technology, Inc.

January 2010

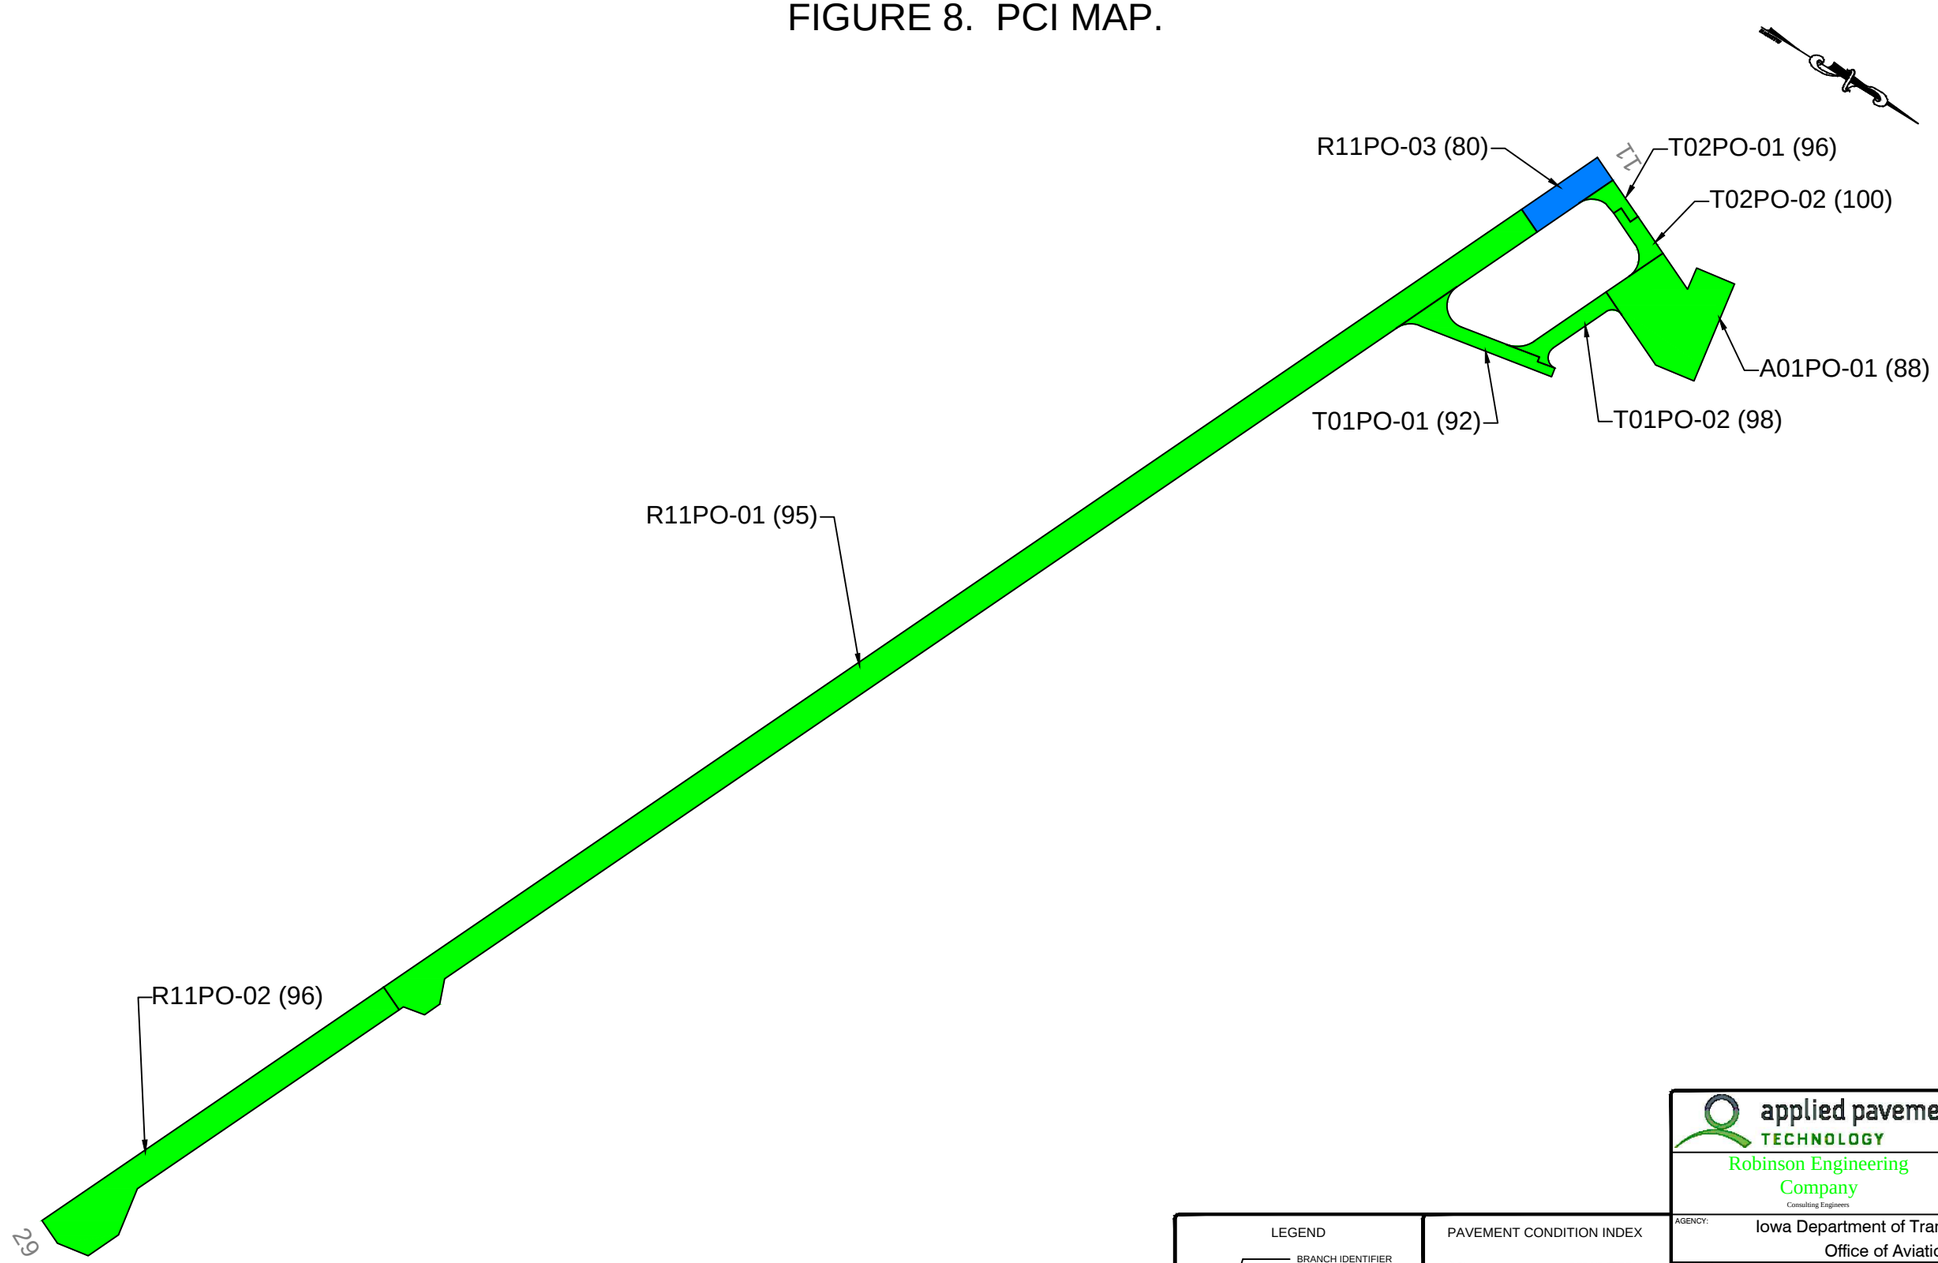
FIGURE 8. PCI MAP.

Runway 11-29 contains three sections that had recently undergone slab replacements. Section 01, which comprises the majority of the runway, is in excellent condition with very small amounts of low-severity linear cracking, patching, and corner spalling recorded. Section 02, located at the Runway 29 approach, is in excellent condition with very small quantities of low-severity linear cracking and patching observed. Section 03, located at the Runway 11 approach, is in satisfactory condition with moderate amounts of low-severity linear cracking and corner breaking identified.

Taxiway 01 consists of two sections. Section 01, located adjacent to the runway, is in good condition with low-severity joint seal damage and small quantities of low-severity linear cracking observed. Section 02, located adjacent to the apron area, is in excellent condition with isolated areas of low-severity joint spalling recorded.

Two sections define Taxiway 02. Section 01, located adjacent to the runway, is in excellent condition with isolated amounts of low-severity corner breaking noted. Section 02, located adjacent to the apron area, is in excellent condition with no distresses observed during the inspection.

The apron area consists of one section in good condition. Low-severity joint seal damage was recorded throughout along with small quantities of low-severity linear cracking, corner breaking, faulting, and corner spalling.
