PERRY MUNICIPAL AIRPORT
PAVEMENT MANAGEMENT REPORT

Prepared By:
Applied Pavement Technology, Inc.

January 2007

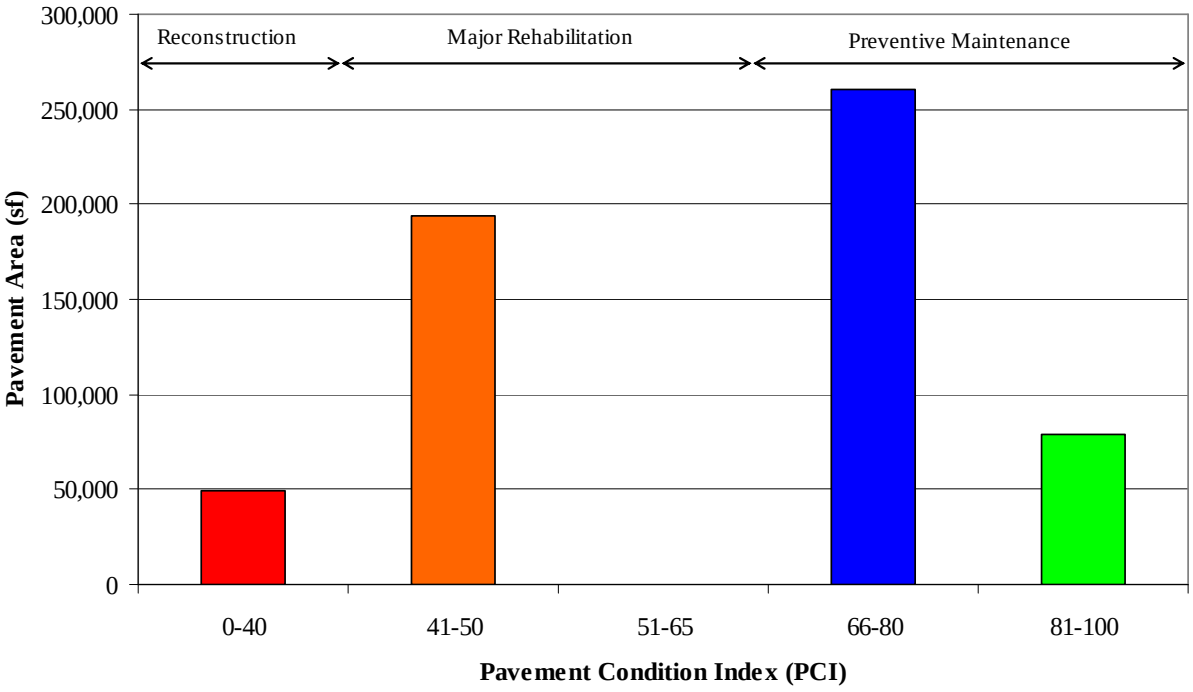
Figure 6. Overall condition.

The pavements at Perry Municipal Airport were inspected on September 16, 2006. The 2006 area-weighted condition of Perry Municipal Airport is 62, with conditions ranging from 14 to 89 (on a scale of 0 [failed] to 100 [excellent]). In 2002 the area-weighted PCI of the airport was 65.

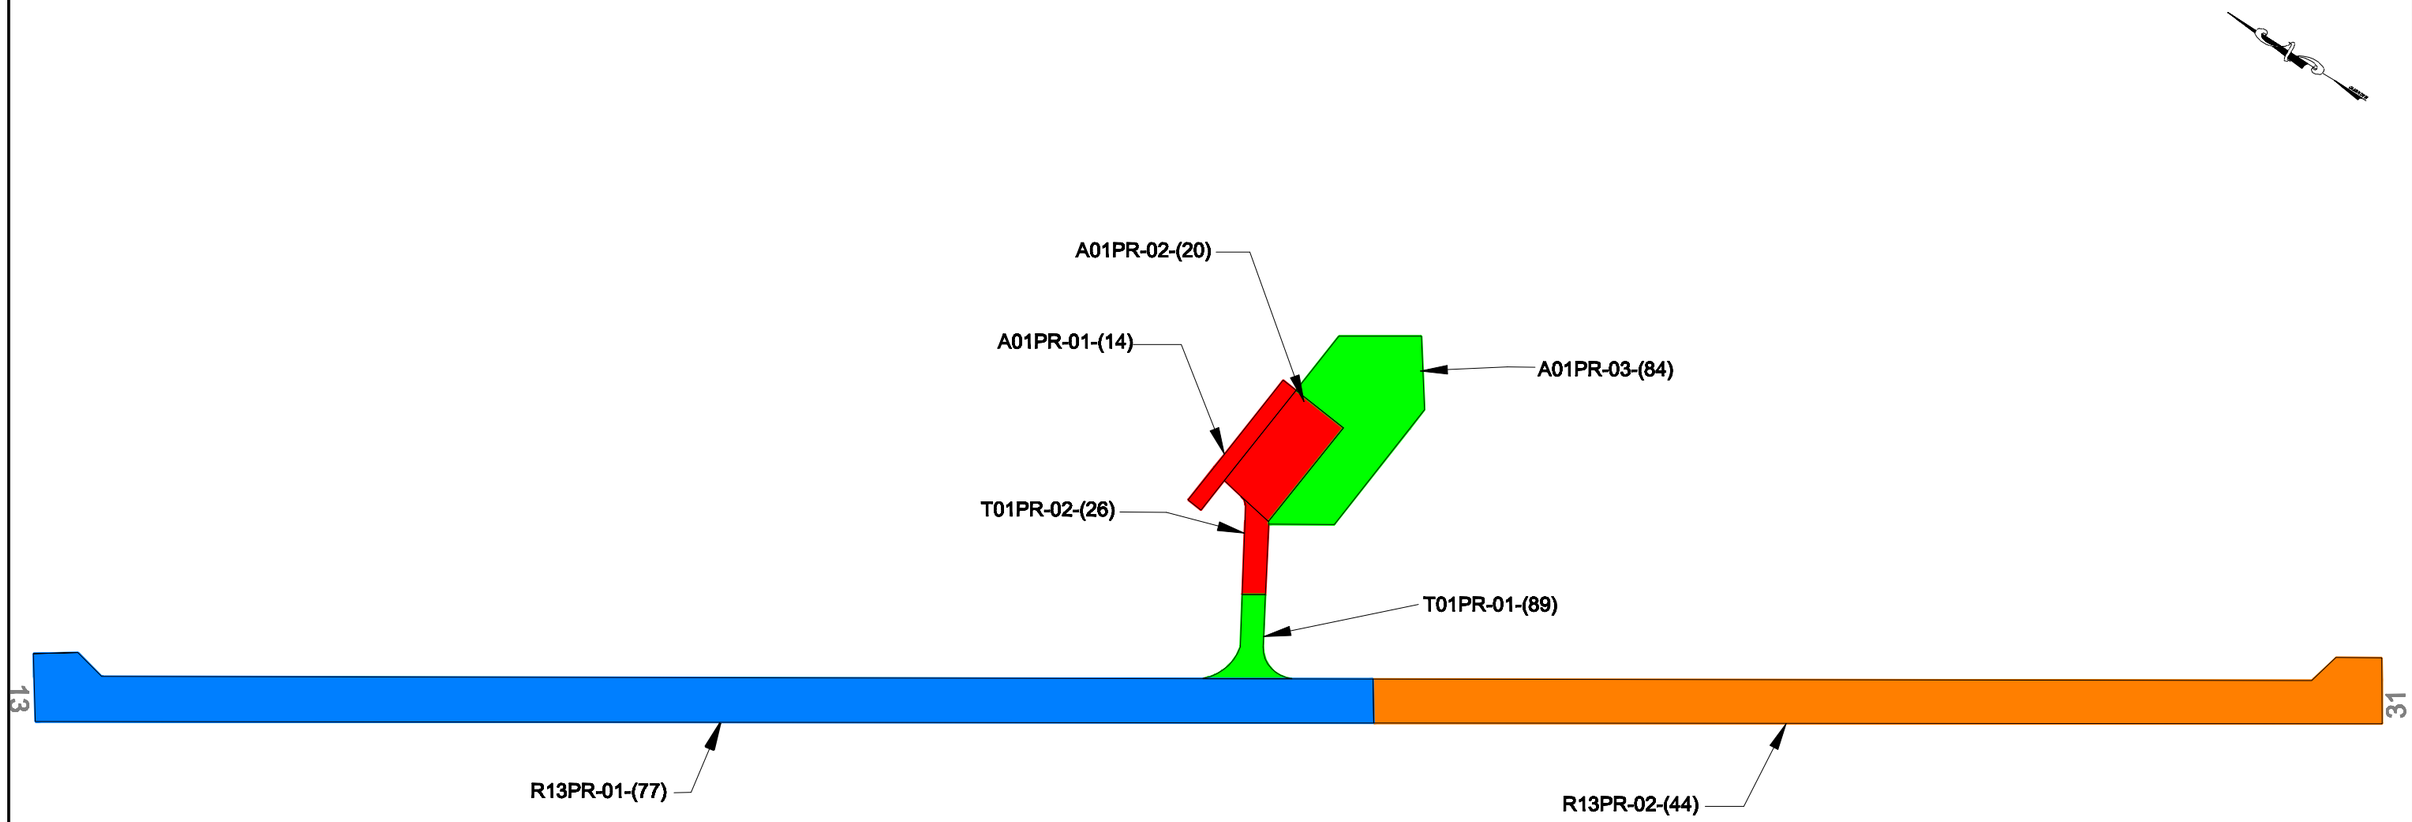
PAGE TITLE: Pavement Condition Index Map

Figures 6 and 7 provide graphs summarizing the overall condition of the pavements at the Perry Municipal Airport. Figure 8 is a map that displays the condition of the pavements evaluated. Table 1 summarizes the results of the pavement evaluation. Appendix C presents photographs taken during the PCI inspection, and Appendix D contains detailed information on the distresses observed during the visual survey. Appendix E includes detailed work history information that
