PERRY MUNICIPAL AIRPORT
PAVEMENT MANAGEMENT REPORT

Prepared By:
Applied Pavement Technology, Inc.

December 2010

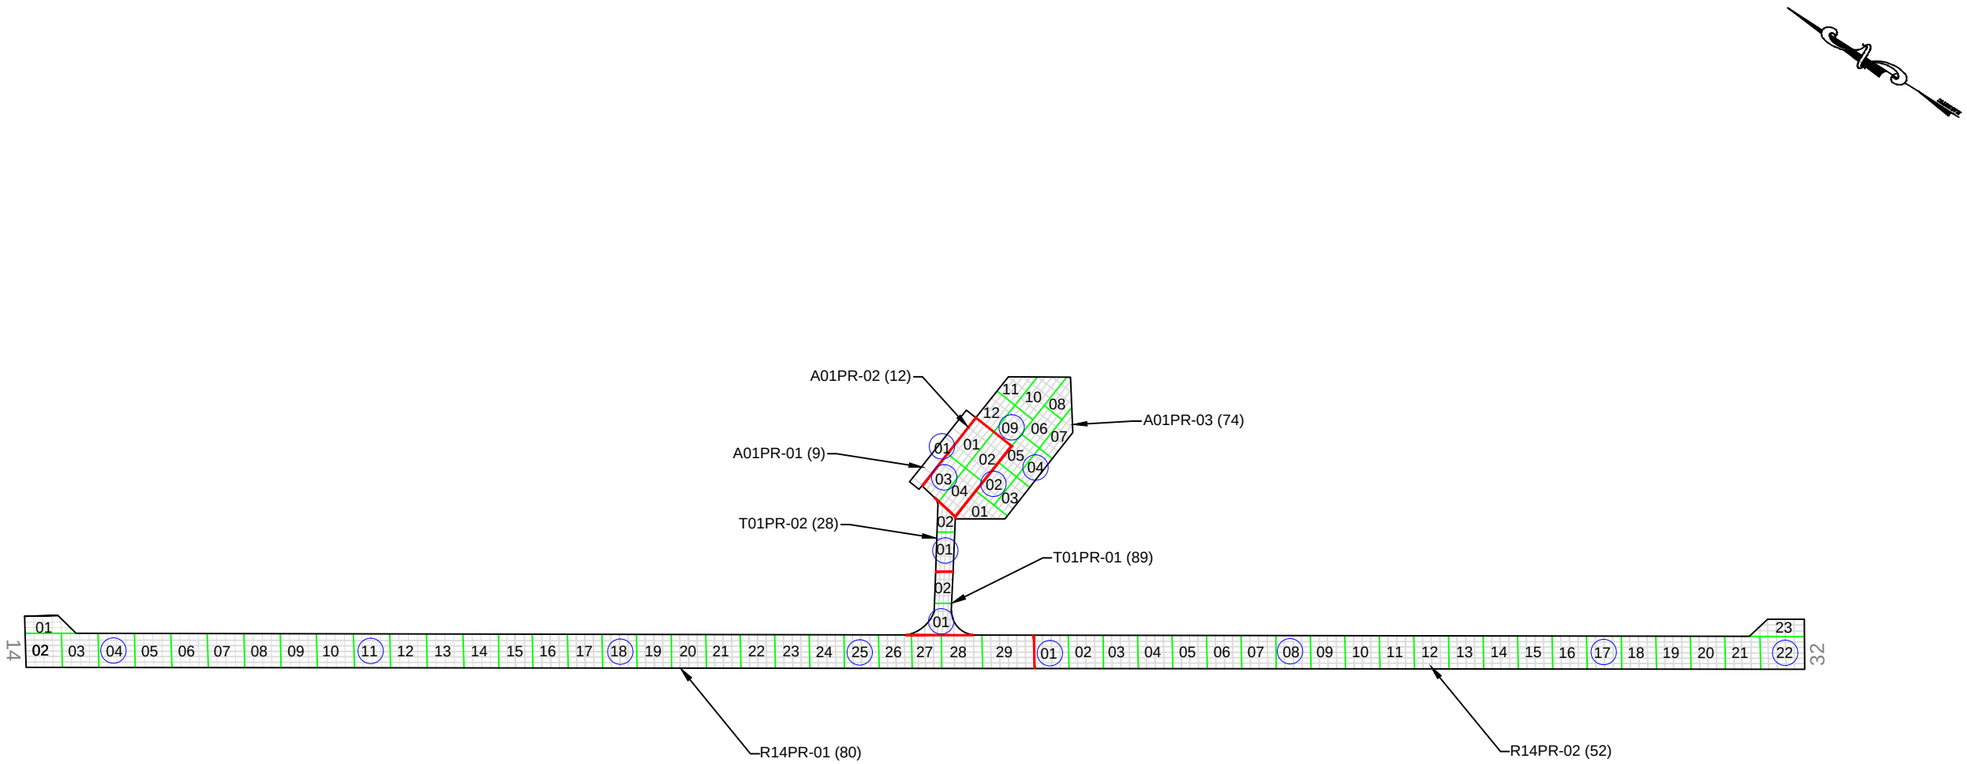
FIGURE 3. NETWORK DEFINITION MAP.

Figure 3 is a network definition map that identifies the pavements at Perry Municipal Airport that were evaluated during this project. This map shows how the pavement network was divided into branches, sections, and sample units for pavement management purposes. It also shows the nomenclature used in the MicroPAVER pavement management database to identify the different pavement areas.

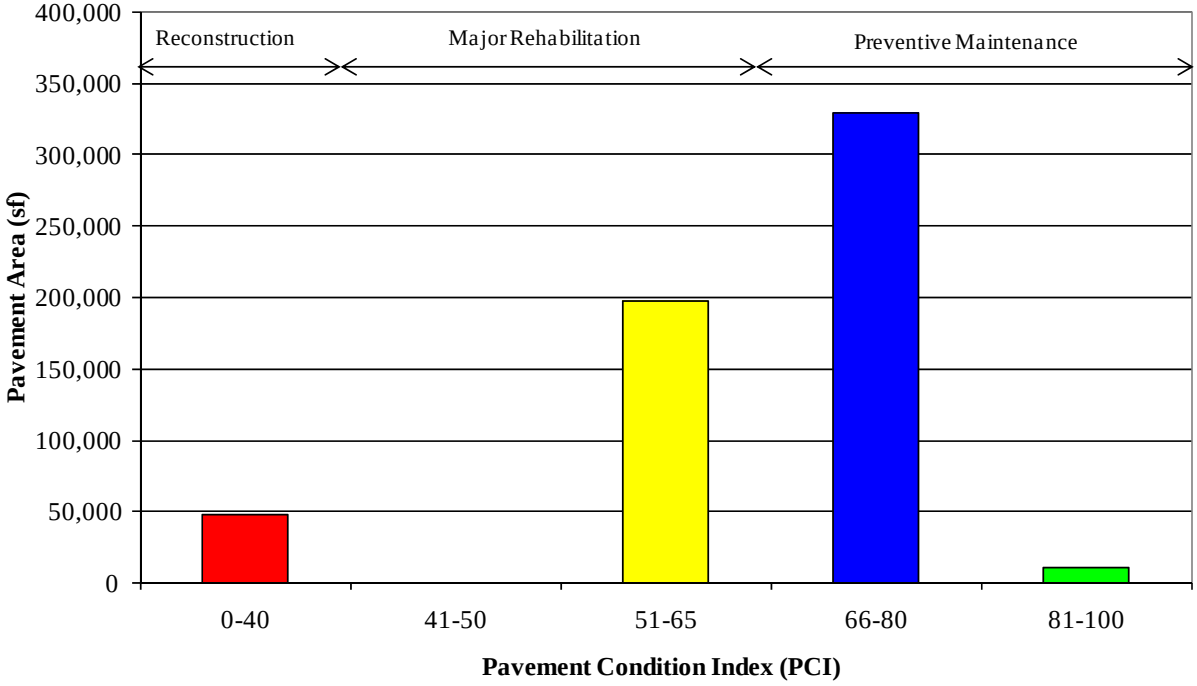
Figure 6. Overall condition.

The pavements at Perry Municipal Airport were inspected on September 17, 2010. The 2010 area-weighted condition of Perry Municipal Airport is 65, with conditions ranging from 9 to 89 (on a scale of 0 [failed] to 100 [excellent]). During the previous pavement inspection in 2006, the area-weighted PCI of the airport was 62.

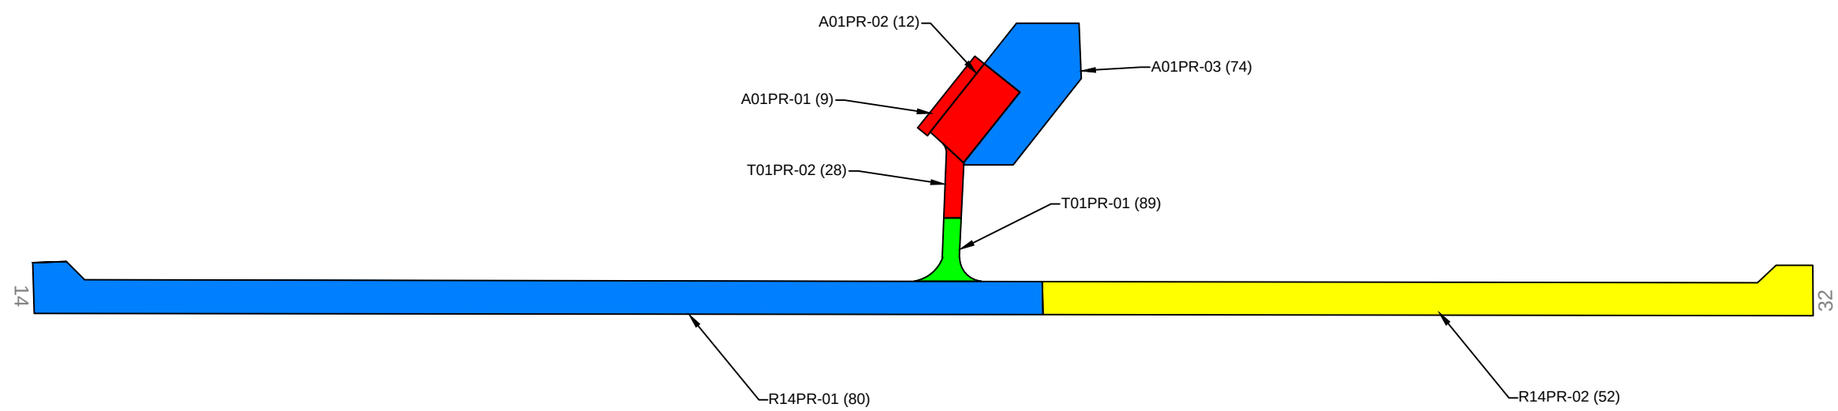
FIGURE 8. PCI MAP.

Runway 14-32 is defined by two sections. Section 01, the majority of the runway, is in satisfactory condition with low- and medium-severity joint seal damage recorded. Moderate amounts of low- and medium-severity faulting and small amounts of low-severity large patching, low-severity joint and corner spalling, and medium-severity linear cracking were also identified. Section 02, the southern portion of the runway, is in fair condition with medium- and high-severity joint seal damage observed. Significant quantities of low-severity large patching; low- and medium-severity small patching and linear cracking; low-severity durability cracking; and popouts were recorded at the time of inspection. In addition, small amounts of low-severity corner spalling and medium-severity joint spalling were noted.

Taxiway 01 connects the runway with the apron area and consists of two sections. Section 01, located adjacent to the runway, is in good condition with medium-severity joint seal damage and isolated quantities of medium-severity joint spalling observed. Section 02, located adjacent to the apron area, is in failed condition with high-severity joint seal damage and extensive quantities of popouts and low- and medium-severity linear cracking observed. In addition, small amounts of low-severity corner spalling, low- and medium-severity faulting, and low- and high-severity durability cracking were identified throughout.

Apron 01 is comprised of three sections. Section 01, the northern portion of the apron area, is in failed condition with high-severity joint seal damage and extensive quantities of low- and medium-severity linear cracking and shattered slabs recorded. Additionally, small amounts of low- and medium-severity corner breaks, medium- and high-severity joint spalling, high-severity corner spalling, low- and high-severity large patching, and low-severity faulting and scaling were identified during inspection. Section 02, located in the middle of the apron area, is also in failed condition with high-severity joint seal damage and extensive quantities of popouts and medium-severity linear cracking recorded. Additionally, small amounts of low-severity shattered slabs, medium-severity corner breaks, and high-severity joint spalling were observed. Section 03, the majority of the apron area, is in satisfactory condition with low-severity joint seal damage and moderate amounts of low- and medium-severity linear cracking and low-severity durability cracking observed. Isolated quantities of medium-severity joint spalling were also noted.

Year	Branch[1]	Section[1]	Type of Repair[2]	Estimated Cost[3]
2011	A01PR	01	Major Rehabilitation	$131,241
		02	Major Rehabilitation	$468,379
	R14PR	02	Major Rehabilitation	$1,443,901
	T01PR	02	Major Rehabilitation	$130,002
			Total:	**$2,173,523**
