RED OAK MUNICIPAL AIRPORT PAVEMENT MANAGEMENT REPORT

Prepared By:
Applied Pavement Technology, Inc.

December 2011

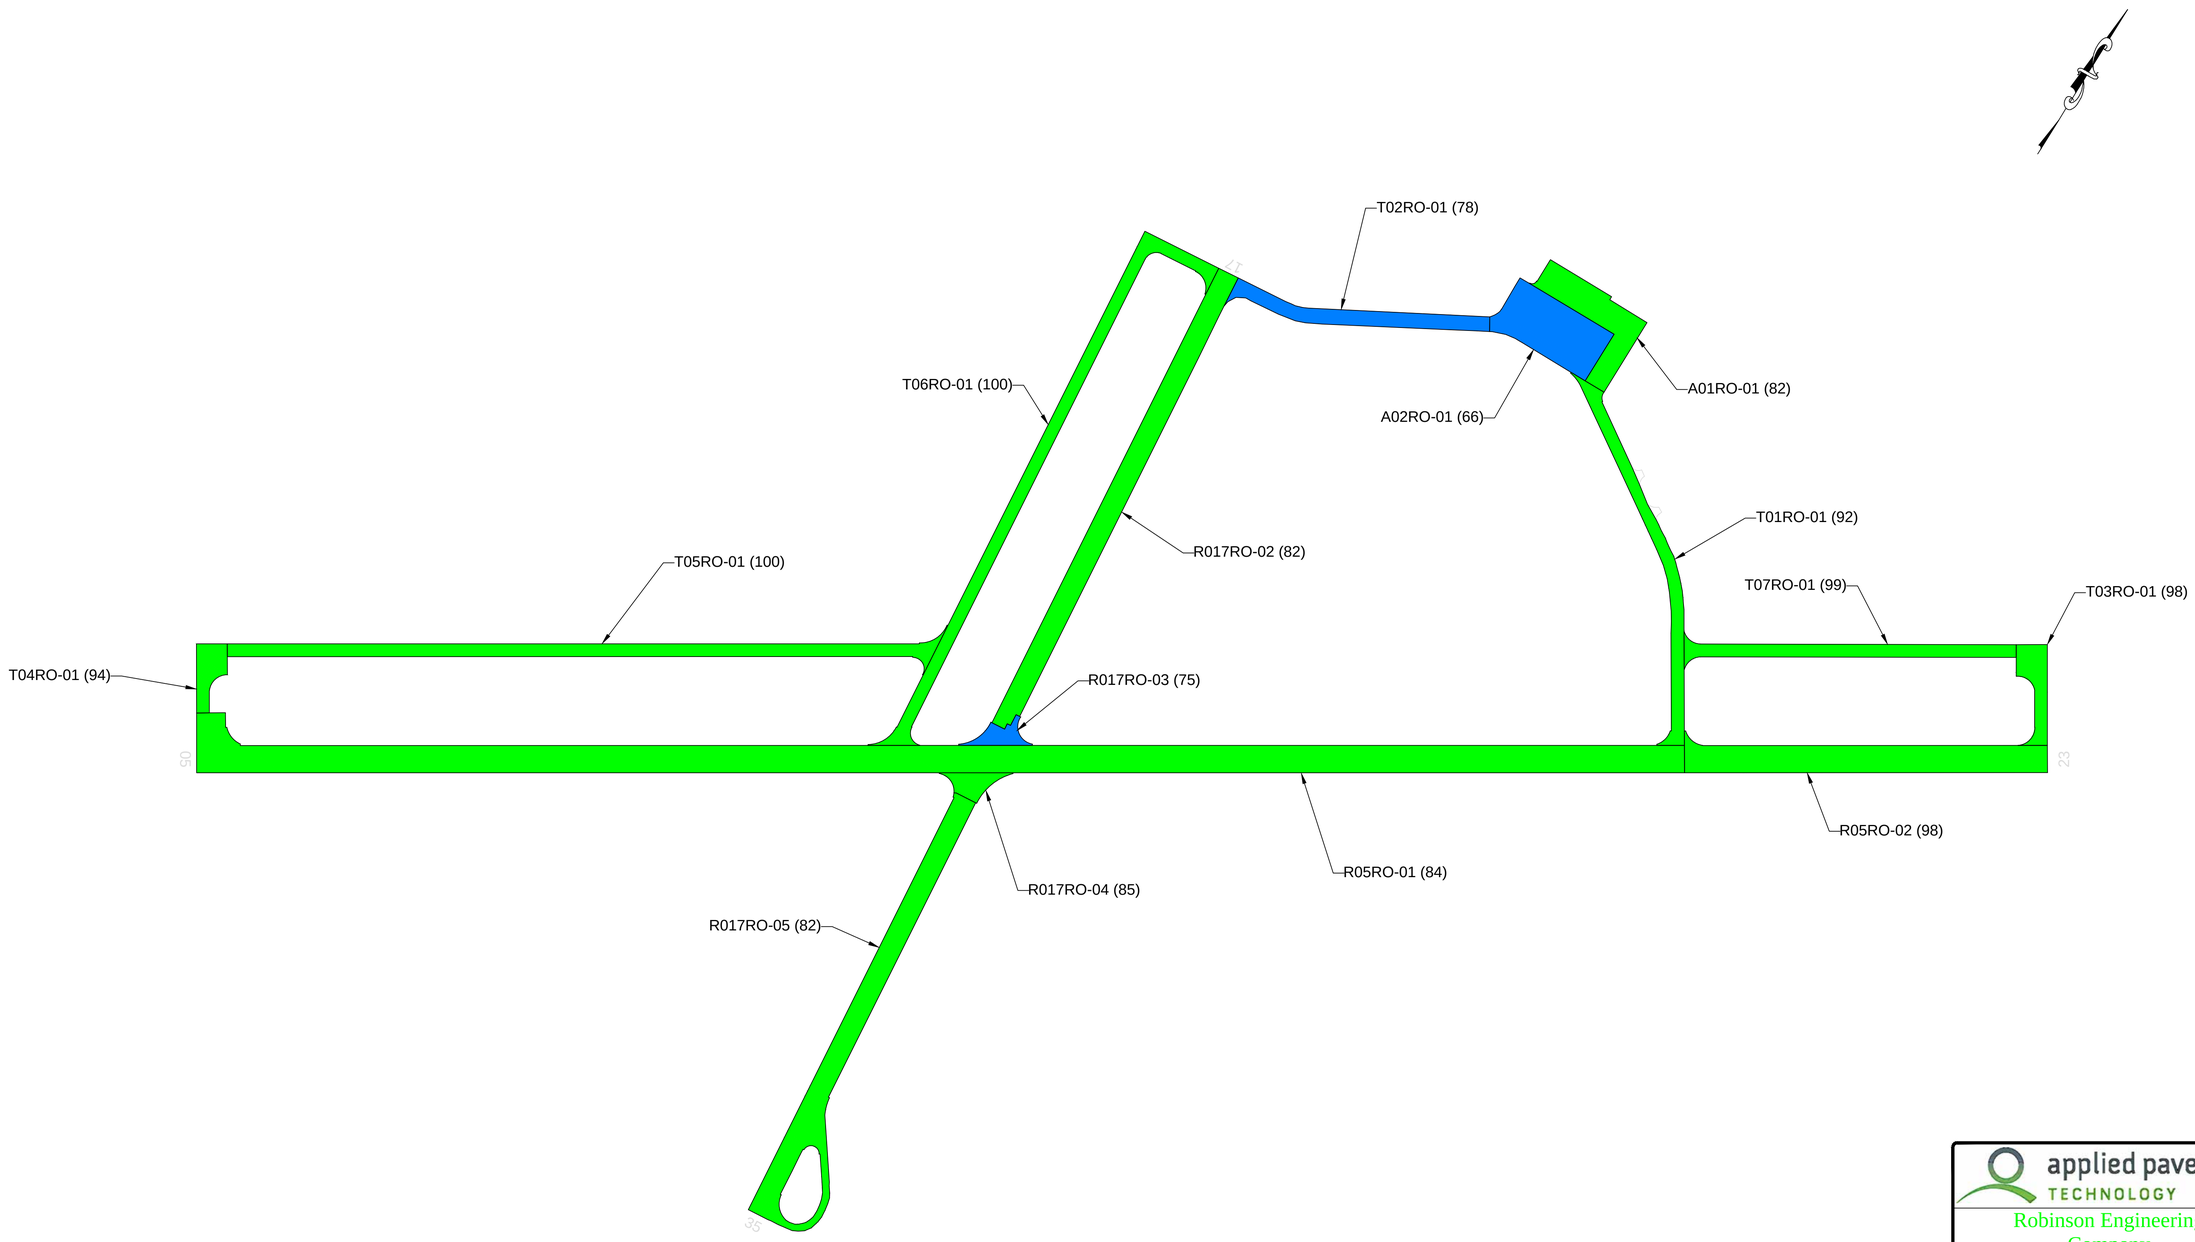
FIGURE 8. PCI MAP.

The pavements at Red Oak Municipal Airport were inspected on September 12, 2011. The 2011 area-weighted condition of Red Oak Municipal Airport is 87, with conditions ranging from 66 to 100 (on a scale of 0 [failed] to 100 [excellent]). During the previous pavement inspection in 2008, the area-weighted PCI of the airport was 87.
