SHELDON MUNICIPAL AIRPORT
PAVEMENT MANAGEMENT REPORT

Prepared By:
Applied Pavement Technology, Inc.

January 2010

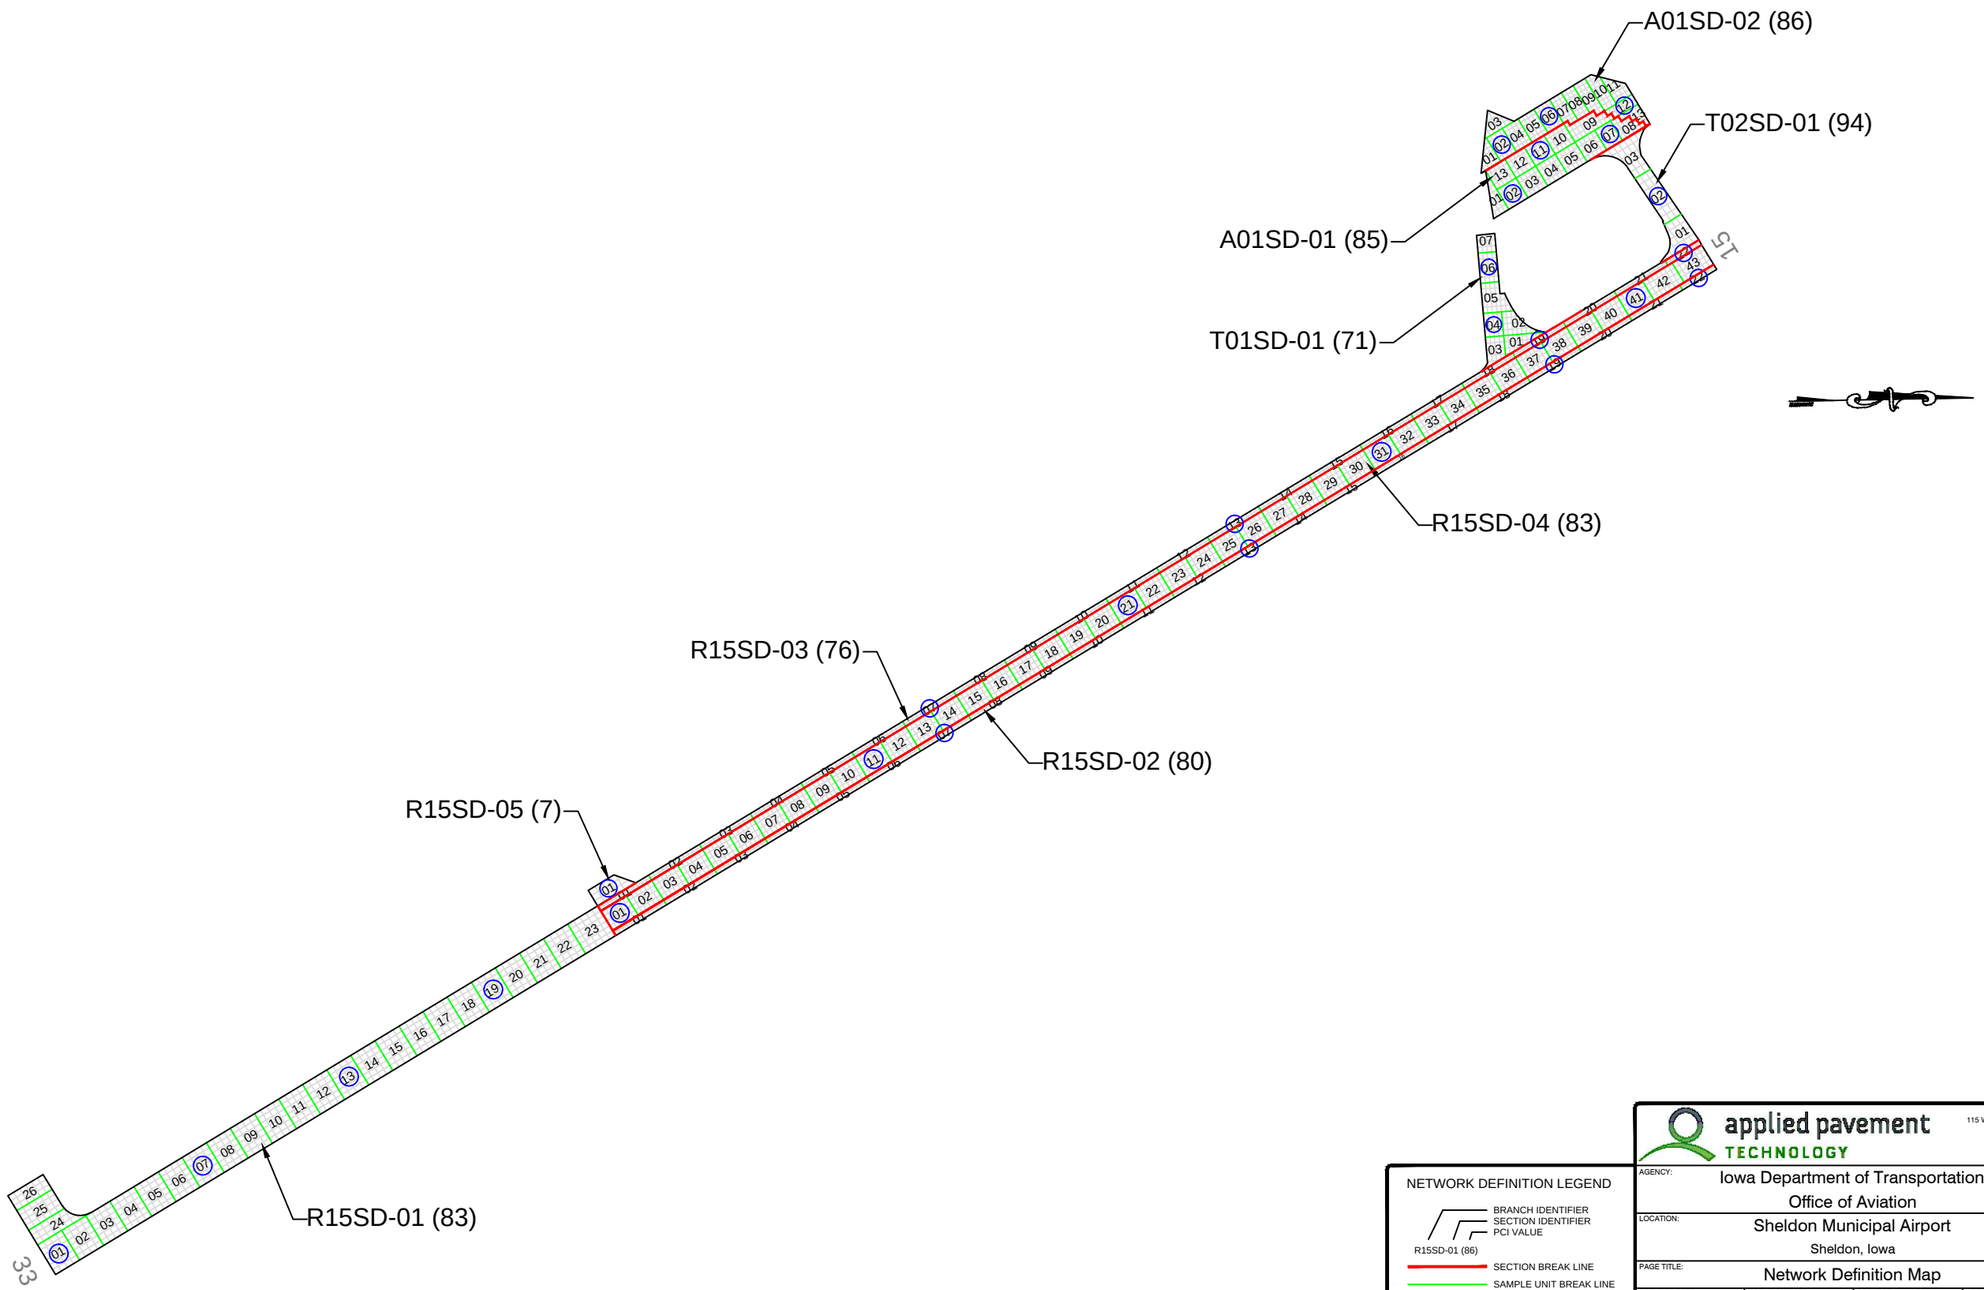
FIGURE 3. NETWORK DEFINITION MAP.

Five sections are defined in Runway 15-33. Section 01, the runway extension located at the Runway 33 approach, is in good condition with low- and medium-severity joint seal damage recorded. Additionally, significant amounts of low-severity linear cracking and all severities of corner spalling were identified. Small quantities of medium- and high-severity joint spalling and isolated areas of low-severity patching were also noted. Sections 02 and 03, located on either edge of the runway, are in satisfactory condition with low- and medium-severity joint seal damage observed. Significant amounts of faulting were identified. In addition, moderate quantities of linear cracking and spalling were noted in both sections, and low-severity shattered slabs and corner breaking in Section 02. Section 04 comprises the majority of the runway's keel section. This section is in good condition with low-severity joint seal damage recorded. Extensive quantities of low- and medium-severity linear cracking and spalling were identified along with small amounts of high-severity patching. Section 05, the turnaround pavement located near the runway extension, is in failed condition with a substantial amount of linear cracking and durability cracking observed. Small amounts of joint spalling and shattered slabs were also recorded.

Taxiway 01 consists of one section located near the Runway 15 approach. Section 01 is in satisfactory condition with low- and medium-severity joint seal damage and significant amounts of low- and medium-severity linear cracking recorded. In addition, isolated areas of low-severity shattered slabs were noted.

Taxiway 02 contains one section located at the Runway 15 approach. Section 01 is in good condition with low-severity joint seal damage and isolated amounts of medium-severity joint spalling observed.

Two sections are defined in the terminal apron area. Section 01, the eastern portion of the terminal apron, is in good condition with low- and medium-severity joint seal damage recorded. Extensive amounts of low-severity linear cracking were also observed. Section 02, the western portion of the terminal apron, is in good condition with significant amounts of low- and medium-severity linear cracking recorded along with isolated areas of low-severity corner breaking.

Year	Branch[1]	Section	Type of Repair[2]	Estimated Cost[3]
2010	R15SD	05	Major Rehabilitation	$50,159
			Total:	**$50,159**

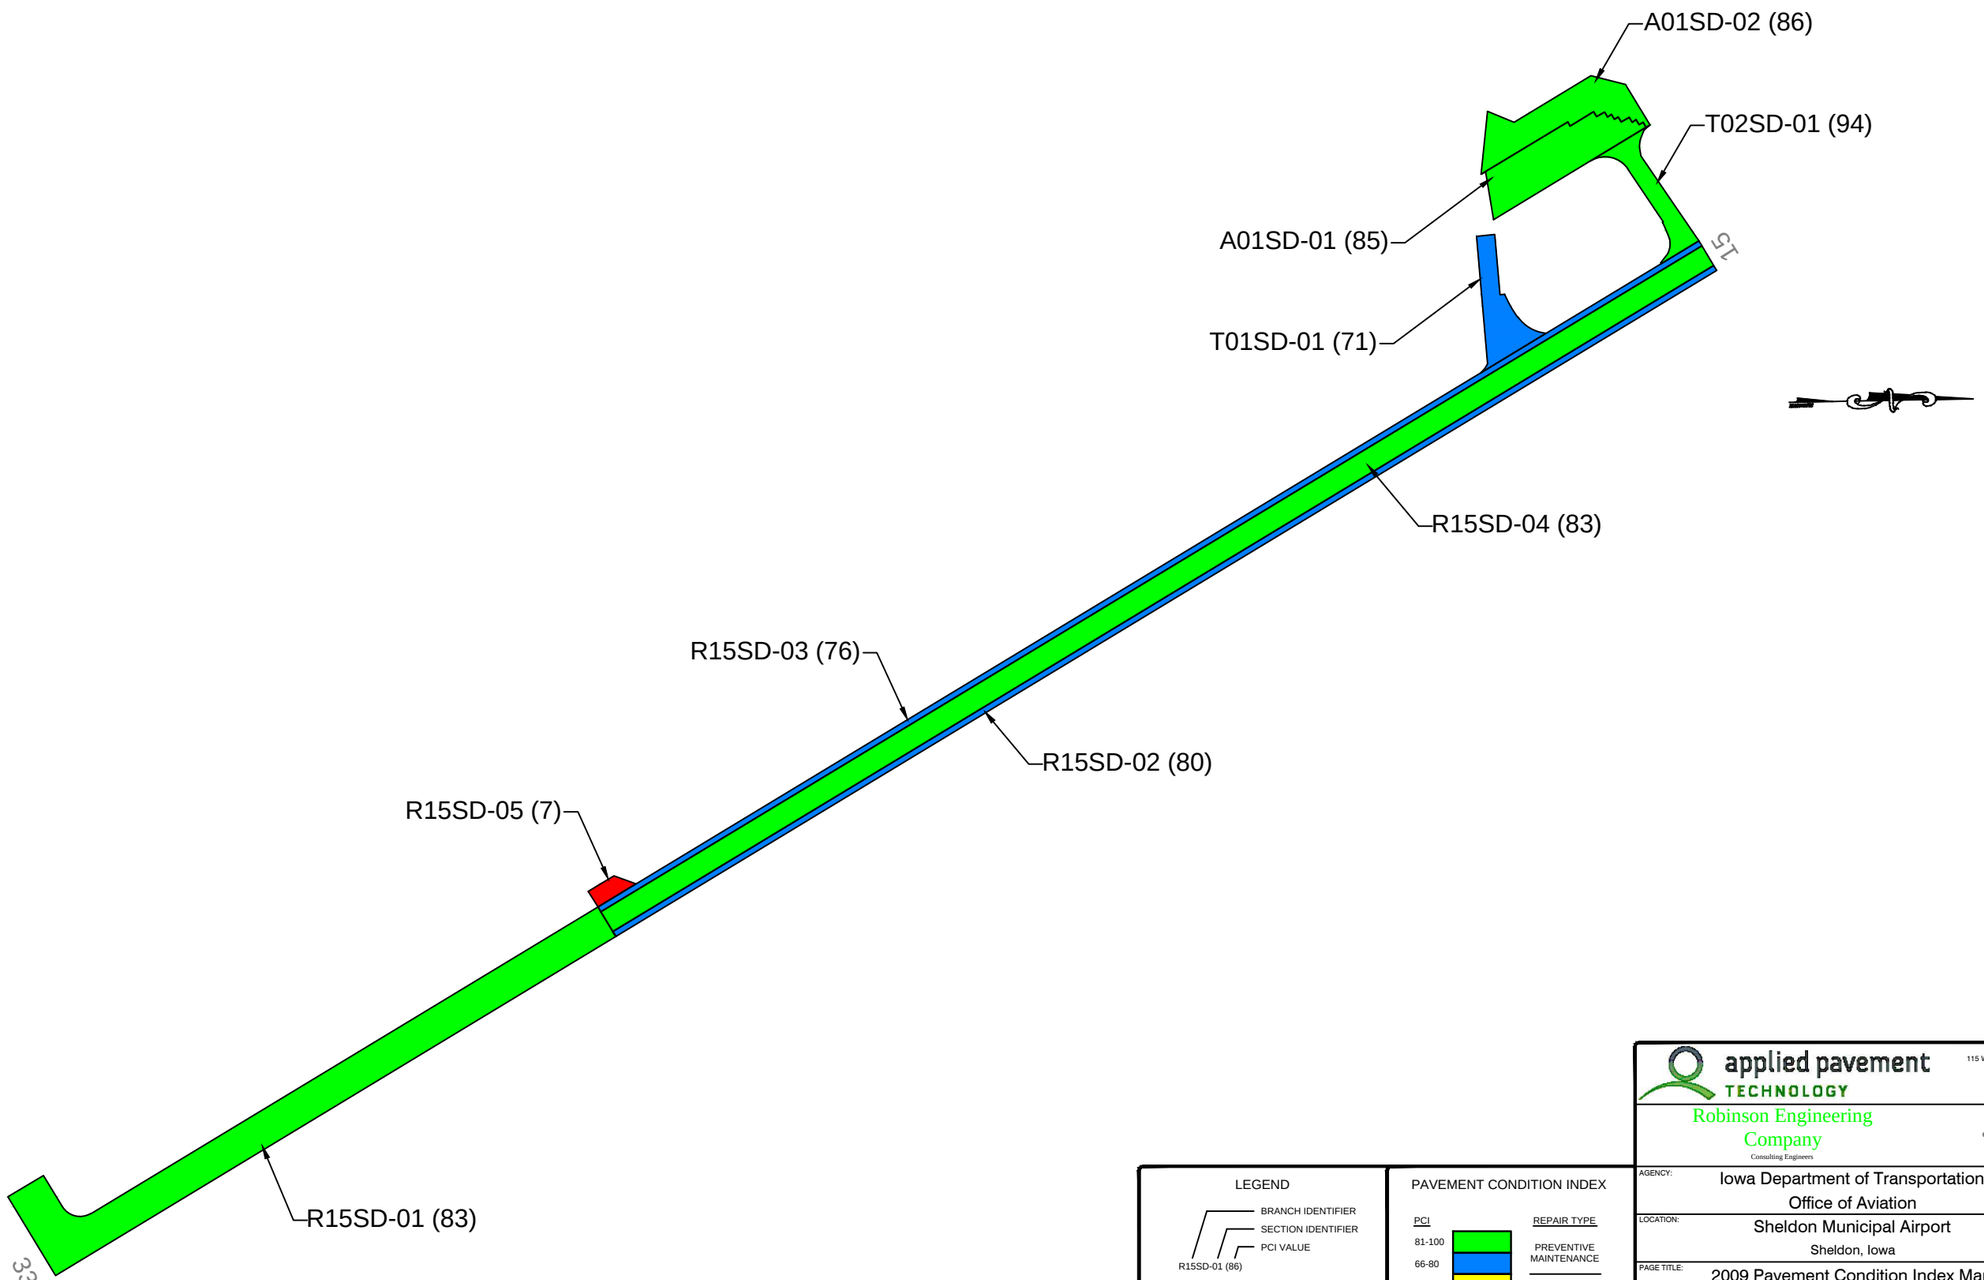
FIGURE 8. PCI MAP.

The pavements at Sheldon Municipal Airport were inspected on September 16, 2009. The 2009 area-weighted condition of Sheldon Municipal Airport is 82, with conditions ranging from 7 to 94 (on a scale of 0 [failed] to 100 [excellent]). During the previous pavement inspection in 2005, the area-weighted PCI of the airport was 89.
