SAC CITY MUNICIPAL AIRPORT
PAVEMENT MANAGEMENT REPORT

Prepared By:
Applied Pavement Technology, Inc.

January 2010

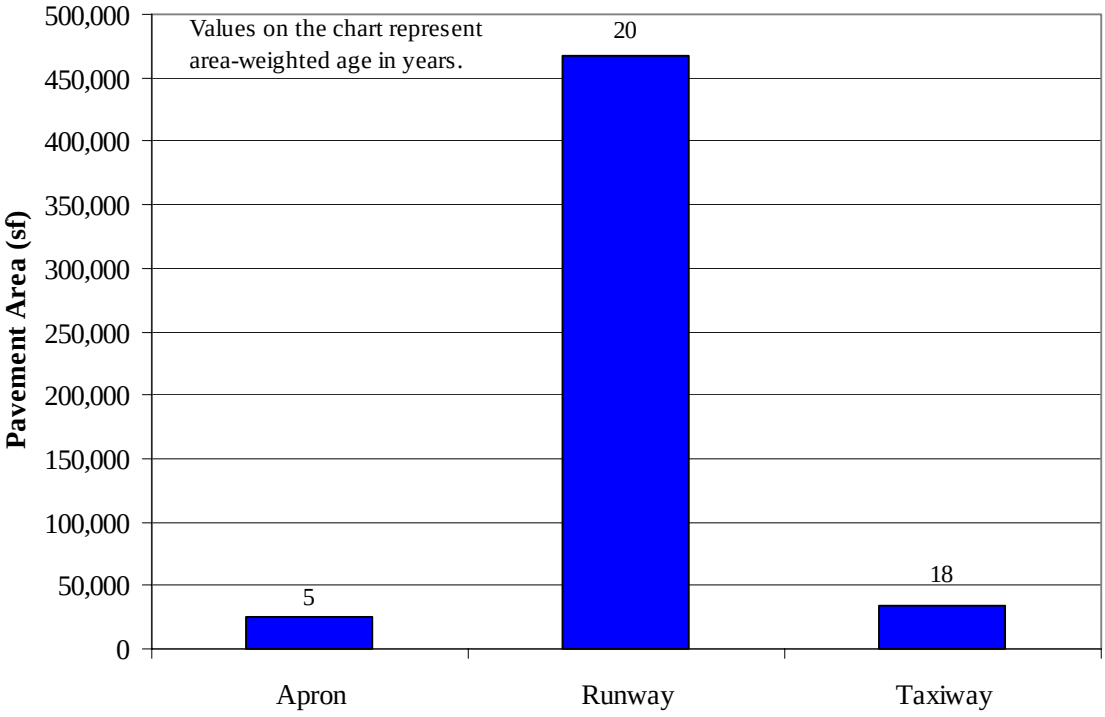
Figure 2. Pavement inventory.

Approximately 526,077 square feet of runway, taxiway, and apron pavements were evaluated at Sac City Municipal Airport, as shown in Figure 2. This figure also shows the area-weighted age of the pavements.

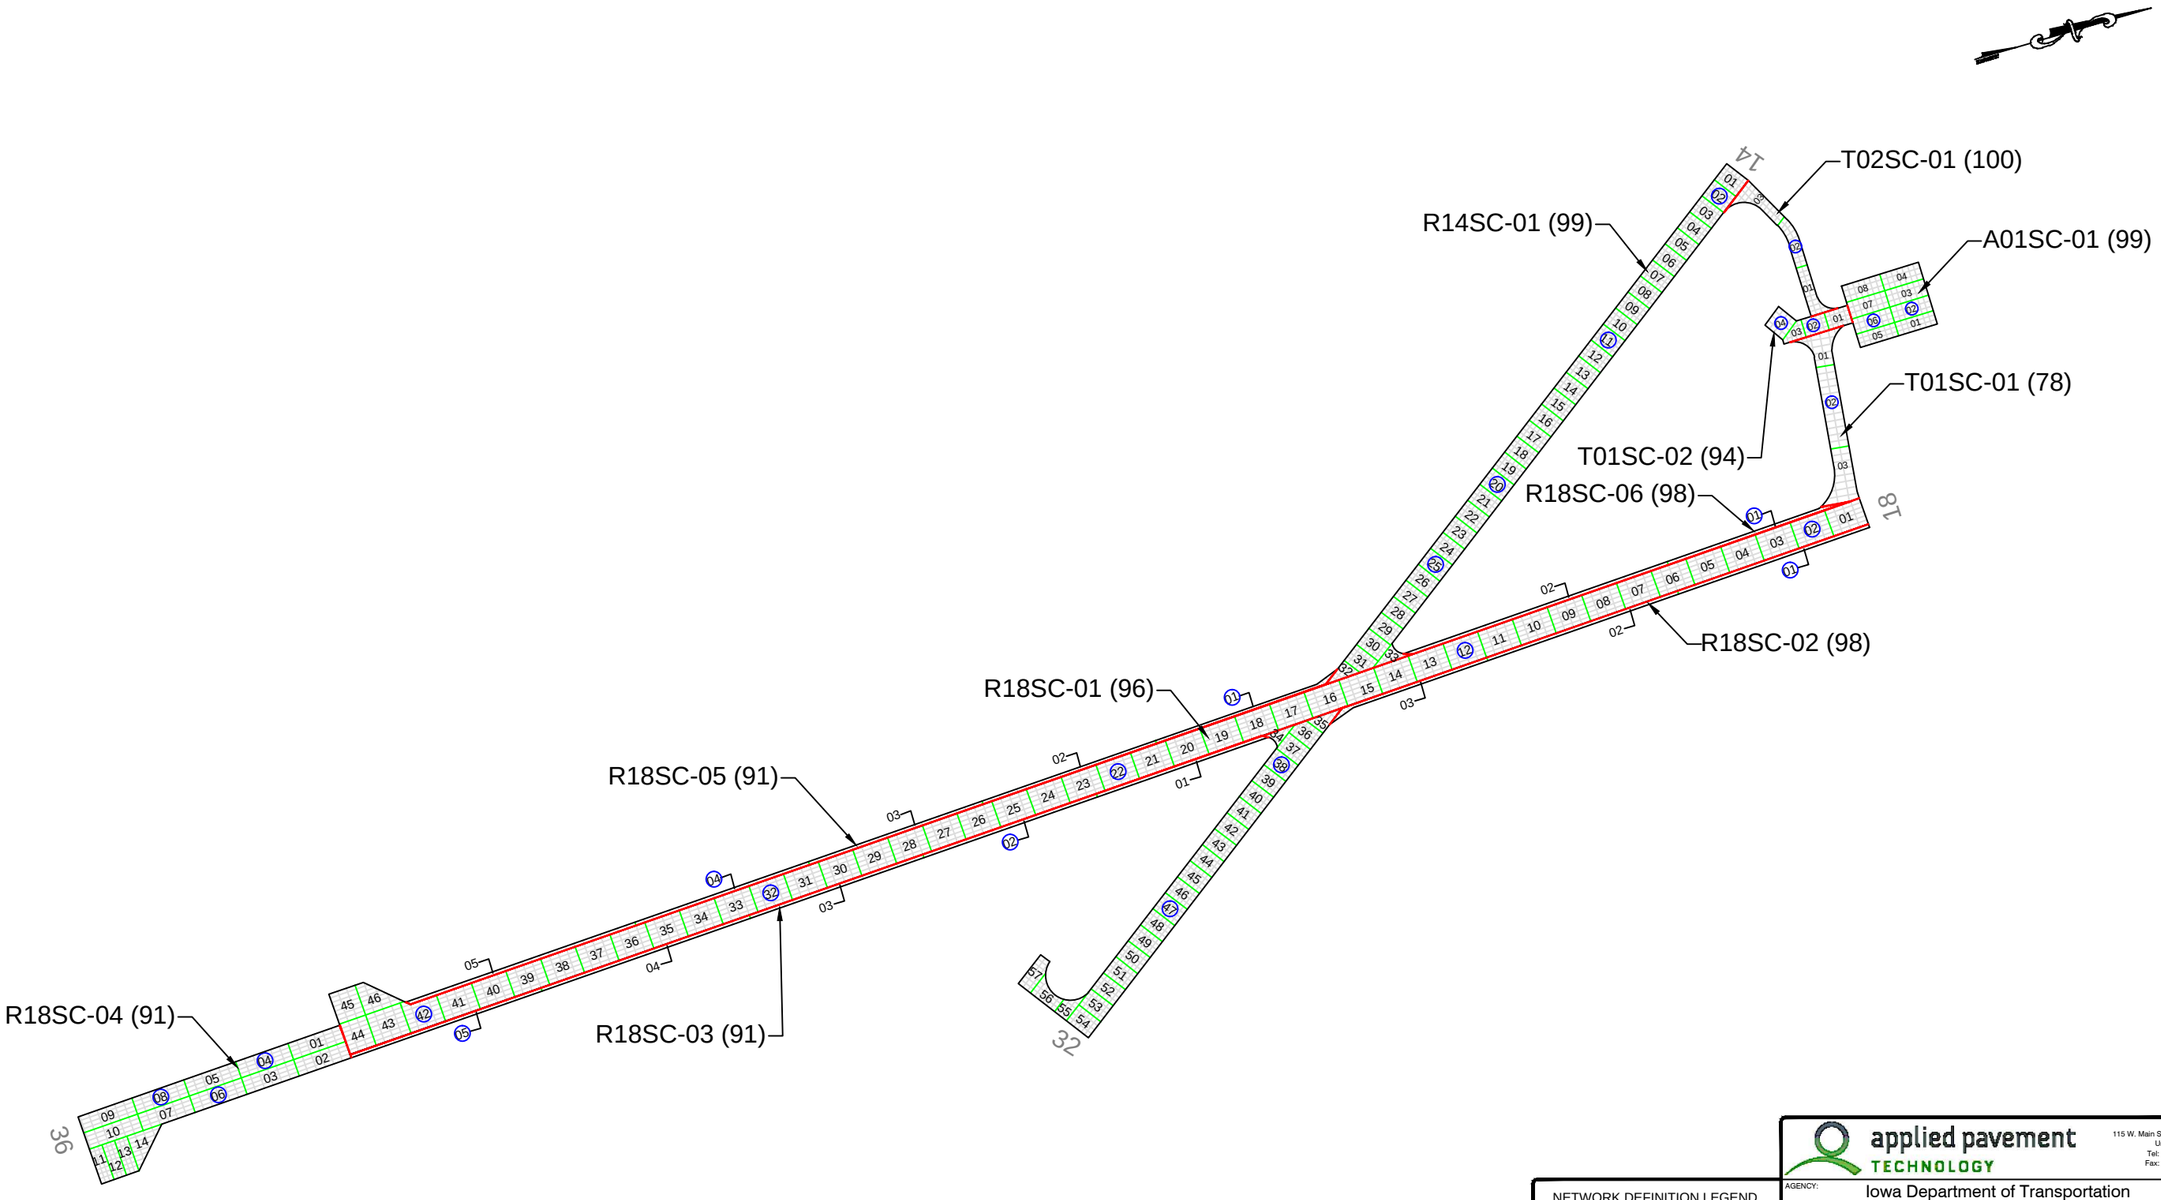
FIGURE 3. NETWORK DEFINITION MAP.

Figure 3 is a network definition map that identifies the pavements at Sac City Municipal Airport that were evaluated during this project. This map shows how the pavement network was divided into branches, sections, and sample units for pavement management purposes. It also shows the nomenclature used in the MicroPAVER pavement management database to identify the different pavement areas.

Runway 14-32 consists of one section in excellent condition with low-severity joint seal damage recorded.

Six sections are defined in Runway 18-36 that recently underwent extensive maintenance repairs. Section 01, the majority of the runway, is in excellent condition with low-severity joint seal damage recorded throughout along with moderate amounts of low-severity patching and corner spalling. Sections 02 and 06, located on either edge of the runway north of Runway 14-32, are both in excellent condition with low-severity joint seal damage observed throughout. Sections 03 and 05, located on either edge of the runway south of Runway 14-32, are both in good condition with low-severity joint seal damage identified. In addition, small amounts of low-severity linear cracking, corner breaking, and faulting were noted in Section 03 while low-severity linear cracking was observed in Section 05. Section 04, the runway extension located at the Runway 36 approach, is in good condition with low-severity joint seal damage recorded along with moderate quantities of low-severity patching and low- and medium-severity spalling.

Taxiway 01 consists of two sections that connect Runway 18-36 and terminal apron. Section 01 is in satisfactory condition with low-severity joint seal damage observed throughout the section along with moderate amounts of low-severity linear cracking. Section 02 is in good condition with medium-severity joint seal damage and joint spalling noted.

Taxiway 02 connects the terminal apron and Runway 14-32 and contains one section in excellent condition. No distresses were identified during the inspection.

The terminal apron is comprised of one section in excellent condition with low-severity joint seal damage recorded.

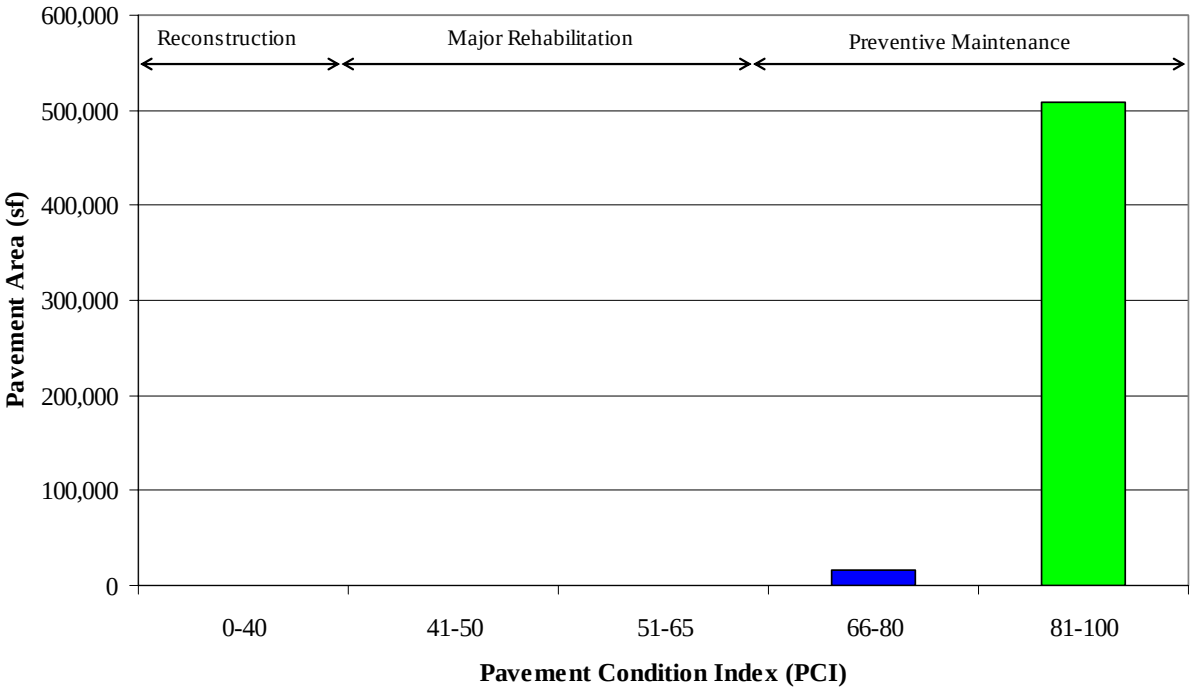
Figure 6. Overall condition.

The pavements at Sac City Municipal Airport were inspected on September 15, 2009. The 2009 area-weighted condition of Sac City Municipal Airport is 96, with conditions ranging from 78 to 100 (on a scale of 0 [failed] to 100 [excellent]). During the previous pavement inspection in 2005, the area-weighted PCI of the airport was 96.

Figures 6 and 7 provide graphs summarizing the overall condition of the pavements at the Sac City Municipal Airport. Figure 8 is a map that displays the condition of the pavements evaluated. Table 1 summarizes the results of the pavement evaluation. Appendix C presents photographs taken during the PCI inspection, and Appendix D contains detailed information on the distresses observed during the visual survey. Appendix E includes detailed work history
