STORM LAKE MUNICIPAL AIRPORT PAVEMENT MANAGEMENT REPORT

Prepared By:
Applied Pavement Technology, Inc.

January 2010

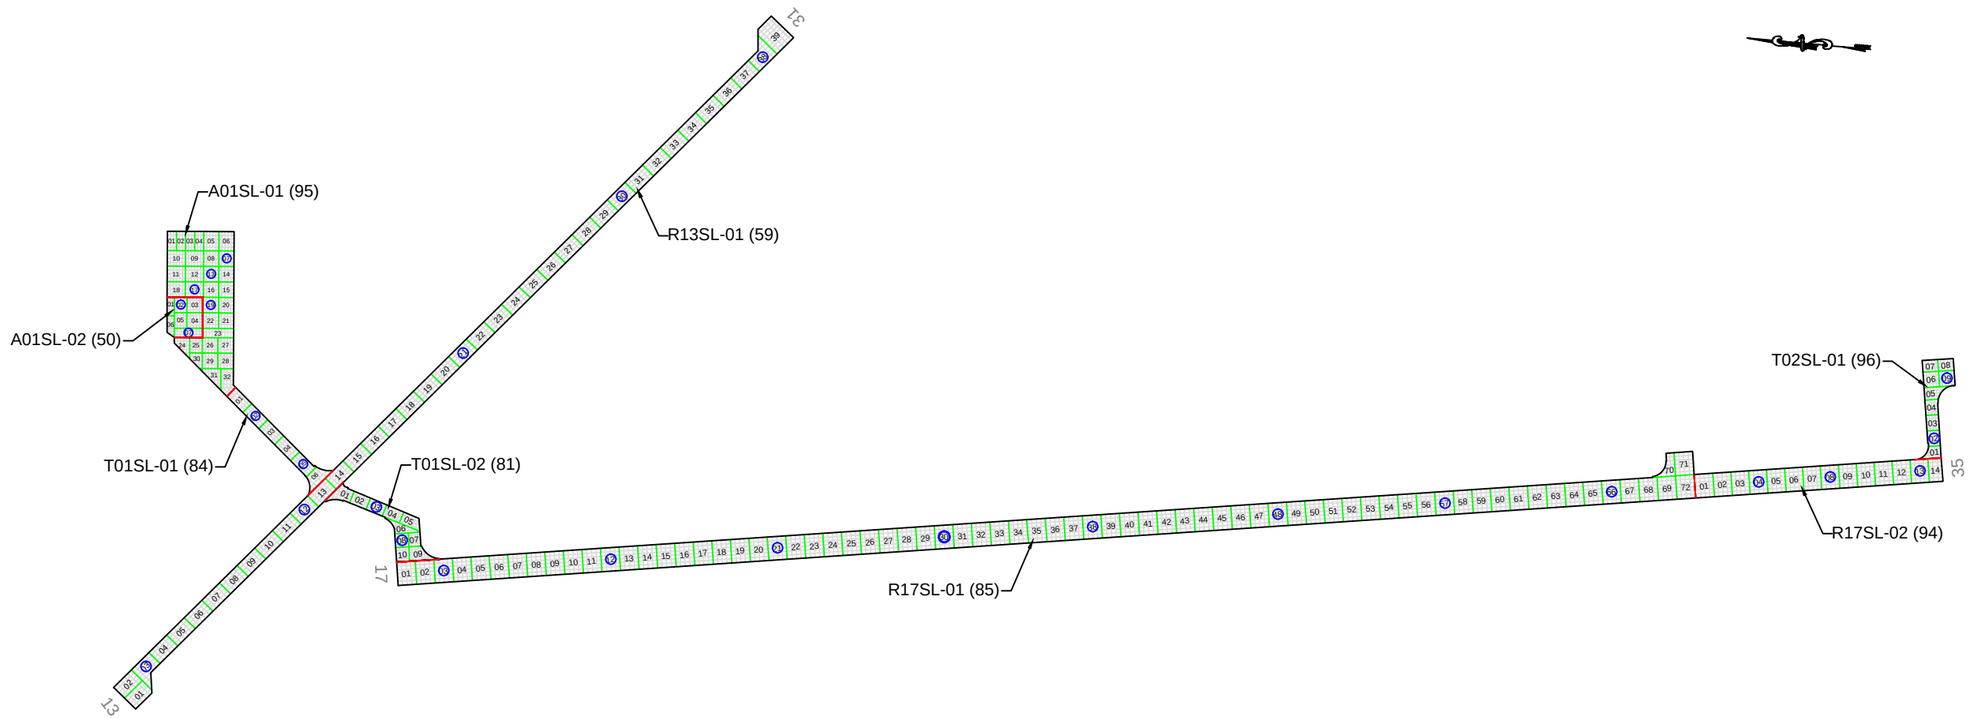
FIGURE 3. NETWORK DEFINITION MAP.

Runway 13-31 consists of one section that is in fair condition with low- and medium-severity joint seal damage and significant amounts of low- and medium-severity linear cracking recorded. Additionally, small quantities of low-, medium-, and high-severity joint spalling, low- and medium-severity corner spalling, and low- and high-severity small patching were identified. Isolated areas of medium-severity shattered slabs and low-severity corner breaking were also noted.

Two sections are defined in Runway 17-35. Section 01 consists of the majority of the runway and is in good condition with low-severity joint seal damage recorded. In addition, significant amounts of low- and medium-severity linear cracking and small amounts of low- and medium-severity joint spalling and low-severity large patching and corner breaking were identified. Isolated quantities of low-severity corner spalling and high-severity small patching were also noted. Section 02, the runway extension located at the Runway 35 approach, is in good condition. Low-severity joint seal damage was observed along with small quantities of low-severity linear cracking, shrinkage cracking, and low-severity joint spalling.

Taxiway 01 is defined by two sections. Section 01, located between the terminal apron and Runway 13-31, is in good condition with low-severity joint seal damage observed. In addition, very small quantities of low-severity linear cracking and medium-severity corner breaking and corner spalling were identified. Section 02, which connects both runways, is in good condition. Medium-severity joint seal damage and moderate quantities of low- and medium-severity joint and corner spalling were recorded. In addition, isolated areas of low-severity linear cracking were noted.

Taxiway 02 contains one section located at the Runway 35 approach. Section 01 is in excellent condition with low-severity joint seal damage and isolated areas of medium-severity joint spalling observed.

Two sections are defined in the terminal apron area. Section 01, the majority of the terminal apron area, is in excellent condition with low- and medium-severity joint seal damage recorded. Section 02 is in poor condition with medium-severity joint seal damage observed throughout. Additionally, moderate amounts of low- and medium-severity linear cracking and corner breaking, medium-severity shattered slabs and corner spalling, and medium- and high-severity joint spalling were identified.

Year	Branch[1]	Section	Type of Repair[2]	Estimated Cost[3]
2010	A01SL	02	Major Rehabilitation	$113,106
	R13SL	01	Major Rehabilitation	$1,176,420
			Total:	**$1,289,526**

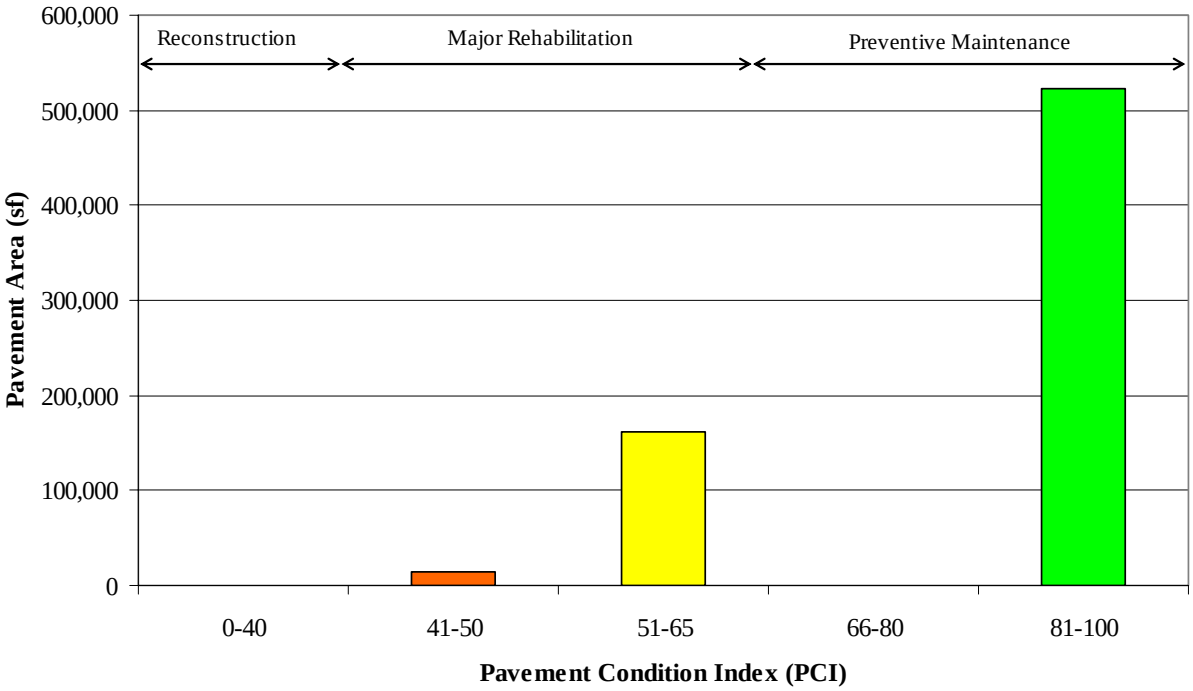
Figure 6. Overall condition.

The pavements at Storm Lake Municipal Airport were inspected on September 15, 2009. The 2009 area-weighted condition of Storm Lake Municipal Airport is 80, with conditions ranging from 50 to 96 (on a scale of 0 [failed] to 100 [excellent]). During the previous pavement inspection in 2005, the area-weighted PCI of the airport was 88.
