SPENCER MUNICIPAL AIRPORT
PAVEMENT MANAGEMENT REPORT

Prepared By:
Applied Pavement Technology, Inc.

January 2010

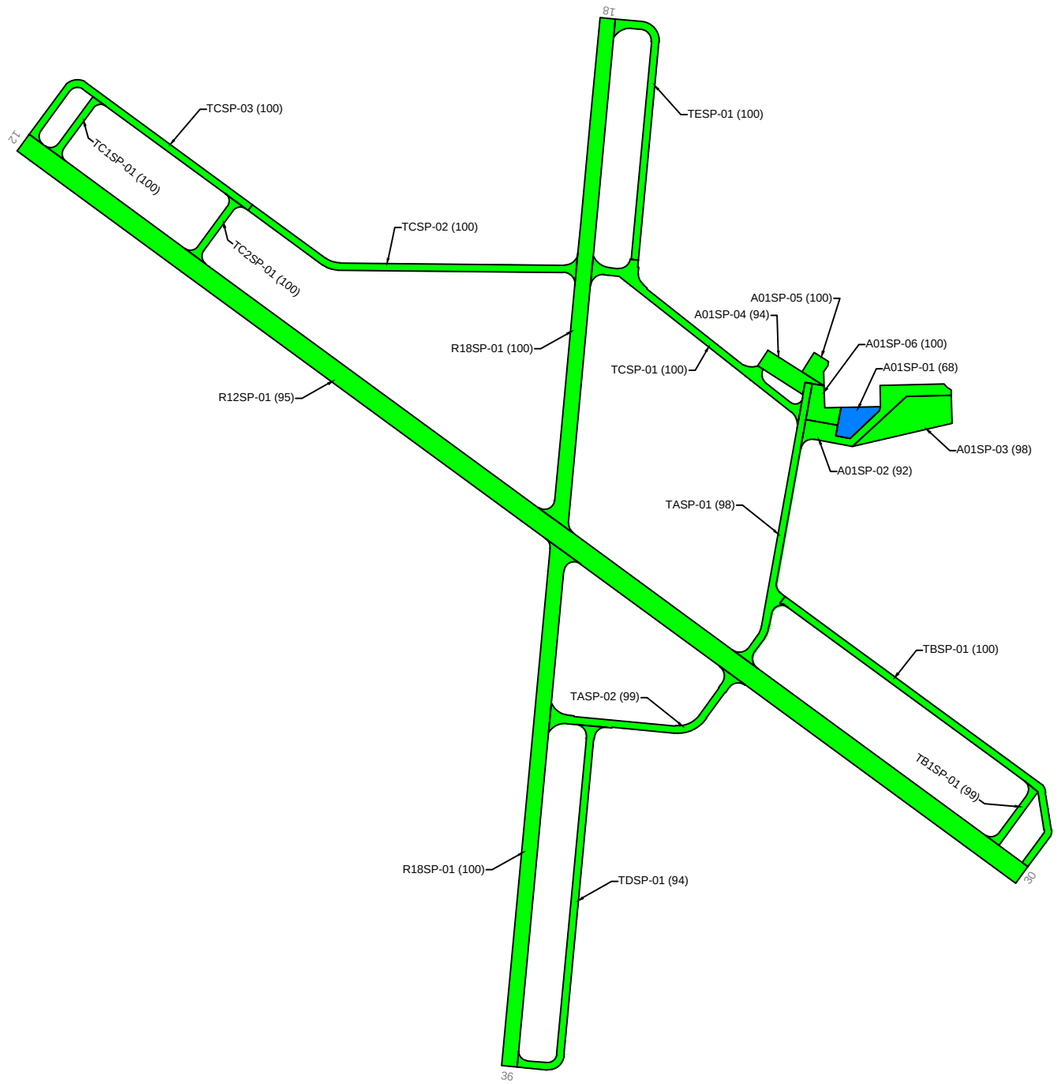
FIGURE 8. PCI MAP.

The pavements at Spencer Municipal Airport were inspected on September 16-17, 2009. The 2009 area-weighted condition of Spencer Municipal Airport is 97, with conditions ranging from 68 to 100 (on a scale of 0 [failed] to 100 [excellent]). During the previous pavement inspection in 2005, the area-weighted PCI of the airport was 95.

Runway 12-30 contains one section in excellent condition with low-severity joint seal damage recorded. Additionally, small amounts of low-severity corner breaking, small patching, and corner spalling were identified along with low- and medium-severity linear cracking and joint spalling.

Runway 18-36 consists of one section that is in excellent condition with only an isolated area of low-severity linear cracking observed.

Taxiway D is a partial parallel taxiway located near the Runway 36 approach that contains one section. Section 01 is in good condition with isolated amounts of low-severity corner breaking and medium-severity linear cracking and joint spalling identified.

Six sections are defined in the terminal apron area. Section 01, located adjacent to the terminal building, is in satisfactory condition with low-severity joint seal damage recorded. In addition, small quantities of low- and medium-severity linear cracking and all severities of joint spalling were observed. Section 02, the center portion of the terminal apron, is in good condition with low-severity joint seal damage identified. Small amounts of low-severity linear cracking and corner breaking and medium-severity joint spalling were noted. Section 03, the southeastern portion of the terminal apron, is in excellent condition with low-severity joint seal damage and isolated quantities of low-severity joint spalling recorded. Section 04, the western portion of the terminal apron, is in good condition with small amounts of low-severity linear cracking observed. Section 05, the northern portion of the terminal apron, and Section 06, located to the west of the terminal building, are in excellent condition with no distresses observed at the time of inspection.
