CENTERVILLE MUNICIPAL AIRPORT PAVEMENT MANAGEMENT REPORT

Prepared By:
Applied Pavement Technology, Inc.

December 2010

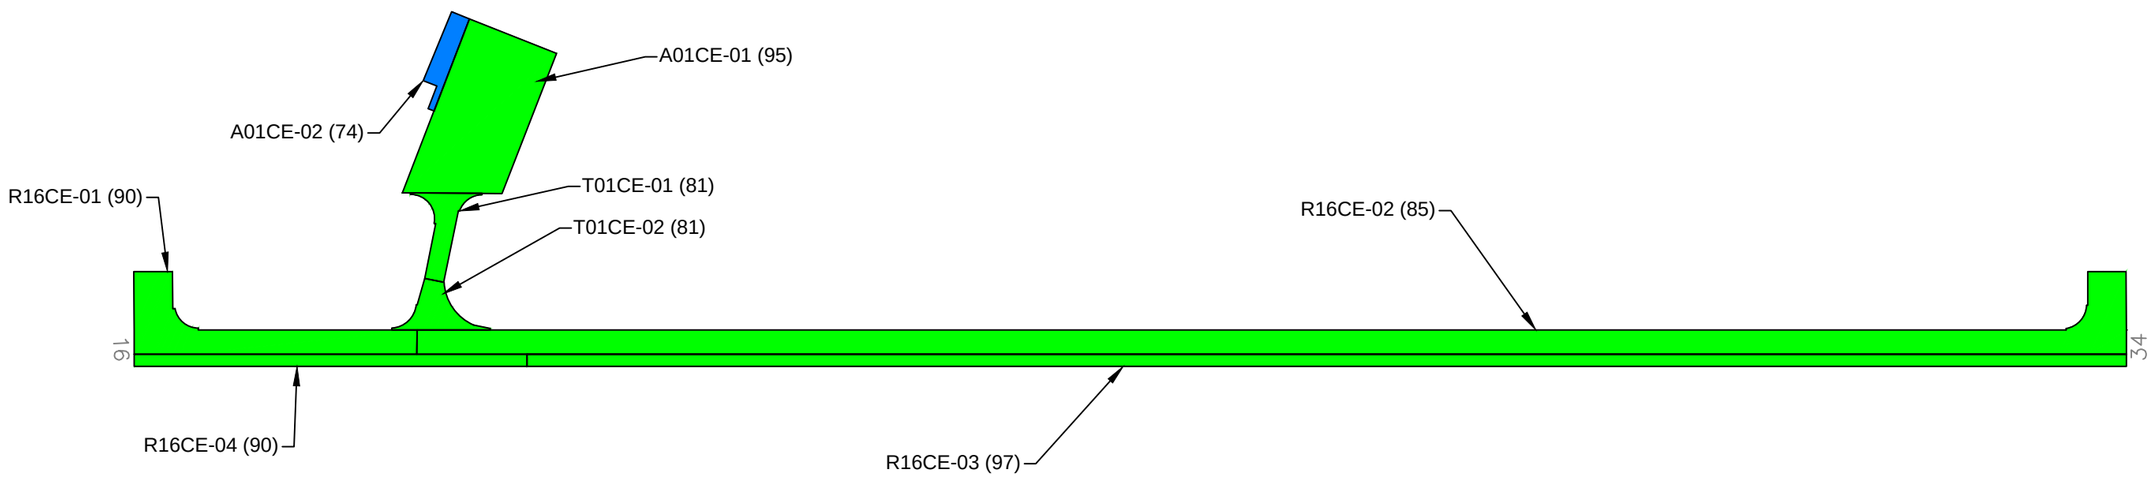
FIGURE 8. PCI MAP.

The pavements at Centerville Municipal Airport were inspected on September 16, 2010. The 2010 area-weighted condition of Centerville Municipal Airport is 89, with conditions ranging from 74 to 97 (on a scale of 0 [failed] to 100 [excellent]). During the previous pavement inspection in 2006, the area-weighted PCI of the airport was 82.
