BELLE PLAINE MUNICIPAL-MANSFIELD TIPPIE AIRPORT PAVEMENT MANAGEMENT REPORT

Prepared By:
Applied Pavement Technology, Inc.

December 2011

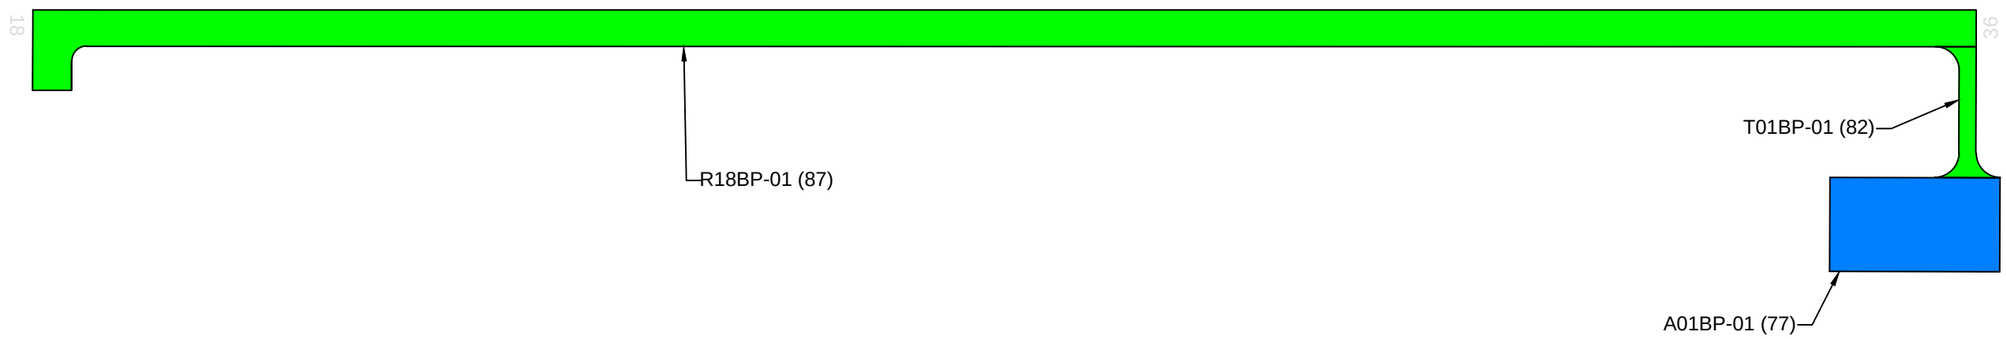
FIGURE 8. PCI MAP.

The pavements at Belle Plaine Municipal-Mansfield Tippie Airport were inspected on September 15, 2011. The 2011 area-weighted condition of Belle Plaine Municipal-Mansfield Tippie Airport is 85, with conditions ranging from 77 to 87 (on a scale of 0 [failed] to 100 [excellent]). During the previous pavement inspection in 2008, the area-weighted PCI of the airport was 87.

Runway 18-36 is defined by one section in good condition with small to moderate quantities of low- and medium-severity longitudinal, transverse, and diagonal (LTD) cracking; joint spalling; and corner spalling observed. In addition, isolated quantities of low- and medium-severity durability cracking and shrinkage cracking were recorded.

Taxiway 01 connects Runway 18-36 with the apron area. This taxiway contains one section in good condition with small amounts of low-severity corner spalling, LTD cracking, and corner breaking identified along with medium-severity joint spalling.

The apron area (Apron 01) is comprised of one section in satisfactory condition with small quantities of low- and medium-severity LTD cracking and low-severity joint spalling and corner spalling observed. Additionally, isolated amounts of low-severity corner breaking, faulting, and shattered slabs were noted.
