VINTON VETERAN'S MEMORIAL AIRPARK PAVEMENT MANAGEMENT REPORT

Prepared For:
Iowa Department of Transportation
Office of Aviation

Prepared By:
Applied Pavement Technology, Inc.

December 2010

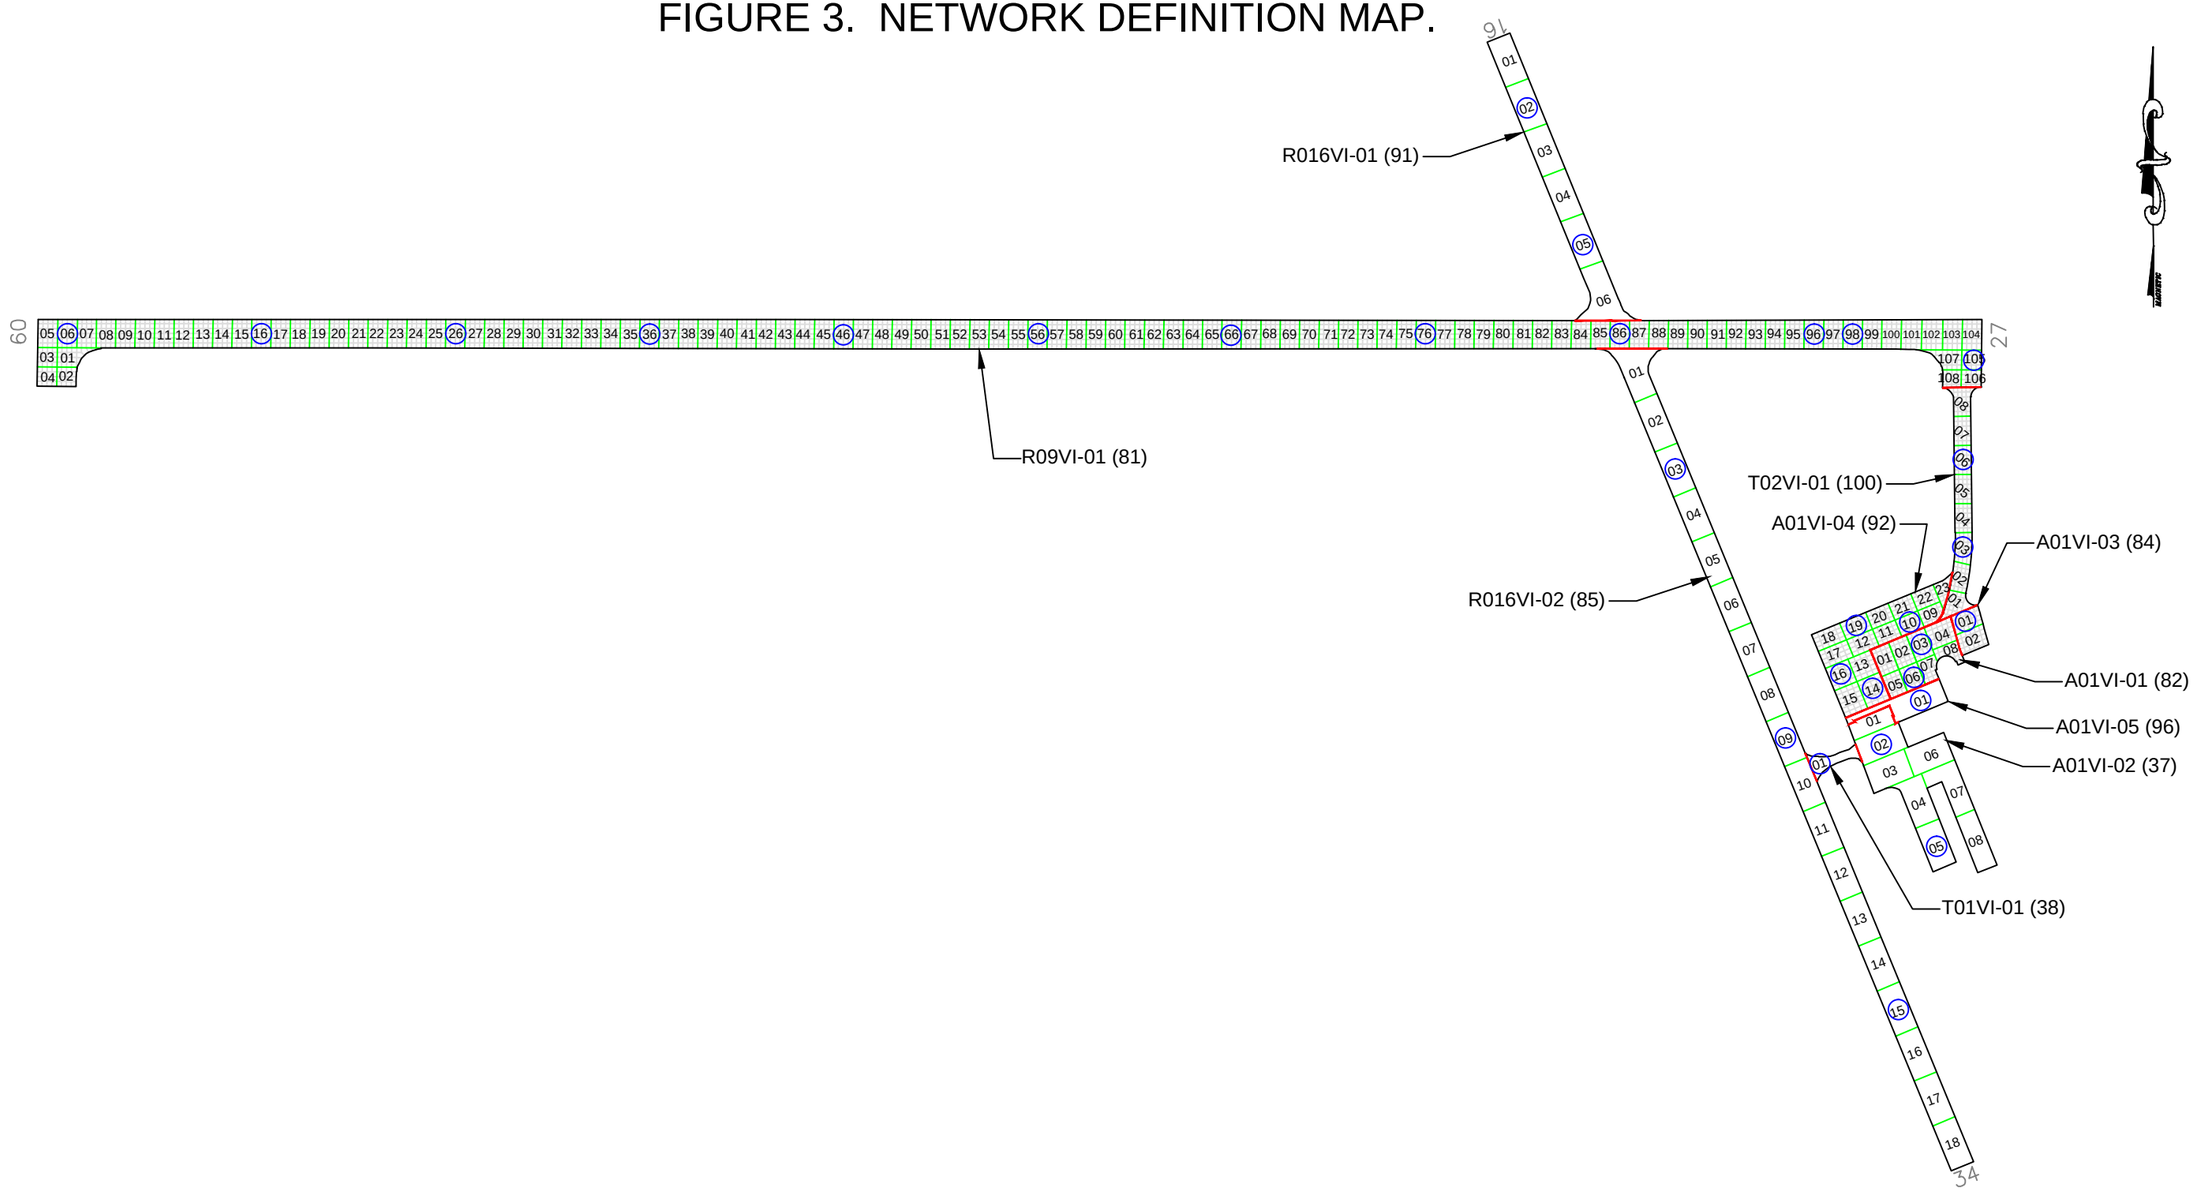
FIGURE 3. NETWORK DEFINITION MAP.

Figure 3 is a network definition map that identifies the pavements at Vinton Veteran's Memorial Airpark that were evaluated during this project. This map shows how the pavement network was divided into branches, sections, and sample units for pavement management purposes. It also shows the nomenclature used in the MicroPAVER pavement management database to identify the different pavement areas.

Runway 9-27 is defined by one section. Section 01 is in good condition. Moderate quantities of low-severity durability cracking and popouts were observed throughout. Small amounts of low-severity linear cracking and medium-severity durability cracking were recorded. Additionally, isolated quantities of low-, medium-, and high-severity joint spalling and low- and high-severity corner spalling were noted.

Runway 16-34 is comprised of two sections. Section 01, the northern portion of the runway, is in good condition with low-severity longitudinal and transverse (L&T) cracking recorded throughout. Most of the low-severity cracking was sealed. Section 02, the southern portion of the runway, is in good condition with low- and medium-severity L&T cracking observed. Most of the low-severity cracking was sealed, and the medium-severity cracking was identified where crack sealant was no longer performing satisfactorily.

Taxiway 01 connects Runway 16-34 to the apron area and consists of one section. Section 01 is in failed condition with extensive amounts of low- and medium-severity L&T cracking and low-severity raveling and weathering identified. In addition, small amounts of high-severity raveling and weathering and low-severity patching were noted.

Taxiway 02 connects the apron area with the Runway 27 approach and is defined by one section in excellent condition with no distresses identified during the inspection.

Apron 01 is comprised of five sections. Section 01, located in the center of the apron area, is in good condition with low-severity joint seal damage recorded throughout. In addition, small quantities of low-severity small patching and medium-severity joint spalling and linear cracking were observed. Section 02, the southern portion of the apron area, is in failed condition with extensive amounts of low- and medium-severity L&T cracking and alligator cracking and low-severity raveling and weathering identified. Additionally, small quantities of low-severity depression and high-severity alligator cracking and bleeding were observed. All of the low-severity cracking was unsealed, and the medium-severity cracking was due to unsealed crack widths greater than ¼ inch. Section 03, the eastern portion of the apron area, is in good condition with low-severity joint seal damage and moderated amounts of low-severity linear cracking recorded. Section 04, the western portion of the apron area, is in good condition with medium-severity joint seal damage and isolated amounts of low-severity joint spalling identified. Section 05, located in front of the terminal building, is in excellent condition with small amounts of low-severity, unsealed L&T cracking and isolated areas of low-severity depression observed.

Year	Branch[1]	Section[1]	Type of Repair[2]	Estimated Cost[3]
2011	A01VI	02	Major Rehabilitation	$381,382
	T01VI	01	Major Rehabilitation	$25,222
			Total:	**$406,604**

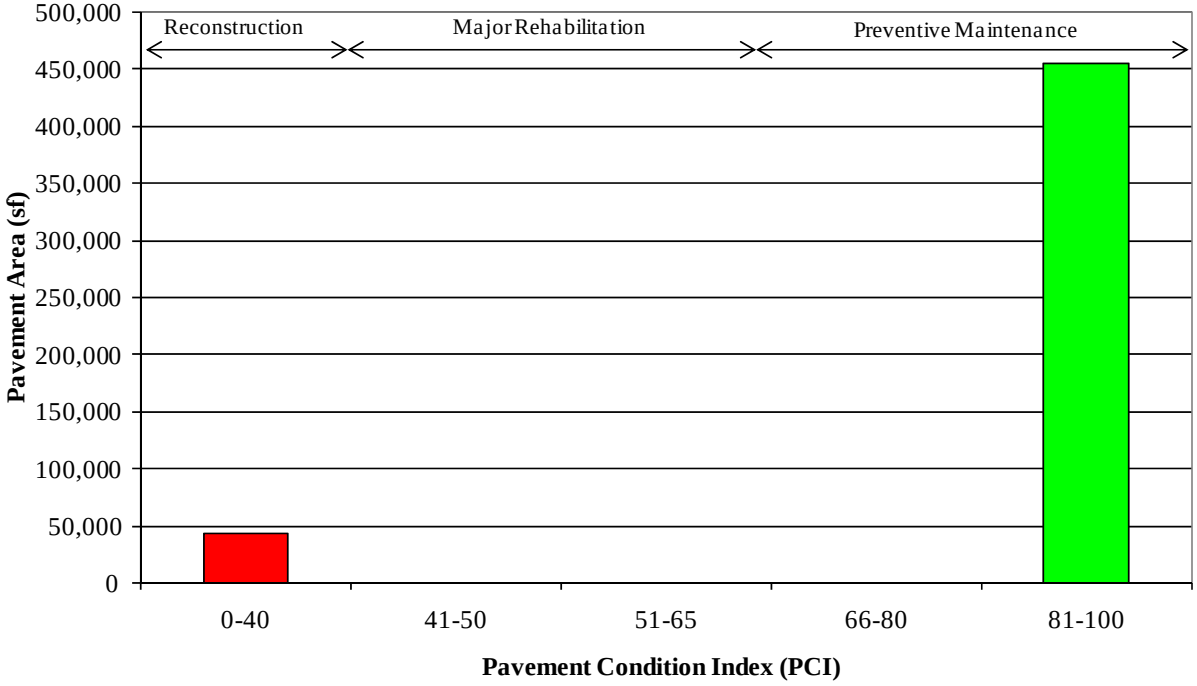
Figure 6. Overall condition.

The pavements at Vinton Veteran's Memorial Airpark were inspected on September 20, 2010. The 2010 area-weighted condition of Vinton Veteran's Memorial Airpark is 80, with conditions ranging from 37 to 100 (on a scale of 0 [failed] to 100 [excellent]). During the previous pavement inspection in 2006, the area-weighted PCI of the airport was 88.

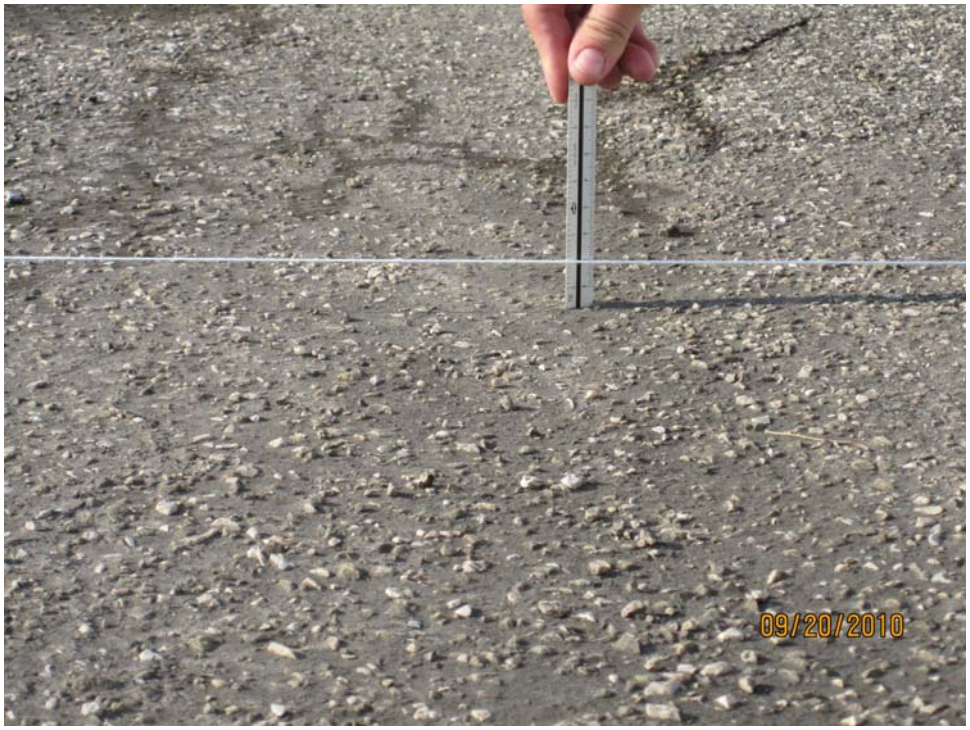
A01VI-02. Depression.
