VINTON VETERAN'S MEMORIAL AIRPARK PAVEMENT MANAGEMENT REPORT

Prepared For:
Iowa Department of Transportation
Office of Aviation

Prepared By:
Applied Pavement Technology, Inc.

January 2007

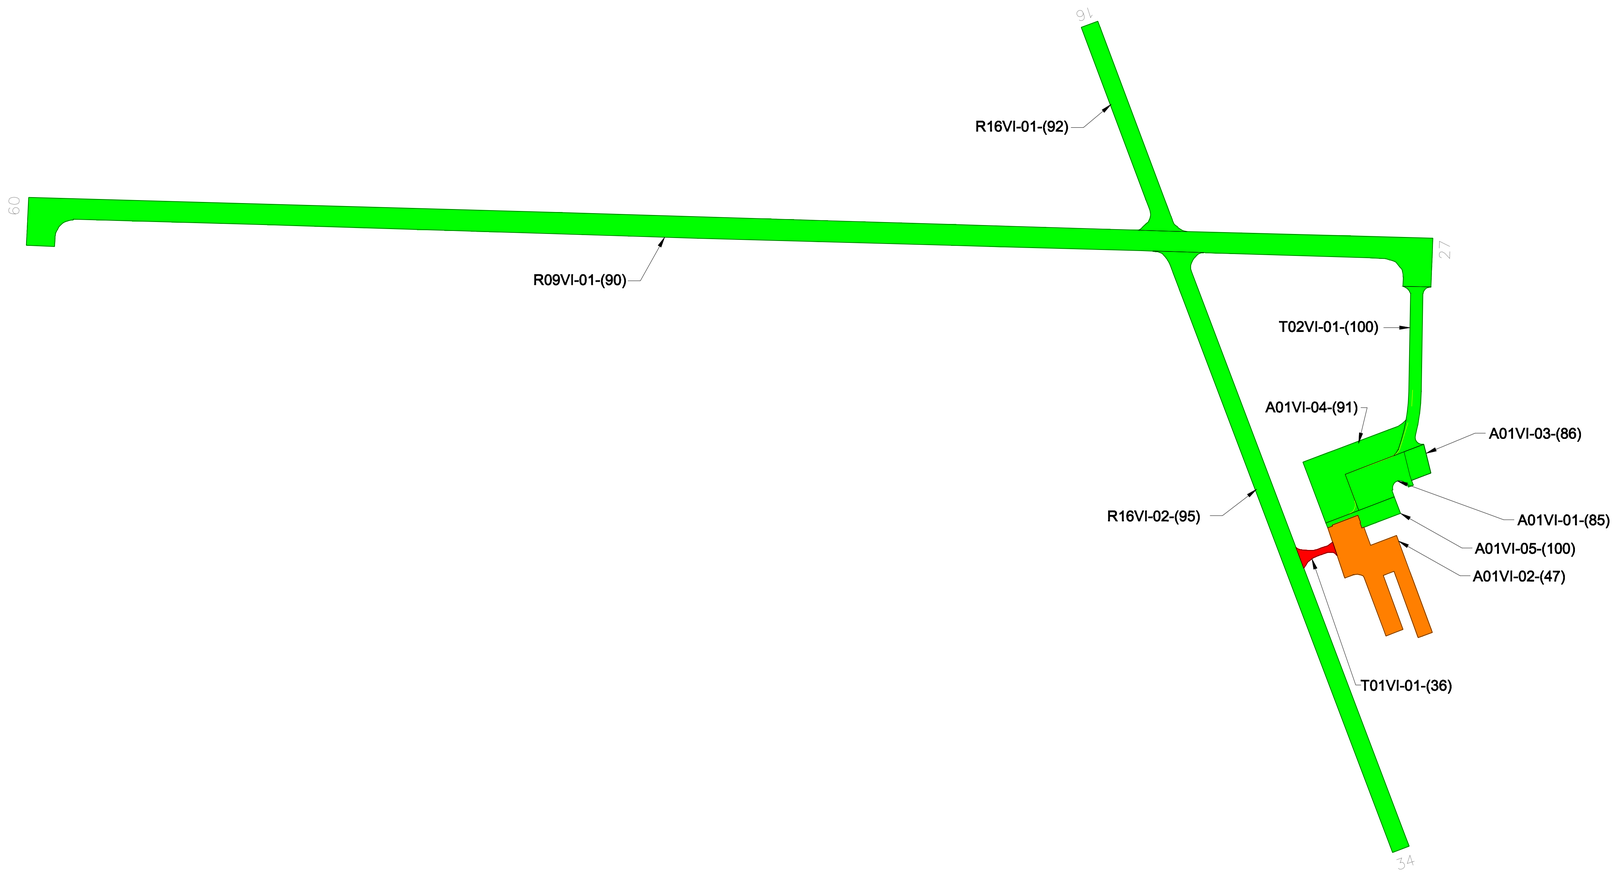
PAGE TITLE: Pavement Condition Index Map

The pavements at Vinton Veteran's Memorial Airpark were inspected on September 20, 2006. The 2006 area-weighted condition of Vinton Veteran's Memorial Airpark is 88, with conditions ranging from 36 to 100 (on a scale of 0 [failed] to 100 [excellent]). In 2003 the area-weighted PCI of the airport was 93.

Figures 6 and 7 provide graphs summarizing the overall condition of the pavements at the Vinton Veteran's Memorial Airpark. Figure 8 is a map that displays the condition of the pavements evaluated. Table 1 summarizes the results of the pavement evaluation. Appendix C presents photographs taken during the PCI inspection, and Appendix D contains detailed information on the distresses observed during the visual survey. Appendix E includes detailed work history
