DETECTION OF STEEL CORROSION IN BRIDGE DECKS AND REINFORCED CONCRETE PAVEMENT

Iowa Highway Research Board
Project HR-156
Final Report

Highway Division
May 1977

by
Vernon J. Marks

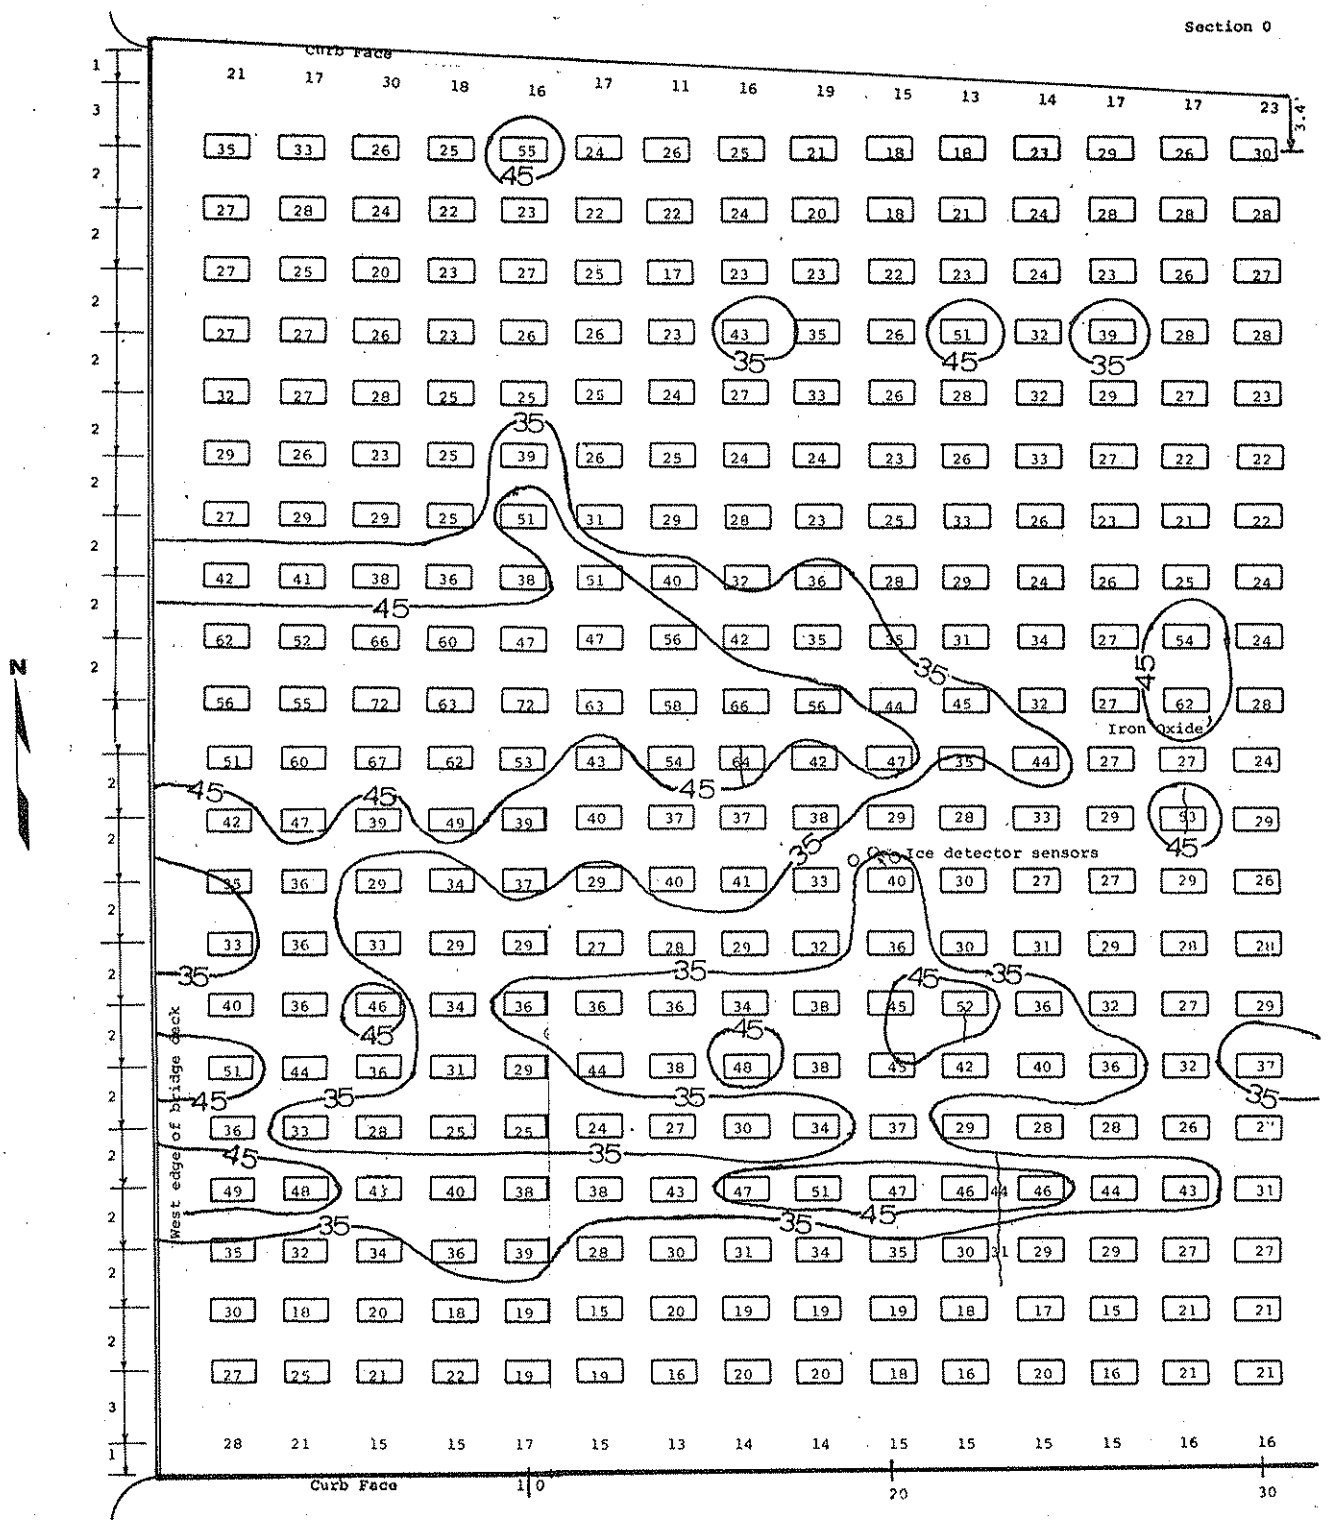
Location Story County, US 30 over US 69 (EBT)

In one case, corrosion detection contours were laid out for a selected area on a bridge deck. At that time, there was essentially no visible deterioration (Figure 3) of the deck. There was, however, one definable area where corrosion detection readings were greater than 0.45 volt. A visual inspection of this same area one year later showed considerable spalling (Figure 4). This further supports the relationship of the potential and active corrosion.

Figure 3. Electrical Potential Contours. There were a few isolated cracks, but no spalling at the time of this survey.

removal. It was decided that all areas exhibiting potential values greater than 0.45 volt should have the concrete removed down to the top reinforcing steel. This decision was based on past repair experience and the conclusion that cracking and spalling were eminent for these areas. This corrosion detection data was to be obtained for use in design of the repair, as well as being used at the time of construction if all of the concrete above the reinforcing steel was not removed. This criteria of 0.45 volt was established and the method of incorporating it into a project has been by a note on the plans. The plans note that the engineer shall conduct a survey at the time of construction and all areas with potentials greater than 0.45 volt shall be included for Class A repair. Class A repair requires removal of the concrete to below the top reinforcing steel. The 0.45 value and the note on the plans remain as present practice.

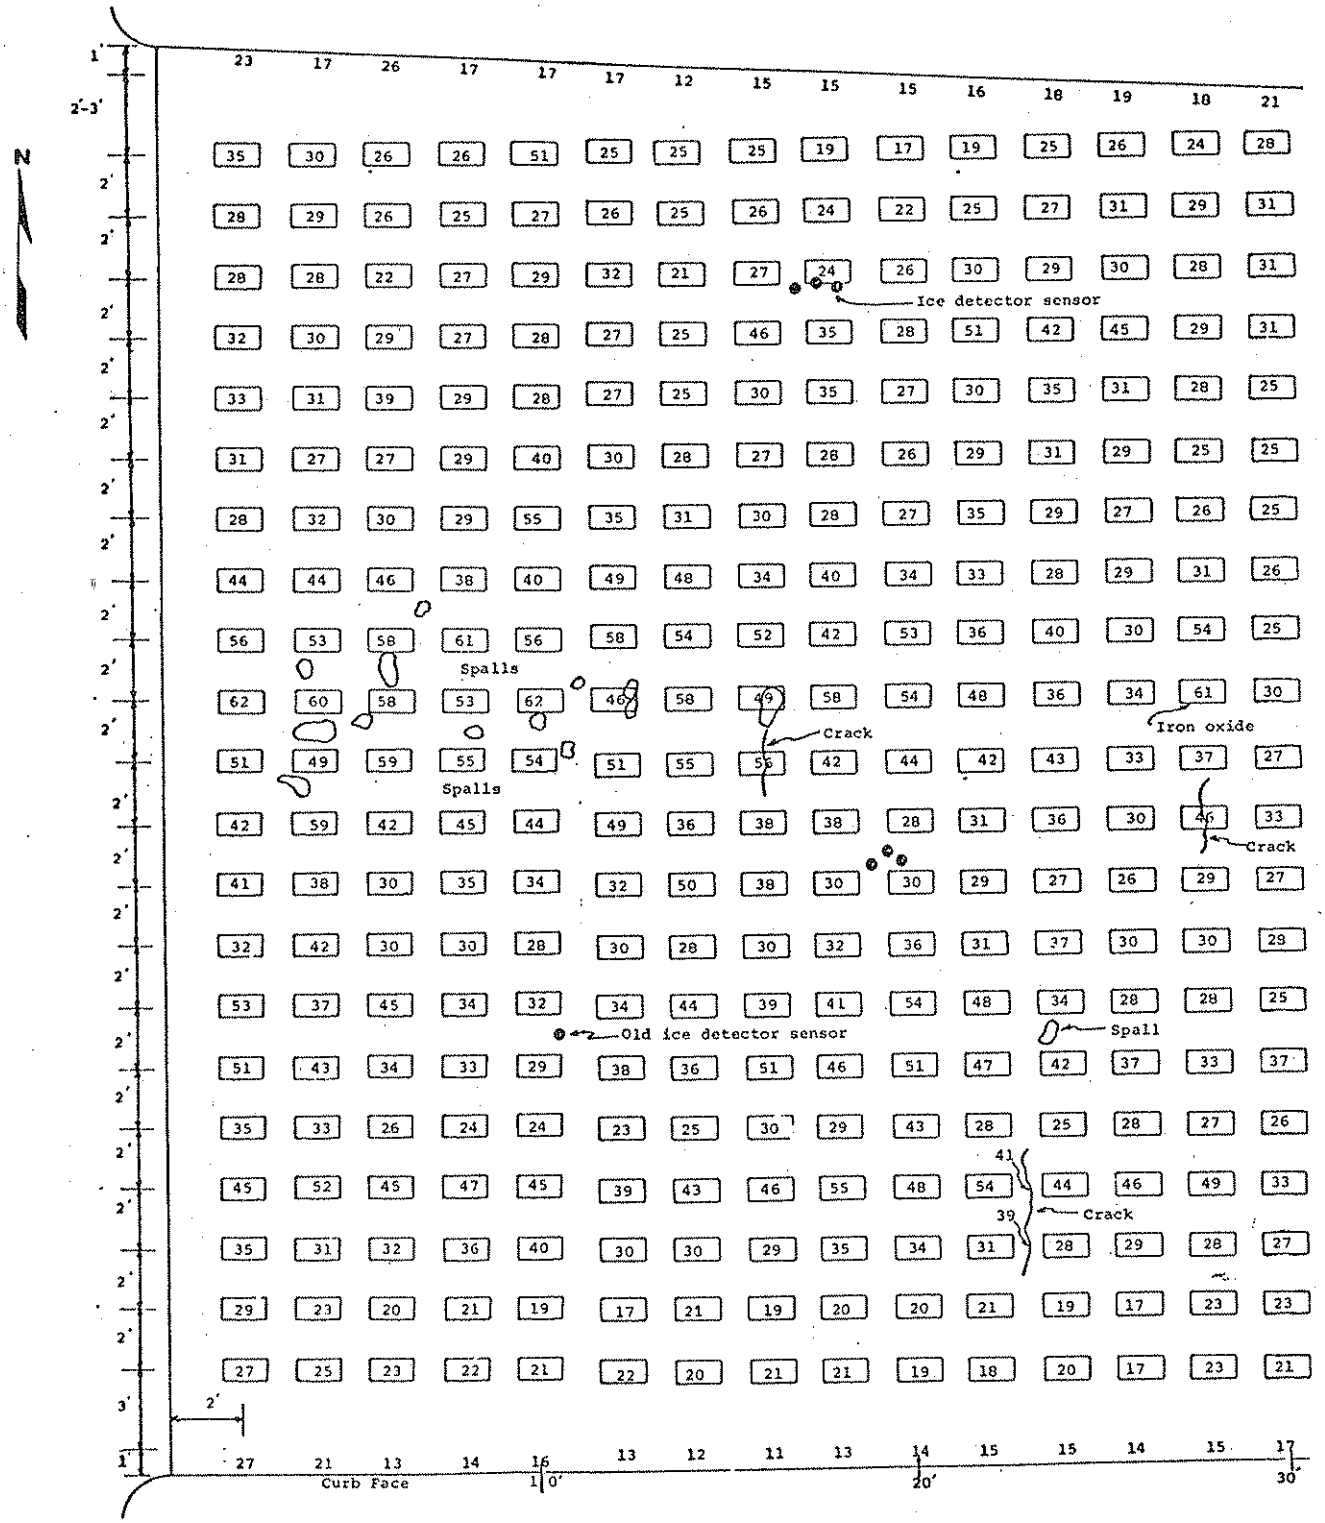
Location Story County US 30 over US 69 (EBT)

Figure 4. Extensive spalling of an area that had shown electrical potentials greater than 0.45 volt one year earlier

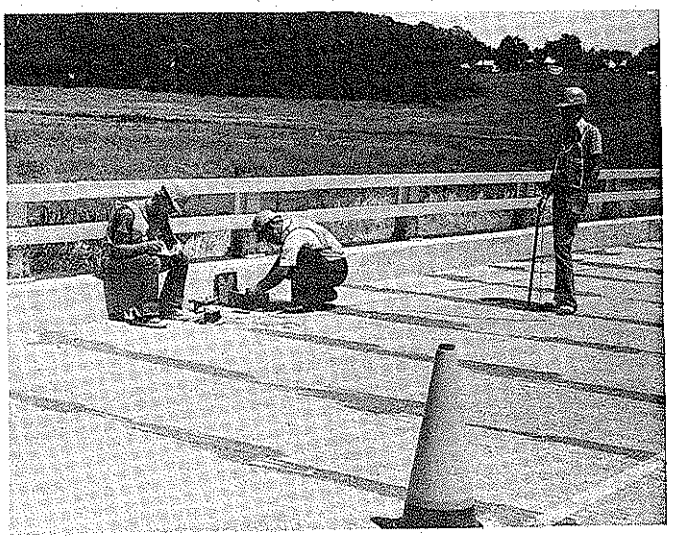
Figure 1

Type and location of bridge Steel Bm/Gird-Cherokee Co. on U.S. 59 Design No. 1934

Maintenance No. 1868.1S059 Date tested 11-5-76 Tested by Richard Renaud

Remarks Over Grey Creek X-marks where ground wire was attached
