Final Report
for
Iowa Highway Research Board
Project HR 203

Transverse Joint Sealing with Various Sealants

Highway Division
September 1983

BY
VERNON J. MARKS
RESEARCH ENGINEER

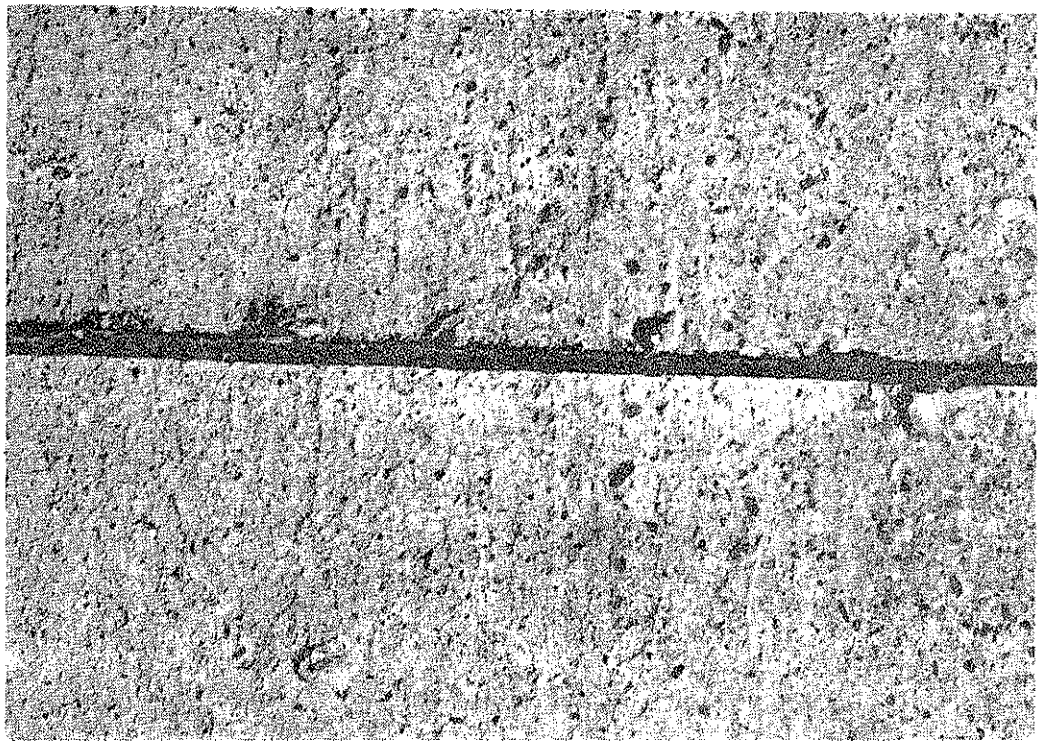
Deterioration of joints and joint related distress of pcc pavements continues to be a major maintenance problem. These joints are constructed to control cracking and provide for movement due to variation in temperature. The difficulty of maintaining these joints in a sealed condition is primarily caused by the opening and closing of the joint, but movement produced by traffic is a contributing factor. Unfortunately, the poured sealants and present joint design and construction practices have not been able to adequately provide for this movement. Even under ideal conditions, the life of most poured sealants rarely exceeds three years.[1] The bond between the sealant and the concrete fails and allows the joint to leak (figure 1).

Figure 1 - Bond Failure of Sealant Material

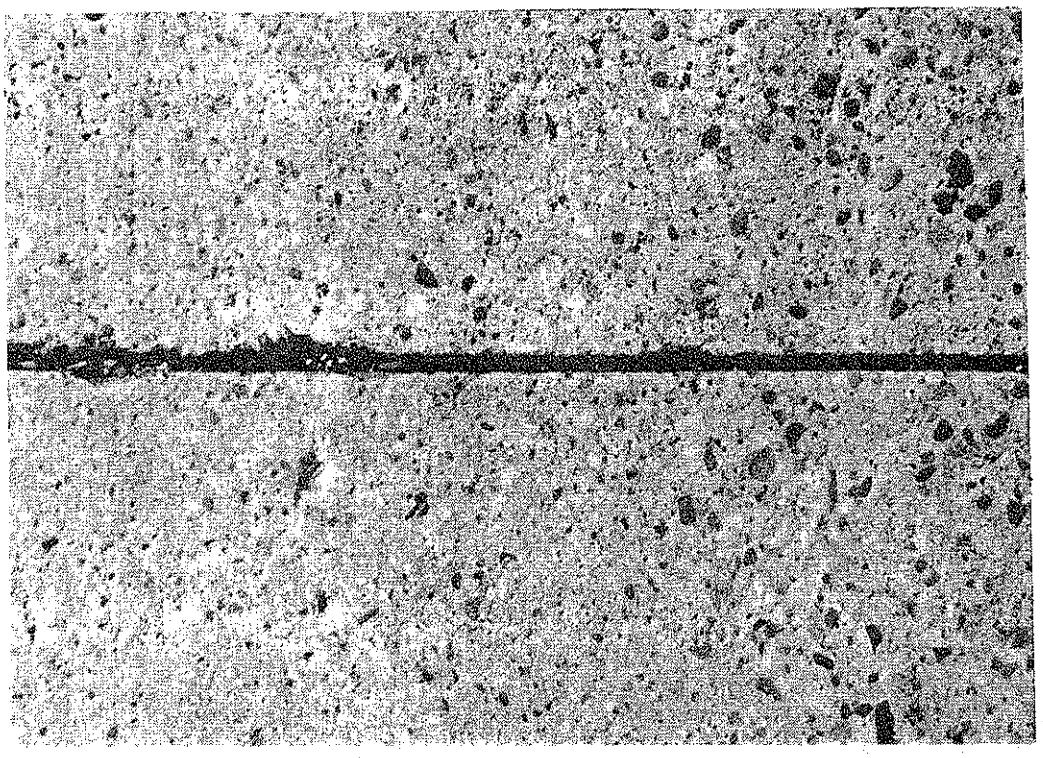
Blowups are the most dramatic of the joint failures. The generally accepted major contributing factor to blowups is incompressibles deposited in the joints (figure 2) during the winter months.

Figure 2 - Incompressibles in Transverse Joint

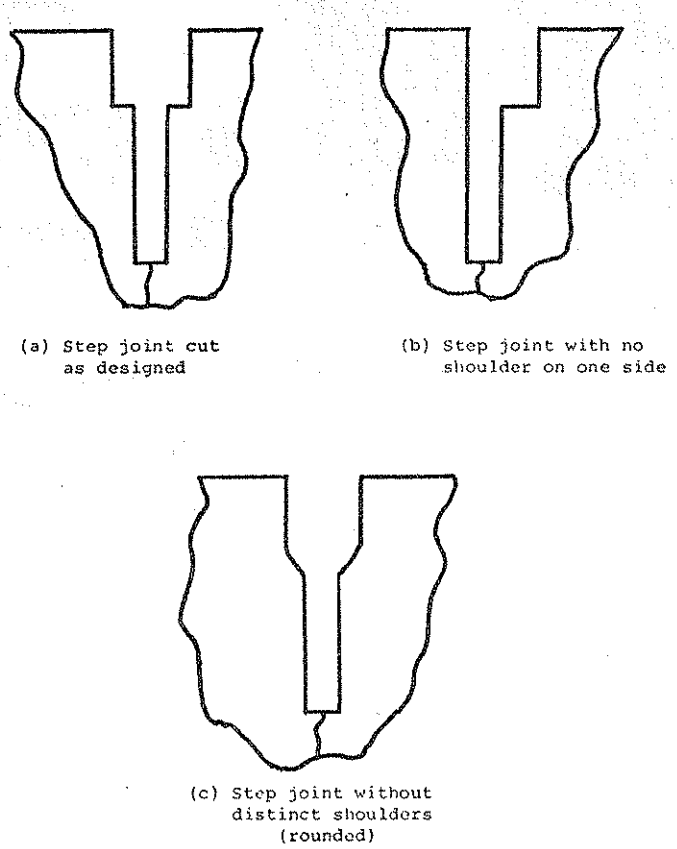
The shoulders of the step joint were generally not equally distributed or wear of the carborundum blade did not produce distinct shoulders for a bearing surface (figure 5).

Due to difficulty in tape placement, the 1/2" deep step joints were soon discontinued.

Figure 5 - Step Joints for Tape Backing

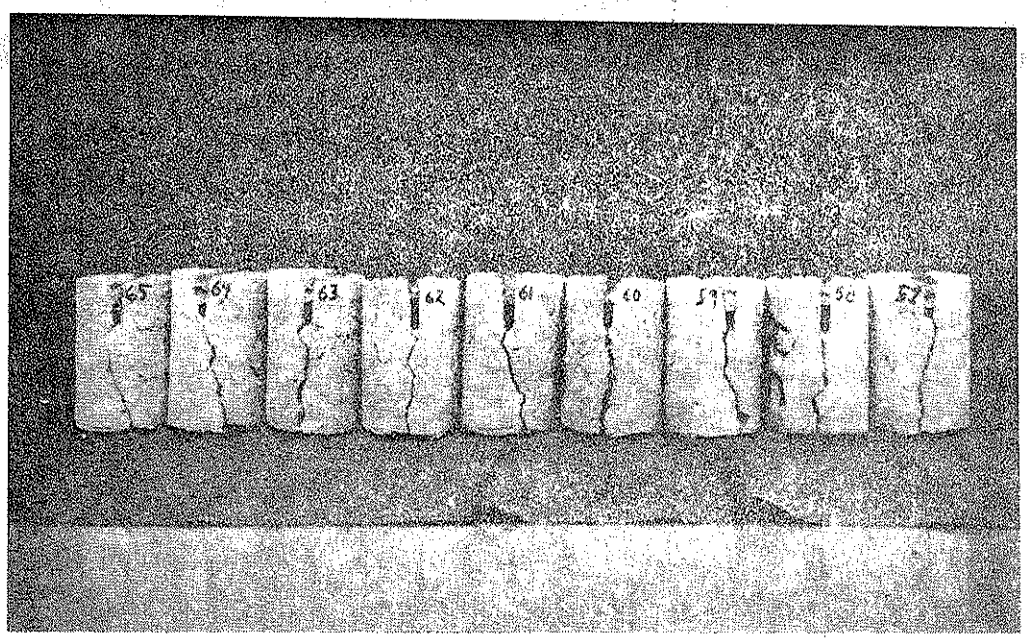
In 1979 one interesting and significant feature was noted while drilling. The cores were drilled with an Acker Drill which supplies cooling and flushing water through a Moyno pump. When drilling the Dow Corning 888 joints, the water was pumped to both edges of the slab where it spurted up in a small stream. This emphasized the tight seal of this joint. This type of spurting was not noted on joints with other types of sealants.

Figure 12 - Cores from Dow Corning 888 Joints

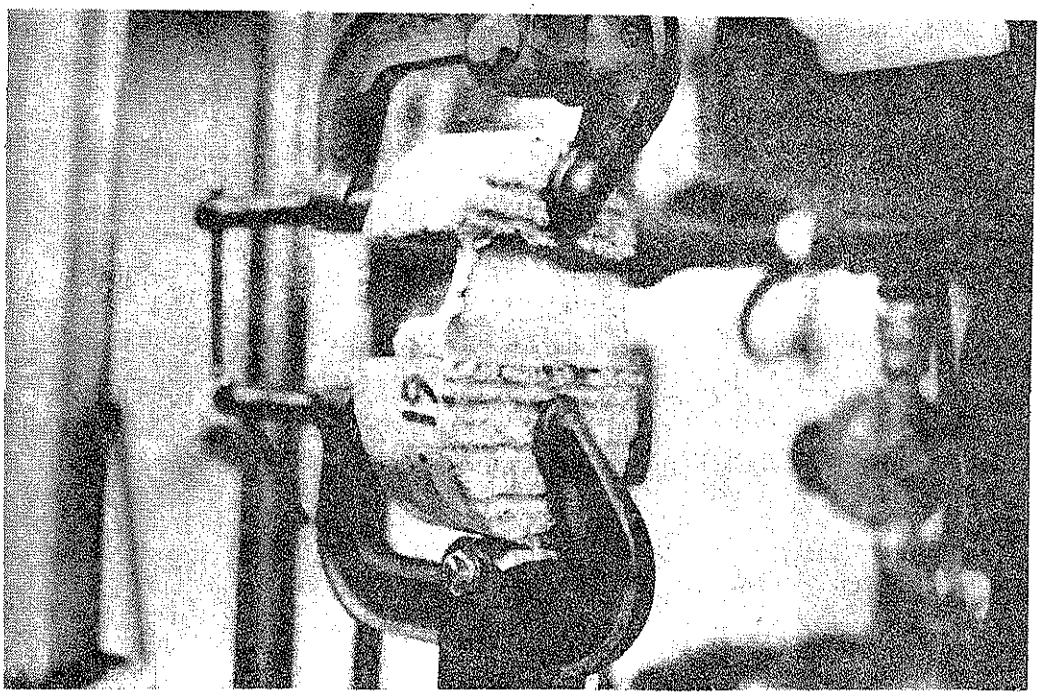
Figure 14 - Elongation of Dow Corning 888

The Dow Corning 888 material exhibited outstanding elongation (figure 14). Some Paraplastic joints had a very deep seal that resulted in a high maximum load (figure 15). A maximum load of 89.5 lbs. was obtained on a Paraplastic joint. The point of failure was somewhat arbitrary but certain criteria were established for this determination. First, if the bond was destroyed on 80% of the 4" length on either interface it had failed. Second, it failed if a load greater than 20 lbs. had been obtained followed by reduction below 10 lbs. The maximum loads and maximum elongations were summarized with respect to the same variables as the visual rating on page B-4. This testing exhibited poor strength and elongation for the Lyon D 200 and High Spec sealants. There was no significant difference due to the cleaning procedure. As expected, the 1/4" saw cut yielded the poorest elongation capabilities.

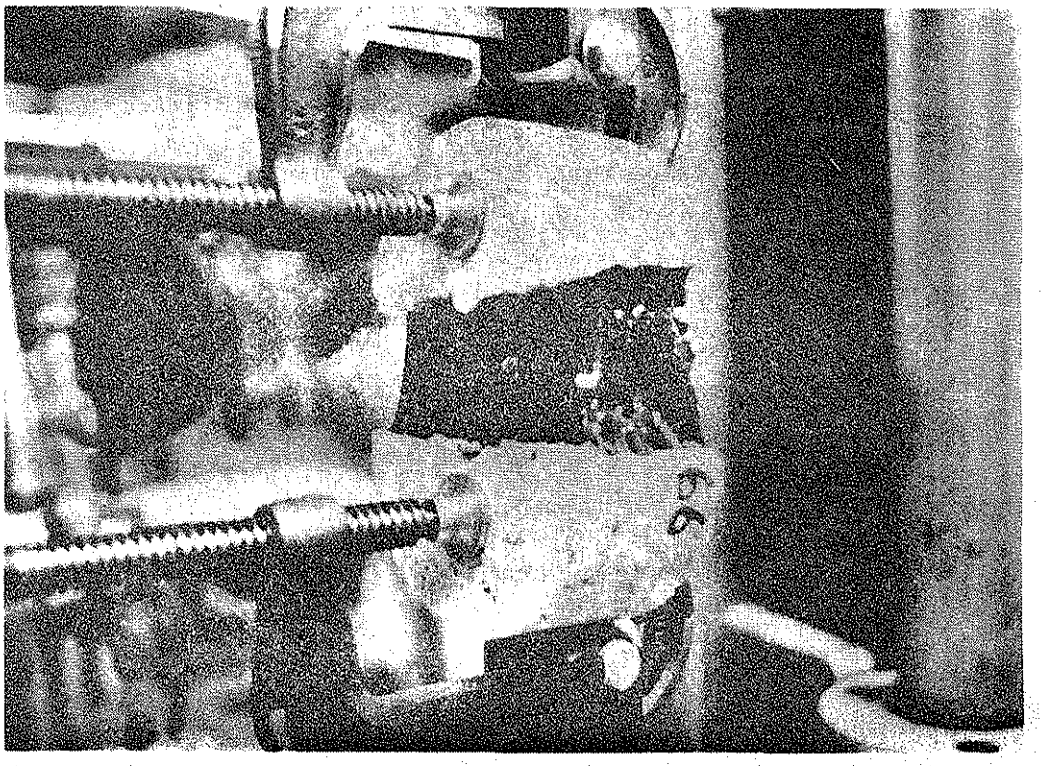
Figure 15 - Deep Seal of a Para Plastic Joint
