# Evaluation of Control Structures for Stabilizing Degrading Stream Channels in Western Iowa

July 1985

Iowa DOT HR-208A
Project 1502
ISU-ERI-Ames-86050

College of Engineering
Iowa State University

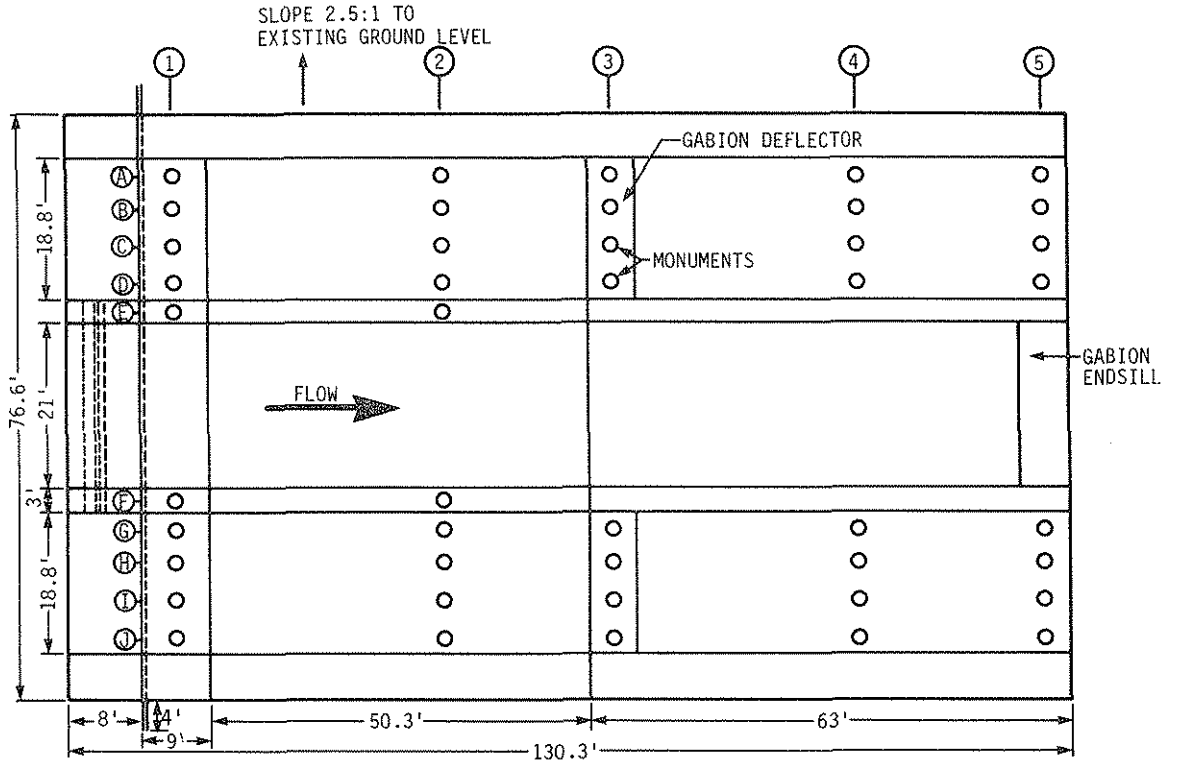
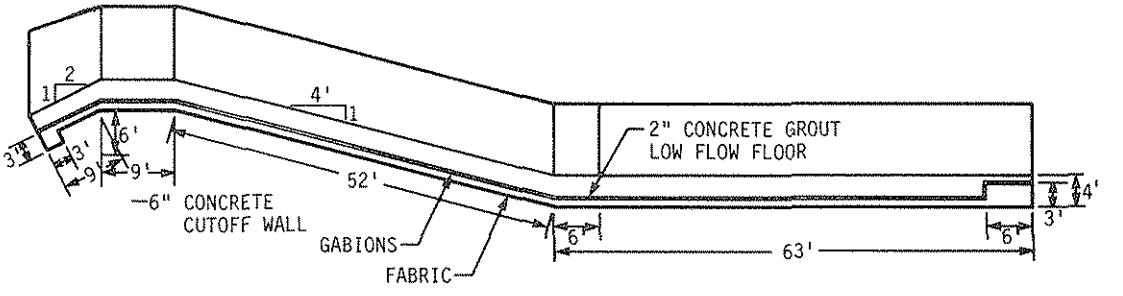
Figure 1. Plan of gabion drop structure showing location of monuments.

In order to monitor the differential movement of the structure, concrete monuments were placed on the surface as shown in Fig. 1. Elevations of the monuments were measured at five different times: 6/29/83, 11/7/83, 6/8/84, 8/22/84, and 6/5/85. The elevation data were used to plot all of the transverse cross sections at the various dates. These plots revealed that virtually no differential settlement has occurred within the structure throughout the course of the investigation. Figure 2 is a typical cross section, and Fig. 3 shows the cross section that exhibited the maximum amount of settlement. In Fig. 3

Minor deterioration of the structure is being observed visually and has been recorded on photographs. Some deformation of the side slope is apparent in the vicinity of monuments 2D and 2E, but this movement occurred during construction after a very high runoff event. Because runoff had filled the channel, the contractor, in an effort to dewater the site and resume work quickly, pumped the water out of the channel in a very short time. It is interpreted that this rapid drawdown condition created instability and caused slippage. A rapid drawdown condition is not likely to occur during normal operation of the structure; consequently, the side slopes are expected to be stable in the future. The stability of the side slopes is verified by the constant elevations of the monuments. Although the observed slope deformation is not of great concern, anchors were placed on the slope as a precaution.

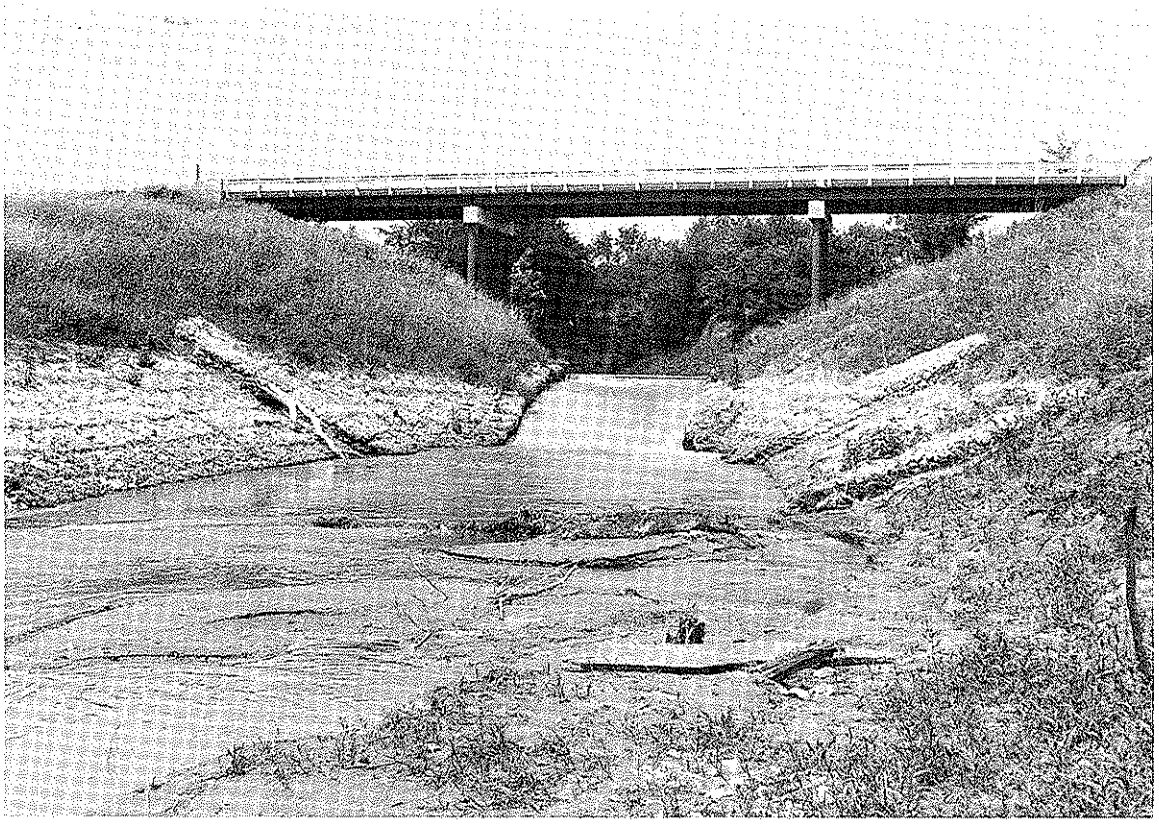
Plate 1. Completed gabion grade control structure as it appeared in June 1985.

The structure consists of a gabion weir and ramp with a net drop of 12.6 ft, which is intended to reduce the effects of the degradation at the bridge site. Fig. 1 shows the plan and profile of the structure. The bottom width of the weir and ramp is 21 ft with 2:1 side slopes extending 27 ft upward. The ramp is 51 ft long with a 4:1 downstream slope. The stilling basin has a length of 63 ft. Photoplate 1 is a photograph of the structure as it appeared in Summer 1985.

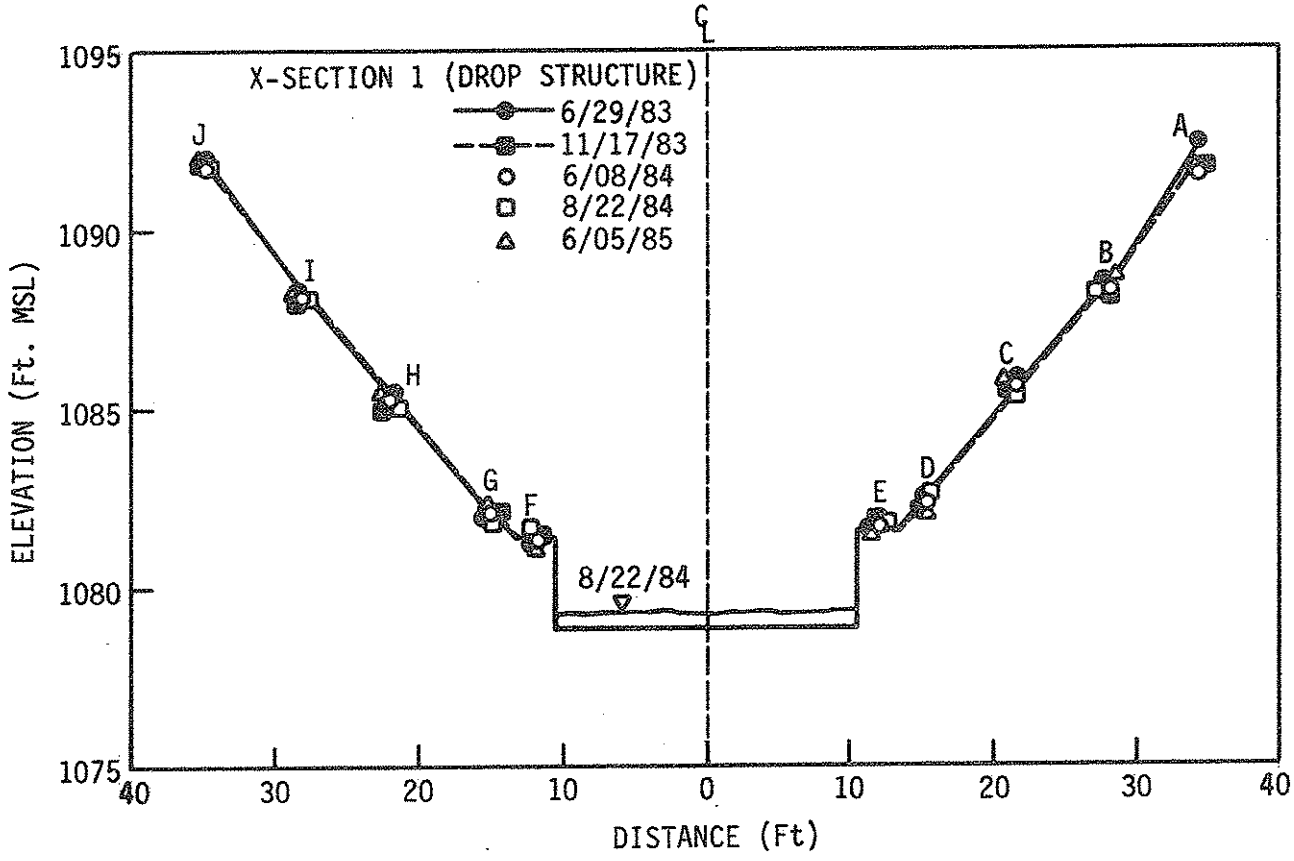
Figure 2. Cross section at top of structure. Note differential movement at monument A. This is the only measurable movement observed in the structure.

the monument 1A, at the top of the sideslope immediately downstream from the crest, settled about four inches between the first two observation dates. No differential movement has been observed since 11/7/83; thus, it has been concluded that differential settlement is not a problem. Because soil consolidation occurs most rapidly soon after loading, it appears settlement will not be a problem.

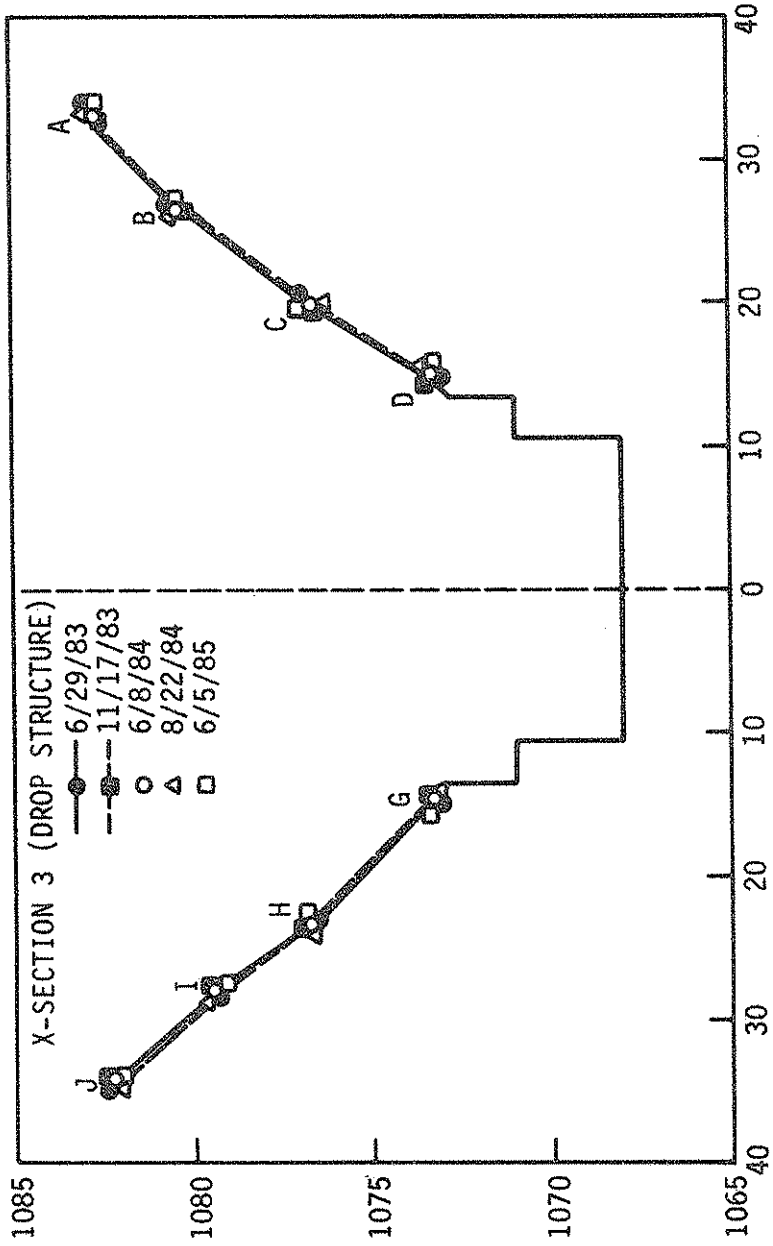
Figure 3. Cross section at about middle of structure. Virtually no differential movement is observed, which is typical of all 5 cross sections.

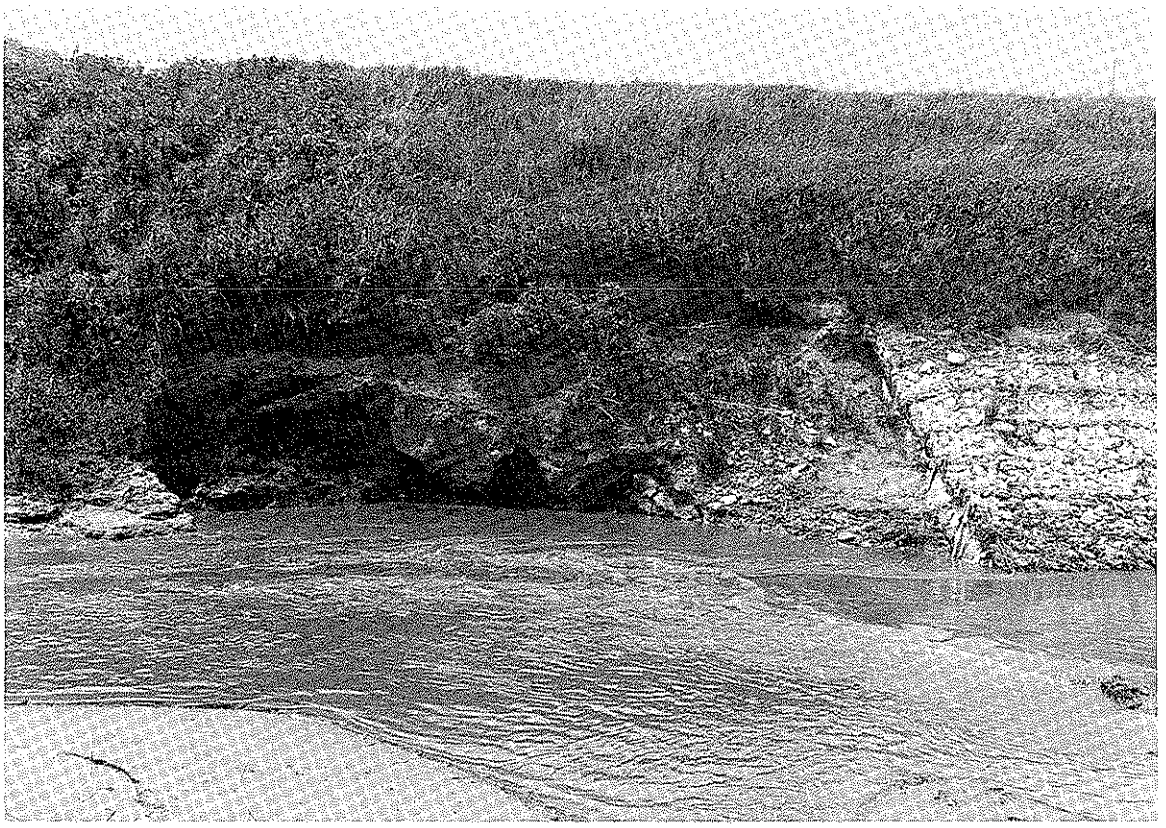
A scour hole, shown in Photoplate 2, has developed immediately downstream of the stilling basin on the west bank. The hole is roughly

ten ft long parallel to the channel and extends about three ft into the bank. This area is where the construction diversion channel was located, and the backfill in this area may have been improperly compacted. This area should be continuously observed for any expansion of the scour hole. If erosion proceeds in the upstream direction, it may undermine the side slope and stilling basin. If the hole expands, it should be protected with riprap or additional gabions.

Plate 2. Scour hole on west bank immediately downstream of stilling basin, June 1985.

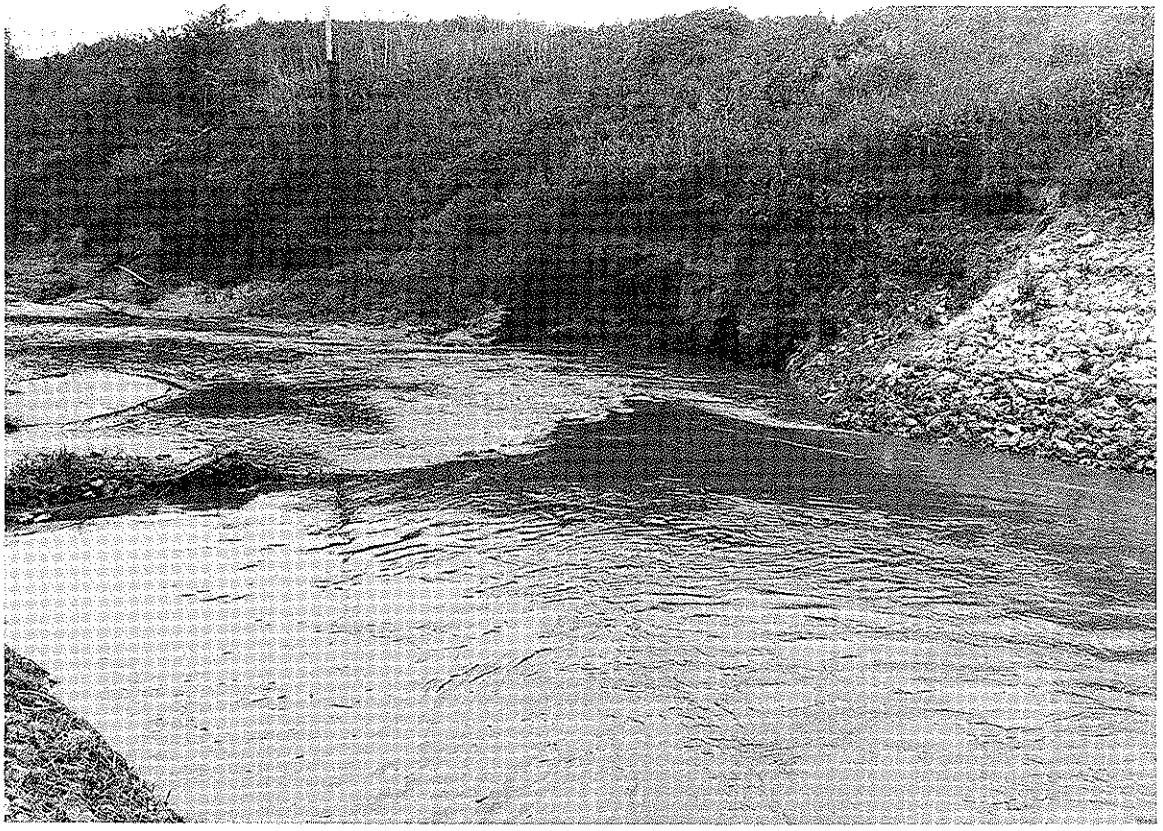
Photoplate 3 reveals that flow is being deflected toward the west bank. The structure was built with a gabion apron extending nine ft downstream from the end sill. The apron has experienced some differential settlement with the west side lower than the east. This seems to be diverting the flow toward the west bank, thereby compounding the scour problem.

Plate 3. Diversion of flow toward scour hole, probably due to some differential settlement of end of stilling basin, June 1985.

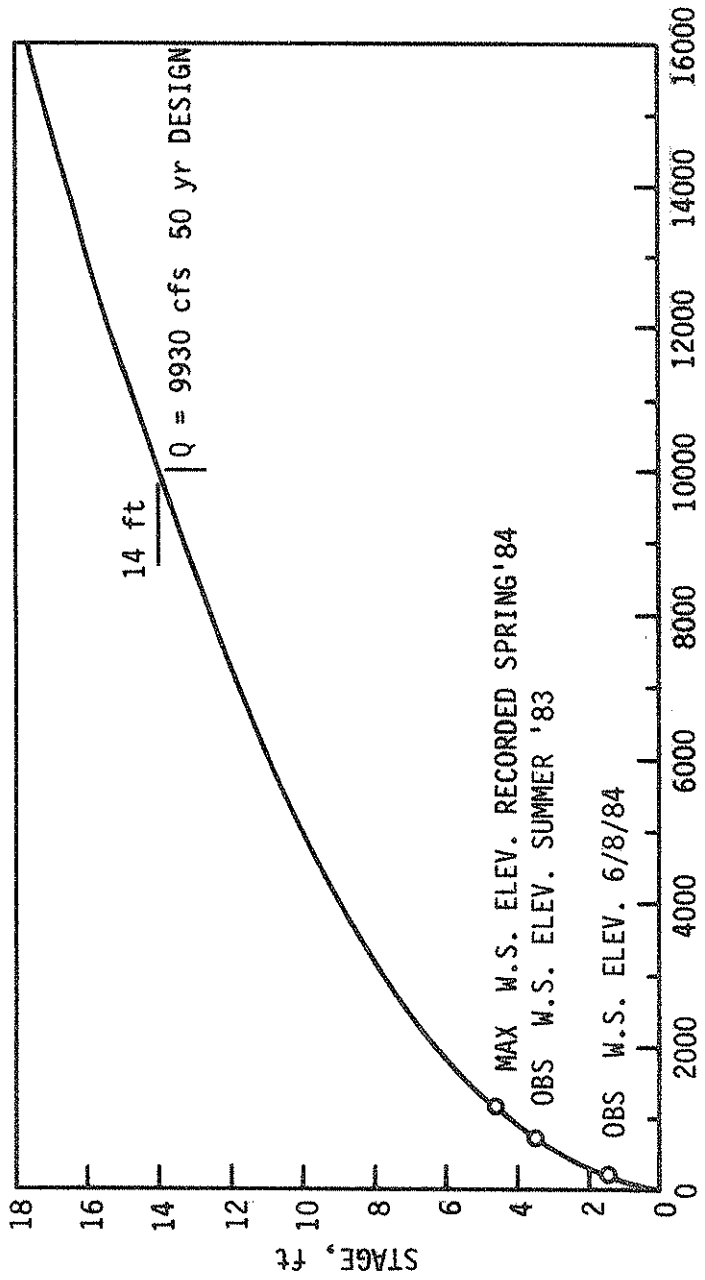
Figure 4. Stage-discharge relationship for drop structure at its crest. Crest elevation is 1079 ft MSL.

was used, and it estimated the flow depth at 13.5. The data shown in Fig. 4 give good agreement with the design estimates.

Debris deposited on the sidewalls of the structure during a flood event are physical evidence of the maximum stage for that event. The elevations of the debris lines were measured during Summer 1983, Spring 1984, on 6/8/84, and on 6/5/85. These depths of flow are plotted on Fig. 4, and indicate that, to date, the flows have been well below the design flood with discharges less than 1,200 cfs.

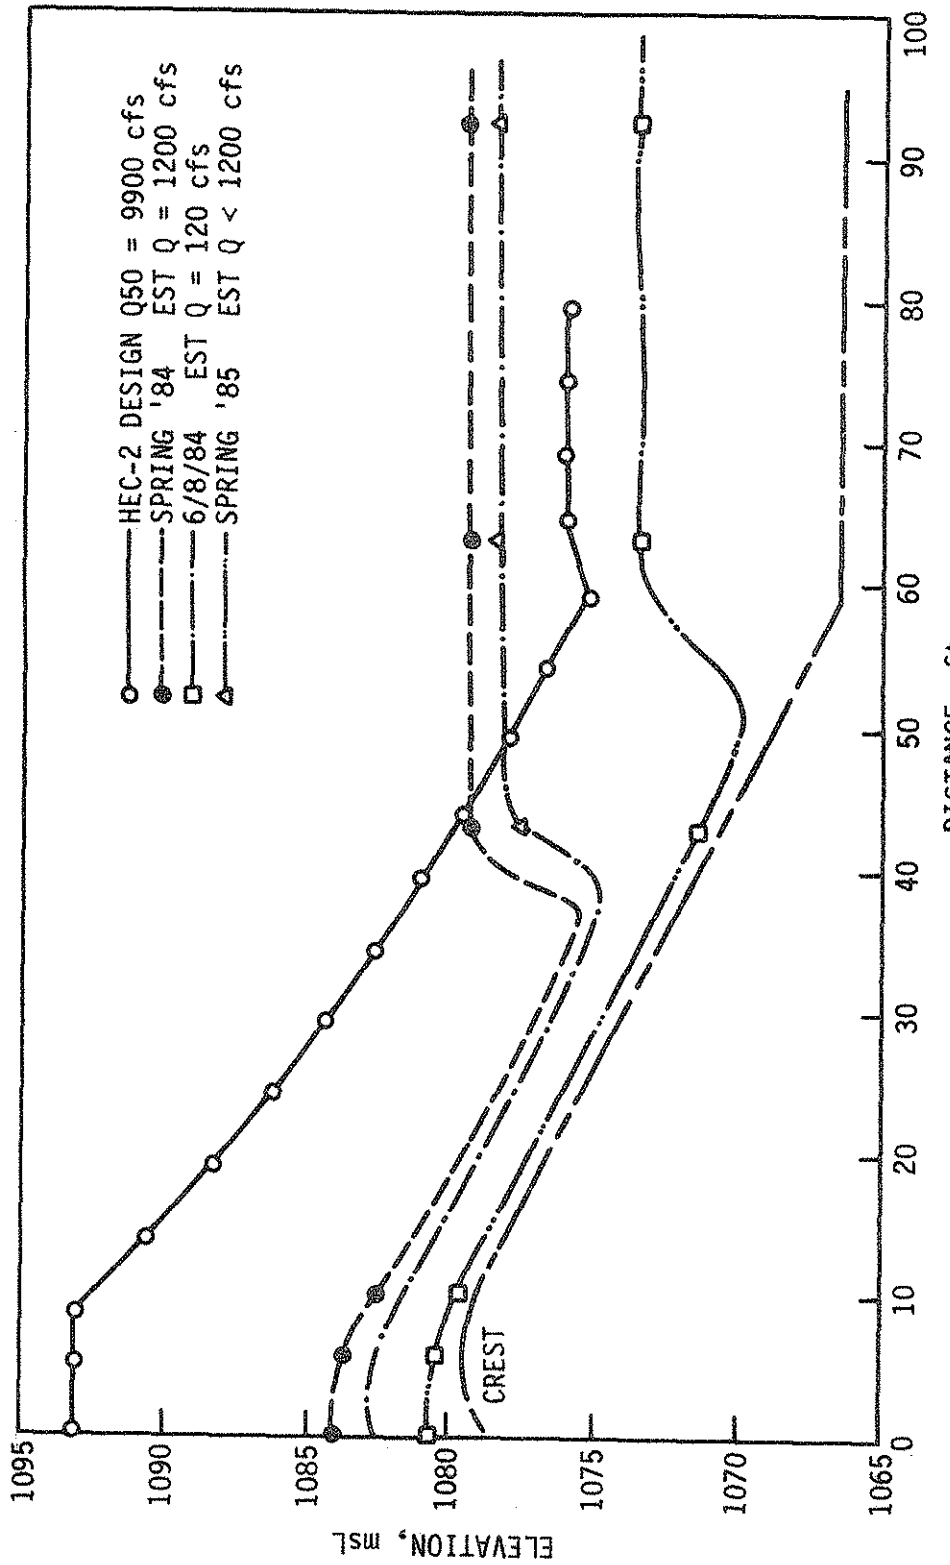
The water surface profile for the design flow of 9,900 cfs was estimated using the HEC-2 program. The design water surface profile and the water surface profiles for 120 and 1,200 cfs discharges, which were estimated from the debris lines, are shown in Fig. 5. These curves suggest that the downstream effects of the structure and stream force the hydraulic jump upstream onto the spillway to create a submerged jump.

Figure 5. Water surface profiles from HEC-2 for design and as estimated from debris lines at various dates.

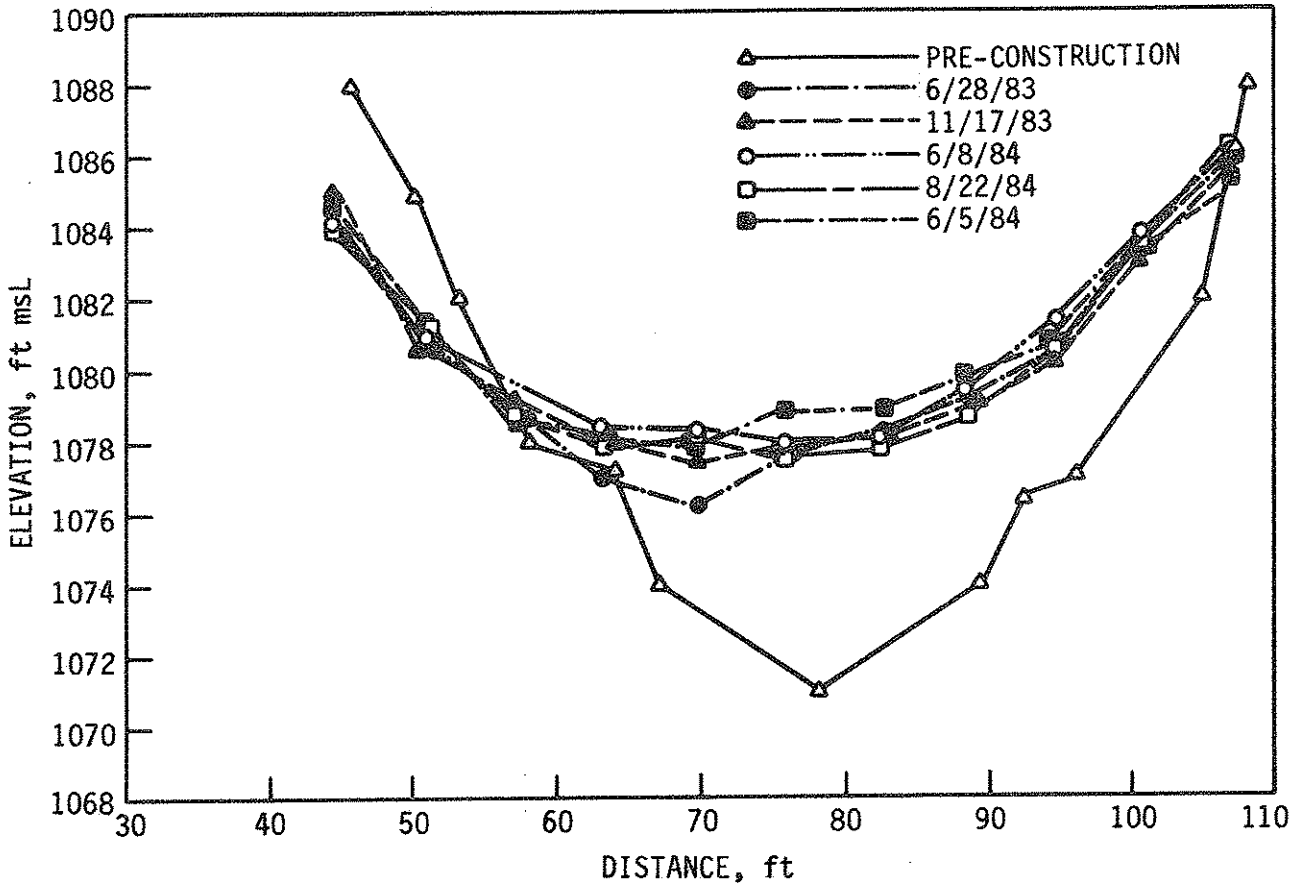
Changes in the upstream channel geometry caused by sedimentation have been monitored by surveying transverse profiles at the bridge and at 500-ft intervals upstream to a distance of 5,000 ft. Transverse profiles at the bridge were measured on 11/12/83, 6/28/83, 6/8/84, 8/22/84, and 6/5/85. A set of transverse profiles is shown in Fig. 6. These sections show that sedimentation to a depth of 6 ft had occurred prior to 6/28/83, but little change has been noticed since that date.

Figure 6. Transverse cross sections of channel bottom for various dates.

This indicates that the major amount of sedimentation above the crest occurred during construction and that the 1,200 cfs event since construction has had little effect on deposition.

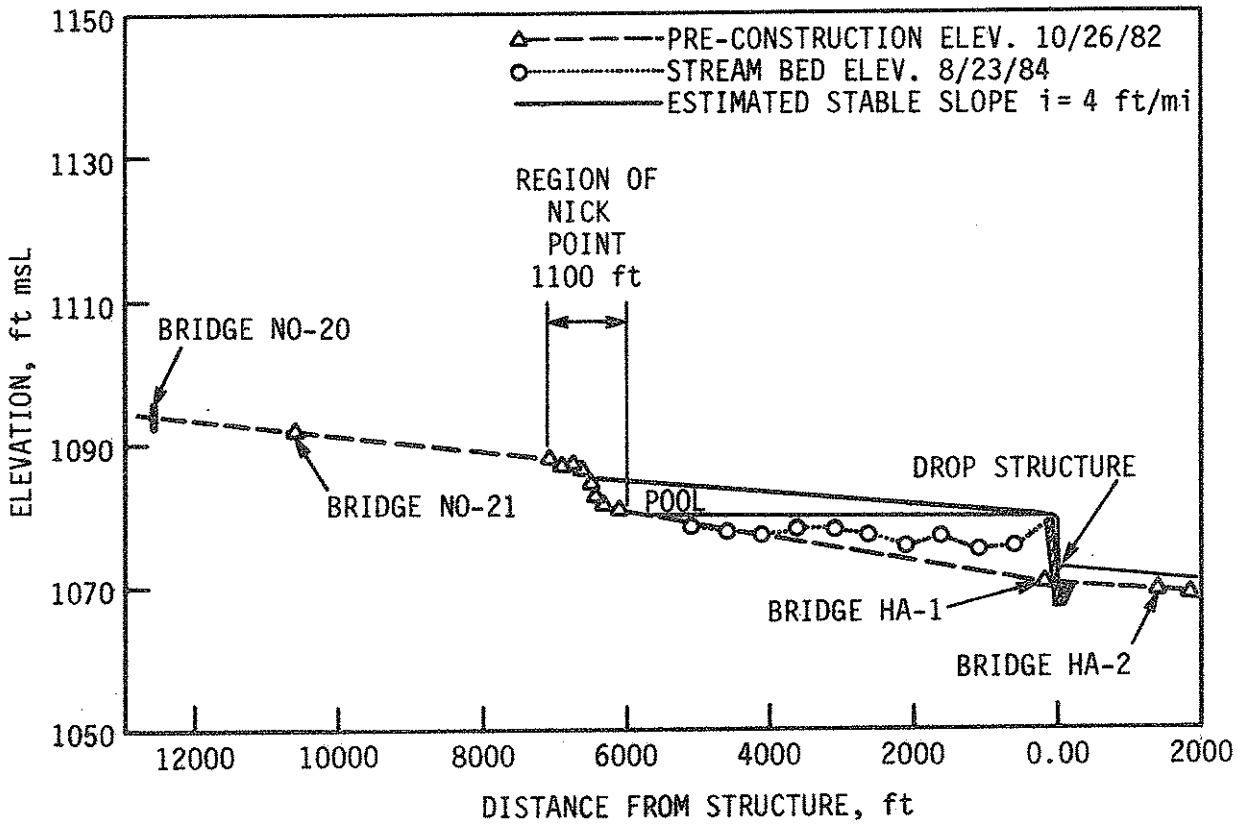
A longitudinal profile surveyed on 8/23/84 is shown in Fig. 7. The water surface extends upstream from the crest of the structure to a distance of 5,500 ft upstream, and the sediment surface extends approximately 4,000 ft upstream from the structure. It is expected that this sediment will extend further upstream in the future. A conservative estimate is that it will continue to the point where the water surface profile intersects the stream bed profile, i.e., about 5,500 ft.

Figure 7. Longitudinal profile of channel bottom and water surface in pool upstream of structure.

application to the gabion structure is in Appendix 3. That analysis estimated a stable slope of 4 ft/mi, which would cause the sediment to extend upstream for a distance of about 6,500 ft. That slope is also plotted on Fig. 7 where it can be seen that the wedge of sediment would intersect the knickpoint at about midheight.

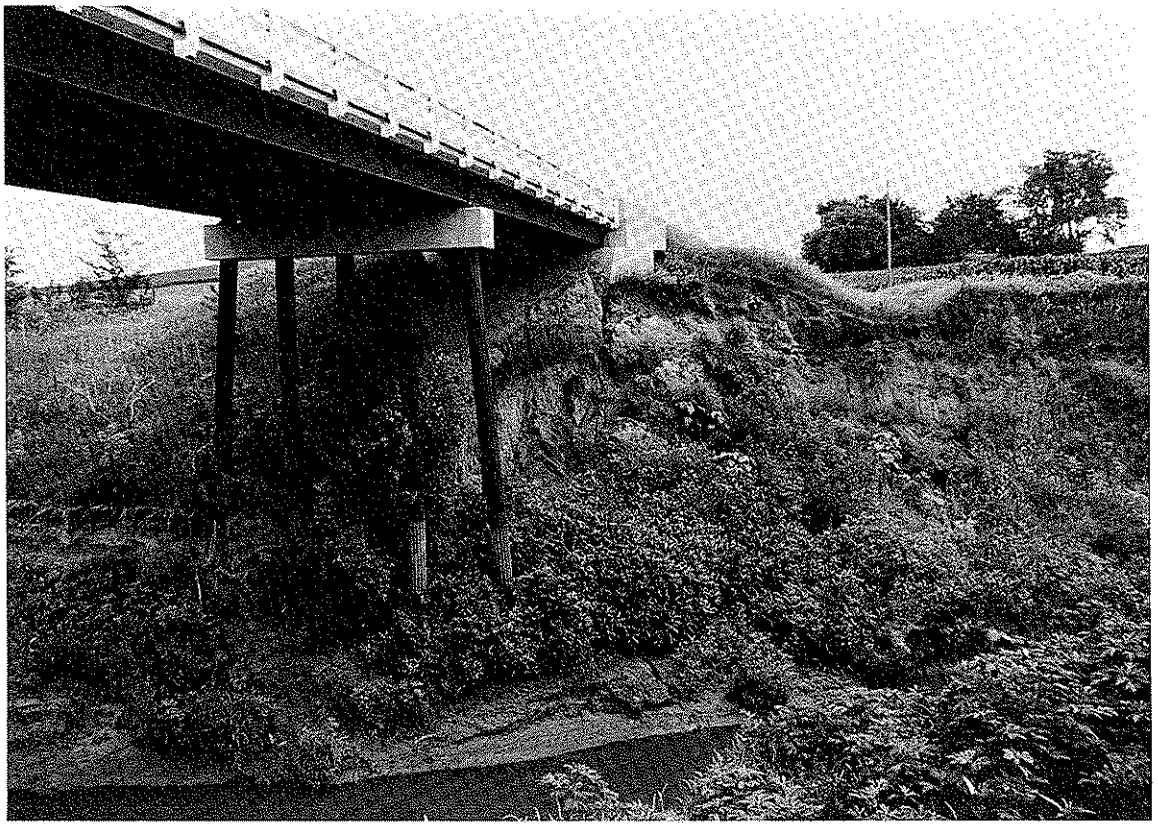
The sedimentation beneath the bridge has been sufficient to cover the piles to their original depth of soil cover and to stabilize the slope beneath the abutment. This is illustrated by comparing Photoplates 4 and 5. Photoplate 4 was photographed in 1979 when erosion had exposed about 6 ft of previously buried piling and pulled soil away from the abutment. Photoplate 5 was taken in June, 1985 and shows that the piles have been covered to their original depth.

Plate 4. East end of bridge showing exposed piling and soil slide away from abutment. Light colored portion of the bottom of piles indicates where soil formerly covered piles, July 1979.

Plate 5. East end of bridge showing piling once again covered by soil and stable soil slope beneath abutment, June 1985.

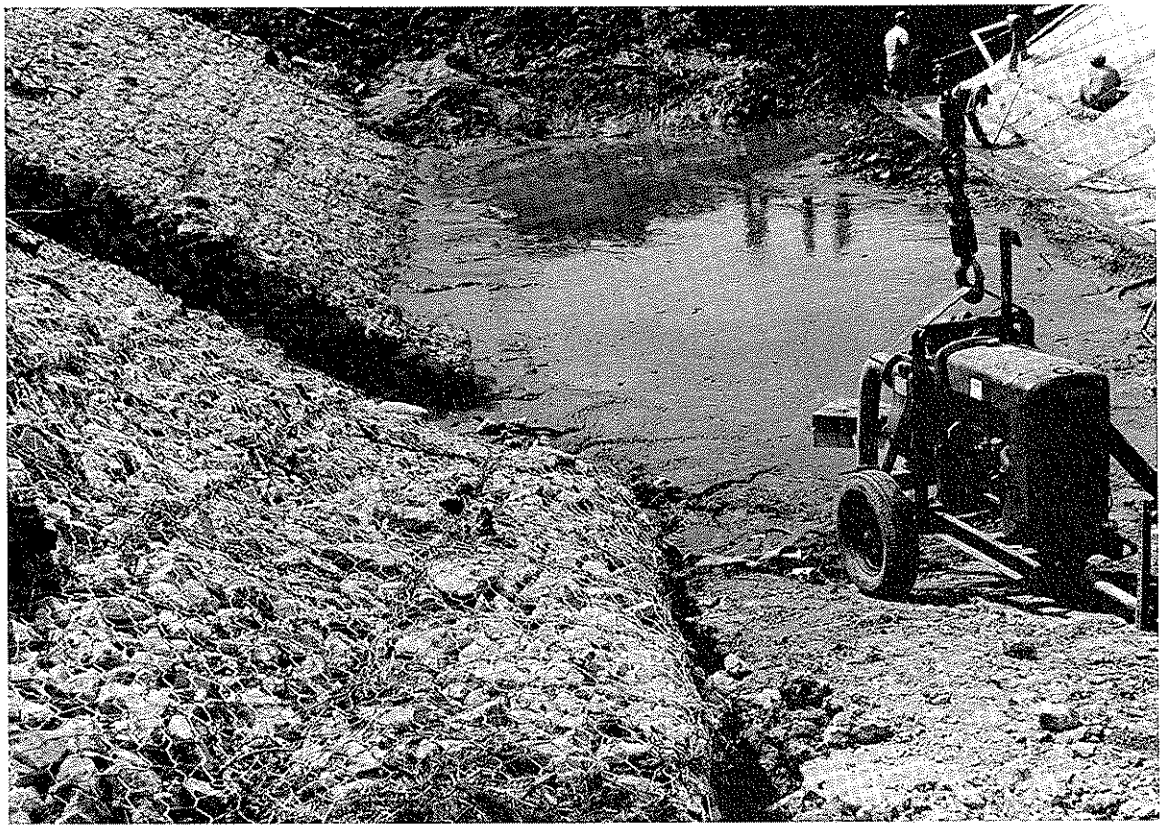
Plate A-6. Dewatering of stilling basin after a high flow event, May 10, 1983.
