Improvement of Longitudinal Joints in Asphalt Pavement

Final Report
Iowa Highway Research Board
Project HR-215

Highway Division
January 1987

Iowa Department of Transportation

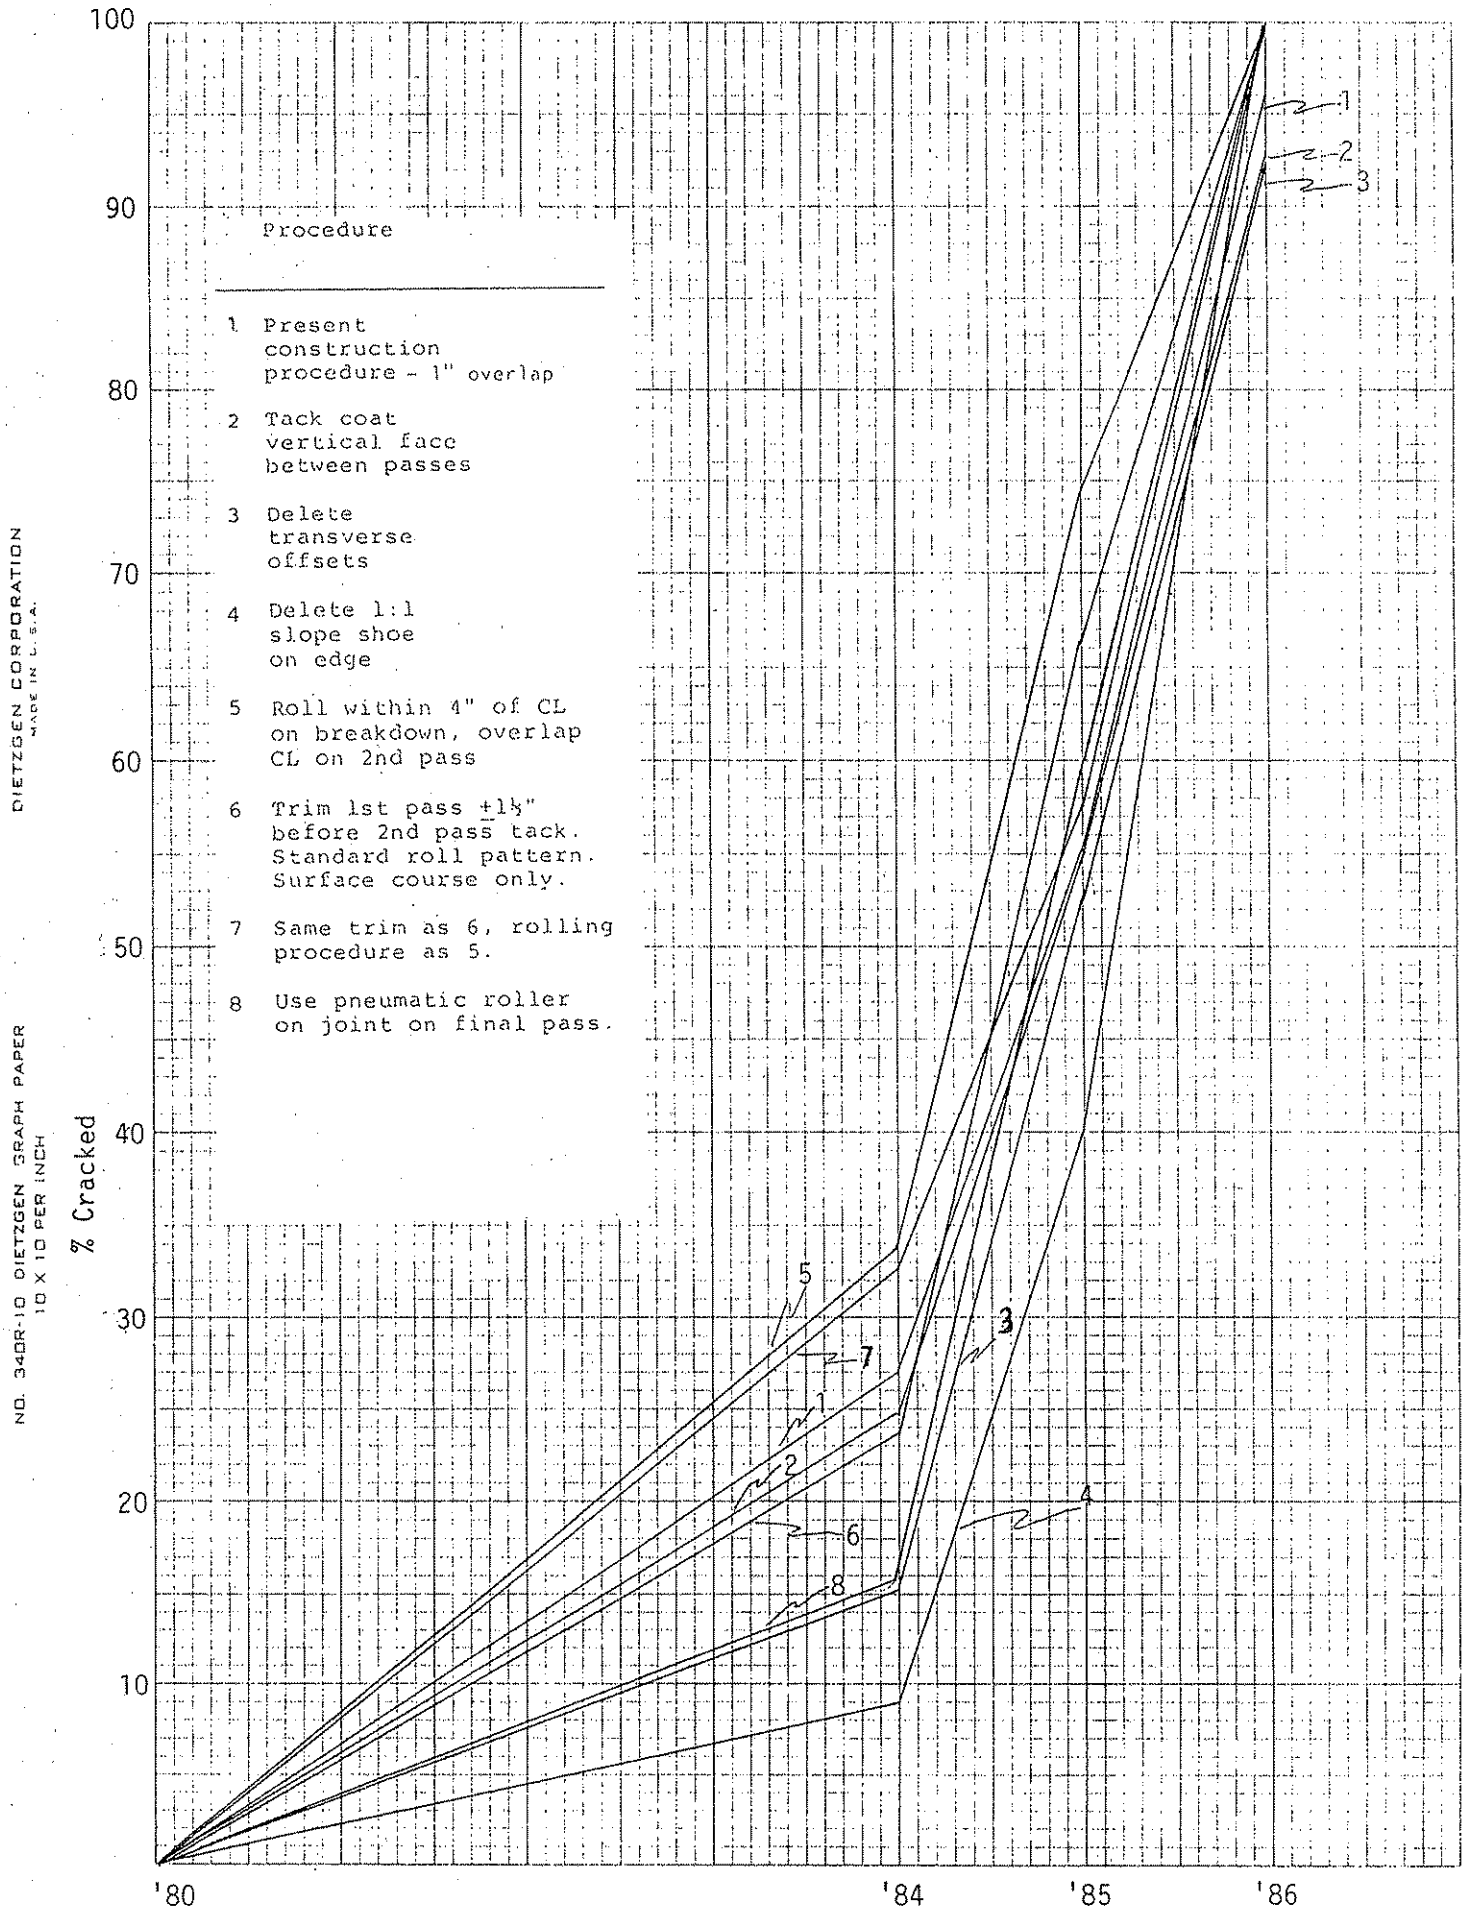
Figure 2: Rate of Cracking

All but procedures 1, 2, and 3 had cracked 100% of their length by November 1986, and they were cracked 96.1%, 92.7%, and 92.5% respectively. Each of those procedures had one section that was 100% cracked. The percentage of cracking by section and year is listed in Table II along with the densities near the centerline that were determined after construction in 1980. After 1984, all procedures exhibited a very steep slope in the rate of cracking (Figure 2).

None of the procedures used on this project succeeded in preventing a longitudinal crack along centerline.

The method providing the best performance for four years after construction was removal of the 1:1 slope shoe from the paver when placing the surface course. This method had 9.0% cracked after four years and 100% cracked after six years of service.

The areas placed with a one inch overlap as presently described in the construction manual had 27.3% of the joint cracked after four years and 96.1% cracked after six years of service.

Between four and six years of service the rate of cracking for all methods used on this project was about the same. Overall, there was no one method that out performed the others in this project.
