REINFORCED EARTH AND STONE COLUMNS FOR WEAK SUBSOIL CONDITIONS

Final Report
Project HR - 510

Highway Division
Office of Road Design

PROJECT: WOODBURY COUNTY
I-IG-F-29-6(13)150--0B-97

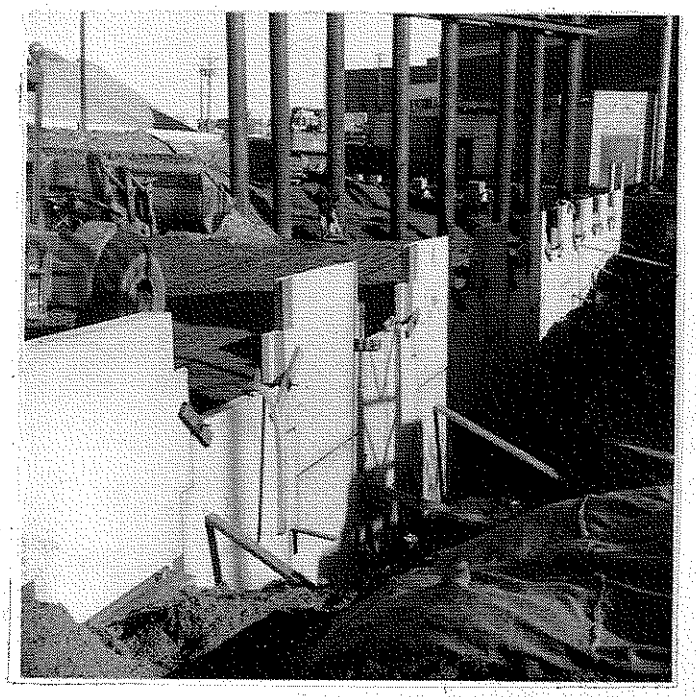
Bridge abutment piling were placed in several of the wall systems. These were encased with a light tubing which was maintained in a "centered" position as the walls were built. These tubes tipped outward (toward the wall face) as much as 6 in. from the constructed position. In one case the movement continued until after the abutment was constructed and the bridge beams had been placed. Fortunately movement stopped before damaging the structure.

Beginning of construction-Reinforced Earth Wall No. 4
Pile covering can be seen (Page 4)

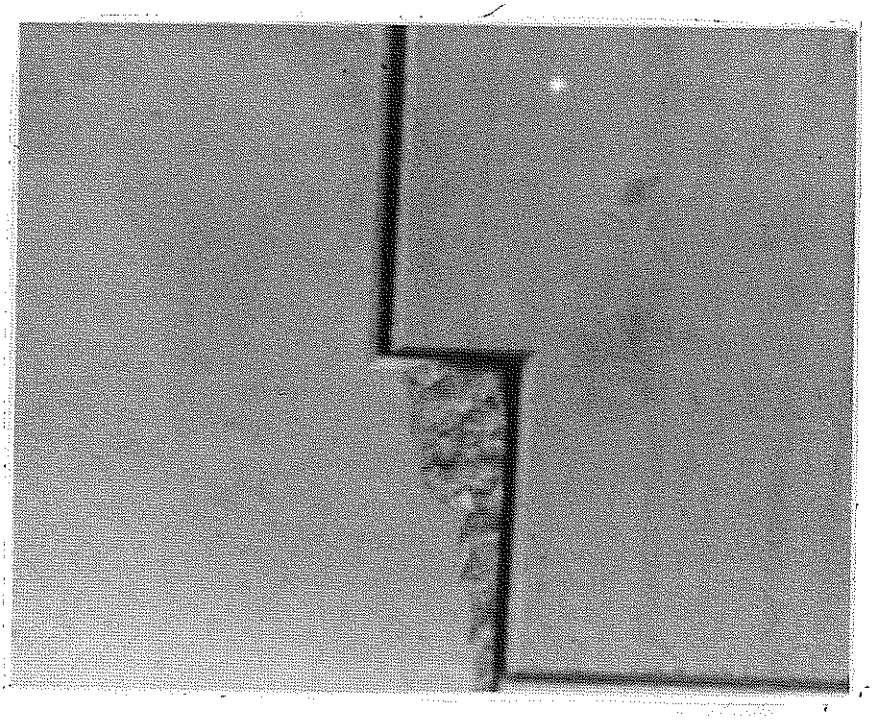
Chipped Reinforced Earth Wall Panel (Typical)
(Page 4)

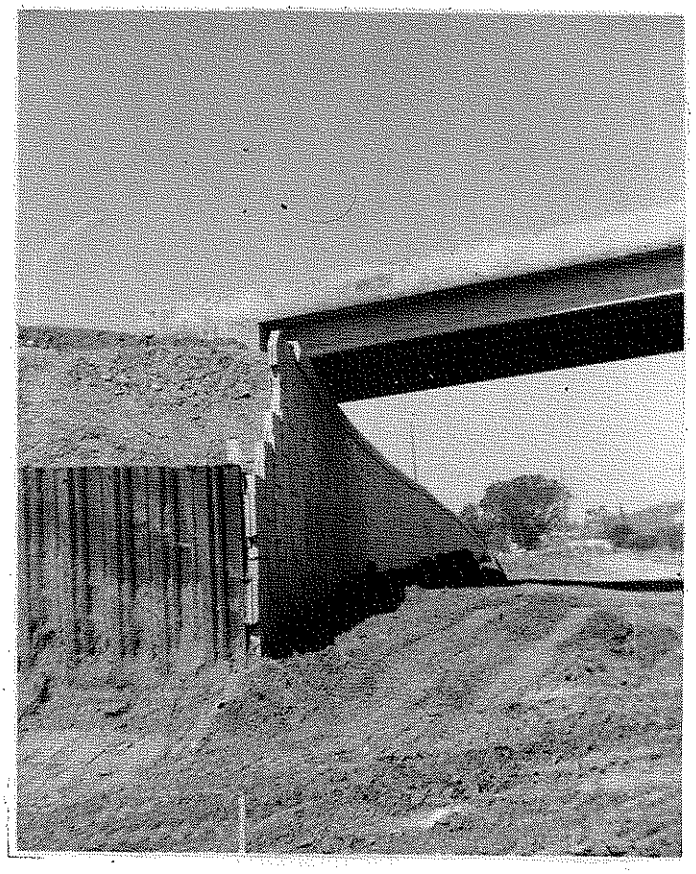
This same problem resulted in some sections of the Reinforced walls eventually obtaining an outward lean of 1 in. to 3 in. from the desired vertical alignment. Wall 4, which was built in conjunction with the stone columns and had only minor settlement, presented the most "movement" problems. This wall was built in several stages in addition to the two which were designed. The wall was built with a one-half inch per panel "construction" batter which proved to be insufficient to maintain vertical alignment. Differential movements occurred between the various stages and at one point the construction contractor yielded to temptation and attempted to straighten a section of wall by pushing inward. This only resulted in breaking several panels. The only other panel breakage, noted to date, has occurred at corners and in two cases alignment rods have broken out of the inside of panels. These breaks have occurred in the lower portion of wall 4 where wood "alignment" wedges were left in place during second and later stage additions. Additional driving of these wedges may have occurred as an effort to maintain vertical alignment.

Wall distortion-Reinforced Earth Wall No. 3
West End (Page 4 and 5)

If this project is representative, these walls should have a minimum completed batter of one-half inch per panel to avoid later outward lean.

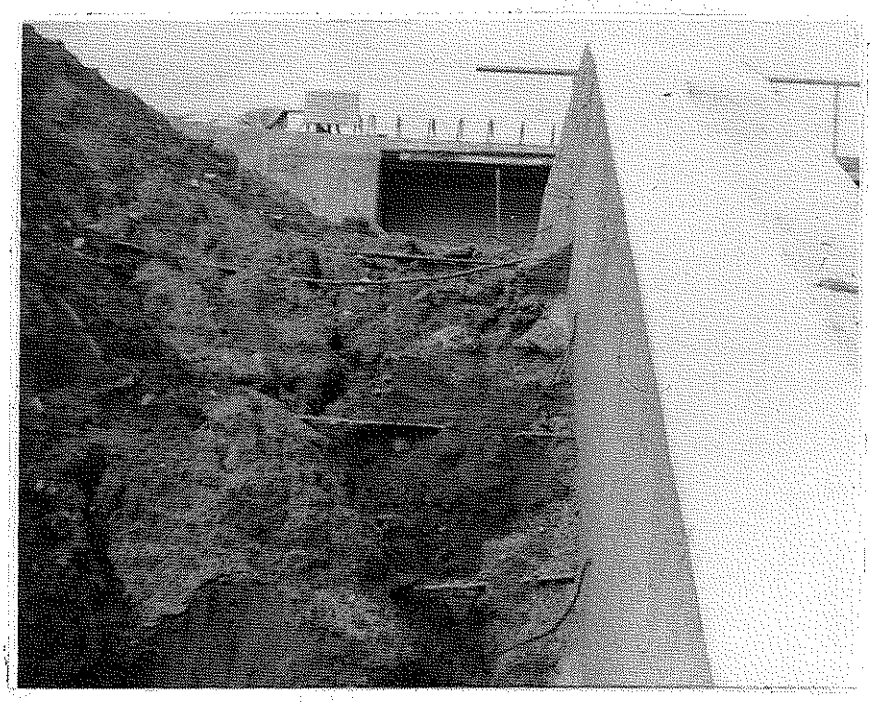
Reinforced Earth Wall No. 3
Strip Exposure from Erosion
between Stages of Construction

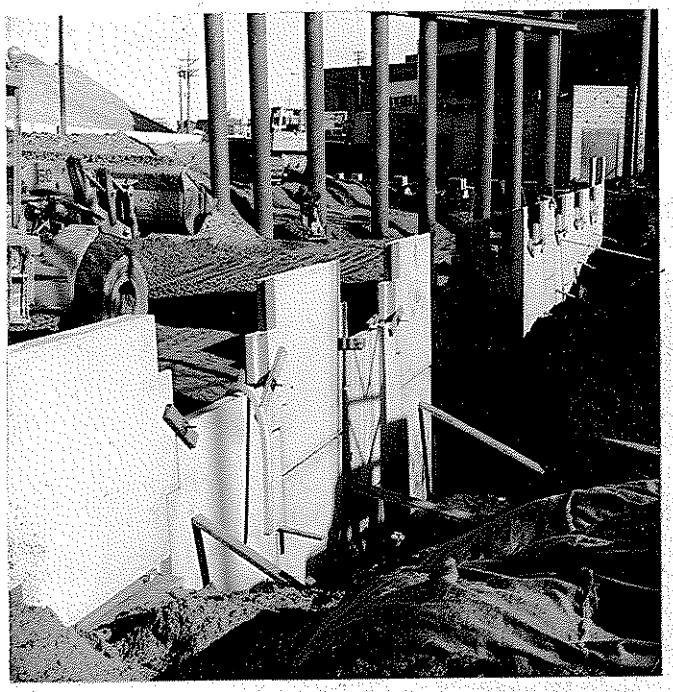
Beginning of construction-Reinforced Earth Wall No.4
Pile covering can be seen (Page 4)

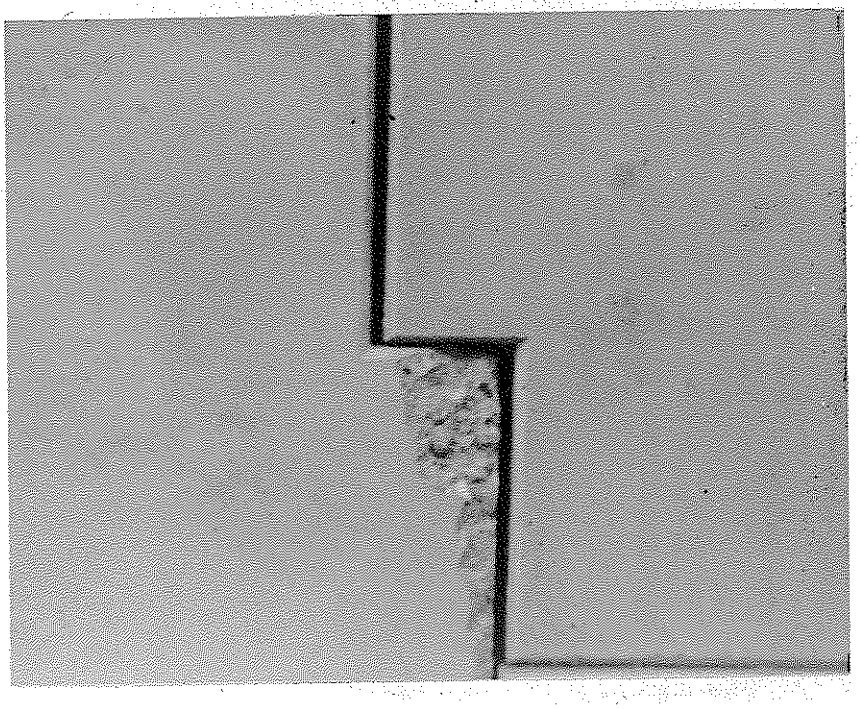
Chipped Reinforced Earth Wall Panel (Typical)
(Page 4)

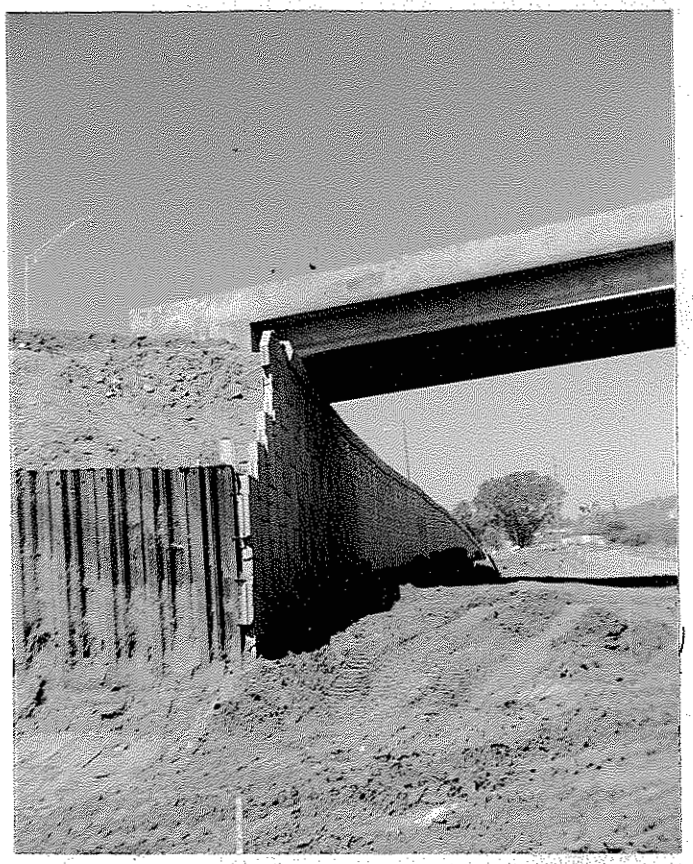
Wall distortion-Reinforced Earth Wall No. 3
West End (Page 4 and 5)

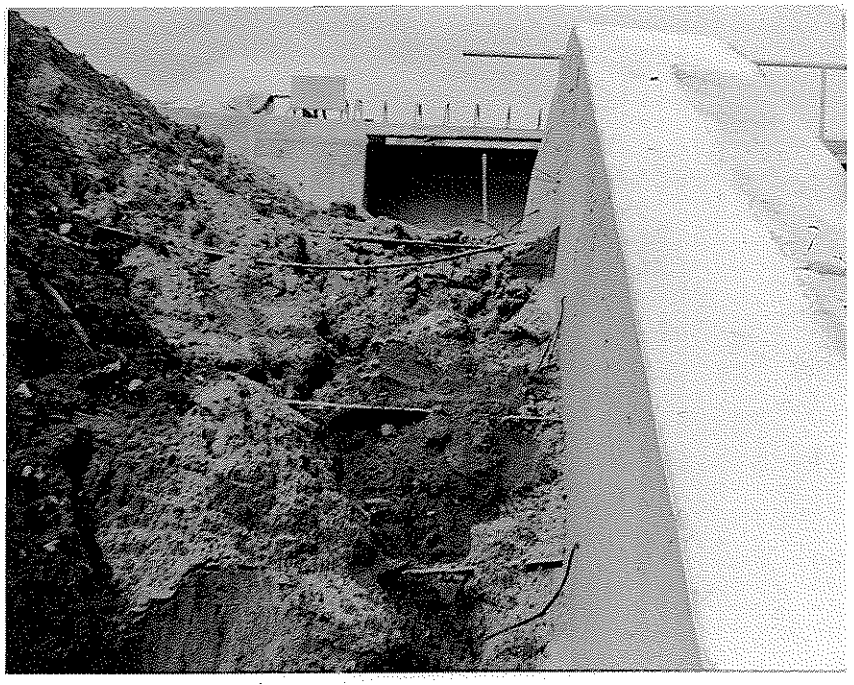
Reinforced Earth Wall No. 3
Strip Exposure from Erosion
between Stages of Construction
