Embankment Quality
Phase II Final Report

Sponsored by the Project Development Division
of the Iowa Department of Transportation
and the Iowa Highway Research Board
Iowa DOT Project TR-401
CTRE Management Project 97-8

December 1999

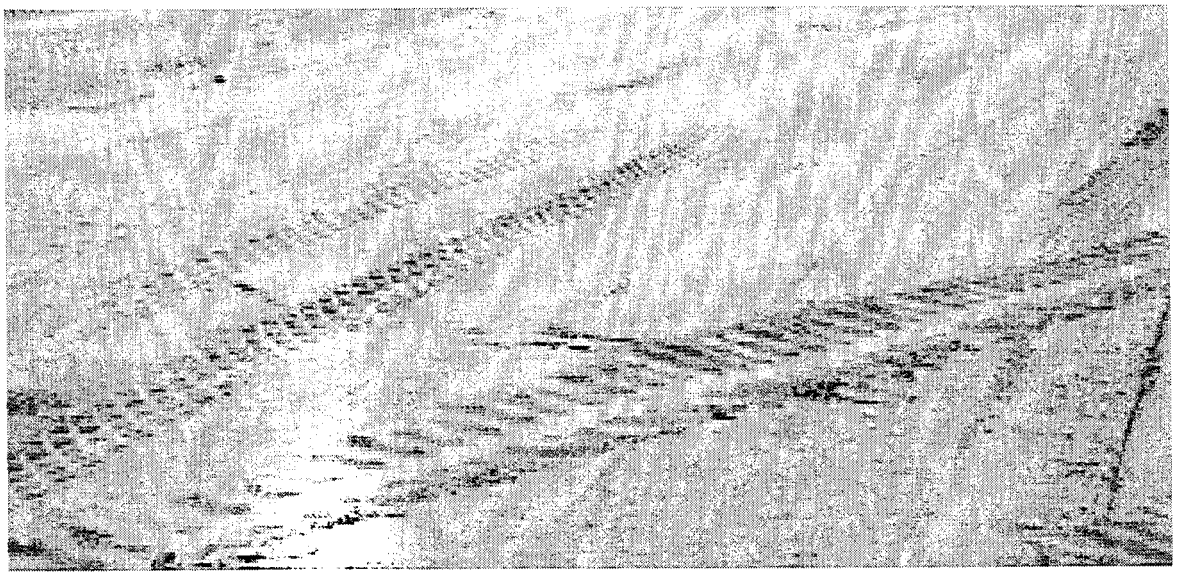
Figures 6 and 7 are photographs of the cohesionless soil embankments for U.S. Highway 61. Figure 6 shows an embankment constructed with A-3 soil and Figure 7 shows an embankment constructed with A-2-4 soil. During compaction both of the soils averaged approximately 13% moisture content. However, the engineering properties of these materials were very different. Figure 8 shows entrapped water in the embankment that was constructed with material sample C1.

FIGURE 6 Sample C-1 fine sand at 13% moisture

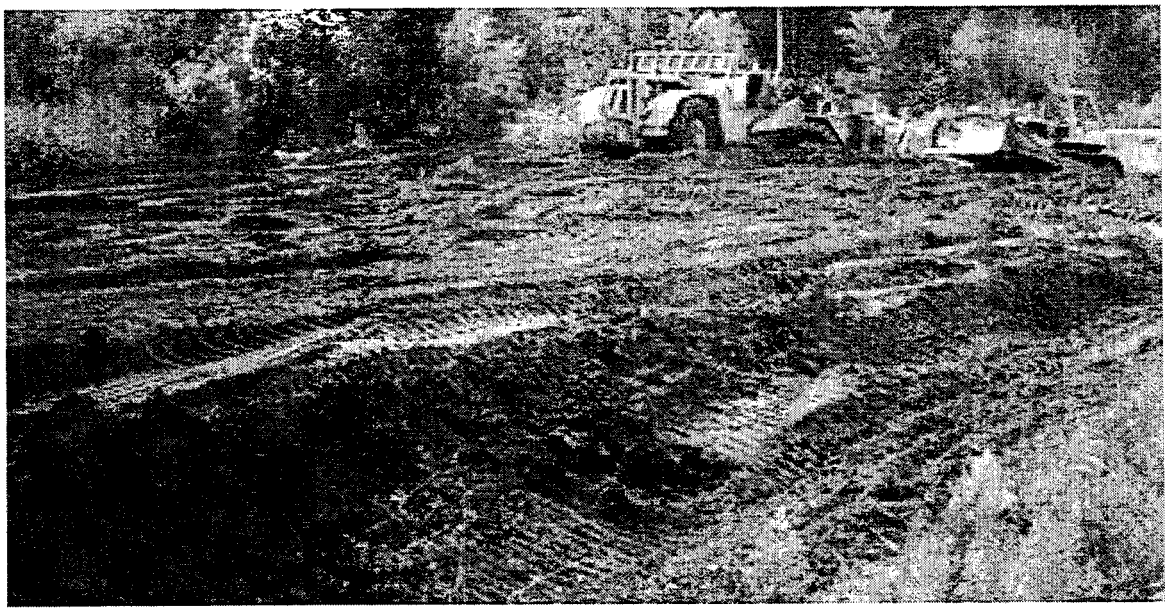
FIGURE 7 Sample B-5 silty fine sand at 13% moisture

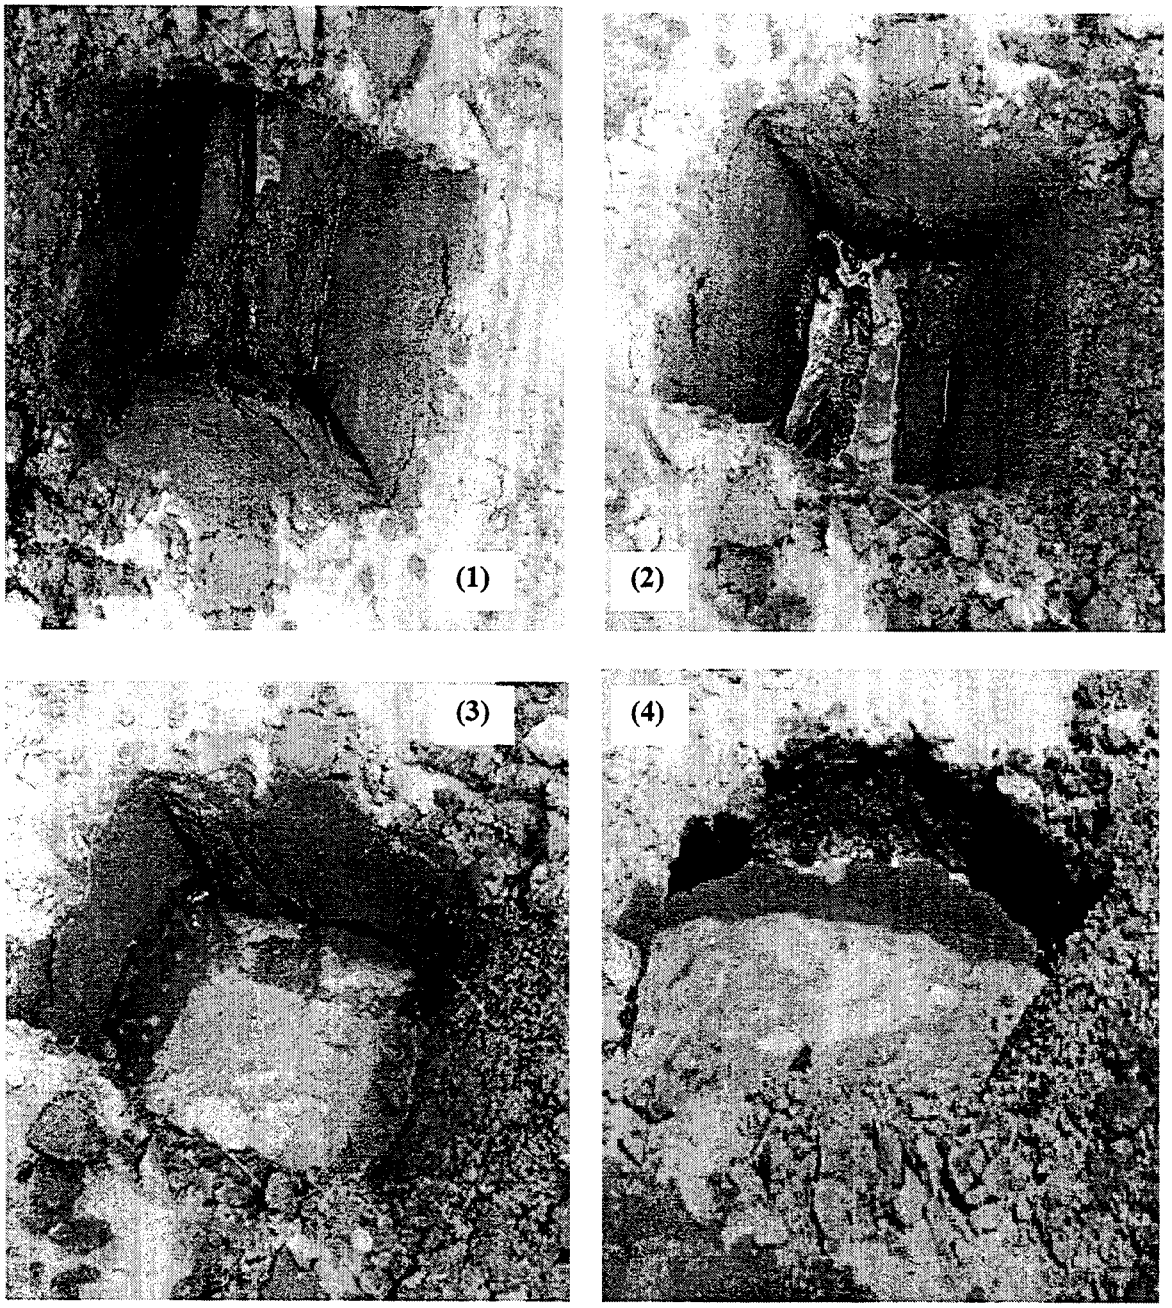
FIGURE 8 Sequential photographs of test pit excavation over a 10 minute span indicating heavily saturated embankment

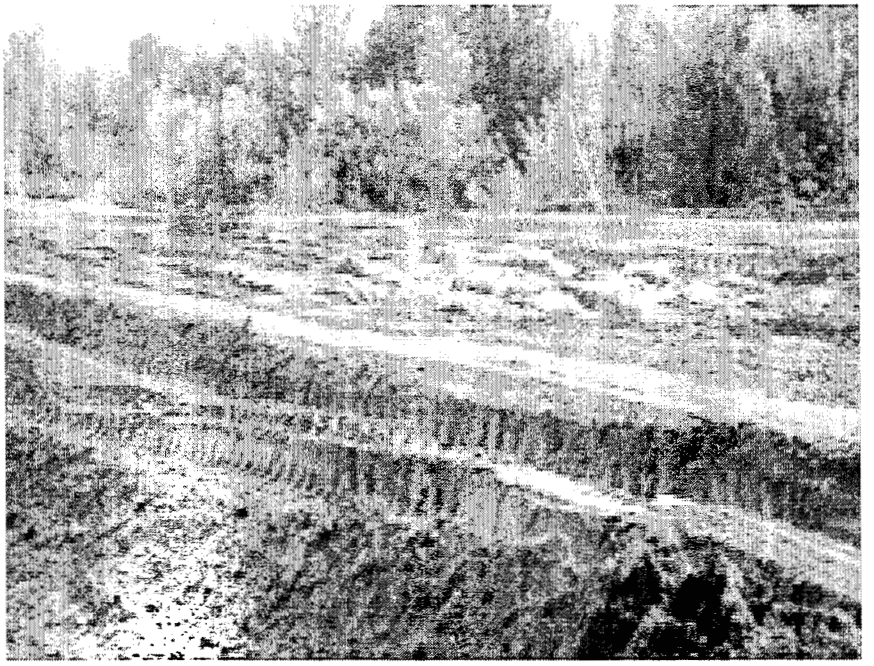
Construction equipment rutting is pictured in Figure 20. The photograph shows the instability of the embankment on which the depth testing was conducted. The ruts evident from construction equipment measured over a foot in depth and the roller was unable to operate. The only option for the contractor was to move the operation to another portion of the embankment and allow this portion to dry. Unfortunately, this material did not dry and the contractor was forced to implement moisture control procedures. Eventually disking was used to aerate and dry the material. Figure 21 is a photograph of the embankment after it had been disked and dried. Notice the difference in stability after disking.

FIGURE 20 Unstable embankment of A-2-4 material

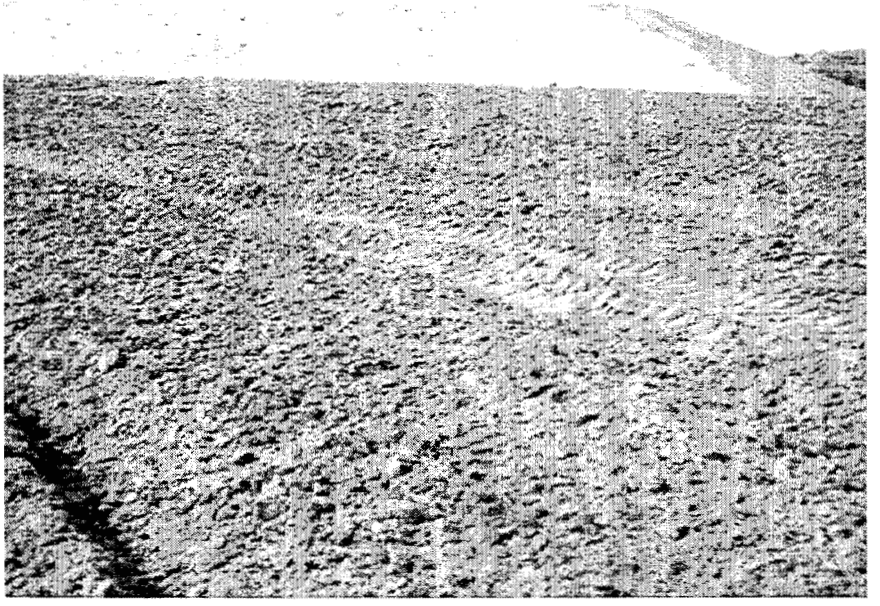
FIGURE 21 Embankment of A-2-4 material with moisture control

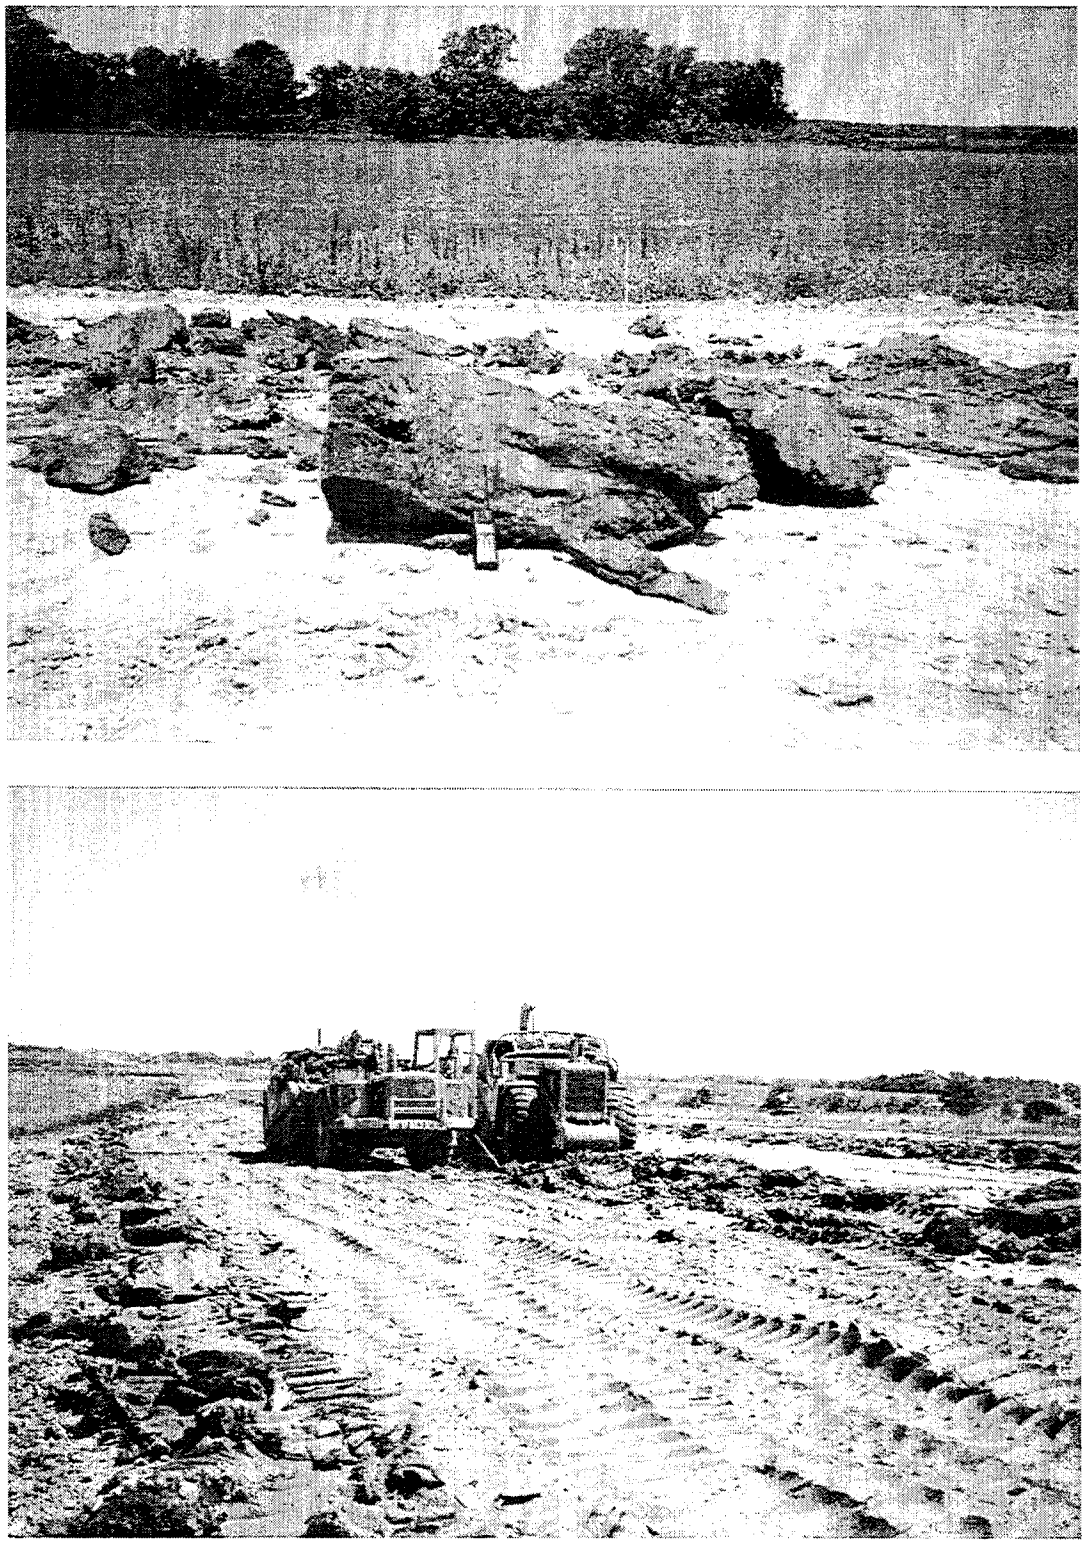
FIGURE 33 Large clod size and compaction from loaded CAT 627 scrapers

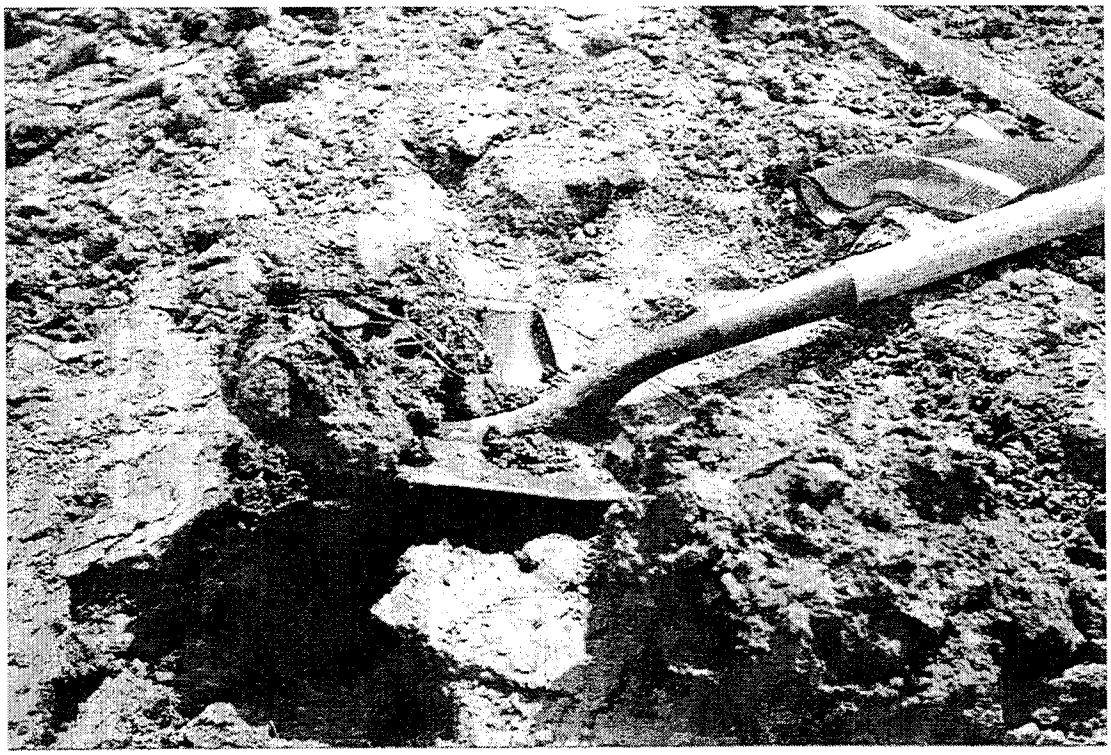
Once a lift of material was placed, compaction was achieved by rolling the soil with the sheepsfoot about 4 to 5 times. Lift leveling was not performed at this fill location. Consequently large clods and overly thick 10 to 18 inch compacted lifts resulted in "Oreo cookie" effects as shown by DCP index results. Rutting and pumping were common of every lift observed at this test location. Consistently sheepsfoot roller walkout was not achieved in accordance with Iowa DOT Specification 2107.05.

FIGURE 40 Organic material and large clods from scraper excavation
