CRESCO MUNICIPAL AIRPORT PAVEMENT MANAGEMENT REPORT

Prepared For:
Iowa Department of Transportation
Office of Aviation

Prepared By:
Applied Pavement Technology, Inc.

November 2003

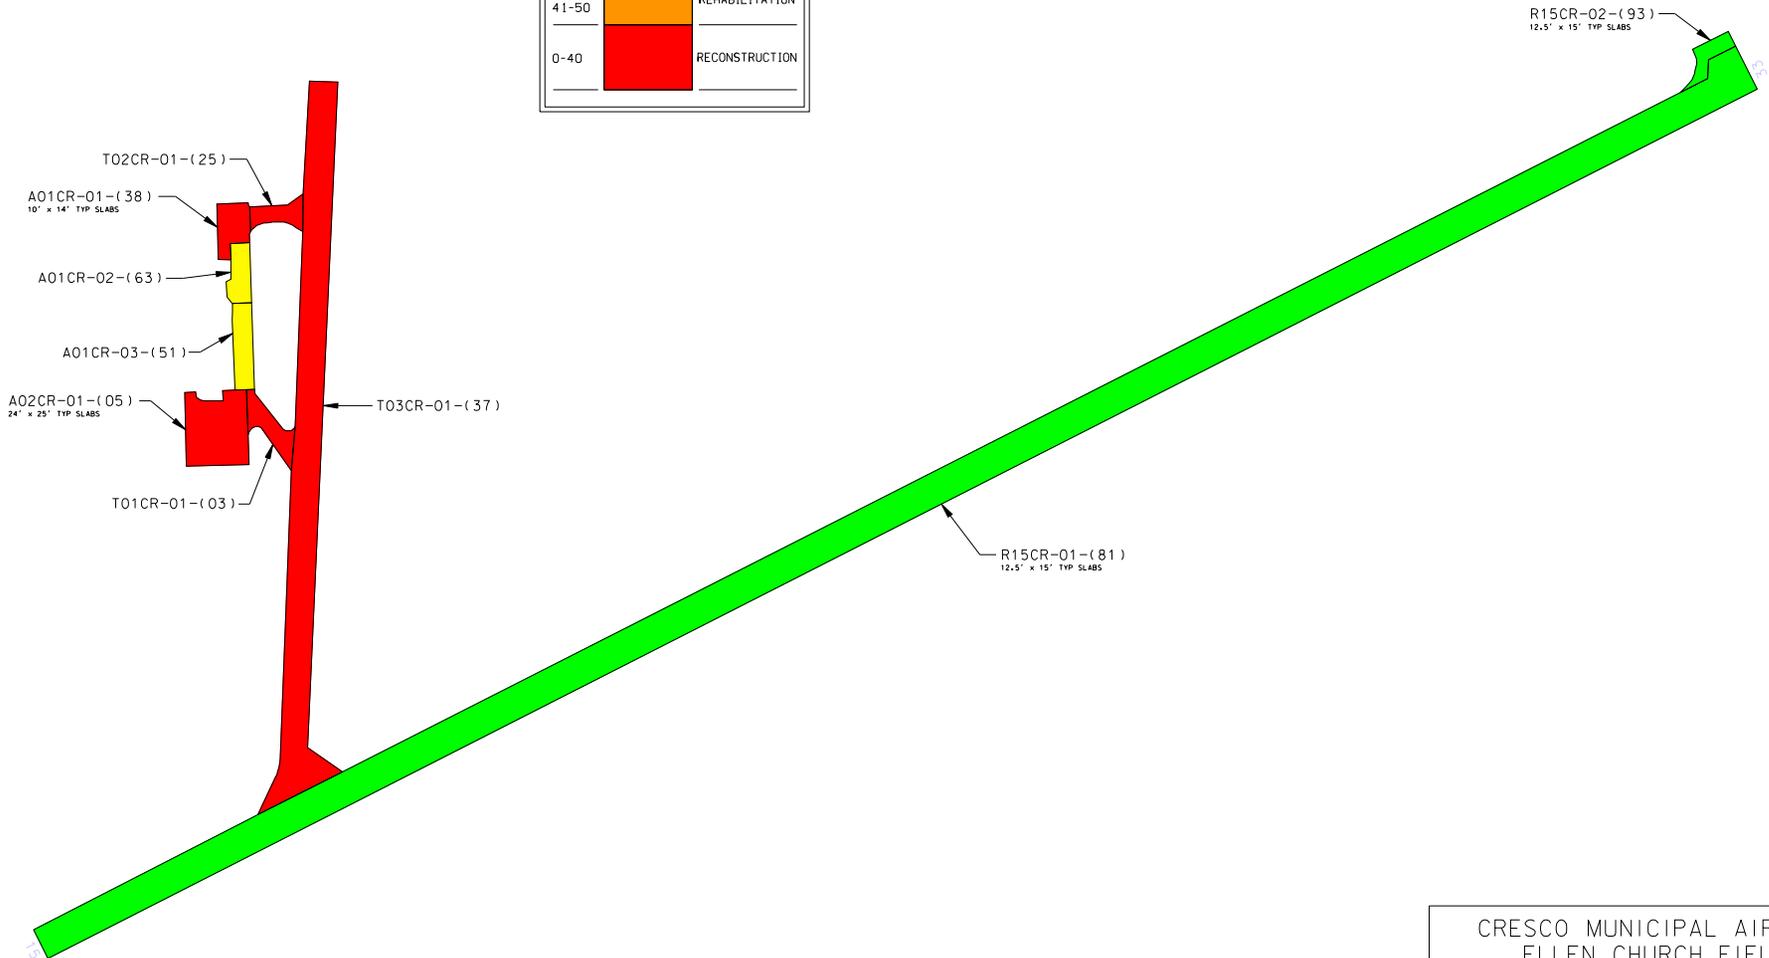
PLAN VIEW

Figures 6 and 7 provide graphs summarizing the overall condition of the pavements at the Cresco Municipal-Ellen Field Airport. Figure 8 is a map that displays the condition of the pavements evaluated. Table 1 summarizes the results of the pavement evaluation. Appendix C presents photographs taken during the PCI inspection, and Appendix D contains detailed information on the distresses observed during the visual survey. Appendix E includes detailed work history
