IOWA STATE HIGHWAY 92 OVER DRAINAGE DITCH #25

Performance Evaluation Galvanized Reinforcing Bars

Louisa County, Iowa

Final Report
June 15, 2015
WJE No. 2012.5759

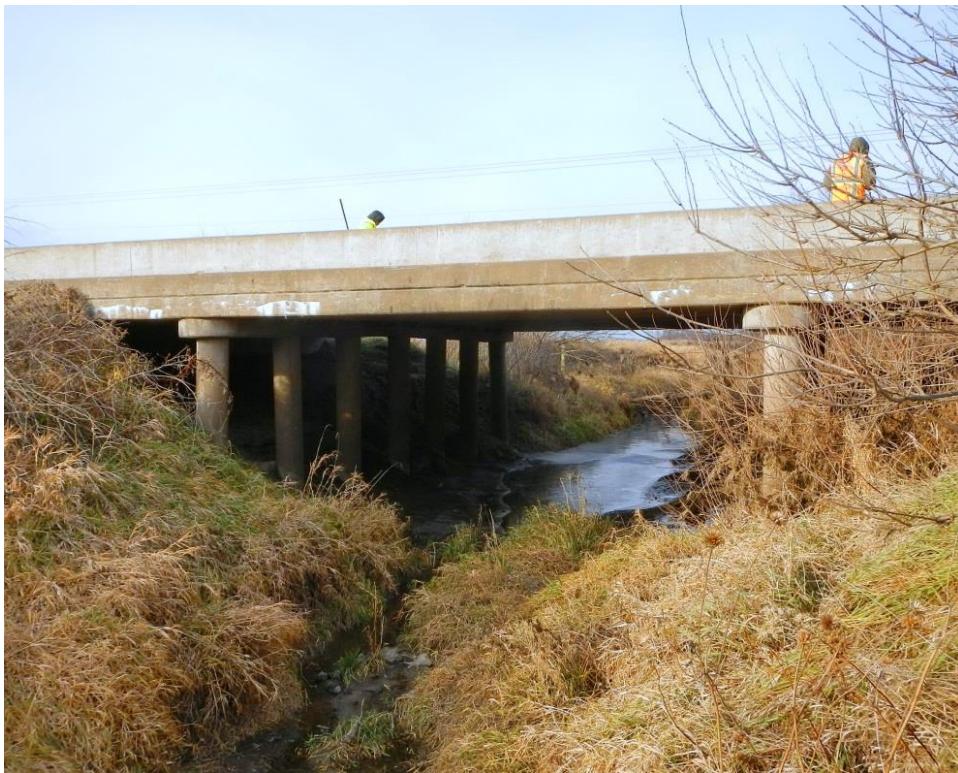
Figure 1.2. South elevation of subject bridge.

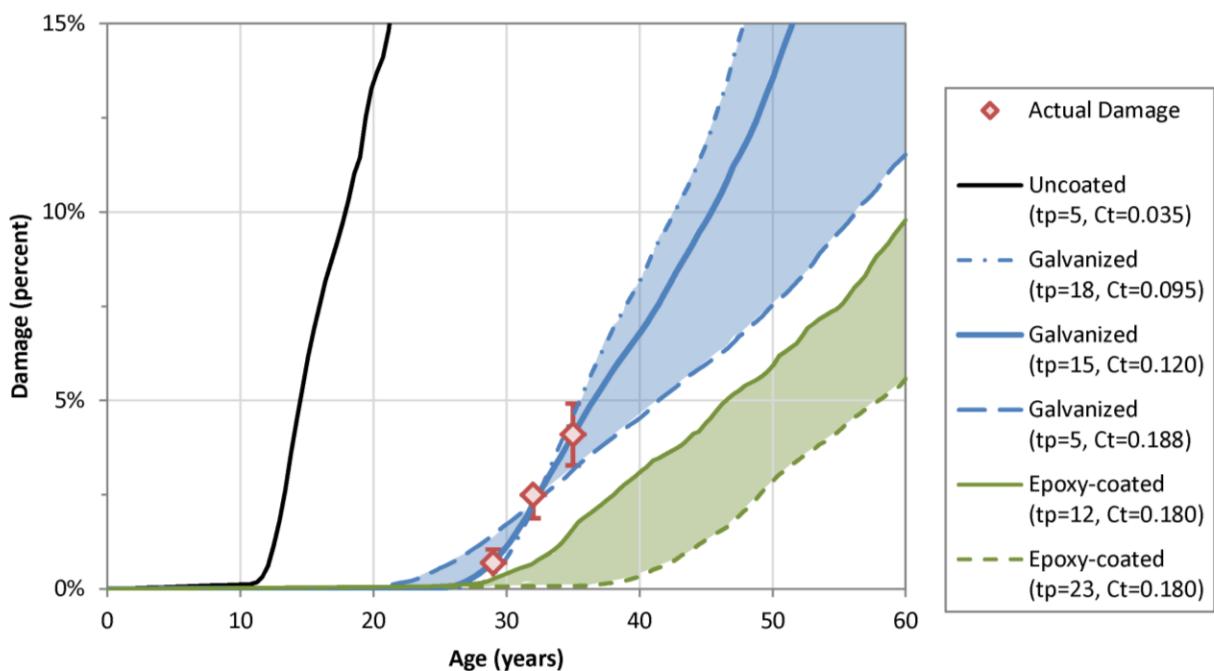
The predicted damage evolution for galvanized bars in Figure 4.3 shows generally good agreement with the damage history for all three modeled cases, considering the uncertainty outlined above, when the assumed chloride thresholds (representing the lower bound, "best estimate" and upper bound based on the laboratory investigation) are paired with the appropriate propagation time (i.e., when the lower threshold is paired with higher propagation time and vice versa). Because the selected chloride threshold effectively controls the slope of the damage curve, chloride thresholds outside the upper and lower bounds found by the laboratory studies would not fit the measured progression of damage.

Figure 4.3. Results of service life model for bridge. (Propagation time (t_p) is given in years, and chloride threshold (c_t) is given in percent by weight of concrete.)
