Report on  
Evaluation of Interstate 80 Sign Truss

**Office of Bridges and Structures  
The Iowa Department of Transportation**

Terry J. Wipf  
Brent M. Phares

September 25, 2002

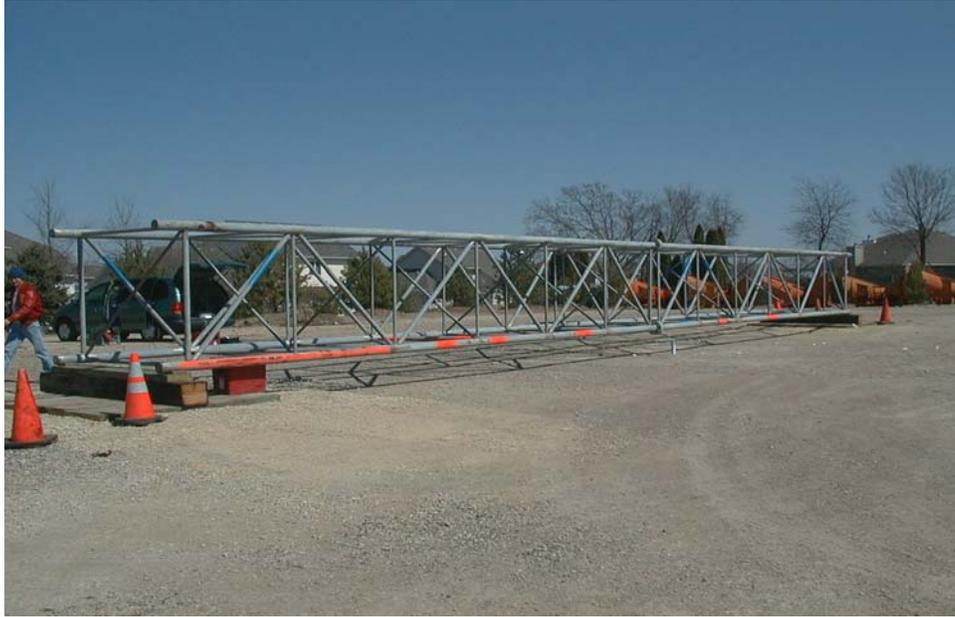
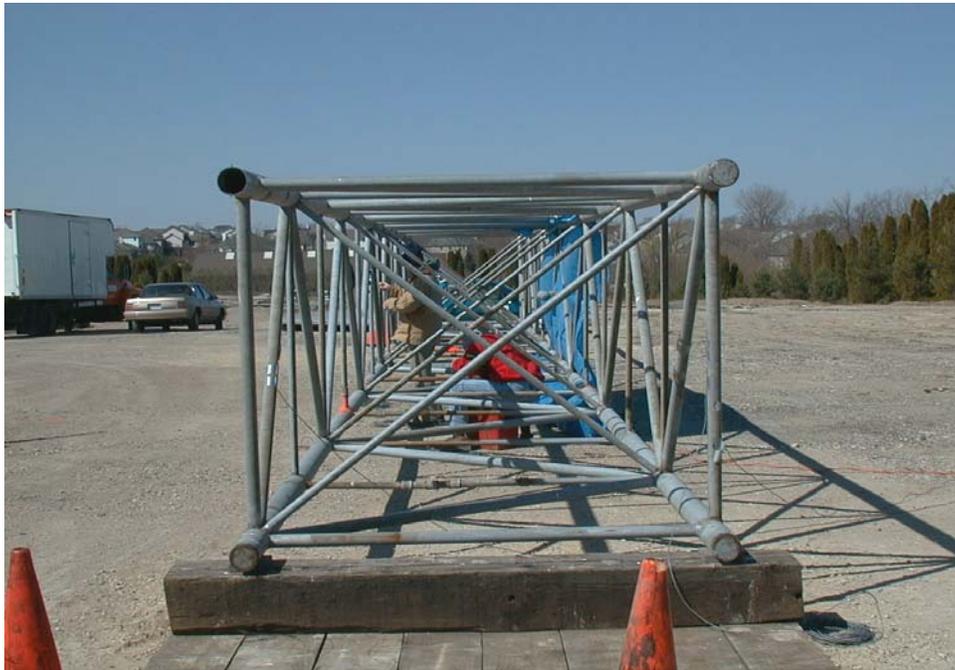
b. Side View of the Sign Truss  
Figure 3. Experimental Setup.

Two load tests were conducted in March and April of 2000. Both tests were performed at the Iowa DOT maintenance garage facility after removing the damaged truss from service. Figure 3 shows photos of the test set-up. Note that the truss was rotated 90 degrees from its normal orientation so that the effect of wind loads could be simulated by applying vertical loads.

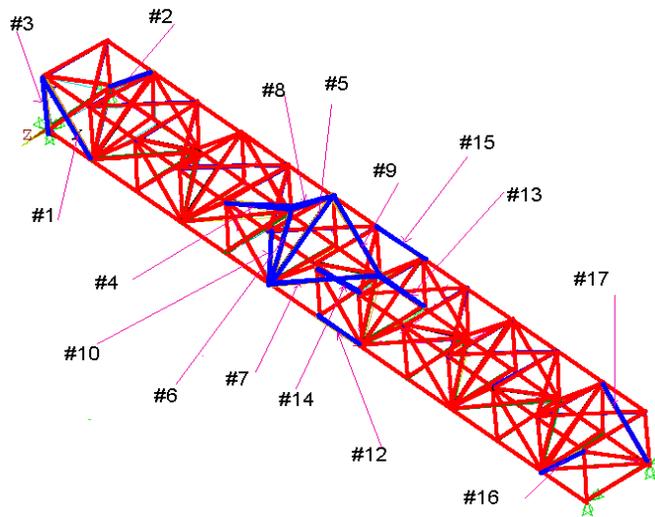
Figure 5. View of Truss Showing the Strain Gage Locations

Before the test, the truss was instrumented with strain gages. The strain gages were mounted on sixteen truss members and oriented such that only axial load was measured. Figure 5 shows a schematic of the truss with the instrumented members highlighted.

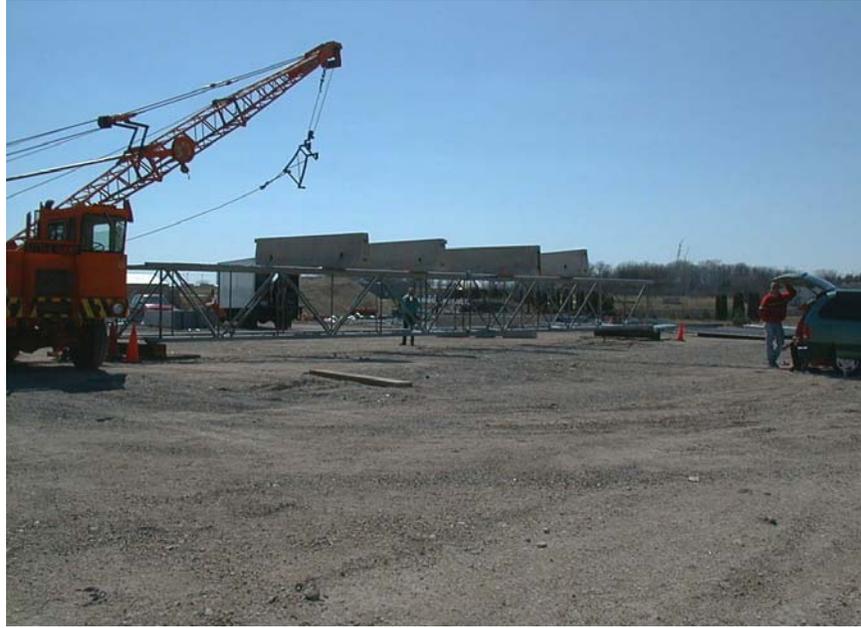
Figure 6: Sign Truss Loaded with Four Concrete Blocks

The tests were conducted by applying four concrete blocks weighing 5.0 kips each to the top of the truss (simulating horizontal wind load). Figure 6 shows a photo of the loaded truss. During the test, strain readings were taken after each concrete block was added.

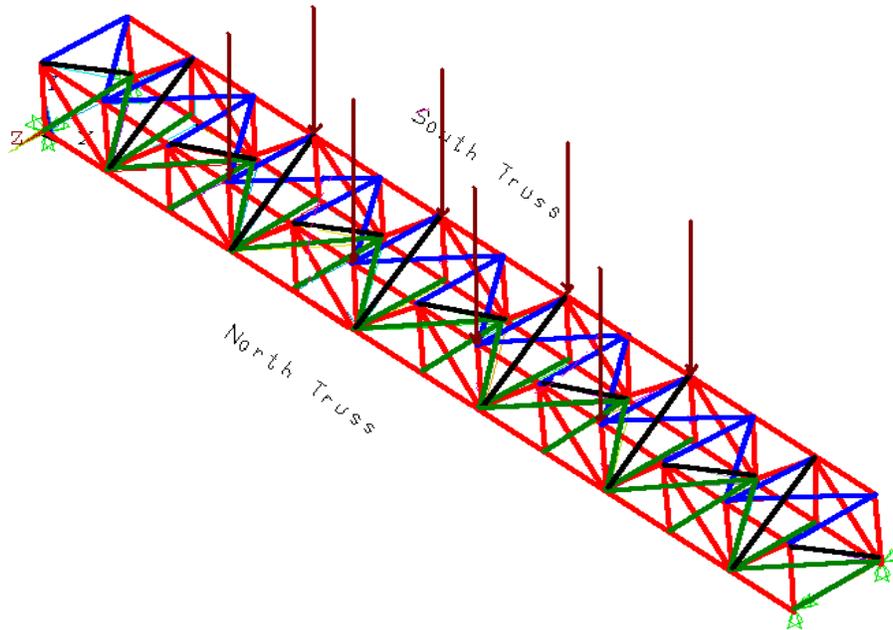
Figure 7. 3D Finite Element Model of the Truss.

A three-dimensional finite element model of the truss was developed using ANSYS. Each member was represented by three-dimensional beam elements (Beam44 element in ANSYS). The geometrical properties of the members were based on the cross sectional dimensions of the truss members given in the design plans. The Beam44 element has six degrees of freedom at each node: translations in the nodal X, Y, Z directions and rotations about the nodal X, Y, Z axes. The loads consisted of 4 concentrated forces applied equally on the north and south trusses. The boundary conditions at the truss ends were considered to be pinned at the west end and a roller at the east end. Figure 7 shows the finite element idealization of the truss structure.

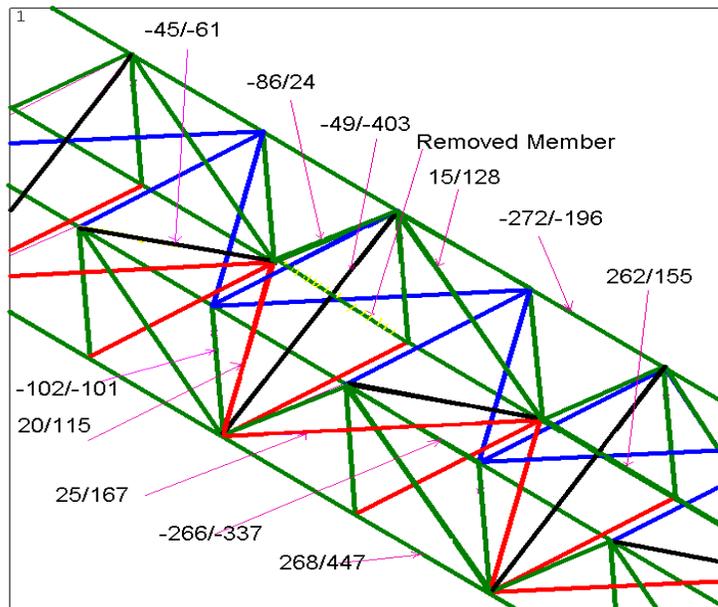
Figure 8. Analytical Element Axial Strains Undamaged/Damaged.

The model was analyzed for both test cases (i.e., undamaged and damaged {element 29 in the model}). The maximum deflection before removing the cut member was found to be 0.59 in.; after removal the deflection was 0.87 in. For comparison purposes, a simple 2D model of the structure was developed and analyzed. The results of the 2D model were found to be very close to those of the 3D model for the undamaged truss. This means that using simple 2D models would be sufficient to assess the overall structural behavior of the truss. However, it was found that a 2D model would not accurately predict the behavior of the damaged truss. The 3D analysis strain results are summarized in Table 2. Figure 8 shows the results for members in the vicinity of the removed member.

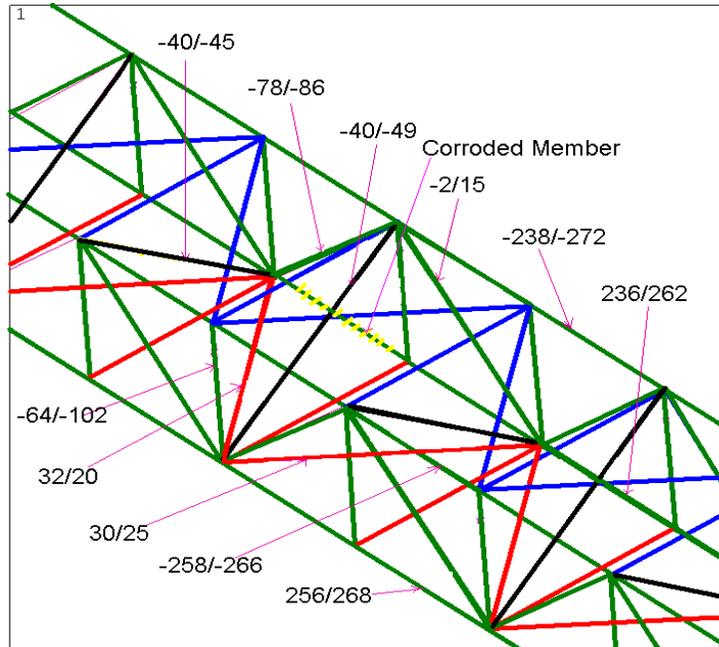
Figure 9. Experimental and Analytical Results for Undamaged Truss.

One objective of this project was to develop an analytical model that accurately represents the structural behavior of trusses so that the performance can be evaluated. To accomplish this, the results of the developed analytical model were validated using strain measurements from the load tests. Table 3 shows the experimental and analytical results before and after the bottom chord element cut. Figures 9 and 10 show the results in the vicinity of the cut member.
