SUBJECT: Potential for Fracture to Occur in Iowa Steel Girder Bridges due to Triaxial Constraint

DATE: January 24, 2011

Potential For Fracture To Occur In Iowa DOT Steel Girder Bridges Due to Triaxial Constraint

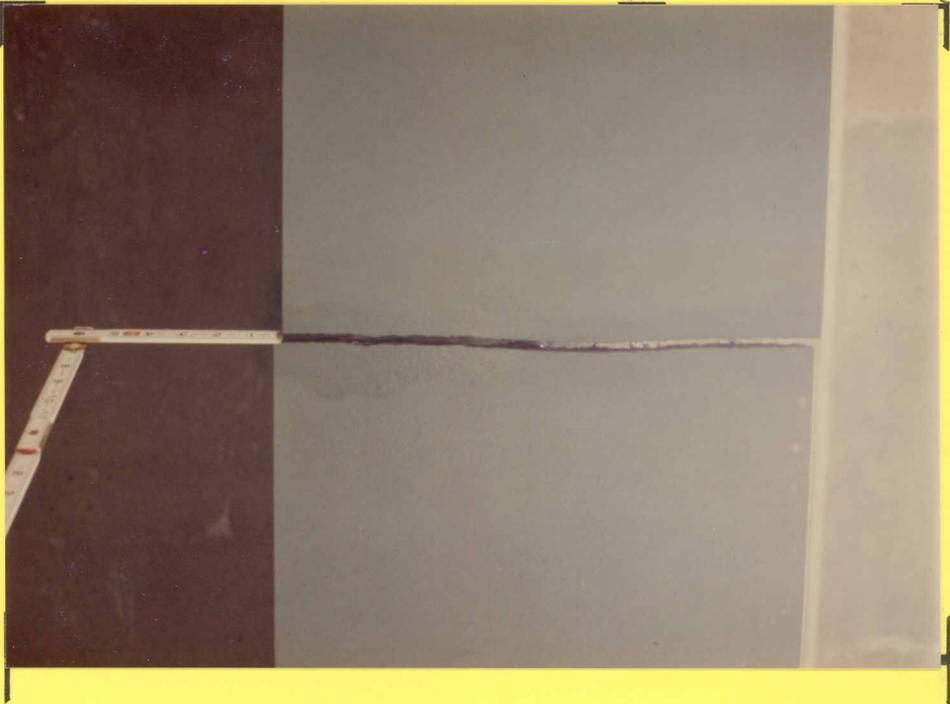
Bottom flange
Down to Up

Full depth crack in the exterior girder of the Cherokee County Bridge.

Investigation determined fracture initiated at web to flange weld. No evidence of fatigue crack initiation or growth prior to fracture.

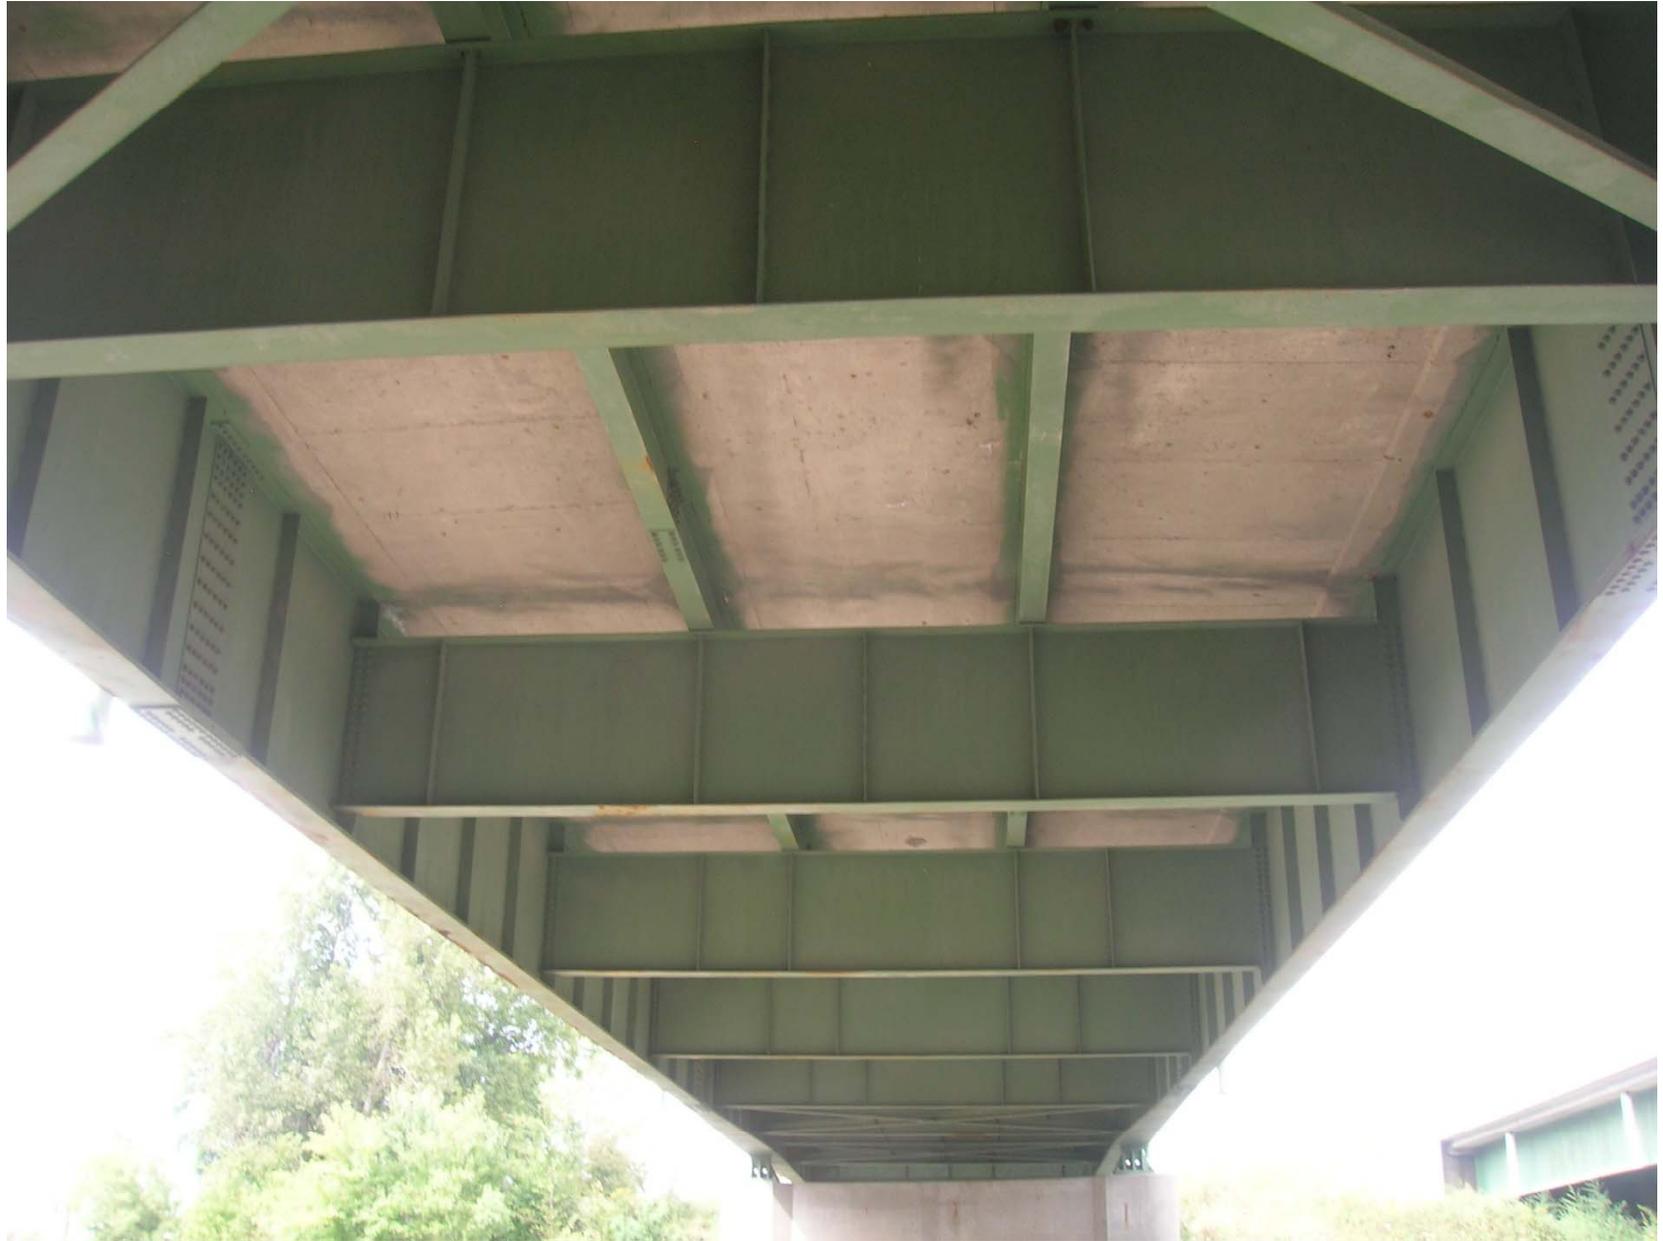
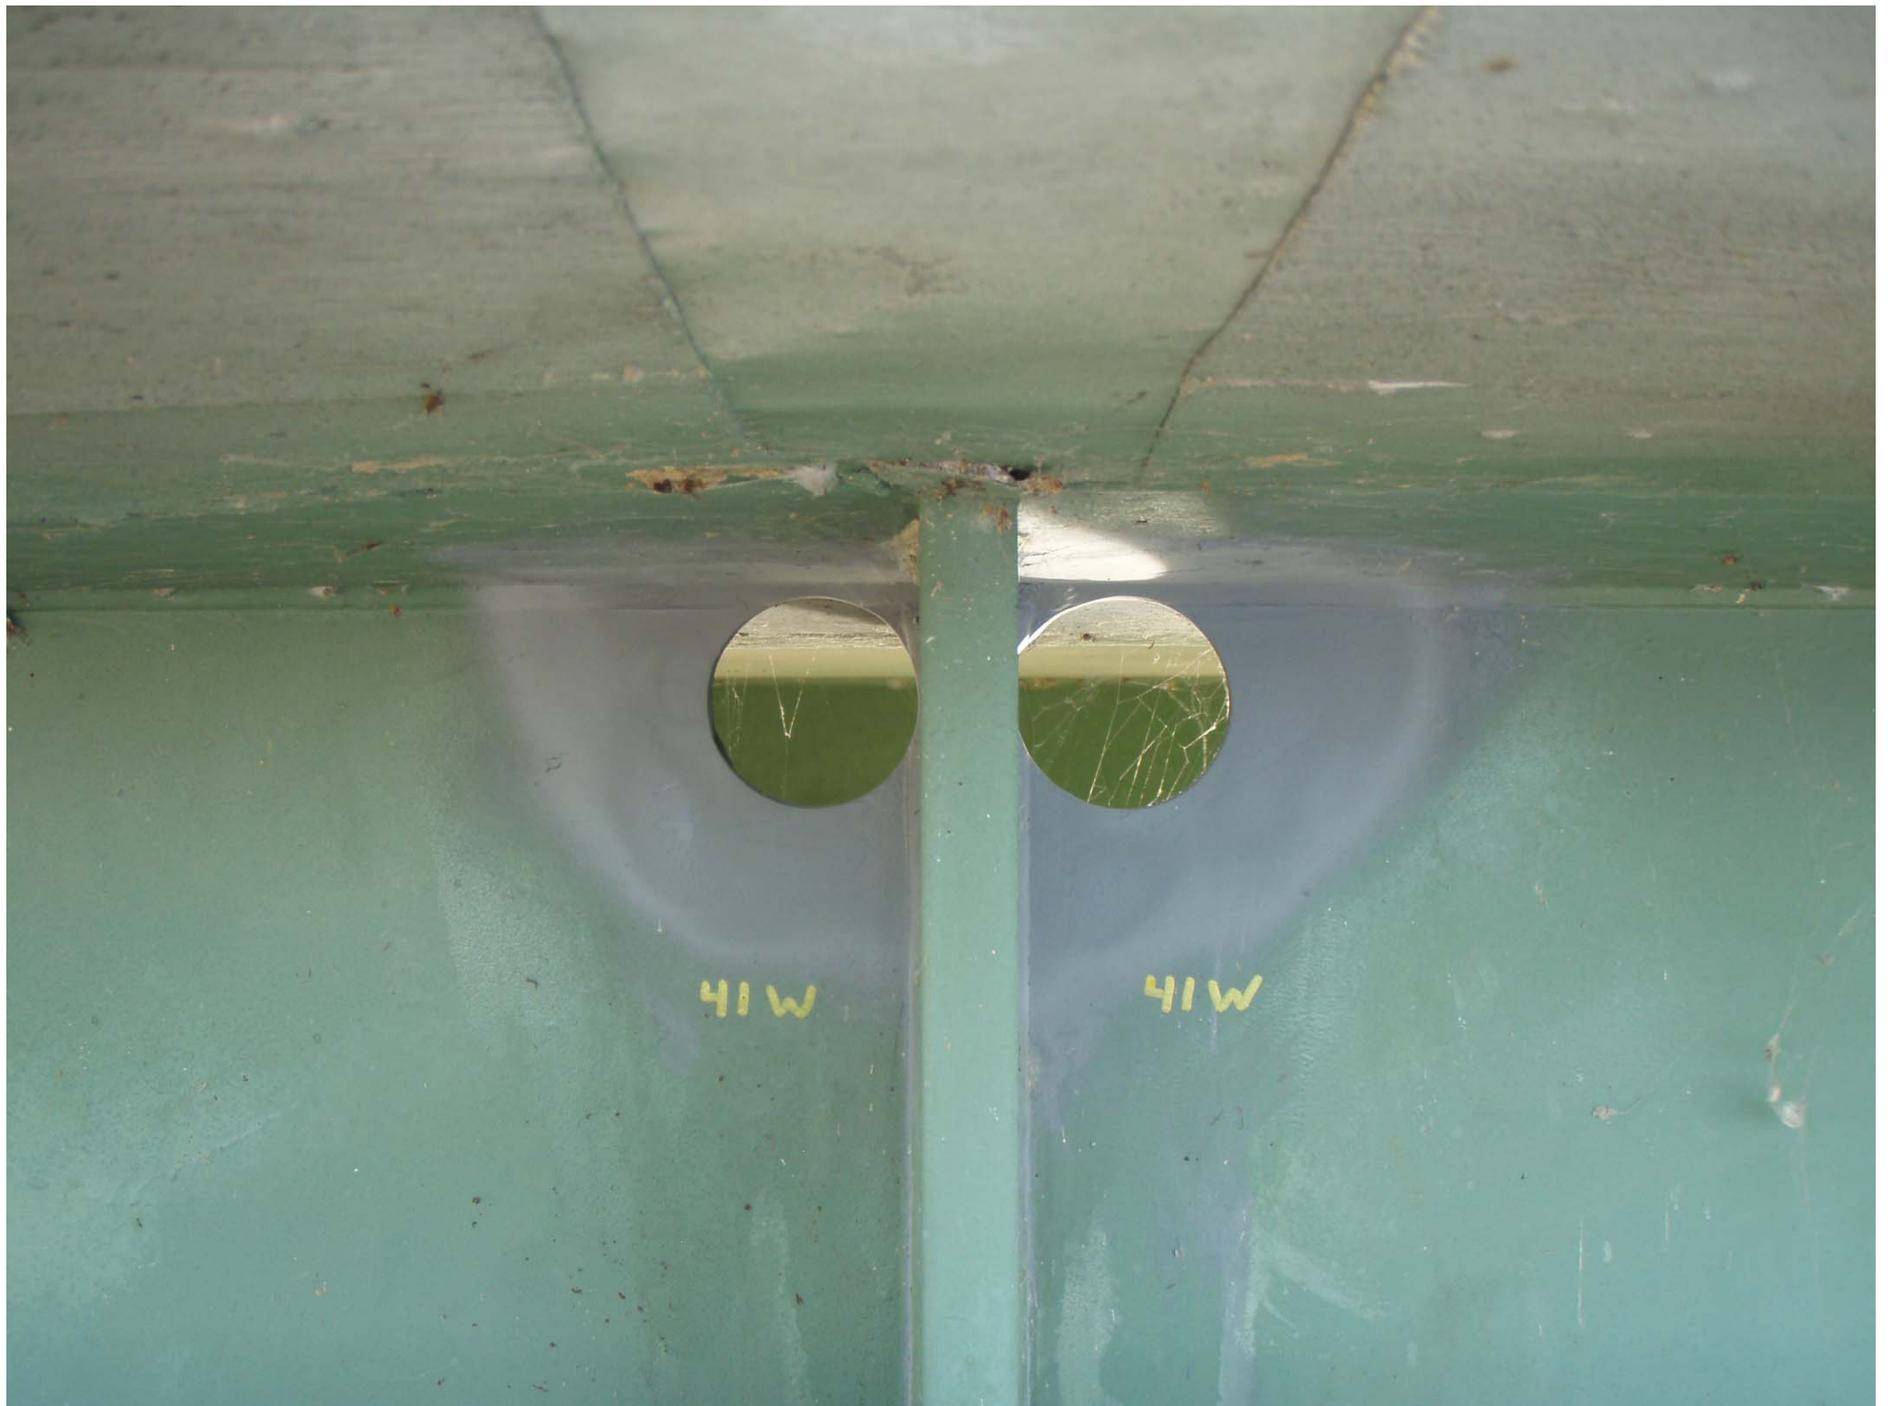
LATERAL GUSSET PLATE RETROFIT DETAIL

Gusset plates for lateral bracing in tension areas should be inspected to determine if there are intersecting welds in the corner formed by the web, gusset plate and connection plate. If this condition exists (or if the gap between the toes of the welds is less than ¼ in.), a hole should be cored thru the gusset plate corner to increase the gap length. This retrofit is shown on Attachment 9.
