R.A. Lohnes, B.H. Kjartanson, and A. Barnes

Regional Approach to Landslide Interpretation and Repair

Iowa DOT Project TR 430

Final

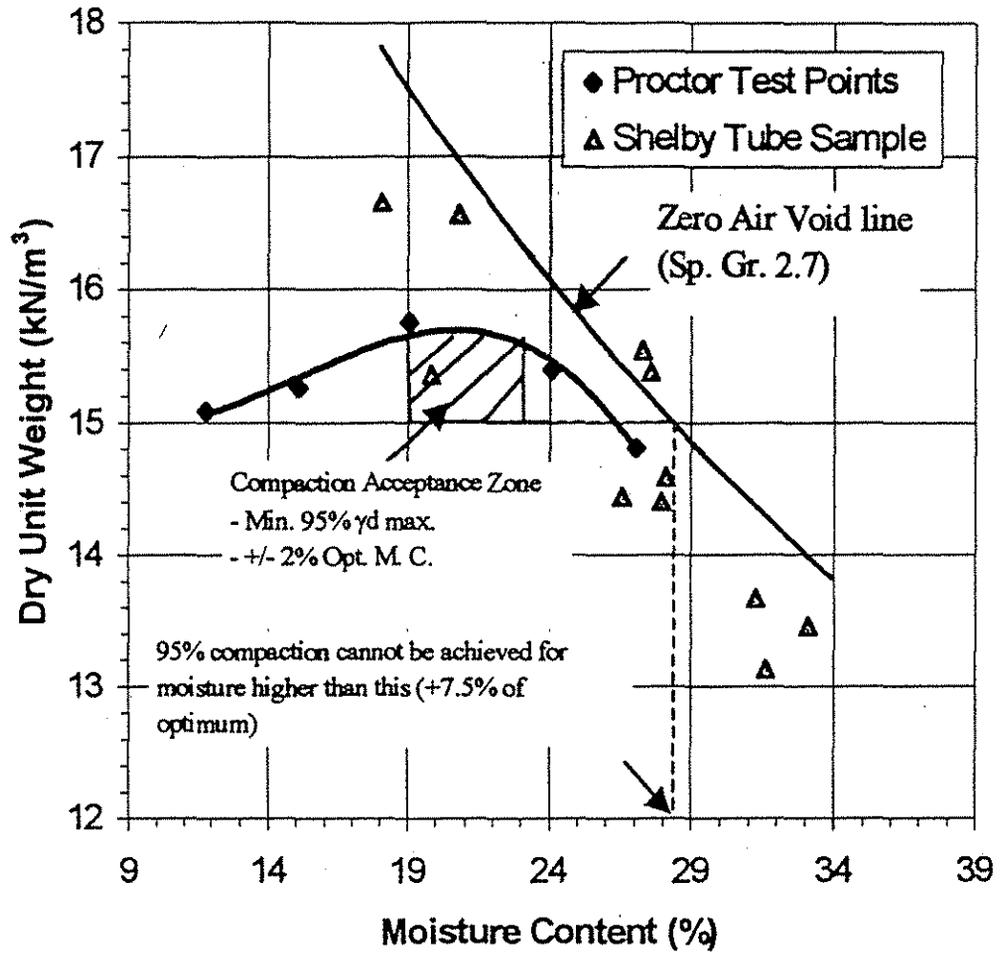
Figure 9.6 Compaction curve and field densities of embankment soils at 160th St. slide.

A “compaction acceptance zone” of 95% maximum unit weight was marked on the Standard Proctor curve to demarcate the acceptable range of dry unit weights and corresponding moisture contents (Bergeson et al, 1998). Figure 9.6 shows that nearly 50% of the samples lie below the zone of 95% compaction. It is likely that the high moisture contents obtained are greater than those at the time of compaction.

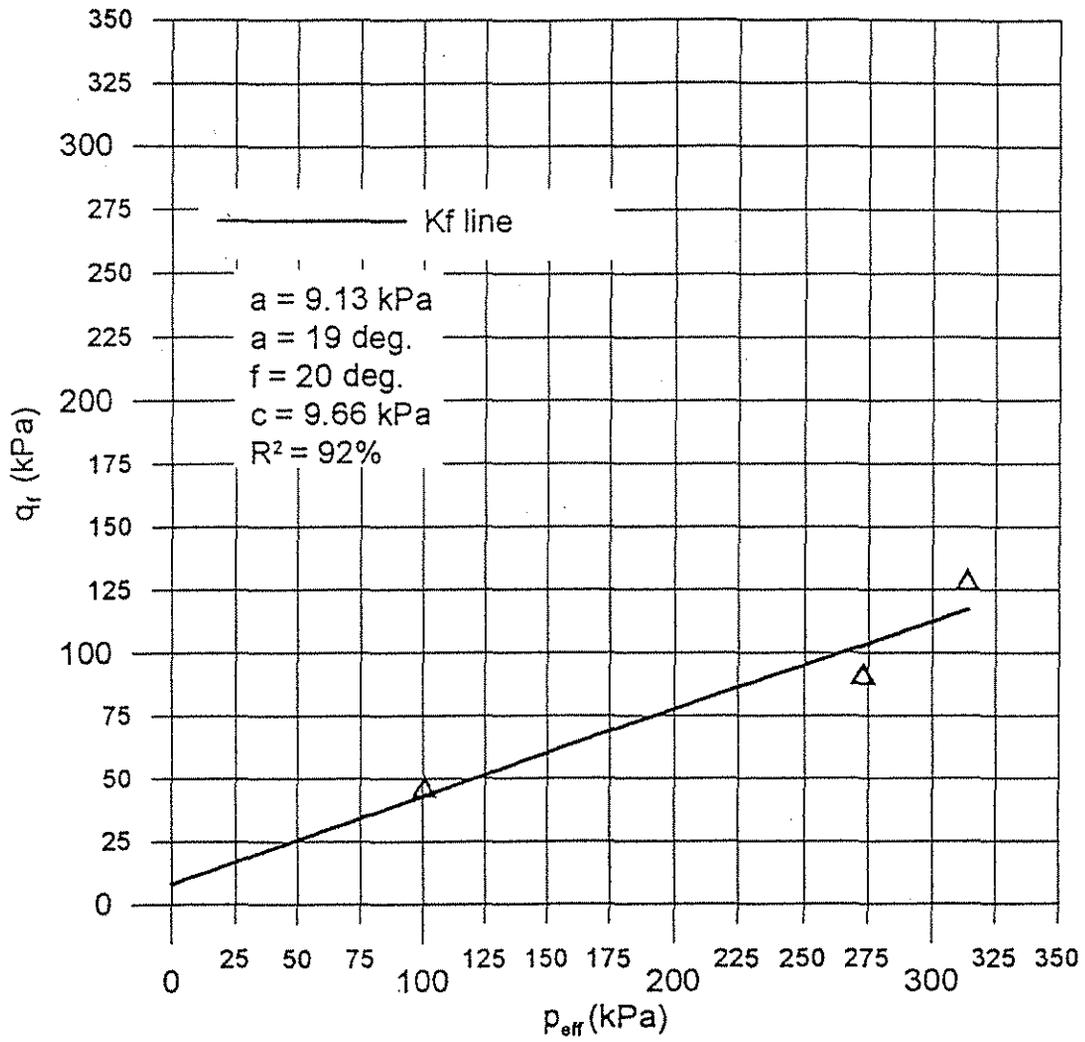
Figure 9.8 Strength (effective p-q) diagram for Shelby tube samples from K Street slide.

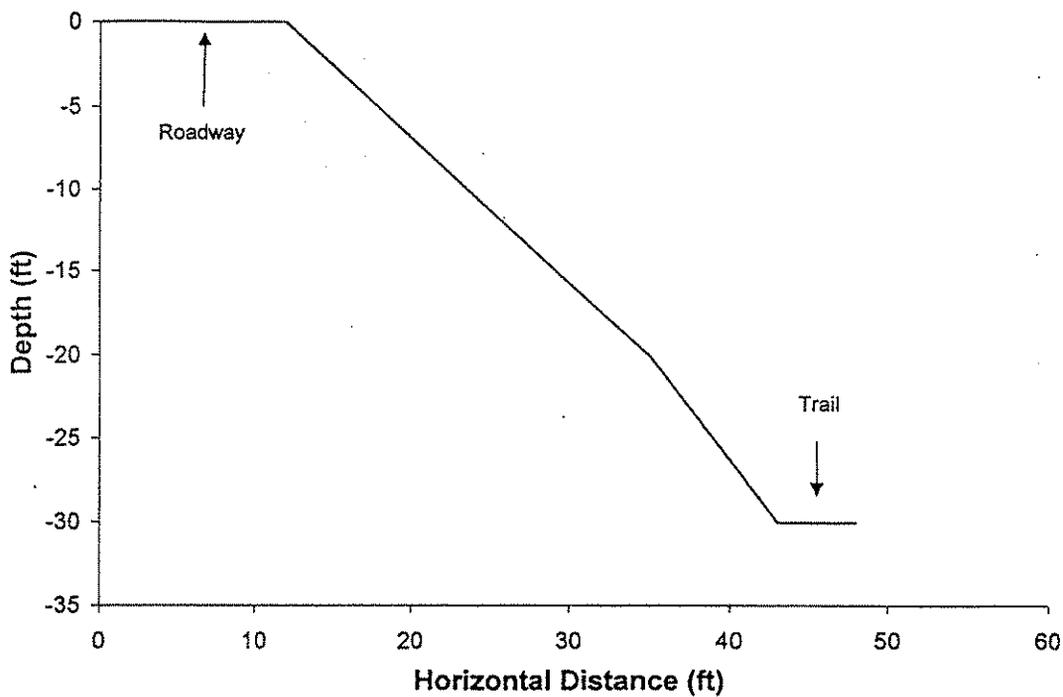
The site is 170 feet (52 m) above the Missouri River floodplain, near the upper part of the upland bluffs. The slopes adjacent to the roadway are vegetated with grasses and trees. During the site investigation carried out by ISU in June 1999, a longitudinal crack was observed along the edge of the existing asphalt pavement, and a minor settlement of 3 inches (8cm) was observed. A horizontal ledge interpreted as an old trail was observed at the bottom of the slope failure, about 25 feet (7.5 m) below the roadway. Slope profiles were measured along the slide and adjacent to it. The original slope profile is 33 feet (10 m) high with angles of 41° in the upper portion and 51° in the lower portion (Figure 9.11). The slope profile in the failed region is shown in Figure 9.12.

Figure 9.11 Original slope profile at Murray Hill slide

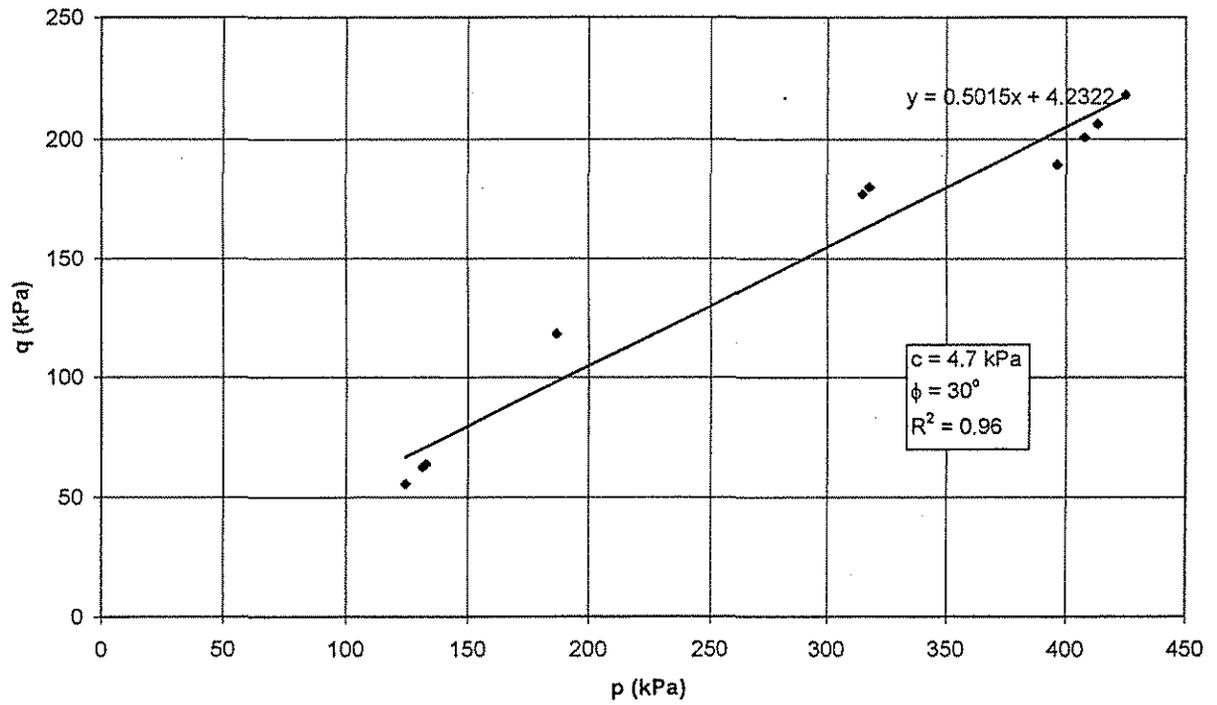
Triaxial tests were performed on the Shelby tube samples to obtain the shear strength parameters of the soil. Consolidated drained (CD) triaxial tests were carried out on samples at natural moisture content. Deviator stress versus axial strain curves were plotted by using the test results. These stress-strain curves and stress paths are shown in Chu (2001). By using the maximum values from the stress-strain curves, the effective stress K_f line was plotted and the "a" and " α " values were obtained by linear regression as shown in Figure 9.13. These values were converted to "c" and " ϕ " values where the cohesion "c" is 98.79 psf (4.73 kPa) and the internal friction angle " ϕ " is 30.1°. These strengths are lower than similar studies of loess at natural moisture contents where cohesion intercepts averaged 259 psf (12.4 kPa) and ϕ averaged 26° and are nearly equal to values for saturated loess (Akiyama, 1964, Olson, 1958). Table 9.4 shows the average shear strength parameters that were reported by Olson (1958), Akiyama (1964), and Benak (1967) for the Hamburg soil along with shear strength parameters obtained as part of this study.

Figure 9.13 Strength diagram for loess at Murray Hill slide

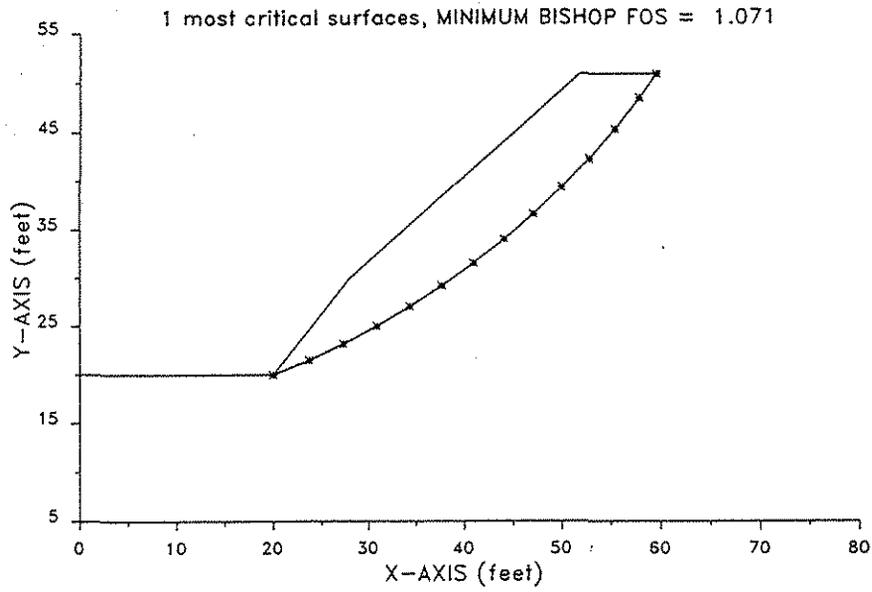
The slope was analyzed by using XSTABL computer software with the Simplified Bishop method using shear strength values obtained in this study and shear strength values reported in other studies. A typical analysis is shown in Figure 9.14. When the average strengths are used, the minimum safety factor is 1.5 for the soil at natural moisture content. For the shear strength values obtained in this study, the safety factor is 1.1 with a theoretical failure surface close to that observed in the field. Although the latter stability analysis indicates a marginal safety factor at Murray Hill, additional analyses were conducted to determine the influence of other possible factors.

During fieldwork, trucks were observed to pass close to the edge of the road with their tires tracking through the depression in the pavement. Therefore, XSTABL analyses with a surcharge load from the trucks were performed. The vehicle surcharge loading represented a tandem truck; a stress of 17000 psf (814 kPa) was applied on each tire in the location shown in Figure 9.15. The minimum factor of safety decreases to 0.8 when the surcharge is included with the load at the shoulder; the failure surface shown by the analysis, however, extends further back below the roadway than suggested by the cracks observed on the pavement. It is interpreted that the slope without surcharge is at a metastable condition; and instability results from the surcharge load of passing trucks.

Figure 9.14 XSTABL results for Murray Hill slide
