# CONSTRUCTION AND EVALUATION OF SUBMERGED VANES FOR STREAM CONTROL

Research Project No. HR-274

Submitted to  
The Highway Division  
Iowa Department of Transportation  
Ames, Iowa

IIHR Report No. 321  
Iowa Institute of Hydraulic Research  
The University of Iowa  
Iowa City, Iowa 52242  
March 1988

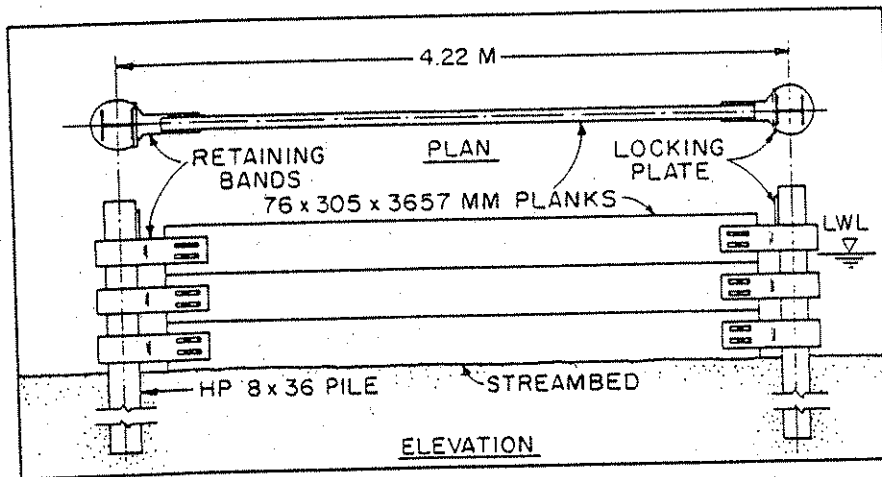
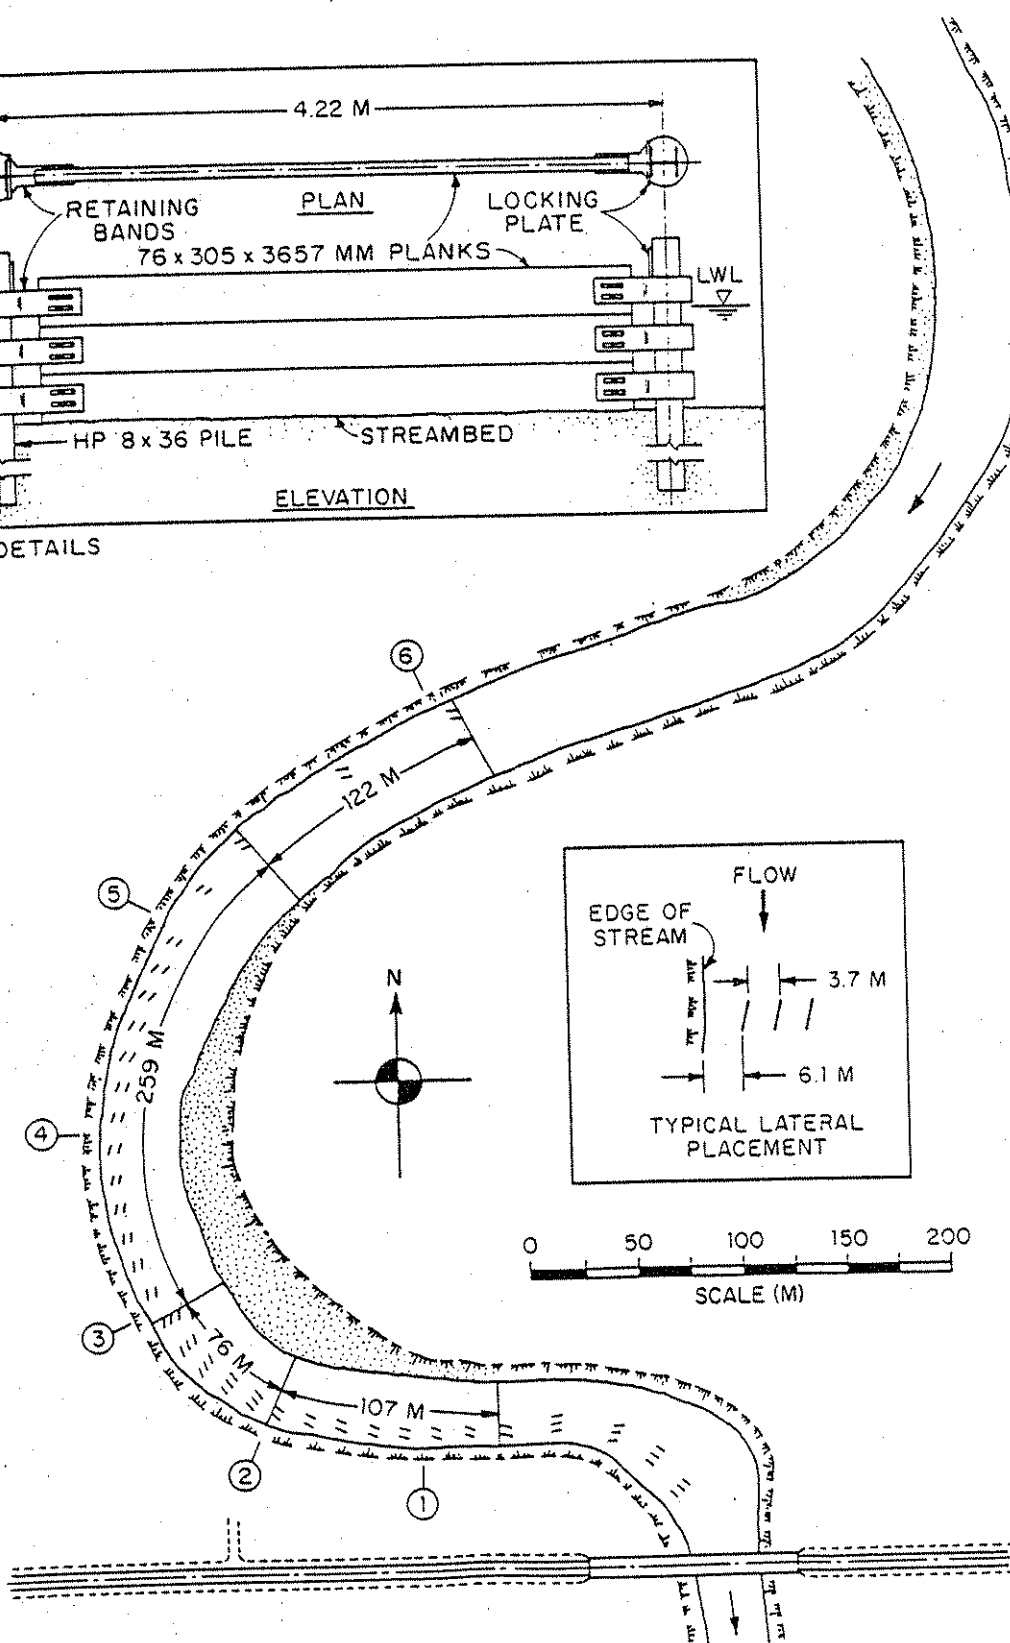
Figure 1. Layout of Vane System.

Figure 1 shows the layout of the vane system and details of the final vane design. Additional details may be seen in the specifications in the attached material. Each vane consisted of three creosoted planks, 7.6 cm by 30.5 cm by 3.66 m, held together in a vertical position by two HP 8 x 36 steel bearing piles driven into the streambed (about 1.5 m into a shale layer underlying a 2 to 4 m layer of sand). The planks were fastened to the piles by straps (135 by 15 by 1 cm bent plates) and were prevented from floating by anchor plates on the flanges of the H piles.

The vanes between Section 1 and the bridge (Figure 1) were installed to generate a widening of the channel-cross section under the bridge and to reduce the velocity at the left abutment. These vanes were positioned to direct the bottom current away from the right bank.

It is further recommended that a new vane design be adopted for the aforementioned additional vanes, as well as for future installations. In recent laboratory studies at IIHR a design has been developed which is significantly more efficient than the design used (Figure 1). The new vane is a streamlined, three-dimensional structure with a double-curved surface mounted on a pile in such a way that the part of the pile which is above the streambed is surrounded and covered by the surface of the vane. The new structure has no sharp edges or corners and presents a lesser hazard to recreational activities on the river than does the design used. The new vane may be placed closer to the bank and possibly with a lower top elevation than the present vanes in the river.

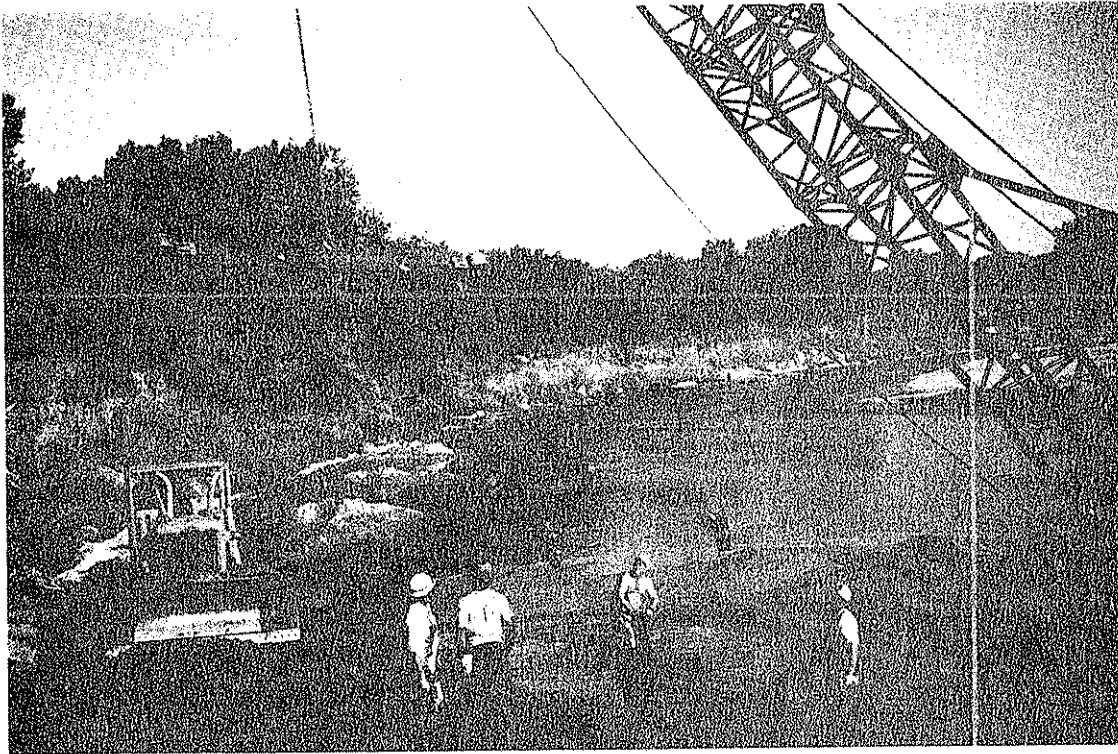
Figure 2. View from the Installation of the Vane System in the East Nishnabotna River Bend.

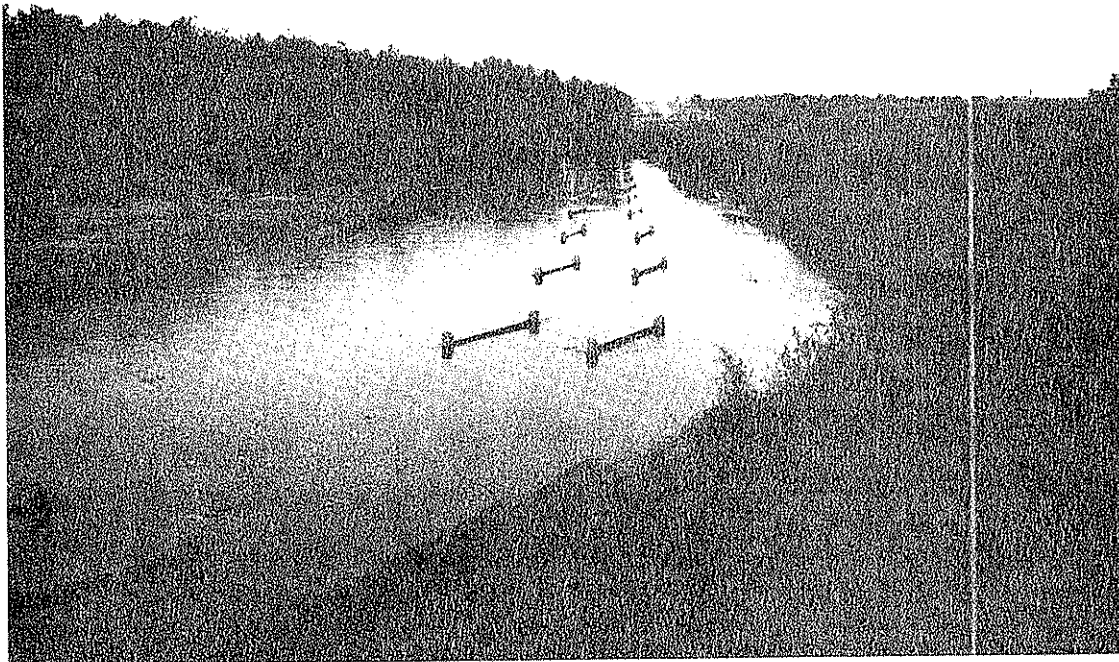
Figure 3. Downstream View of Completed System.

Figure 3 is a downstream view of the completed system at low flow (3-4 m<sup>3</sup>/s).
