USE OF LONGITUDINAL SUBDRAINS IN THE 3R PROGRAM

**FINAL REPORT
Project HR-509**

**Highway Division
December 1981**

BY
VERNON J. MARKS
RESEARCH ENGINEER
515/239-1447

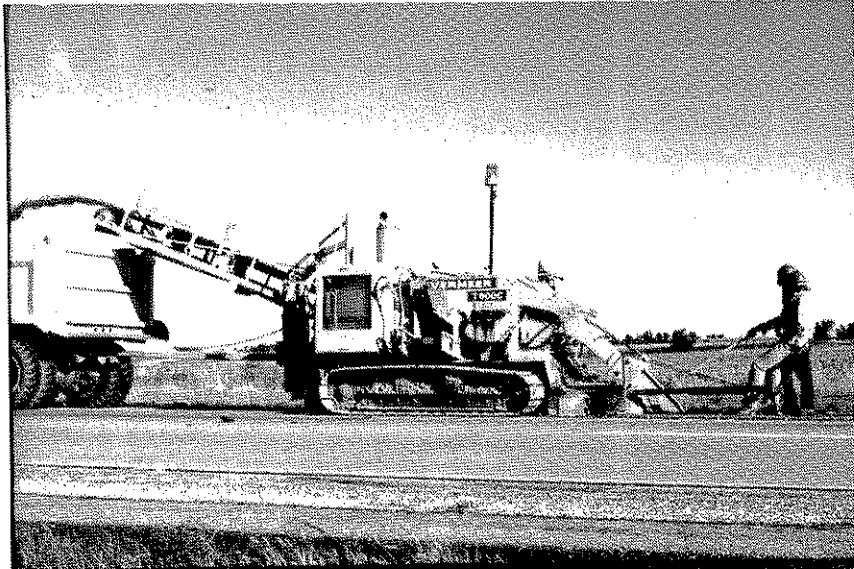
A side elevator of the trencher deposited the material directly into trucks (Figure 3).

Figure 3: Loading Excavated Material.

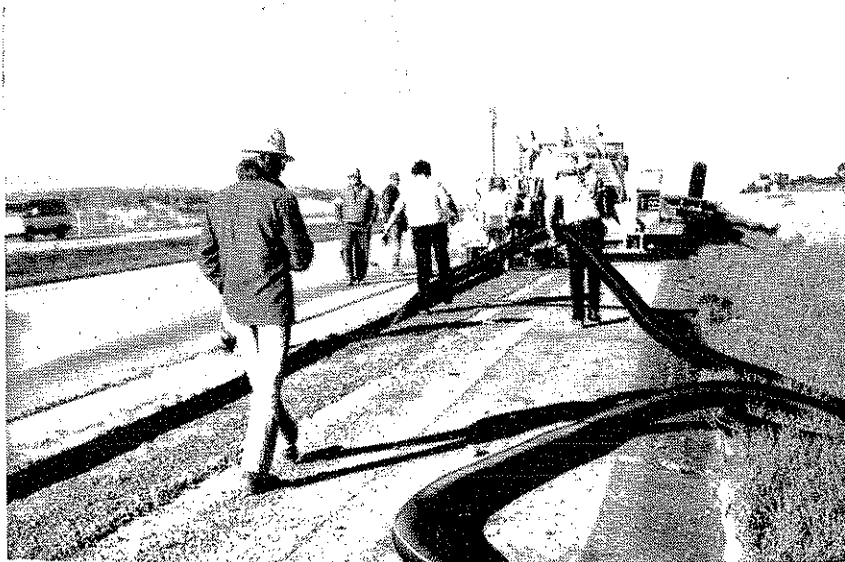
Polyethylene tubing deteriorates if exposed to sunlight and therefore, a note on the plans required protected storage even though the producer claimed that an additive would protect the tubing for up to six months. The tubing was placed in the trench manually (Figure 4).

Figure 4: Hand Placement of the Tubing

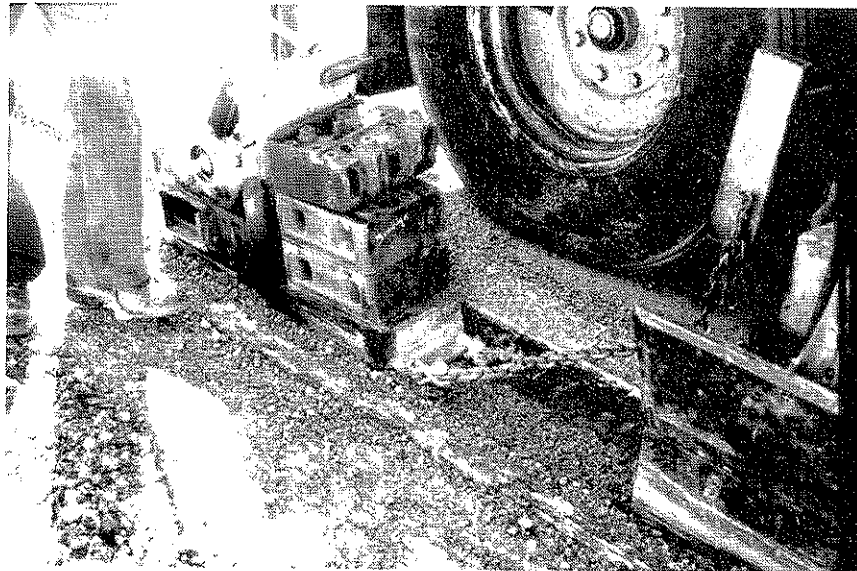
Figure 6: Vibrating Pan Compaction of Porous Backfill

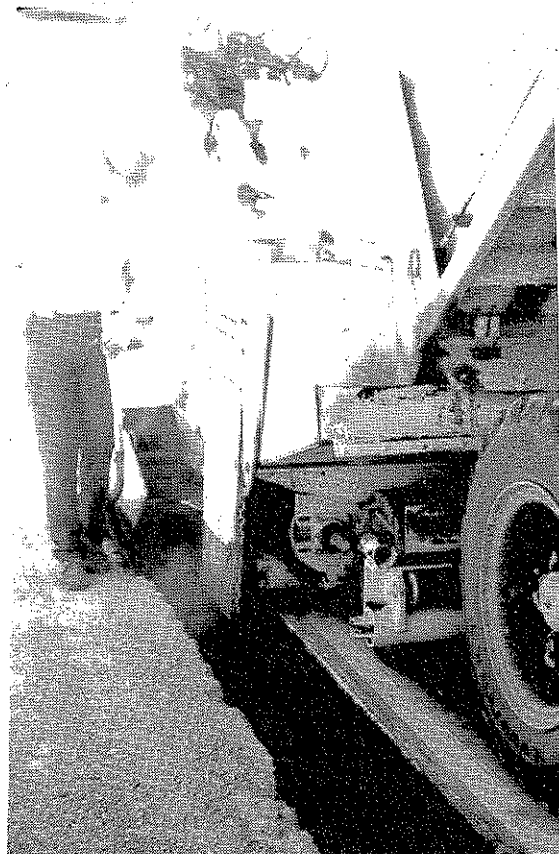
The pavement was then broomed prior to placement of the 6" thick 3/4" type B asphalt concrete surface. The asphalt was placed with a second Blawnox RW-38 road widener (Figure 7). The asphalt concrete was compacted with a small 30" vibratory roller. The filled trench was very neat (Figure 8) even before the 1/2" cover aggregate placement over the full width of the shoulder.

Figure 7: Placing Asphalt Concrete with Blawnox RW-38

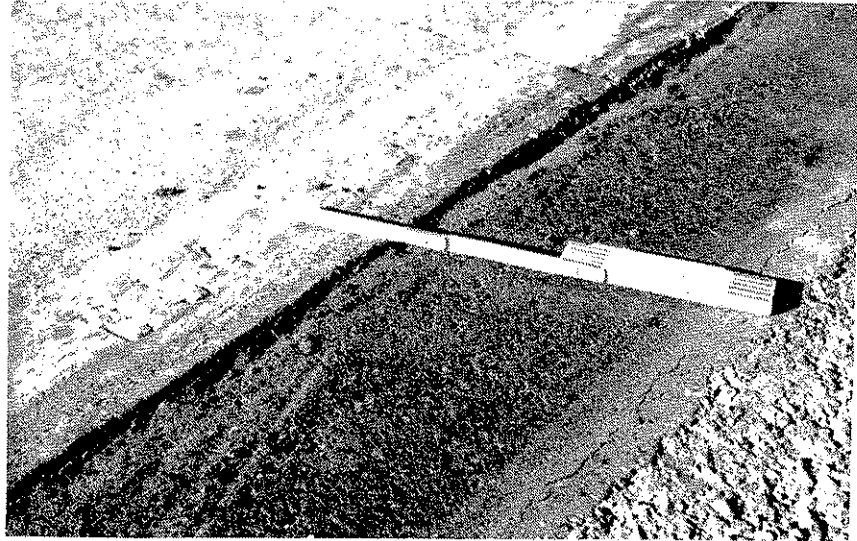
Figure 8: Finished Trench Prior to Cover Aggregate Placement

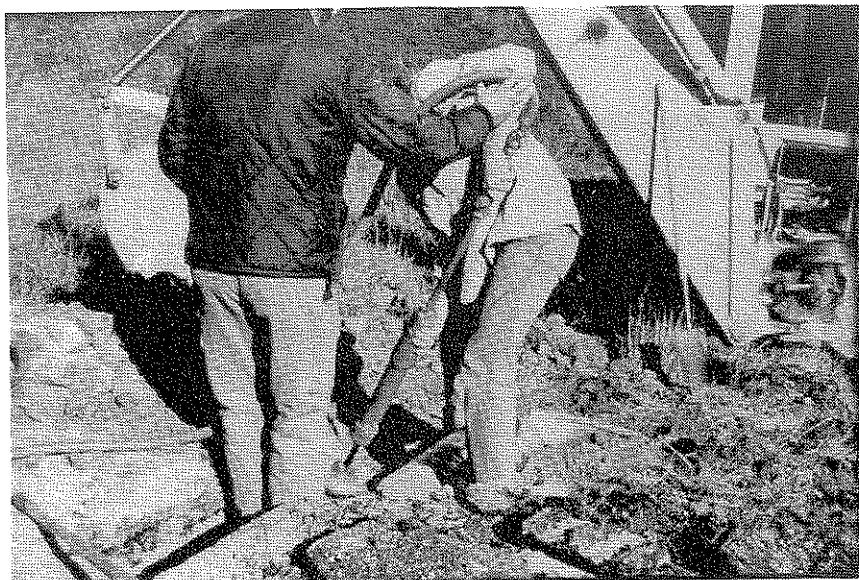
Figure 10: Tamping Earth Fill Around the RF-22 Outlets
