FINAL REPORT
EVALUATION OF BOND RETAINAGE
IN
PORTLAND CEMENT
CONCRETE OVERLAYS
USING
INFRARED THERMOGRAPHY
AND
GROUND PENETRATING RADAR

PROJECT NO. 50389
COPYRIGHT, DONOHUE 1989

January 30, 1989

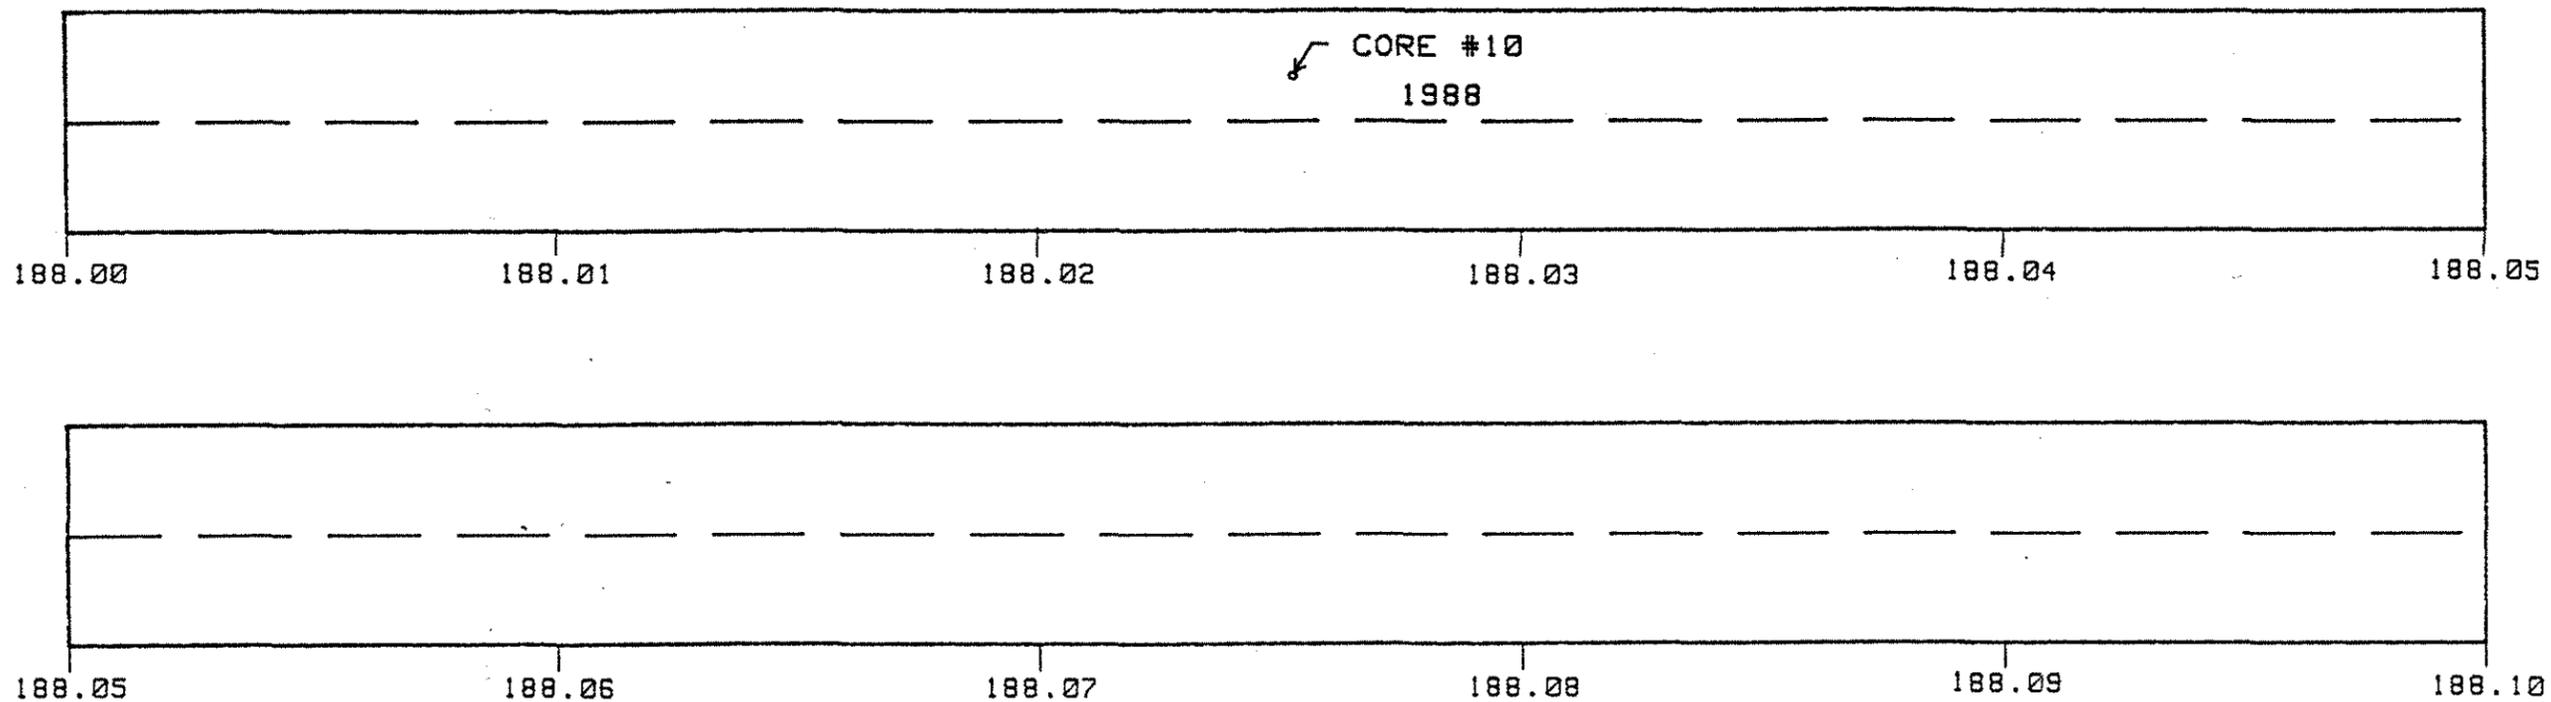
AREAS	WESTBOUND LANES
Total Area	12,672 (sq.ft.)
Debond (IR)	None (sq.ft.)
Concrete Patch	None (sq.ft.)
Deterioration (GPR)	None (lin.ft.)
Inspection Date:	August, 1987 August, 1988
