DETERMINE INITIAL CAUSE FOR CURRENT PREMATURE PORTLAND CEMENT CONCRETE PAVEMENT DETERIORATION

FINAL REPORT

Sponsored by the Project Development Division
of the Iowa Department of Transportation
and the Iowa Highway Research Board
Iowa DOT Project TR-406
CTRE Management Project 97-13

OCTOBER 2000

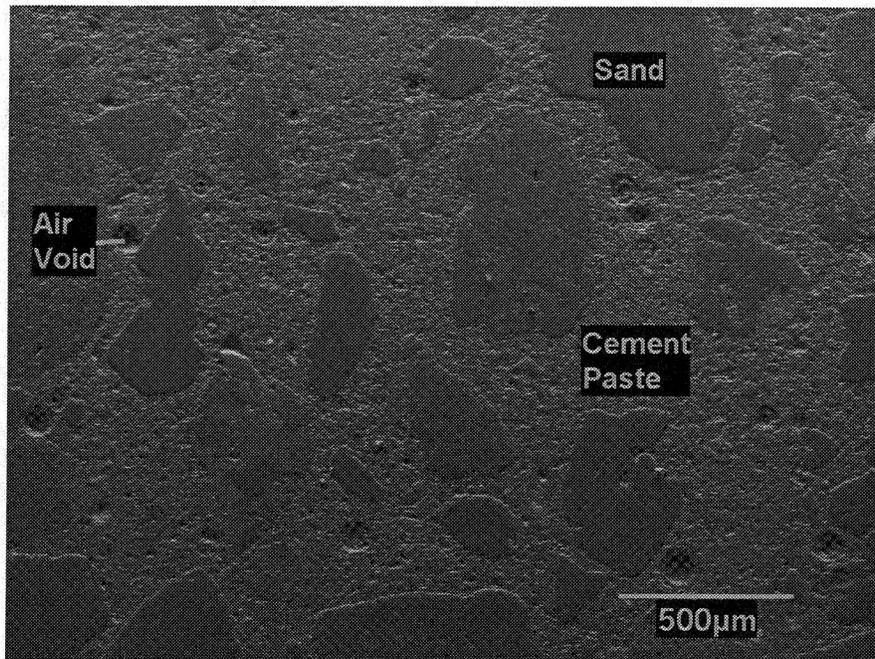
FIGURE 4 Bad section of US 20.

The image analysis procedure utilized a series of low-magnification (40x) digital images to measure the air voids present in a test specimen. Typical digital images obtained from “good” and “bad” sections of pavement are illustrated in Figures 3 and 4, respectively. The images represent concrete from the top three inches of cores that had been taken from the midpanel region of two different pavement slabs. Both figures contain similar features; however, the good section contained more entrained-air voids than did the bad section. This discrepancy could be due to the fact that (1) the air void system in the bad section was lower to start with (because of improper admixture dosage, poor mixing, or excessive vibration) or (2) because the air voids have been filled with a sulfate mineral that has a chemical composition close to the mineral ettringite [$\text{Ca}_6\text{Al}_2(\text{SO}_4)(\text{OH})_{12-25}\text{H}_2\text{O}$]. The image analysis technique cannot count the air voids that have been filled with ettringite because of the very poor contrast between the cement paste and the filled voids. However, another analytical procedure, commonly referred to as X-ray mapping, can be used to produce a detailed image of the initial air void system. This is illustrated in Figure 5. The figure shows that the initial air void system has been filled with a phase that is rich in sulfur (ettringite in this instance, as determined by energy dispersive X-ray analysis). Likewise, the silicon map exhibits dark areas (holes) where the initial air voids resided in the cement paste.

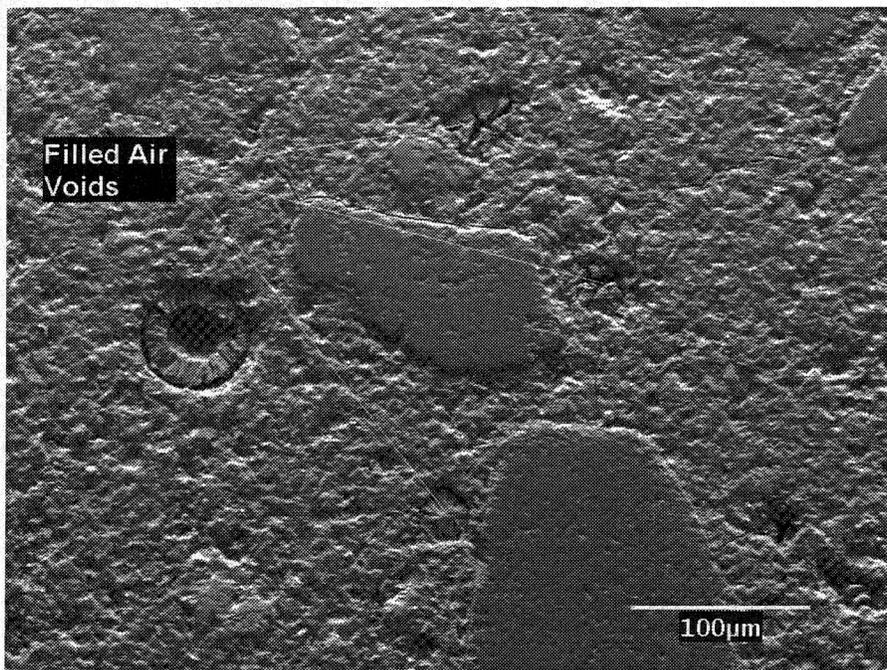
FIGURE 6 Higher magnification image from Figure 4; note the filled voids.

Higher magnification (see Figure 6) can also be used to distinguish the filled voids from the cement paste. However, this causes a dramatic increase in the number of images that need to be collected to provide a reliable estimate of the air content of the sample. The image shown in Figure 6 indicates that, in this particular specimen, most of the air voids with diameters less than about 100 microns have been filled with ettringite. This should have a negative impact on the freeze-thaw resistance of the concrete because it causes an increase in the spacing factor of the concrete.

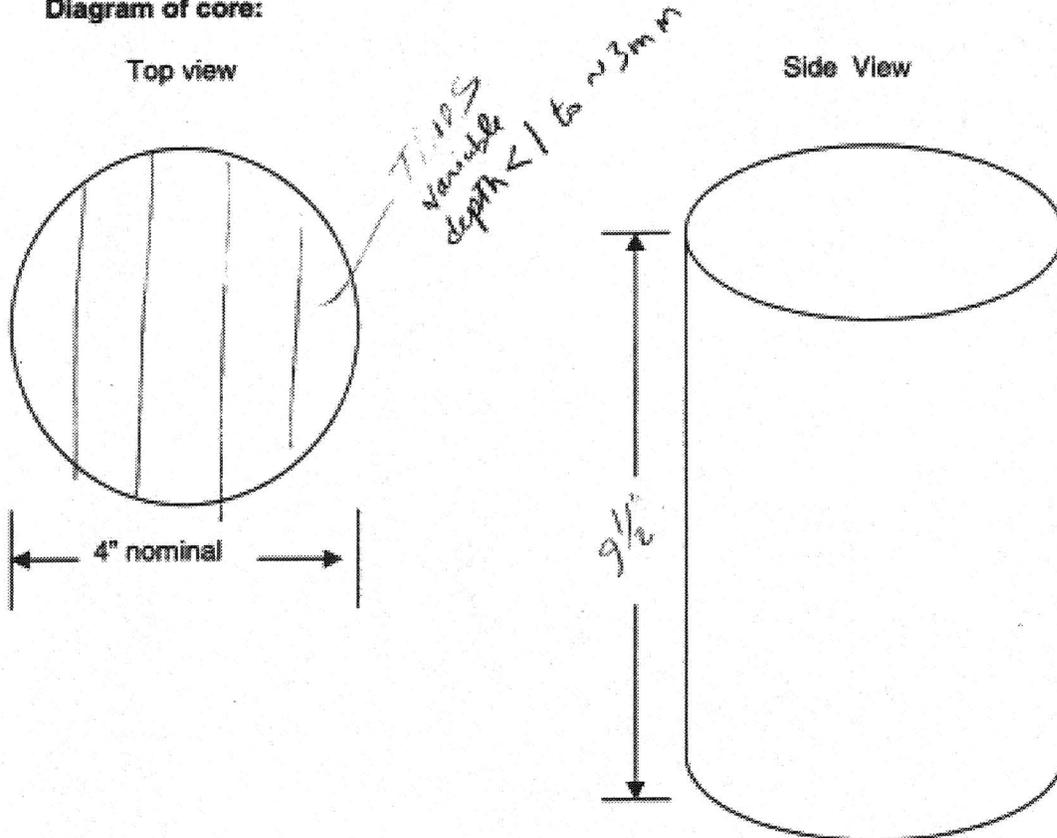
Sample Identification: US 520 WB @ MP/27.55
STA 2002 Mid panel

Cracks, comments: No cracks evident on core
some white residue was present
on inner of core

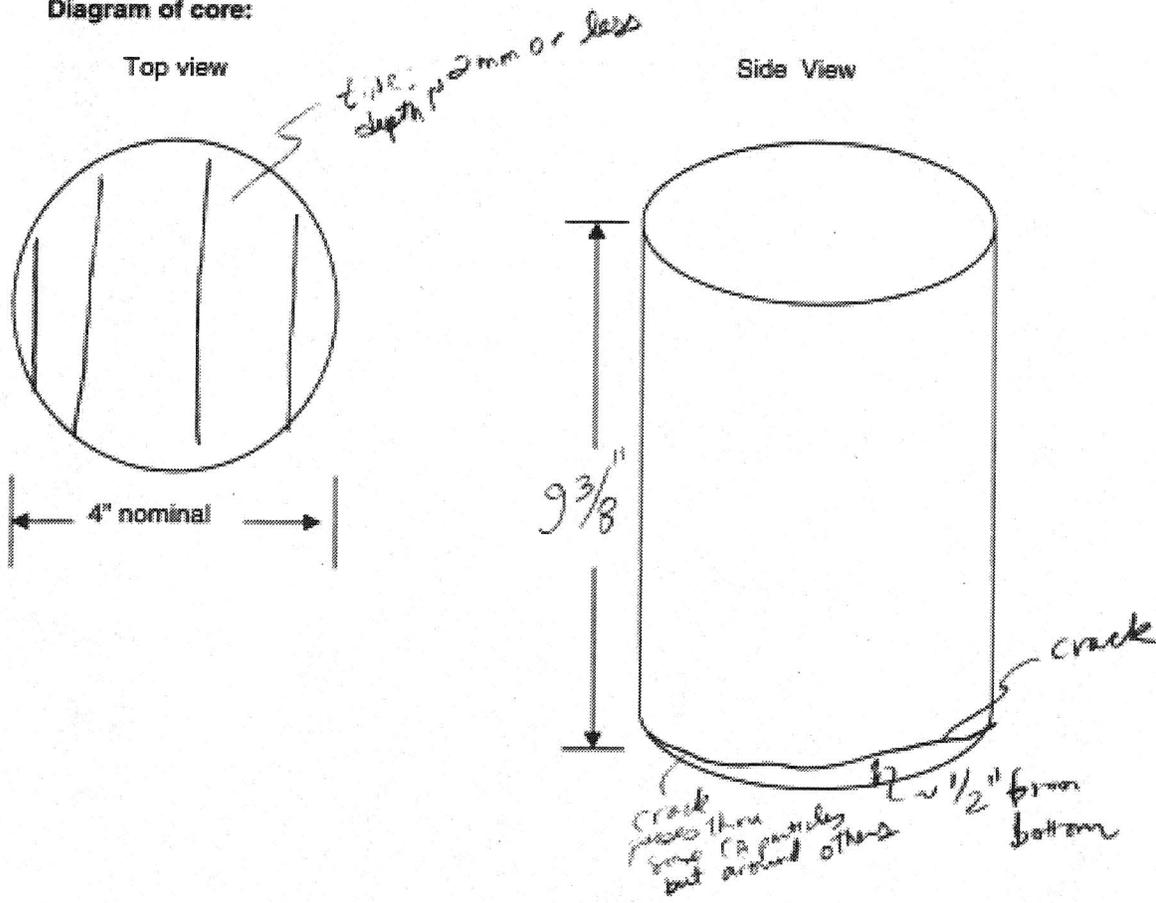
Sample Identification: 520 WB m P 135.4
(Transverse Joint Near Longitudinal Joint)

Cracks, comments: severe crack at bottom of core -
difficult to say why - cracked -
some evidence of paste bond between
paste & aggregate.

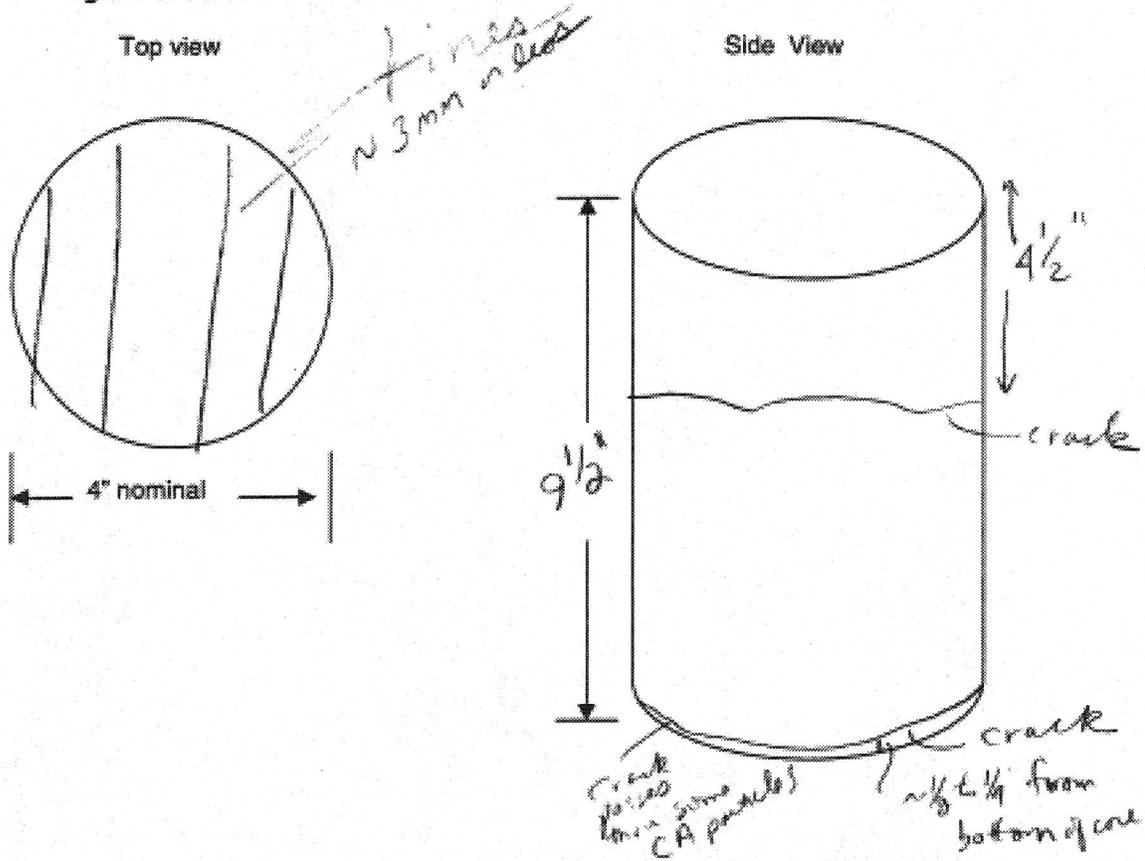
Sample Identification: 520 WB MP 135.4
of Trans Joint near shoulder

Cracks, comments: core cracked all way thru @ ~4 1/2"
Some shale noted on failure plane
again a crack ran around the
circumference of the bottom of the core

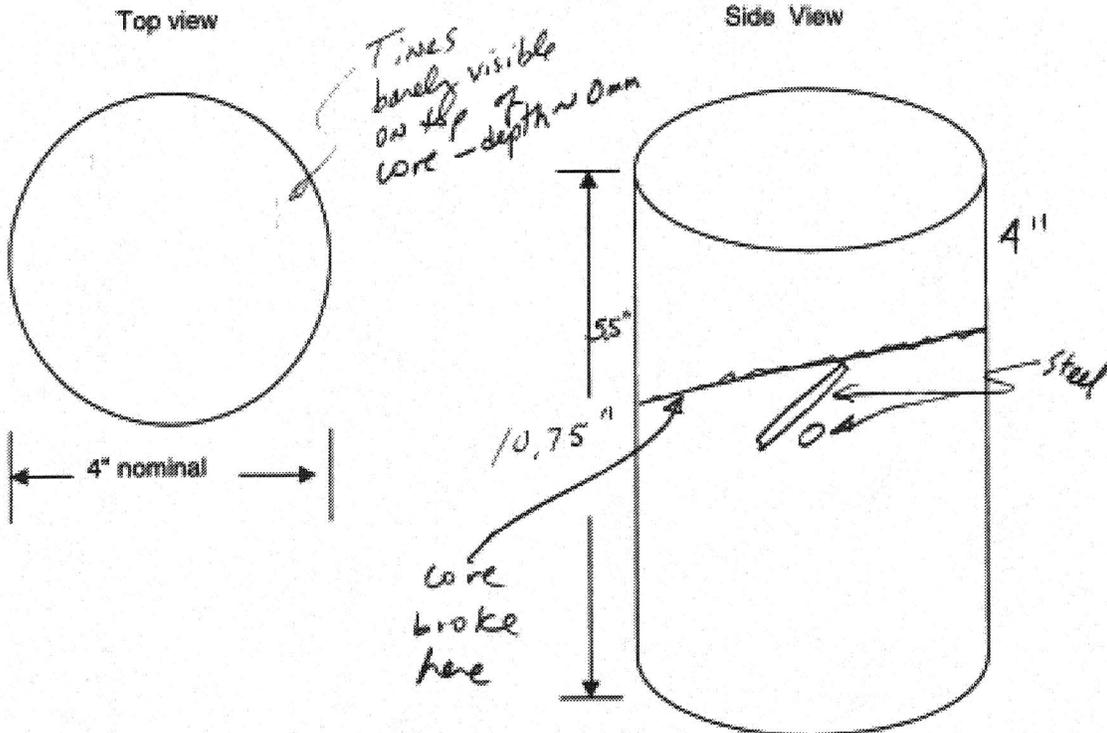
Sample Identification: US-169 Webster SB
 Core 1 (Just north of JET 520) Joint in paving line 6' ctr of pavement

Cracks, comments: Several clayey type of particles evident on top surface of core and in fracture surface - some were surrounded by white residue
Subparallel cracks noted at depth of 2" and 4" that ran through core.

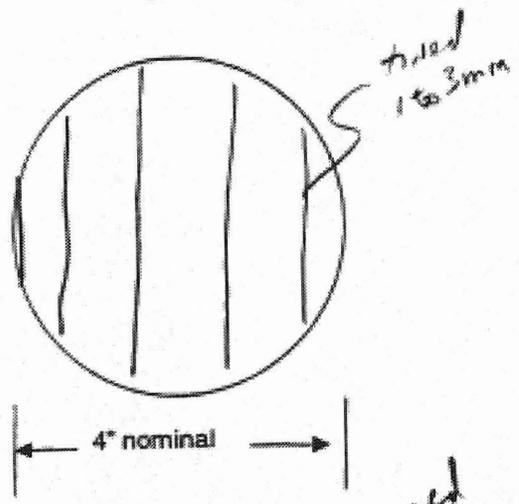
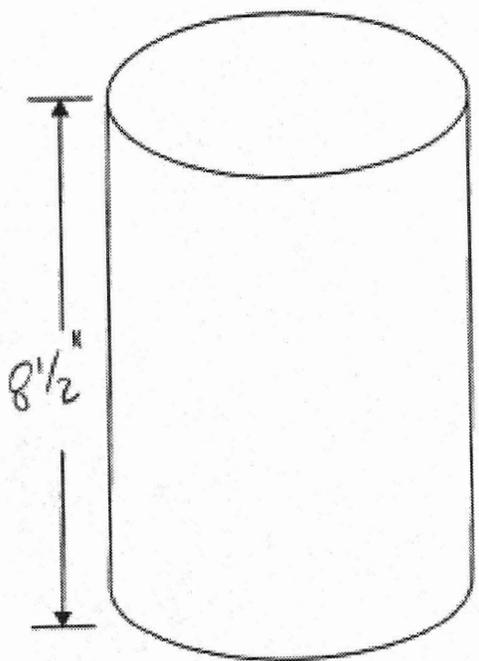
Some agg. exposed on lower surface

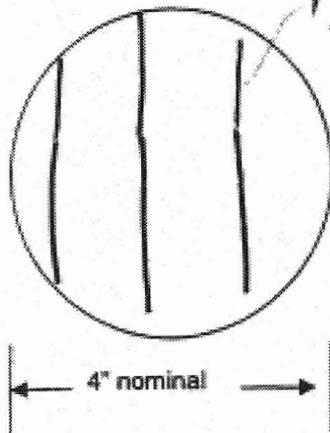
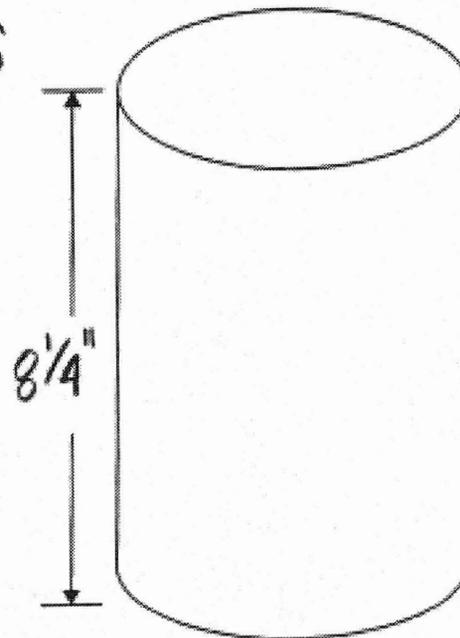
Sample Identification: HWY 175 EB MP 157.5
Midpanel

*Lines sloppy
very
2 to 5mm
deep*

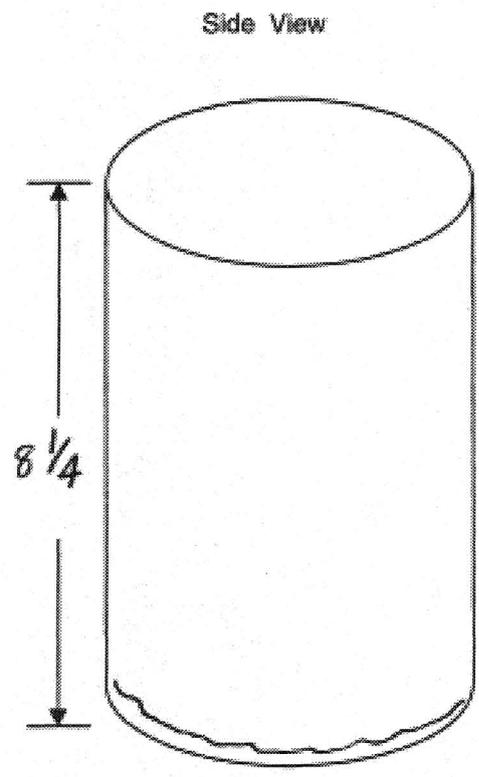
Cracks, comments: 1 CRACK RUNNING HALF WAY AROUND BOTTOM

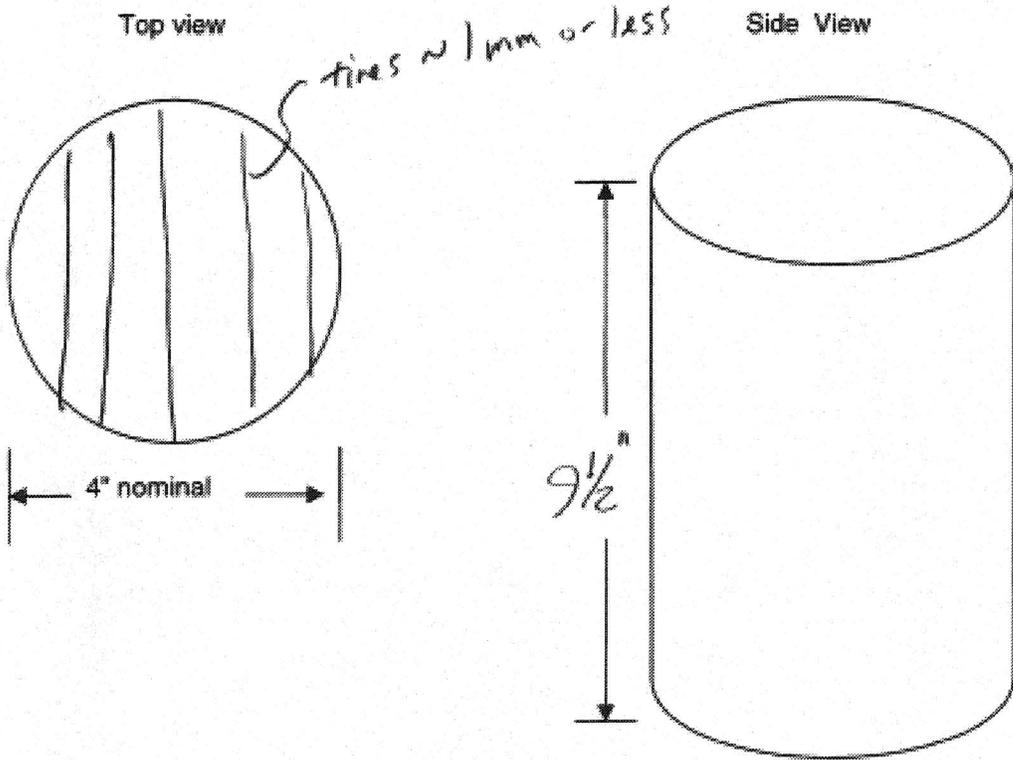
Sample Identification: IA 330 Marshall Co.
A-panel G MP 6.8 North

Surface conditions: Some white residue evident

Cracks, comments: None evident
Gravel coarse Aggregate

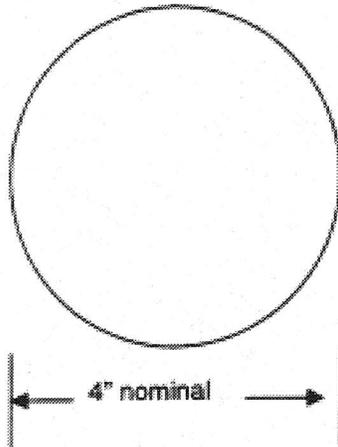
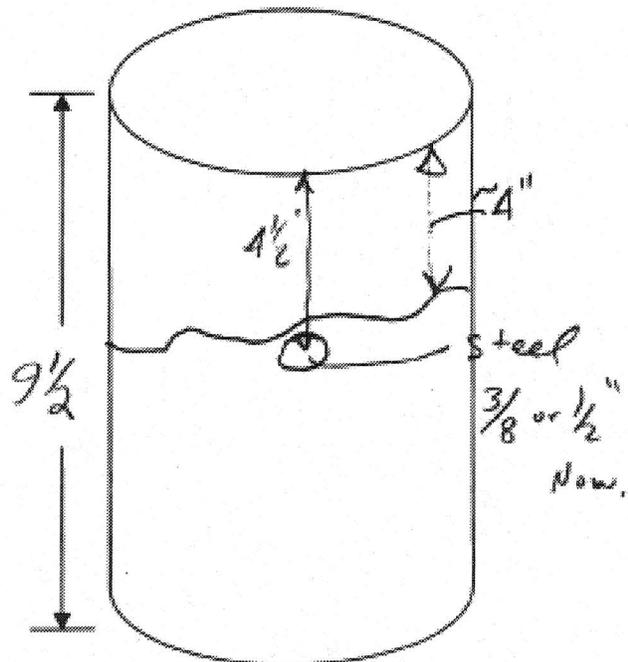
Sample Identification: IT 330 Marshall
St B @ G MP 6.8

Cracks, comments: Steel was extensively corroded
Core broke at ~4" due to steel
Some cracked aggregates noted

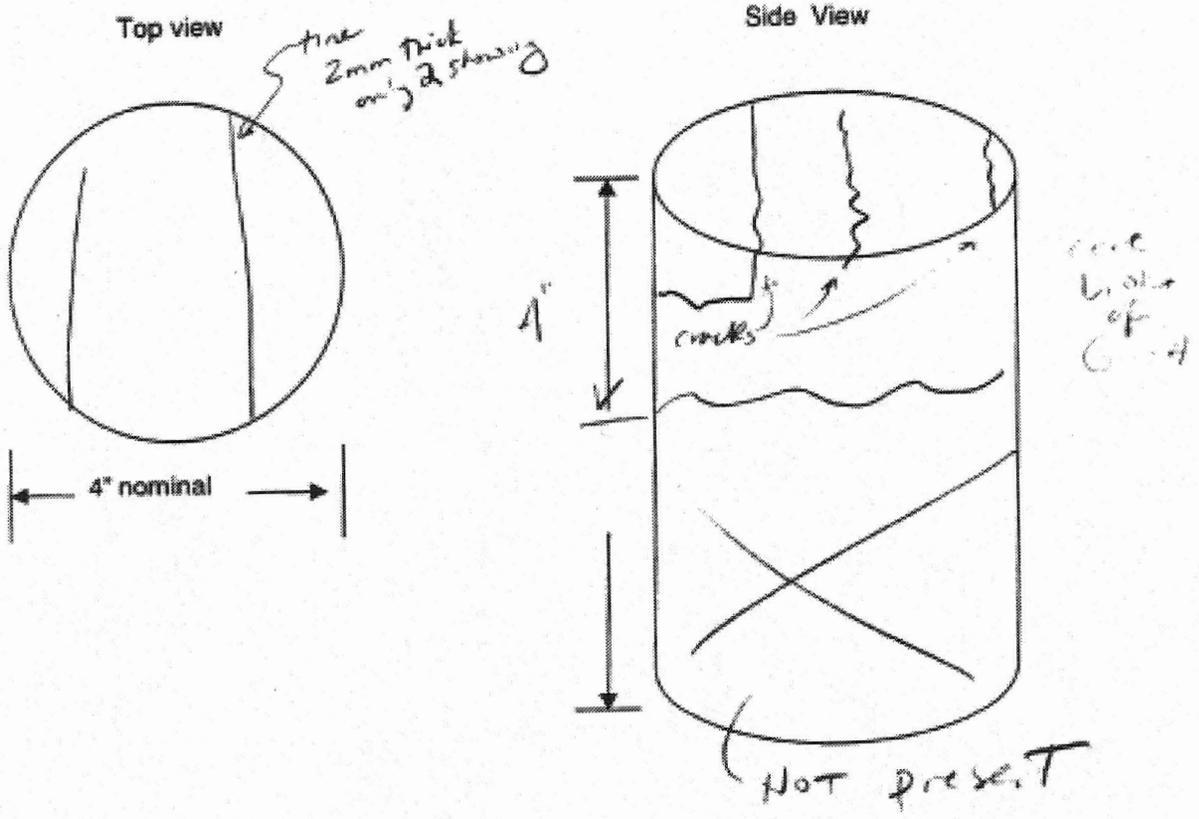
Sample Identification: I-80 EB Iowa Co. hwy 210.36
top 1/3 of extra core

Surface conditions: Poor - surface cracks

Cracks, comments: surface cracks prevalent

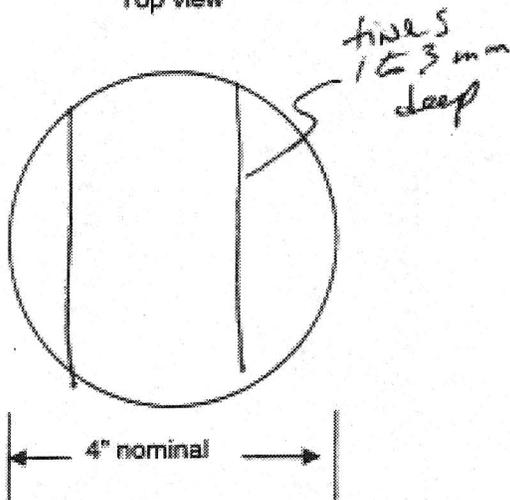
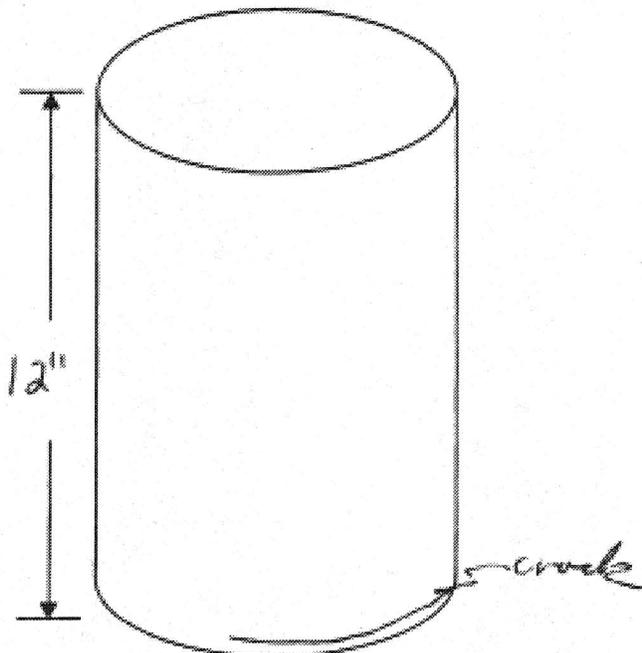
Sample Identification: L80-EB Iowa County MP 210.36
Joint

Surface conditions: many regions of patchy white material

Cracks, comments: crack @ base (within 1/4" of
bottom of core) that
fractured several aggregate particles

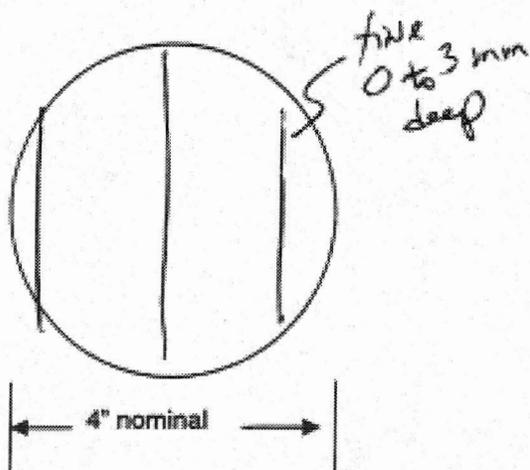
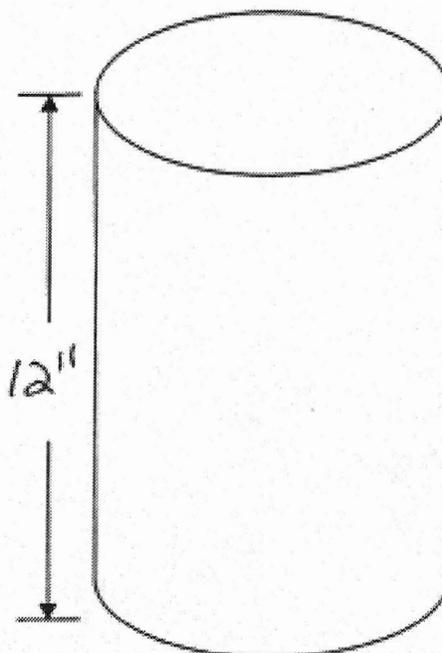
Sample Identification: I-80 EB Iowa County MP210.36
midpanel

Surface conditions: large entrapped airvoids common

Cracks, comments: NONE evident

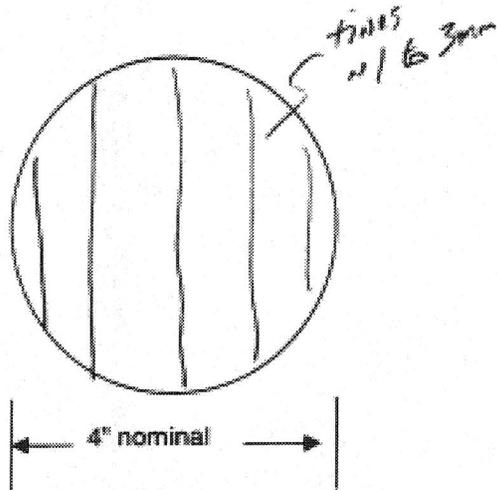
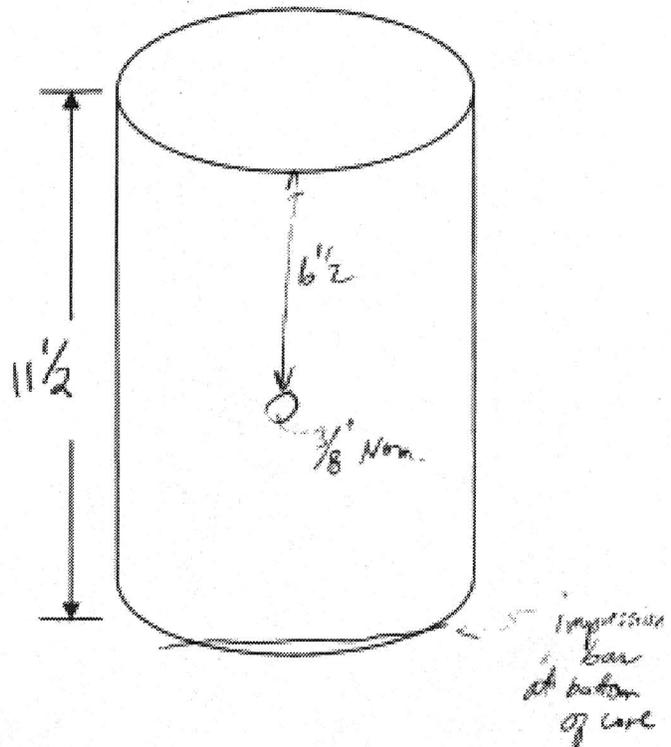
Sample Identification: ISO DALLAS STA 509
It Near $\frac{1}{2}$

Cracks, comments: Shale particles common - No white residue evident
No cracks

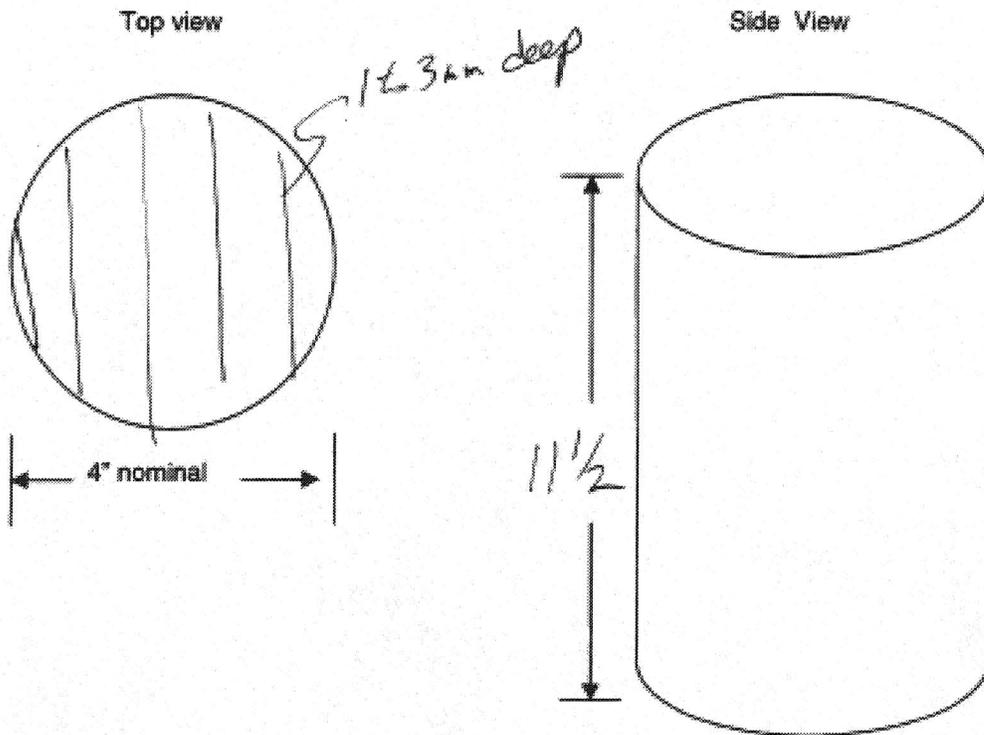
Sample Identification: IA-80 DALLAS STA 509
midpanel

Cracks, comments: No cracks evident
Shale particles common - some with
white residue near them (? ASR gel)

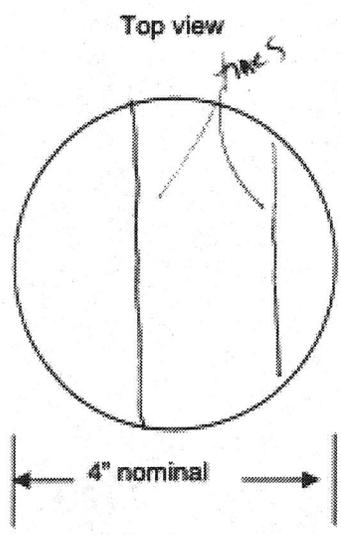
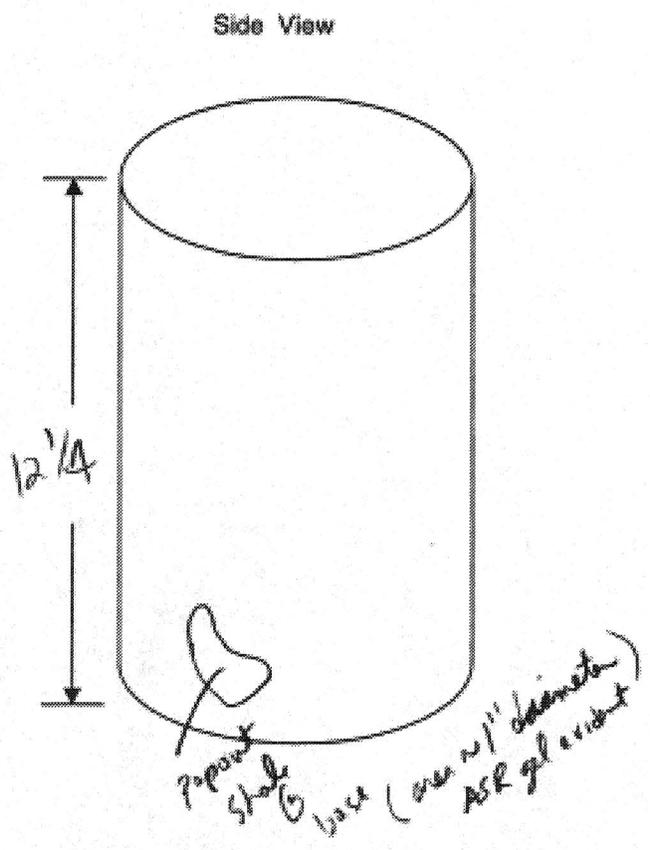
Sample Identification: I-80 DALLAS Sta 810+40
Joint outside

Surface conditions: Irregular fines

Bottom: Cracked Ang Base

Cracks, comments: some popouts evident due to scale
entrapped air voids common by
typical < 5mm diam.
Dried uniformly

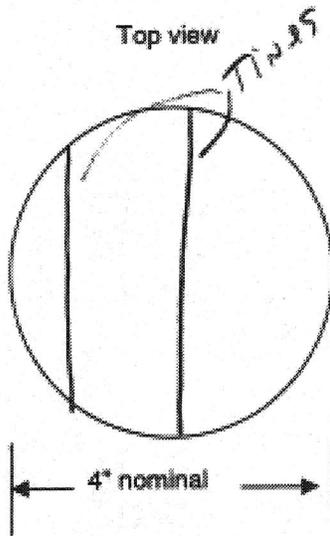
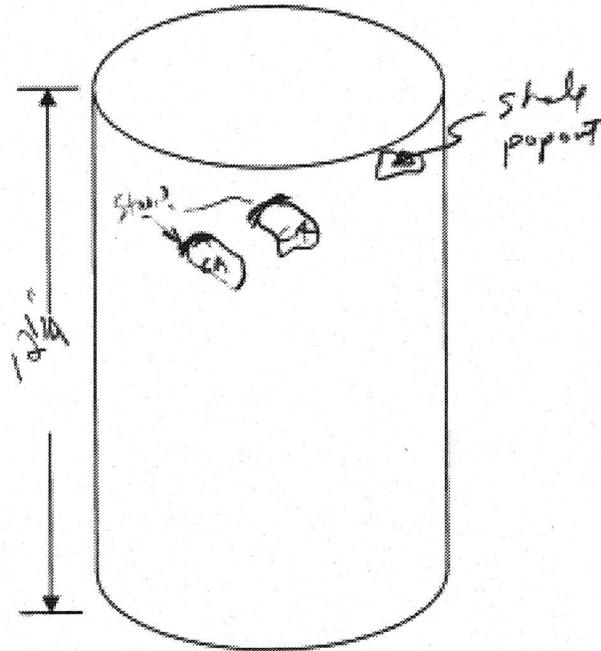
Sample Identification: I 80 Dallas Sta 810 + 40
Midpanel

Surface conditions: Irregular finish ~ 1 to 2 mm deep

Cracks, comments: some chipping staining water

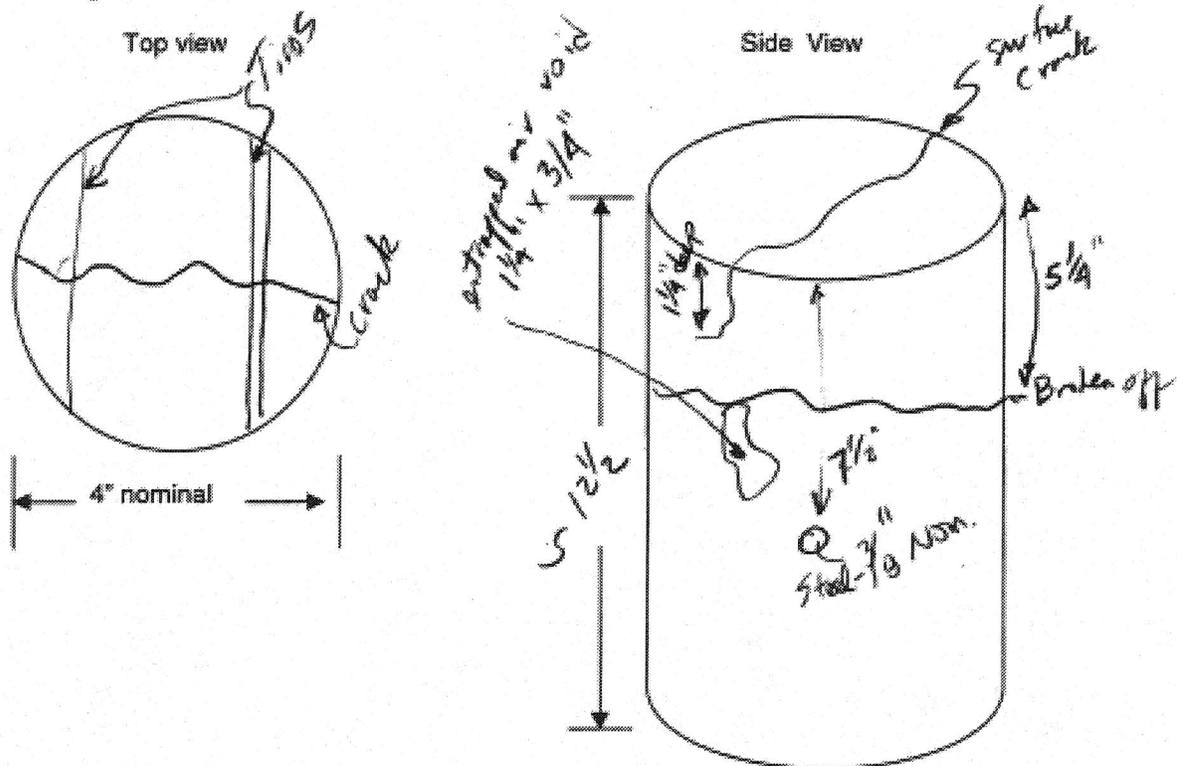
Sample Identification: I-80 DALLAS Sta B10 + 40
JT Near E

General Observations:
 Dimensions: 4 x ~12 1/2
 Surface conditions: Tiny irogelaw (only 3 tubes show on core)
 Bottom: crush egg base
 Reinforcement: steel @ 7 1/2"
 Cracks, comments: cracked extensively - surface crack across core
core. core broken off @ 5 1/4" from top
some white residue noted on surface
of core; scale particles present + pop outs,
some CA staining

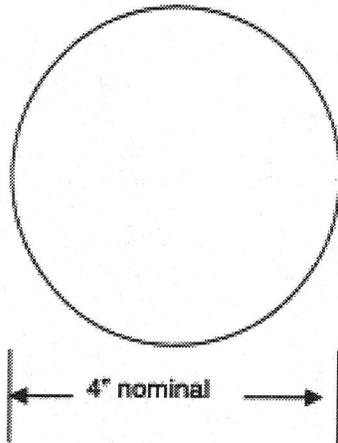
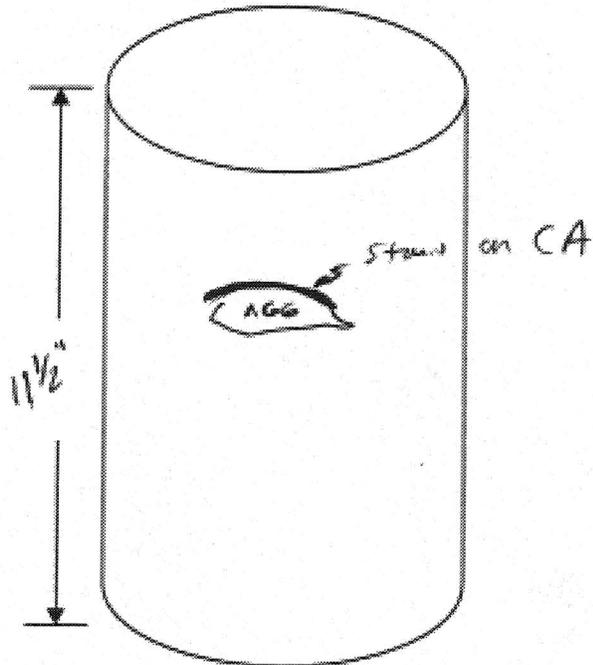
Sample Identification: IA-80 DALLAS Sta 966+20
Joint outside

Surface conditions: TINES barely cut surface < 1 or 2 mm deep

Cracks, comments: some finer diameter voids
noted @ mid core - some agg staining (CA)

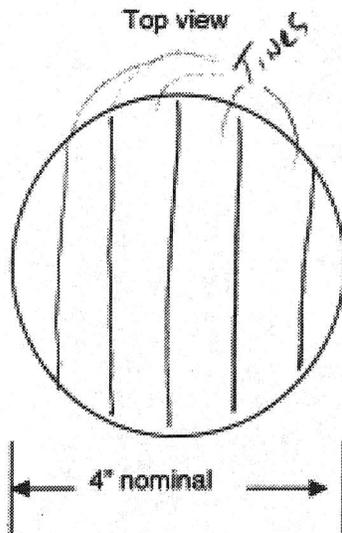
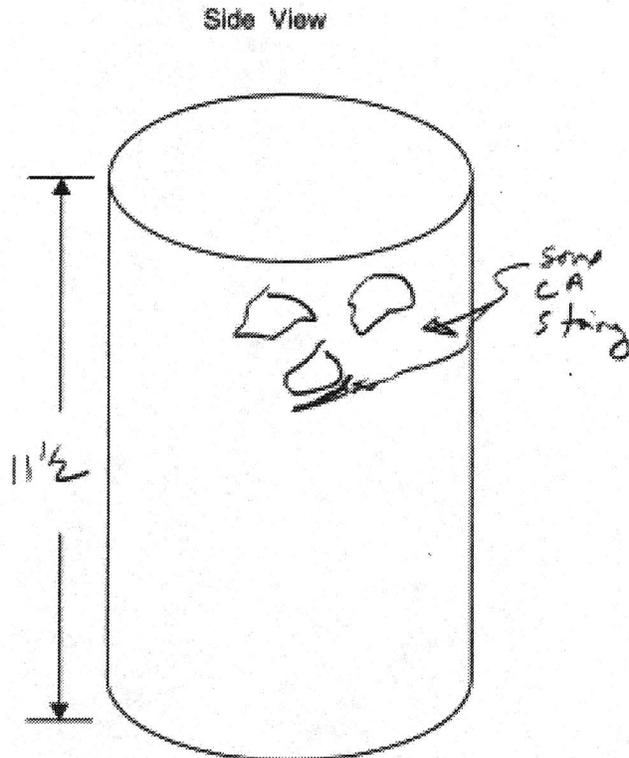
Sample Identification: IA 30 - DALLAS sta 966+20
mid panel

Surface conditions: Tines cut surface to depth of ~2mm

Cracks, comments: some staining on 3 coarse
aggr particles near top of
core - did not wash off

Dried uniformly except for entrapped air voids
- some white residue noted near top of specimen

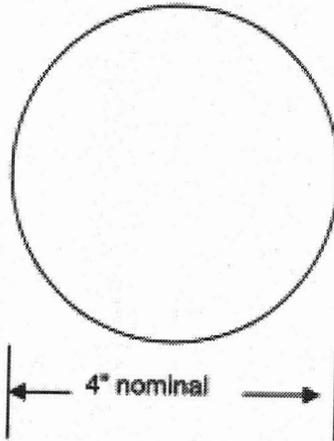
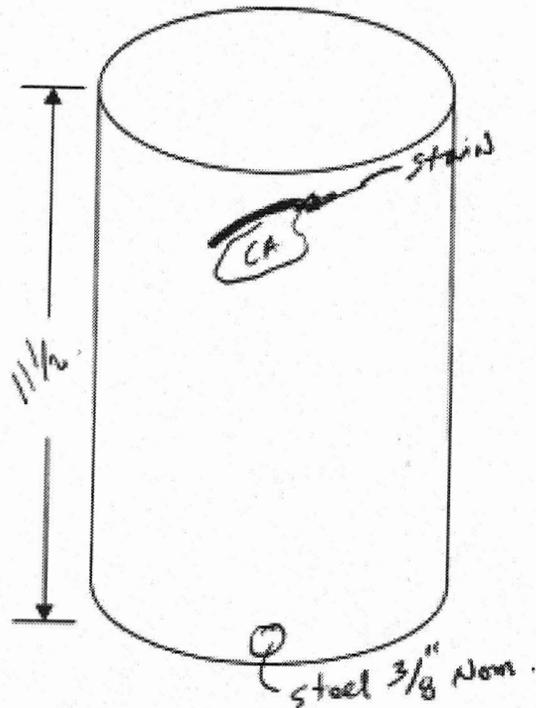
Sample Identification: I-80 DALLAS Sta 966+20
It Near Q

Surface conditions: Tined ~ 1 to 2mm deep

Cracks, comments: Some CA staining that doesn't wash off
Dried uniformly except for entrapped voids

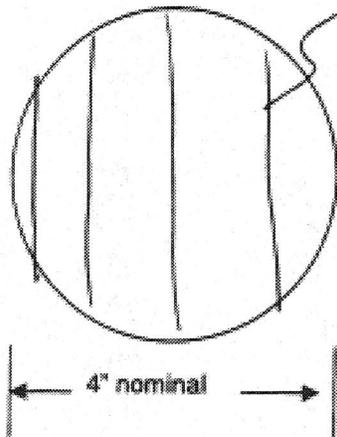
Sample Identification: I80 WB Cass Co.
about 4' from G

Surface conditions: looked good ^{few} ~~no~~ entrapped air voids

Cracks, comments: No cracks observed (except
for some marks at interface of
base & concrete)

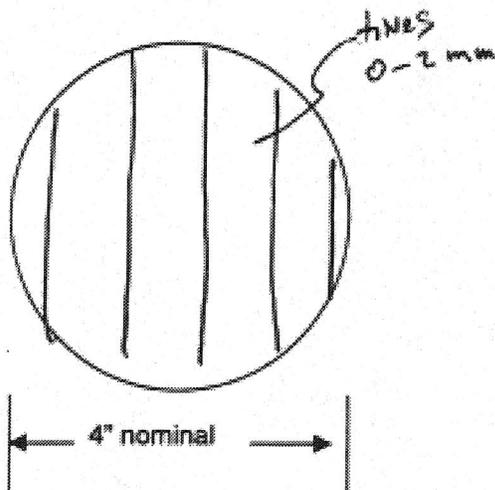
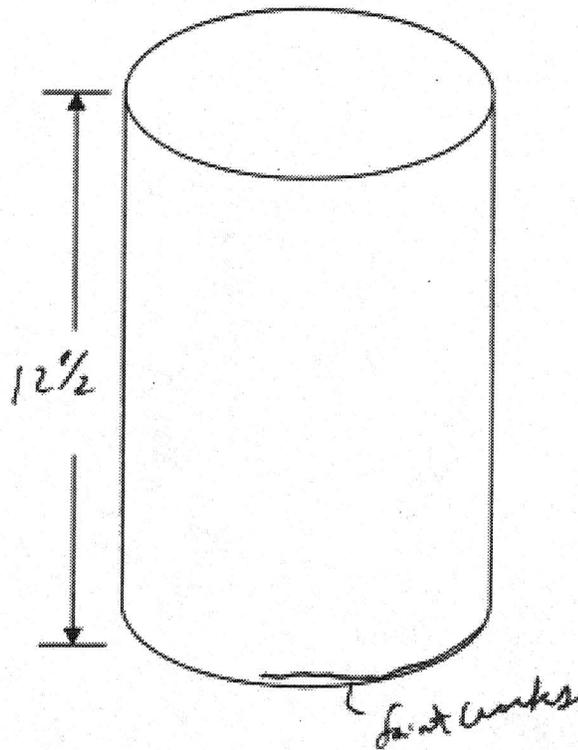
Surface conditions: Entrapped Air voids common (~0.5")

Cracks, comments: No cracks evident (except
some questionable ones at very base)

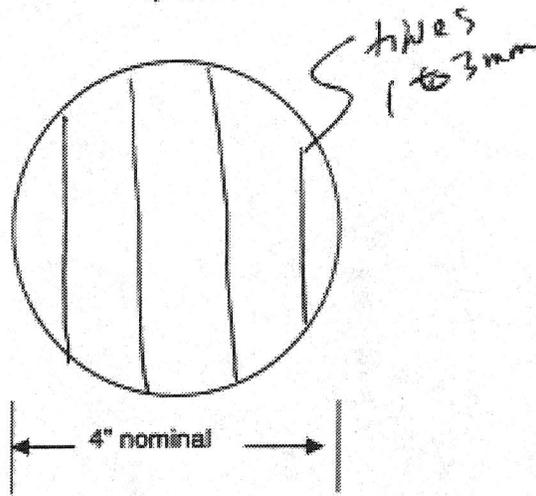
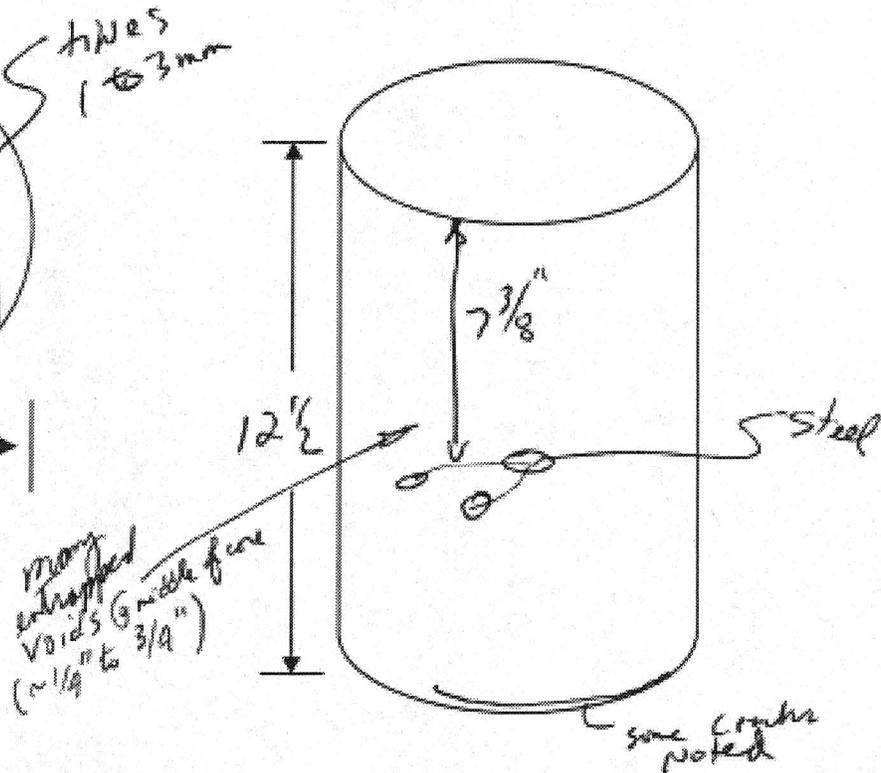
Sample Identification: I-80 WB Cass Co.
Joint

Cracks, comments: Some cracking noted @ bottom of core

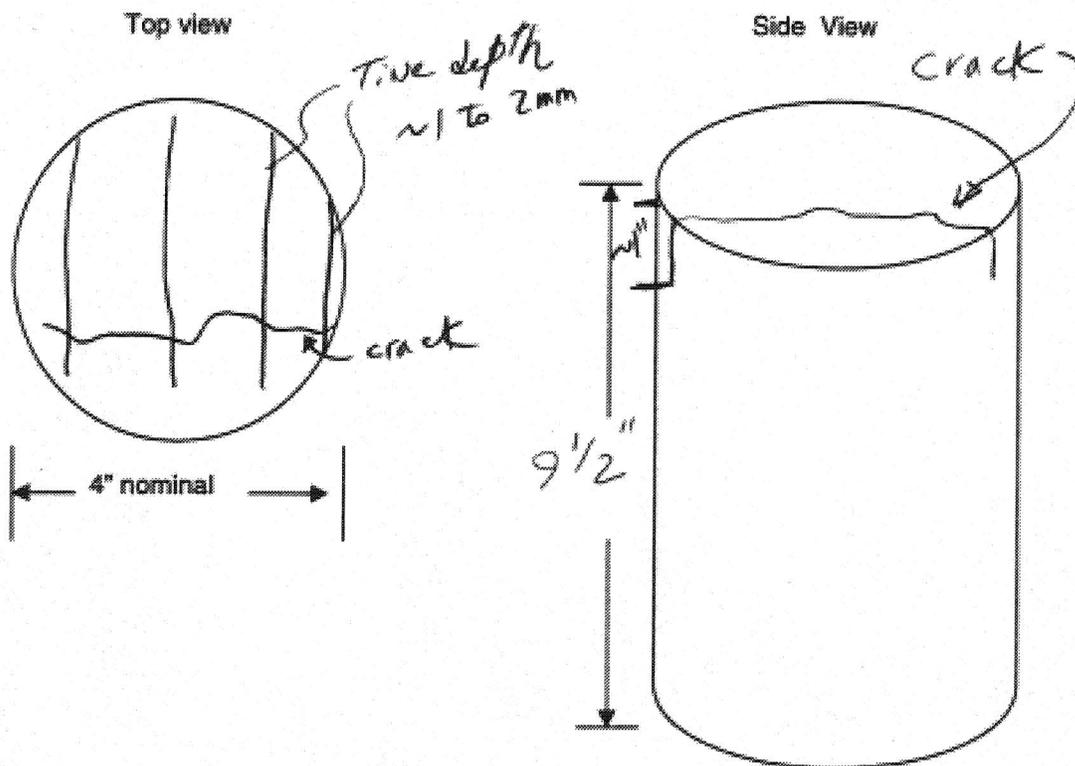
Sample Identification: IA-2 MP2.6 WB
STA 1498+95 JOINT

Cracks, comments: Crack on Top surface of core,
penetrates about 1" below top surface
No material filled the crack
Some damp spots dried to leave white material

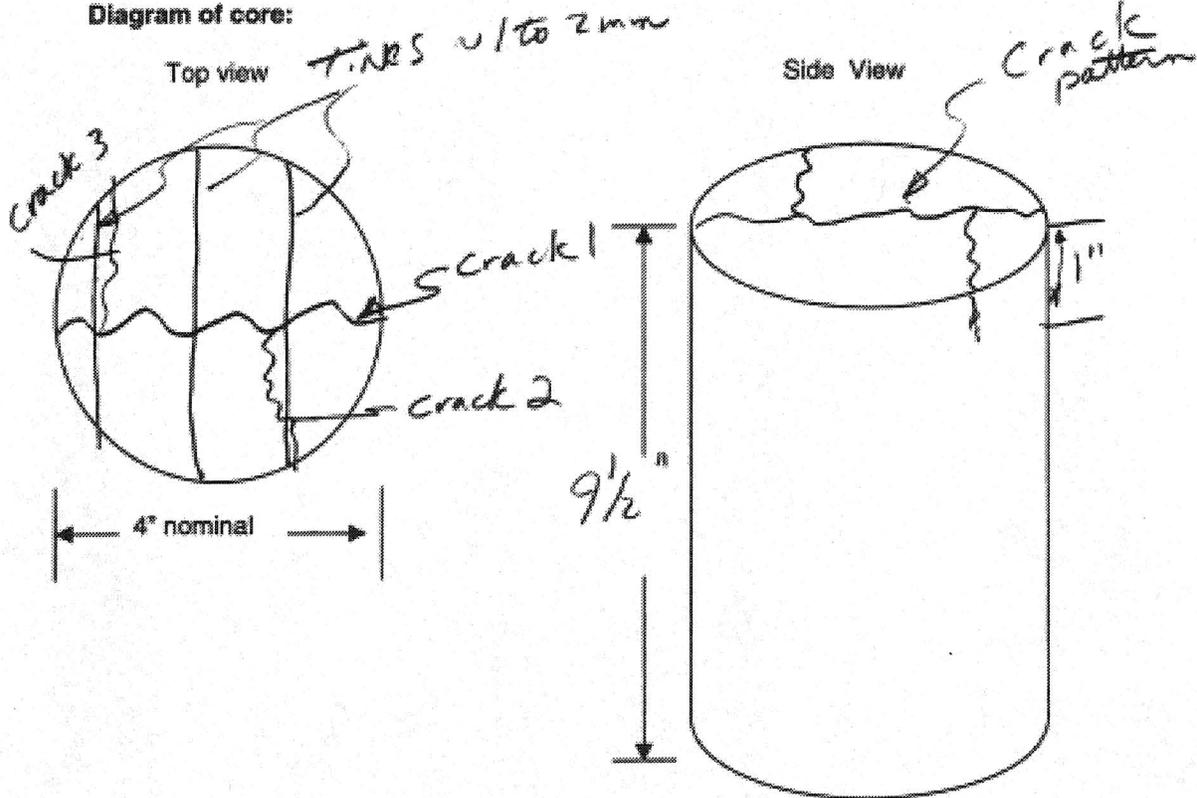
Sample Identification: IA-2 MP 2.6 WB
STA 1498+85 Midpanel

Surface conditions: cracking noted on top surface

Cracks, comments: Cracks evident on top surface - random
from main crack - The cracks
penetrated about 1" into core. No
material found in cracks. One shell
particle popout noted.

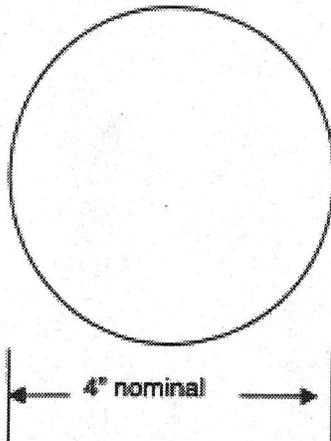
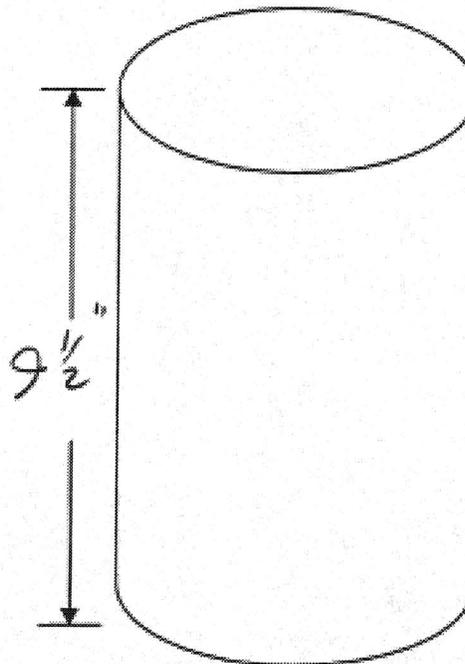
Sample Identification: IA - 2 WB
STA 1499 ? Joint or Midpanel

Cracks, comments: No cracks
some areas dried to leave a
white residue

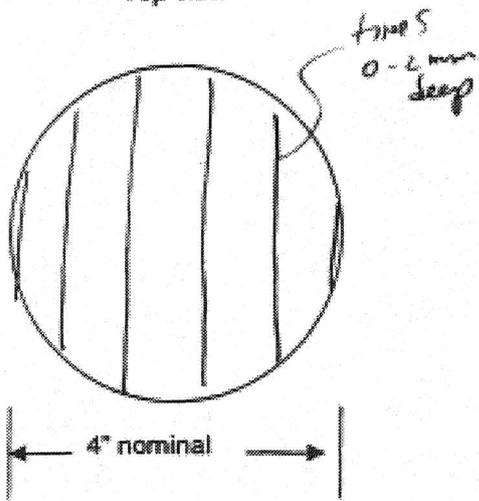
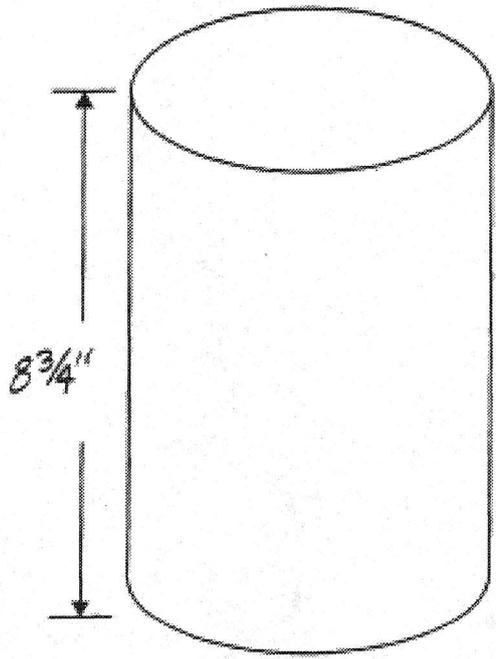
Sample Identification: IA - No 0 EB STA 362
mid panel

Surface conditions: Some spotty white deposits noted near shale particles

Cracks, comments: NONE evident on core

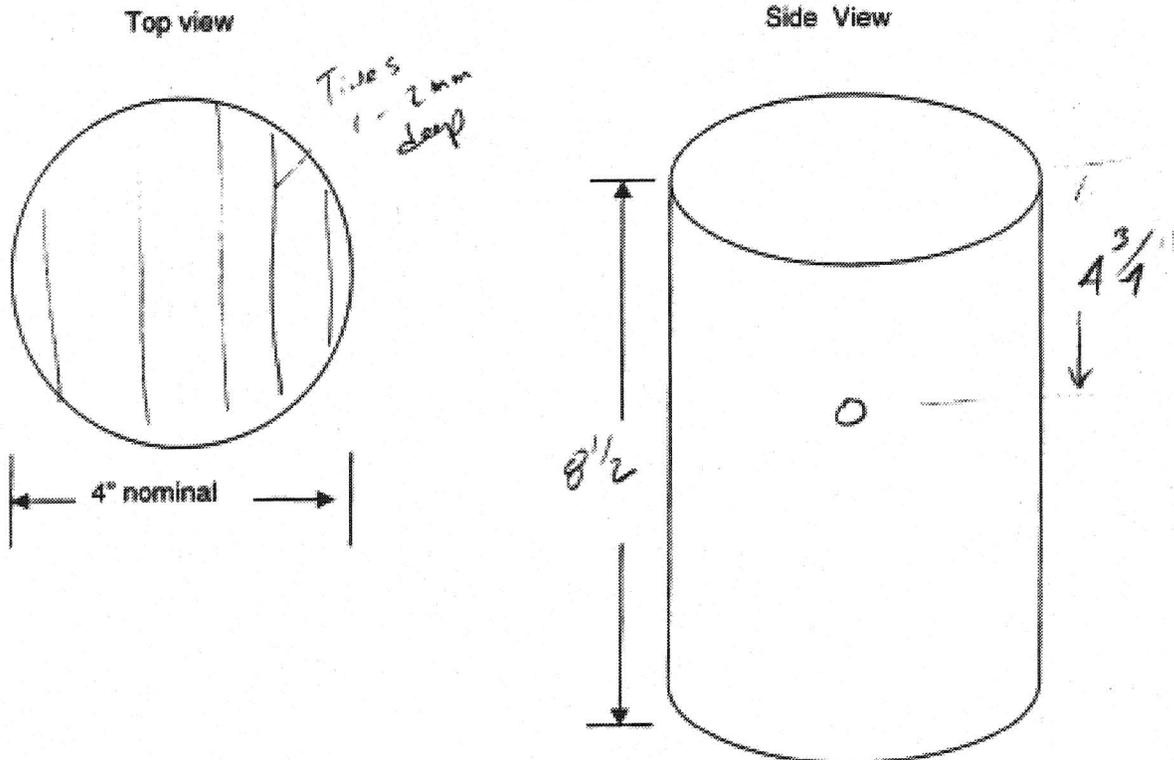
Sample Identification: IA - 160 EB STA 362
Joint 4' from G

Surface conditions: Note - some reactive shale particles

Cracks, comments: Note some reactive shale particles
on outside of core - no real
cracking was evident
