DETERMINE INITIAL CAUSE FOR CURRENT PREMATURE PORTLAND CEMENT CONCRETE PAVEMENT DETERIORATION

FINAL REPORT

Sponsored by the Project Development Division
of the Iowa Department of Transportation
and the Iowa Highway Research Board
Iowa DOT Project TR-406
CTRE Management Project 97-13

OCTOBER 2000

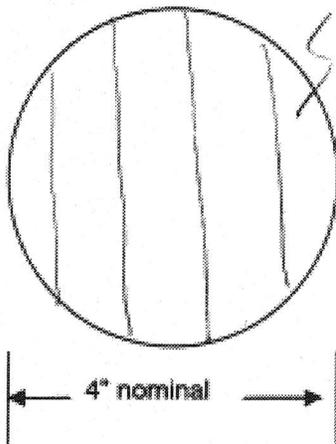
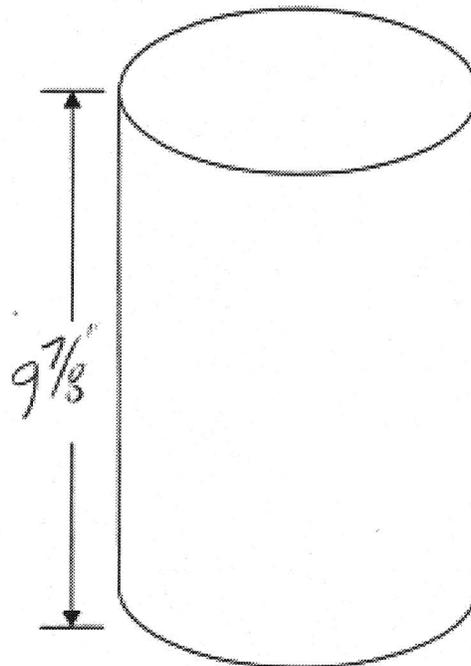
Sample Identification: US 218 SB
CA JOINT 6 MP95

Surface conditions: some large entrapped voids in top 6" of core

Cracks, comments: No cracks evident
White residue sometimes evident
near fine aggregate particles
Core did not feel very slick when wet

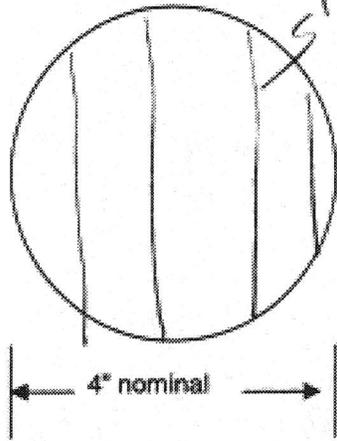
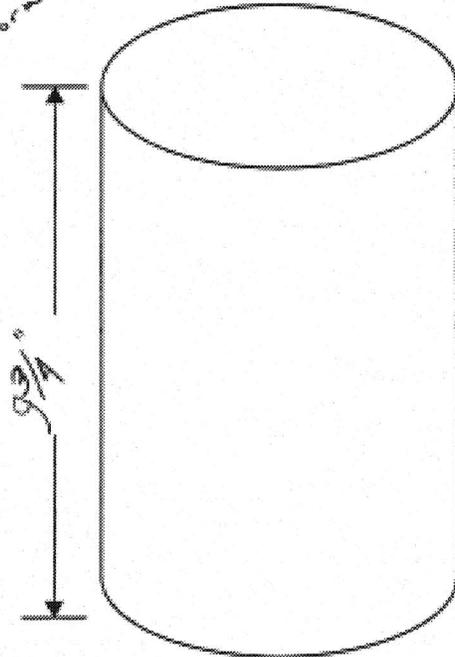
Sample Identification: US 21B SB (Passing lane)
mid panel CA MP 25

Surface conditions: Many entrapped air voids noted in top 6" of core

Cracks, comments: No cracks evident
little white residue as noted compared
to NB cores

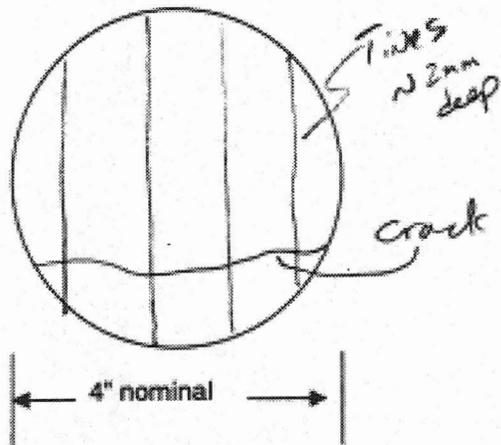
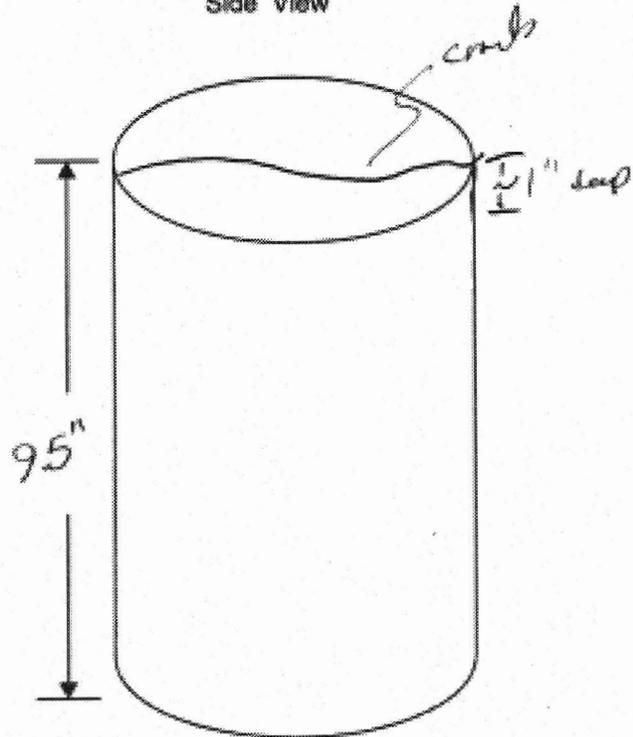
Cracks, comments: Much white residue on side of
core associated with fine aggregate
particles - some shale + some dirt
top surface crack penetrated ~1" into core

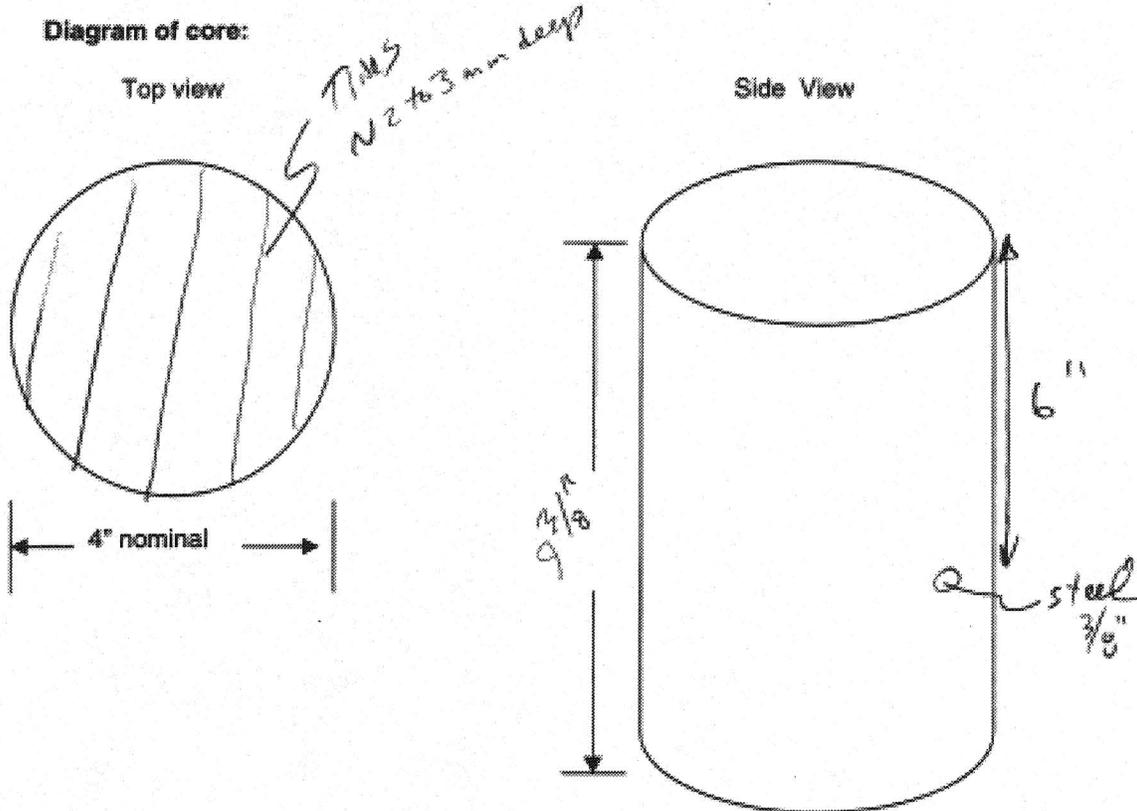
Sample Identification: US 218 NB
NB - MP 91.96 (9 dia of long + 7 cov) 0.15

Surface conditions: Good - fines ~ uniform - no cracking

Cracks, comments: much white surface staining on sides of core
some shade; clast particles
Surface feels slick when wet - perhaps
white residue is Ca(OH)₂

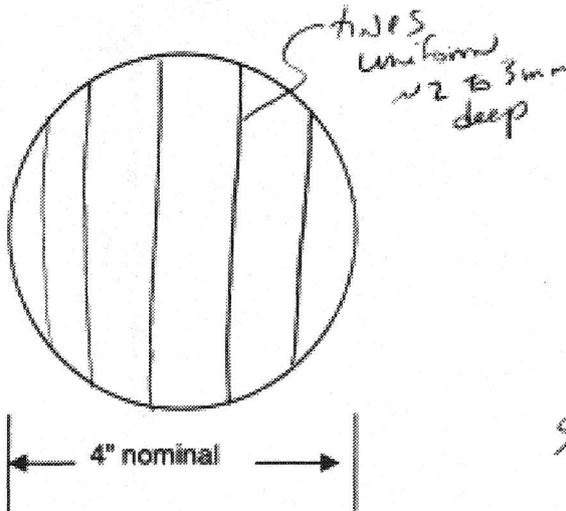
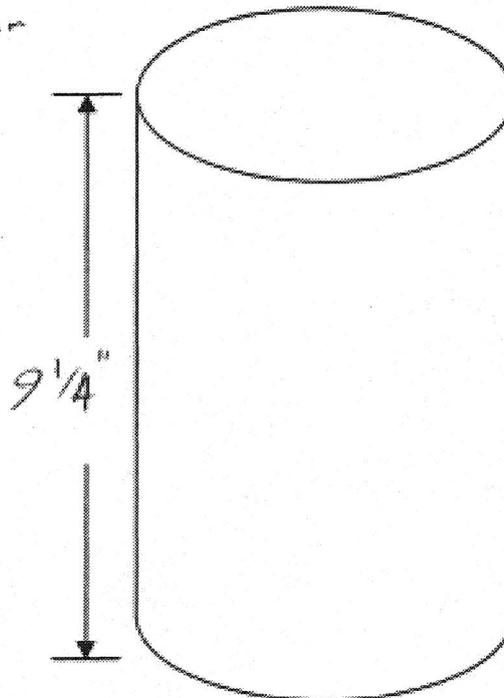
Sample Identification: US 218 NB
Mid panel @ MP 91.76

Surface conditions: Good - No cracks evident

Cracks, comments: Sides feel slick when wet
and less white residue on sides as
compared to joint specimens

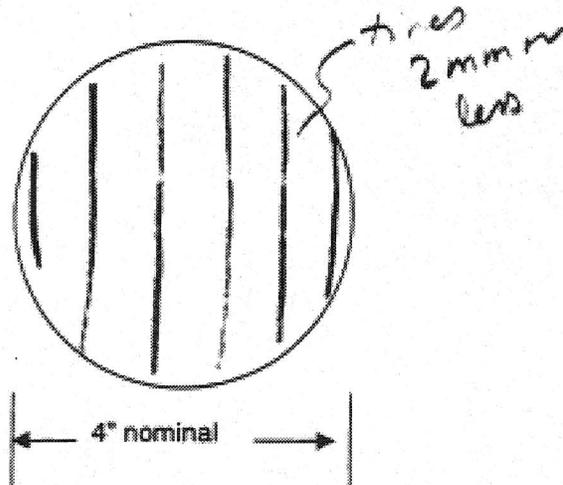
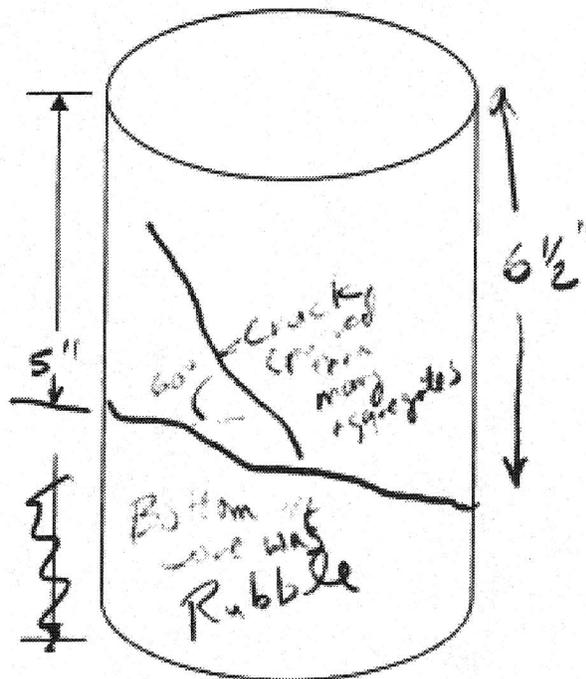
Sample Identification: HWJ61 Near MP 125
C JOINT

Surface conditions: TINES uniform but shallow

Cracks, comments: Bottom 1/3 of core was rubble
Some cracked as shown in drawing
Some white efflorescence on portions
of the core

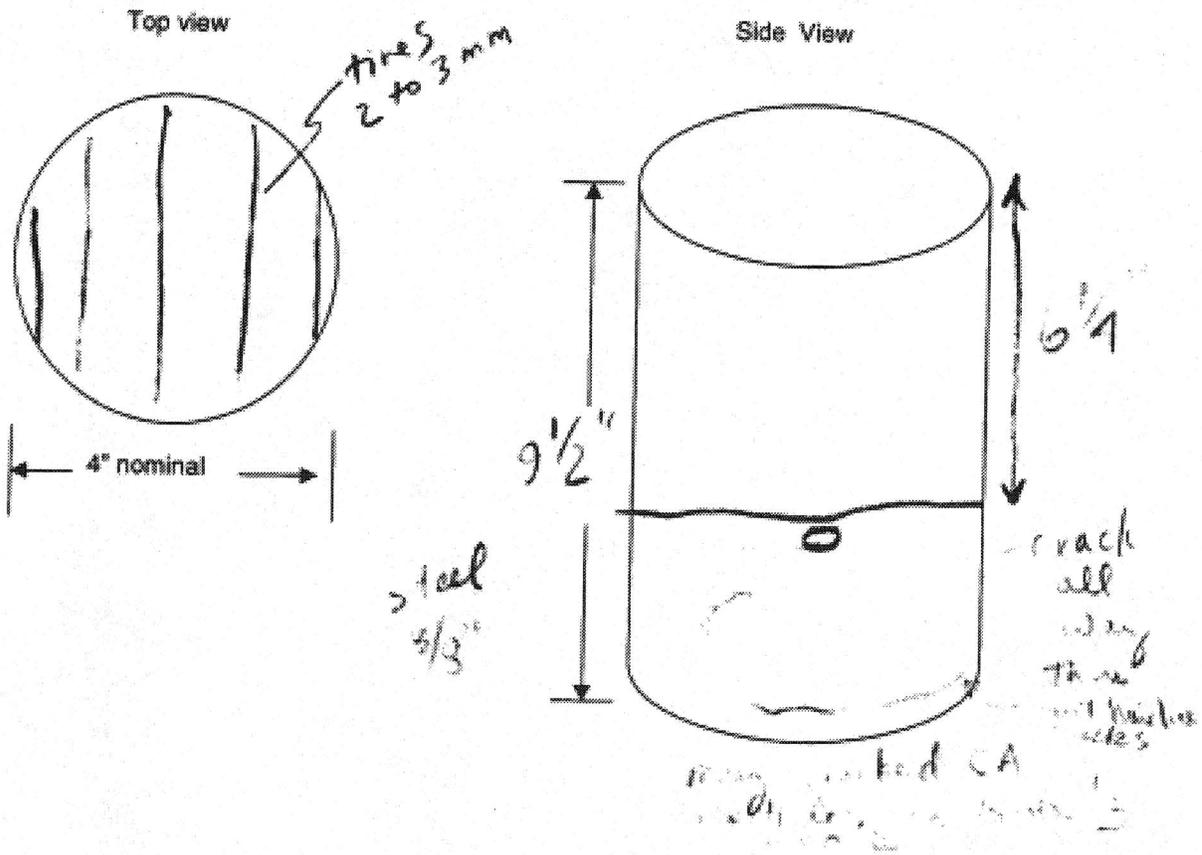
Sample Identification: HWY 61 North Near MP 125
Hole Near joint

Surface conditions: fair uniform

Cracks, comments: Cracking of CA common below
steel reinforcement. None noted
above steel.

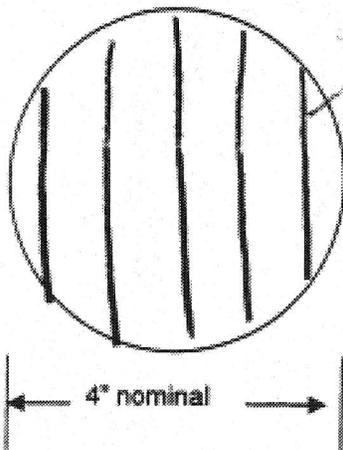
Sample Identification: HWY 61
1' from JOINT

Cracks, comments: Bottom of core (last 1/2")
shows fine hairline cracks
thin paste & CA - many
CA particles are cracked

*fine cracks
some
thin
paste &
CA*

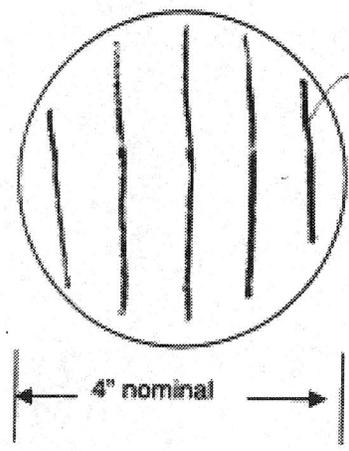
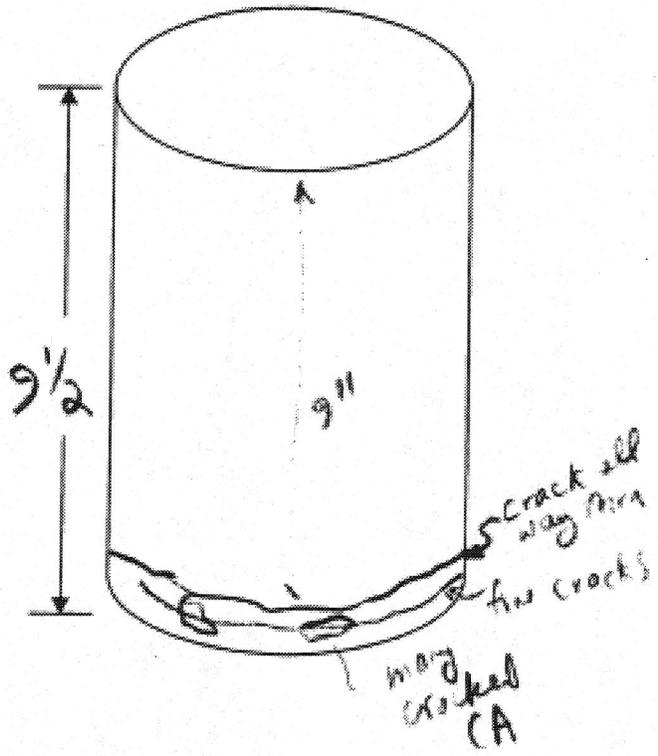
Cracks, comments: severe cracking @ base of
core
