# **Effective Structural Concrete Repair Volume 1 of 3**

## **Repair of Impact Damaged Prestressed Concrete Beams with CFRP**

March 2004

Iowa DOT Project TR - 428

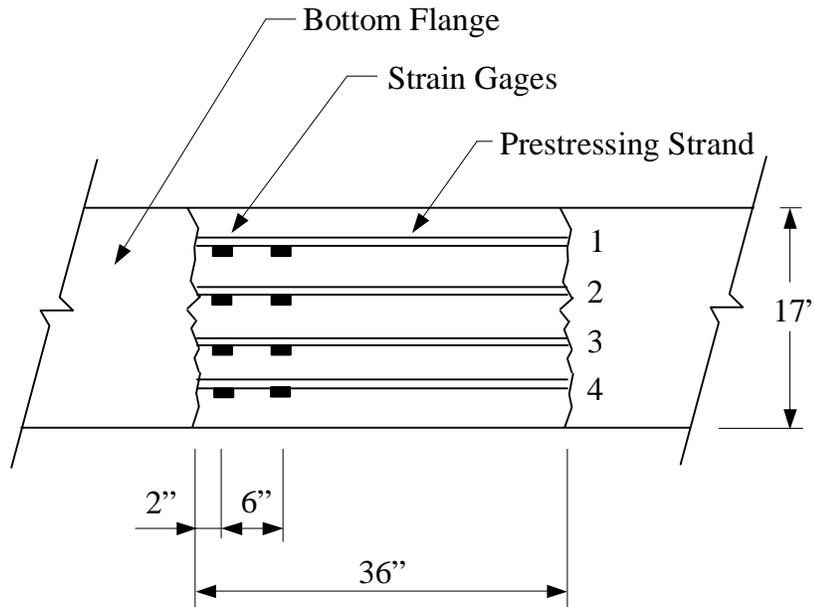
Figure 3.11. Plan view showing the location of the strand strain gages.

In addition to the concrete and CFRP strain gages, strain gages were also installed on the exposed prestressing strands after all of the concrete was removed. A total of eight gages (two per strand) shown in Figure 3.11 were used to monitor the strain levels in the bottom level of prestressing strands. The gages were positioned as closely as possible to one end of the exposed prestressing strands. This was necessary to minimize vibrations at the location of the strain gages when the strands were severed which could damage the soldered

Once the concrete was removed, the first two prestressing strands (Strands 1 and 2 shown in Figure 3.11) on the bottom row were severed with a cutting torch. Strands were heated slowly to allow the wires to neck down under the prestressing force. Strand strain readings were taken during the cutting process to determine the effective prestressing force and to determine how the released forces were distributed to the remaining strands. Metal heat shields were used to insulate adjacent strands from the extreme heat. After each strand was severed, a service load test was completed to determine the change in beam stiffness and the changes in stress levels in the remaining strands and in the concrete. The strands were cut at the ends opposite the strain gages; they were also clamped to other strands to minimize vibrations.

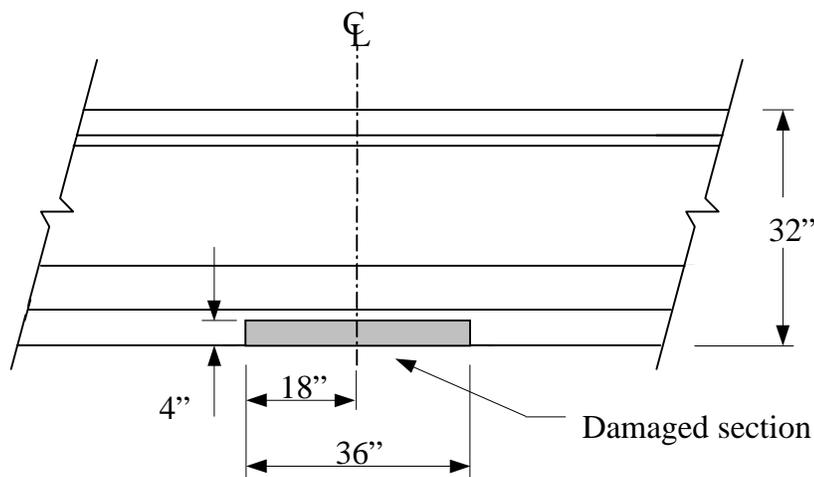
Figure 3.12. Location of beam damage.

Concrete was removed from the bottom flange of the P/C beams using a handheld demolition hammer. The section of the bottom flange removed was 3 ft long and 4 in. deep across the entire width of the bottom flange. This was enough to expose two layers of prestressing strands (i.e. eight prestressing strands). Special care was taken to avoid damaging the exposed prestressing strands with the demolition hammer. To produce the maximum effect from the given loading, the damage was located at the beam centerline as shown in Figure 3.12. After the concrete was removed, a service load test with a maximum load  $P$  of 25 kips (i.e. 50 kips applied to the beam) was conducted to determine changes in the stiffness characteristics of the beam. The results of these tests are presented and discussed in Chapter 5. A photograph of the beam with 4 in. of concrete removed is shown in Figure 3.13. Two exposed stirrups are also clearly visible in this photograph.

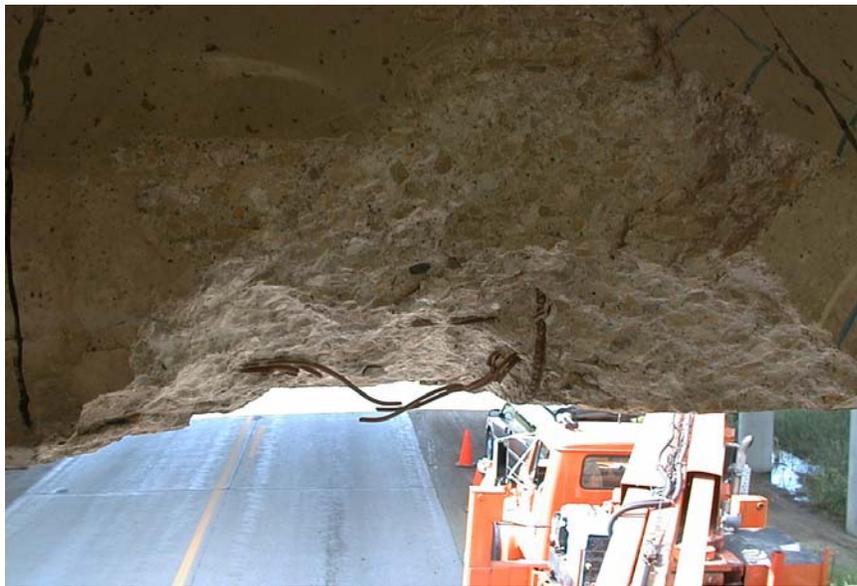
The bridge incurred some damage due to an overheight vehicle traveling south on Highway 169. The vehicle missed the seven northernmost beams and struck the final two, Beams 8 and 9. Beam 1 sustained significant concrete loss and also lost a prestressing tendon. Two of the damaged areas are shown in Figure 3.40 and 3.41. Appendix B contains a more thorough report of the damage.

Figure 3.40. Photograph of severed prestressing strand on Beam 9 in the De Soto bridge.

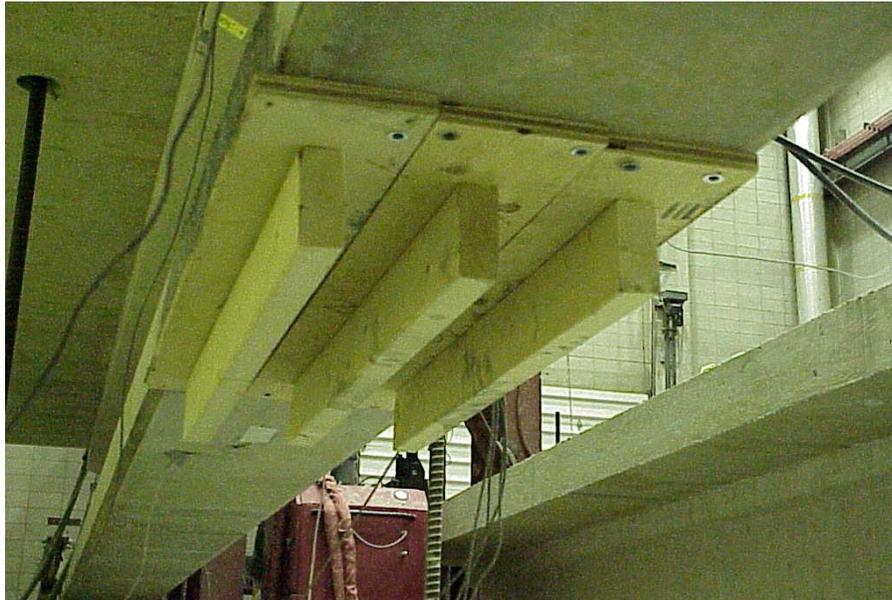
Figure 4.1. Completed patch formwork.

A photograph and an elevation view of the completed patch formwork in the laboratory are shown in Figures 4.1 and 4.2. Once the patch material was placed, the opening on the side of the flange was finished with a hand trowel. Approximately four 55-lb bags of EMACO S88 C1 were required to fill each patch ( $\approx 2.0 \text{ ft}^3$ ).

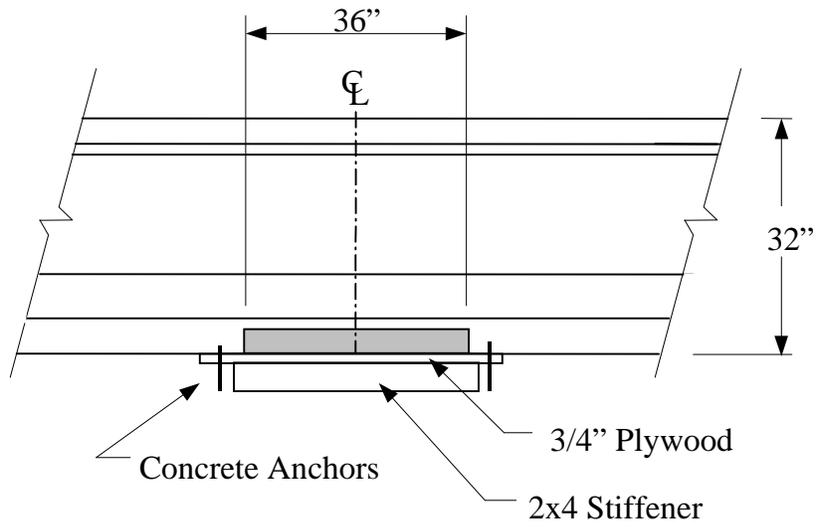
Figure 4.2. Elevation view of patch and patch formwork.

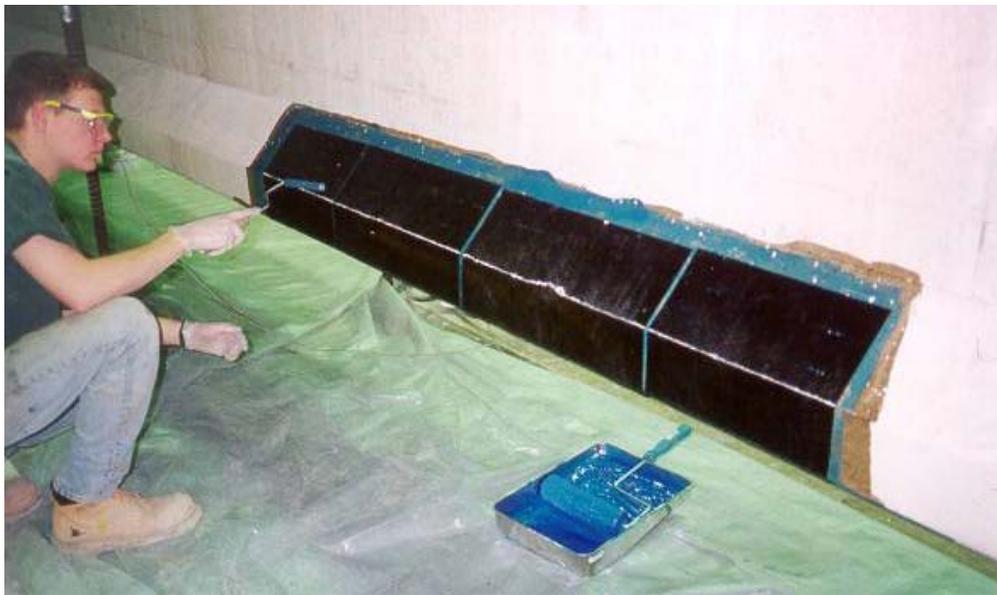
Figure 4.11. Installation of transverse CFRP jacket on Beam 2.

Installation of the CFRP jacket around the bottom flange of Beam 2 is presented in Figure 4.11. The same type of CFRP sheet that was used for the longitudinal fibers was also used in the transverse direction. The longitudinal fibers were allowed to cure for one day before the jacket was installed. As with the longitudinal fibers, a hand-held grinder was used

to prepare the sides of the beam. The continuous CFRP sheets completely wrapped the entire bottom flange of the P/C beam as shown in Figure 4.12. A gap of approximately 1/4 in. was provided between the individual jacket pieces to avoid disturbing adjacent jacket pieces during installation. Four individual CFRP sheets 14 in. wide were required to complete the jacket. After sheets were positioned in the proper location, a topcoat of epoxy was added to encase the jacket.

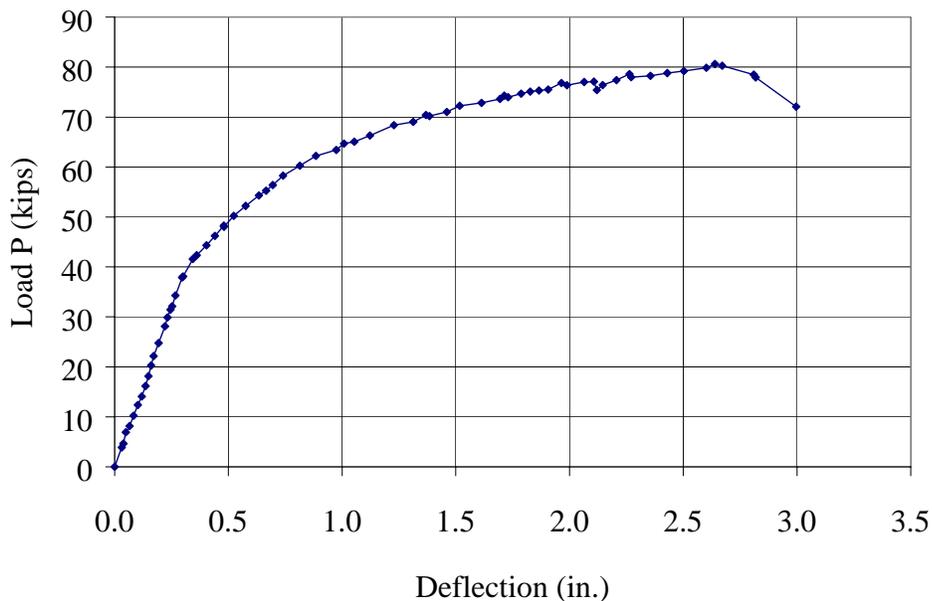
Beam 1 was damaged and repaired with two sheets of CFRP. A plot of the load/deflection behavior to failure is shown in Figure 5.2. Sheet debonding occurred at a load of 80.6 kips with a centerline deflection of 2.65 in. Note that the load  $P$  shown only represents one-half of the total load applied to the beam. Cracking occurred at a load of approximately 40 kips. This was about 31% higher than the predicted cracking load of 30.4 kips. The CFRP sheets and the epoxy tended to confine the concrete and increase the cracking load. After the section cracked, the behavior remained linear until a load of 55 kips. At this point, the prestressing strands began to yield. The CFRP sheets began to make small

Figure 5.2. Centerline deflection of Beam 1 during the ultimate strength test.

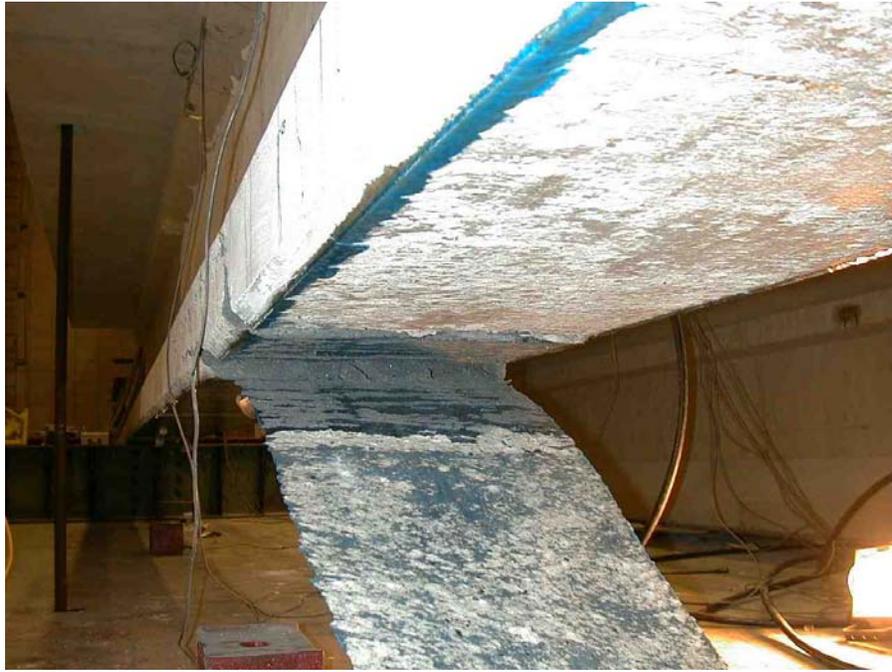
Figure 5.7. CFRP/concrete interface of Beam 1 after sheet debonding.

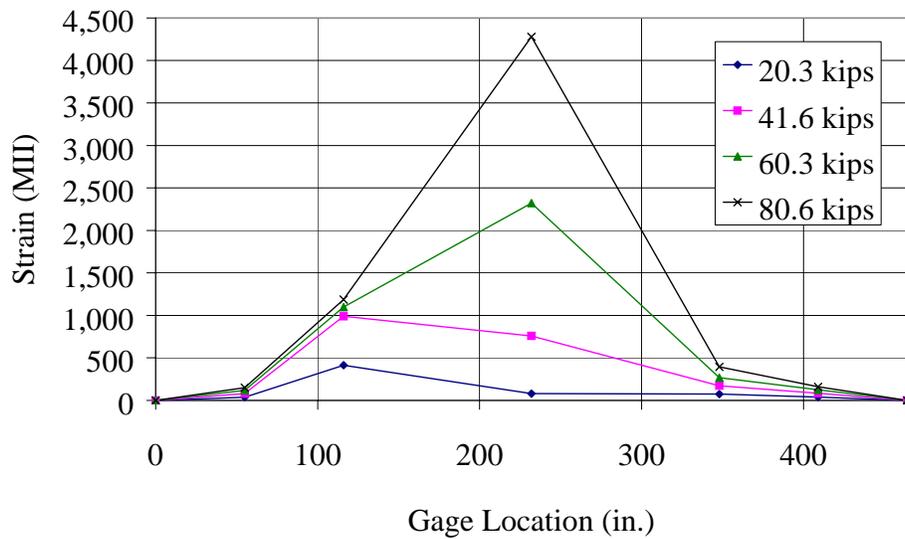
Strain values along the CFRP sheets during various stages of loading are presented in Figure 5.8. Strain gages were placed at the centerline, quarter points, and termination points of the sheets (Section 3.1.2). The strain in the bottom of the beam was assumed to be zero at the ends. As shown in the figure, the strain values at the sheet termination points were very small. Even at the ultimate load, the strain at the end of the sheets did not exceed 200 MII. This is an indication that the sheets were properly detailed and installed thus avoiding debonding at the ends. The maximum-recorded strain value was approximately 4,300 MII at the beam centerline. The design strain specified by the manufacturer for the CFRP sheets was 16,700 MII. Therefore, the sheets only developed 26% of their design strength when failure occurred. Also, the strain values at the left quarter point (116 in. from left support) were considerably higher than those at the right quarter point. These values should have been equal due to beam symmetry. At failure, the strain values at the left quarter point were three times higher than the right quarter point. The theoretical strain at the quarterpoint with a load  $P$  of 41.6 kips was 230 MII ( $M_{1/4}=4,826$  in - kips,  $c_b=24.88$  in.,  $E=4,800$  ksi, and  $I_c=109,775$  in<sup>4</sup>), which agrees with the values measured at the right quarterpoint.

Figure 5.8. Tensile strains along the CFRP sheets in Beam 1.

These larger values at the left quarterpoint indicate some type of stress concentration in this area. As expected from these results, the debonding action initiated just left of the patch material.

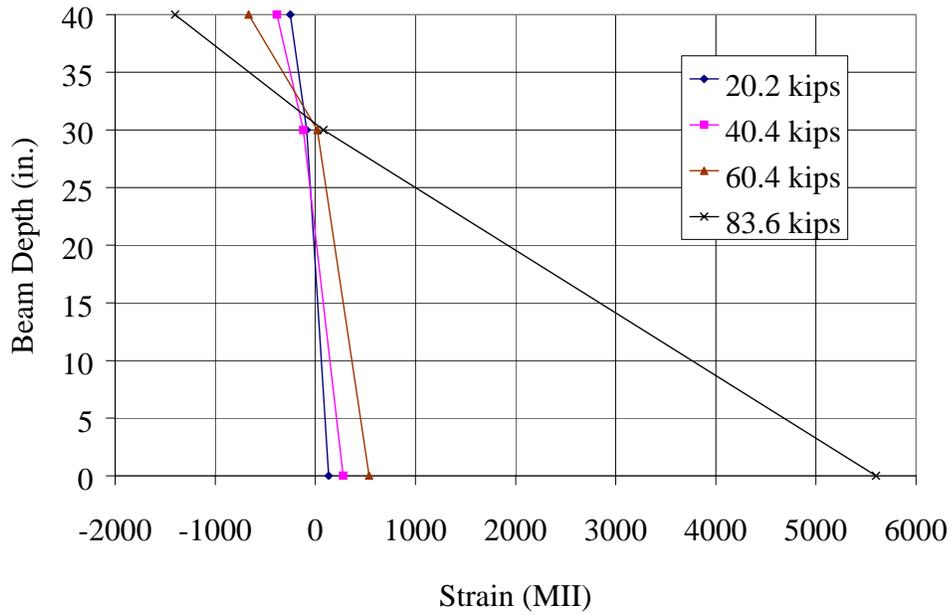
The strain distribution at the centerline of Beam 2 at various depths in the ultimate load test are presented in Figure 5.16. The maximum tensile strain in the CFRP sheets at debonding was 5,500  $\mu\epsilon$  (33% of the ultimate design strain). This represents a 28% increase in maximum tensile strain compared to the Beam 1 results. Another point of interest is the relatively low level of strain in the CFRP sheets at 60.4 kips. As shown in the graph, a large increase in tensile strains takes place between 60.4 kips and the ultimate load of 83.6 kips. This difference is evident when comparing the strains in Figure 5.16 with the strain

Figure 5.16. Strain distribution at the centerline of Beam 2.

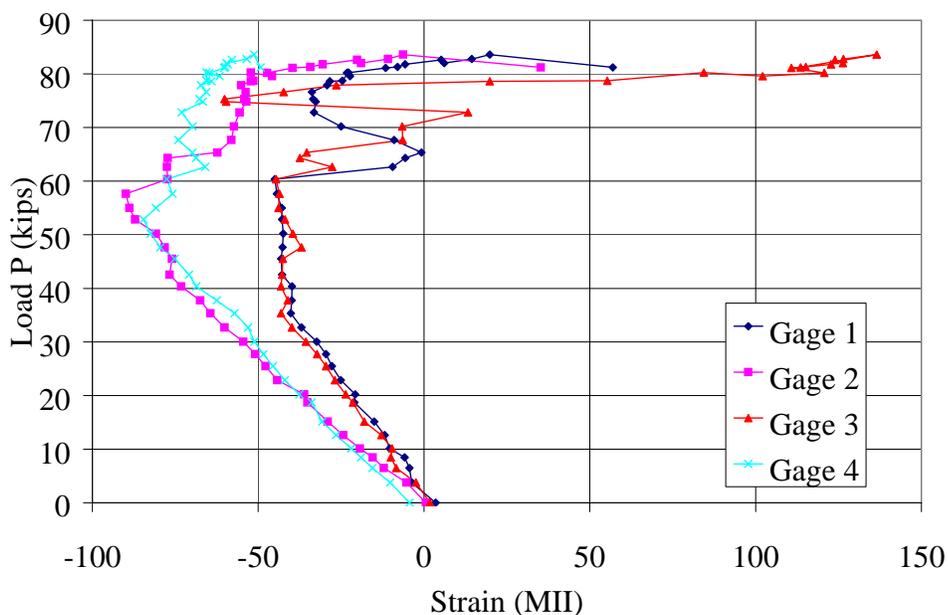
The purpose of the CFRP jacket was to confine the patch material and to help prevent premature debonding of the longitudinal CFRP sheets. Strain readings from the strain gages placed on the CFRP jacket are presented in Figure 5.18. The four strain gages were oriented in the vertical direction with two gages on each side of the bottom flange of the P/C beam (Section 4.6.1.1). All of these gages clearly went into compression as the applied load was increased. This decrease in strain is due to the Poisson's ratio effect. Using the corresponding longitudinal strain results, the Poisson's ratio of the test specimen was found to be  $-0.22$  at 30 kips (Note: Poisson's ratio for concrete is commonly taken to be  $-0.20$ ). The jacket strains remained linear until the beam cracked at a load of 40 kips. Gages 1 and 3

undamaged side of the beam were slightly higher. This difference would indicate that a small amount of out-of-plane bending was taking place because of the simulated impact damage. Strain levels remained constant with small fluctuations between loads of 40 and 80 kips. However, rapid increases in jacket strains were present immediately before the longitudinal sheets debonded (83.6 kips). This would indicate that the jacket was carrying tension and resisting a portion of the normal force from the patch and/or longitudinal sheets. The maximum CFRP jacket strain at failure was close to 140 MII.

Figure 5.18. Strains on the CFRP jacket on Beam 2.

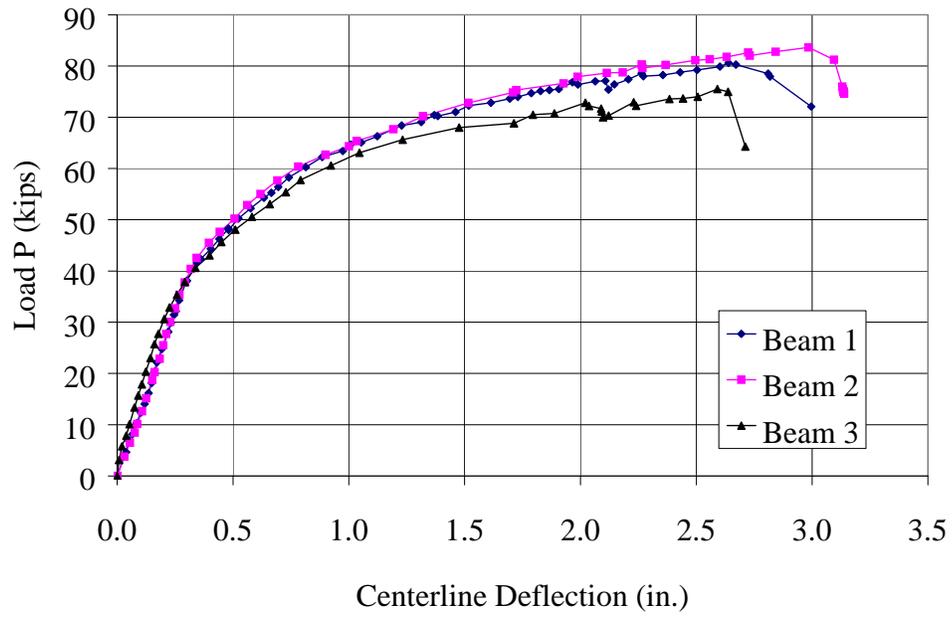
Load/deflection results from the ultimate load test of Beam 3 are presented in Figure 5.23. The load/deflection curves for Beams 1 and 2 are also included to show the relative behavior of beams with two prestressing strands severed. Beam 3 cracked at a load of 32 kips (8 kips less than Beams 1 and 2). This was 46% higher than the predicted value for a composite beam with four severed strands. The increase in the calculated cracking load was consistent with the results from Beams 1 and 2. After the beam cracked, the behavior remained linear until the prestressing steel began to yield at a load of approximately 58 kips. The ultimate capacity of Beam 3 was 75.5 kips with a centerline deflection of 2.59 in. This

ultimate capacity was 22.4% higher than the predicted strength (54.0 kips) for an unstrengthened beam with four severed strands but was still 11.7% under the original beam strength (86.7 kips). Approximately 66% of the lost beam strength was recovered by the carbon fiber sheets. As with Beams 1 and 2, failure was initiated by the longitudinal CFRP sheets debonding from the bottom of the beam. Cracking noises before the sheets debonded indicated that the debonding started at the load point and moved out towards the support.

Figure 5.23. Load vs. deflection plots for Beams 1, 2, and 3.

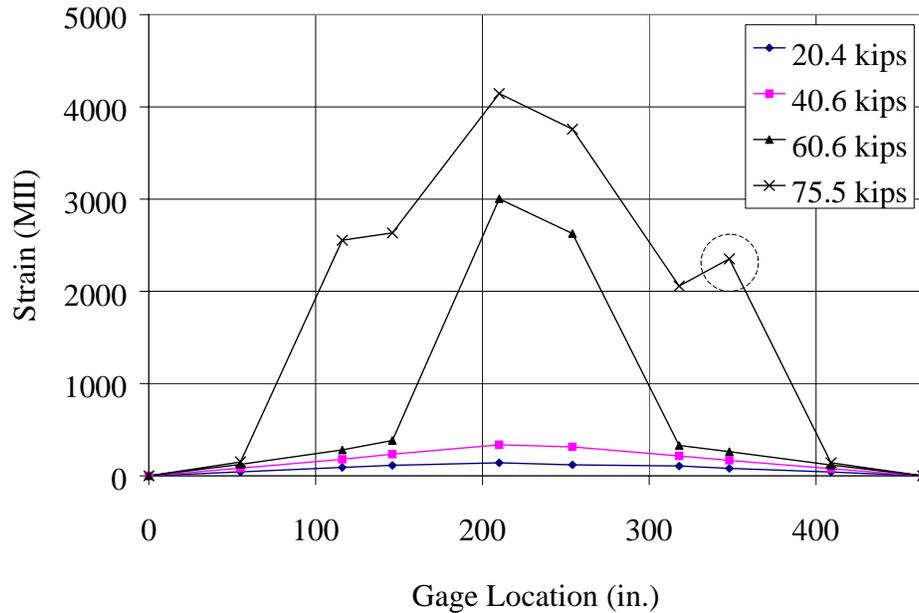
Tensile strains in the CFRP sheets along the length of Beam 3 at various levels of loading are presented in Figure 5.27. The maximum-recorded tensile value was 4,150 MII, or 25% of the design strain specified by the manufacturer. For comparison, the maximum recorded values for Beams 1 and 2 were 4,300 and 5,300 MII, respectively. The CFRP sheets debonded to the right of the beam centerline and was consistent the first two beam failures. The spike in Figure 5.27 at the gage location marked 348 in. (circled) most likely created a stress concentration that initiated the debonding process.

Figure 5.27. Tensile strain readings along the CFRP in Beam 3.

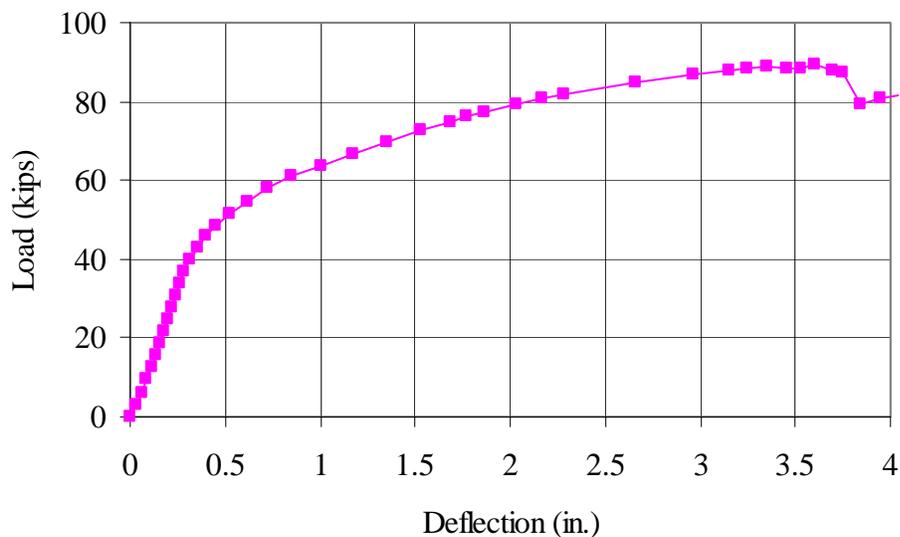
After completing the cyclic loading and the service tests, Beam 4 was statically loaded to failure. Figure 5.30 shows the ultimate load test deflection results. Cracking of the beam occurred at approximately 44 kips. With increased loading, the CFRP sheets began to make popping noises at approximately 75 kips. The load peaked once at 89.2 kips per actuator before it decreased slightly. The mid-span deflection at this point was 3.42 inches. The load then increased to 89.4 kips before major failure occurred. Failure resulted when the CFRP caused the concrete to delaminate. Concrete was still attached to the CFRP after failure indicating that the epoxy bond was not the cause of the failure.

The deflection just prior to failure was 3.61 inches. The total applied load of 178.8 kips was higher than previous tests of similar CFRP reinforced beams. A similar beam tested with the same longitudinal CFRP and a wrap only around the bottom flange of the beam reached 167.2 kips before failure. Thus, the additional wrap length up the entire web of the

Figure 5.30. Load vs. centerline deflection for ultimate test of Beam 4.

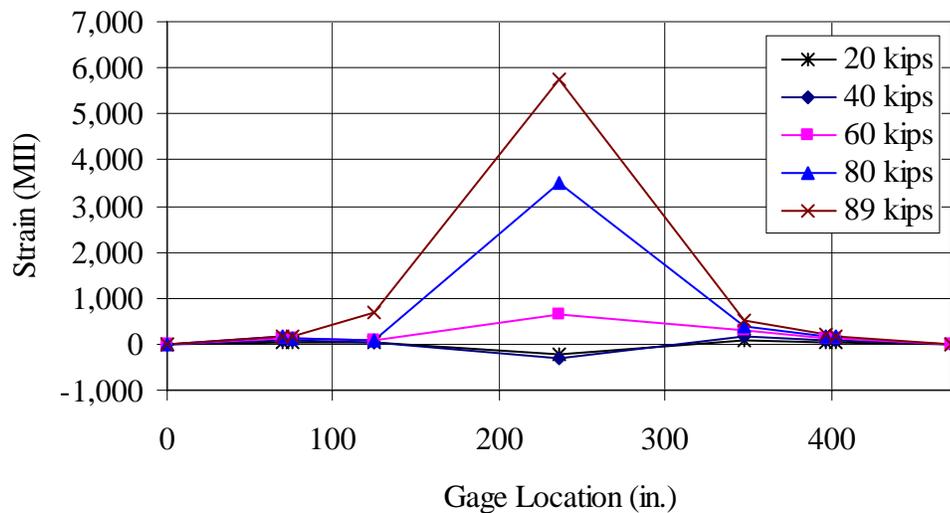
The strains in the longitudinal CFRP reached a maximum of 5,850 MII at the failure load. The maximum strains measured in previous laboratory beam ultimate tests were 5,300 MII or less. Perhaps the full web wrap again helped to prolong the delamination allowing the CFRP to carry higher strains. The design strain for the CFRP sheets as stated by the manufacturer was 16,700 MII. Obviously, with the CFRP only reaching 35% of its design tensile capacity, it was not the cause of failure. The longitudinal strains in the CFRP are shown in Figure 5.32.

Figure 5.32. Tensile strains along the CFRP sheets in Beam 4.

The strains appear to be quite symmetric under the symmetric loading conditions. Although at one of the quarter points, the increase in strain from the 80 kip load to the 89 kip load looks larger than the increase at the other quarter point. This could be an indicator of an eventual failure mode. The strains near the termination points of the CFRP were still quite low, 194 MII at failure, therefore, debonding near the end of the CFRP was not a cause of failure.

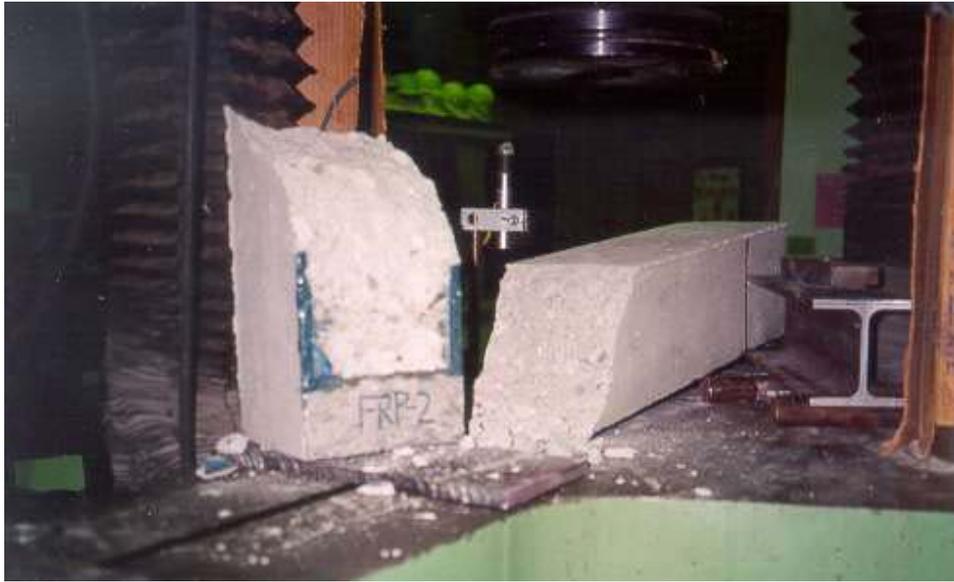
beams strengthened with CFRP sheets. The failure planes for all of the beams started at a point outside the constant moment region and traveled at an angle to one of the load points. The angled failure plane indicates that shear a factor in the beam failure. For comparison, the modulus beams not strengthened with CFRP failed on a nearly vertical plane. The CFRP sheets also pulled off a layer of concrete from the bottom of the beams when they debonded. As mentioned before, this is an indication that the concrete was the controlling factor in the bond strength.

Figure 5.39. Modulus of rupture beam positioned to show the debonding surface.

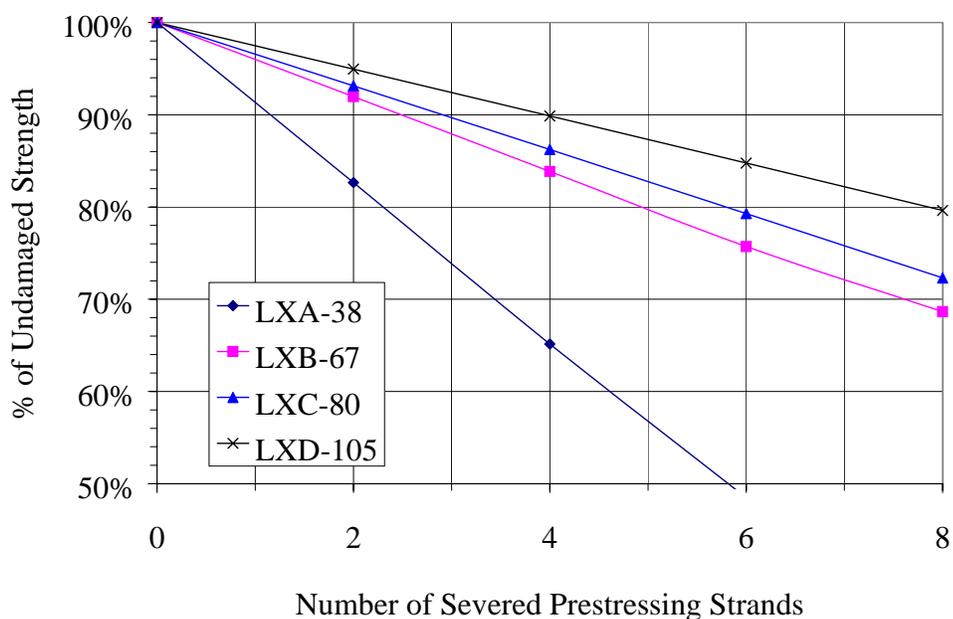
The LXA-38 composite beams used for this project are clearly more sensitive to severed strands than the larger “C” and “D” girders. For example, when two strands are severed in a LXA-38 the flexural design strength is reduced 28%. However, a LXD-105 composite beam still has 95% of its original flexural strength with the same amount of damage (two strands severed out of a total of 40). As illustrated in Figure 5.56, this difference becomes even more pronounced as the number of severed prestressing strands

increases. The results from the strengthening tests in this study indicate that CFRP is most effective when a damaged girder has at least 85% of the undamaged ultimate strength after the impact. With this limit in mind, CFRP systems should be considered as a strengthening option for impact damaged girders in the field. However, fatigue life of the remaining prestressing strands needs to be evaluated if the damaged girder has developed flexural cracks. For example as shown in Figure 5.56, CFRP sheets would be a viable strengthening option for an uncracked LXC-80 with up to four severed prestressing strands.

Figure 5.56. Comparison of damage to different size P/C girders.

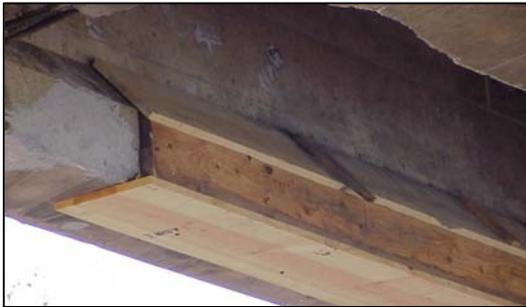
Figure C1. Formwork example.

Step 1: Repair concrete using mortar and epoxy injections according to current standards available. Forms must be used to maintain the original shape of the beam. Figures C1 and C2 show formwork and a completed patch.

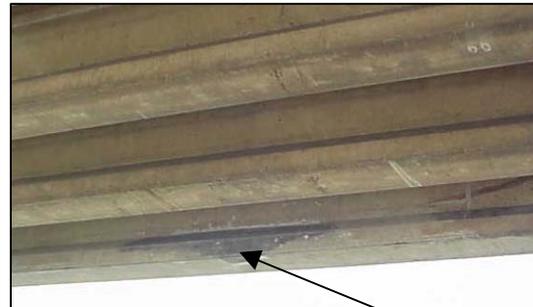
Figure C2. Cured Patch.

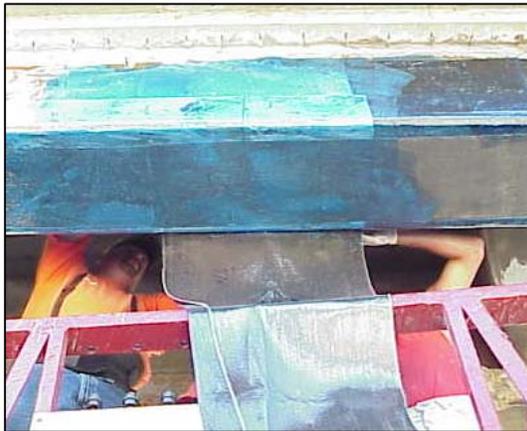
Figure C18. Transverse wrap over the longitudinal FRP.

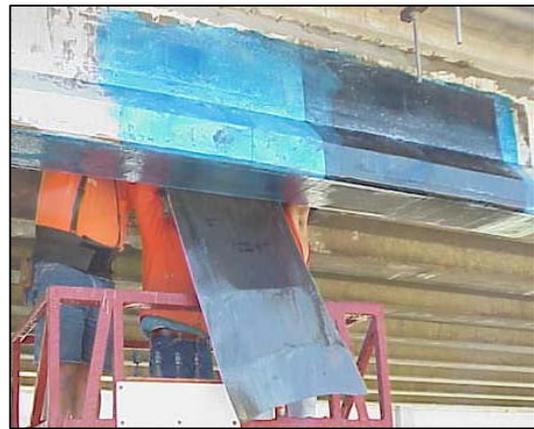
Figure C19. Transverse wrap (cut to designed length).

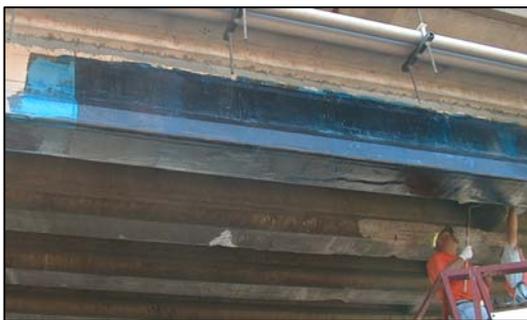
Figure C20. Entire beam after the longitudinal and transverse FRP are installed.

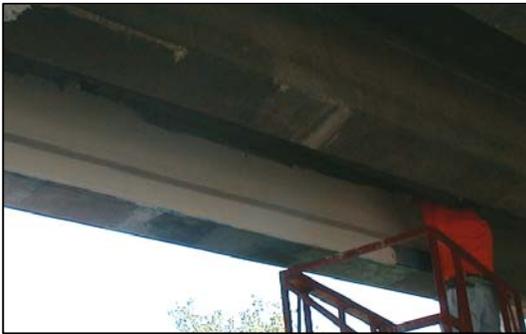
Figure C21. The painting of the topcoat.

Step 3: Apply over the dried saturant and FRP using rollers and brushes. Figures C21 through C23 show the painting of the topcoat and the complete repaired structure.

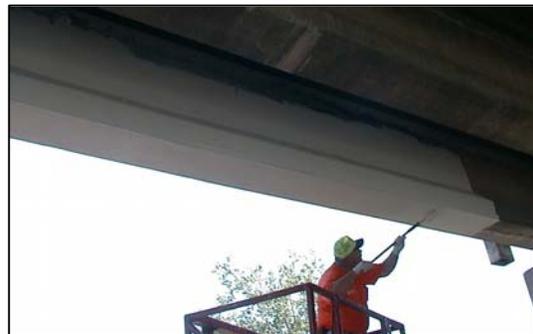
Figure C22. Using a roller to paint bottom flange.

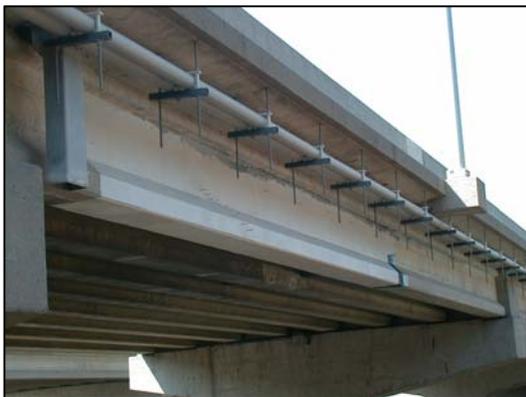
Figure C23. Final view of completely repaired bridge.
