IDENTIFICATION OF THE BEST PRACTICES FOR DESIGN, CONSTRUCTION, AND REPAIR OF BRIDGE APPROACHES

Iowa DOT Project TR-481 CTRE Project 02-118

Final Report

January 2005

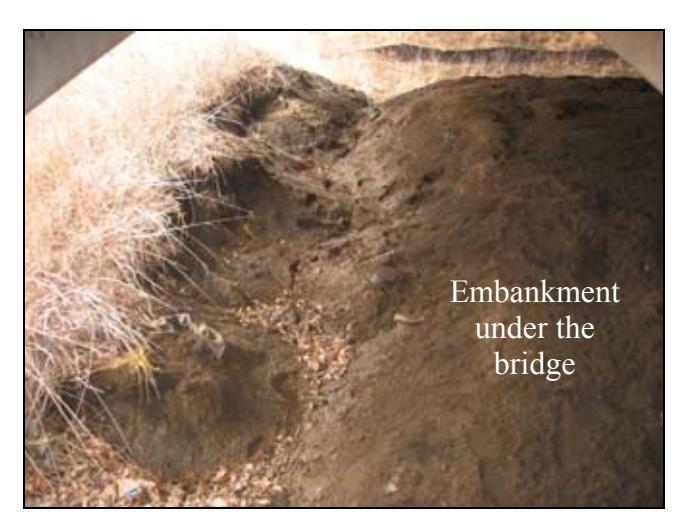
Figure 17. Soil erosion of the embankment under the bridge (South end of North bound)

This bridge was constructed in 1999 with non-integral abutments. At the north end of the north bound approaches, significant settlement was observed. Soil erosion of the embankment under the bridge was also observed (Figure 17). Moreover, concrete spalling was noted at the ends of the bridge deck.

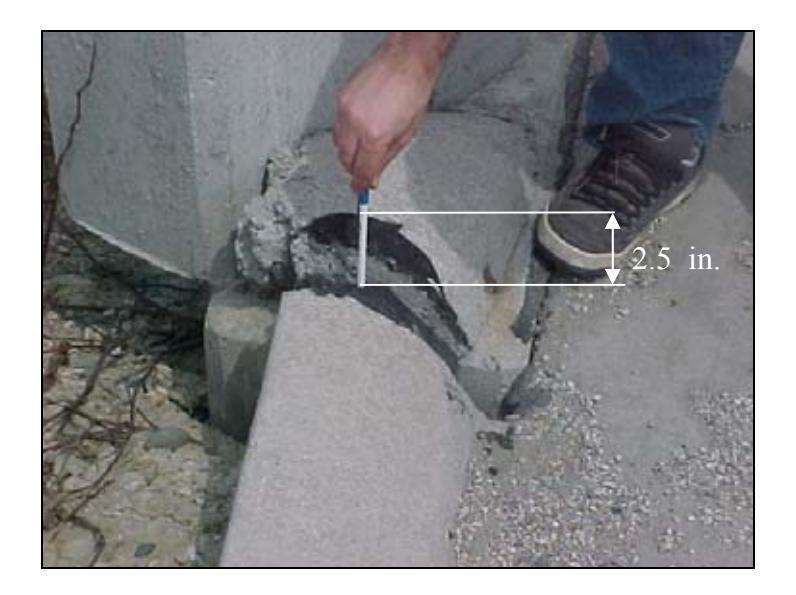
At the south end of the southbound lane (SBL), a 1 inch gap was measured between the abutment and embankment. The soil of the embankment under the bridge was very wet. The differential settlement of the approach slab at the end of the abutment wingwall was approximately 2.5 in., as shown in Figure 19. The width of the expansion joint was 5.0 and 5.3 inches at the north and south ends, respectively, and the width of the 'CF' joint was 4.1 and 4.4 inches at the north and south ends, respectively.

Figure 19. Differential settlement of 2.5 inches at the end of the abutment wingwall (South end SBL)

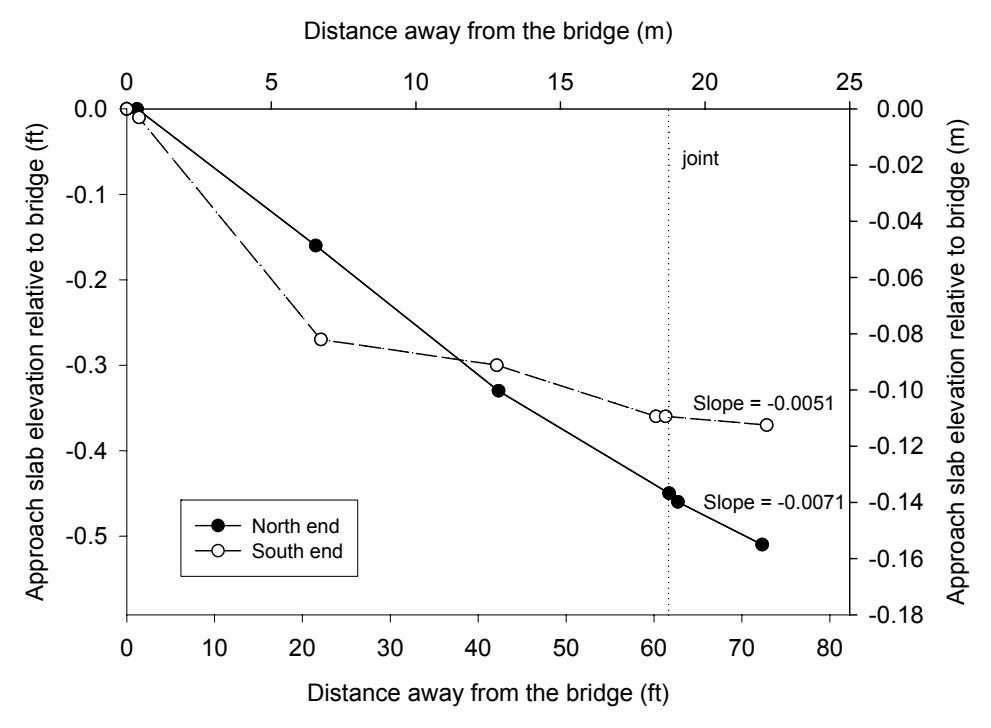
Figure 20. Elevation of bridge approaches relative to bridge slab

The bridge approach profiles for both ends of the northbound lane were obtained in spring 2003 and are shown in Figure 20. The profiles show that the south end approach slab has experienced more settlement compared to the north end. Further, the slope gradients of both the south and north ends are -0.0071 and -0.0051 (i.e., sloping away), which indicates either compression of the embankment fill material or settlement of the embankment foundation soil.

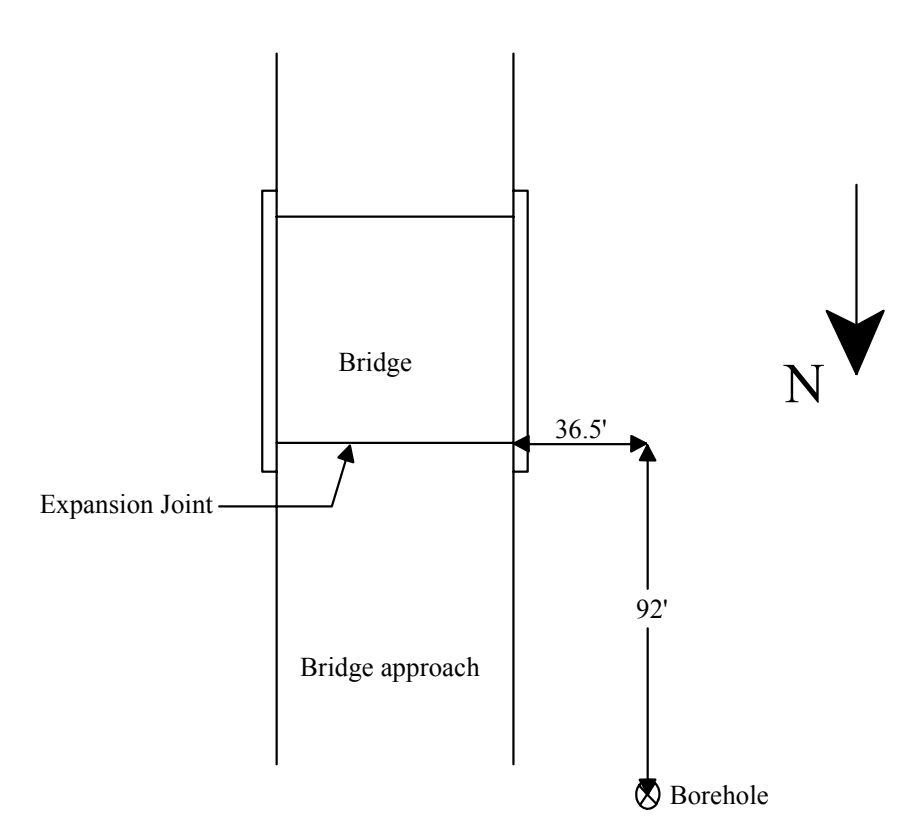
Figure 21. Location of test borehole

To investigate and characterize the embankment soils, Standard Penetration Tests (SPTs) were conducted at the north end of the northbound lane, as indicated in Figure 21. The soil was classified as loose to medium dense sand with a moisture content varying from 12% to 17%. The SPT blow counts provided in Figure 22 range from 5 at the surface to 20 at about 35 ft. According to the drillers, the water table was located at a depth of 25 ft immediately after completing the boring. The height of the embankment was approximately 20 ft.

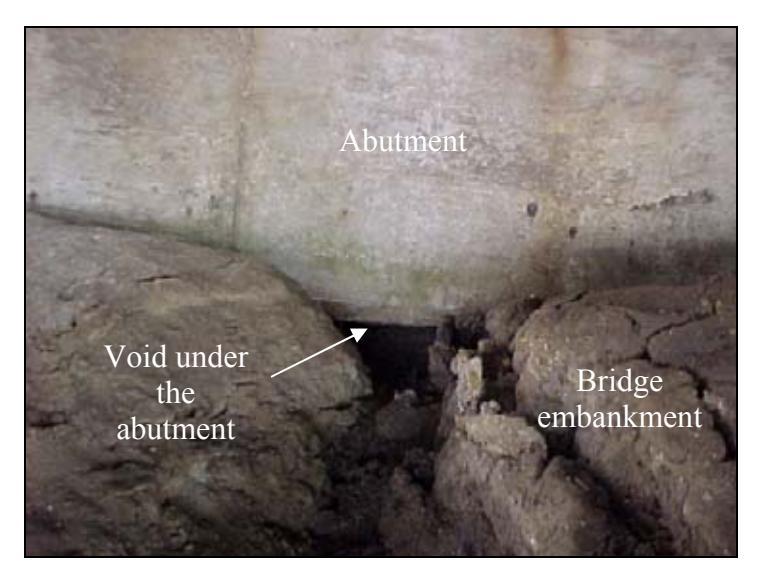
This bridge has non-integral abutments. Water was observed running through the expansion joints and under the bridge abutment. Soil erosion was severe at both ends of the bridge. Severe soil erosion shown in Figure 23 was observed at the north end of the northbound lane. At the south end of the northbound lane, the approach slab at the guardrail settled about 6 inches from its original elevation, as shown in Figure 24. At both the north and south ends of the southbound lane, severe erosion and settlement of the embankment was noted. The embankments were constructed using sandy soils which are considered highly erodible (Figures 25 to 27).

Figure 23. Erosion of soil under abutment (North end of NBL)

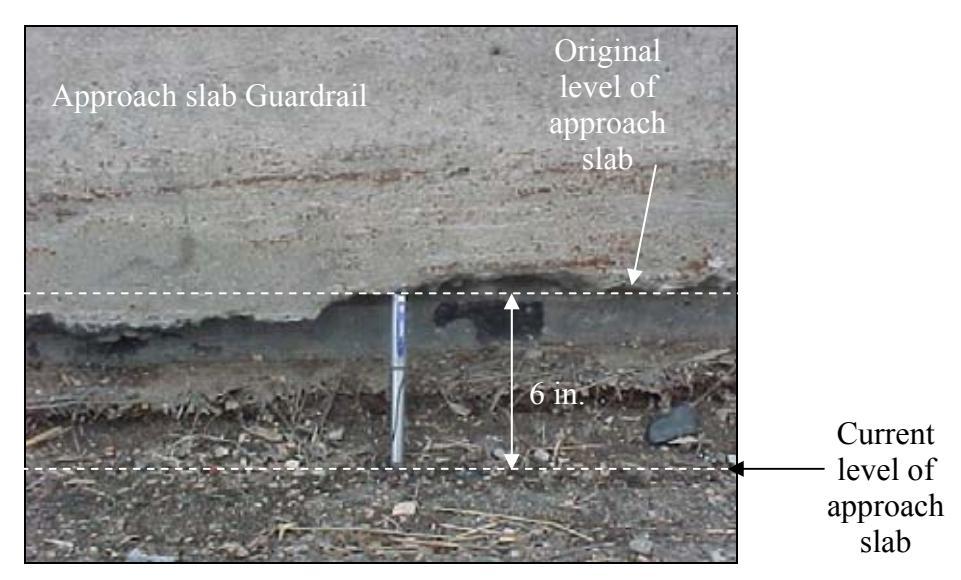
Figure 24. Settlement of bridge approach slab at the guardrail (South end of NBL)

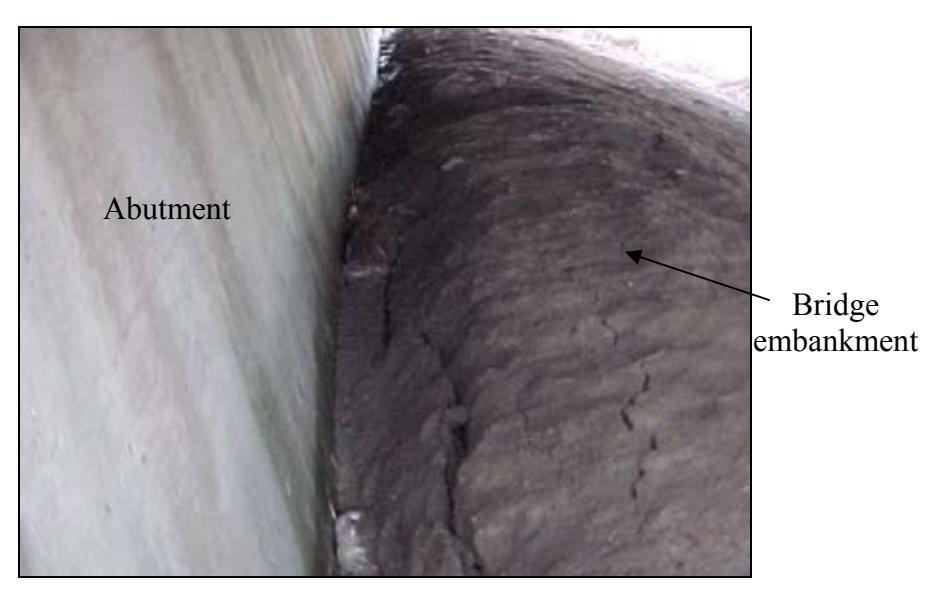
Figure 25. Erosion between abutment and embankment (North end of SBL)

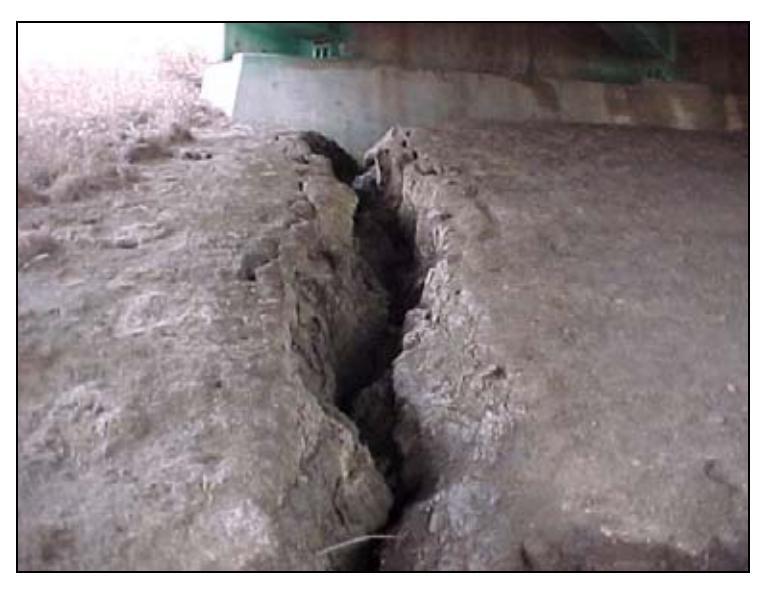
Figure 26. Erosion of the soil under the bridge (North end of SBL)

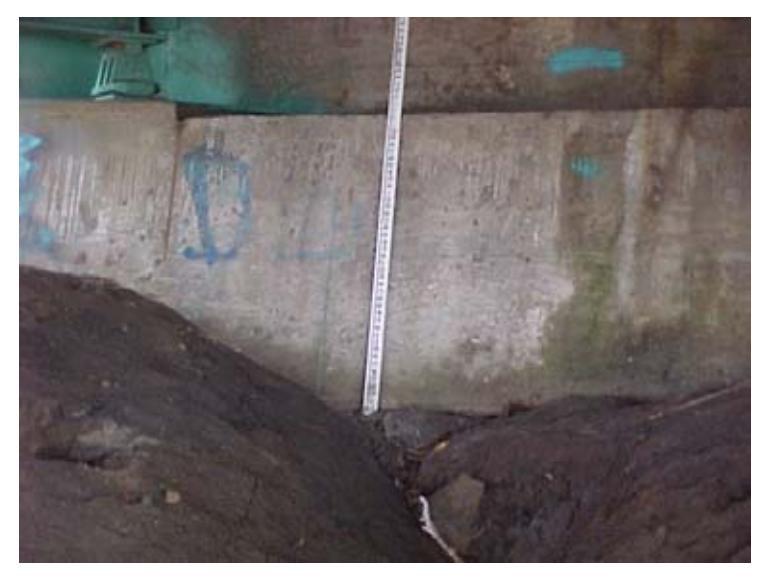
Figure 27. Erosion of the soil under the bridge (South end of SBL)

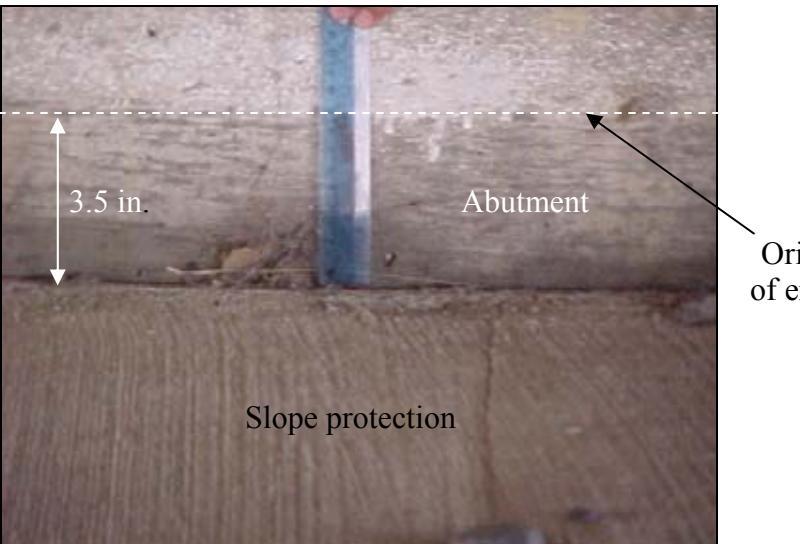
This bridge has integral abutments and concrete girders. The embankment under the bridge settled about 3.5 inches from its original level, as shown in Figure 28. Figure 29 shows the differential settlement at the end of the wingwall at the north end of the northbound lane, which is approximately 6 inches. Figure 30 shows cracks near both expansion joints at the northbound lane. Moreover, at the south end of the northbound lane, differential settlement of 2 inches was measured between the bridge deck and the end of the approach slab.

Figure 28. Settlement of embankment under the bridge

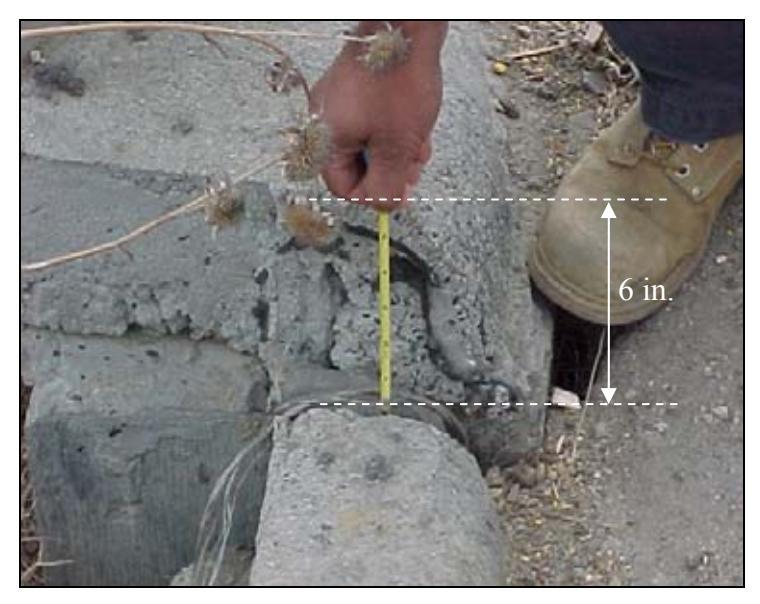
Figure 29. Differential settlement at the approach slab (North end of NBL)

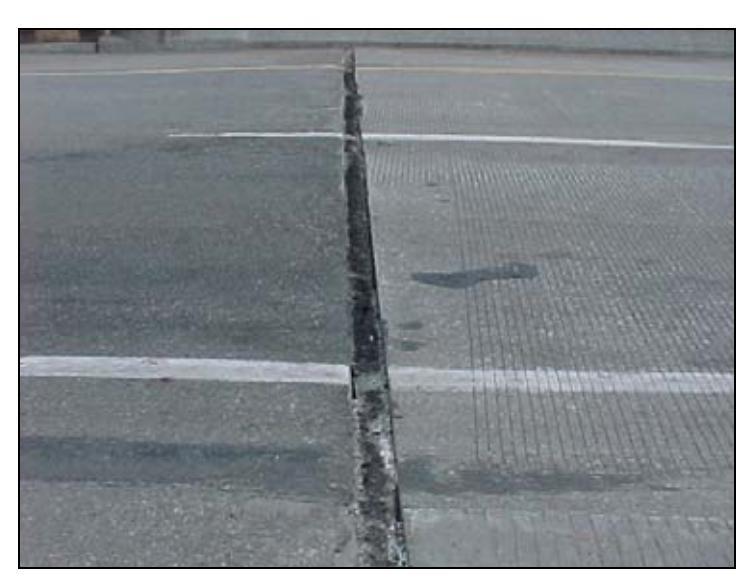
Differential settlement between bridge deck and the end of the approach slab was observed at the north end of the southbound lane. The width of the expansion joint was approximately 5 inches, which is wider than the designed joint width of 4 inches. This could be due to concrete deterioration or thermal contraction of the bridge. At the north end of the southbound lane, fewer cracks at the expansion joint were observed (Figure 31).

Figure 31. Poorly filled expansion joint with recycled tires used as a joint filler (North end SBL)

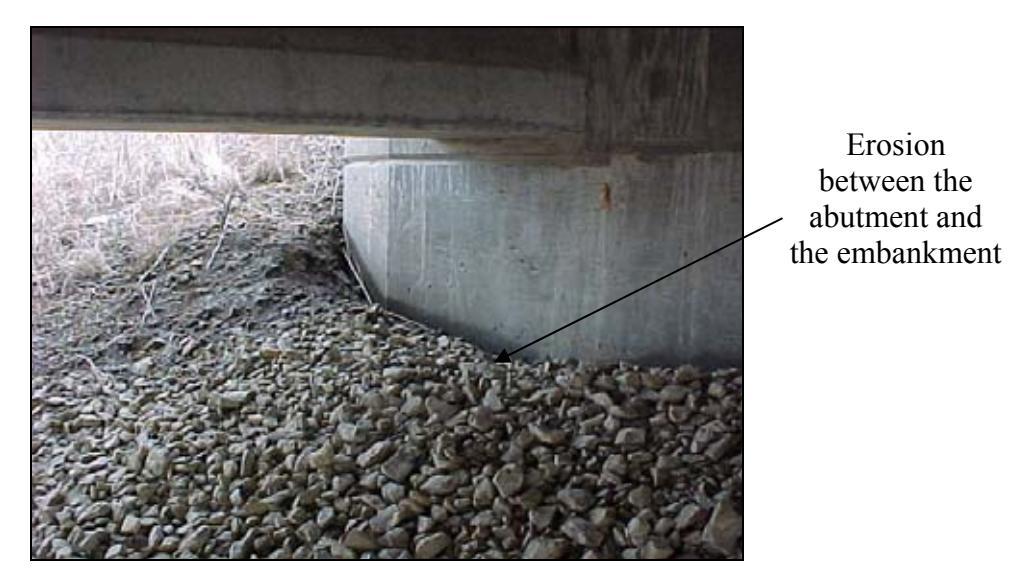
This bridge has an integral abutment and concrete girders. Aggregate was used under the bridge as slope protection, as shown in Figure 32. Significant soil erosion was observed between the embankment and the backwall at both the north and south bounds lanes. Figure 33 shows a 3-inch void that developed under the approach slab.

Figure 32. Aggregate used as slope protection at the embankment under the bridge

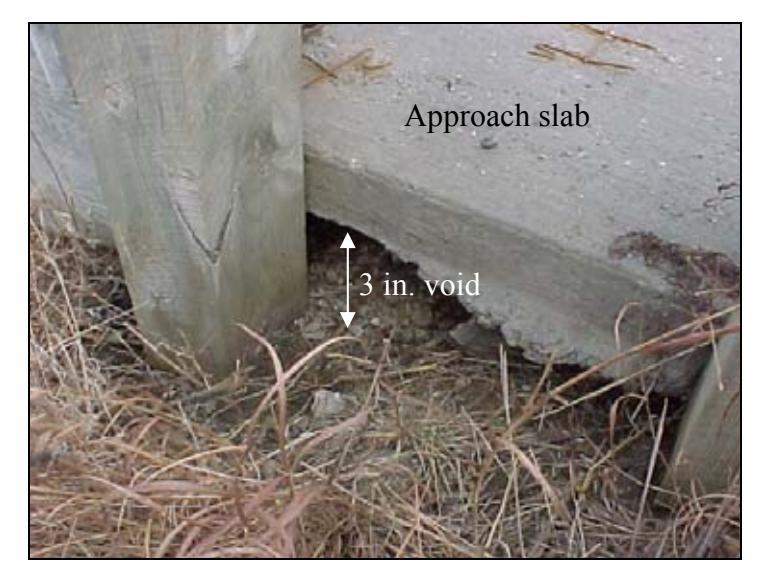
Figure 33. Void developed under the approach slab (South end of North bound bridge)

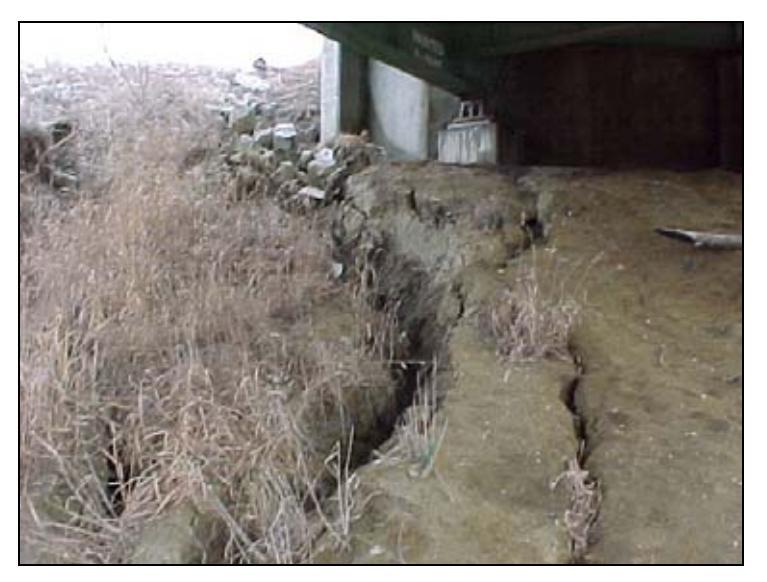
This bridge has non-integral abutments. The east bound bridge is supported on concrete girders, while the west bound bridge is supported on steel girders. Soil erosion was observed, as shown in Figure 35. No other major problems were noticed.

Figure 35. Soil erosion of the embankment under the bridge

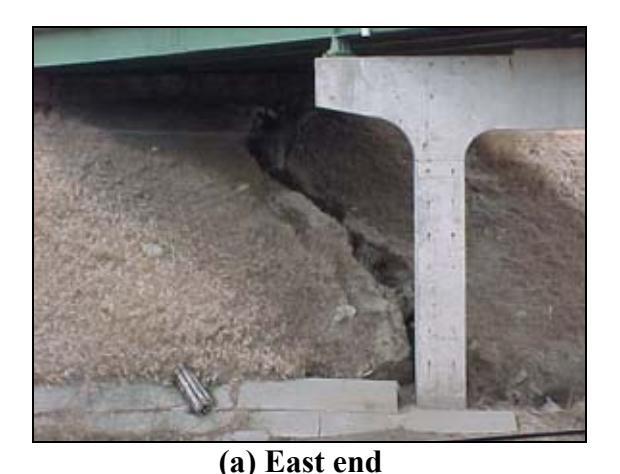
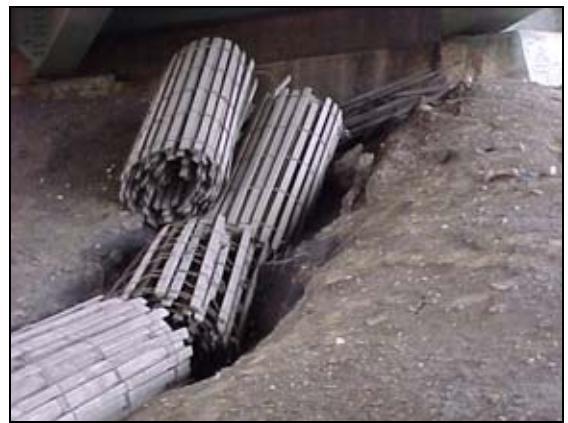
This bridge has non-integral abutments and steel girders. Significant erosion was observed under the bridge at both the east and the westbound lanes, as shown in Figure 36. However, the approach slab appeared to be in a good condition.

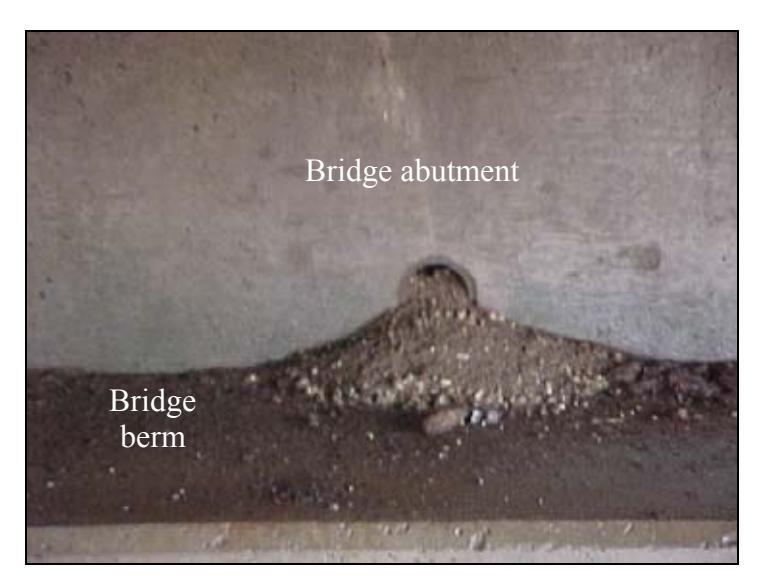
This bridge has steel girders and non-integral abutments. No significant settlement of the bridge approach was noted. Soil erosion of the embankments under the bridge was observed. The abutment weep holes were filled with eroded backfill material, as shown in Figure 37.

Figure 37. Weep holes filled with backfill material

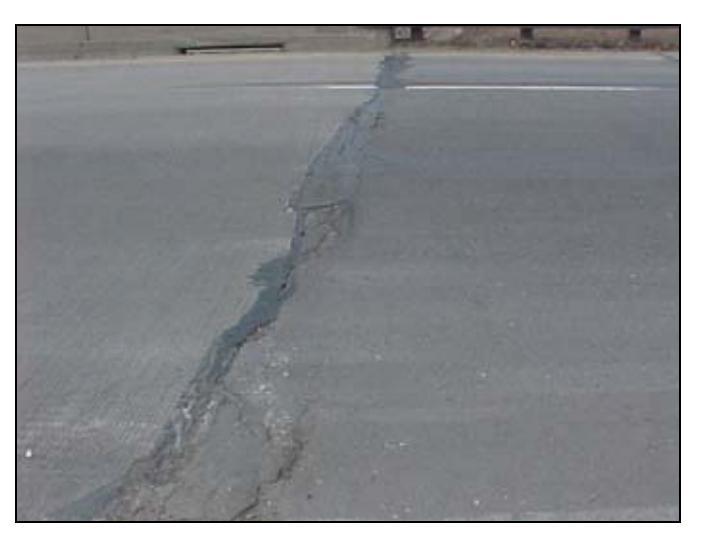
This bridge has non-integral abutments with concrete girders. Concrete spalling was observed at the girder ends. Figure 38 shows a damaged expansion joint that was paved over during a previous maintenance effort. A dip in the original approach slab of about 4 inches was observed between the approach slab and the wingwall.

Figure 38. Expansion joint covered after placing the approach slab overlay (EBL)

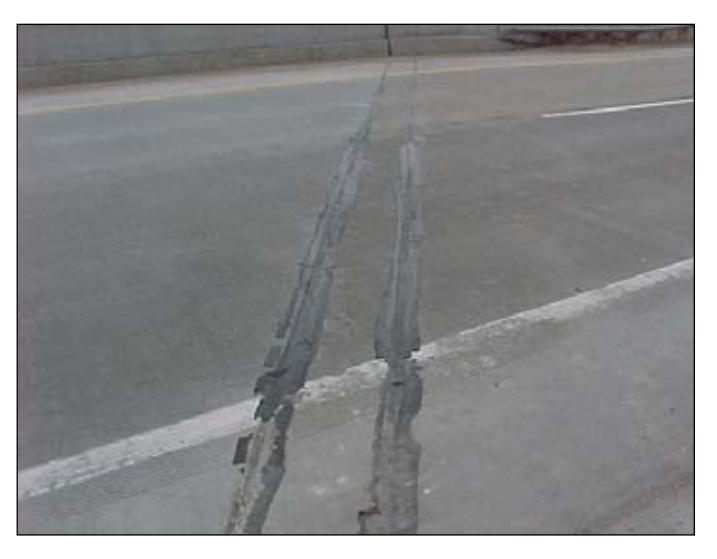
This bridge has non-integral abutments and steel girders. Differential settlement of 4 inches was measured at the end of the wingwall. No other major problems were observed. Figure 39 shows deterioration of the expansion joint sealer.

Figure 39. Deteriorated sealer at the expansion joint

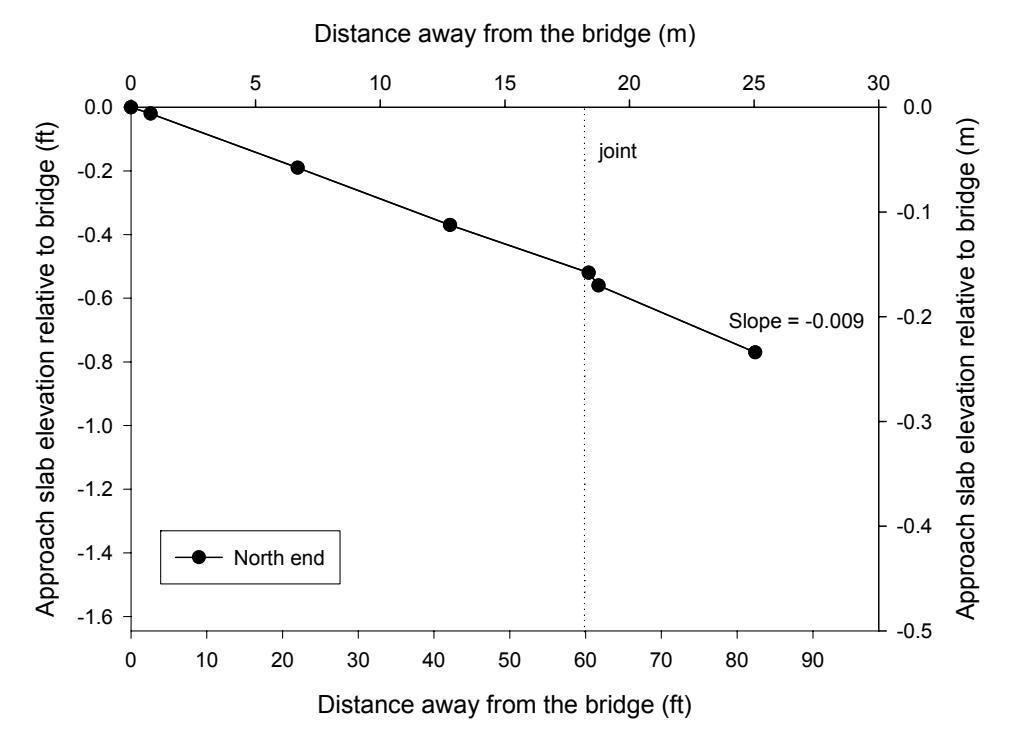
Figure 40. Profile of bridge approaches relative to bridge deck

This bridge has integral abutments and concrete girders. Profiles of both ends of the northbound lane were measured in fall 2002. Figure 40 shows the profiles collected at the centerline for both approaches. About 0.5 in. of elevation difference was measured between the end of the approach slab and the pavement at the EF joint at the north end of the northbound lane. The north end approach slab appears to be in a good condition. The slope of the bridge approach is -0.009.

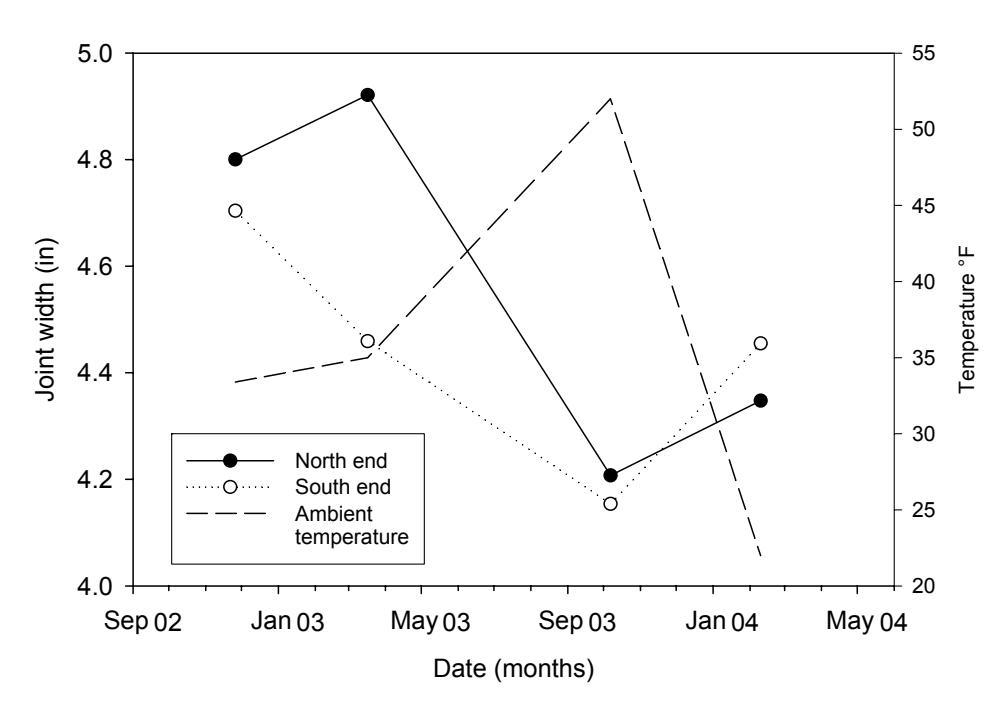
Figure 41. Change in expansion joint width with respect to thermal variation

The width of the expansion joint at both ends of the bridge and the corresponding ambient temperature were measured over 15 months (Figure 41). As the air temperature increased, the joint width decreased. The largest variation in joint width was about 0.8 in. (2.0 cm) at temperatures ranging from 22 °F to 55 °F. Greater variation in temperatures could result in larger joint width changes.

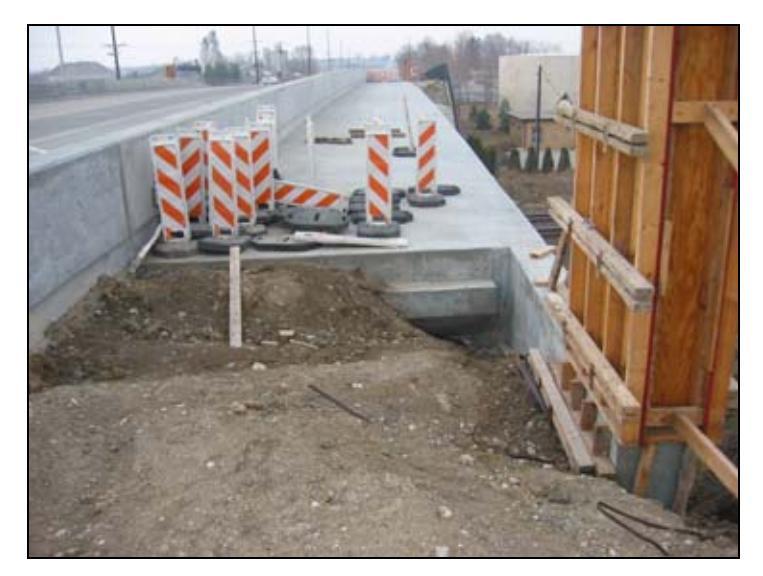
This bridge has integral abutments with concrete girders. Although the bridge is newly constructed, a dip in the approach slab could be seen. No measurement was made. Figure 42 shows non-compacted granular backfill behind the abutment.

Figure 42. Non-compacted granular backfill behind the bridge abutment

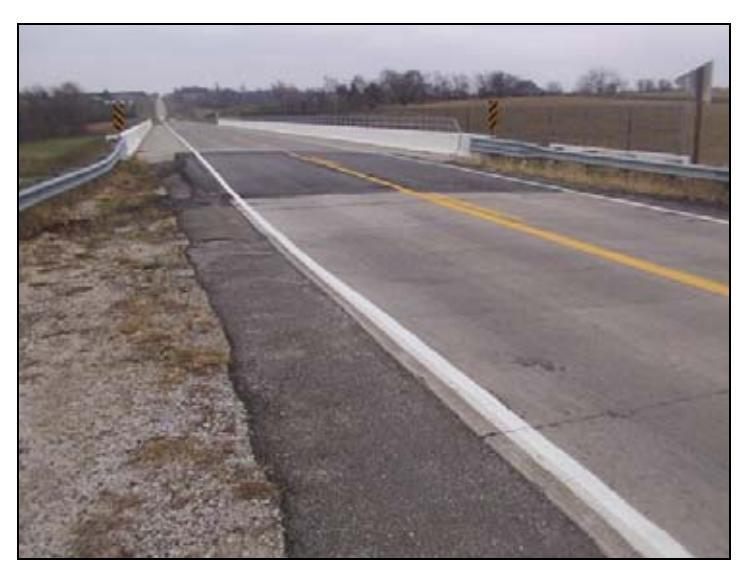
This bridge is a four-span bridge with integral abutments and concrete girders. Asphalt overlays were placed at both ends of the bridge (Figure 43). Figure 44 shows some cracks in the overlay. Differential settlement at the bridge approach of about 3 inches was measured at the approach slab shoulder. Minor erosion of the embankment under the bridge and the abutment sides was noted. Furthermore, the 4 inches expansion joints were poorly filled at the east end (Figure 45). As shown in Figure 46, aggregate was used as slope protection for the embankments under the bridge.

Figure 43. A view of the bridge showing recently placed asphalt overlay at the bridge approach (East end)

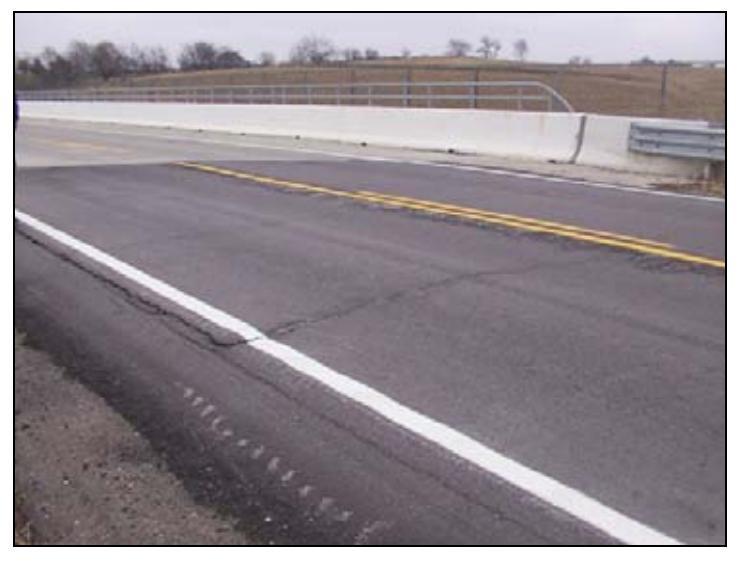
Figure 44. Cracking of the asphalt overlay (East end)

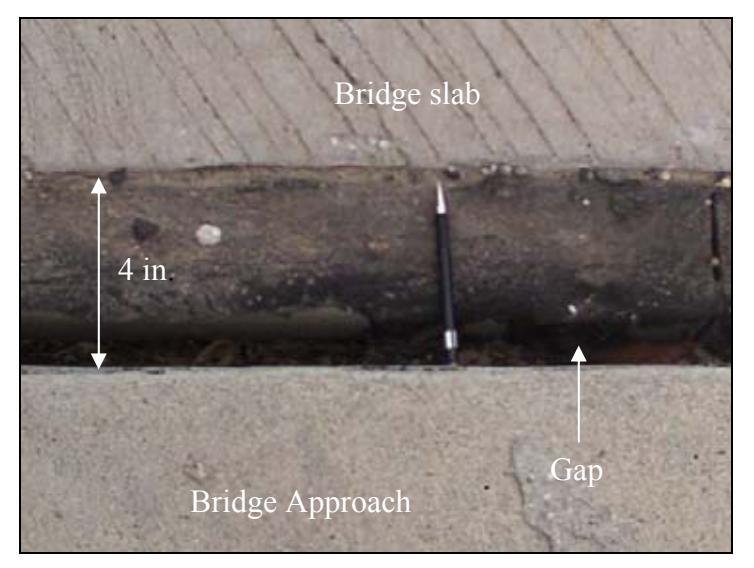
Figure 45. Poorly filled expansion joint (East end)

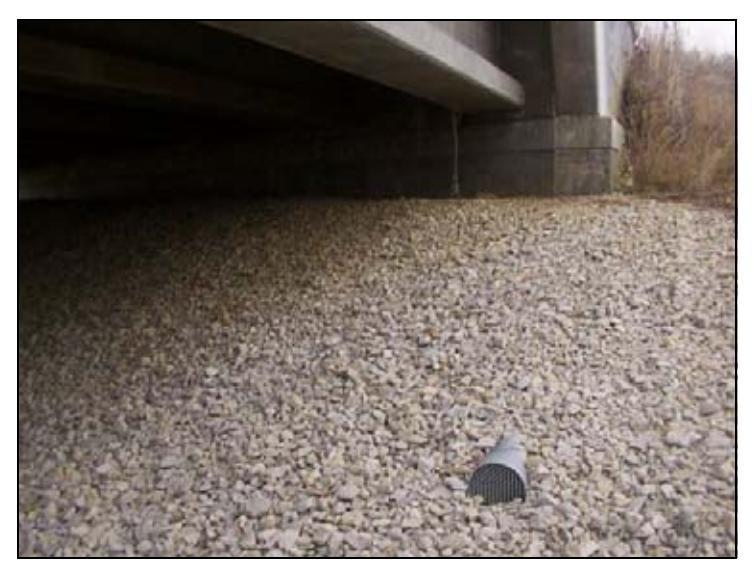
Figure 46. Aggregate used as a slope protection at the embankment under the bridge

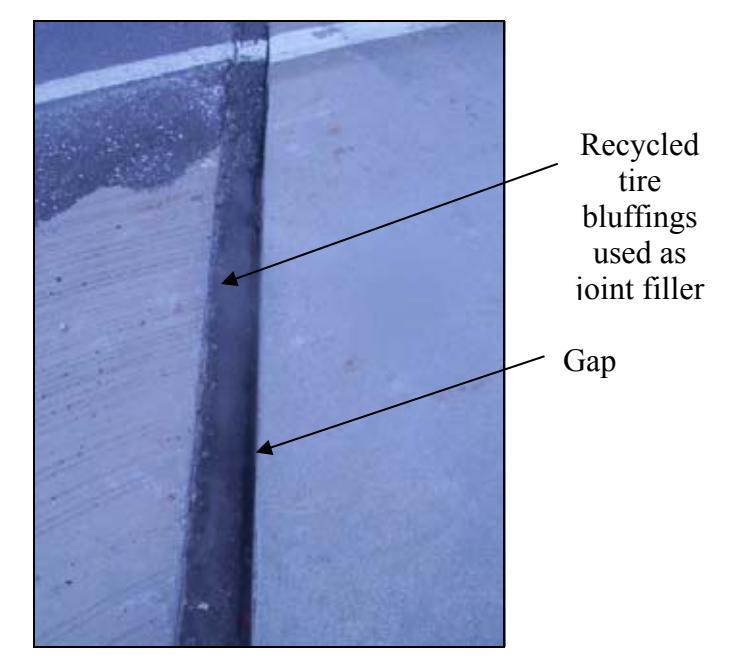
The bridge was visited again in summer 2004. At the east end, differential settlement of 6.5 inches at the guardrail at the approach slab and a void depth of 5.5 inches under the approach slab were observed. The width of the expansion joint was 5.5 inches (Figure 47). More transverse cracks were noted on the asphalt overlay, as shown in Figure 48.

Figure 47. Poorly sealed expansion joint (East end)

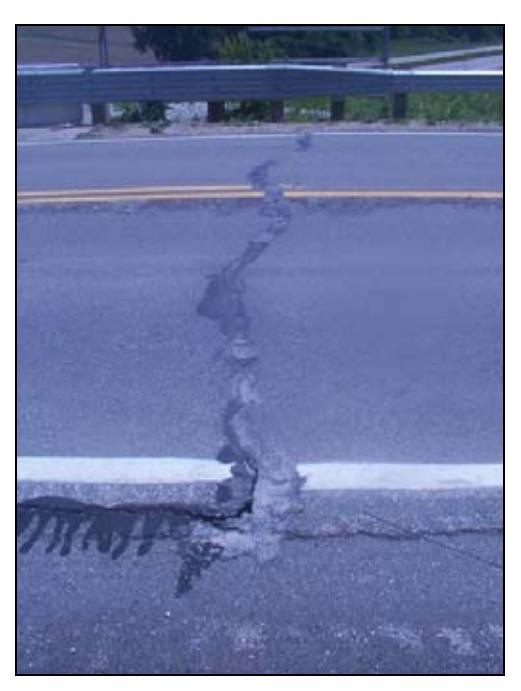
Figure 48. Transverse cracks of asphalt overlay (East end)

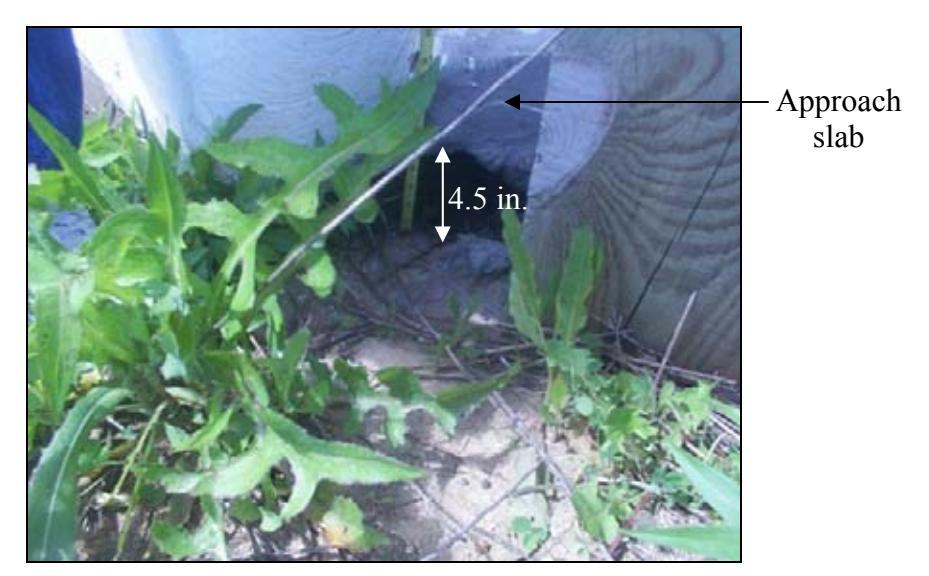
At the west end, a void has developed under the approach slab. The void was 5.5 inches at the expansion joint and 4.5 inches at the end of the wingwall (Figure 49). Furthermore, soil erosion at the abutment side was observed (Figure 50). Soil near the abutment sides is silty sand and is considered highly erodible. An aggregate slope protection cover was used at the embankment under the bridge and appeared to be in good condition.

Figure 49. 4.5 in. void developed under the approach slab (West end)

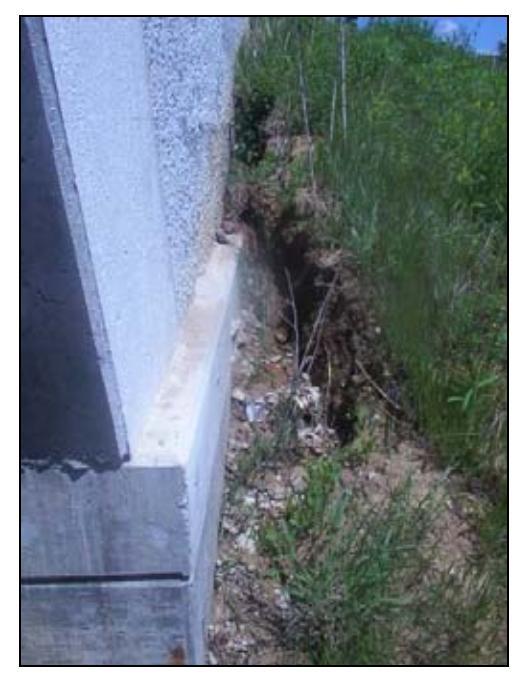
Figure 50. Soil erosion at the abutment side (West end)

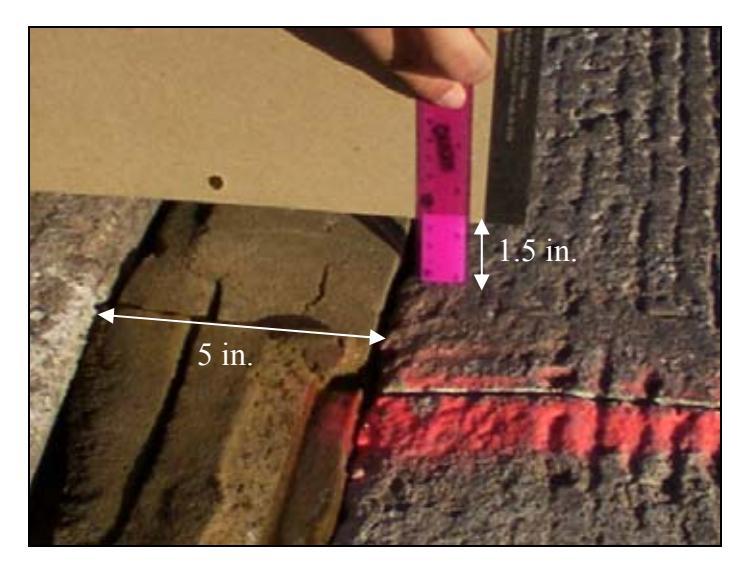
The bridge has integral abutments and concrete girders. Differential settlement between the bridge deck and the approach slab of 1.5 inches was measured at the east end (Figure 51). The embankment under the bridge has settled 3.5 inches and a gap of 3 inches was measured between the abutment and the embankment under the bridge (Figure 52). The width of the expansion joint, which has flexible foam filler, was approximately 5 inches.

Figure 51. Differential settlement of 1.5 in. at the bridge approach (East end of WBL)

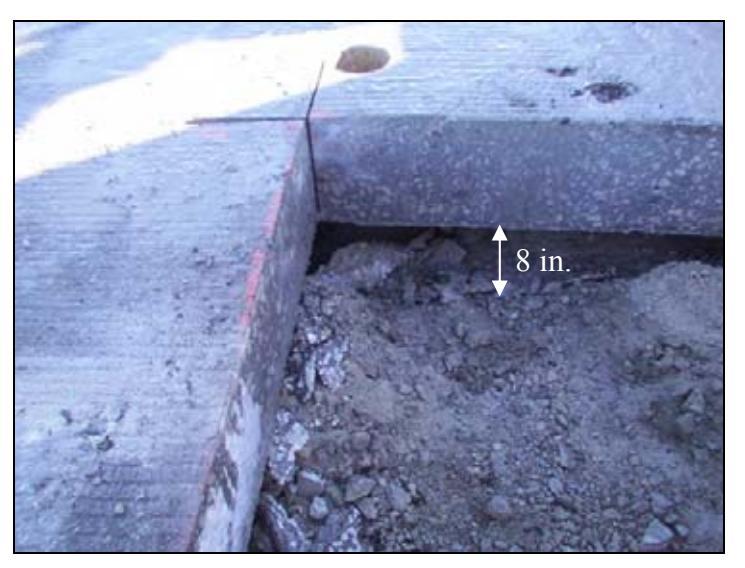
Part of the approach slab at the east end of the westbound lane was removed by Iowa DOT personnel as part of their endeavor to determine the cause of differential settlement between the end of approach slabs and bridge decks. A 3-foot-long by 15-foot-wide section extending from the centerline of the approach slab to the center of the shoulder was removed (Figures 53 to 55). After removing the approach slab segment, an 8-inch void was measured under the approach slab (Figure 56). Also, the base material appeared to be poorly placed and not compacted. Upon inspection of the paving notch, it was observed that about 1.5 inches of fine sand was under the joint filler (Figure 57). The thickness of the approach slab was 7 inches over the paving notch and 8.5 inches over the approach slab embankment (Figure 58). The difference in thickness is attributed to poorly cleaning the paving notch prior to placement of the approach slab. The width of the paving notch is 10 inches. As shown in Figure 59, flexible foam was used as a joint filler material.

Figure 56. Eight-inch void observed under the approach slab

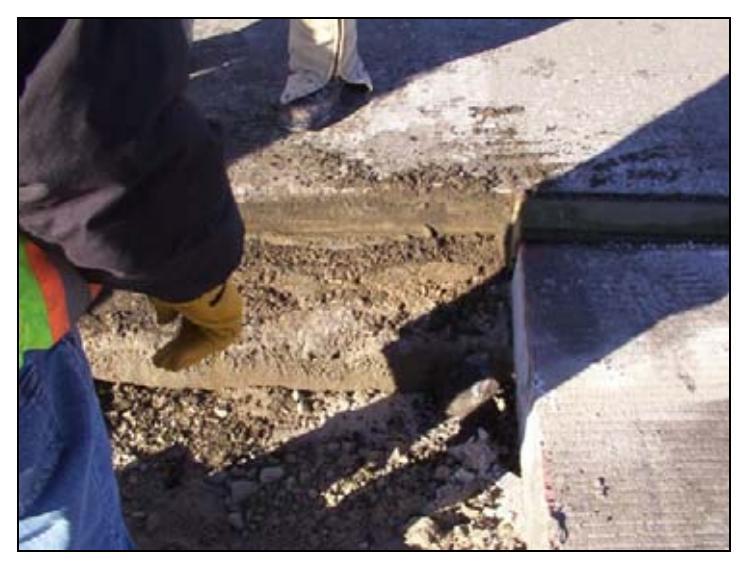
Figure 57. Layer of fine sand covering the paving notch

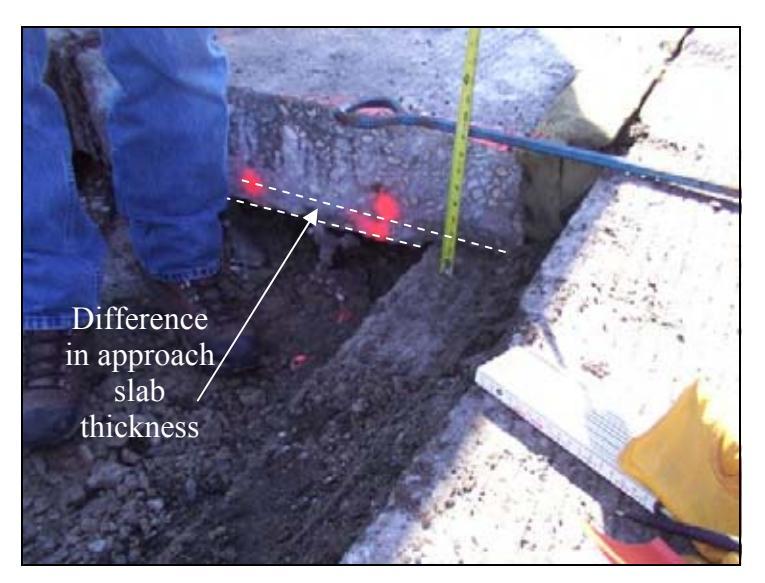
Figure 58. Non-uniform approach slab thickness with 1.5 in. increase over the backfill compared with the thickness over the paving notch

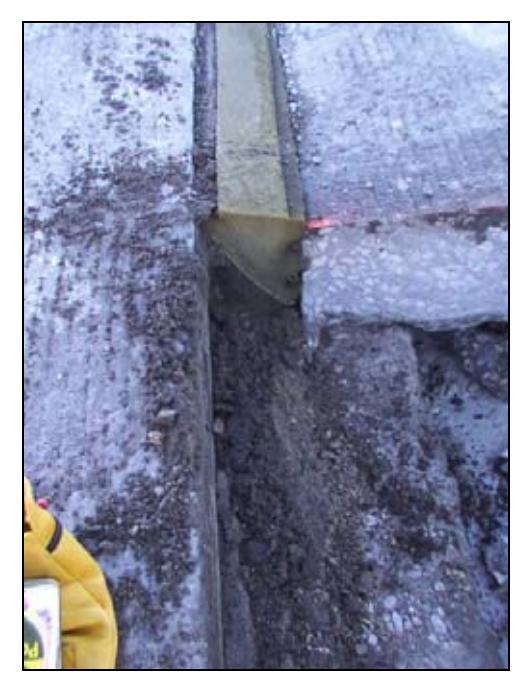
Figure 59. Contaminated expansion joint

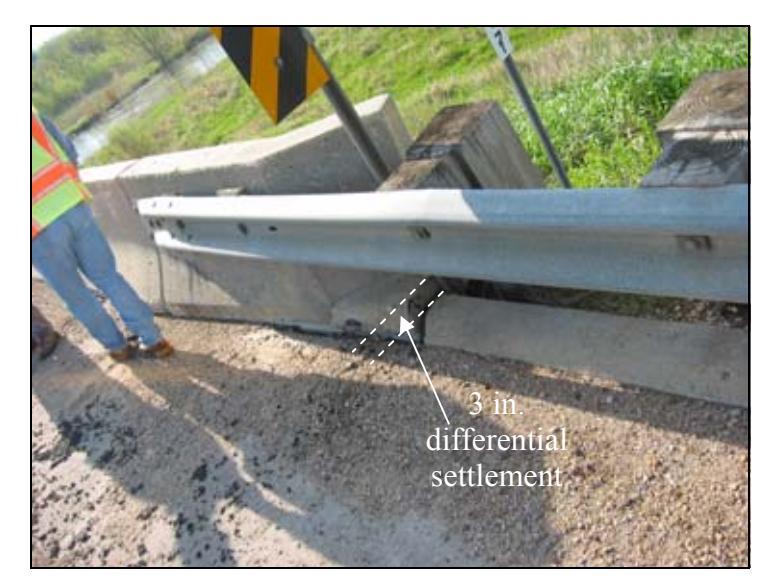
This bridge was constructed in 1984 and has three spans with integral abutments. Figure 60 shows 3 inches of differential settlement between the bridge slab and the bridge approach at the end of the south-west wingwall. Figure 61 shows concrete deterioration at the west end CF joint, as well as longitudinal cracks in the approach slab. A crack developed between the bridge approach and the wingwall due to the settlement of the approach relative to the wingwall. The width of the crack was 1.5 inches and extended to a length of 4.5 feet. No major erosion was observed at this bridge.

Figure 60. Differential settlement of 3 in. at the south-west corner

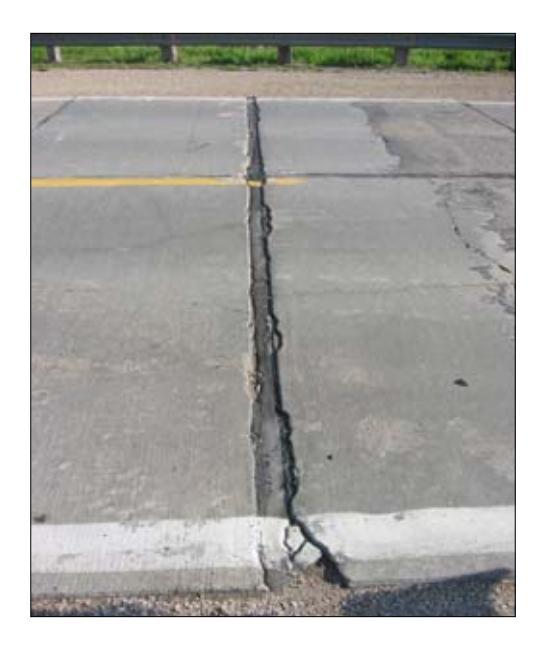
Figure 61. Concrete deterioration at the EF joint (West end)

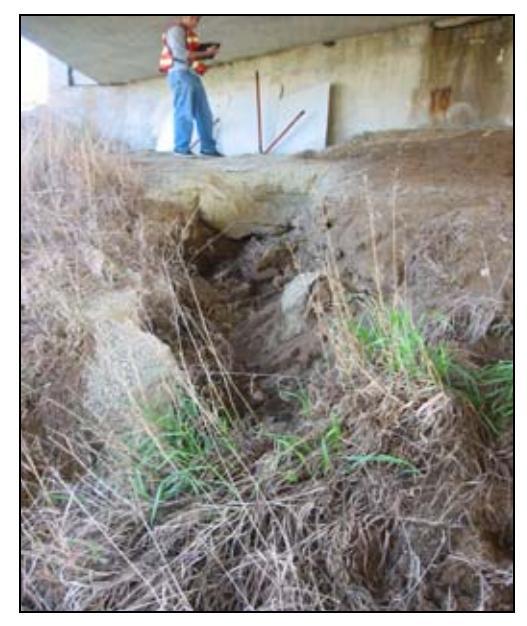
This bridge is a three-span concrete slab bridge (Figure 62). Figure 63 shows erosion of the embankment under the bridge. Cracks were observed in the asphalt overlay around the expansion joint (Figure 64).

Figure 63. Erosion of the embankment soil under the bridge

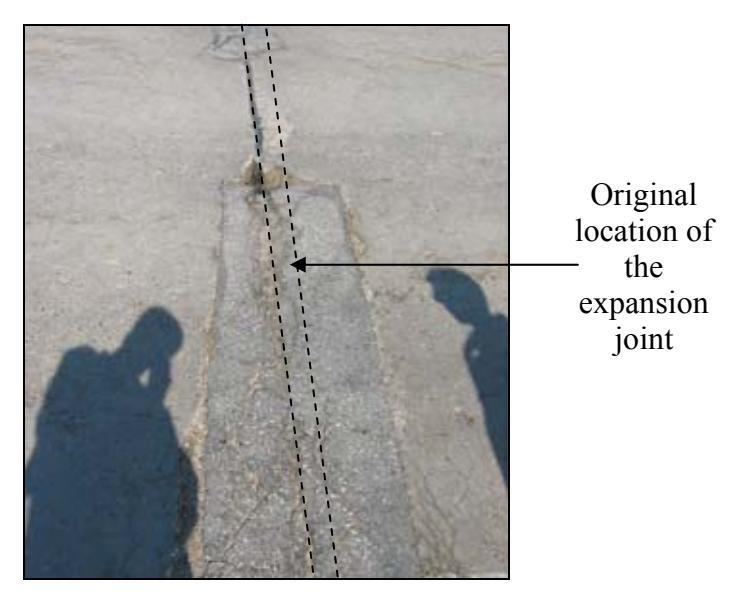
Figure 64. Cracked asphalt patch covering the expansion joint
