IDENTIFICATION OF THE BEST PRACTICES FOR DESIGN, CONSTRUCTION, AND REPAIR OF BRIDGE APPROACHES

Iowa DOT Project TR-481 CTRE Project 02-118

Final Report

January 2005

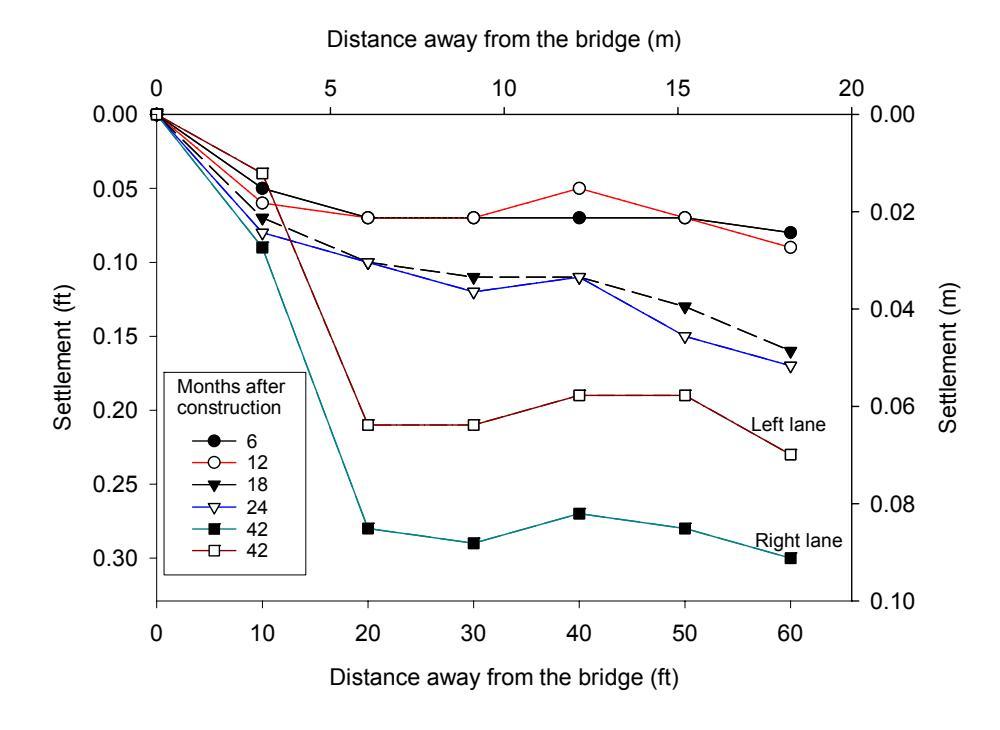
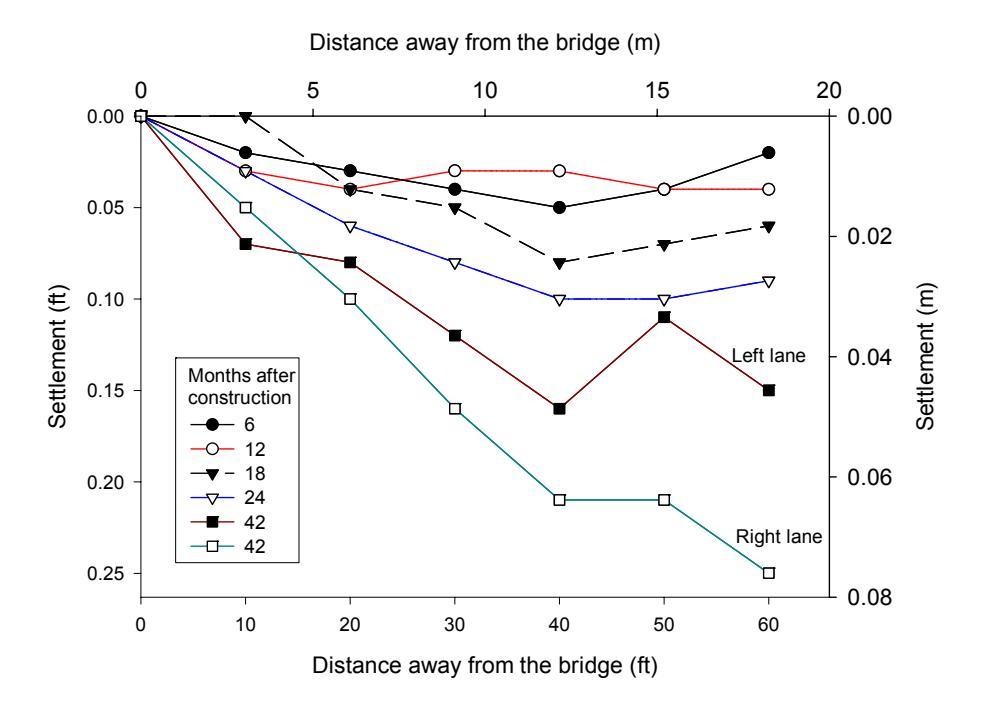
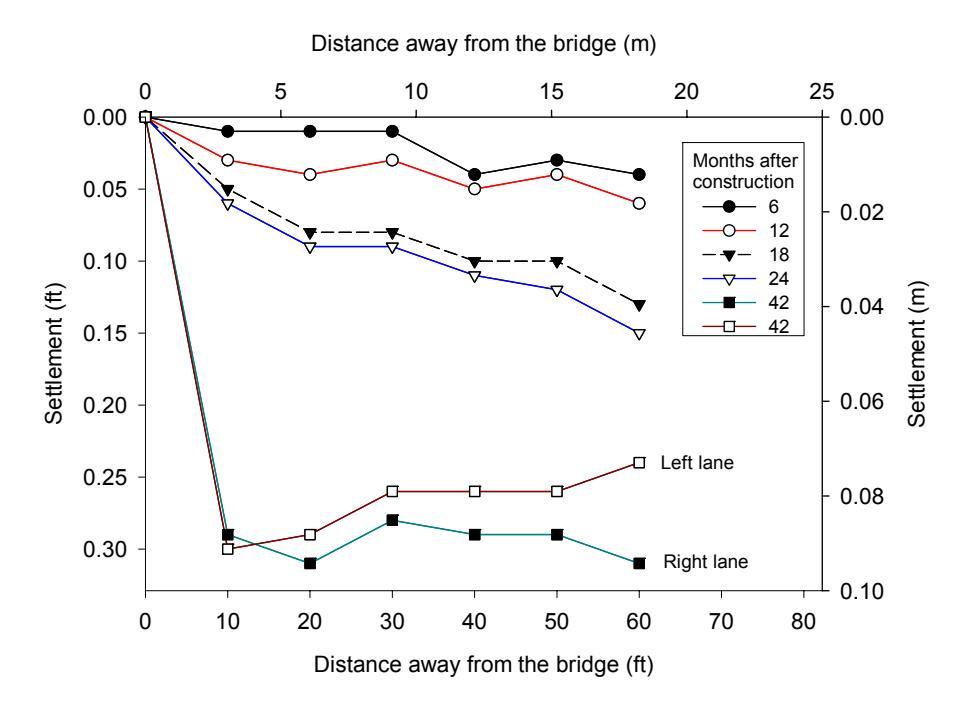
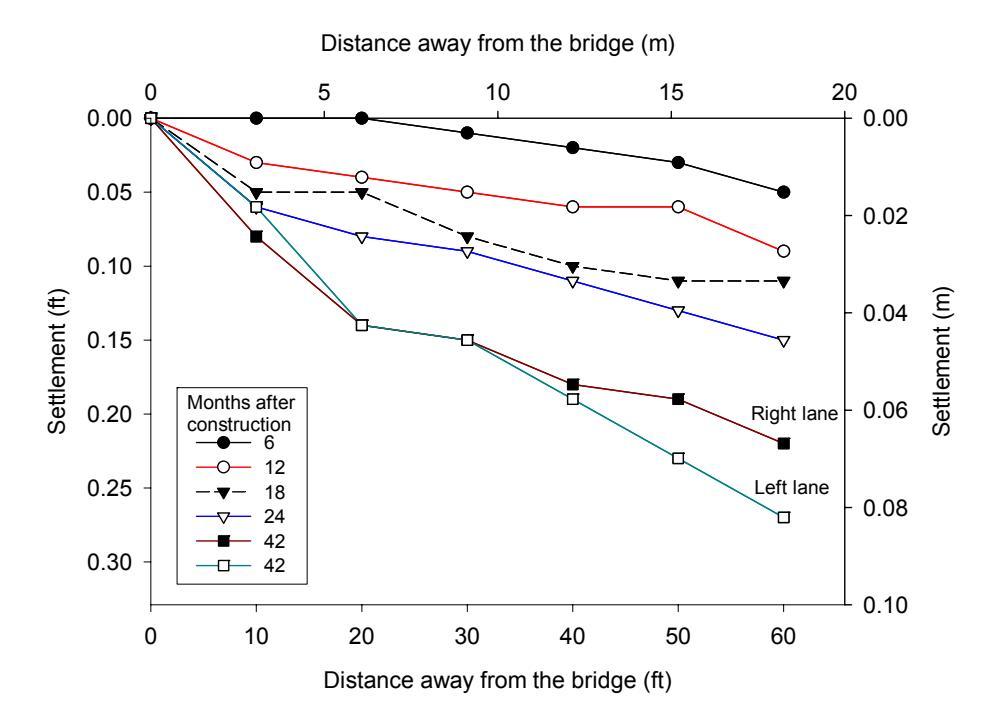
Figures 67 and 68 show the settlement for the bridge approaches at both the north and south ends of the northbound bridge, respectively. Settlement was measured in 10 ft. increments away from the bridge end. Settlement data for both approaches indicate that the approach slab settlement has been increasing with time.

Figures 69 and 70 show the settlement of the bridge approaches of the north and south ends of the southbound bridge, respectively. It is observed that approach slab settlement increases with time at both approaches. Figures 67 through 70 show no settlement difference between approach slabs supported on Geopier elements or embankment fill. This suggests that the embankment fill

is not the contributor to differential settlement and that perhaps settlement of the embankment foundation is the contributing factor.

Figure 67. Settlement of the approach slab supported on Geopier elements (North end of NB bridge)

Figure 68. Settlement of the approach slab supported on Geopier elements (South end of NB bridge)

Figure 69. Settlement of bridge approach supported on the embankment soil (North end of SB bridge)

Figure 70. Settlement of bridge approach supported on embankment soil (South end of SB bridge)

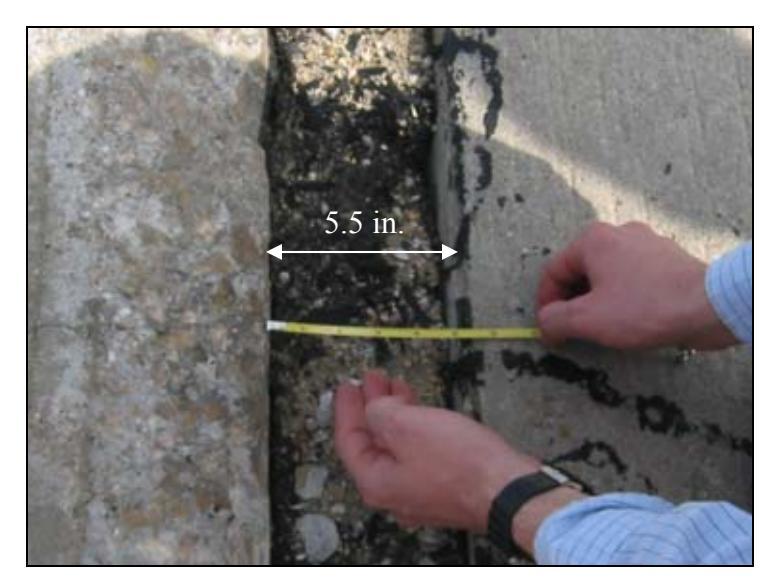
This bridge has integral abutments and concrete girders. Figure 71 shows that the width of the expansion joint is about 5.5 inches. Recycled tire chips were used as filler material at the expansion joint. Deterioration of the concrete at the expansion joint was also observed. Figure 72 shows about 1 inch differential settlement between the approach slab and the bridge deck. In the summer 2003, profiles of all approach slabs were measured and are shown in Figures 73 and 74. All four approach slabs show nonlinear profiles indicating settlement of the approach slab. Approximately 3.9 inches of differential settlement was measured at the west end of the eastbound bridge approach at the end of the wingwall. The slopes of the eastbound lane approach slabs are -0.009 and 0.017 for the east end and west end, respectively, and -0.009 and 0.02 for the east and west end approach slabs of the westbound lane, respectively.

Figure 71. Expansion joint with recycled tire filler and a width of 5.5 in. (top view)

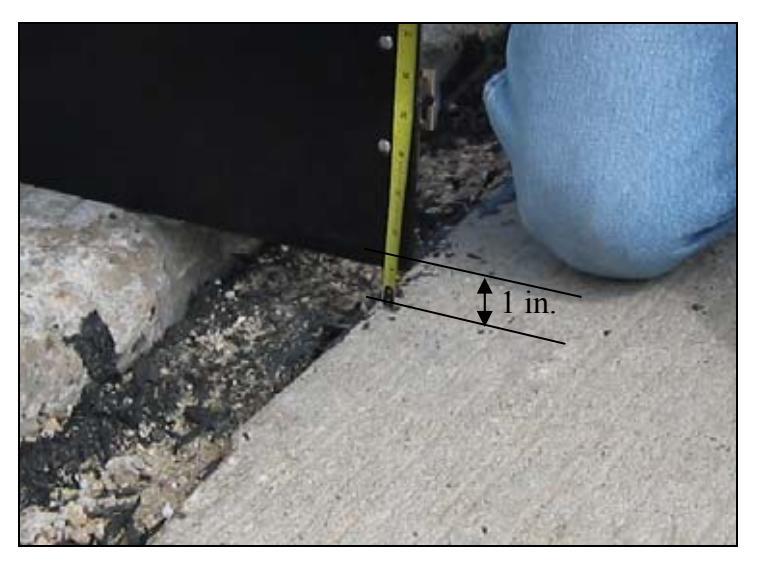
Figure 72. Differential settlement of 1 inch at the bridge approach

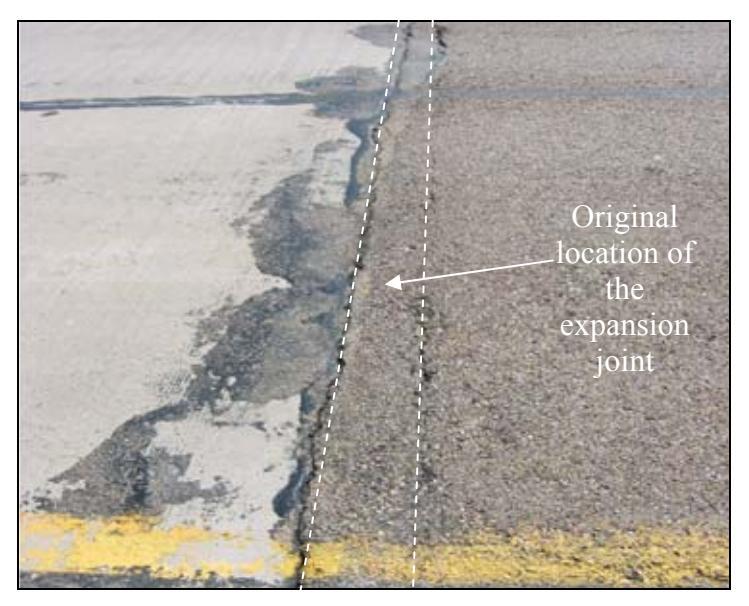
This bridge was constructed in 1976 with integral abutments. Currently, an asphalt resurfaced approach slab covers the expansion joint, as shown in Figure 75. According to the maintenance reports, the approach slab has been resurfaced more than once.

Figure 75. Asphalt overlay covering the expansion joint at the bridge approach

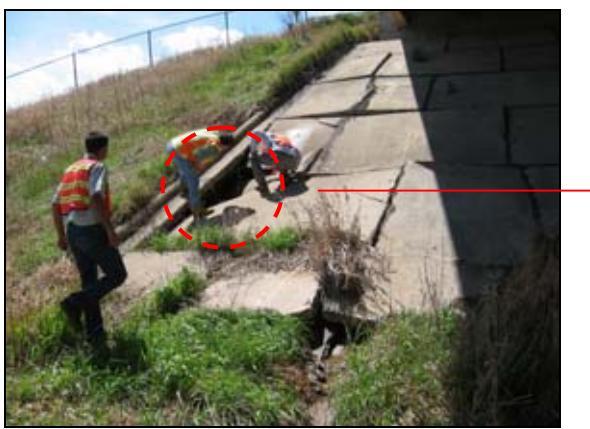
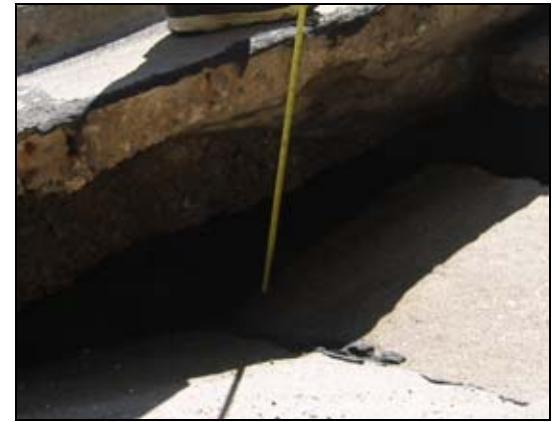
This bridge approach was also resurfaced with an asphalt overlay. The embankment has concrete slope protection. Figures 76 and 77 show damage of the concrete slope protection at the south

end of the northbound lane. The depth of the void under the concrete slope protection was approximately 1.6 feet. Figure 78 shows the settlement of the embankment under the bridge. A gap was also observed between the abutment and embankment. The width of the gap between the abutment and the embankment was 6.5 in. In addition, water was running over the concrete slope protection, indicating poor drainage.

(a) Damaged slope protection
 (b) Closer image of the damaged concrete
 Figure 76. Failure of slope protection due to loss of support (south end NBL)

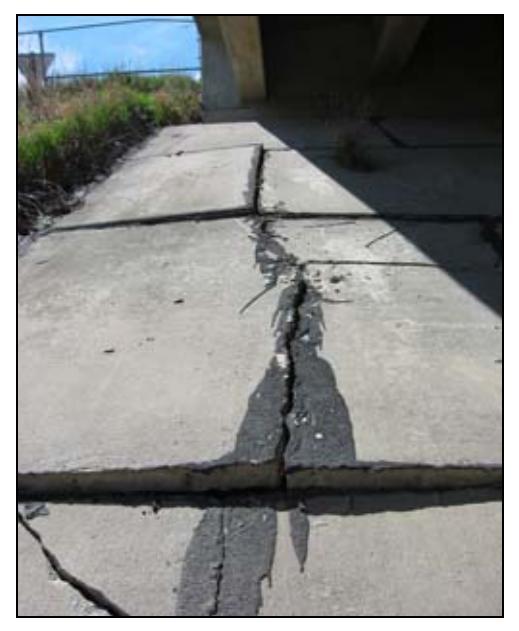
Figure 77. Fractured concrete slope protection

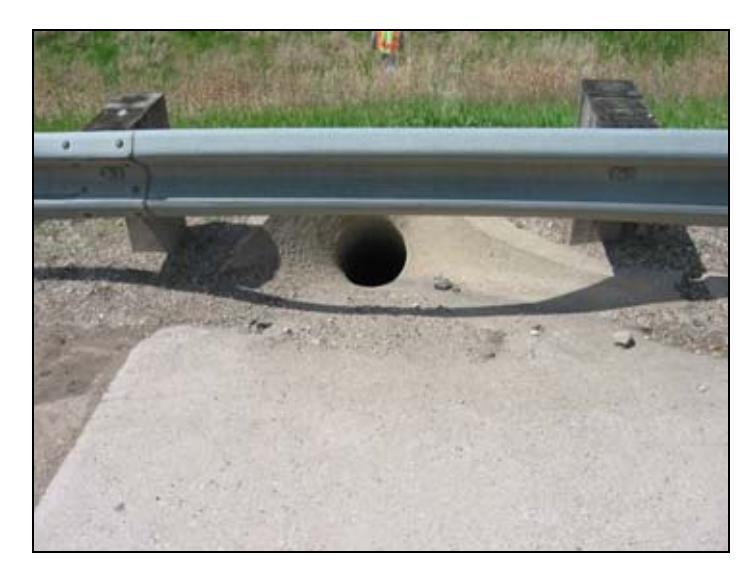
Figure 81. Surface drainage inlet at the bridge approach

- Some bridges do not have a surface drain. The current Iowa DOT surface drain detail shown in Figure 94 is not effective. The surface drain observed at 5596.2S169 bridge (Figure 81) is effective and is believed to have helped in reducing erosion around the bridge abutment.

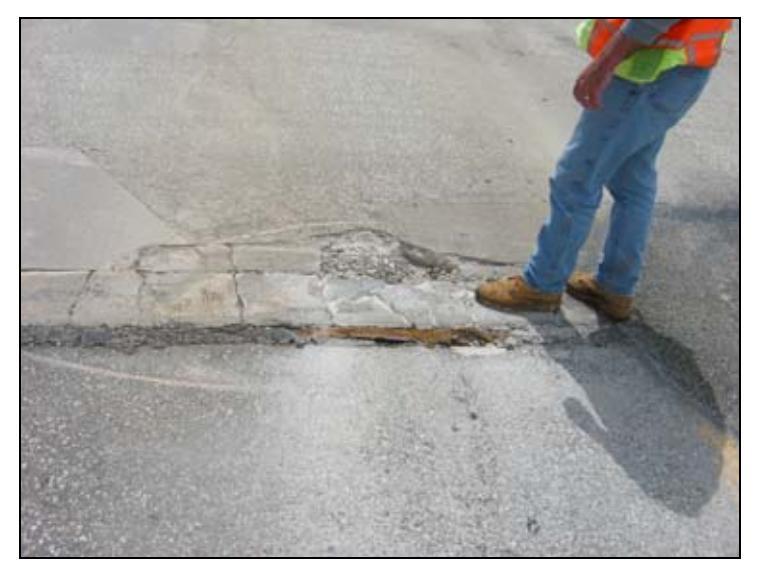
This bridge has integral abutments and concrete girders. Similar to the previous two bridges, cracks developed at the bridge slab (Figure 83). No soil erosion was observed at the embankment under the bridge; however, erosion along the abutment sides was visible.

Figure 83. Cracks in the bridge deck concrete

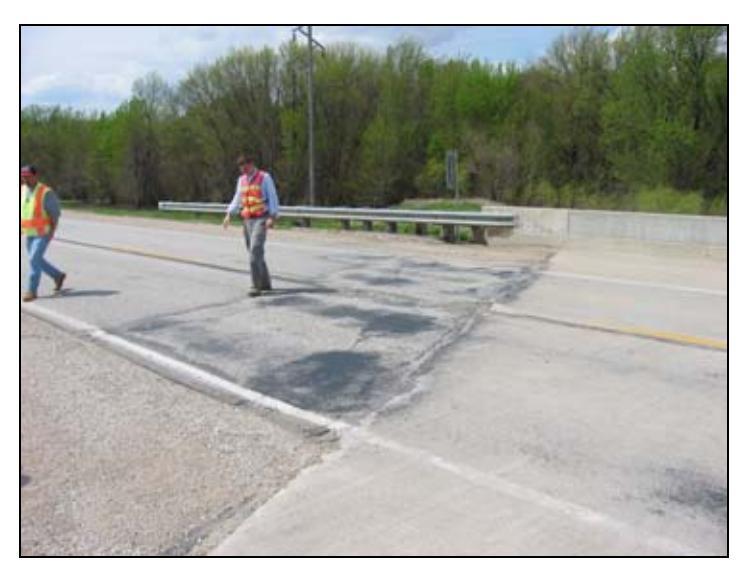
This bridge has integral abutments with concrete girders. No significant soil erosion was observed. Settlement of the embankment of 4.5 inches under the bridge was measured. Both approach slabs had been patched; however, deterioration and cracks were observed on both approach slabs (Figure 84).

Figure 84. Cracking of asphalt overlay (East end)

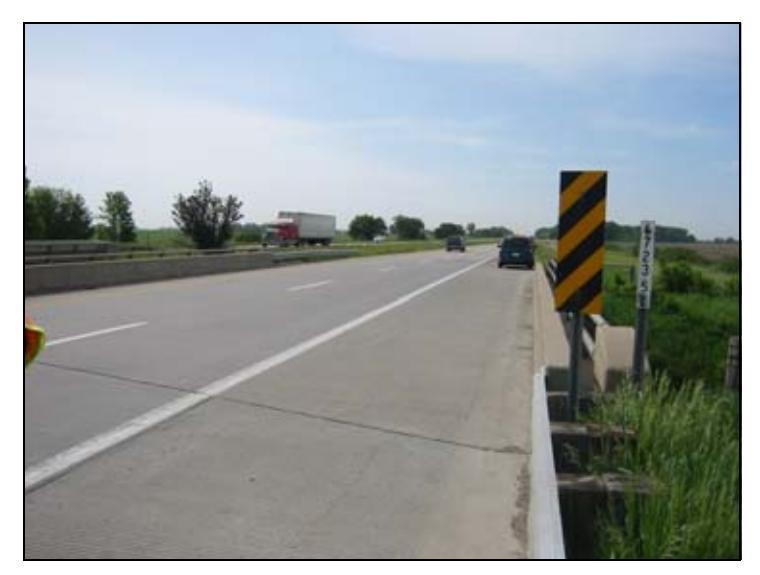
This bridge was constructed in 1960. The approach slab had been recently replaced for the south bound bridge lanes and no major problems were observed (Figure 85).

Figure 85. Recently replaced bridge approach slab (SBL)

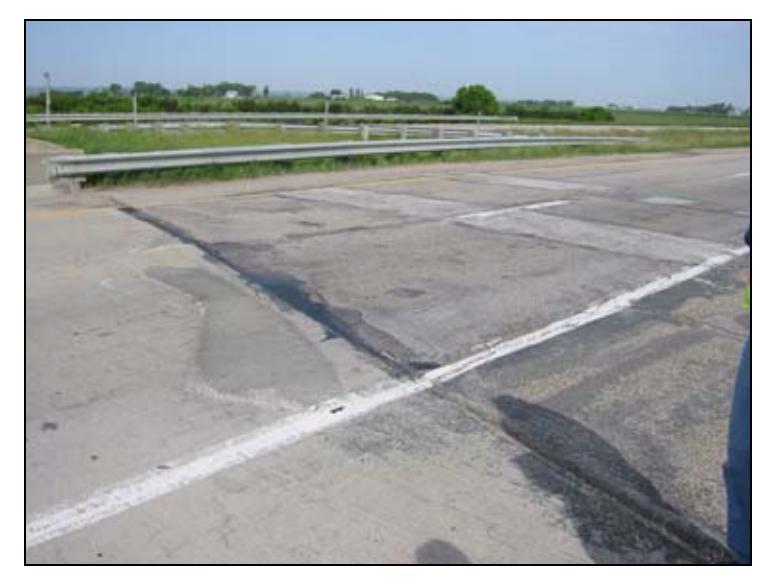
Approach slabs for the north bound bridge were resurfaced with asphalt overlays at both ends. However, wavy approach slabs, longitudinal cracks, and differential settlement of 4 inches relative to the wingwall were observed at both ends (Figures 86 to 88). Figure 88 shows differential settlement and cracks at the bridge slab. The cracks were similar to the ones observed at District 2 (See Bridge no. 5596S169). Figure 88 also shows an asphalt patch that was placed over the crack at the bridge slab while inspecting the bridge.

Figure 86. Significant damage of the asphalt overlay on the approach slab (NBL)

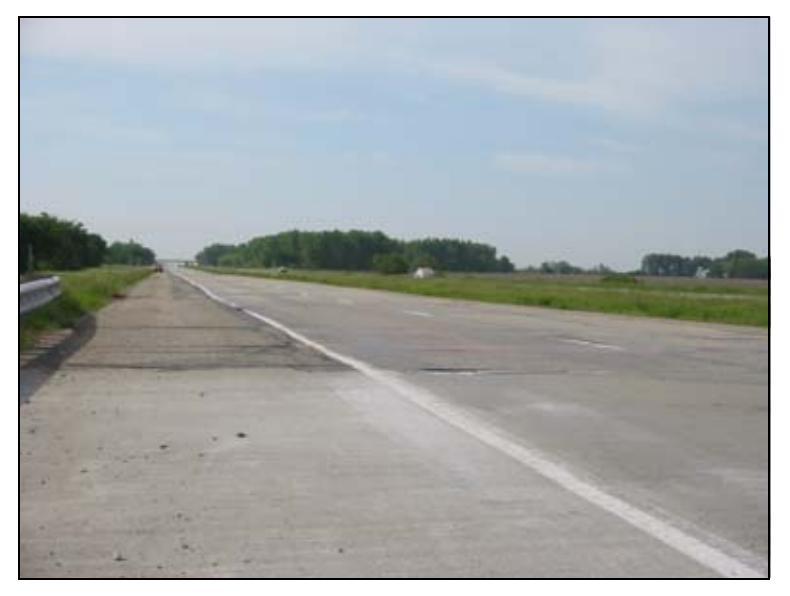
Figure 87. Wavy approach slab (NBL)

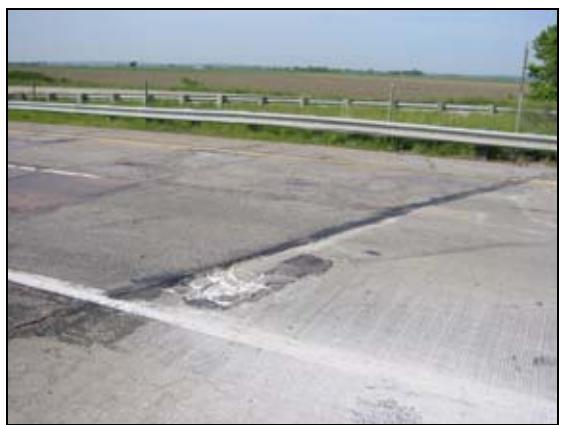
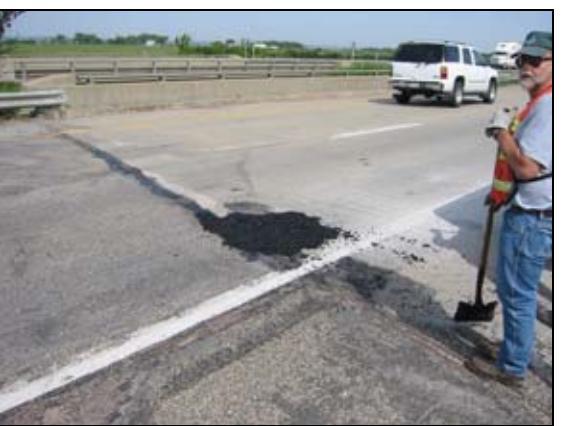
(a) Cracks on the bridge deck

(b) Asphalt patch covering the cracks Figure 88. Asphalt patch placed over cracked bridge slab (NBL)

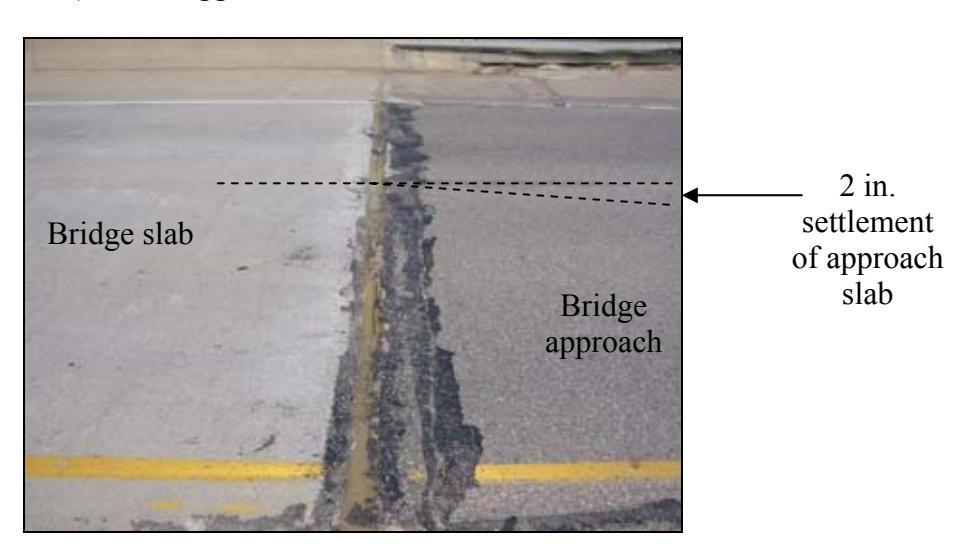
This bridge has an integral abutment and concrete girders. Damage to the expansion joint and 2inch differential settlement, which was measured at the expansion joint, were observed (Figure 89). The bridge has an asphalt overlay. The slope protection at the embankment under the bridge settled about 3 inches relative to the abutment. Grout, which was pumped to fill the void developed under the approach slab, was observed seeping out between the concrete panels of the slope protection (Figure 90). This suggests that the void extended under the abutment.

Figure 89. Differential settlement between bridge slab and bridge approach

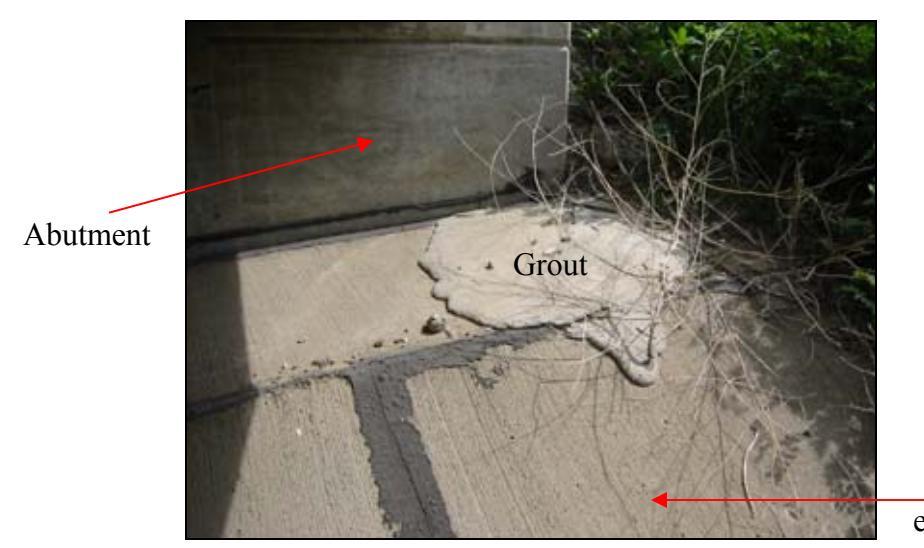
Figure 90. Grout observed on the concrete slope protection overlay indicating that void extended under the abutment

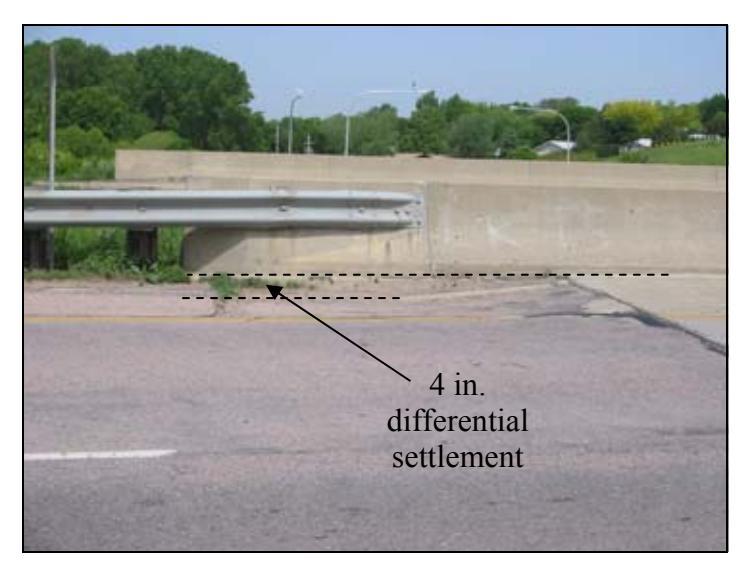
This bridge has integral abutments and concrete girders. The embankments under the bridge had a slope protection. The expansion joint at this bridge was 2 inches wide. Figure 91 shows the 4 inches of differential settlement measured between the bridge deck and the shoulder of the bridge approach. This figure also shows alligator cracking at the bridge shoulder. Grout was pumped behind the abutment at the west end of the eastbound lane and under the embankment slope protection cover. The concrete slope protection settled about 6.5 inches relative to the abutment (Figures 92 and 93).

Figure 91. Differential settlement between the bridge deck and the approach slab

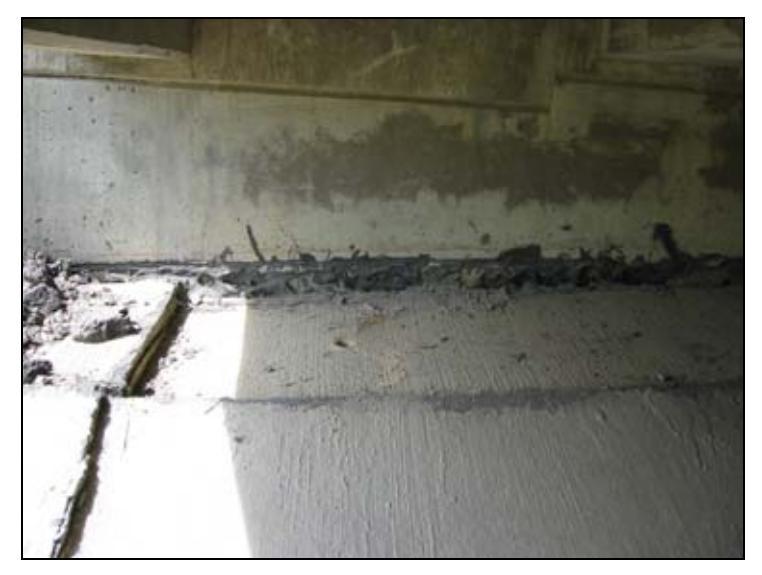
Figure 92. Uneven settlement of concrete slope protection

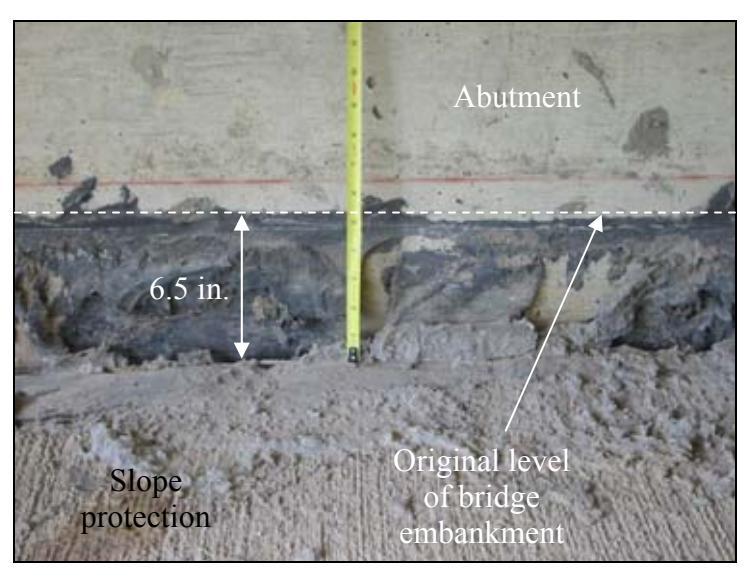
Figure 93. Settlement of the embankment slope protection of 6.5 inches

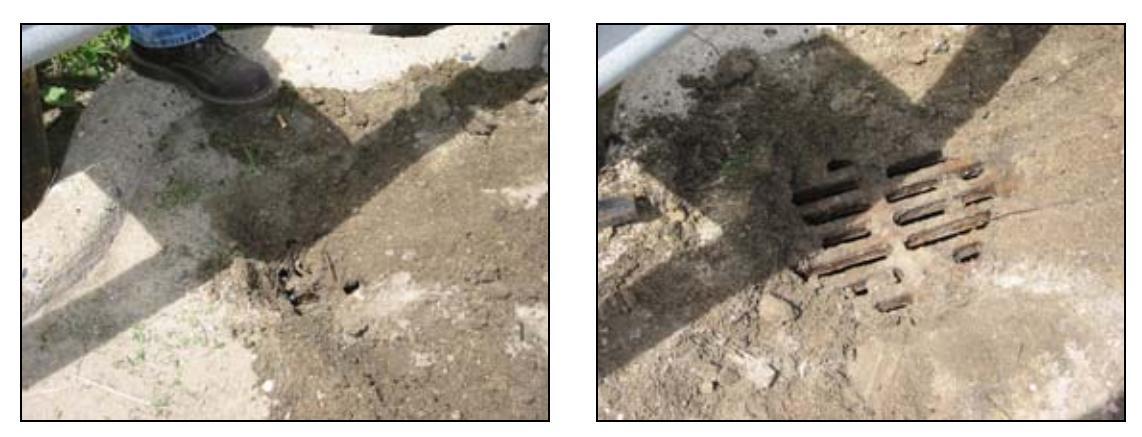
This bridge has non-integral abutments and concrete girders. The approach slab was grouted to prevent water infiltration. This caused water to run along the bridge shoulder to the other end of the bridge. Although surface drainage was used on the west side of the bridge, it was plugged (Figure 94). As a result, water eroded the approach slab shoulder, as shown in Figure 95. With no slope protection under the bridge and silty soil used for the embankment, severe erosion was also observed (Figure 96).

(a) Bridge approach surface drain blocked by debris

(b) Bridge approach surface drain after debris removal

Figure 94. Drainage intake before and after debris removal

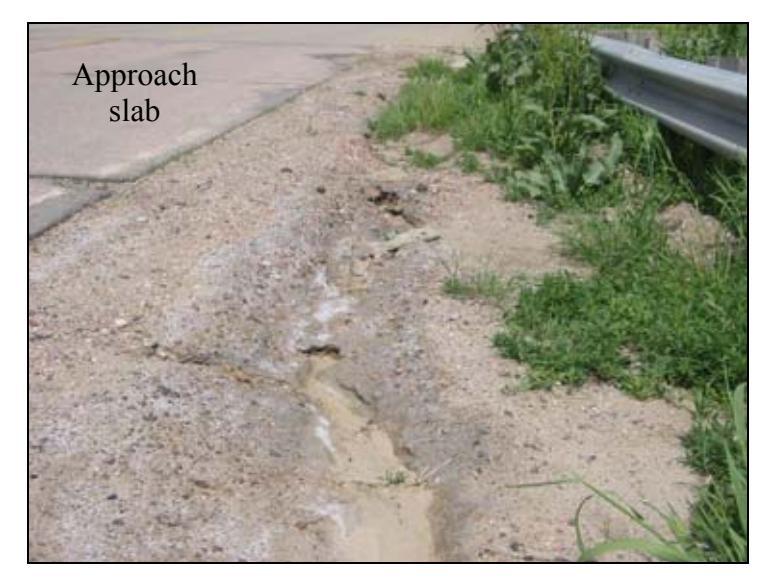
Figure 95. Erosion caused by runoff water at the approach slab shoulder

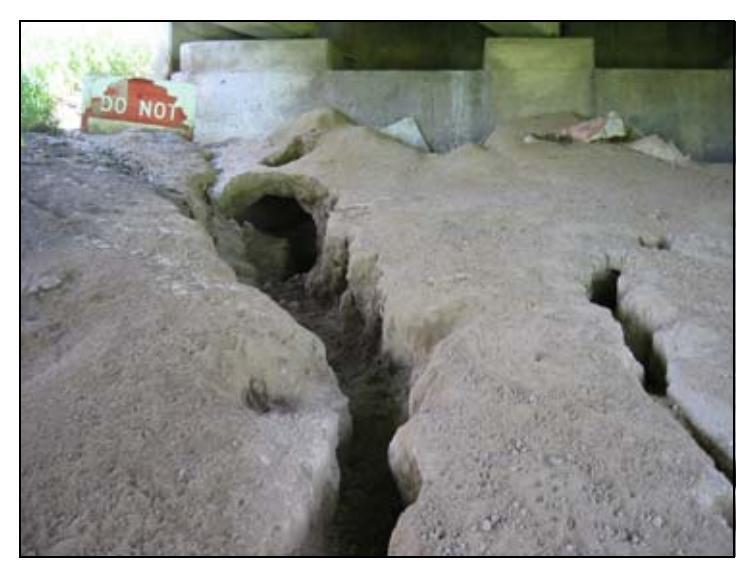
Figure 96. Severe erosion under the bridge

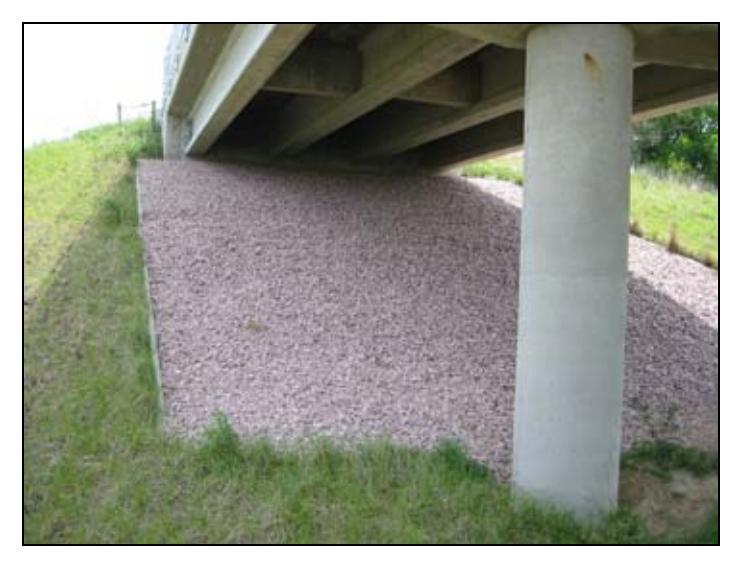
This bridge has concrete girders with integral abutments. The foundation soils under bridges on U.S. Highway 75, including this bridge, were allowed to consolidate under the embankment weight for one year before construction. The approach slab was in a good condition. The bridge has aggregate embankment slope protection, as shown in Figure 97. A 4-inch void under the approach slab was observed. No other major problems were observed.

Figure 97. Aggregate slope protection of the embankment under the bridge

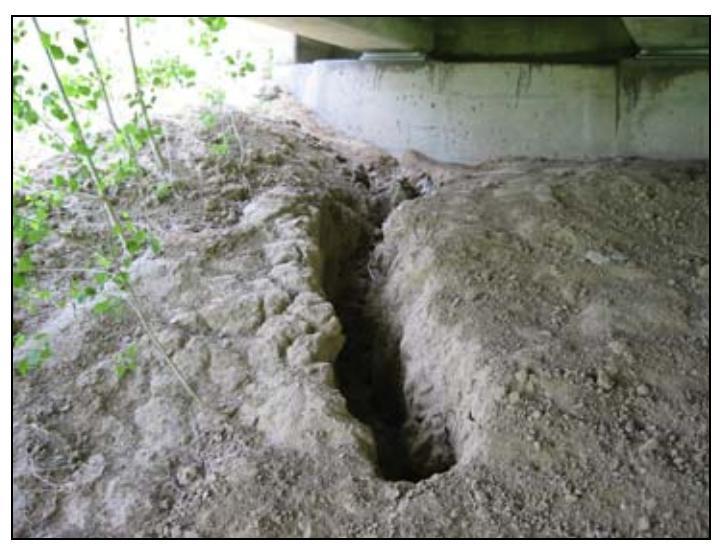
The bridge was constructed in 2000 with non-integral abutments. The foundation soils at this bridge were allowed to consolidate under the embankment weight for one year prior to construction. No differential settlement was observed at the approach slabs. Erosion of the soil under the bridge was observed because the strip seal of the expansion join was cut short at both sides of the north bound lane, causing water to run down the sides of the bridge (Figures 98 and 99). At the opposite end of the bridge, the same strip seal problem was noticed and erosion of the embankment soil was observed.

Figure 98. Soil erosion of the embankment under the bridge

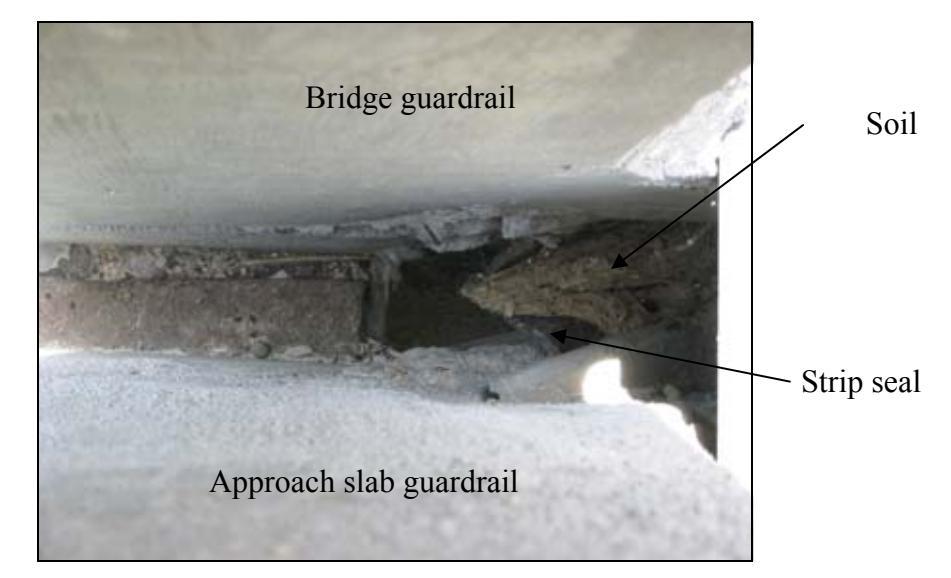
Figure 99. Top view of the strip seal cut short (North bound)

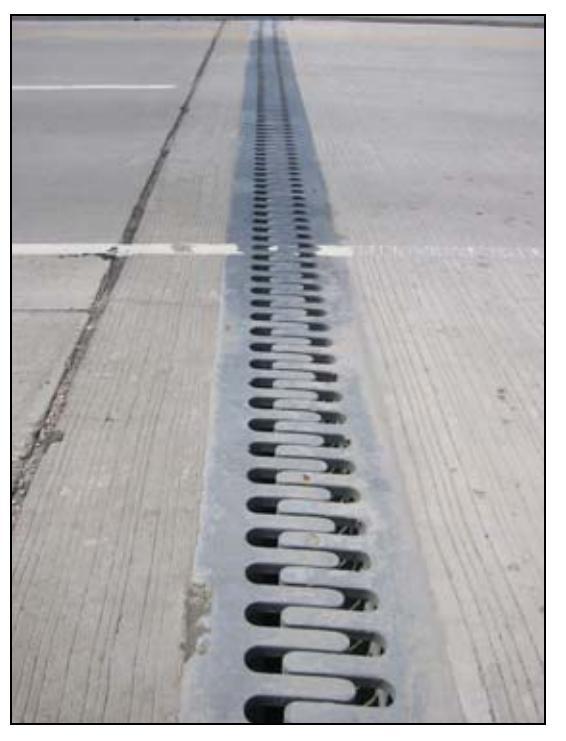
This bridge has non-integral abutments and steel girders. A finger joint was used at the end of the bridge, as shown in Figure 100. The foundation soil was allowed to consolidate under the embankment weight for one year before construction. The embankment under the bridge has aggregate slope protection. No major problems were observed at this bridge.

Figure 100. Finger type joint

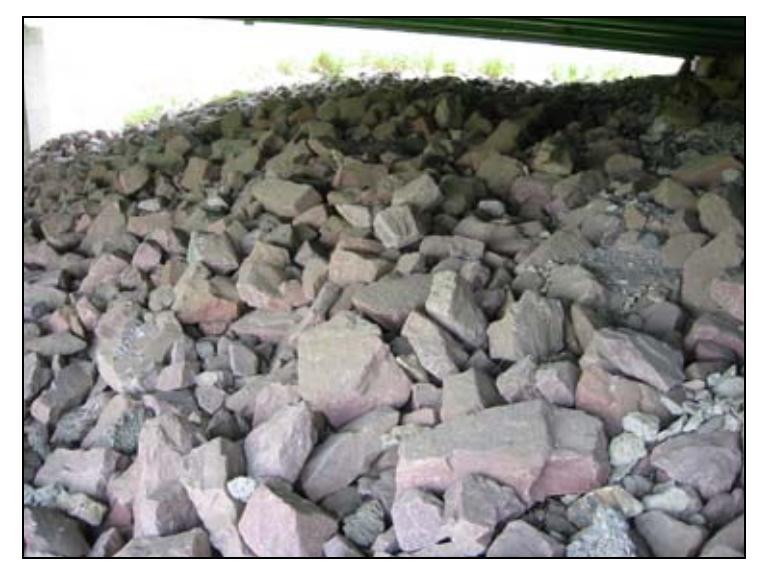
This bridge was constructed in the 1960s and has steel girders with non-integral abutments. Longitudinal and transverse cracks were visible on the approach slab. Figure 101 shows the aggregate that was used as a slope protection under the bridge. After overlaying the approach slab with asphalt, which also covered the expansion joint, a pressure relief joint was made by cutting the approach slab. More pressure relief joints were made as previous joints were deemed non-functional due to debris. The additional joints provide opportunity for water to infiltrate into the subgrade under the approach slab (Figure 102).

Figure 101. Aggregate used as embankment slope protection

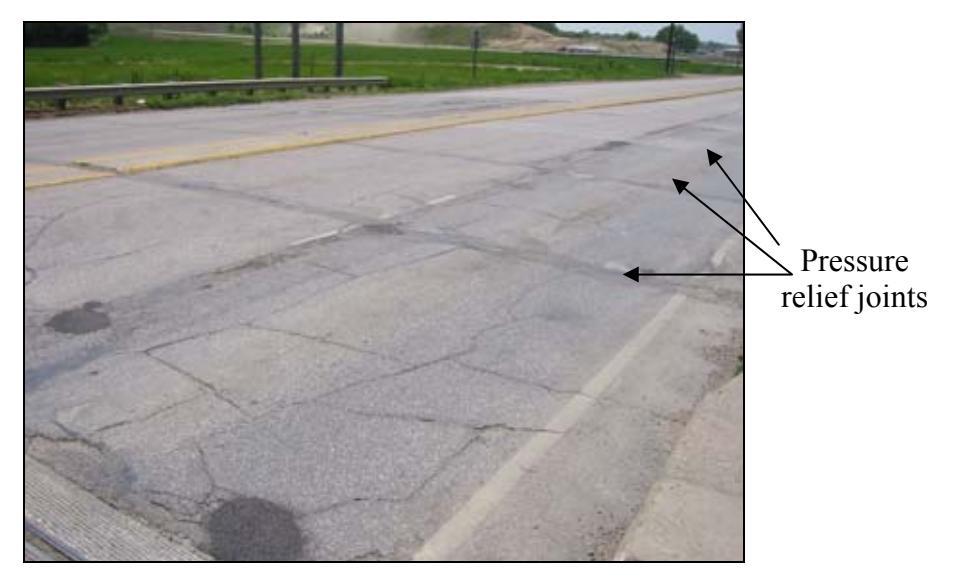
Figure 102. Pressure relief joints cut at the approach slab

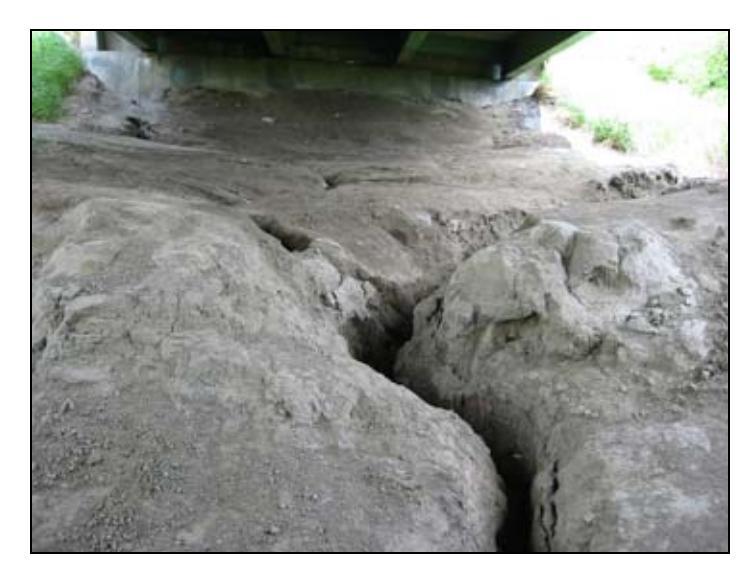
This bridge has steel girders with non-integral abutments. About 2 inches of settlement of the approach slab was measured at the wingwall. Although the soil of the embankment was silty, no embankment slope protection was used under the bridge. As a result, soil erosion was observed, as shown in Figure 103.

Figure 103. Soil erosion of the embankment under the bridge

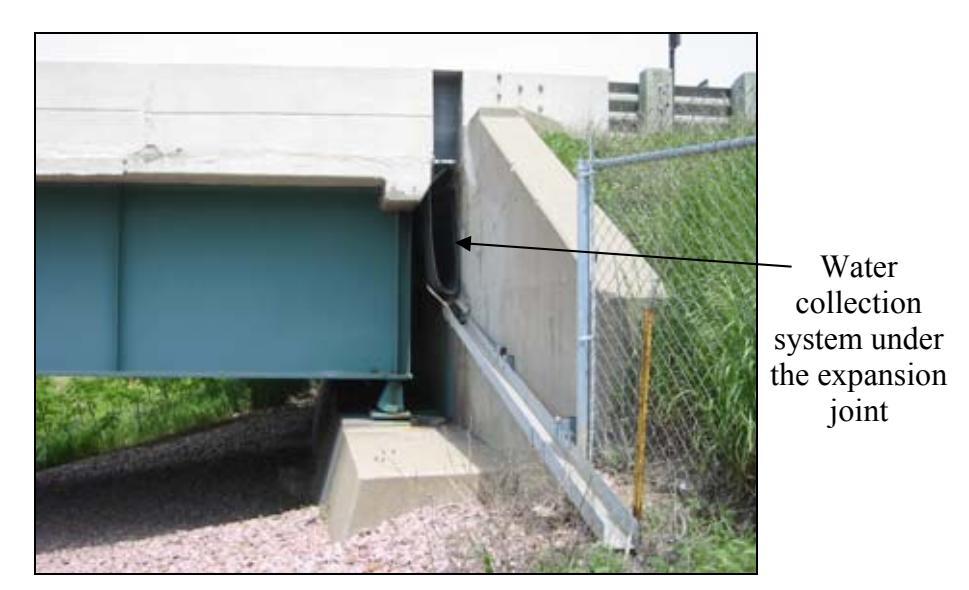
This bridge is maintained by South Dakota State DOT and has non-integral abutments and steel girders. Aggregate was used for slope cover under the bridge. The bridge has a unique drainage system, as shown in Figure 104, which consists of a rubber container under a finger joint collecting the water and directing it to a gutter system away from the bridge.

Figure 104. Drainage design at the end of the bridge in South Dakota
District 4

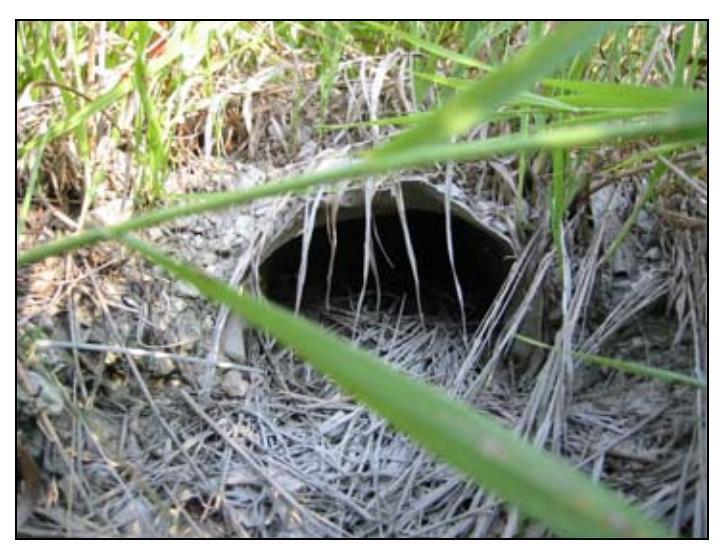
Figure 108. End drain plugged with soil

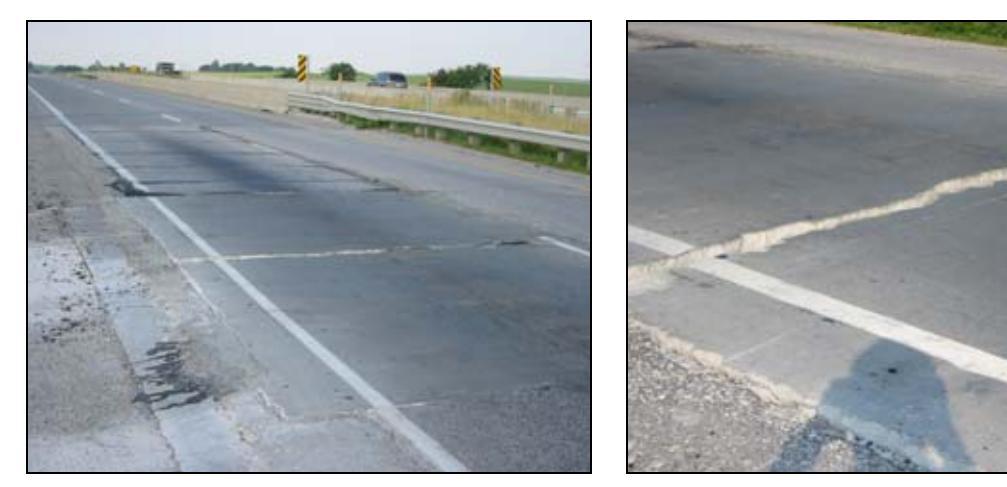
This bridge was constructed in 1968 and has four spans with non-integral abutments. Figure 109 shows severe faulting of the bridge approach panels. Maintenance records indicate that this approach slab had been previously repaired with the most recent patch places in spring 2003. The outlet of the end drain could not be located (Figure 110), which may be blocked with soil that caused the observed cracking and faulting of the approach slab. Cracked concrete slope protection of the embankment under the bridge was also observed (Figure 111).

(a) Cracked approach slab panels

(b) Closer image of faulted approach slab

Figure 109. Faulting of bridge approach panels

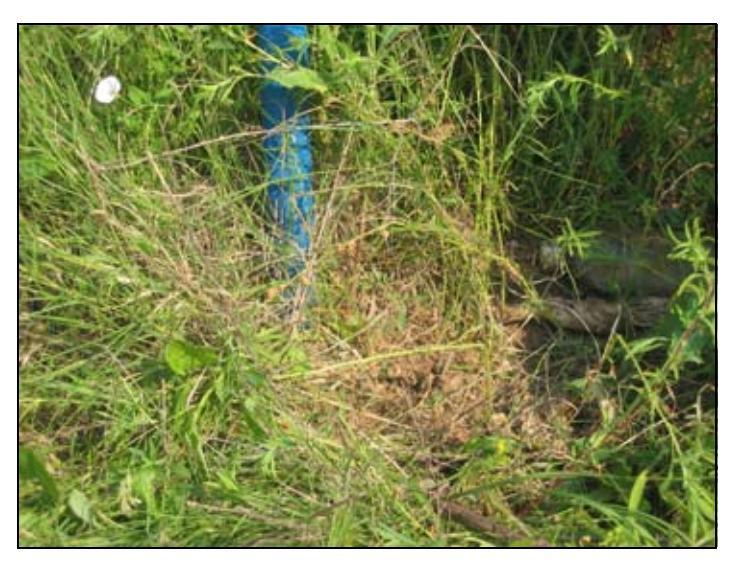
Figure 110. Drainage outlet could not be located

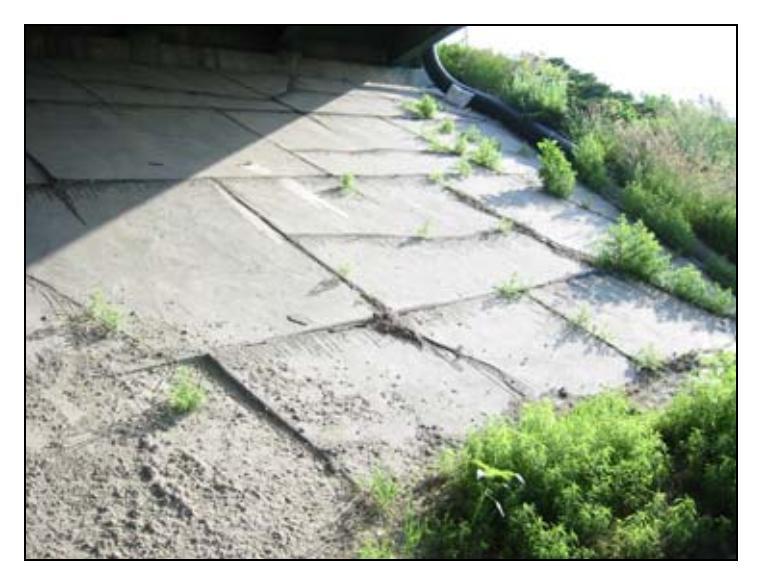
Figure 111. Cracking of concrete slope protection

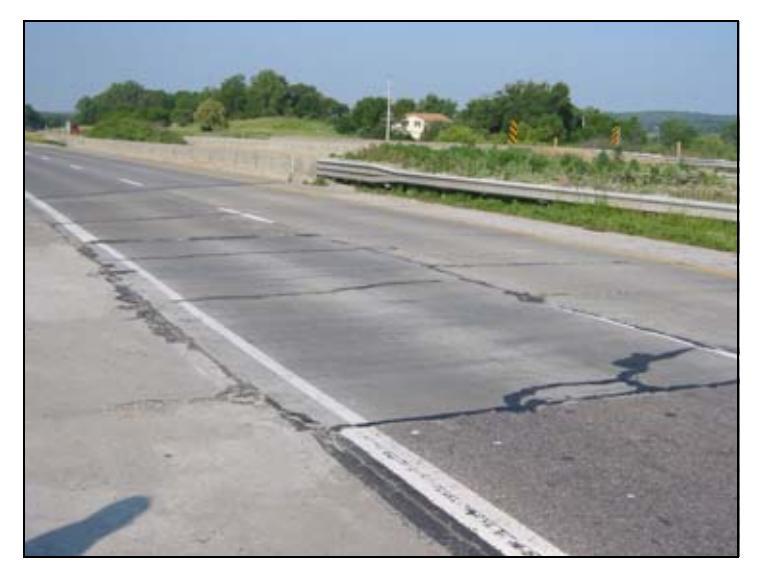
This bridge was constructed in the late 1960s and has three steel spans with non-integral abutments. According to interviews with Iowa DOT field personnel, the approach slab has been replaced 5 times in the last 13 years and, and although it was recently replaced, transverse cracks and settlement were observed (Figure 112). The outlet of the end drain was dry with no signs of water or fine soil particles at the time of the inspection (Figure 113). With no slope protection and loess soils used as embankment soil (Figure 114), erosion was observed around the bridge.

Figure 112. Cracking and settlement of recently replaced approach slab

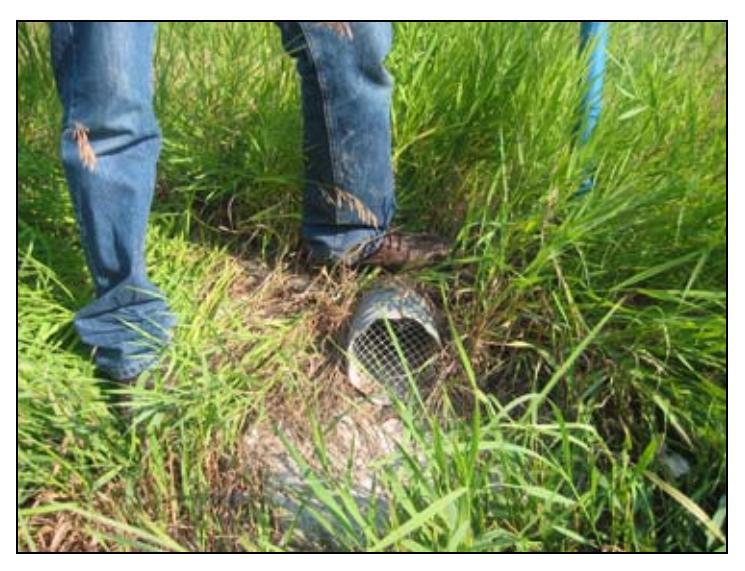
Figure 113. Dry end drain with no indication of water flowing out

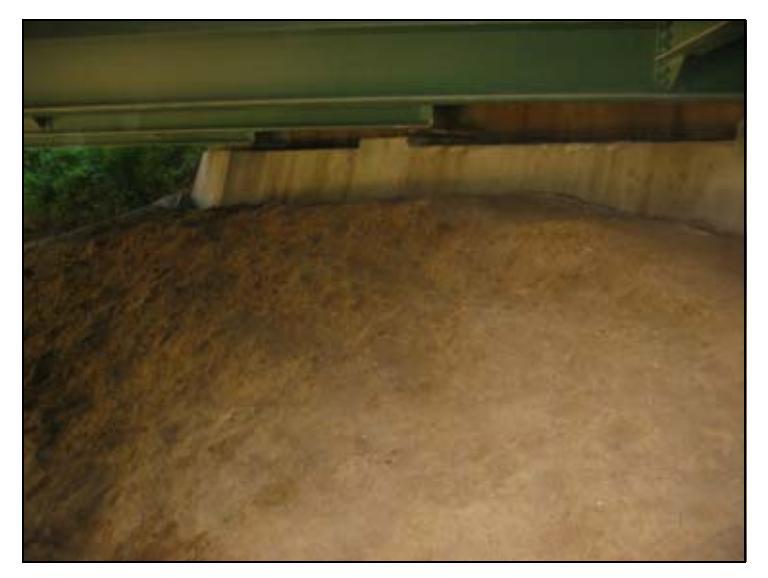
Figure 114. Loess soil used for the embankment

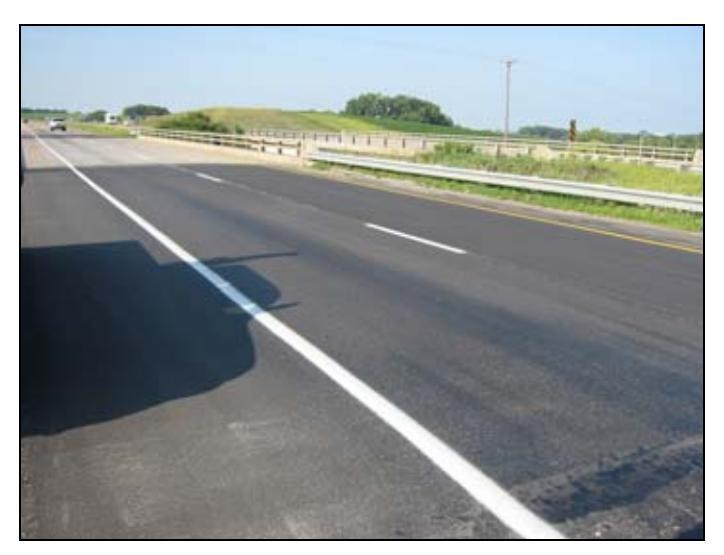
This bridge has integral abutments and concrete girders. A new asphalt overlay was placed in May 2004 (Figure 115). Figure 116 shows the concrete slope protection cover which was in satisfactory condition. The end drain outlet at the east bound of the bridge was plugged with soil. Cracking of center pier–girder connection (Figure 117) and deteriorated guardrail exposing the steel reinforcement were also observed.

Figure 115. New asphalt-resurfaced approach
