IDENTIFICATION OF THE BEST PRACTICES FOR DESIGN, CONSTRUCTION, AND REPAIR OF BRIDGE APPROACHES

Iowa DOT Project TR-481 CTRE Project 02-118

Final Report

January 2005

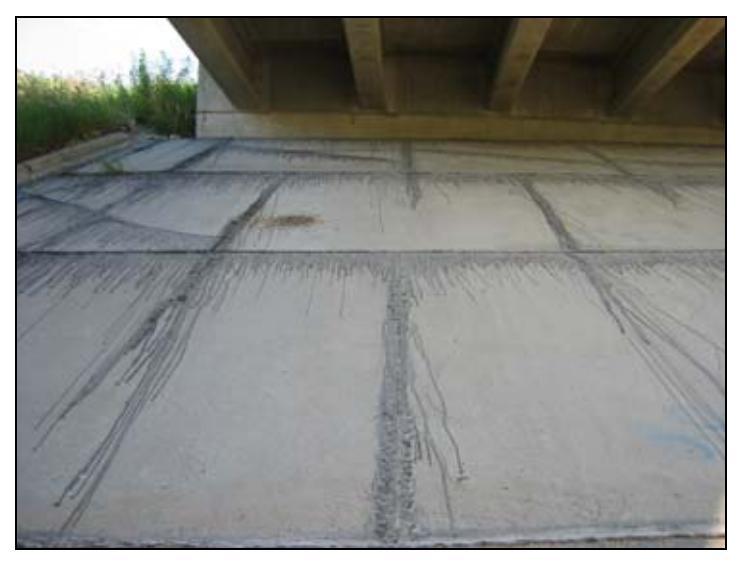
Figure 116. Sealed concrete slope protection cover

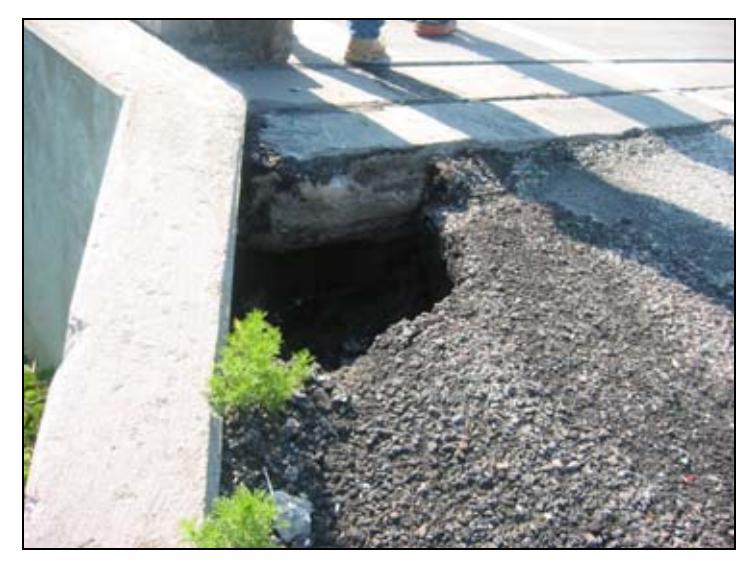
The bridge has three spans with non-integral abutments. At the westbound end, the expansion joint was poorly sealed and erosion at the shoulder of the approach slab (Figure 118) was observed. Figure 119 shows map and longitudinal cracks developed at the expansion joint. Differential settlement of 2 inches between the approach slab and the wingwall was also noted. There was no slope protection under the bridge. Soil erosion and settlement of the embankment were observed.

Figure 118. Failure at the shoulder of the approach slab (WBL)

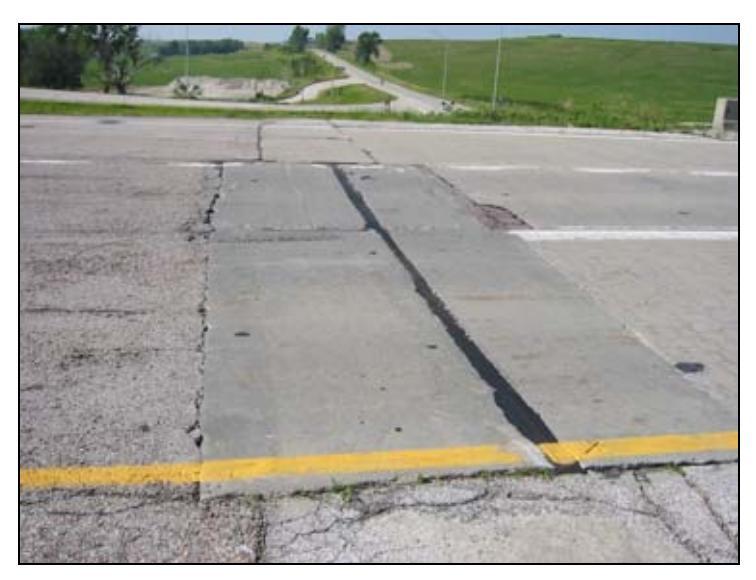
Figure 119. Various cracking at the bridge approach (EBL)

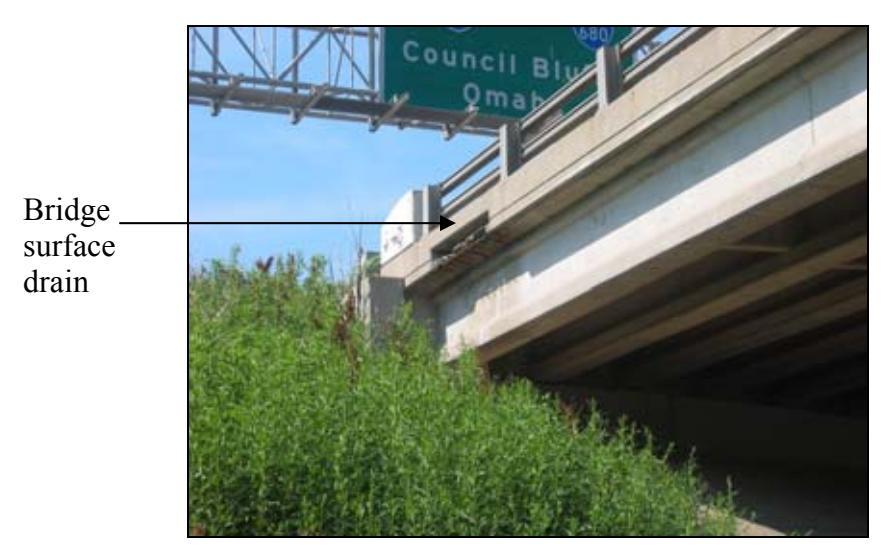
This bridge has integral abutments and concrete girders. Damage of the expansion joint was visible. Figure 120 shows the bridge surface drain at the northbound lane. This figure illustrates that no drainage pipe was used to direct the water collected on the bridge deck away from the embankment, which may have caused soil erosion under the concrete slope protection. Excessive erosion led to failure of the slope protection at both ends of the bridge and the exposure of H-piles supporting the abutments (Figures 121 and 122). Settlement of the embankment under the bridge at the southbound lane of 10.5 inches was measured (Figure 123). Ponding water was observed at the bottom of the bridge embankment (Figure 124).

Figure 120. Surface drain of the bridge deck allowing water to fall on the embankment

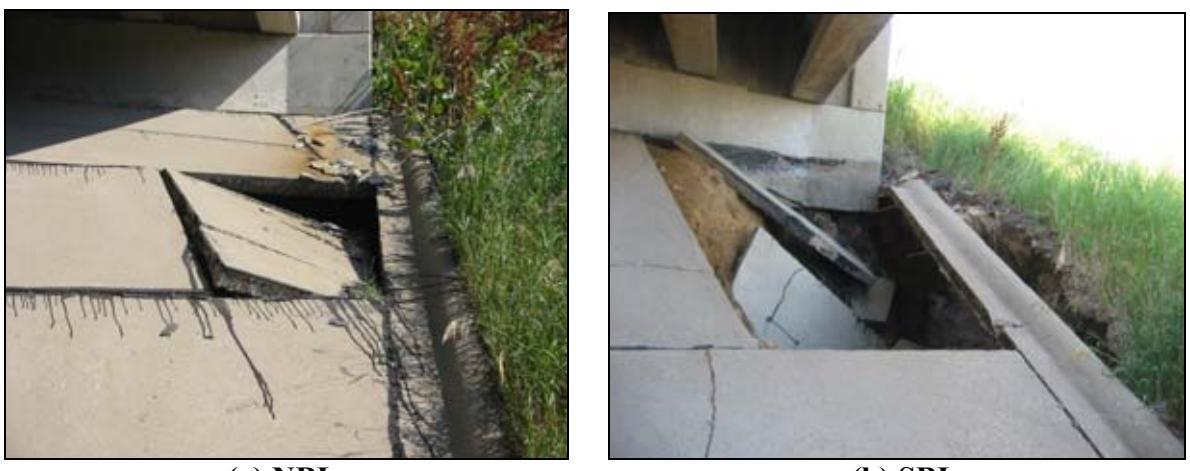
Figure 121. Failure of concrete slope protection

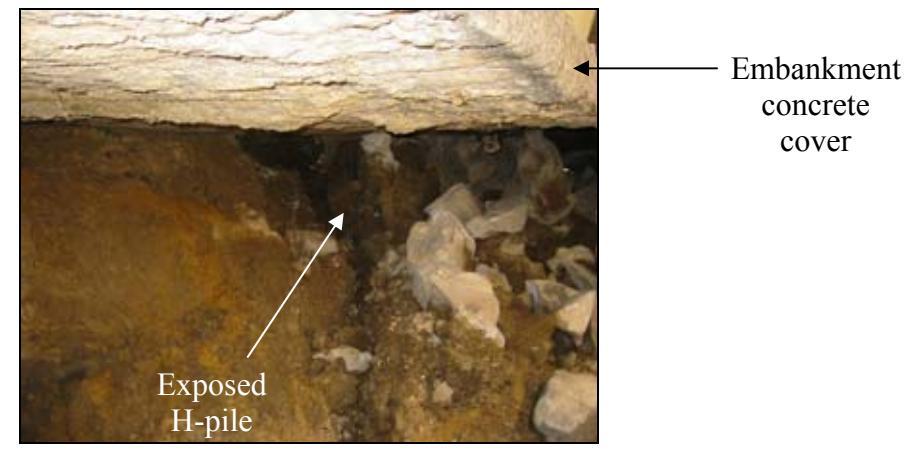
Figure 122. Exposed H-pile (side view)

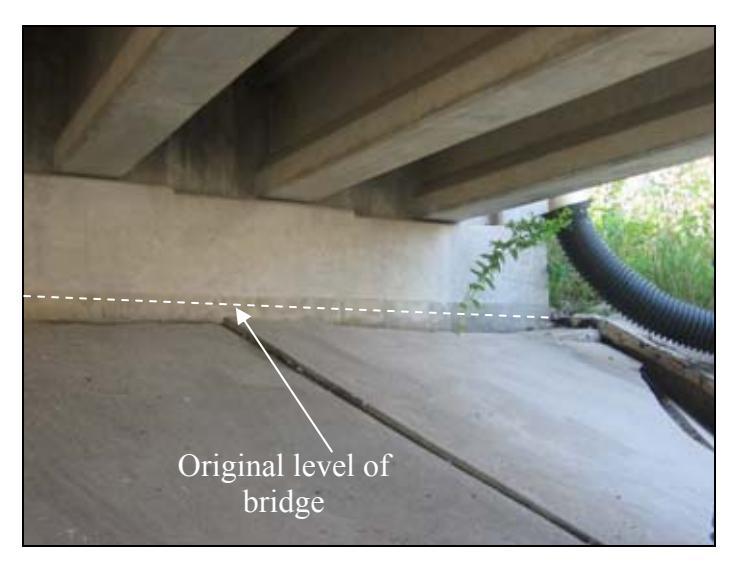
Figure 123. Concrete cover settlement of 10.5 in.

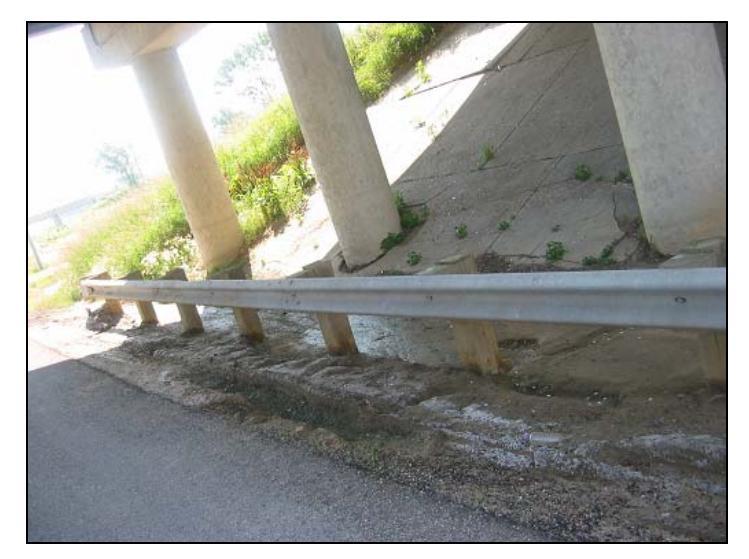
Figure 124. Ponding water and debris observed at the bottom of the embankment

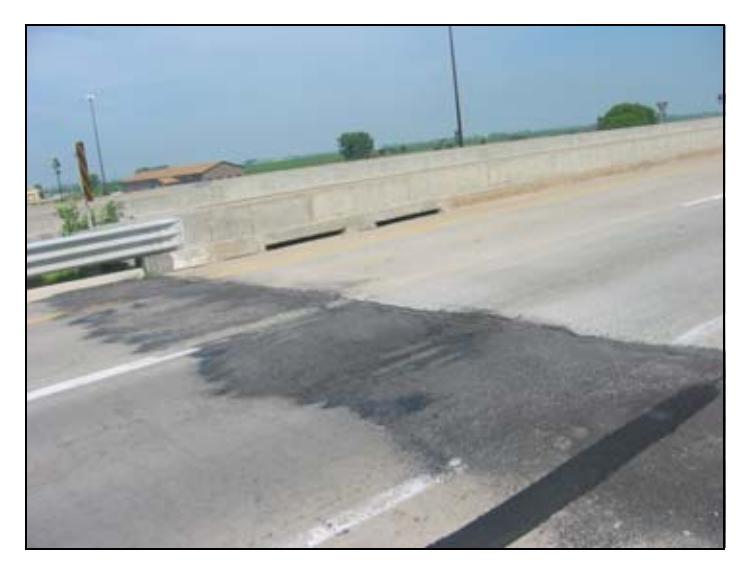
This bridge has four spans and non-integral abutments. Figure 125 shows the asphalt overlay placed at the bridge approach to compensate for the approach slab settlement relative to the bridge deck. In spite of the asphalt overlay, 3 inches of differential settlement was still observed at the end of the wingwall. The concrete slope protection on the embankment under the bridge had been replaced with aggregate. Where recycled tires were used as a filler material, the expansion joint was in a satisfactory condition (Figure 126).

Figure 125. Asphalt patch placed at the approach slab

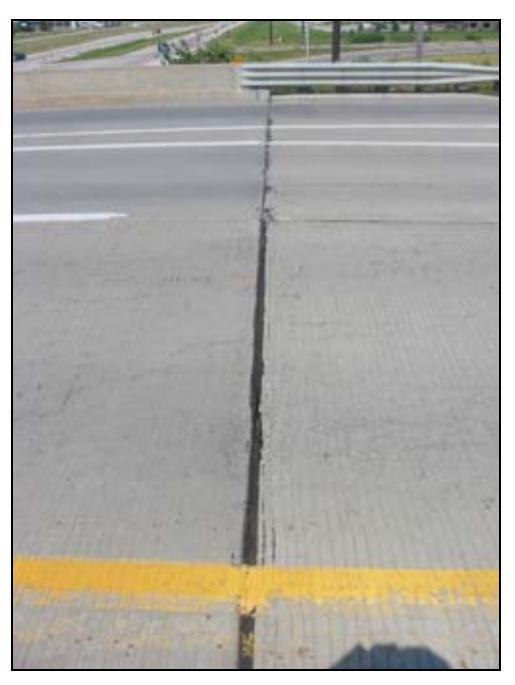
Figure 126. Expansion joint 2 inches wide and in good condition

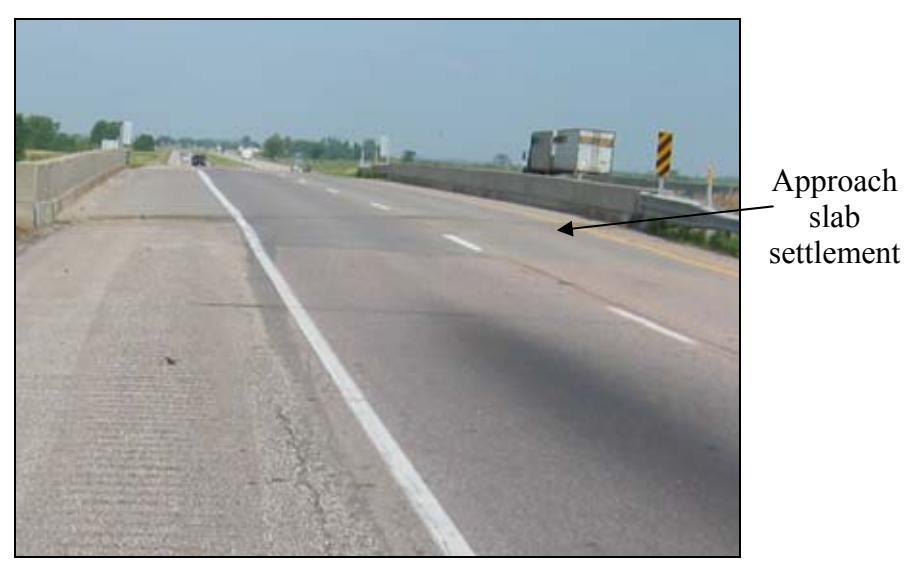
This is a three-span concrete bridge with non-integral abutments. Figure 127 shows settlement of the approach slab. Concrete spalling and cracking at the expansion joints were observed (Figure 128). Faulting of the bridge approach panels was also noted (Figure 129). The voids developed around the abutments were grouted. The embankments under the bridge had no slope protection and soil erosion was observed.

Figure 127. Settlement of bridge approach

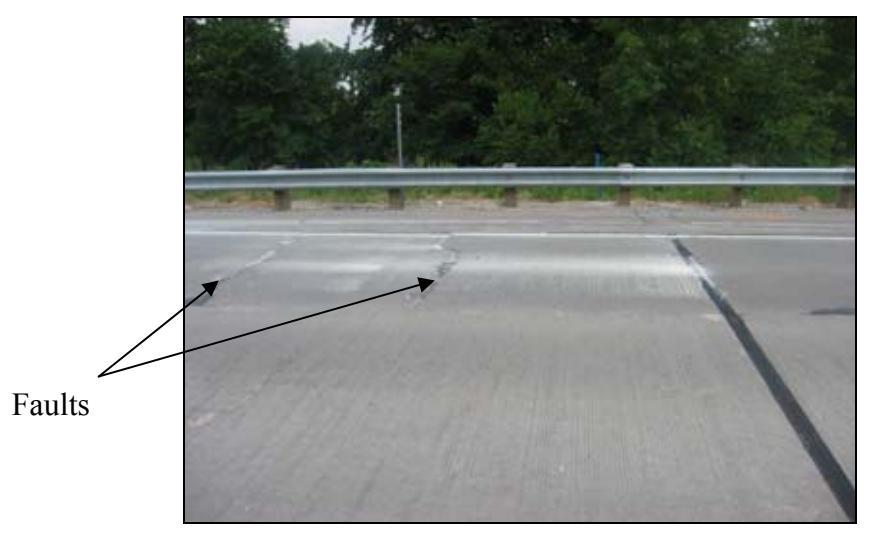
Figure 129. Faulting of approach slab panels

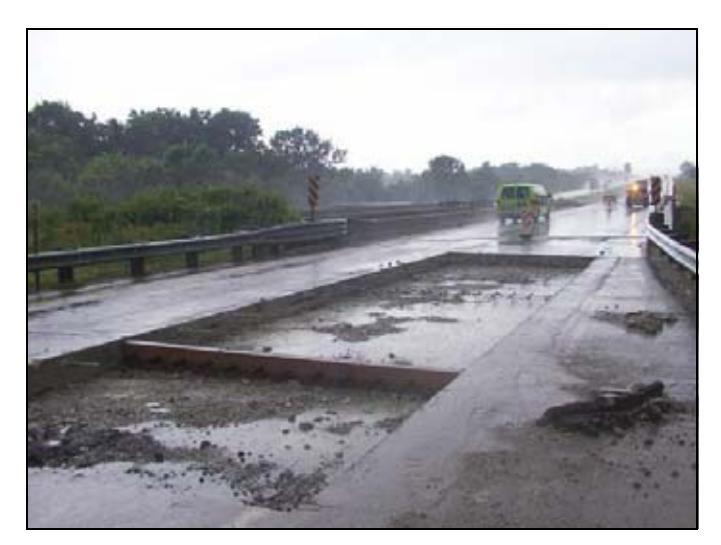
Figure 130. Bridge approach panel removed for replacement

Due to the significant damage of the approach slab, the approach slab panels were replaced in July 2003. Figure 130 shows the exposed subgrade after removing the old pavement. Two sections at both ends of the westbound lane were replaced. These sections were at the right lane starting 15 feet away from the bridge and extended over 40 feet. After removal, it rained and saturated the underlying subgrade. A subgrade sample was obtained from the exposed subgrade and was classified as well-graded gravel (GW) (see Appendix B for detailed results).

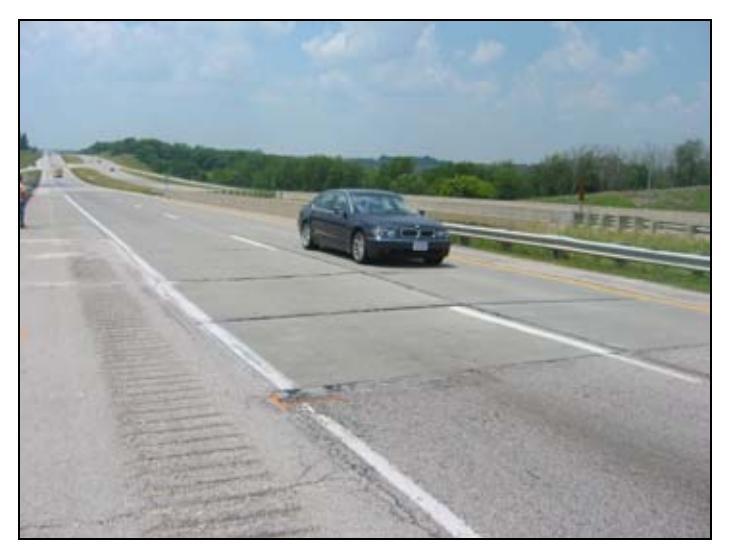
This is a three-span concrete bridge with non-integral abutments. Settlement and damage of the approach slab and damage of the expansion joint were observed (Figure 131). The embankment under the bridge has concrete slope protection. In addition, the end of drain outlet was blocked with soil.

Figure 131. Damage of the approach slab section

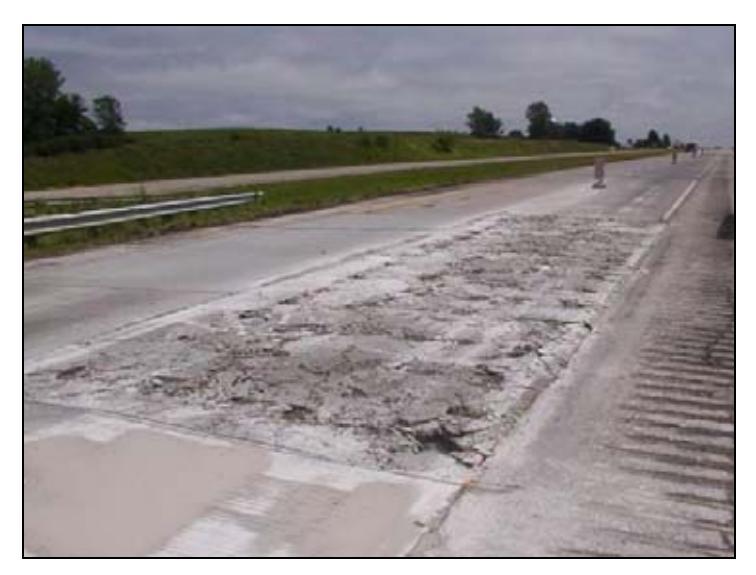
Figure 132. Approach pavement broken before replacement

The approach slab of this bridge was replaced in summer 2003. This section, which is on the right lane at the east end of the eastbound lane, was 30 feet long and approximately 15 feet away from the bridge. Figure 132 shows the broken approach slab pavement before removal and replacement. Figure 133 shows the approach slab section being replaced after removing the old pavement. A sample of the base material was tested in the laboratory and classified as well-graded gravel (GW) according to the Unified Classification System (See Appendix B for results).

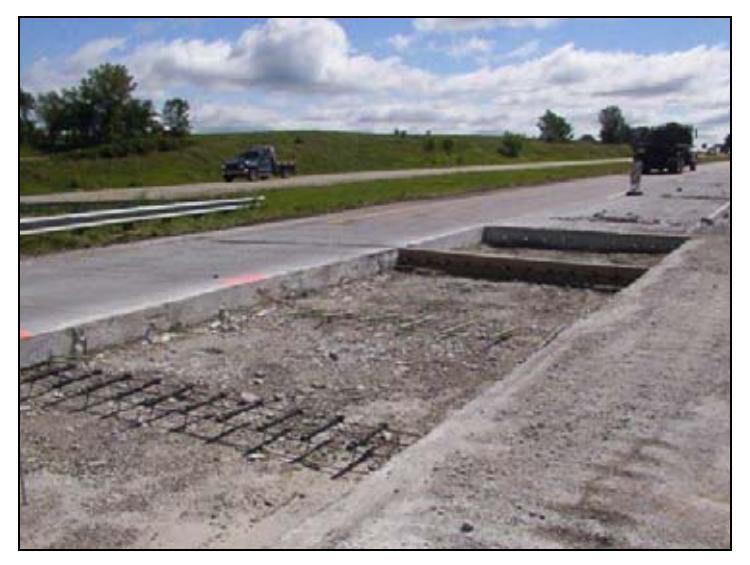
Figure 133. Replacing the bridge approach slab section

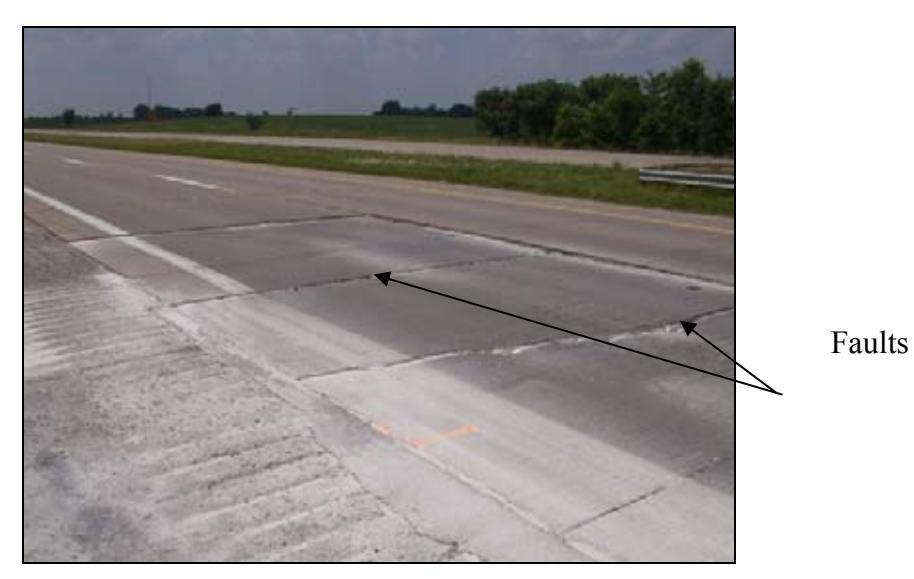
This bridge has four spans with non-integral abutments. The expansion joint was not properly sealed and cracks around the joint were observed at both the east and westbound lanes (Figure 134). Faulting of the approach slab was noticed at the west end of the eastbound lane, as shown in Figure 135, and replaced in summer 2003 (Figure 136). The embankments of the bridge had an aggregate slope protection cover.

Figure 135. Faulting of bridge approach concrete panels (West end of EBL)

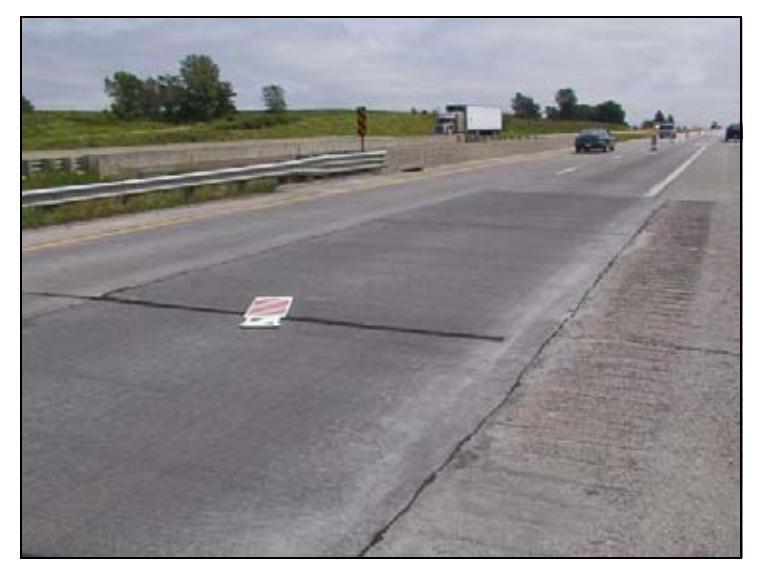
Figure 136. Replaced bridge approach slab

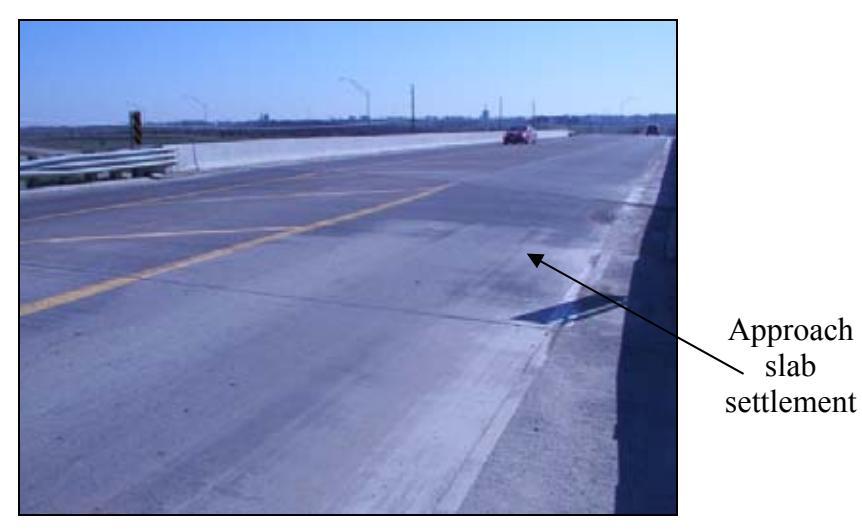
At the west end, differential settlement of 3 inches was observed between the approach slab and wingwall (Figures 137 and 138). The width of the expansion joint at the west end was 5.5 inches. Part of the joint filler material was missing (Figure 139), allowing water to flow behind the bridge abutment, which contributed to increasing soil erosion. As a result, a void developed under the approach slab was 11 inches deep at the abutment and extended to 6 feet away from the abutment (Figure 140). The end drain at the west end was observed to be in good working condition.

Figure 137. Settlement of approach slab

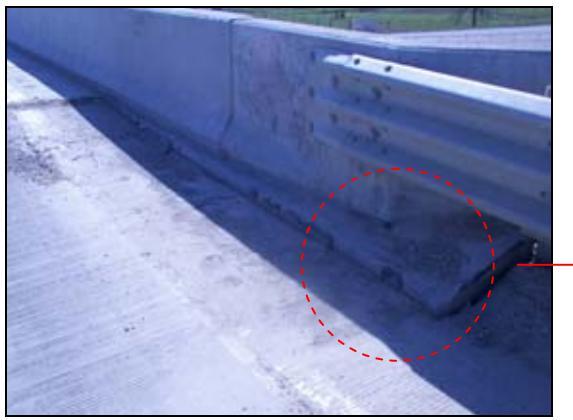
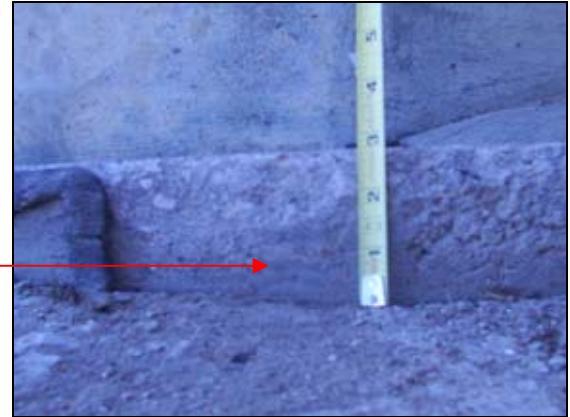
(a) Settlement of approach slab (

(b) Closer image of approach settlement

Figure 138. Settlement of approach slab relative to wingwall

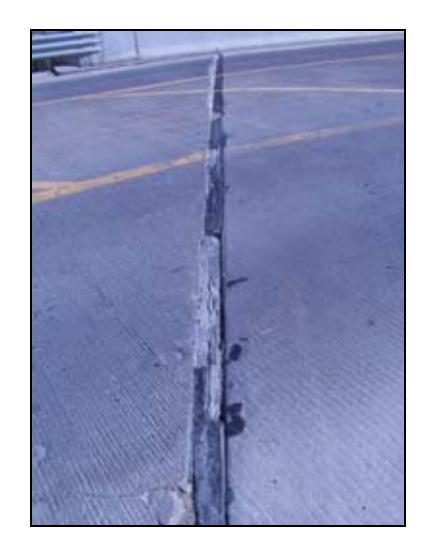
Figure 139. Deteriorated expansion joint filler

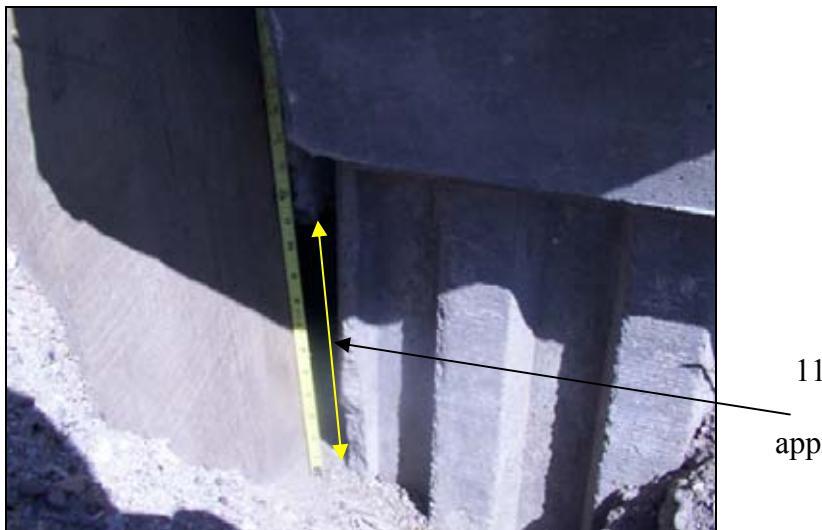
11 in. void under approach slab

Figure 140. Void developed under the approach slab

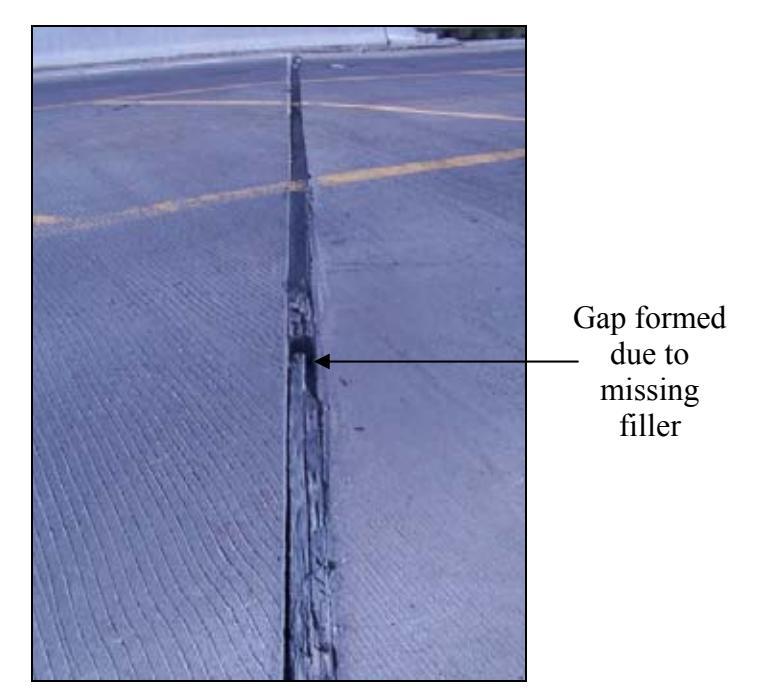
At the east end, differential settlement of about 1 inch between the approach slab and the bridge deck was measured (Figure 141). The expansion joint width was 5 inches. The sealer used to keep the joint filler in place deteriorated shortly after construction, and the forks used to hold the joint material in place were not found. As a result, the joint filler was missing leaving a large gap (Figure 142) allowing water to erode the backfill material under the approach slab. The void developed under the approach slab was about 4 inches deep (Figure 143). Another indication of poor water management was the observed erosion at the sides of the abutment (See Figure 144). Furthermore, concrete spalling was observed at the expansion joint.

Figure 142. Missing and deteriorated filler material at the expansion joint (East end)

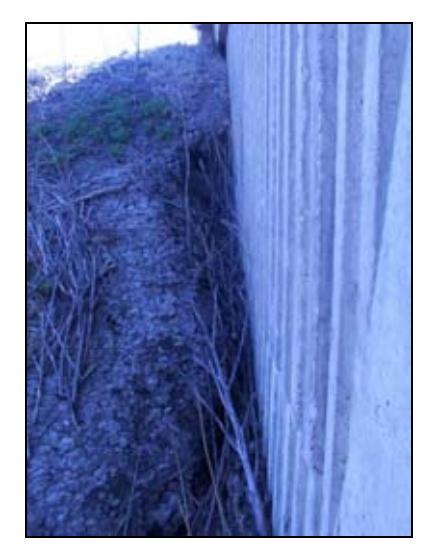
Figure 144. Erosion around the abutment (East end)

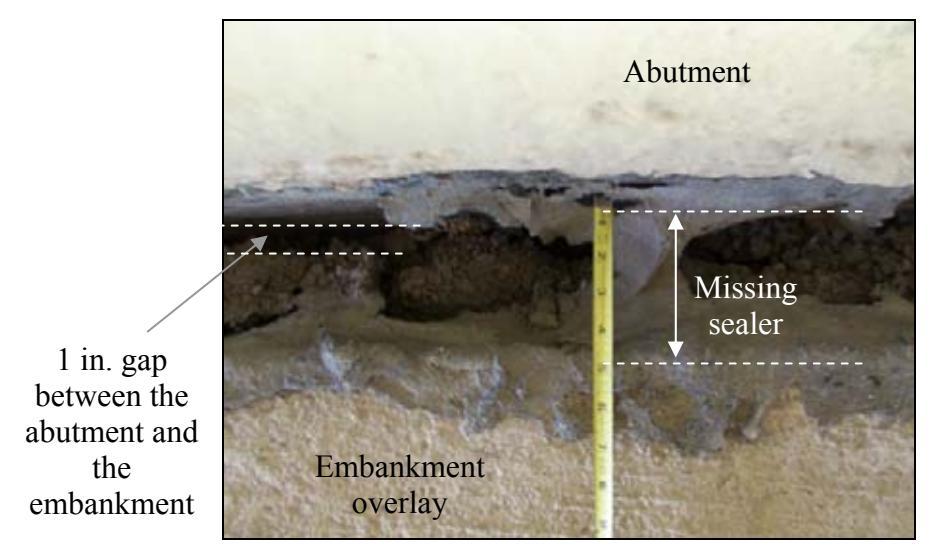
Figure 146. Lateral movement of the abutment (Top view)

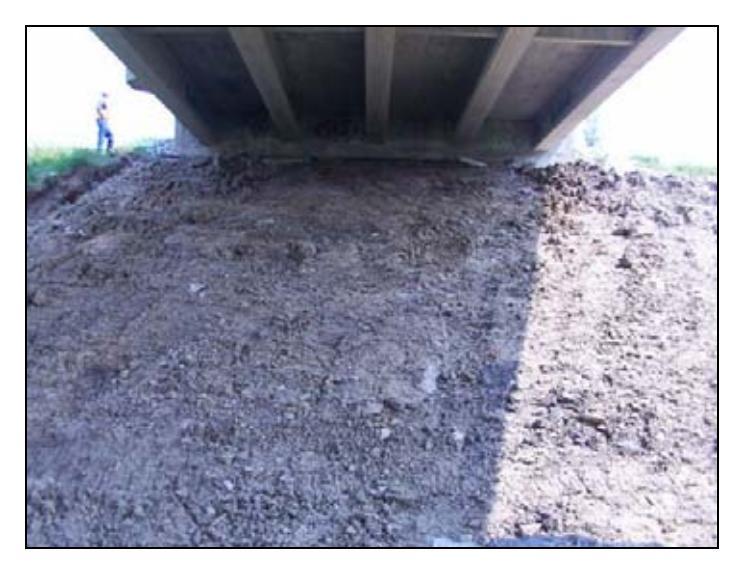
Figure 147. Bridge embankment prior to placing the new overlay

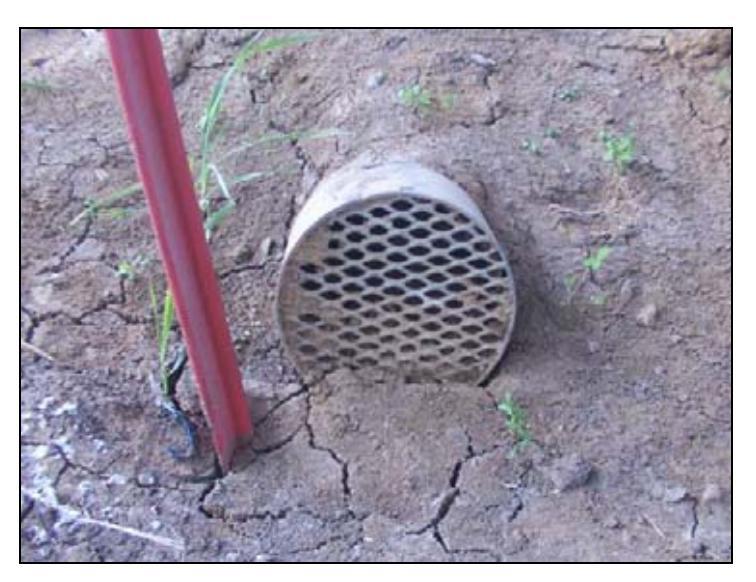
Figure 149. Perforated drain tile filled with soil (South end of SBL)

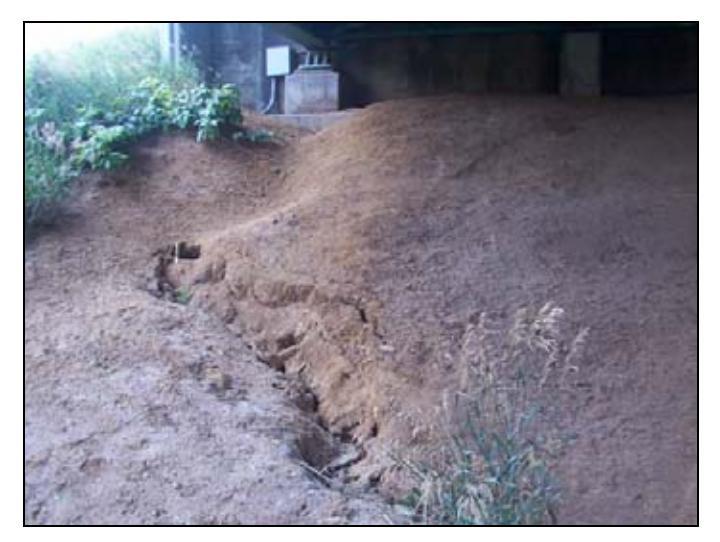
This is a five-span bridge with concrete girders at the south bound and steel girders at the north bound. The bridge has non-integral abutments. Glacial till soil was used to build the embankment with no slope protection under the bridge. At the south end of the south bound bridge, the approach slab was not yet constructed at the time of inspection. It was observed that the strip seal at the expansion joint was cut short which would allow water to flow downward to the embankment under the bridge (Figure 148). Perforated drain tile were used during embankment construction to allow for faster consolidation of the foundation soil. These drains were observed filled with soil (Figure 149). At the north end of the north bound, erosion of the embankment under the bridge was observed (Figure 150).

Figure 150. Erosion of the embankment under the bridge (North end of NBL)

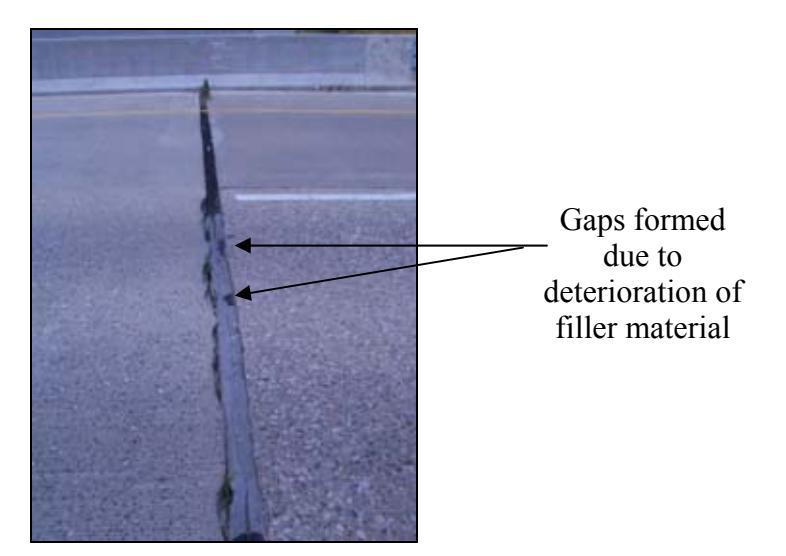
This is a two-span bridge with steel girders and integral abutments. Aggregate was used as slope protection for the embankment under the bridge. At the north end of the northbound bridge, a void under the approach slab that ranged from 3 to 8 inches developed and may have contributed to approach slab faulting. The void was grouted and the approach slab panels were replaced. After replacement, the expansion joint was 3 inches wide and flexible foam was used as joint filler. The joint was poorly sealed, as shown in Figure 151, and concrete spalling was still noticeable. No surface drain on the bridge was constructed; however, water was directed away from the bridge by sloping the shoulders away from the bridge. This lead to erosion along the sides of the abutment. At the south end of the northbound bridge, differential settlement of 3 inches was measured. A 4-inch void developed under the approach that was grouted (Figure 152). Erosion at the sides of the abutment was also noted.

Figure 151. Deteriorated flexible foam which was used as joint filler (North end of NBL)

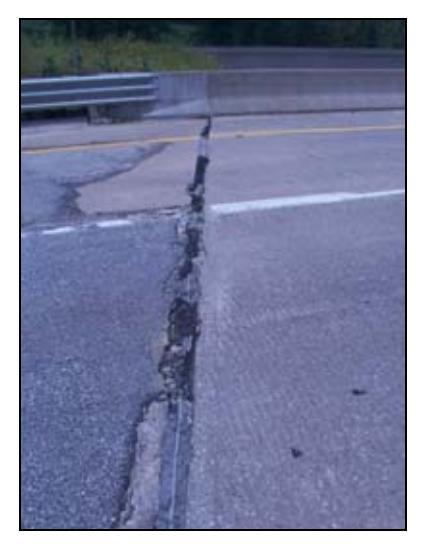
This is a three-span bridge with concrete girders and integral abutments. The bridge approach was resurfaced with an asphalt overlay at the west end of the west bound bridge, which was significantly deteriorated and cracked, as shown in Figures 153 and 154. The width of the expansion joint was 4 inches and consisted of flexible foam. Differential settlement between the approach slab and the bridge deck of 1 inch was measured. Grout was pumped under the approach slab due to void development. Glacial till was used as embankment material with no slope protection. Erosion between the embankment and abutment backwall was noticeable (See Figure 155). The subdrain outlet was blocked with soil (Figure 156).

Figure 153. Poor performing resurfaced bridge approach (West end of WBL)

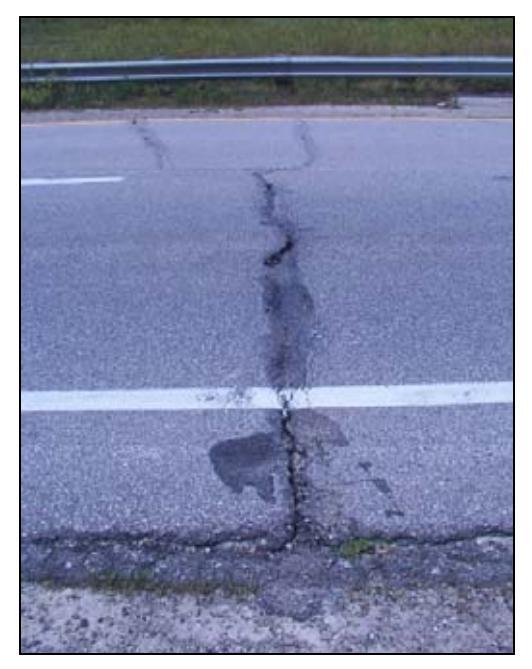
Figure 154. Transverse cracking of asphalt overlay (West end of WBL)

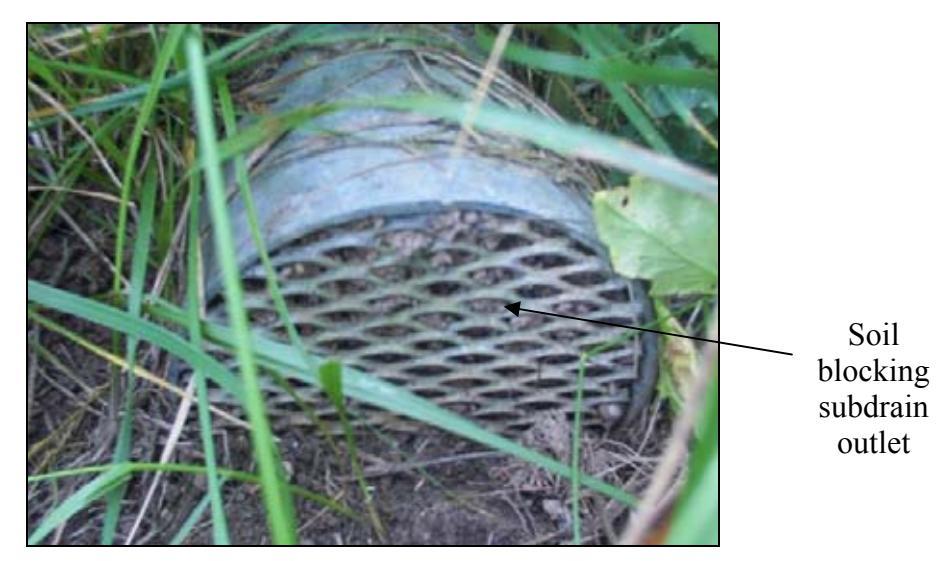
Figure 156. Subdrain outlet blocked with soil (West end of WBL)

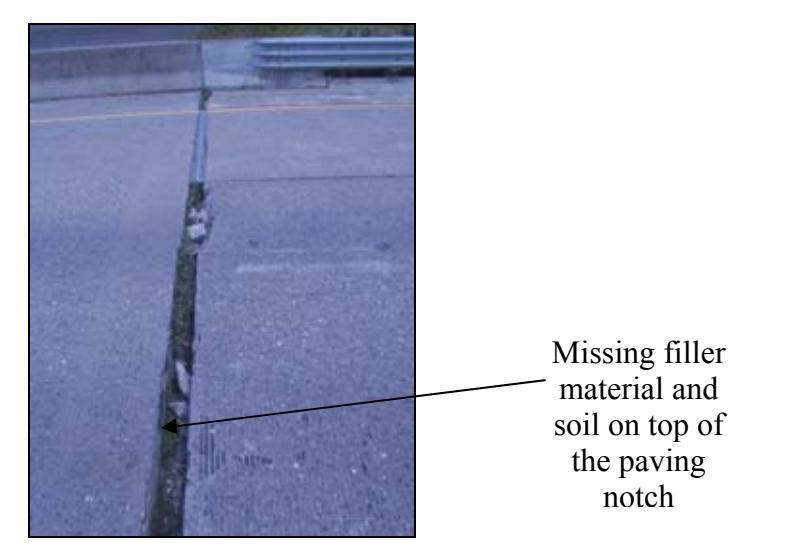
This is a three-span bridge with integral abutments. At the east end of the bridge, differential settlement between the approach slab and the wingwall of 1 inch was measured. The width of the expansion joint was 4.5 inches. Parts of the flexible foam joint filler completely came out exposing the paving notch (Figure 157), which was covered with about 3 inches of soil debris. Grout was pumped under the approach slab to fill a void developed behind the abutment. Furthermore, erosion between the embankment under the bridge and the backwall was observed (Figure 158a) where rip-rap was used to control erosion (Figure 158b).

Figure 157. Missing filler material exposing the pavement notch (East end of WBL)

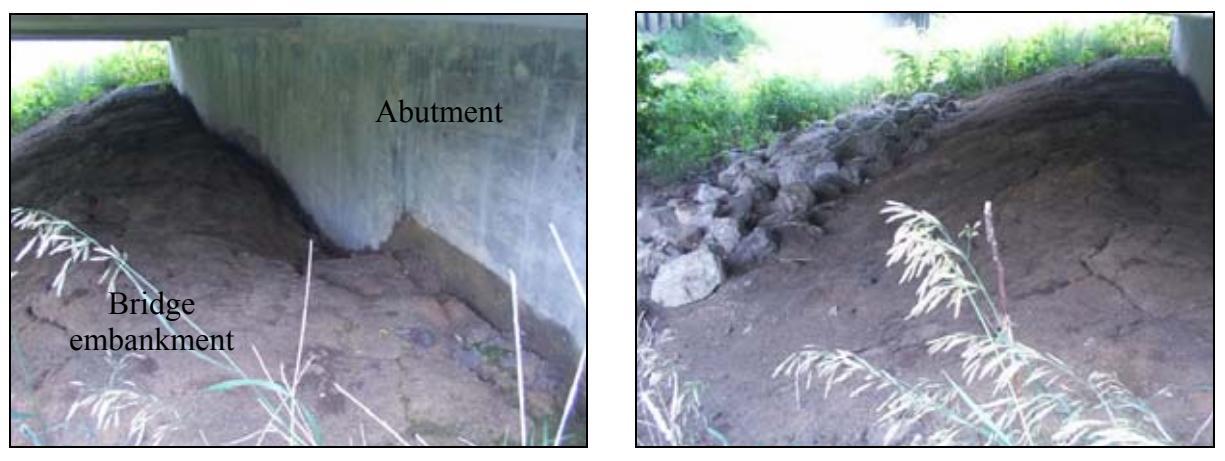
(a) Erosion at the abutment

(b) Rip-rap used to control erosion

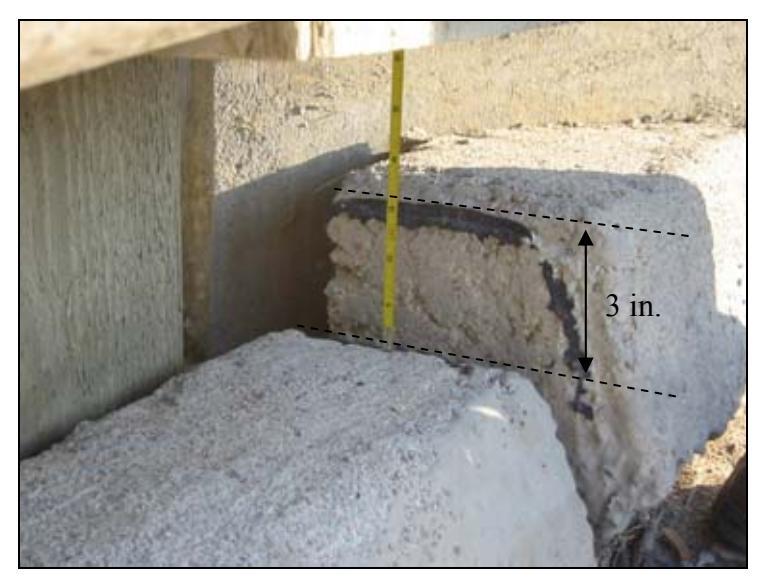
This bridge was constructed in 1992 and has concrete girders with non-integral abutments. Three inches of differential settlement was observed at the bridge approach guardrails (Figures 159). The strip seal was cut short. The embankment under the bridge was built with loess soil with no slope protection (Figure 160). Water appeared to be flowing through the expansion joint to the embankment under the bridge. To fill the void developed behind the abutment, the bridge was grouted in 2003.

Figure 159. Differential settlement at the bridge approach (South bound)

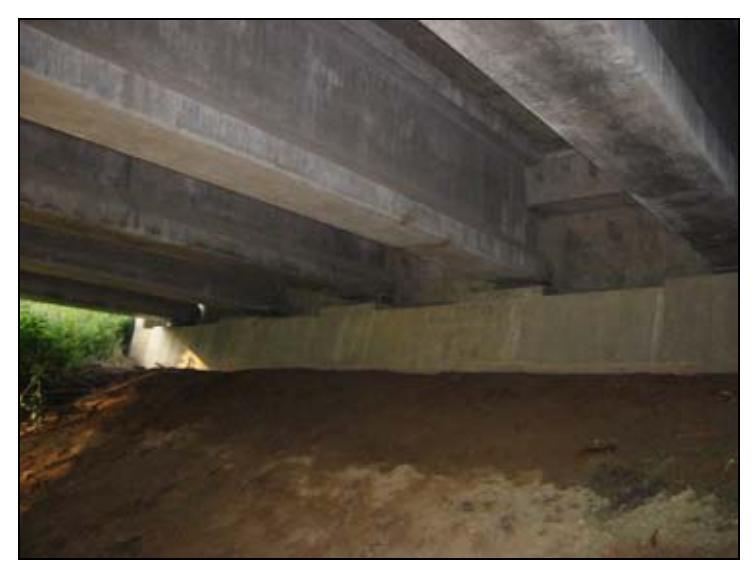
Figure 160. Wet loess soil observed at the embankment under the bridge

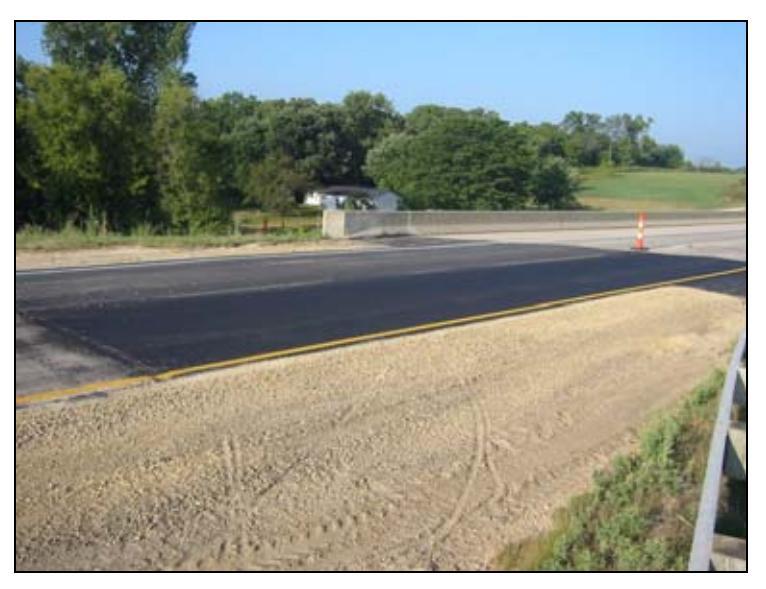
This bridge was constructed in 1992 and has three spans with integral abutments. No slope protection was used under the bridge and wet embankment soil was observed. Erosion along the sides of the abutment was also observed. According to the maintenance reports, a void developed around the abutment and has been grouted twice in the last 10 years. The second grouting was performed in June 2003. The approach slabs were also overlaid with 2 inches of asphalt to alleviate the differential settlement at the bridge approach, as shown in Figure 161.

Figure 161. Approach slab asphalt overlay

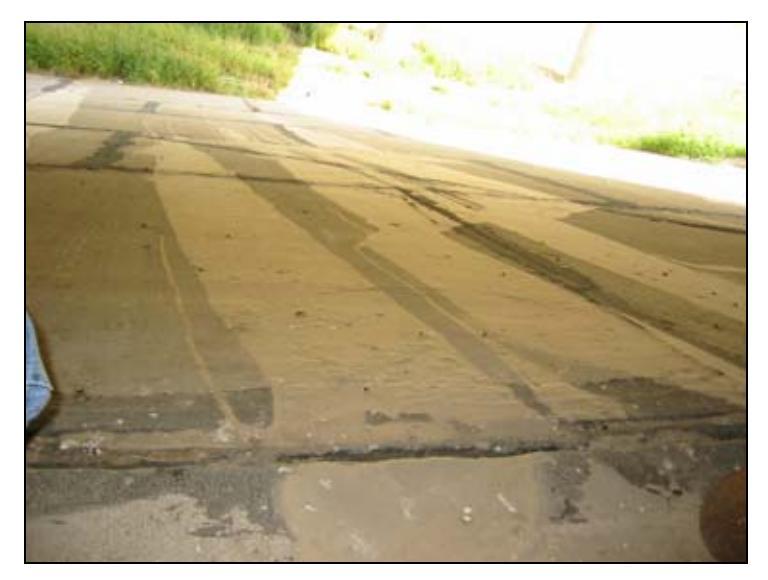
This bridge was constructed in 1983 and has three spans with integral abutments. Although maintenance reports indicate that grouting was performed twice to fill the void developed under all approach slabs (Figures 162 and 163), additional settlement and loss of material lead to a void forming under the approach slab. Noticeable vibration occurred on the approach slab as vehicles passed. The approach slab shoulder was drilled by Iowa DOT personnel during inspection to measure the depth of the void. The three drilled holes indicated a 2-inch gap under the bridge approach. Figure 164 shows that the distance between the approach slab surface and the base material was about 14 inches. The void development may have accounted for about 2 in. differential settlement between the bridge deck and the bridge approach (Figure 165) and significant cracks and faulting of the approach slab (Figure 166). Flexible foam was used as expansion joint filler (Figure 167).

Figure 162. Grout seeping from under the concrete cover

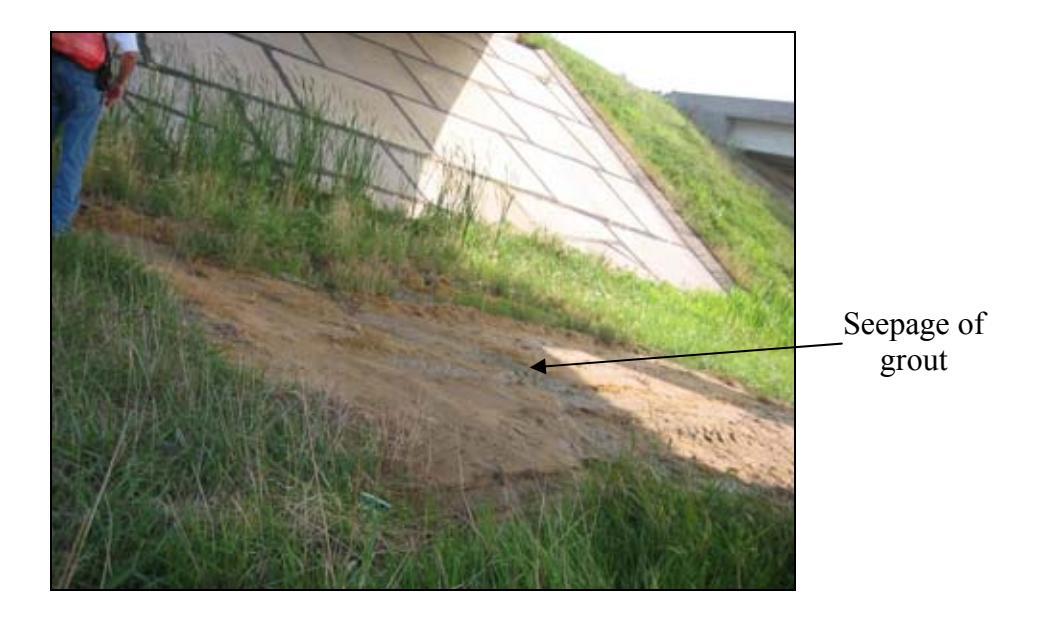
Figure 163. Grout seeping from the bottom of the embankment

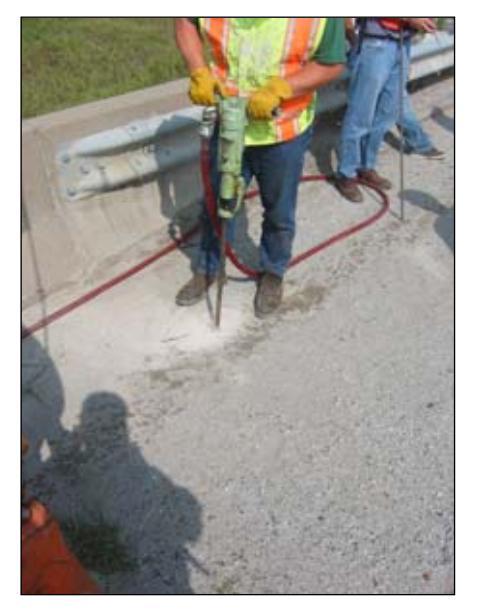
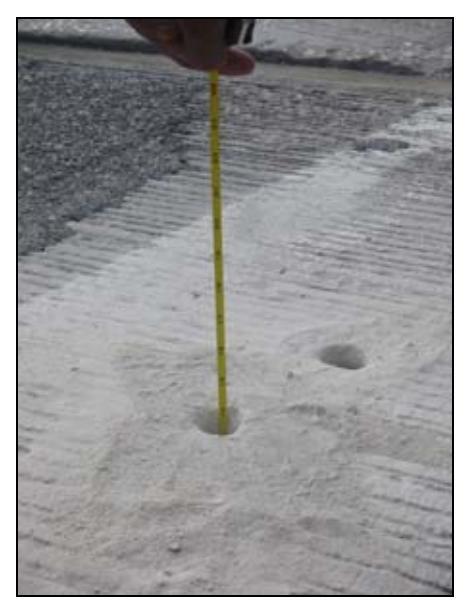
(a) Drilling at the approach slab(b) Measuring the voidFigure 164. Drilling at the approach slab shoulder indicating 2 in. deep void

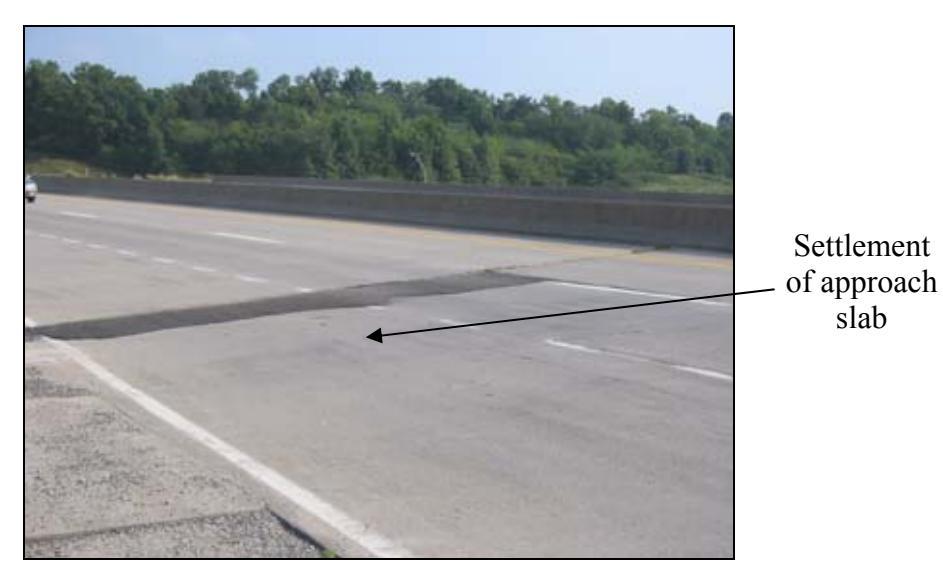
Figure 165. Differential settlement at approach slab

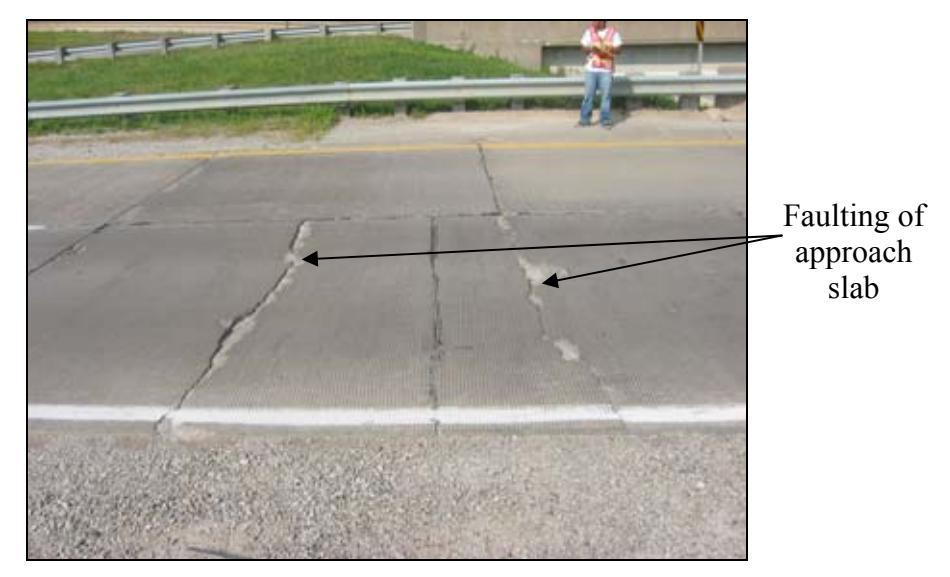
Figure 166. Faulting of approach slab concrete panels
