IDENTIFICATION OF THE BEST PRACTICES FOR DESIGN, CONSTRUCTION, AND REPAIR OF BRIDGE APPROACHES

Iowa DOT Project TR-481 CTRE Project 02-118

Final Report

January 2005

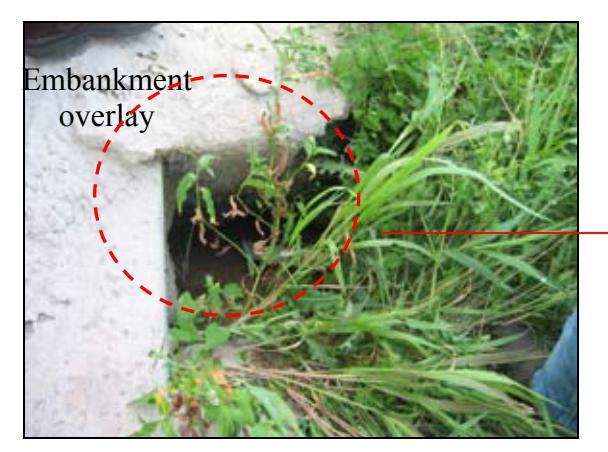
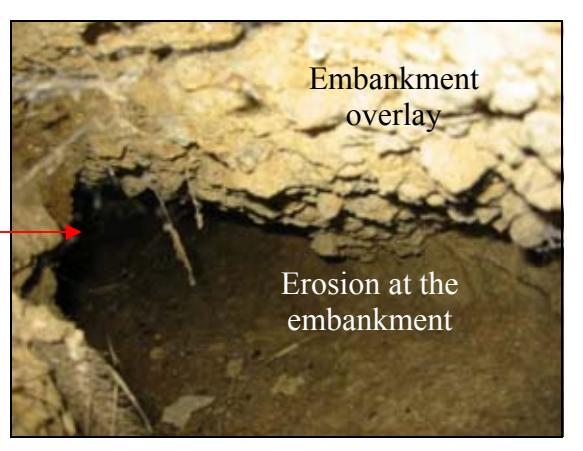
A void under the concrete slope protection (Figure 168) and uneven settlement and cracking of the concrete slope protection panels were observed (Figure 169). Furthermore, the embankment under the bridge settled 4.5 inches relative to the abutment. A 1.5 in. wide by 4.5 ft. deep void was observed on the downslope side of the abutment (Figure 170).

(a) Void under slope protection

(b) Closer image of the developed void

Figure 168. Void created by erosion and settlement after grouting

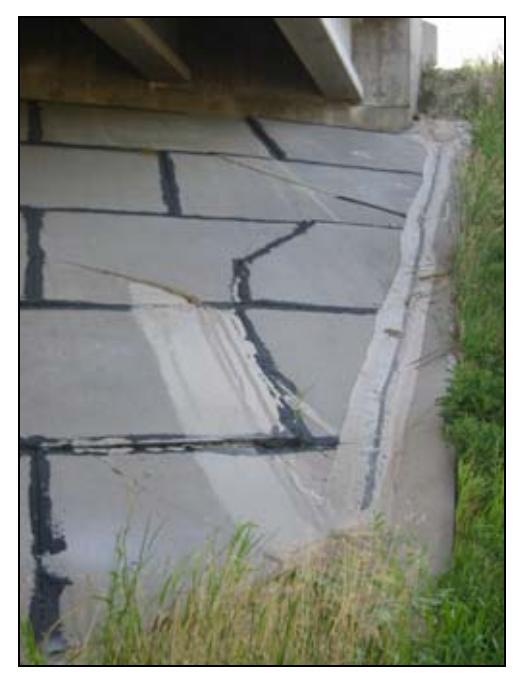
Figure 169. Cracking of the concrete slope protection overlay

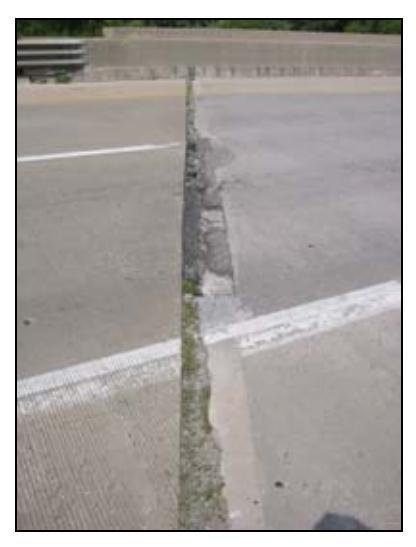
This bridge was constructed in 1971 and has three spans with integral abutments. Cracks and concrete spalling were observed around the expansion joint (Figure 171). Soil erosion and ponding of water were noted on the embankment under the bridge (Figures 172 and 173). Aggregate and an erosion blanket were used for slope stabilization, as shown in Figure 174. According to the maintenance records for this bridge, the near end of the right lane of the bridge approach was grouted using 5 cubic yards of flowable mortar in fall 2002.

Figure 171. Concrete spalling and cracking at the expansion joint

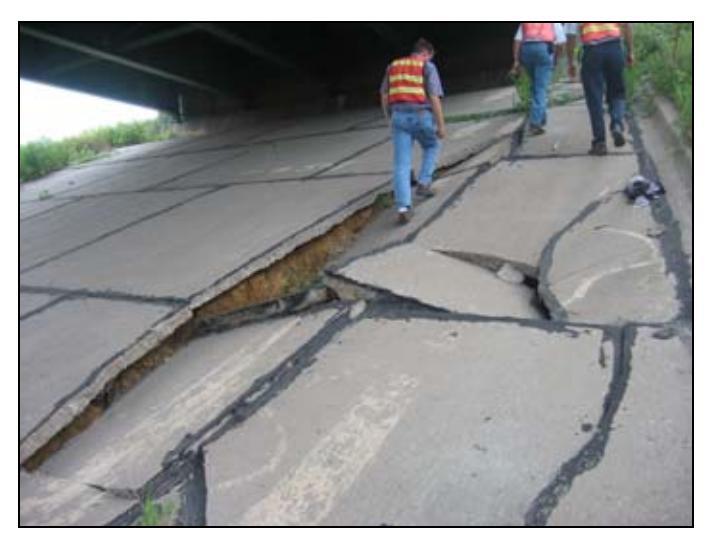
This bridge was constructed in 1970 and has three spans with steel girders and non-integral abutments. The concrete slope protection of the embankments at both ends of the bridge was significantly damaged, as shown in Figure 175, due to erosion. Furthermore, the embankment under the bridge experienced about 5 inches of settlement relative to the abutment. A 2 inches wide gap was measured between the abutment and embankment. No differential settlement was observed between the bridge slab and the bridge approach, and the expansion joints were in a satisfactory condition. Maintenance report for this bridge indicated that flowable mortar was used to fill a void developed at the far end of the left lane in fall 2002. Flowable fill was used again in July 2003 to fill an additional void developed at the same approach slab.

Figure 175. Severe damage of concrete slope protection due to erosion

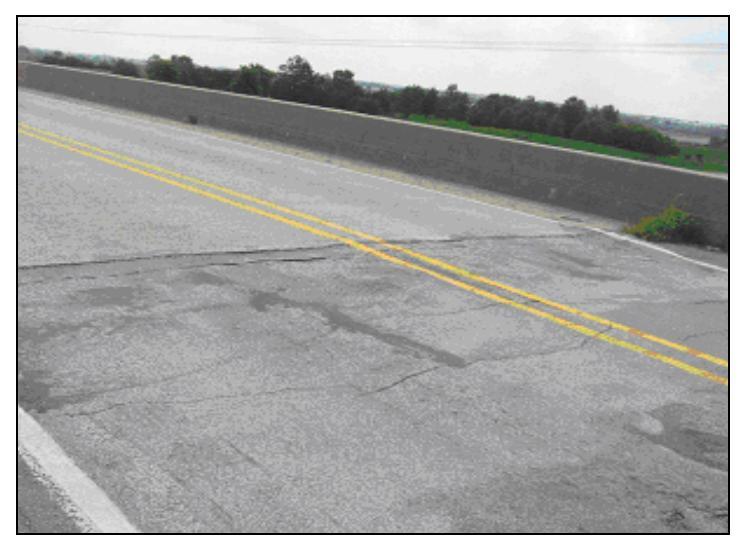
This bridge was constructed in 1972 and has four spans with integral abutments. Figure 176 shows the observed transverse and map cracks at the approach slab. The bridge approach slab had been grouted and overlaid. The asphalt overlay was deteriorated, as shown in Figure 177. Differential settlement between the approach slab and wingwall of about 3 inches was measured. Severe cracking near the expansion joint was also observed. A 3-inch wide gap was observed between the abutment and embankment.

Figure 176. Transverse and map cracking at the approach slab

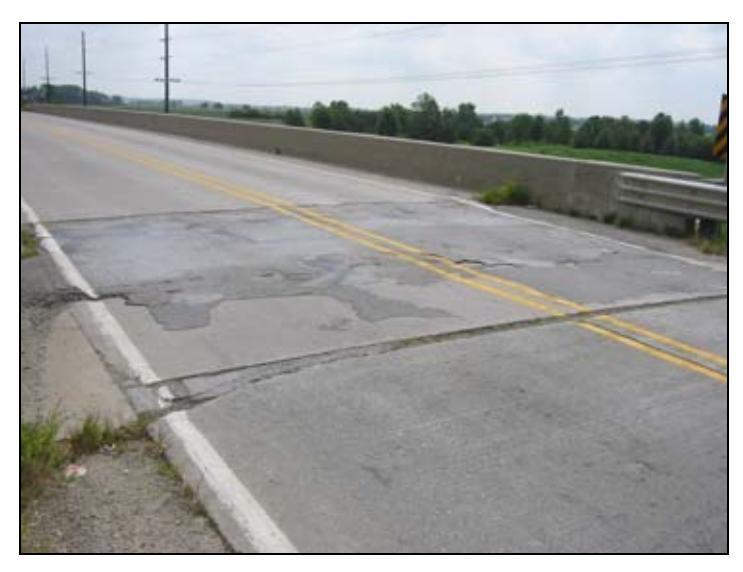
Figure 177. Deterioration of asphalt overlay at bridge approach

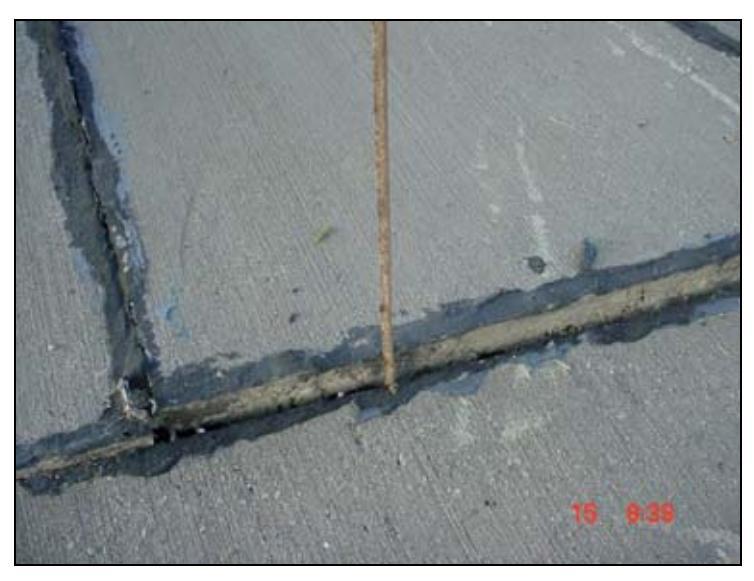
This bridge was not inspected during the field visit; however, some figures and maintenance reports were provided by Iowa DOT. This bridge has four spans with non-integral abutments. Figure 178 shows uneven settlement of the concrete slope protection of the embankment under the bridge. The near end of the right lane of the bridge was grouted in August 2003 to fill the void developed behind the abutment, which exposed the H-piles (Figures 179 to 182).

Figure 178. Uneven concrete slope protection

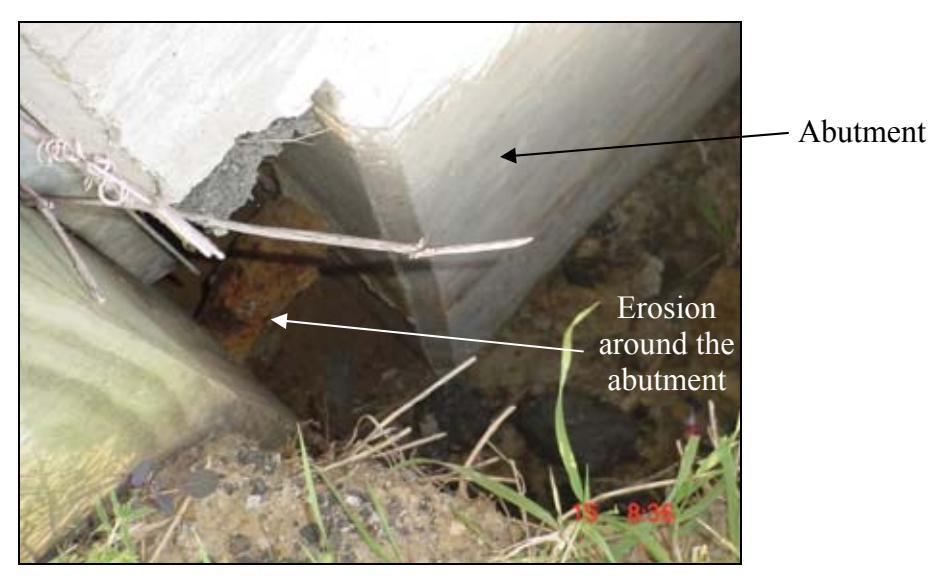
Figure 179. Soil erosion around the abutment

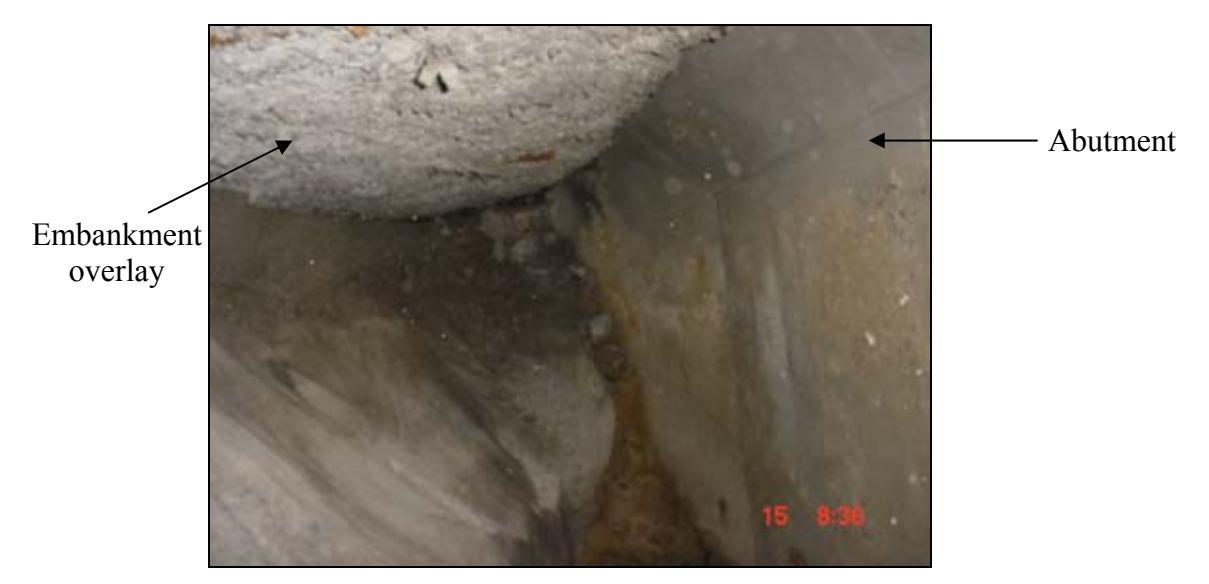
Figure 180. Erosion under the concrete slope protection (Side view)

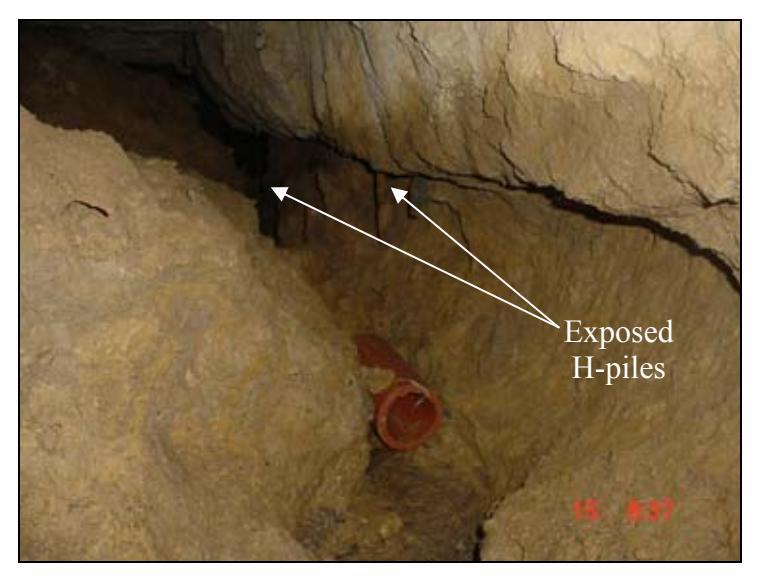
Figure 181. Void created under bridge approach exposing H-piles (Side view)

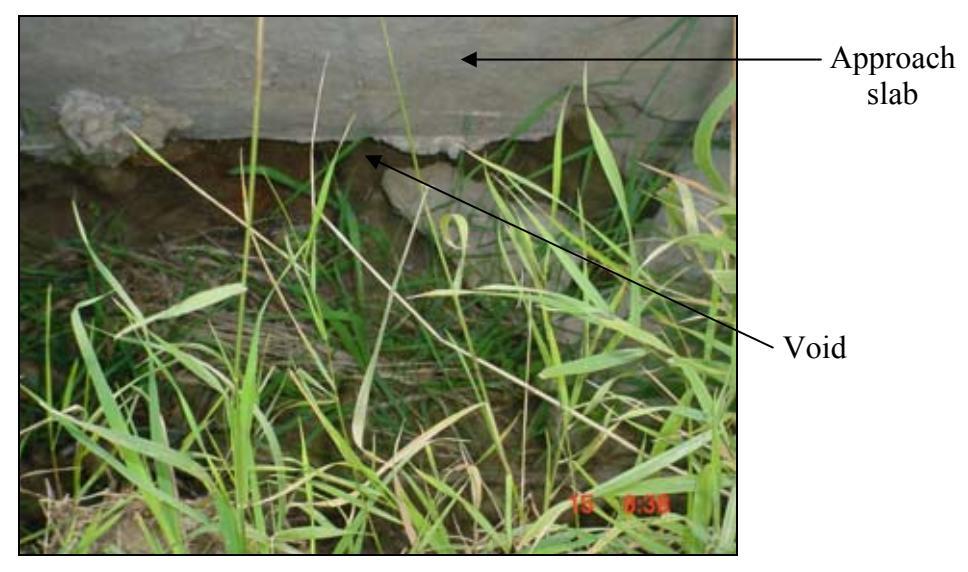
Figure 182. Void developed under the approach slab

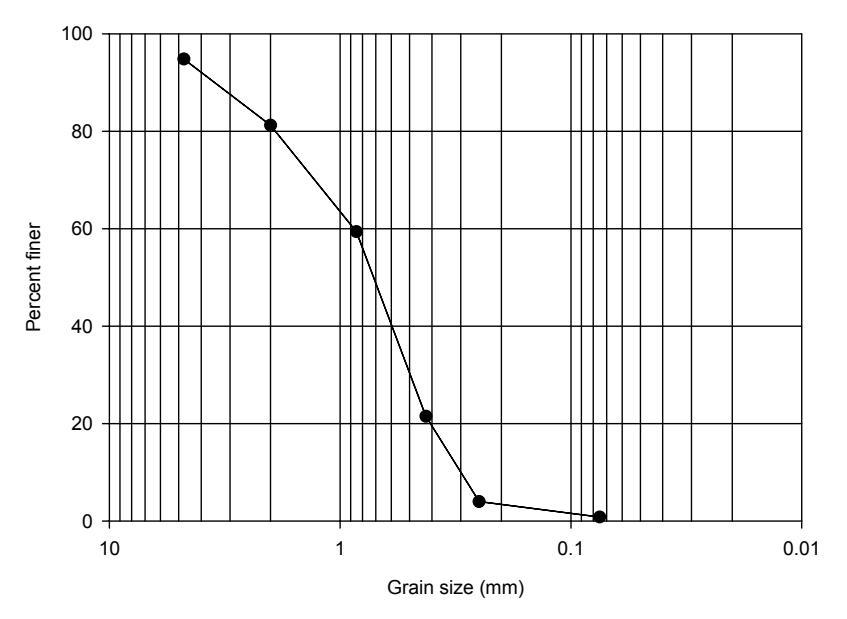
Table 15 summarizes the results of the laboratory tests performed on backfill materials. Figures 189 and 190 show the grain-size distribution of granular and porous backfill materials used at the north and south ends, respectively. According to Unified Soil Classification System (USCS), the granular backfill classifies as poorly graded sand (SP), while the porous backfill classifies as poorly graded gravel (GP). Relative density tests (ASTM D4253-00) were performed on the granular backfill material at several moisture contents to evaluate the minimum and maximum densities, material compactibility, and the bulking moisture content range (Figure 191). For the porous backfill materials, respectively, which indicate relatively high compactibility for the granular backfill and low compactibility for the porous backfill (Hilf 1991). The natural moisture content for the granular and porous backfill materials were 3.9% and 4.2%, respectively. The natural moisture content of the granular backfill was within the bulking moisture content range ($\approx 3\%$ to 7\%) where compaction requirements could not be achieved.

Figure 189. Gradation of granular backfill material used at the north end; classified as SP

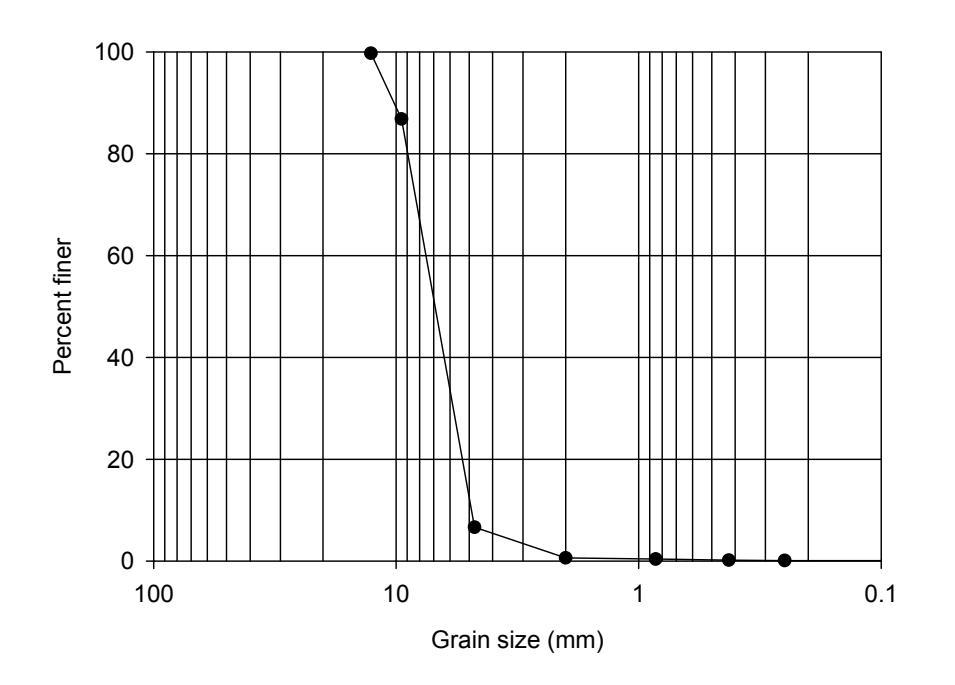
Figure 190. Gradation of porous backfill material used at the south end; classified as GP

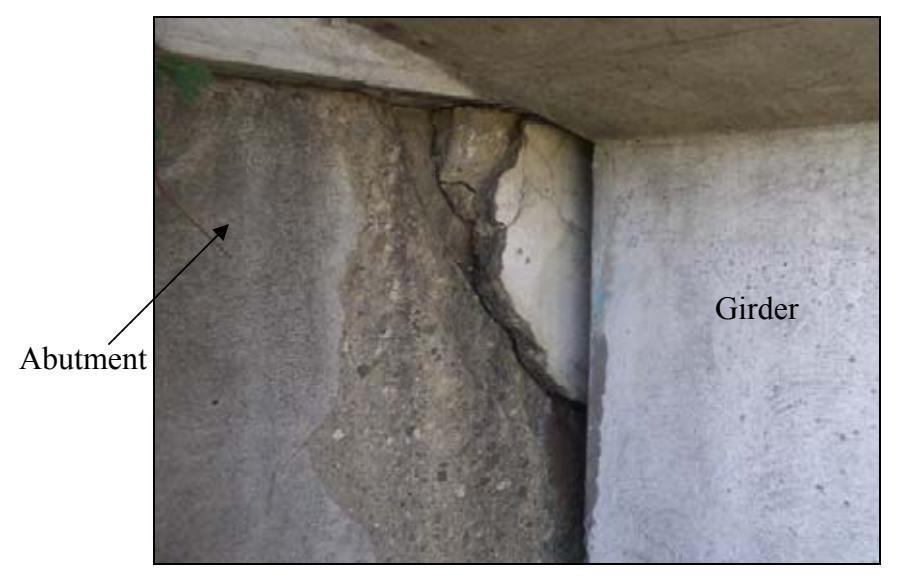
This bridge was inspected four times—twice in June, once in July, and once in October of 2003. At this location, the old bridge was being replaced and widened. The new bridge has concrete girders with integral abutments. During the first inspection, the old bridge at the north bound had been removed and the center pier of the new lane was being constructed (Figures 192 and 193). The old southbound lane bridge was still open for traffic and had non-integral abutments. At the southbound lane, concrete spalling of the abutment was observed (Figure 194). This bridge had a concrete slope protection cover for the embankment under the bridge.

Figure 194. Concrete spalling at the abutment (SBL)

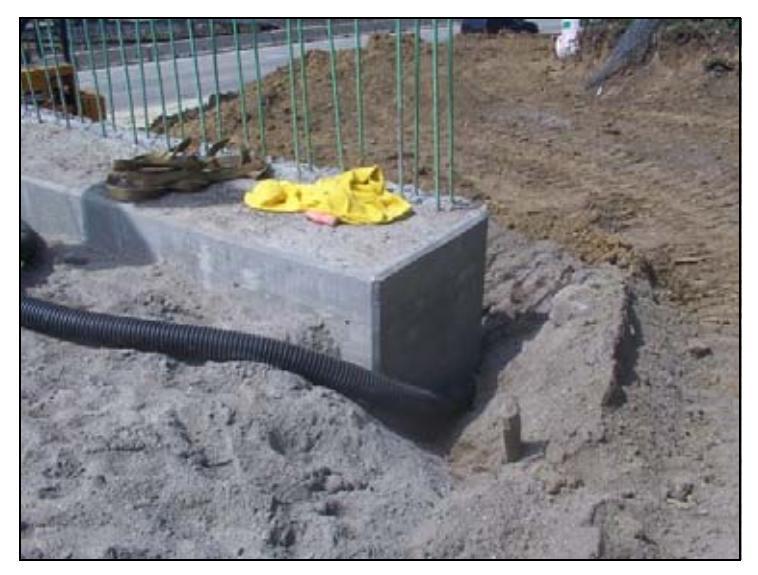
The bridge was inspected again in June 2003. During this field visit, the H-piles were being installed at the north end of the northbound lane, as shown in Figure 195. In July 2003, the bridge was visited again where retaining wall construction was taking place at the south end of the northbound lane (Figure 196). At the north end, the backwall was already constructed. Granular backfill material was used behind the abutment, as shown in Figure 197. No porous backfill was observed around the subdrain (Figure 198). When examined, the perforated drainage pipe was filled with sand particles.

Figure 198. No porous fill surrounding the subdrain (North end NBL)

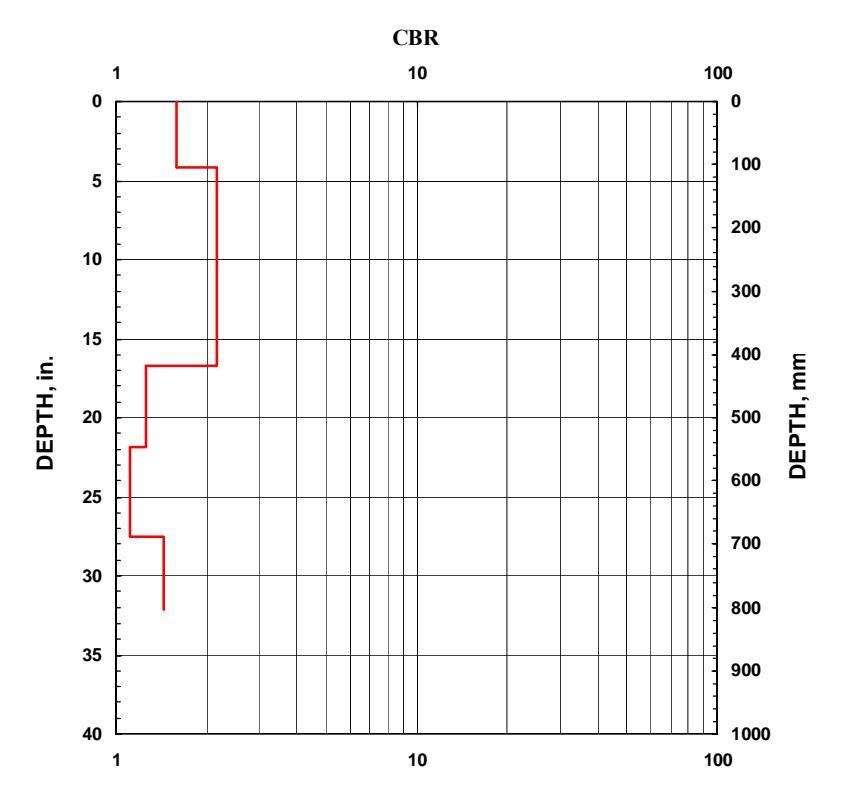
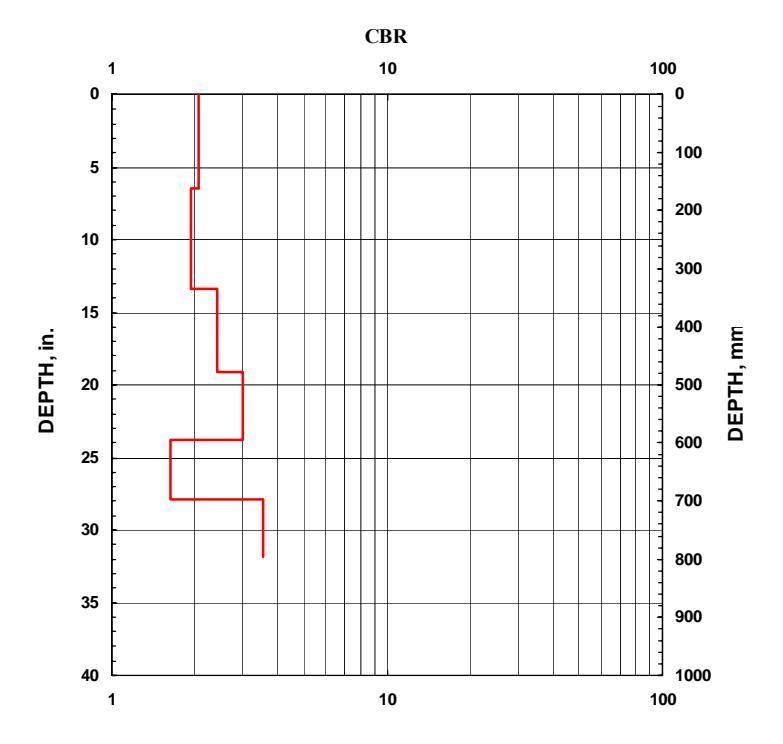
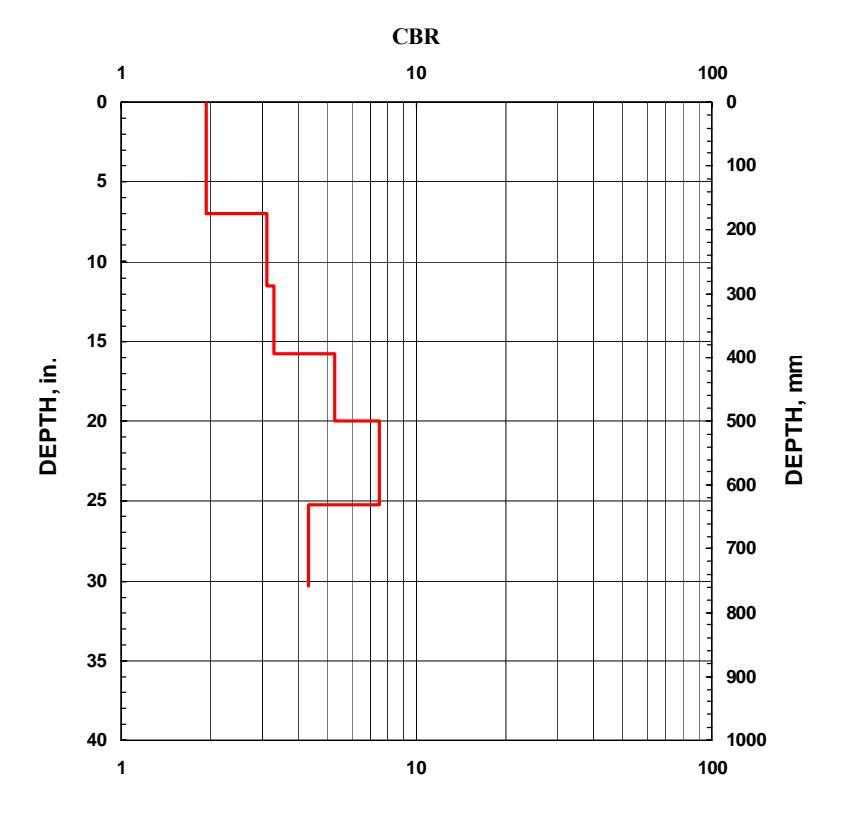
Dynamic Cone Penetration (DCP) tests were performed at three locations behind the backwall at the north end of the north bound. Estimated California Bearing Ratio (CBR) values ranged from 1 to 8 at all test locations (Figures 202 through 205) indicating a soft/loose backfill material. Nuclear gage tests were also conducted at two locations behind the north end backwall. The average measured dry density was 105 pcf and the moisture content was 4.7%.

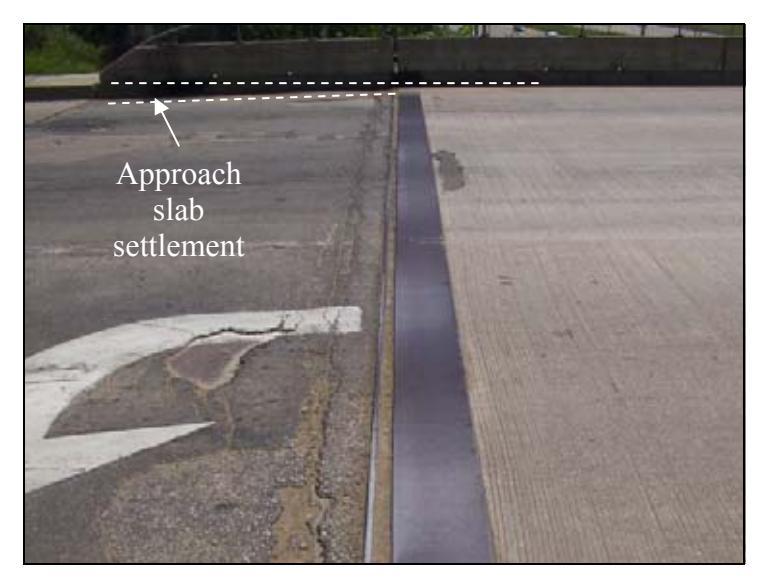
This bridge site was inspected in June 2003. When the bridge was inspected, the old bridge was still open for traffic. This bridge has three spans and concrete slope protection of the embankment. Two inches of differential settlement was observed at both ends of the bridge. Both ends of the bridge have an asphalt approach with visible longitudinal cracks (Figure 208). When the bridge was visited again in October 2003, the girders and the backwall of the southbound lane were constructed (Figure 209). Backfill material samples were collected to perform laboratory tests.

Figure 208. Cracks at asphalt approach with visible differential settlement

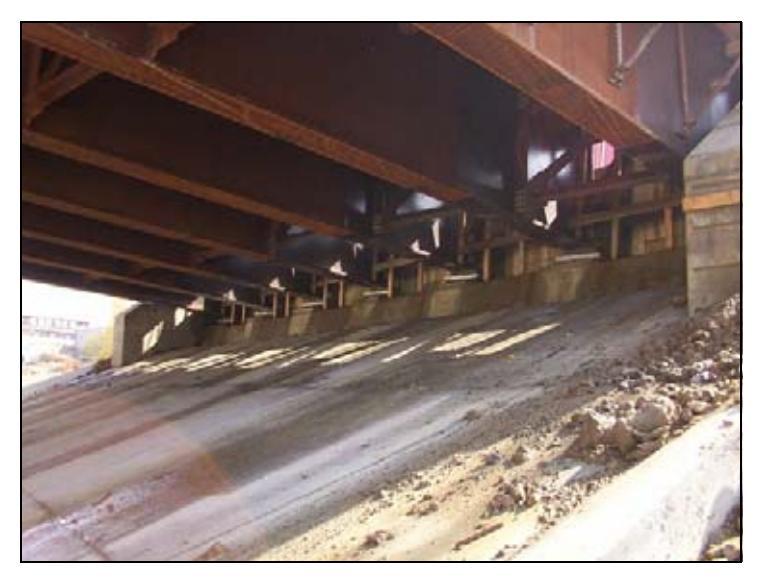
This bridge was inspected in June and October 2003. In June, the center piers were still under construction, as shown in Figure 212. In October, the concrete slope protection for the embankment under the bridge was constructed (Figure 213). No porous backfill was placed around the subdrain. Figure 214 shows the outlet of the subdrain at the bottom of the embankment surrounded by granular backfill. When inspected, the subdrain was filled with soil.

Figure 213. Embankment concrete slope protection

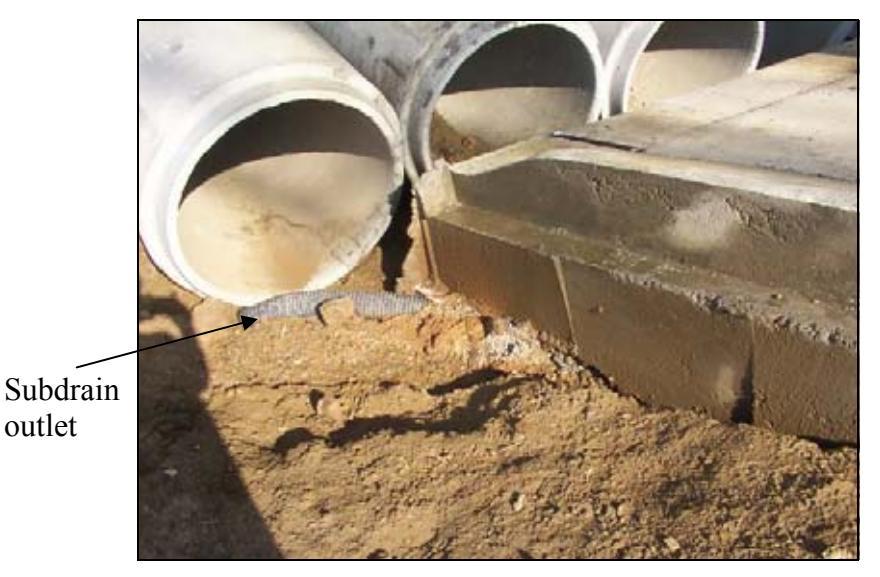
Figure 214. Subdrain outlet at the bottom of the embankment

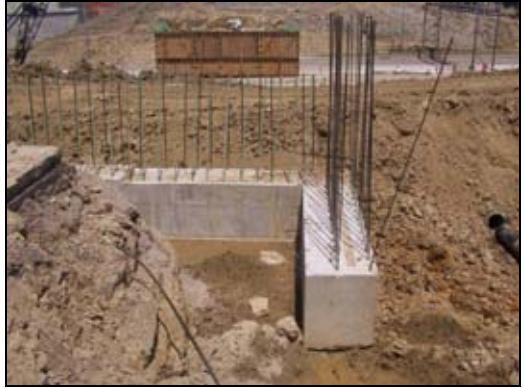
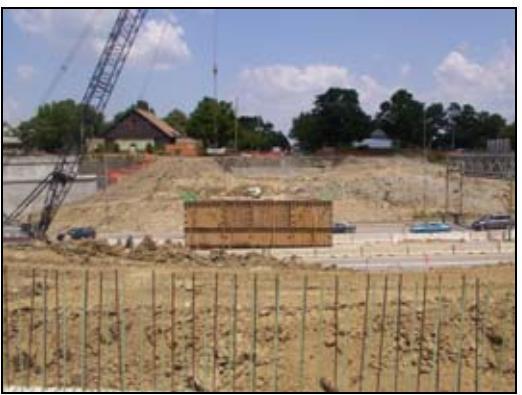
During the first inspection in June 2003, the center pier and the backwall of both ends were under construction (Figure 215). As shown in Figure 215a, the soil near the south end of the northbound abutment appeared to be wet sandy soil. When inspected in October 2003, the construction of the bridge slab was in progress (Figure 216). Figure 217 shows the reinforcement of the abutment which was at 1 ft. spacing. A sample of backfill material was tested in the laboratory to determine the classification and compactibility.

(a) Backwall construction(b) Center pier constructionFigure 215. Construction of backwall and center pier

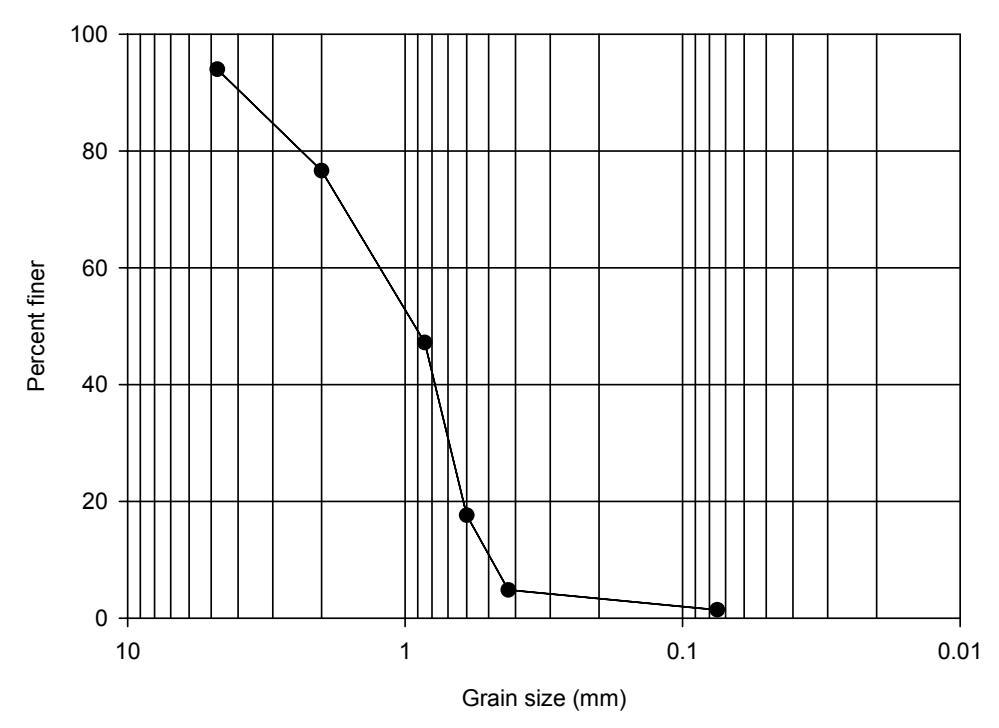
obtained at the backwall of the south bound was classified as SP according to the USCS. Relative density tests resulted in minimum and maximum dry densities of 96 pcf and 125 pcf and the bulking moisture content range of 3% to 5% (Figure 219). Compactibility of 1.227 was calculated indicating good compactibility of the backfill material (see Appendix C for calculations).

Figure 218. Gradation of granular backfill classified as SP

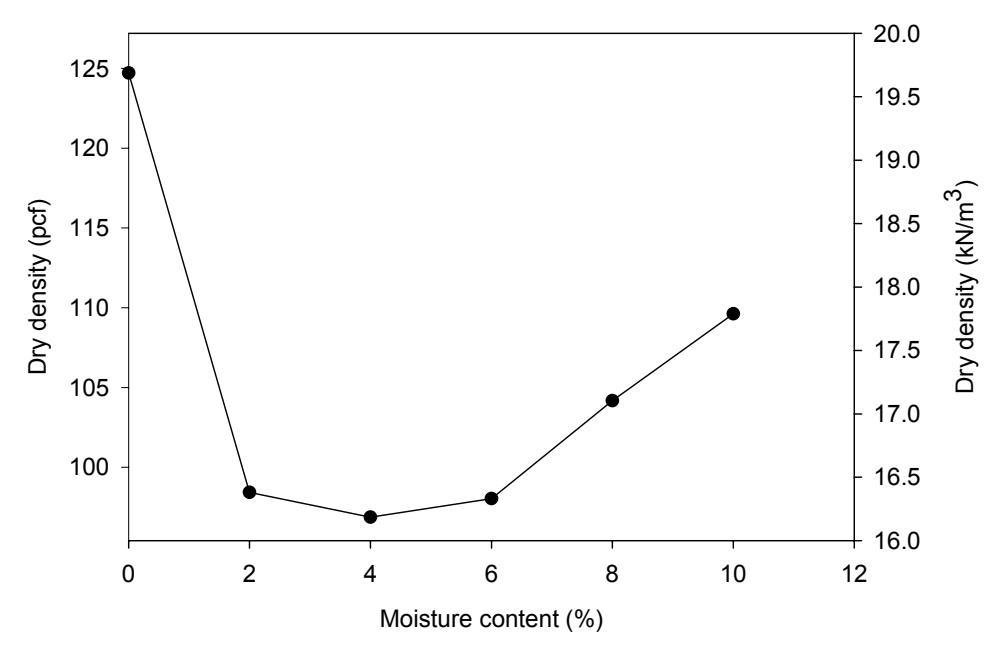
Figure 219. Relative density-moisture relationship for granular backfill. Vibrating table tests (ASTM D4253-00).

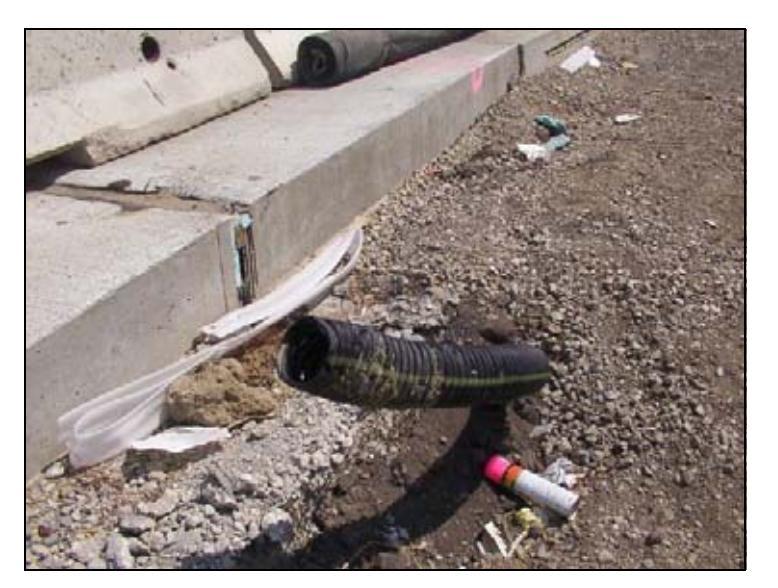
This bridge was also inspected twice in August 2003. During the first inspection, construction of the north bound was completed and construction of the south bound was taking place, as shown in Figure 222. Figure 223 shows the end drain filled with soil. Construction of the backwall was taking place, as shown in Figures 224 and 225. During the second inspection in August 2003, construction of the abutment was still underway. Poor construction of the approach slab at the north bound, which was recently completed and opened for traffic, was observed. When the south bound was removed for replacement, the loose backfill behind the northbound abutment collapsed as a result of removing the sheet piles supporting the backfill creating a void (Figures 226 and 227).

Figure 223. End drain outlet filled with soil

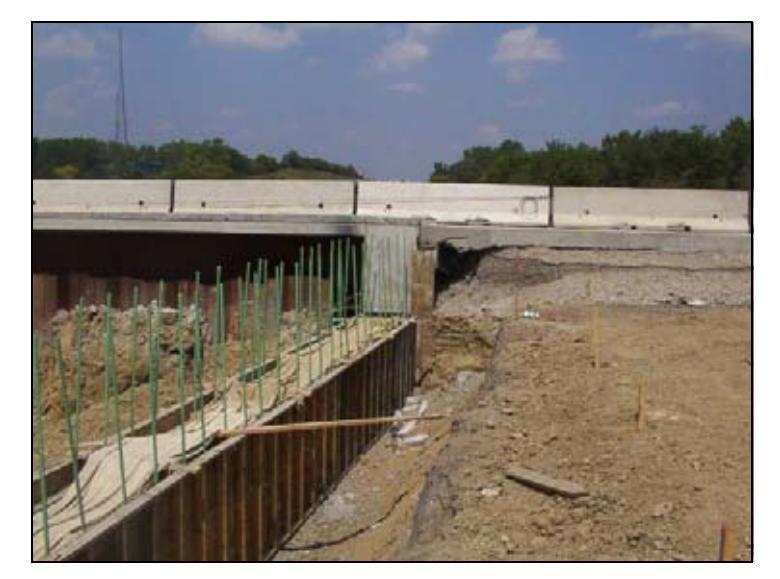
Figure 226. Abutment reinforcement and backfill placed at the northbound approach slab

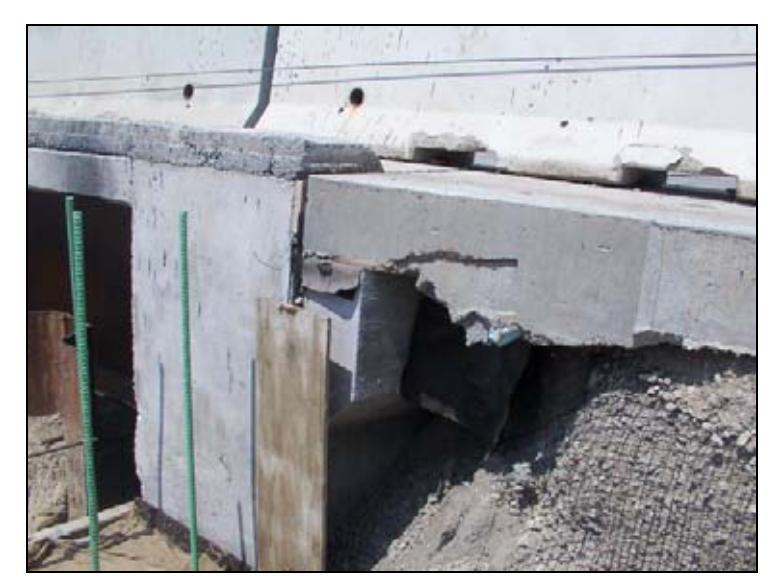
Figure 227. A closer image of the poorly-placed granular backfill (NBL)

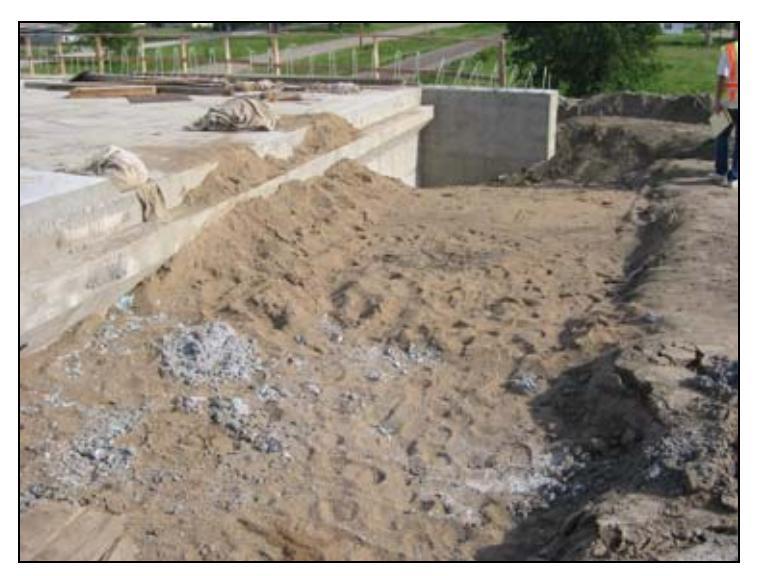
This bridge was constructed with integral abutments and concrete girders. Aggregate was used as slope protection on the embankment under the bridge. The foundation soil of this bridge was allowed to consolidate under the embankment weight for one year prior to construction of the bridge superstructure. Figure 230 shows the granular backfill poorly placed behind the abutment. As shown in Figure 231, no porous backfill was used around the subdrain. Figure 232 illustrates the poor construction of the paving notch with poorly consolidated concrete.

Figure 230. Poorly placed granular backfill

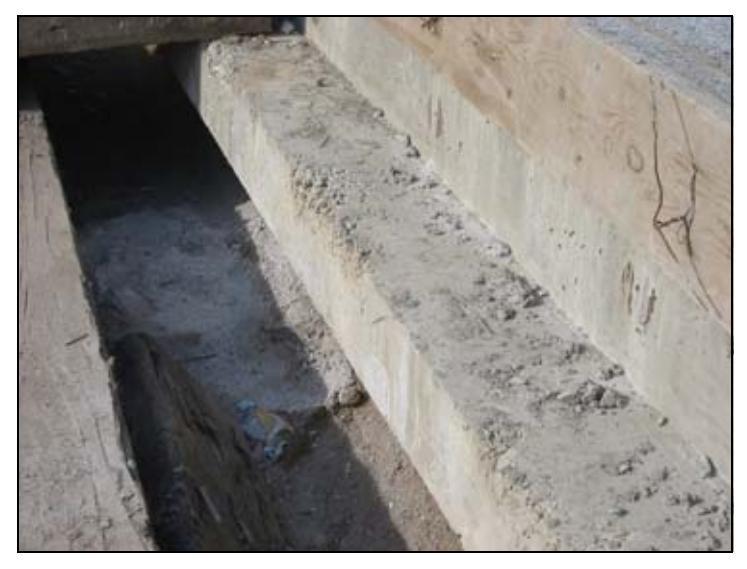
Figure 232. Poor construction of bridge paving notch

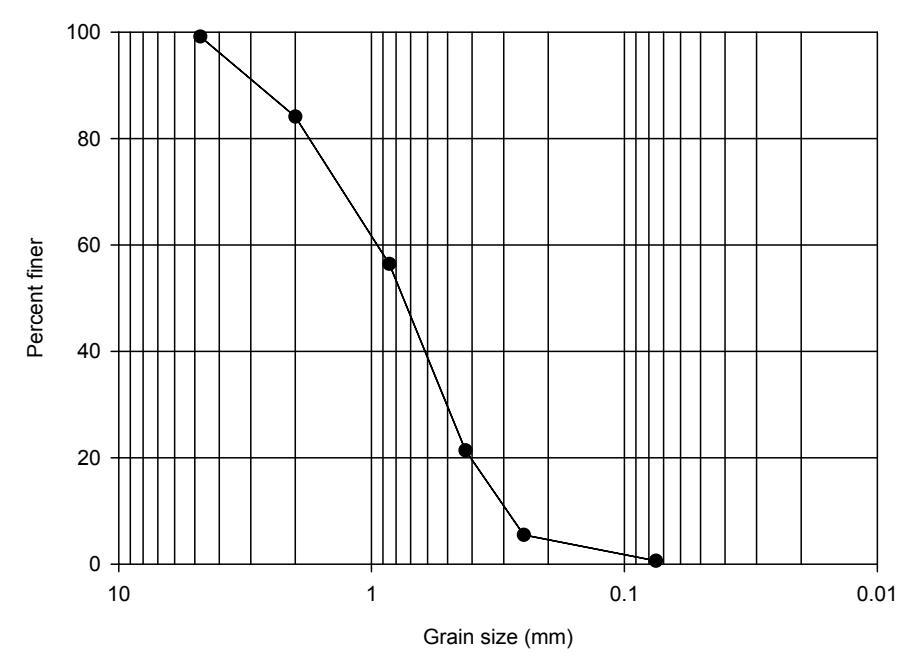
The backfill material sample obtained at the bridge site, which had a moisture content of 4.1%, classifies as SP according to the USCS. Figure 233 shows the grain-size distribution of the granular backfill material. A coefficient of permeability of 0.01 cm/s (see Appendix C for calculations) was measured following constant head permeability tests methods (ASTM D 2434).

Figure 233. Gradation of granular backfill classified as SP

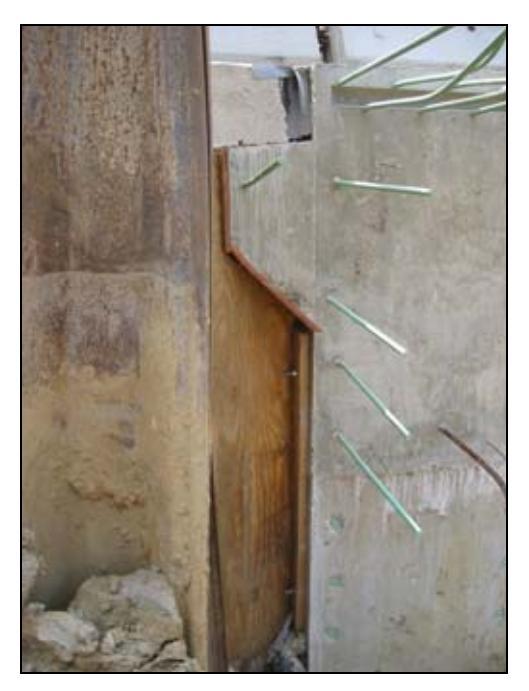
This bridge was still under construction when inspected in August 2003. The paving notch was observed to be declined in the direction of the approach slab (See Figure 234). Figure 235 shows the grain-size distribution of the granular backfill material used at this bridge. The granular backfill classifies as SP according to the USCS.

Figure 234. Declined paving notch

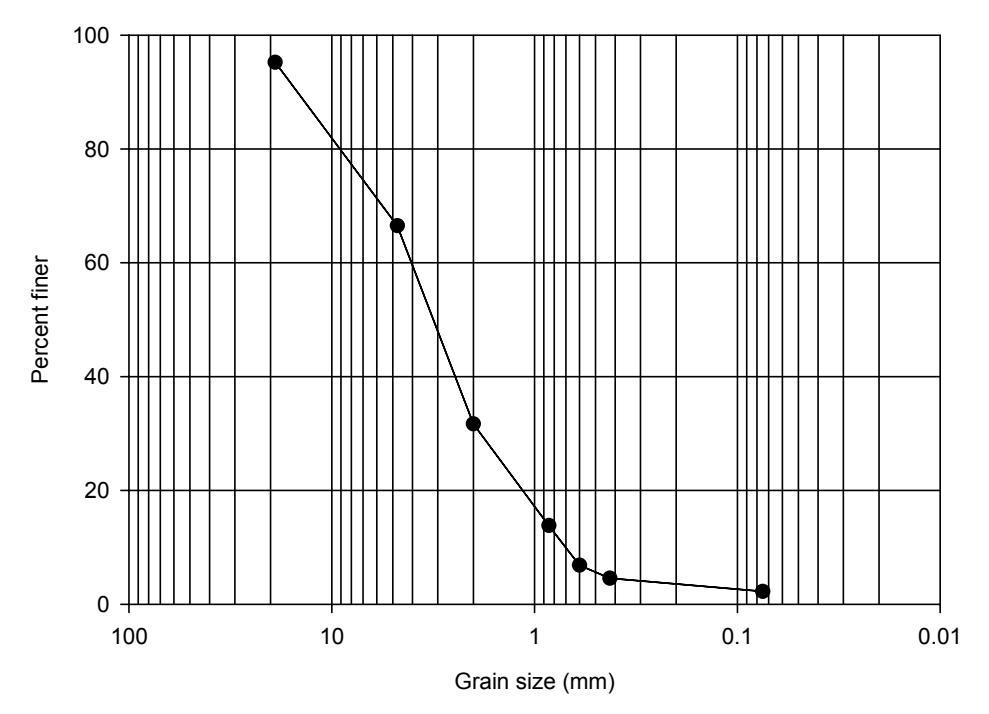
Figure 235. Gradation of granular backfill classified as SP

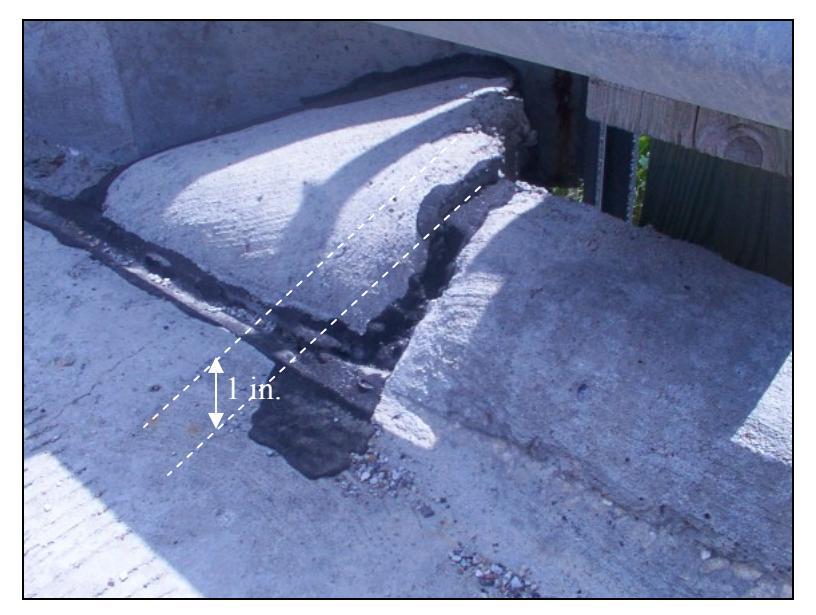
At the south end of the southbound bridge, differential settlement of 1 inch was measured relative to the wingwall (Figure 240), and a 2-inch void was observed under the approach slab. The embankment under the bridge was covered with aggregate and showed no signs of erosion or differential settlement. Aggregate cover was also used along the sides of the abutment to control erosion (Figure 241). The end drain was in a satisfactory condition, as shown in Figure 242.

Figure 240. Differential settlement of 1 inch between the bridge slab and the bridge approach (South end of SBL)

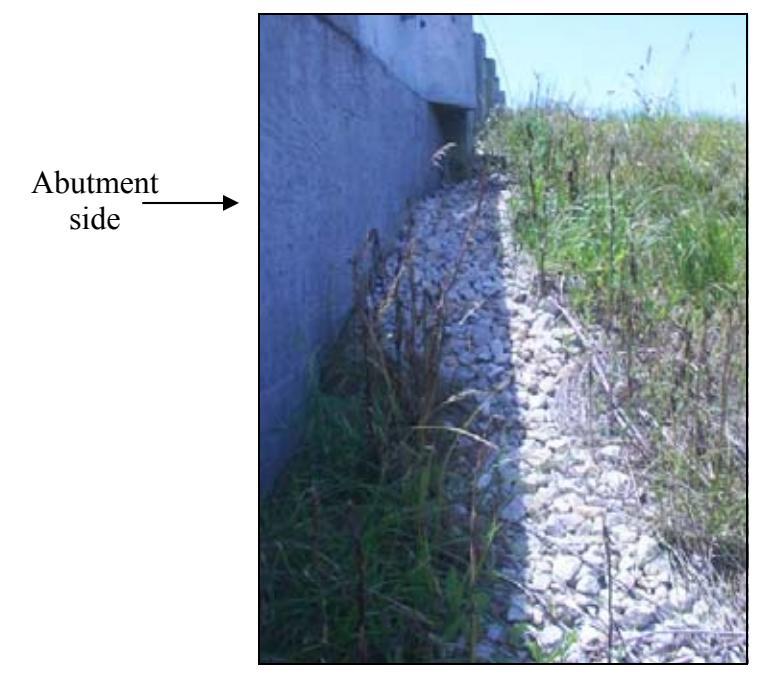
Figure 241. Aggregate placed at the sides of the abutment to control erosion (South end of SBL)

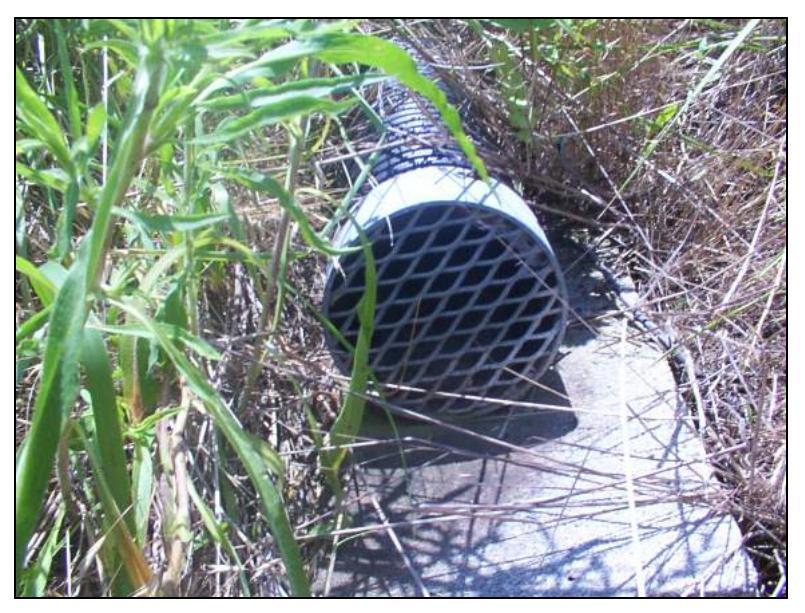
Figure 242. End drain in a satisfactory condition (South end of SBL)

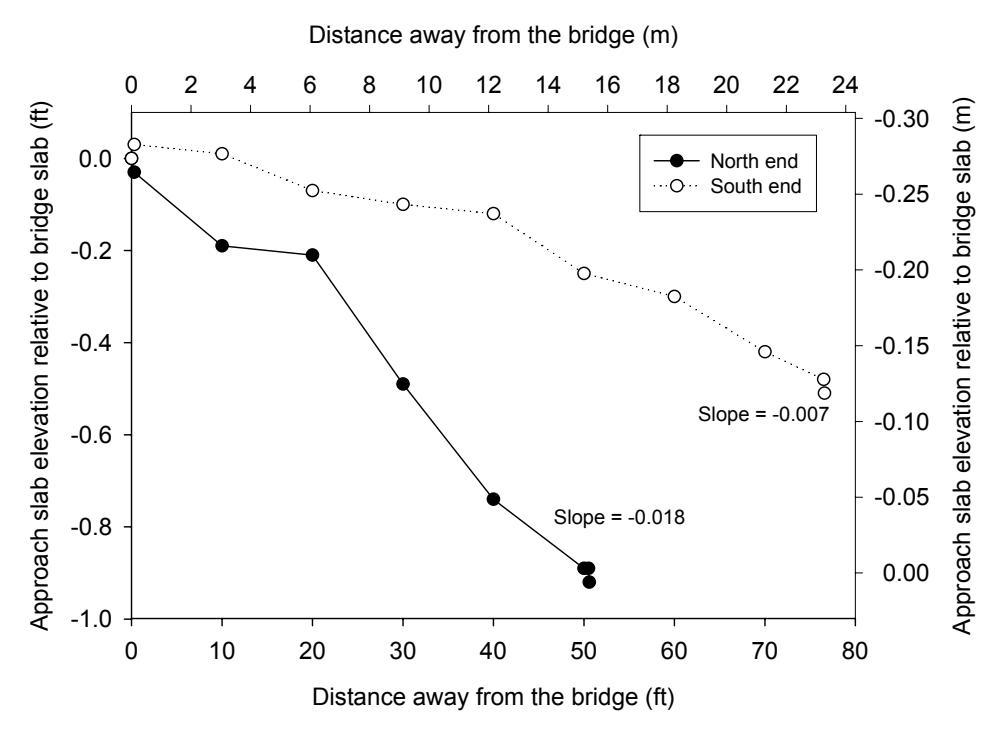
At this bridge, profiles of the north and south ends of the southbound lane are shown in Figure 243. Differential settlement of 0.5 inches was estimated between the approach slab and the roadway at both ends of the southbound lanes. The slopes for the north and south end approach slabs are -0.007 and -0.018. The approach slabs are sloping away from the bridge, which may indicate settlement of the foundation soil or compression of the embankment material. According to the Iowa DOT repair recommendation, only the approach slab at the north end was replaced.

Figure 243. Profiles of the approach slab relative to bridge slab (SBL)

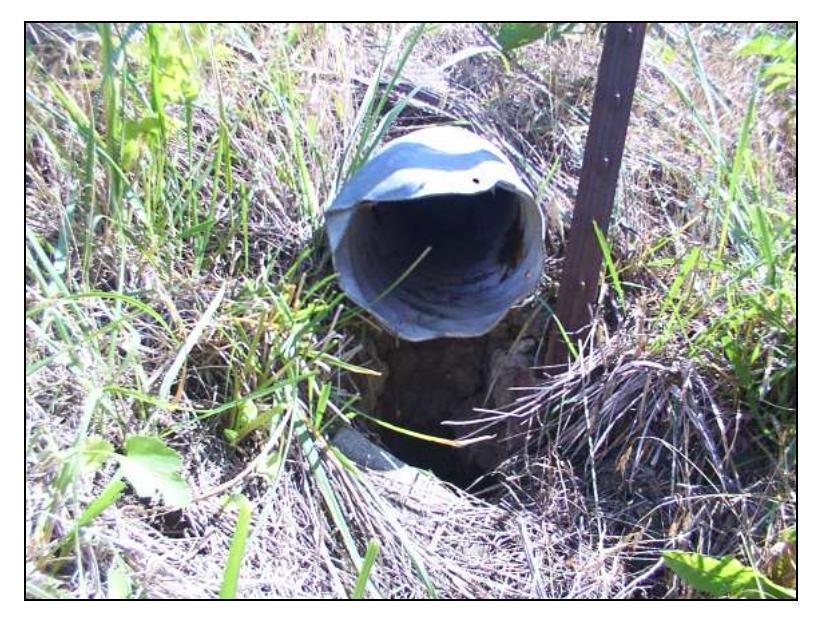
The subdrains of the northbound lanes were inspected using the Iowa DOT snake camera (Figures 244 and 245). At the north end, water and mud were observed within the first 9 ft. inside the subdrain (Figures 246 and 247). The snake camera was pulled out, cleaned, and

Figure 246. Subdrain prior to insertion of snake camera (North end of NBL)
