IDENTIFICATION OF THE BEST PRACTICES FOR DESIGN, CONSTRUCTION, AND REPAIR OF BRIDGE APPROACHES

Iowa DOT Project TR-481 CTRE Project 02-118

Final Report

January 2005

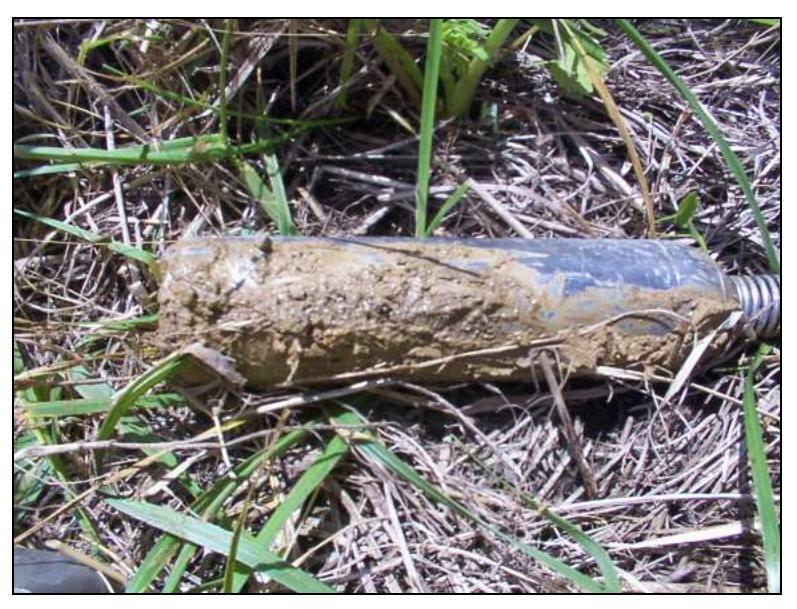
The subdrains of the northbound lanes were inspected using the Iowa DOT snake camera (Figures 244 and 245). At the north end, water and mud were observed within the first 9 ft. inside the subdrain (Figures 246 and 247). The snake camera was pulled out, cleaned, and

reinserted. However, the camera could not be pushed beyond 14.4 ft., where the subdrain had collapsed. At the south end, the subdrain was completely dry and did not have any observed water or soil debris. The camera, however, could not be pushed beyond 9.8 ft. into the subdrain because of subdrain collapse.

Figure 247. Snake camera covered with mud (North end of NBL)

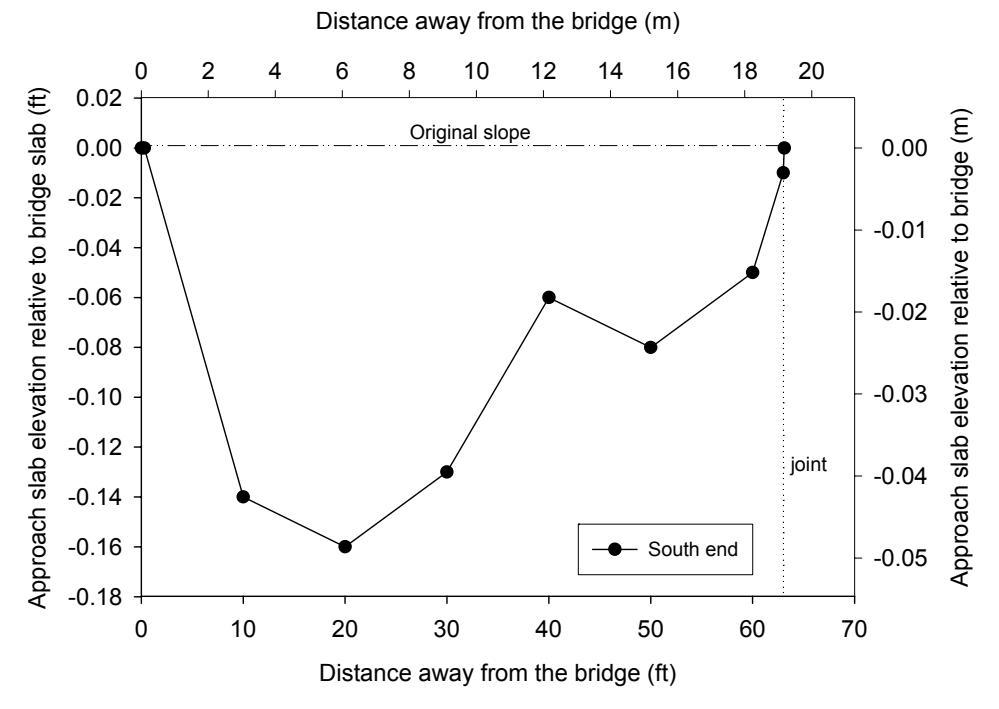
Approach slab coring at the south end of the south bound indicated a 0.5-inch void at both the center line and the edge line of the right lane. The profile of the south end approach slab revealed a non-uniform pavement elevation. The profile shows a maximum settlement of 1.9 inch at 20 feet from the bridge abutment. The original slope of the approach slab is horizontal (Figure 249).

Figure 249. Profile of the bridge approach relative to the bridge slab (South end of SBL)

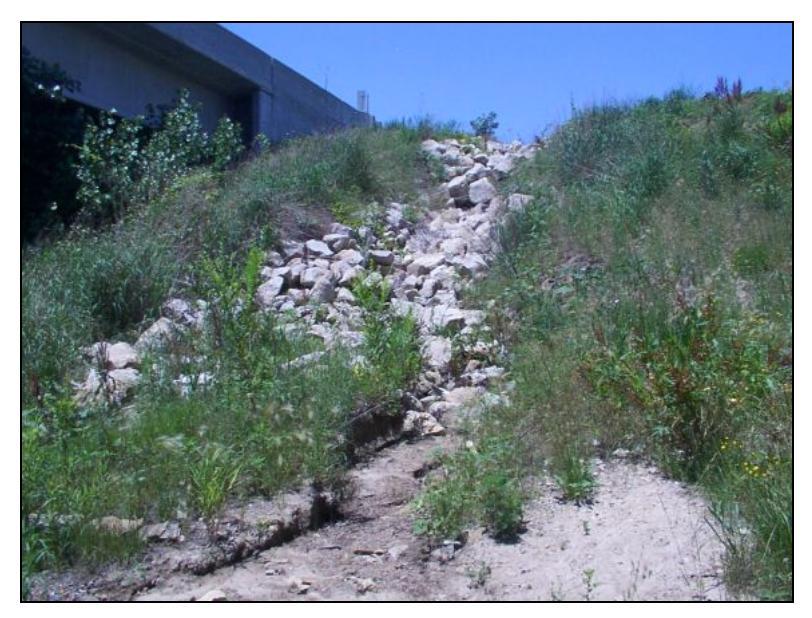
This bridge is a seven-span bridge with concrete girders and non-integral abutments. At the north end of the northbound lanes, the embankment consists of silty sand and has no slope protection. Some erosion of the bridge embankment was observed. At the sides of the abutment, large riprap had been placed to reduce erosion, as shown in Figure 250.

Figure 250. Rocks placed at the abutment side to prevent erosion (North end of NBL)

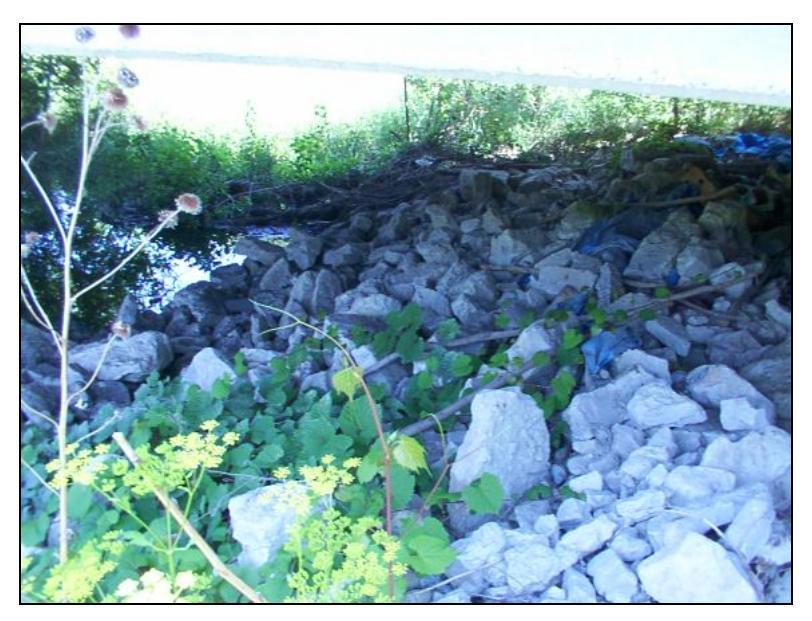
At the south end of the northbound lanes, differential settlement of 1.5 inches was measured at the end of the wingwall. The expansion joint was in satisfactory condition. Large rip-rap covered the embankment under the bridge as shown in Figure 251. Some erosion was observed along the side of the abutment.

Figure 251. Rocks placed at the embankment under the bridge to prevent further erosion (South end of NBL)

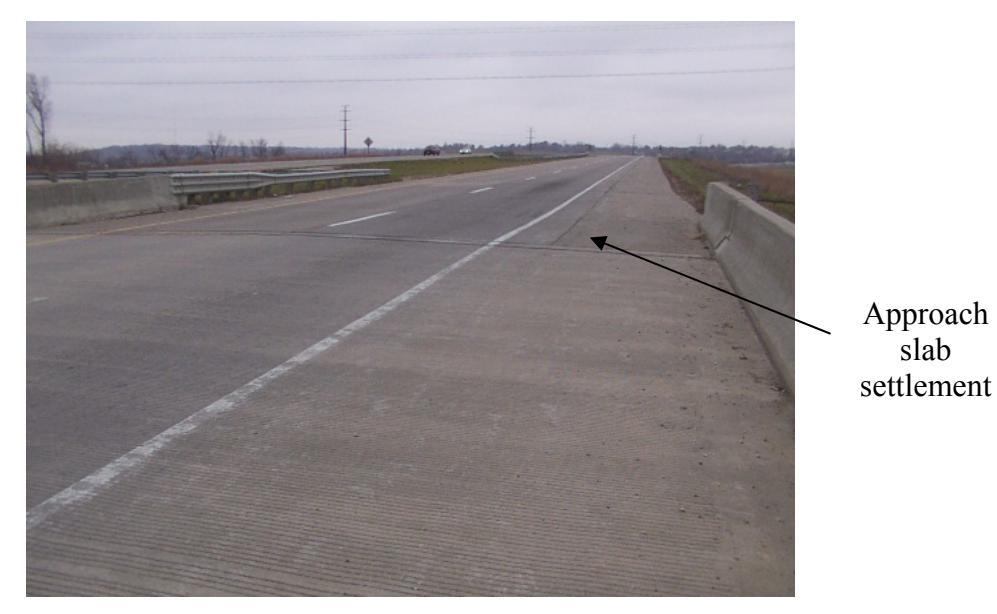
At the south end of the southbound lanes, the strip seal was cut short causing erosion at side of the abutment. Settlement and erosion of the bridge embankment was also observed. At the north end of the southbound lanes, 3.5 inches of differential settlement was measured (Figure 252). No slope protection was used and erosion of the embankment was observed.

Figure 252. Settlement of approach slab (North end NBL)

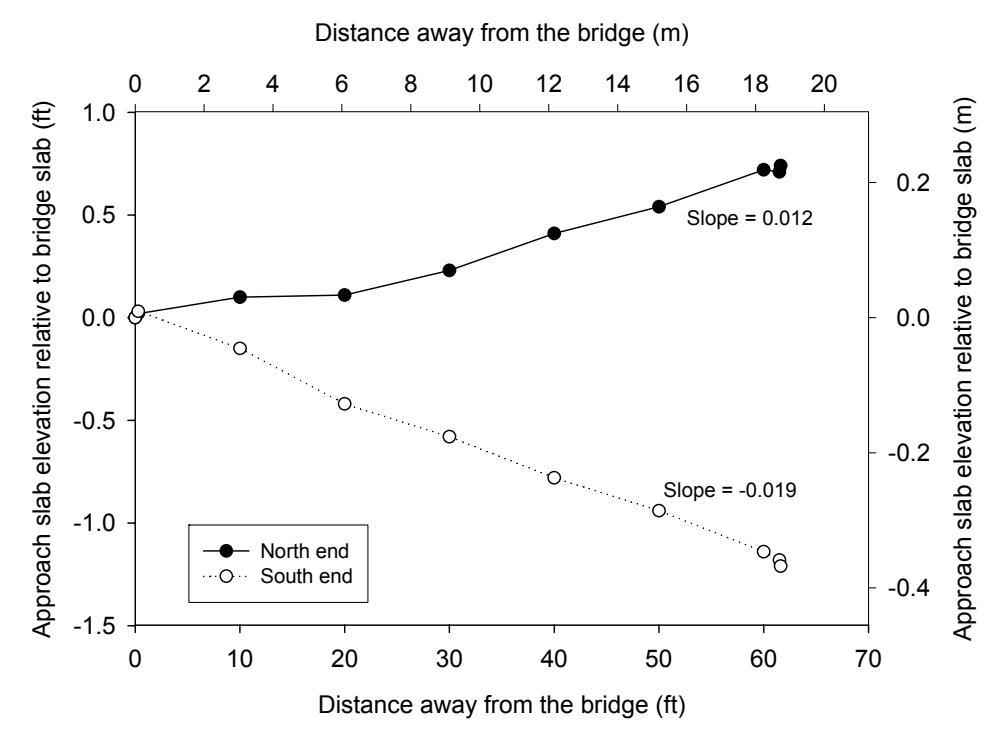
The approach slab elevation profiles for north and southbound lanes are shown in Figures 253 and 254. Differential settlement of the approach slab at the north end of the southbound lanes was about 1.2 inches at 5 ft. from the bridge abutment, while the south end approach slab settled about 3.5 inches at 50 ft. away from the bridge abutment. The slopes of the north and south end approach slabs of the southbound lane are 0.01 and -0.019. Differential settlement between the approach slab and the roadway of both ends of the northbound lanes was about 0.5 inches. The slopes of the north and south end approach slabs of the northbound lane are 0.012 and -0.019, respectively.

Figure 253. Profiles of the approach slab relative to bridge slab (NBL)

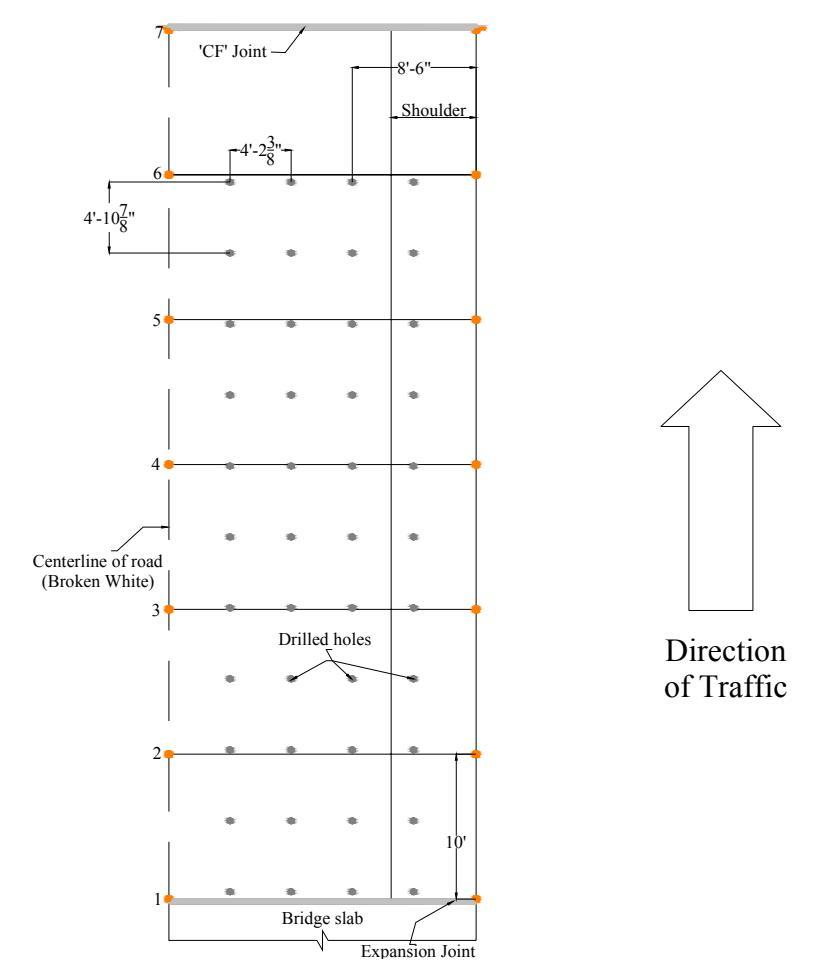
Figure 255. Location of holes drilled on the bridge approach slab

As a demonstration at this bridge site, URETEK, Inc., repaired the right lane of the north end of the northbound lanes. Figure 255 shows the locations where the URETEK expanding foam was injected through 5/8 inch drill holes in the slab. The drill holes were spaced about 4 to 5 feet apart (Figures 256 and 257). A dial gauge was placed just past the 'CF' joint, located 60 feet from the abutment, to monitor elevation changes in the approach slab pavement (Figure 258). After drilling was completed, pumping of the high density polyurethane was performed. Some holes were re-drilled after the material had hardened to inject additional material as needed (Figures 259 and 260).

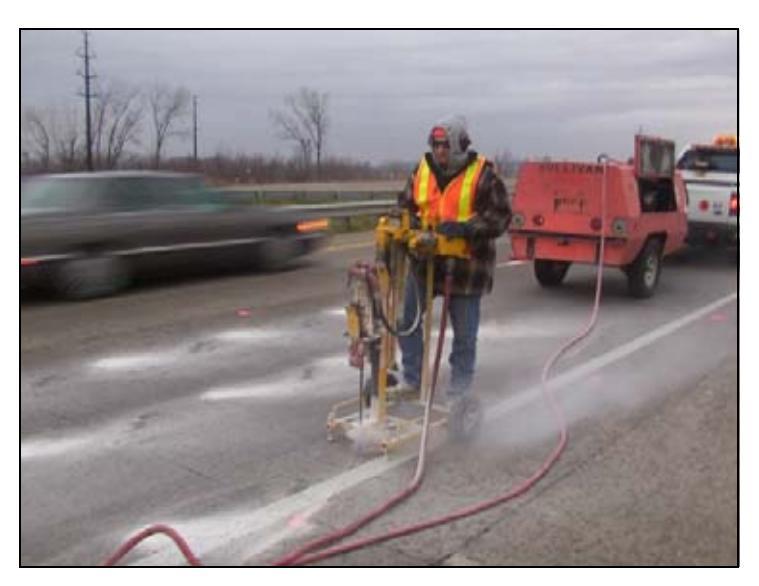
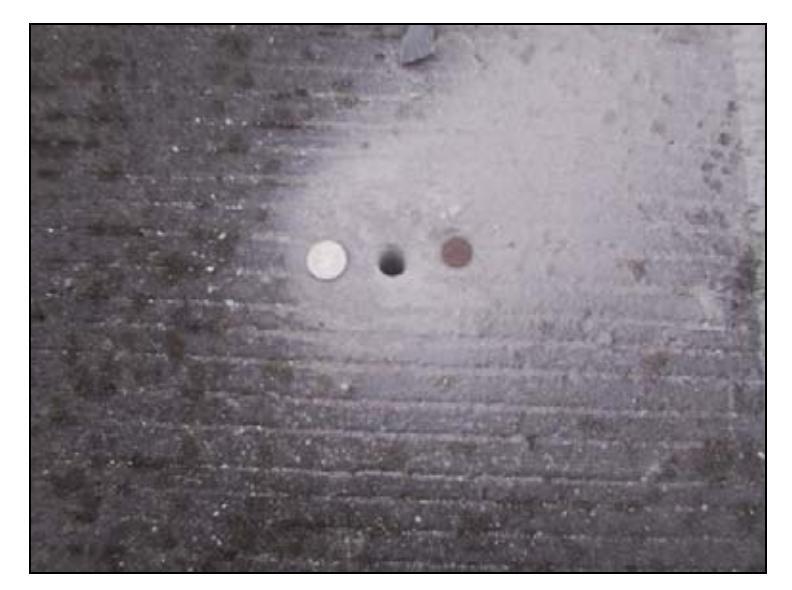
Figure 256. Holes drilled on the approach slab

Figure 257. Holes drilled for injecting expansive material under the approach

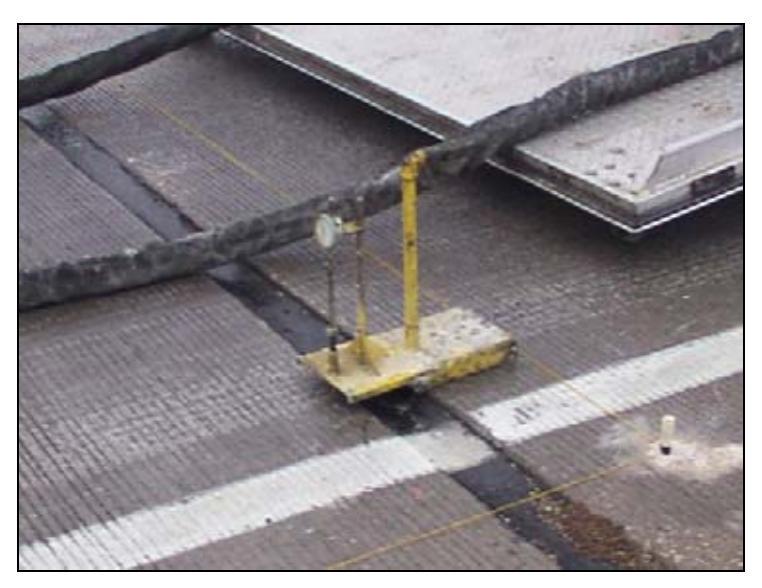
Figure 258. Dial gauge to measure change in approach slab elevation

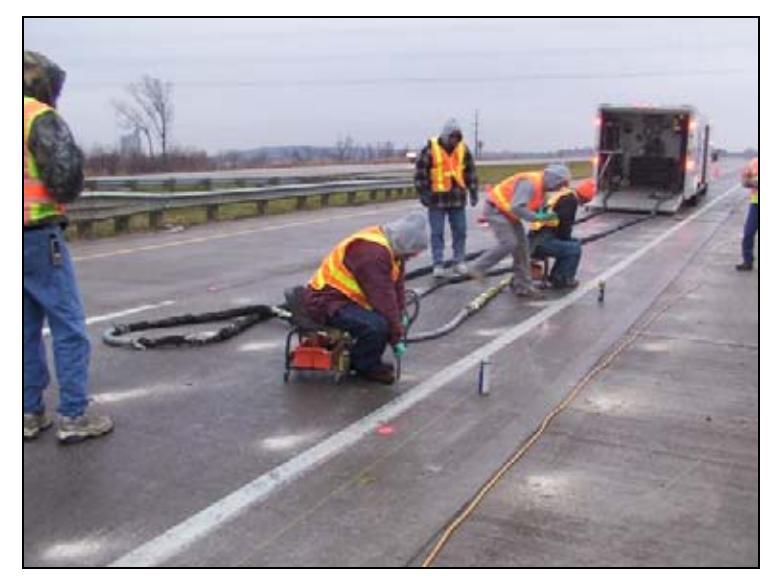
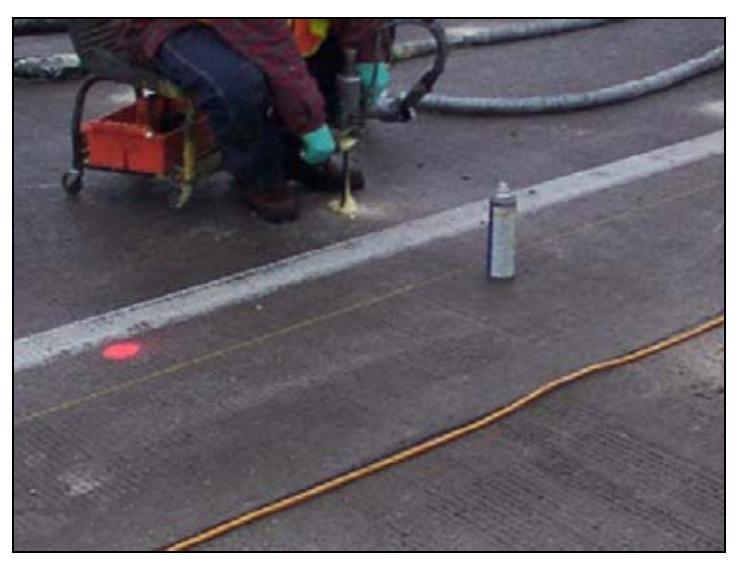
Figure 259. Injecting high-density polyurethane under the approach slab

Figure 260. Steady injection until material leaks out of hole

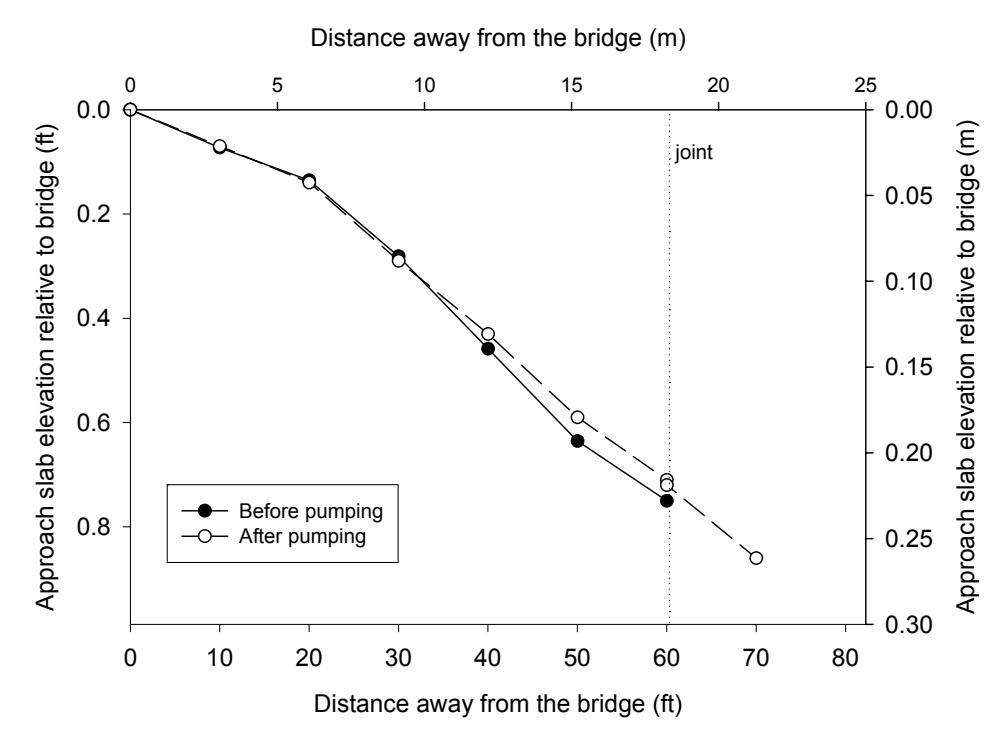
The research team measured the profile of the approach at 10 ft. intervals before and after injecting the expanding foam. The approach slab was raised approximately 0.25 inches at 40 to 60 ft. from the abutment. Unfortunately, due to bad weather, the URETEK crew was not able to inject the material from 0 to 30 ft (Figure 261).

Figure 261. Elevation of approach relative to expansion joint before and after pumping

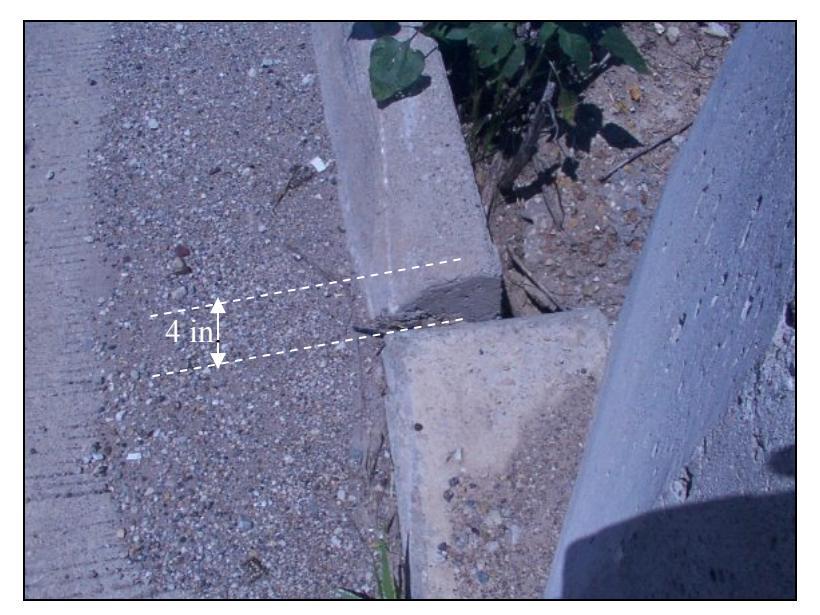
This bridge is a five-span bridge with integral abutments and concrete girders. At the north end of the northbound lanes, about 4 inches of differential settlement was measured at the end of the wingwall (Figure 262). A 6-inch void developed under the approach slab, as shown in Figure 263. Flexible foam was used as filler of the expansion joint—gaps were observed and concrete deterioration was observed at the expansion joint. Although the embankment under the bridge had an aggregate cover, erosion was observed between the abutment and the bridge embankment.

Figure 262. Differential settlement at the bridge approach (North end of NBL)

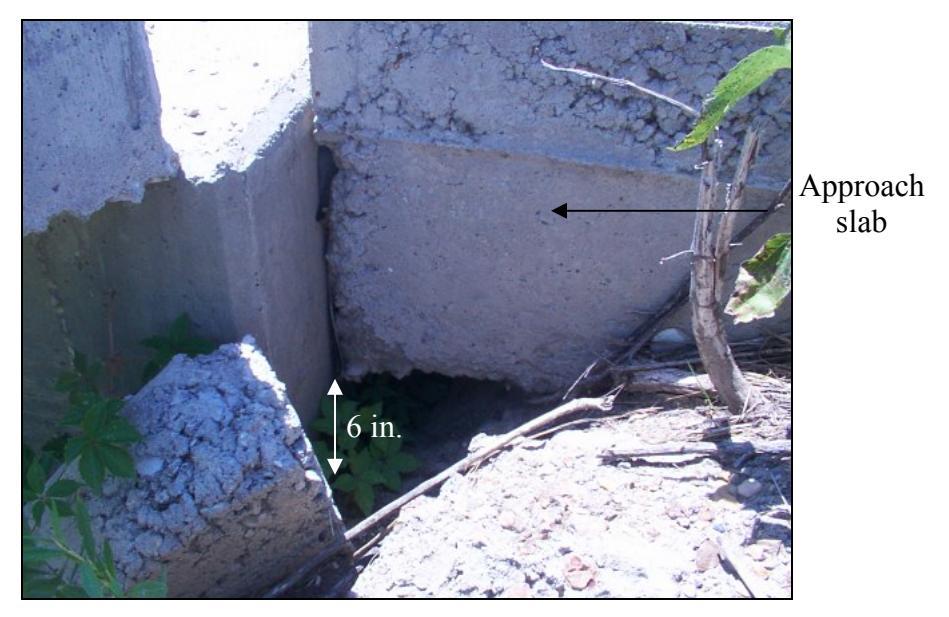
Figure 263. A 6 in. void developed under the approach slab (North end of NBL)

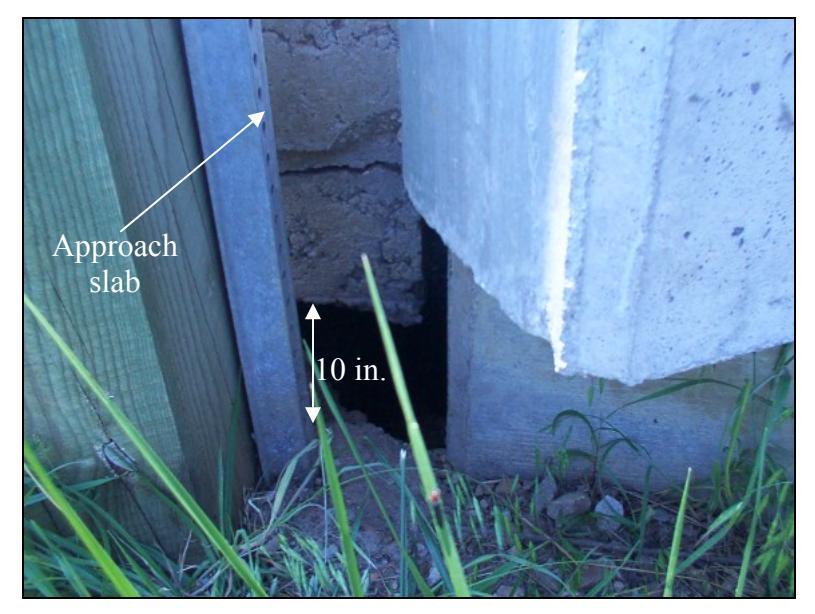
At the south end of the northbound lanes, a 10-inch void was observed under the approach slab (Figure 264). Figure 265 shows 1.5 inches of differential settlement between the approach slab and wingwall. The expansion joint was deteriorated, as shown in Figure 266. Furthermore, erosion along the abutment sides was observed (Figure 267). The embankment has concrete slope protection which appeared to be in relatively good condition. The embankment, however, had settled about 7 inches (Figure 268), and a 1-inch horizontal gap was measured between the embankment and abutment face (Figure 269).

Figure 264. A 10 in. void developed under the approach slab (South end of NBL)

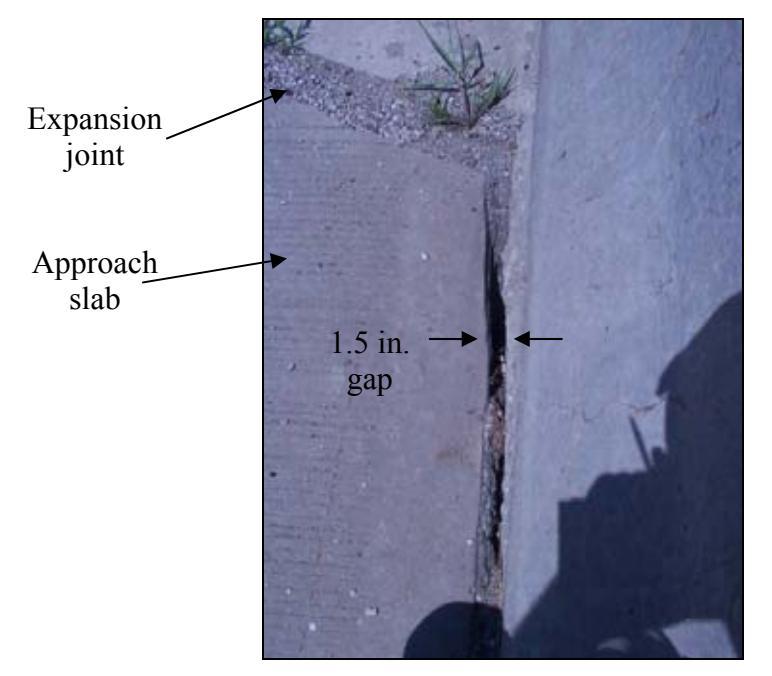
Figure 265. Gap between the approach slab and the wingwall (South end of NBL)

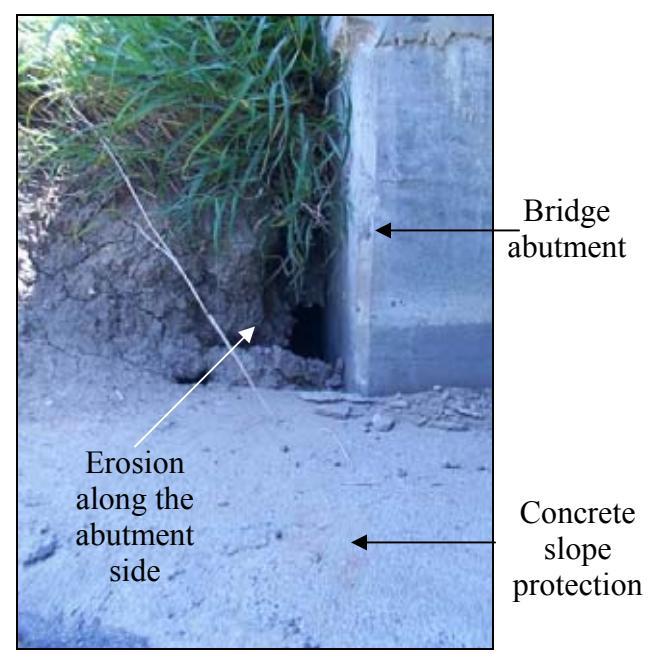
Figure 267. Erosion along the abutment sides (South end of NBL)

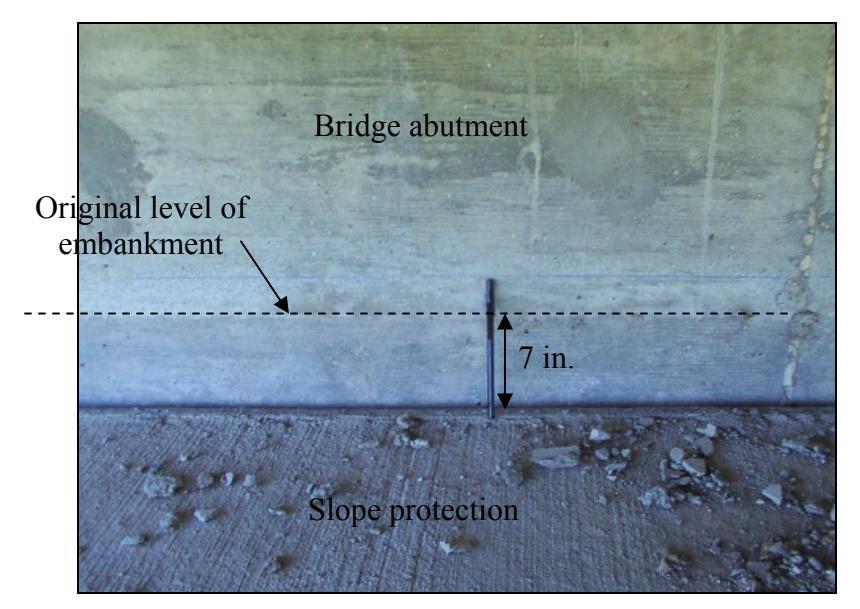
Figure 268. Settlement of the embankment under the bridge (South end of NBL)

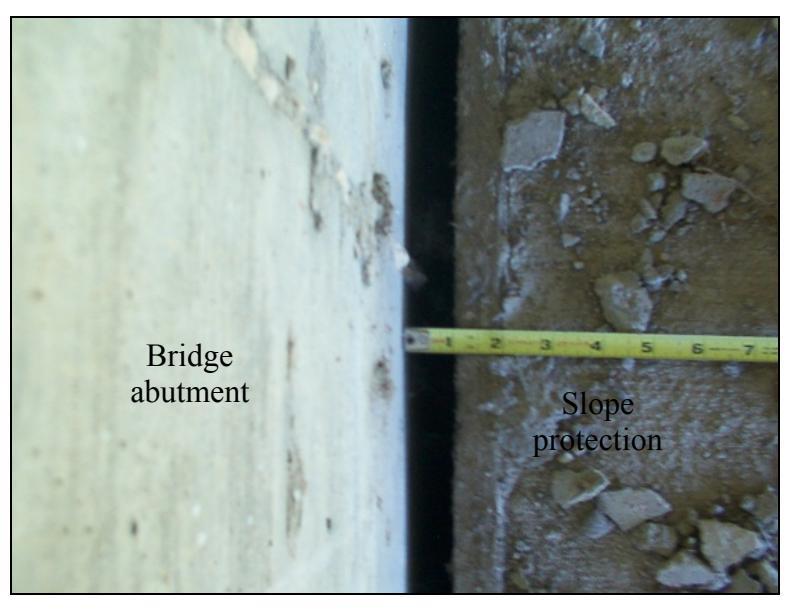
Figure 269. Top view showing the 1 in. gap between the abutment and concrete slope cover (South end of NBL)

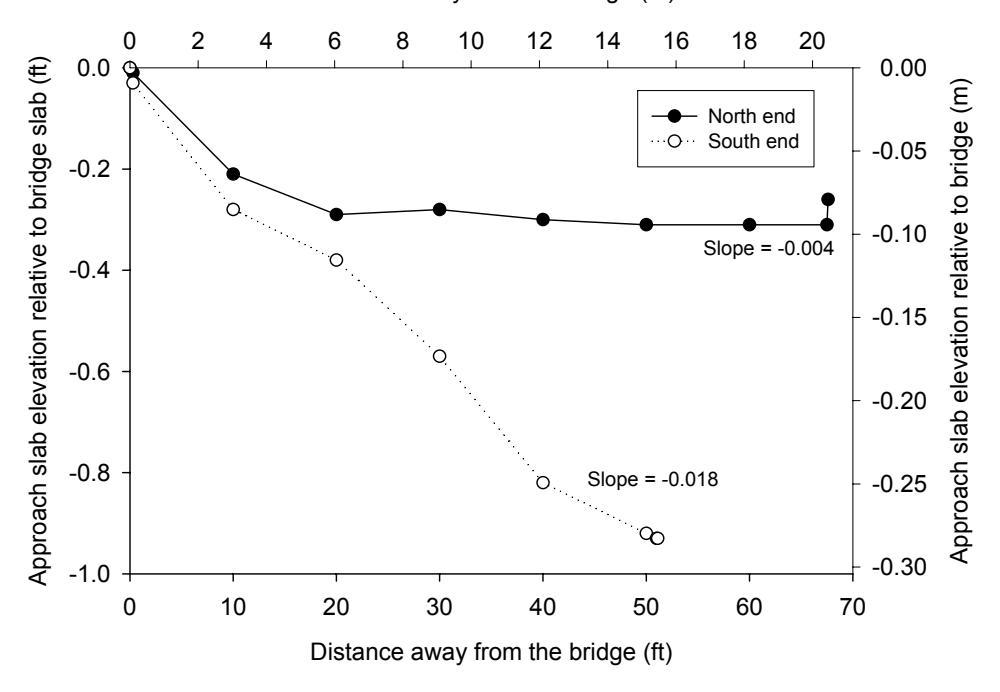
Figure 270. Profile of the bridge approach relative to bridge slab (NBL)

Bridge approach profiles were obtained for both ends of the northbound bridge, as shown in Figure 270. When compared with the assumed original profiles, differential settlement at the north end was about 1.5 inches at 20 feet from the bridge abutment and 0.6 inches between the approach slabs at 68 feet. The maximum settlement of the south end approach slab was 1.3 inches at 40 feet away from the bridge. The slopes of the north and south end approach slabs are -0.004 and -0.018, respectively. Both approach slabs are sloping away from the bridge, which may indicate settlement of the foundation soil or compression of the embankment material.

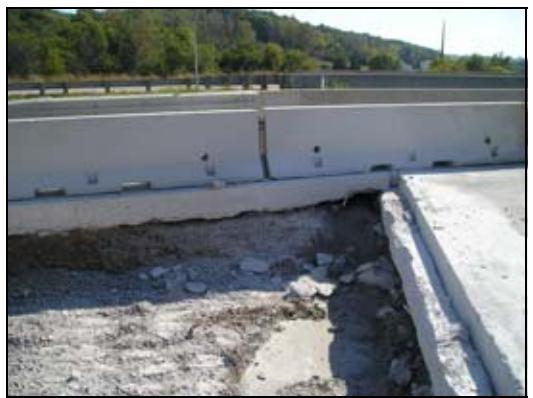
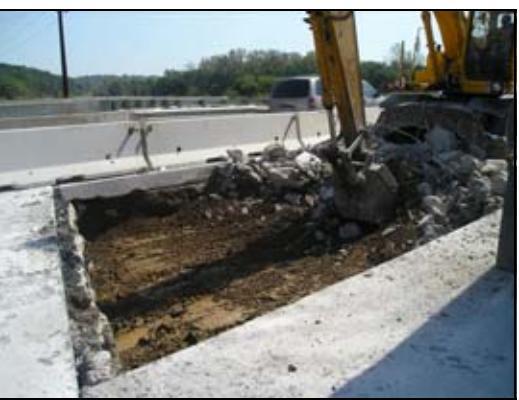
Figure 271. Replacement of approach slabs at the south bound

inspection, replacement of the right lane approach slabs at the south bound bridge was in progress (Figure 271). The left lane was still opened to traffic. The north end approach slab was removed while the south end approach slab was torn down and being removed.

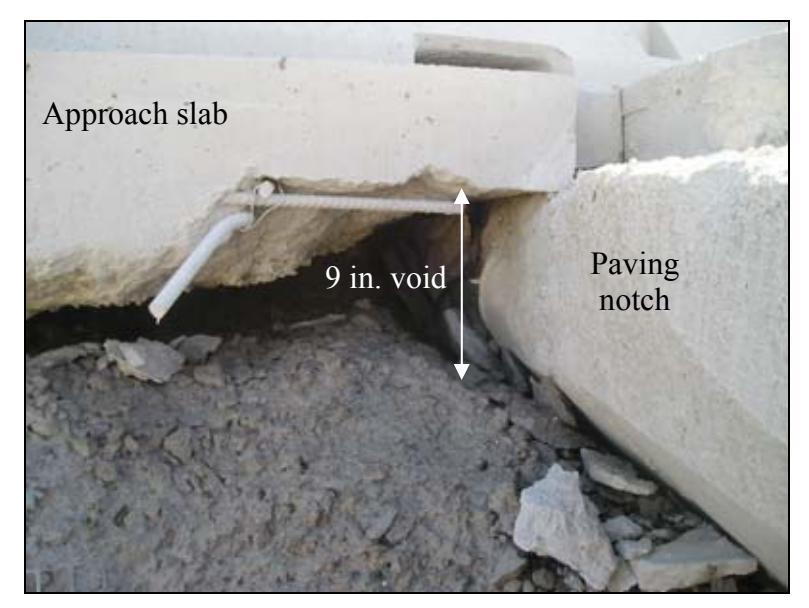
A void was observed under the left lane of the north end, as shown in Figure 272. The void was 9 inches deep at the abutment and about 1 inch at 4 feet away. Figure 273 shows that shear failure of portions of the paving notch of the left lane occurred such that the approach slab was only resting on about 0.5 inches of the paving notch (Figure 274).

Figure 272. A 9 in. void developed under the left lane approach slab (North end of SBL)

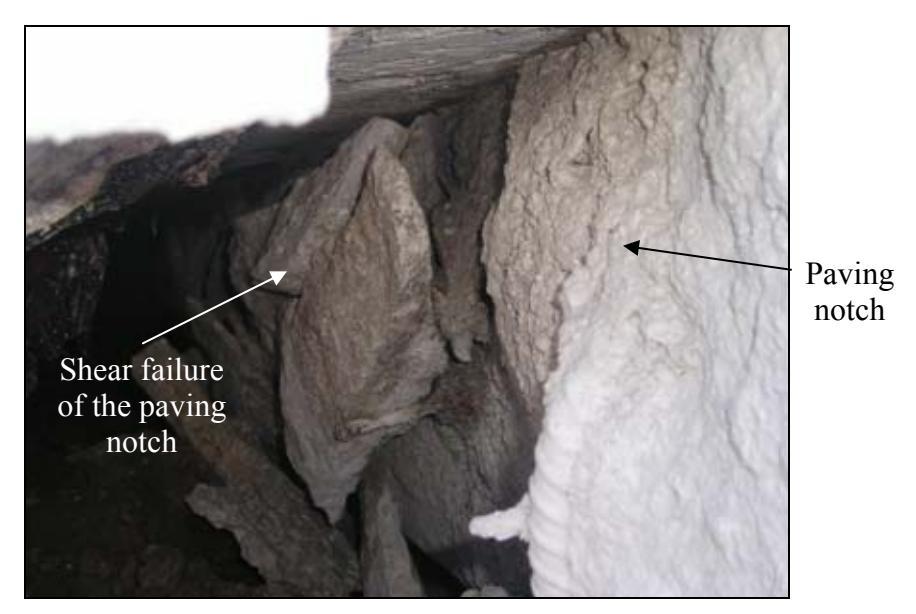
Figure 273. Shearing of paving notch (North end of SBL)

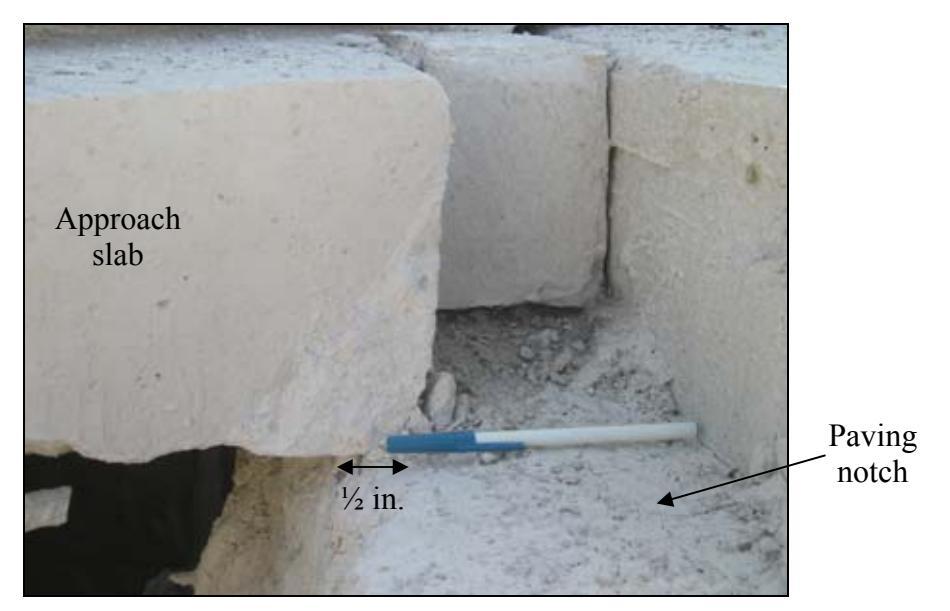
Figure 274. The approach slab resting on 0.5 in. of the paving notch (north end of SBL)

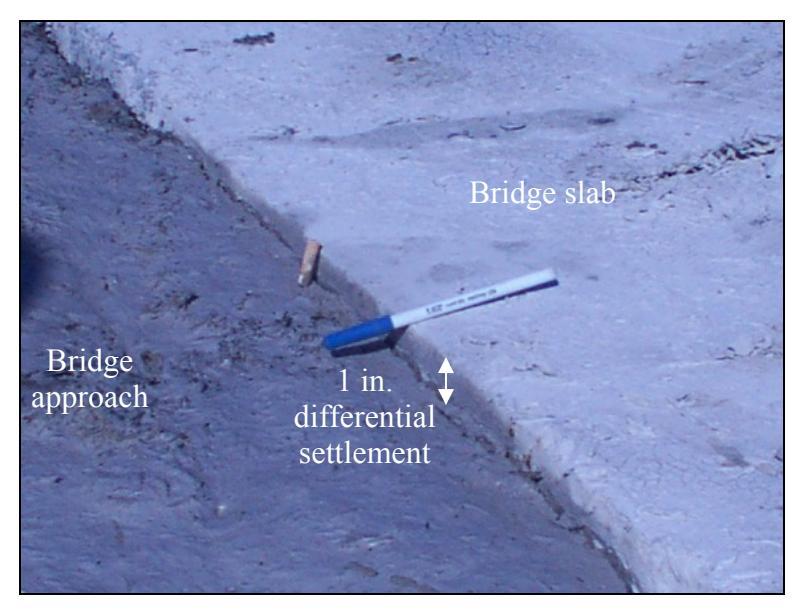
At the south end approach slab, about 1 inch of slab drop at the bridge deck was observed (Figure 275). Recycled tire chips were used as a joint filler material at the expansion joint. Similar to the north end, the approach slab at the south end was resting on only 1 inch of the paving notch, as shown in Figure 276. Under the approach slab, a 10-inch-deep void was measured at the abutment and extended 5 feet away from the bridge.

Figure 275. Differential settlement between the bridge slab and the bridge approach (South end of SBL)

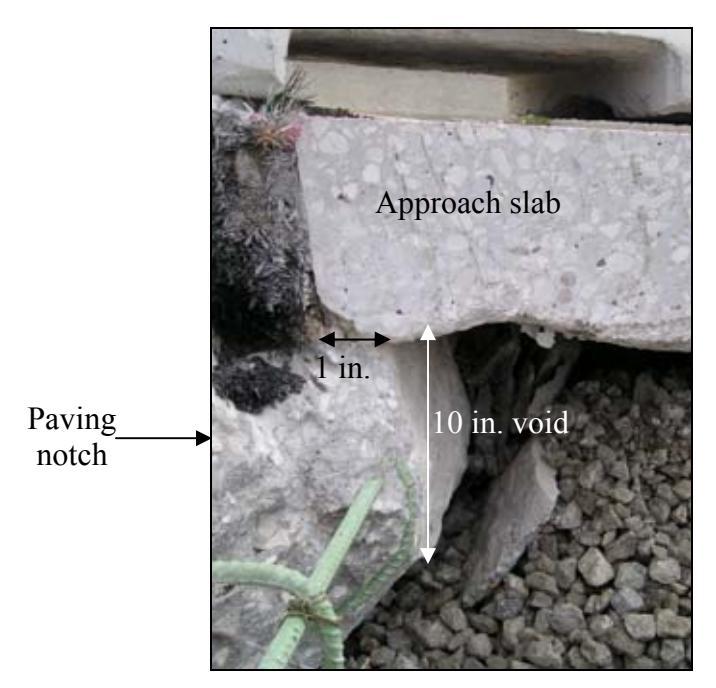
Figure 276. Approach slab resting on 1 inch of the paving notch, and a 10-inch-void developed under the approach slab (South end of SBL)

The study also examined the potential failure of an unreinforced concrete segment in the pavement notch and the approach slab independently as a result of transferring loads through this segment. The unreinforced segments may be found at the end of an approach slab and/or in the end region of a pavement notch. This condition occurs mainly due to inaccurate placement of the reinforcing steel during construction (e.g., see Figures 276 and 413).

In this failure case, it was assumed that the approach slab was supported over a reduced width on the notch, as shown in Figure 412. This condition can be attributed to poor construction practice, thermal effects, or a combination thereof (see an example of this condition in Figure 276 – HW65 bridge). The width of the failure segment was conservatively taken as 2 in. from the free edge of the pavement notch. This small segment of the notch was assumed to have no steel reinforcement. Because the shear plane runs in the direction of the bridge is very small, SLC2 governs this failure case by producing a lower capacity to demand ratio.

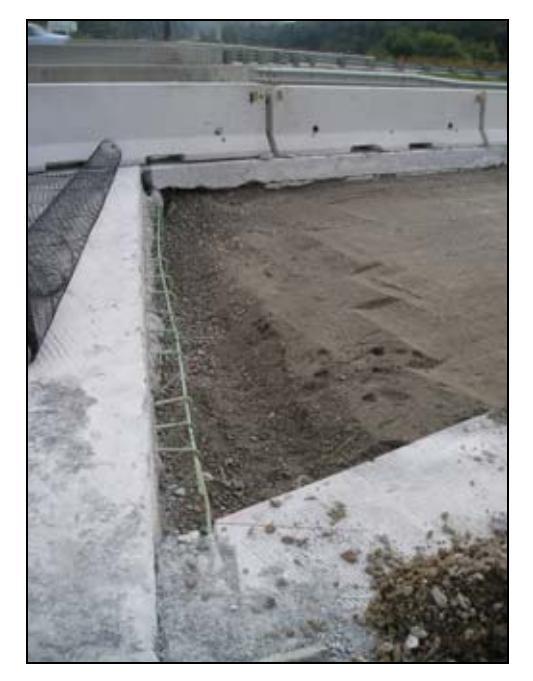
To evaluate subgrade strength, DCP tests were performed at the north and south ends of the southbound bridge at 2 feet from the abutment. At the north end, the DCP test was conducted on the old special backfill material. At the south end, the DCP test was conducted on the new compacted special backfill (Figure 277). The results of the DCP testing conducted on the old backfill material showed that the CBR values ranged from 2 to 15, as shown in Figure 278. DCP test results conducted on the new compacted special backfill shows that the CBR values range from 1.5 to 15. No significant difference was measured between the CBR values of both the old and the new compacted special backfill (Figure 279).

Figure 277. Compacted special backfill (South end of SBL)

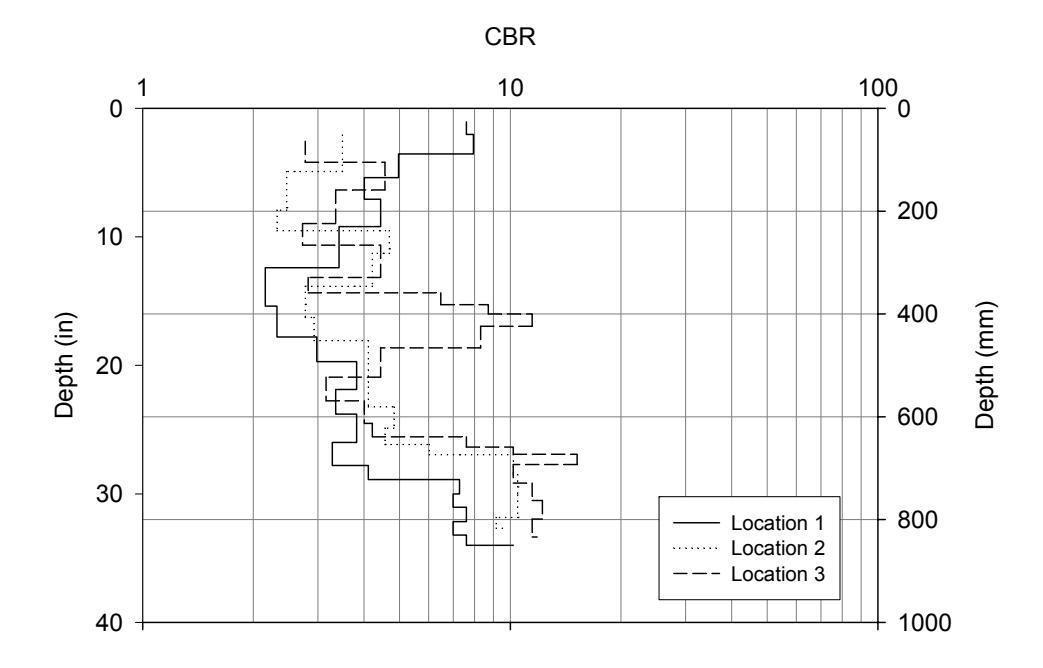
Figure 278. Results of DCP tests conducted on the old backfill material (North end of SBL)

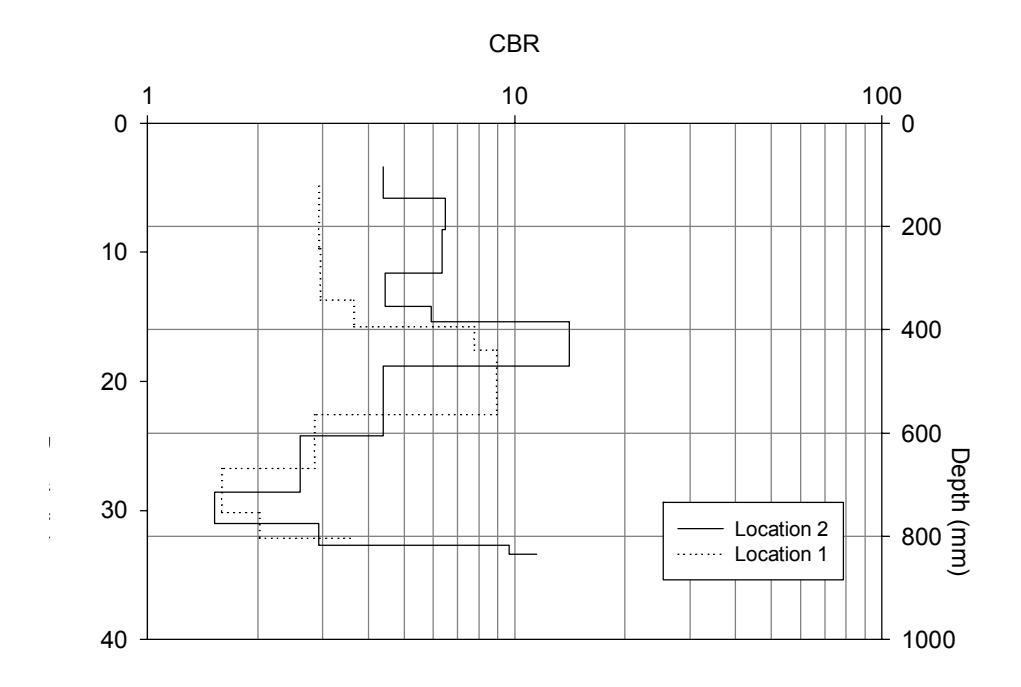
Figure 279. DCP test conducted on the replaced special backfill (South end of SBL)

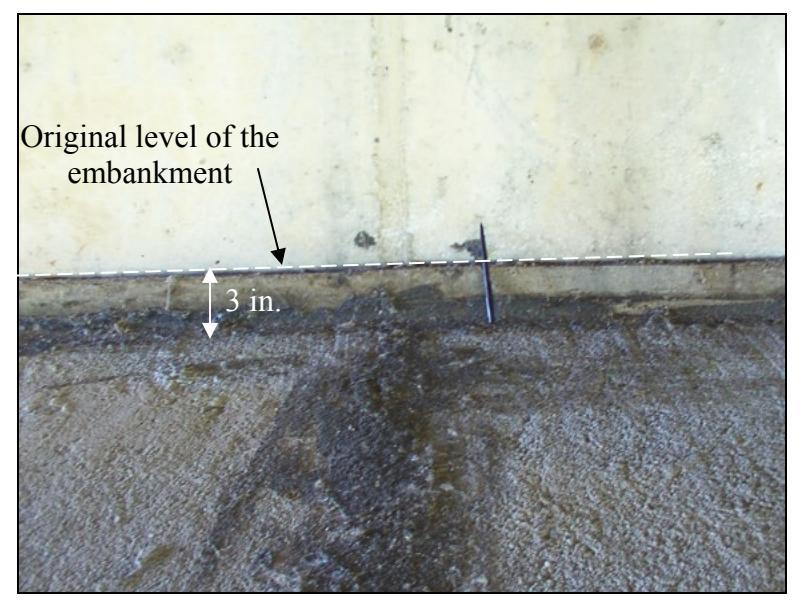
erosion along the sides of the abutment. The embankment has a slope protection which appeared to be in good condition with no settlement. At the north end of the northbound bridge, erosion along the abutment sides was also observed. The embankment had settled about 3 inches, as shown in Figure 280. The embankment has a slope protection that appeared to be in good condition.

Figure 280. Settlement of the embankment under the bridge (North end of NBL)

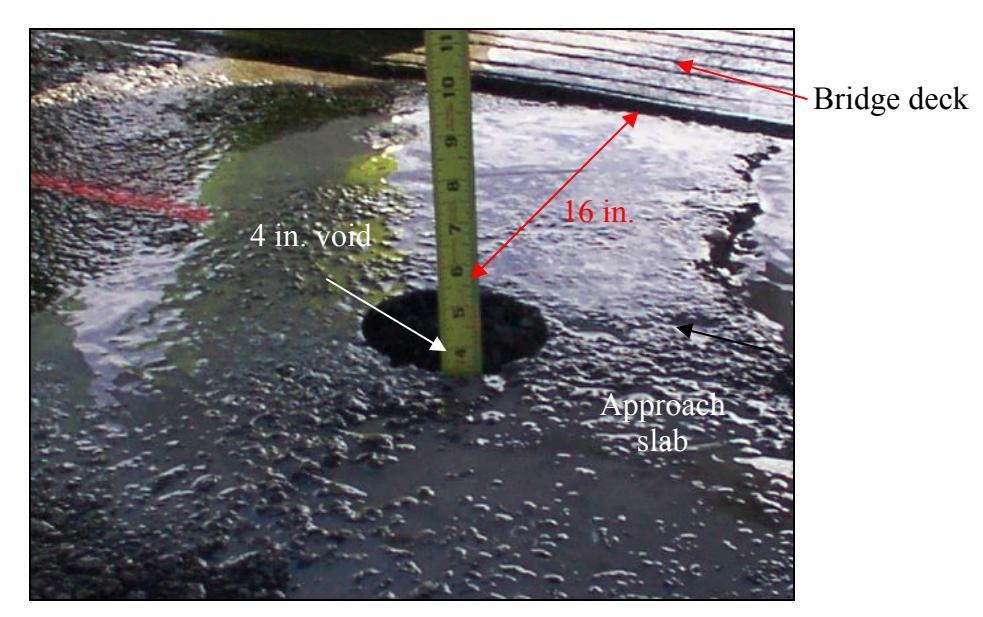
Figures 282 and 283 show how coring by the Iowa DOT was used to determine void size at the north end of the southbound bridge. The pavement thickness was 15.5 inches, which was determined by measuring the length of the core obtained at the white line (Figure 284). Table 17 summarizes the void sizes. The south end of the southbound lanes was not cored because no significant bridge approach pavement distress was observed.

Figure 282. A 4-inch-void under the approach slab estimated by measuring the distance the core dropped (North end of SBL, center line)

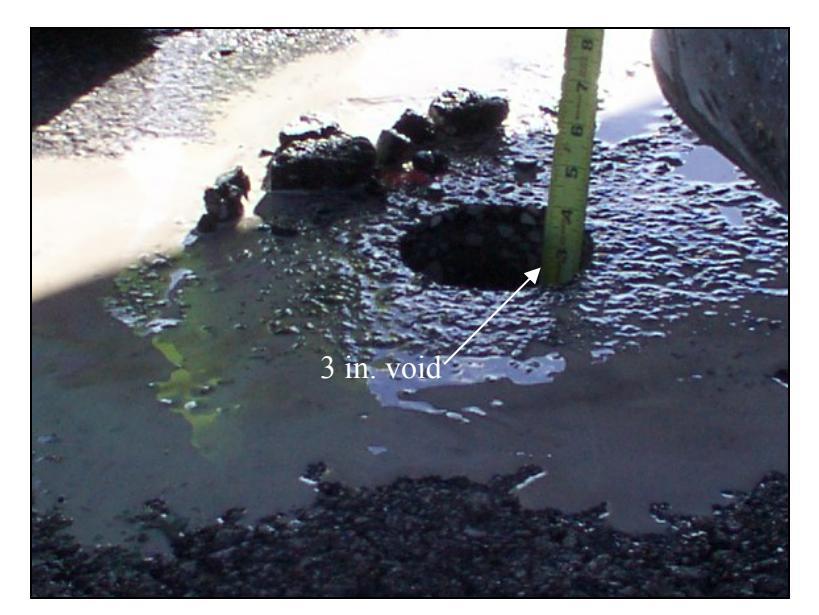
Figure 283. A 3-inch-void under the approach slab estimated by measuring the distance the core dropped (North end of SBL, edge line)

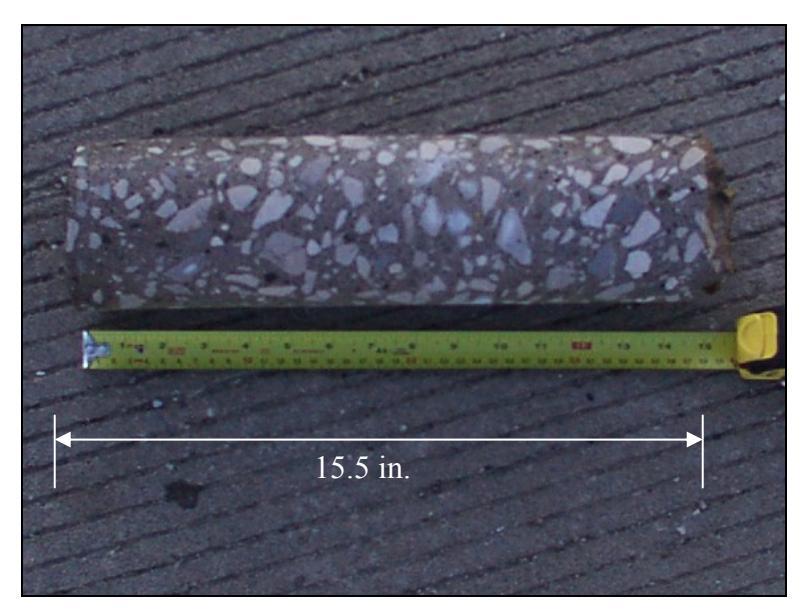
Figure 284. Pavement thickness determined from measuring the length of the core (North end of SBL, edge line)

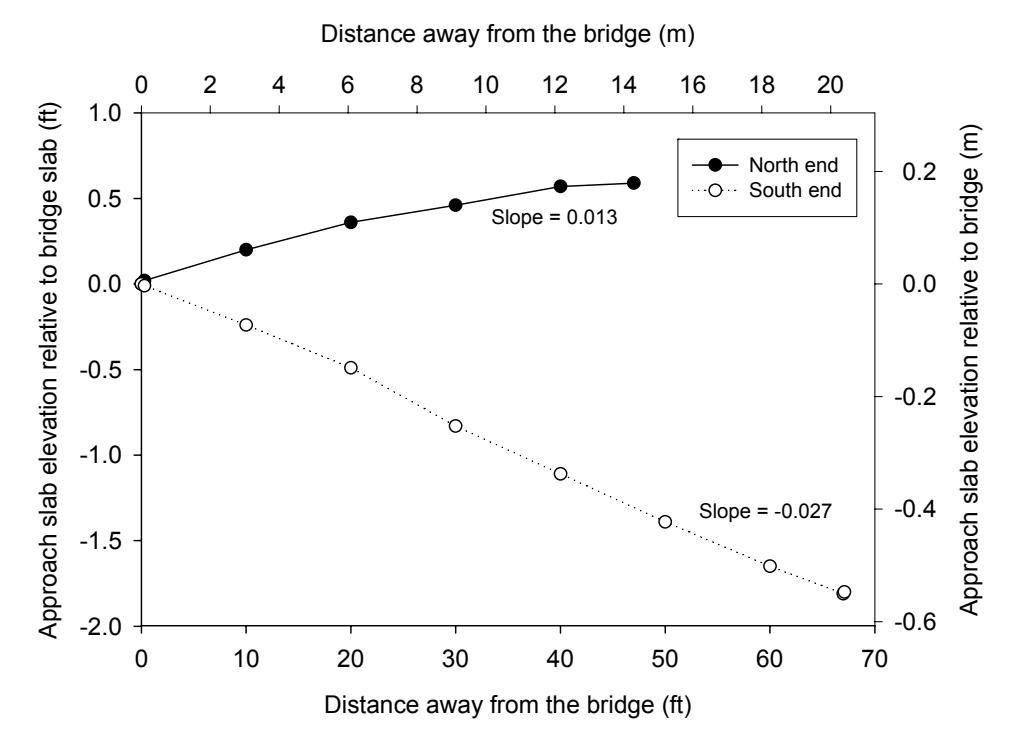
Figure 285. Profile of the bridge approach relative to bridge slab (NBL)

Elevation profiles of the bridge approaches are shown in Figures 285 and 286. Both the north and south approaches of the northbound lanes settled about 2.5 inches relative to the original slope at distances of 50 feet and 60 feet away from the bridge abutment. The slopes of the north and south end approach slabs are 0.012 and -0.027, respectively (Figure 285). The approach slab settled about 1.5 inches relative to the pavement past the CF joint. Settlement along the approach slab varied from 1 to 1.5 inches relative to the original slope. The slope of the north end approach slab is 0.017 (Figure 286).
