IDENTIFICATION OF THE BEST PRACTICES FOR DESIGN, CONSTRUCTION, AND REPAIR OF BRIDGE APPROACHES

Iowa DOT Project TR-481 CTRE Project 02-118

Final Report

January 2005

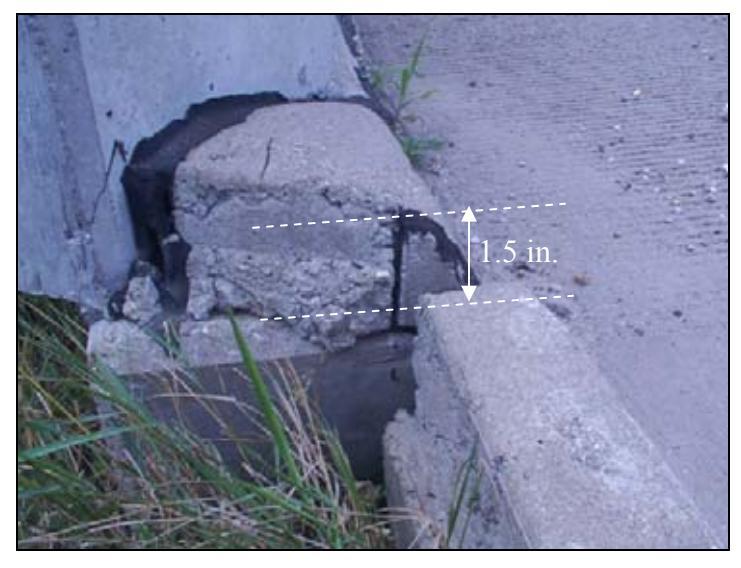
This bridge is a three-span bridge with concrete girders and integral abutments. At the north end of the northbound lanes, 1.5 inches of differential settlement was observed at the end of the wingwall (Figure 287). The width of the expansion joint was about 5.5 inches and poorly filled. The concrete slope protection of the embankment under the bridge was in good condition; however, the embankment had settled about 2 inches relative to the abutment (Figure 288).

Figure 287. Differential settlement between the bridge slab and the bridge approach (North end of NBL)

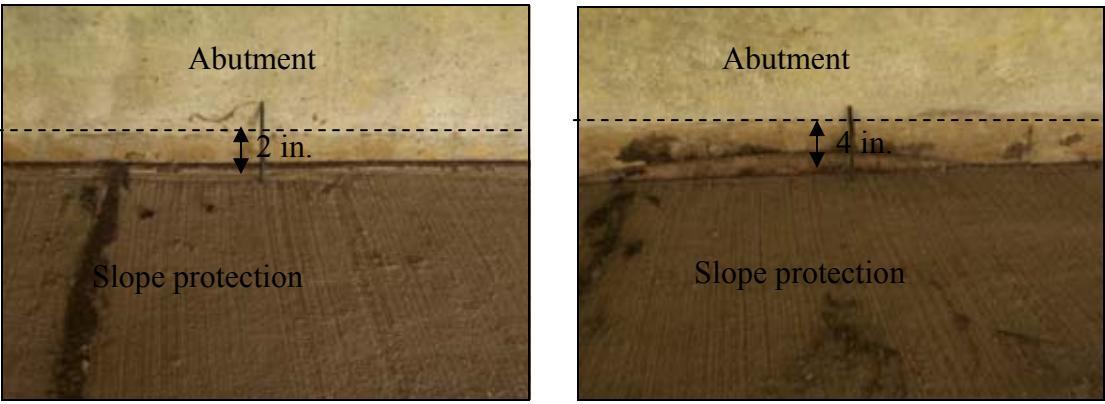
At the south end of the northbound lanes, erosion along the sides of the abutment was observed. Furthermore, the embankment under the bridge had settled about 4 inches relative to the abutment and a 1.5-inch horizontal gap existed between the abutment face and slope protection (Figures 288 and 289).

(a) North end(b) South endFigure 288. Settlement of the embankment under the bridge (NBL)

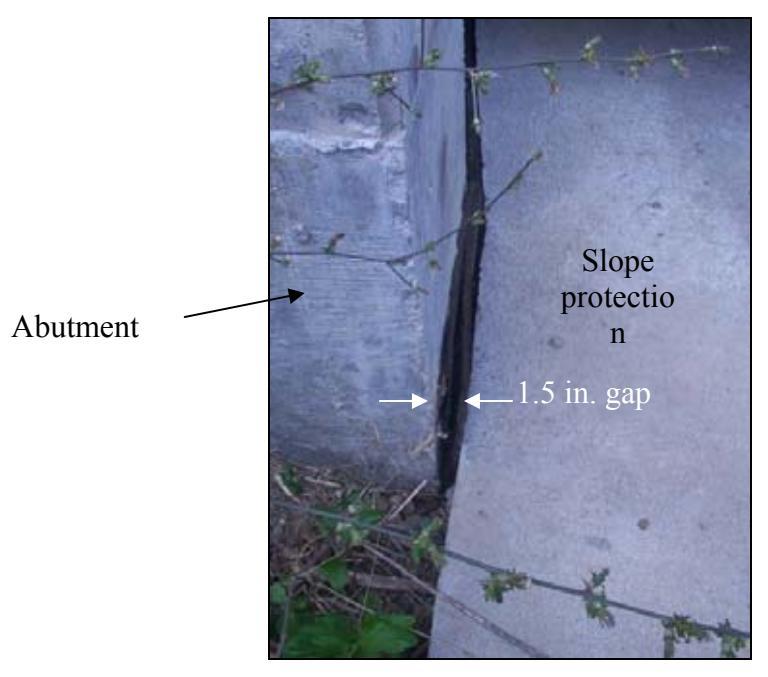
Figure 289. A 1.5 inch gap between abutment face and slope protection (South end of NBL)

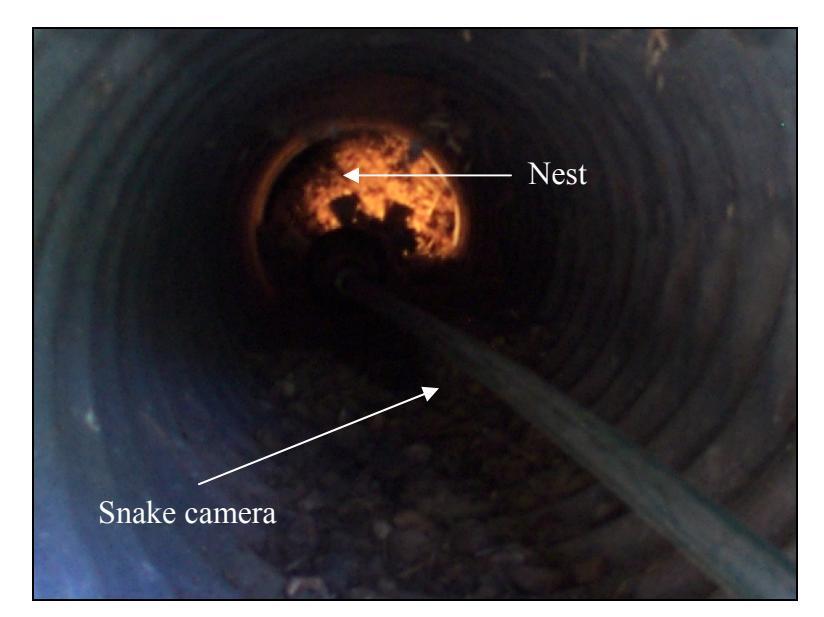
The snake camera was used to inspect the subdrains of both ends of the north bound. At the north end, the subdrain was dry. At 5 feet inside the subdrain, a rodent nest was observed blocking the subdrain (Figure 290). At the south end, the subdrain was completely dry with some fines at the bottom of the drain (Figure 291).

Figure 290. Rodent nest blocking the subdrain at 5 feet from the outlet

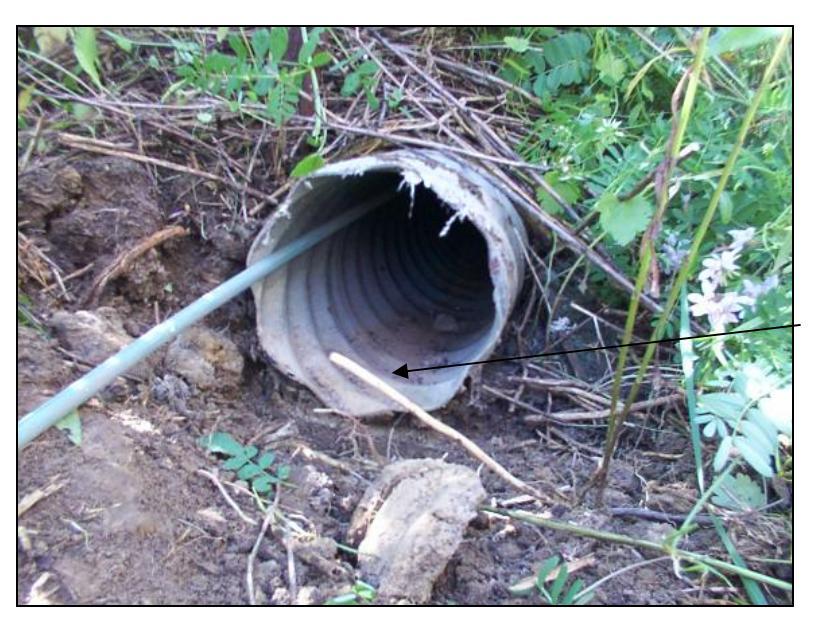
Figure 291. Iowa DOT snake camera inserted inside the subdrain

Fine soil particles at the bottom of the subdrain

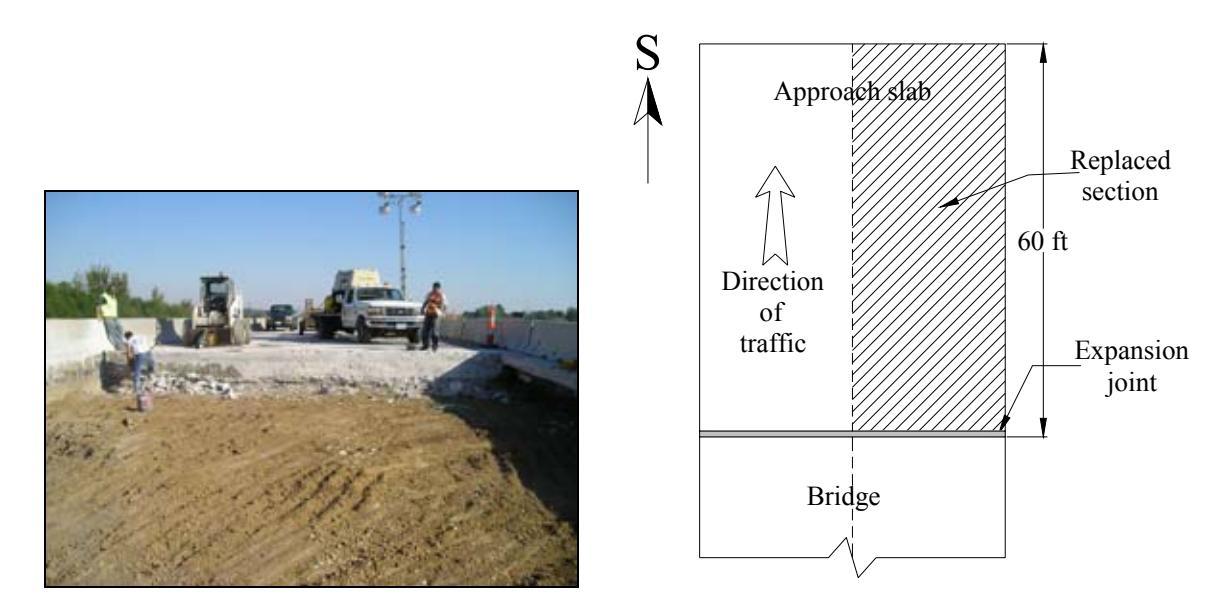
(a) Replaced approach slab(b) Schematic of the replaced sectionFigure 292. Replacement of the right lane approach slab (South end of SBL)

This bridge was also inspected in September 2004 while major maintenance operations were underway. During inspection, replacement of the approach slab at the south end of the southbound lanes was in progress. The replaced section was on the right lane, while the left lane approach slab was still open to traffic (Figure 292). Figure 293 shows removal of the existing 10-inch-wide paving notch. The void under the existing approach (left lane) was approximately 18 inches deep at the abutment and 6 inches deep at 3 feet from the abutment (Figure 294). A new subdrain pipe was installed behind the bridge abutment. The subdrain was connected to the end drain. Figure 295 shows the trench excavation to place the subdrain and end drain. Porous backfill was placed around the new drains.

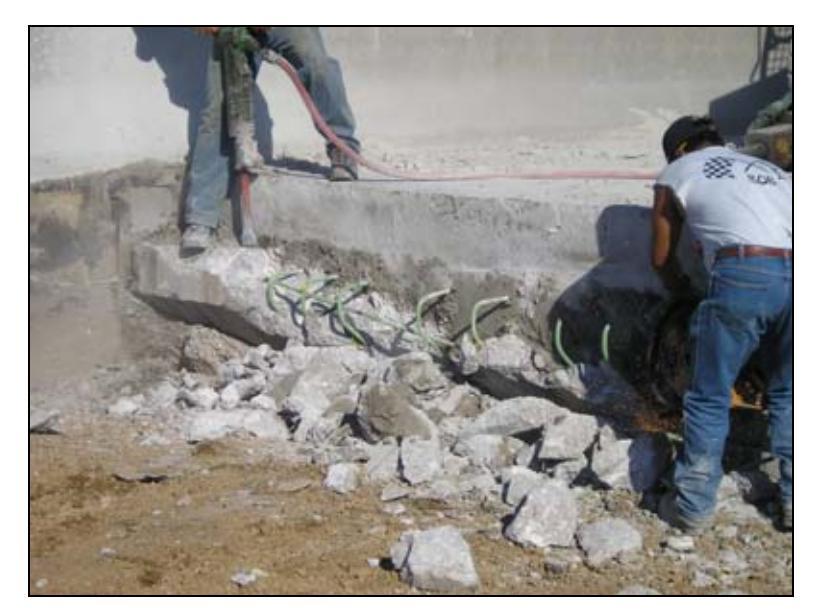
Figure 293. Tearing down the old pavement notch (South end of SBL)

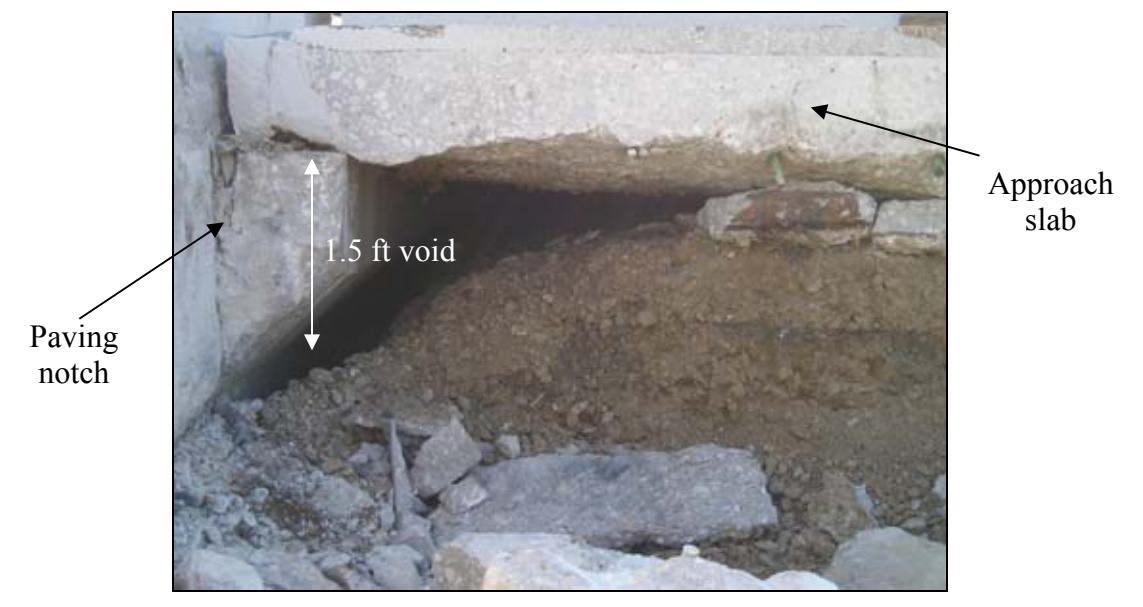
Figure 294. A void developed under the left lane approach slab which was 1.5-feet-deep at the bridge abutment (South end of SBL)

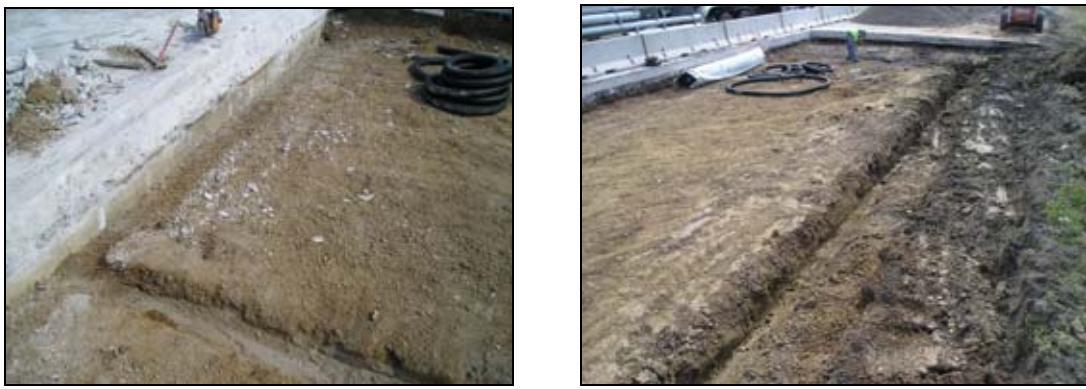
(a) Trench excavated to install subdrain

(b) Trench excavated to connect the subdrain to the end drain

Figure 295. Installing a drainage system under the right lane approach slab

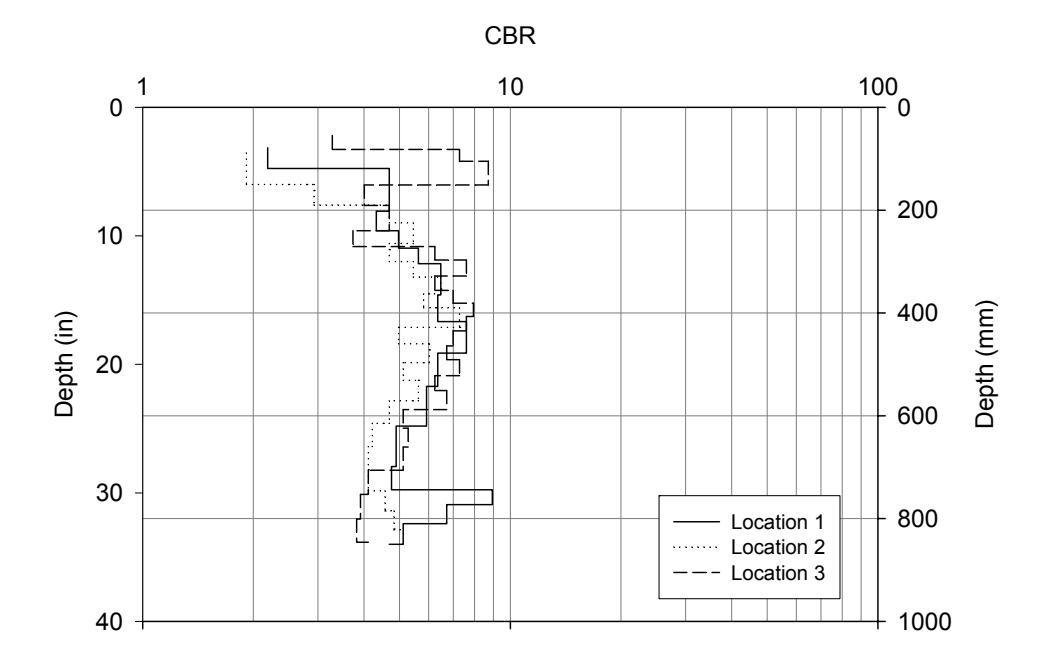
To measure subgrade strength, DCP tests were conducted at three locations about 2 feet from the abutment. Tests were performed before excavating the old special backfill and after placing the new special backfill. DCP test results presented in Figures 296 and 297 show that the old special backfill CBR values ranged from 2 to 9. The new special backfill CBR values ranged from 3 to 18. It did not appear that the new special backfill had been compacted.

Figure 296. Results of DCP test conducted on special backfill material before excavation (South end of SBL)

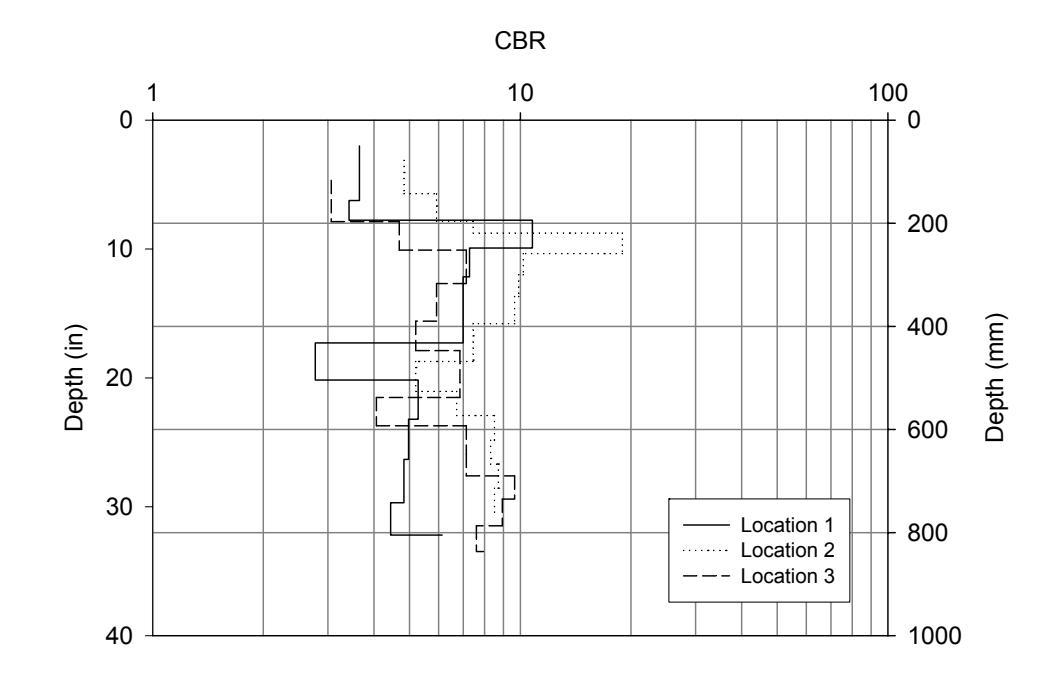
Figure 297. Results of DCP test conducted on special backfill material after replacement (South end of SBL)

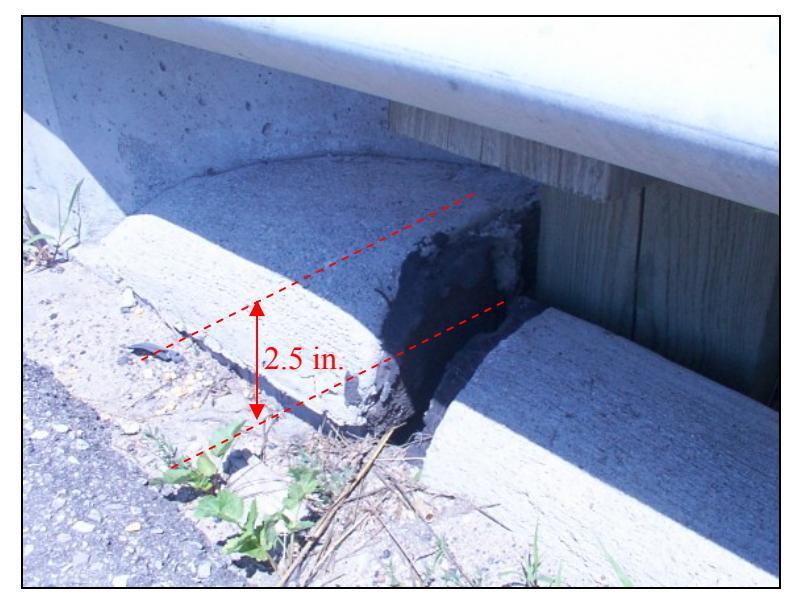
At the south end of the northbound lanes, differential settlement of 2.5 inches was measured at the end of the wingwall (Figure 298). Concrete spalling and cracking of the asphalt overlay were observed at the expansion joint (Figure 299). Concrete slope protection of the embankment under the bridge was in good condition; however, it settled about 3.5 inches relative to the abutment (Figure 300) and had a 0.5-inch gap at the abutment face.

Figure 298. Differential settlement at the bridge approach (South end of NBL)

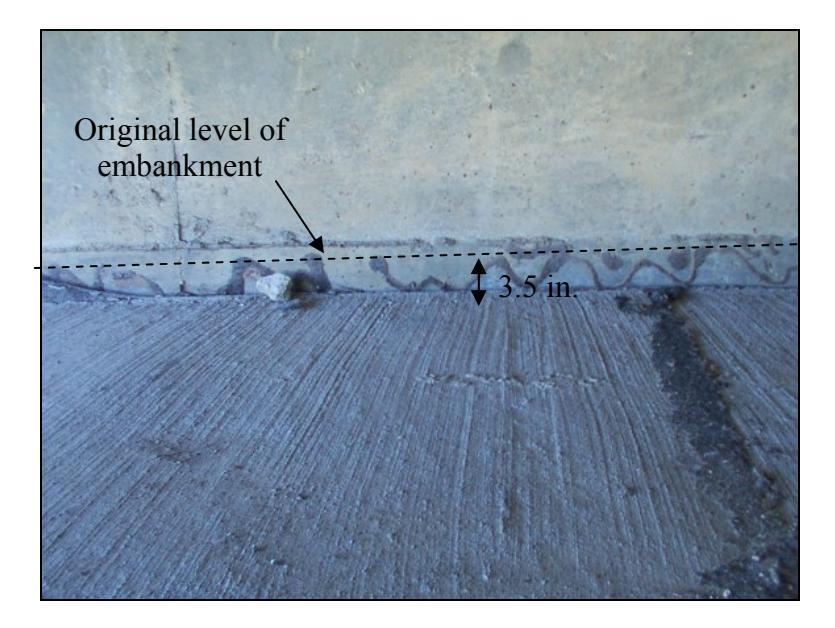
Figure 300. Settlement of the embankment at distance of 3.5 in. (South end of NBL)

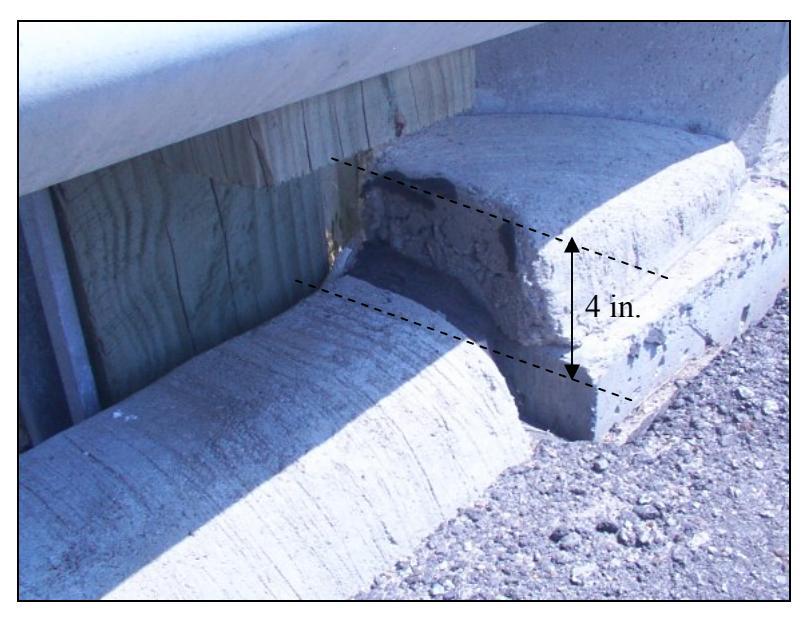
At the north end of the southbound lanes, 4 inches of differential settlement at the bridge approach was measured at the end of the wingwall (Figure 301). Recycled tire chips were used as joint filler for the expansion joint, as shown in Figure 302. The width of the expansion joint was about 5 inches. The concrete slope protection was in good condition.

Figure 301. A 4 in. differential settlement at the bridge approach (North end of SBL)

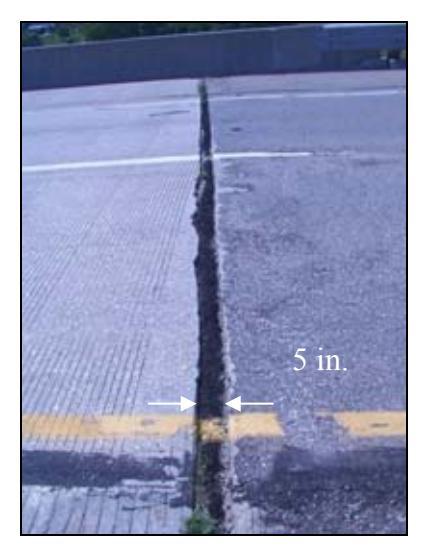
Figure 302. Recycled tires used as joint filler

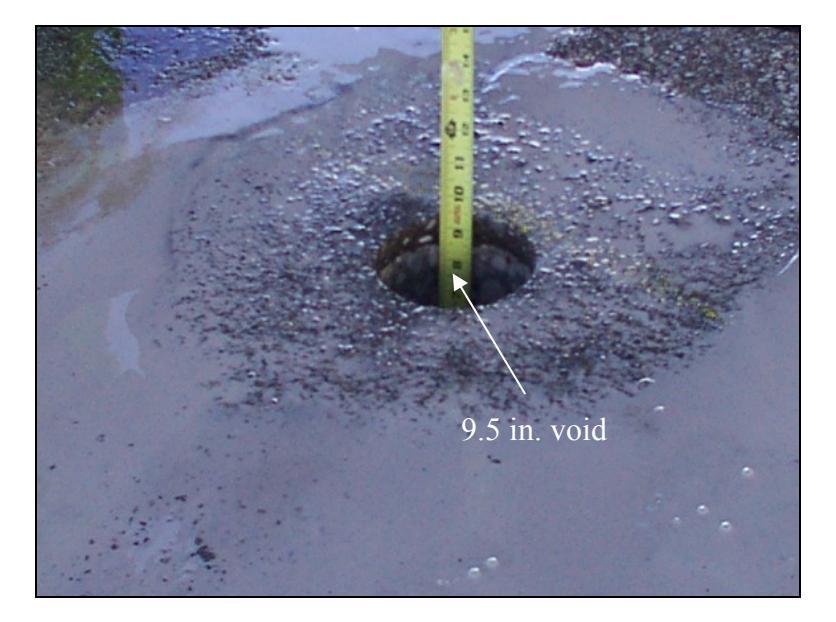
Approach slabs at both ends of the southbound lane were cored. Table 18 summarizes the measured void size, pavement thickness, and paving notch dimensions at the approach slabs. The void under the approach slab was about 9.5 inches at the edge line of the north end approach slab (Figure 303).

Figure 303. A 9.5 in. void under the approach slab estimated by measuring the distance the core dropped (North end of SBL)

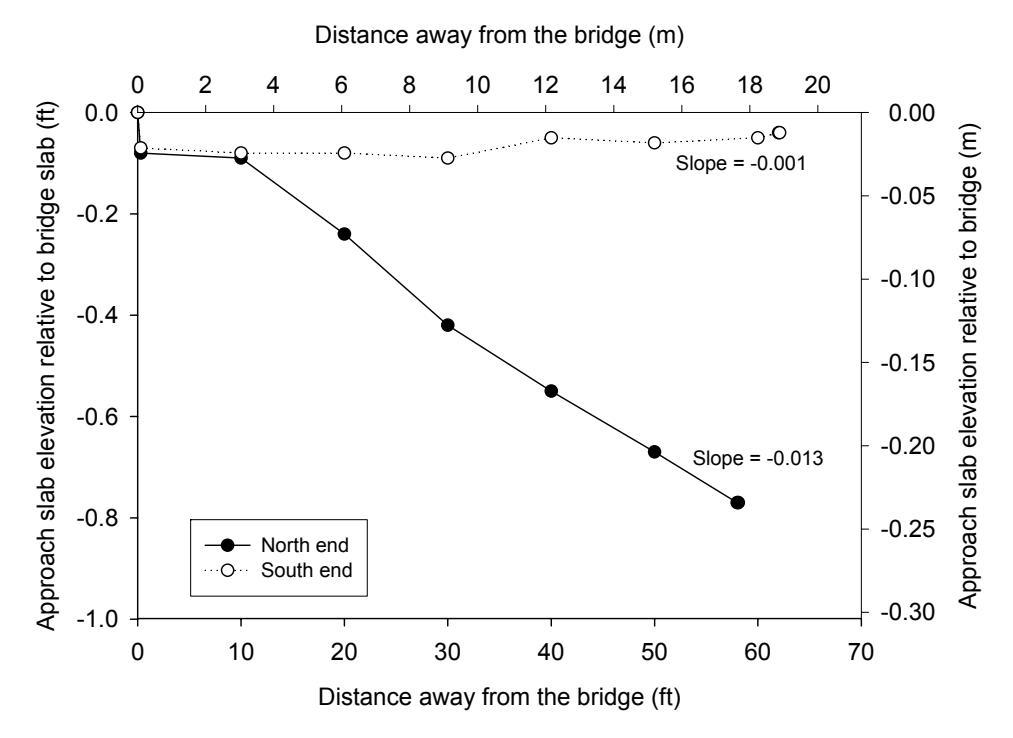
Profiles were obtained for all four ends of the bridge approach pavements (Figures 304 and 305). Differential settlement of the approach slab relative to the bridge slab for both ends of the northbound lane was about 1 inch. The slopes are -0.013 and -0.001 for the north and south end approach slabs, respectively. For the southbound lanes, the maximum settlement relative to the original profile was about 2 inches and 1.8 inches for the north and south end approaches, respectively. The slopes for the north and south ends approach slabs of the southbound lane are - 0.015 and -0.002, respectively. Both approach slabs are sloping away from the bridge, which may indicate settlement of foundation soil or compression of the embankment material.

Figure 304. Profile of the bridge approach relative to bridge slab (NBL)

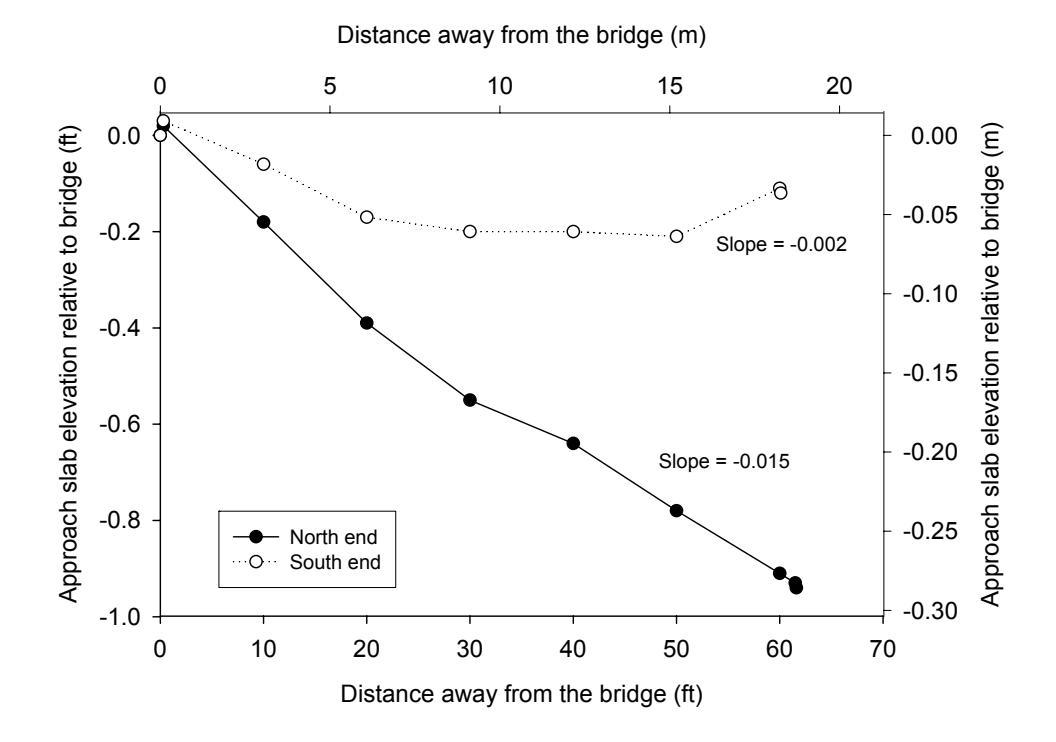
Figure 305. Profile of the bridge approach relative to bridge slab (SBL)

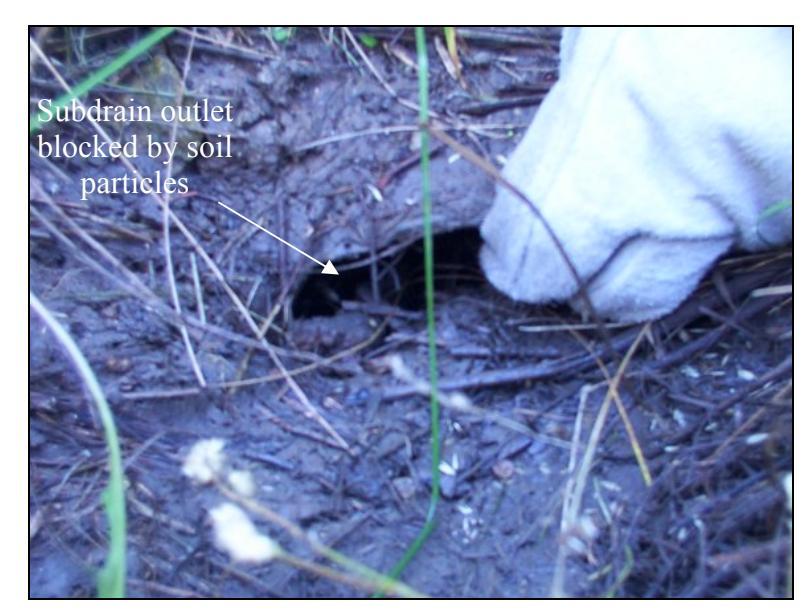
By using the snake camera at the north end of the northbound subdrain outlet, it was revealed that the subdrain was blocked with soil debris (Figure 306). Unlike other bridges where the subdrain outlet was day-lighted horizontally away from the abutment, this outlet was located at the bottom of the downslope embankment.

Figure 306. Subdrain outlet, located at the bottom of the embankment, blocked by soil debris

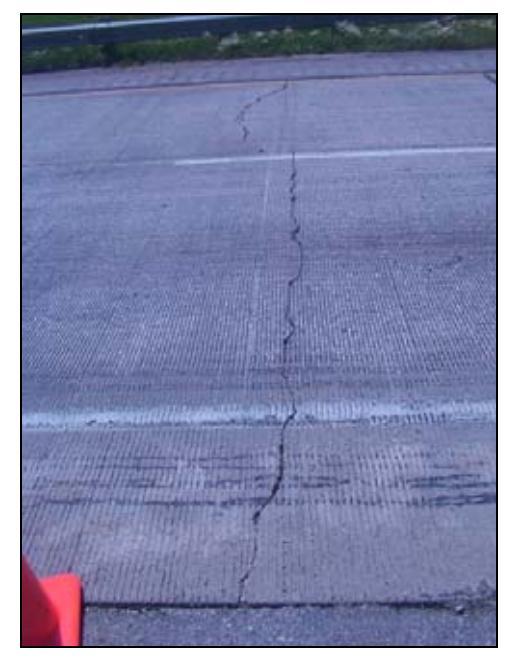
This bridge is a three-span bridge with concrete girders and integral abutments. At the north end of the northbound lanes, differential settlement of 2.5 inches was measured relative to the wingwall. Transverse cracks at the approach slab were visible (Figure 307). The expansion joint was 3.25 inches wide and filled with flexible foam filler, but not sealed. No settlement was observed at the embankment under the bridge, and the concrete slope protection appeared to be in a good condition. The outlet of the subdrain was in a satisfactory condition but was dry.

Figure 307. Transverse cracks at the bridge approach

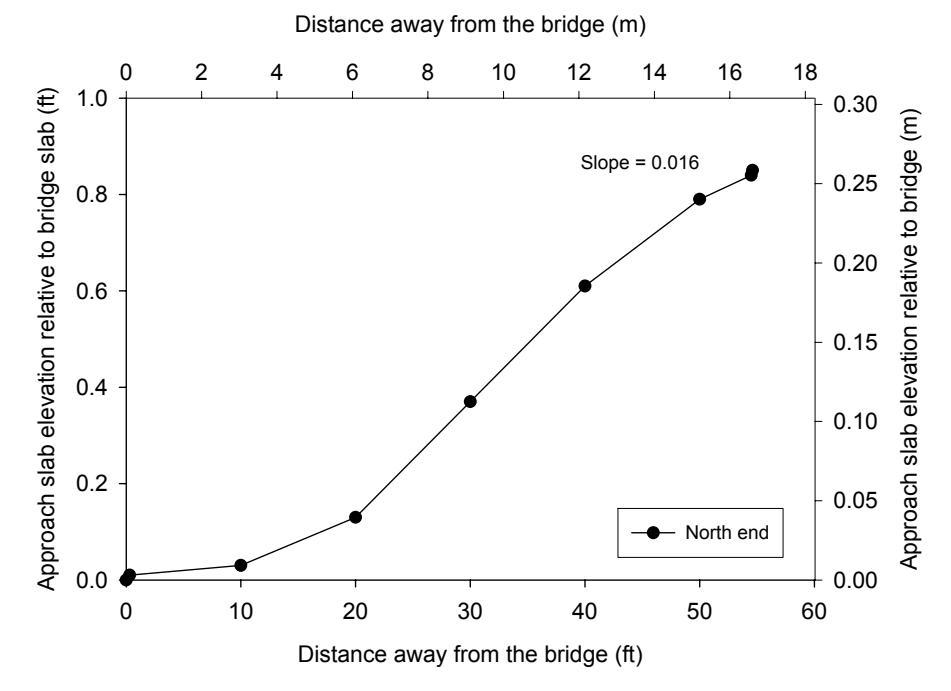
Elevation profile measurements are shown in Figure 308. The maximum settlement relative to the original profile was about 2 inches at 20 feet from the bridge abutment. The slope of the approach slab is 0.016.

Figure 308. Profile of the bridge approach relative to bridge slab (North end of NBL)

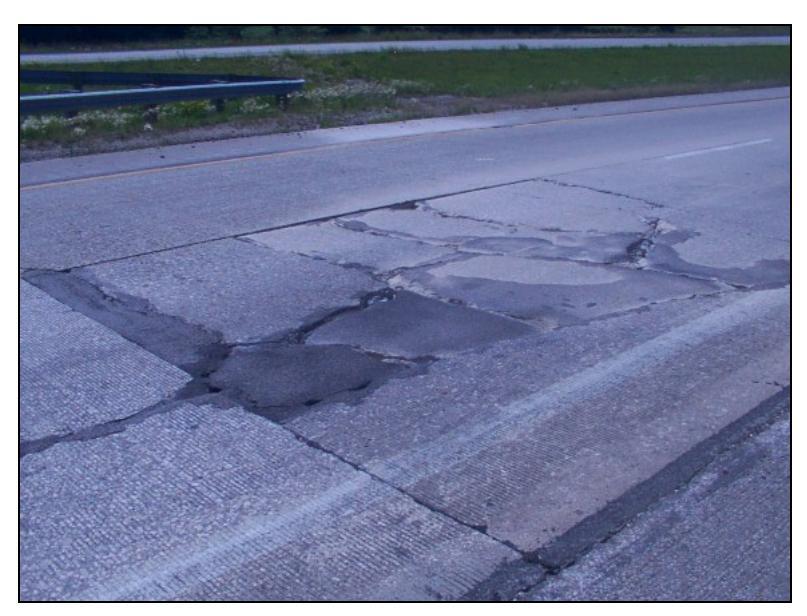
Significant damage to the approach pavement was observed (Figure 309). Although, the expansion joint condition was satisfactory, the strip seal was cut short allowing water to erode soil from around the abutment. At the embankment under the bridge, the unprotected slope was moderately eroded. The outlet of the end drain was damaged and appeared to be dry and not functioning (Figure 310).

Figure 309. Severe cracking at the bridge approach pavement (North end of NBL)

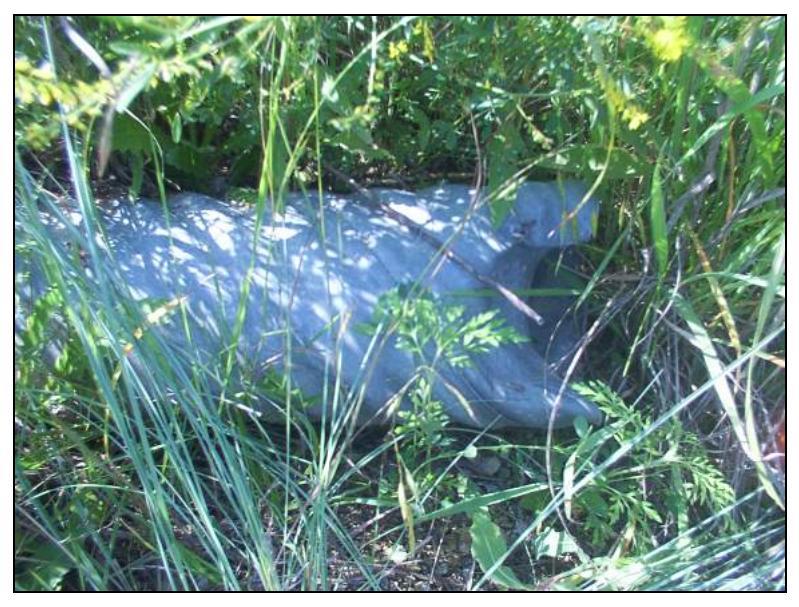
Figure 310. Damaged end drain (North end of NBL)

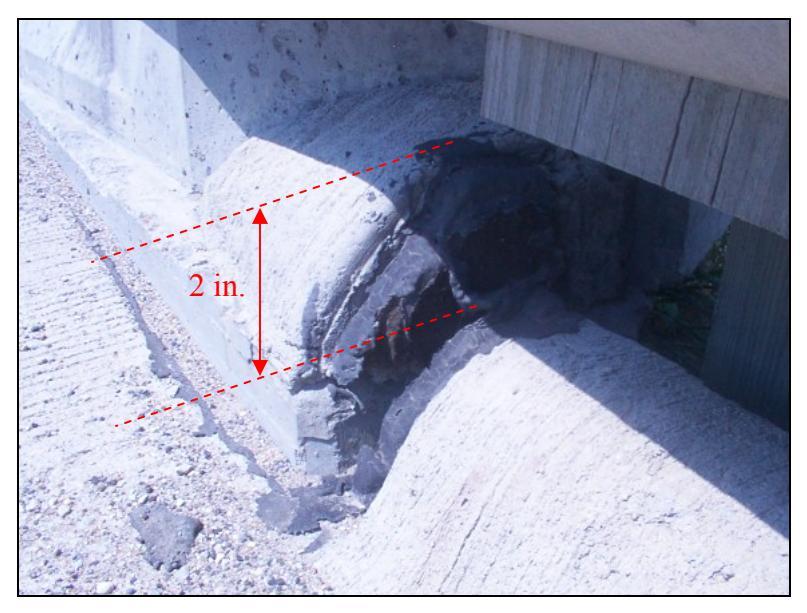
At the south end, an asphalt overlay had been previously placed because of differential settlement at the bridge approach. Nonetheless, differential settlement of 2 inches was observed relative to the wingwall (Figures 311 and 312). The end drain appeared to be in good condition.

Figure 312. Differential settlement at the bridge approach (South end of NBL)

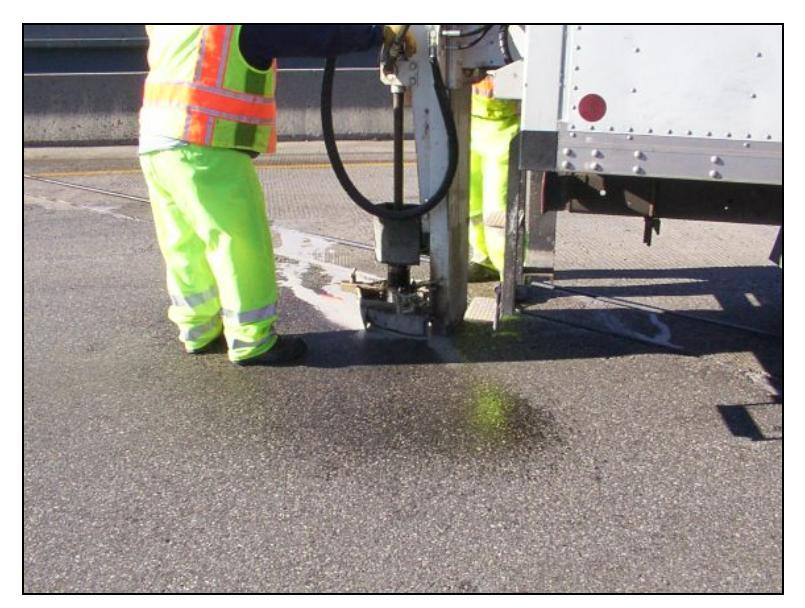
Figure 313 shows the approach slab cores at both bounds. Table 19 presents the void sizes measured under each approach slab. The maximum voids measured at the north and south end approach slabs were 4.5 and 5 inches at the edge line, respectively. The void under the north end of the southbound approach slab was about 0.5 inches, as shown in Figure 314. As performed at other bridges, expanding foam was placed after obtaining cores to plug the core hole, as shown in Figure 315.

Figure 313. Coring at bridge approach (NBL)

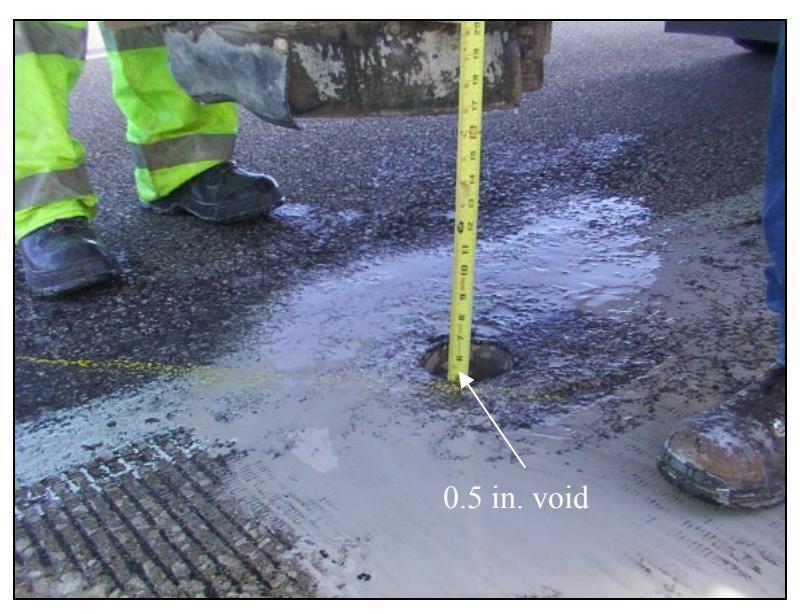
Figure 314. Measuring the void under the approach slab (North end of SBL)

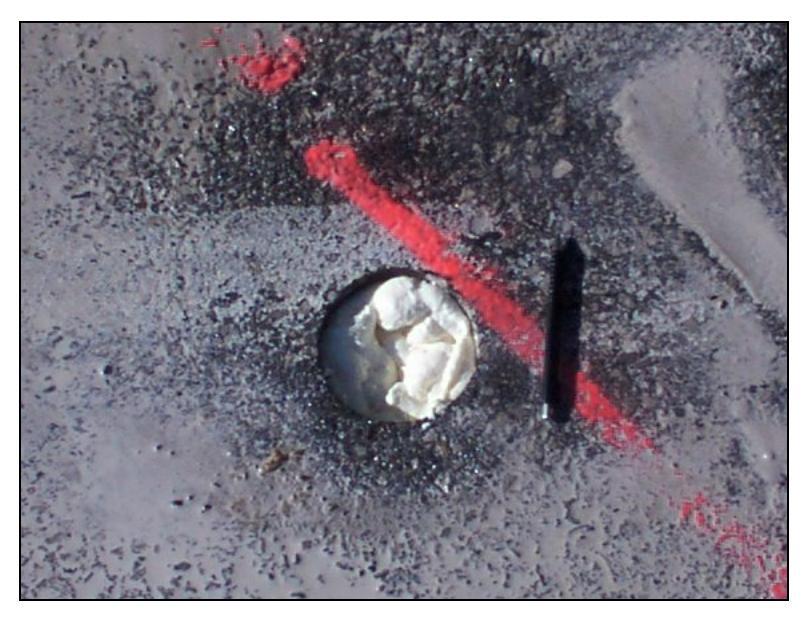
Figure 315. Expanding foam placed in the core hole of the approach slab (NBL)

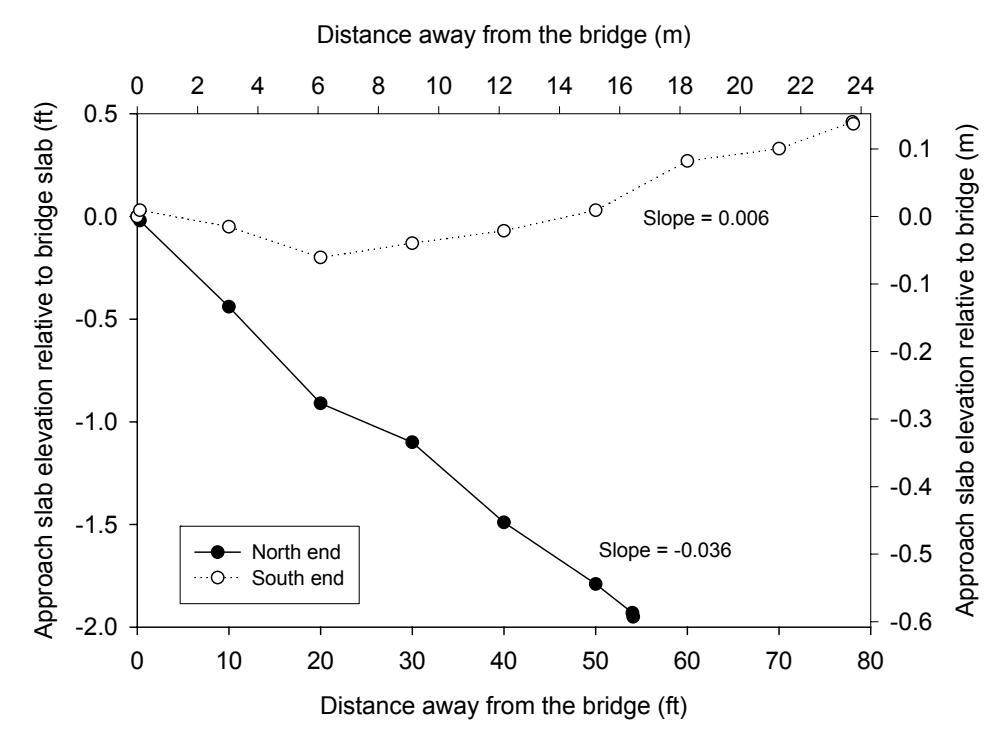
Figures 316 and 317 show the bridge approach profiles at all four ends. The approach slab at the north end of the north bound settled about 2 inches at 20 feet from the bridge abutment. The south end approach slab settled about 4 inches at 20 feet from the bridge abutment. The slopes for the north and south end approach slabs are -0.036 and 0.006, respectively. At the southbound lanes, the north end approach slab settled about 1 inch at 40 feet away from the bridge relative to the original profile, and the south end settled about 5 inches at 20 feet from the bridge abutment. The slopes for the north and south ends approach slabs are -0.029 and -0.001, respectively.

Figure 316. Profile of the bridge approach relative to bridge slab (NBL)

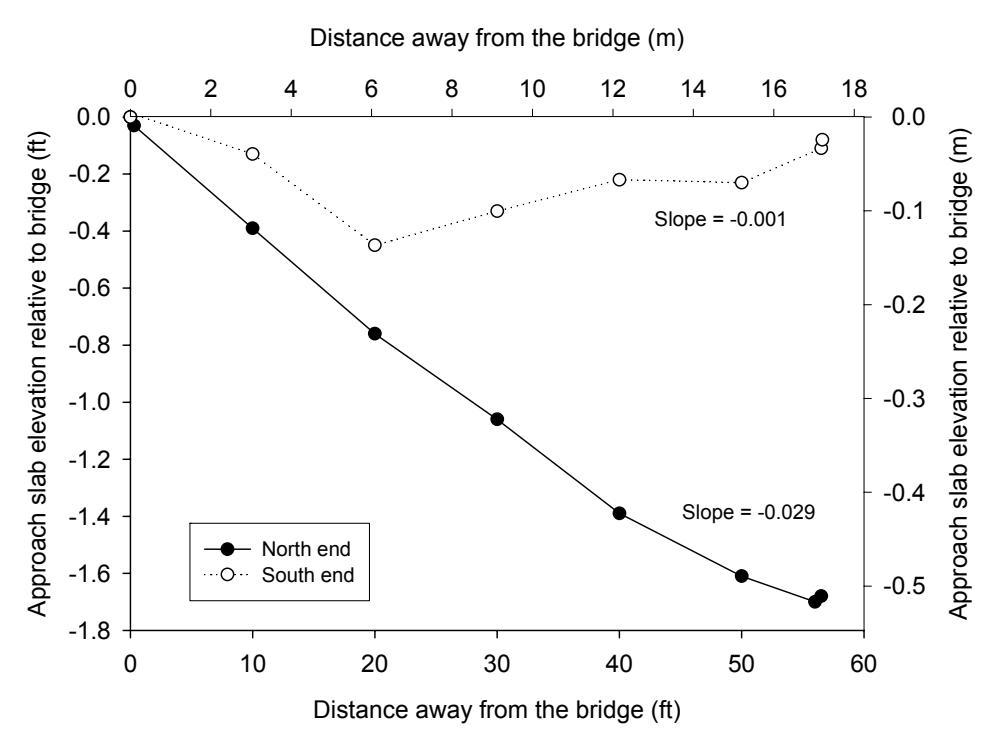
Figure 317. Profile of the bridge approach relative to bridge slab (SBL)

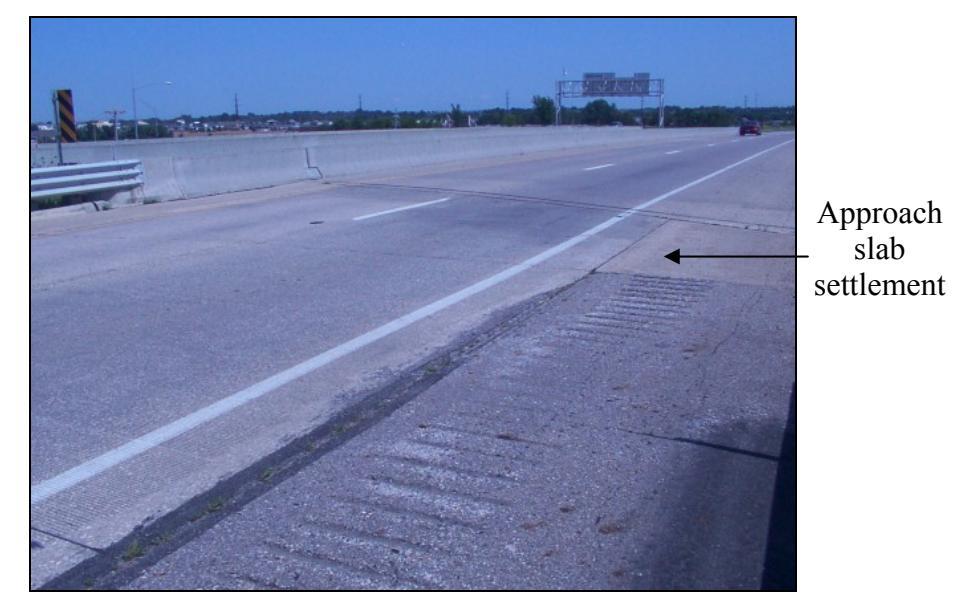
This bridge is a three-span bridge with steel girders and non-integral abutments. At the north end of the southbound lanes, differential settlement at the approach slab was observed (Figure 318). Transverse cracking across the approach slab was also noted (Figure 319). The expansion joint was not sealed. The strip seal was also observed filled with soil particles and cut short. Concrete slope protection of the embankment was in good condition.

Figure 318. Settlement of bridge approach (North end of SBL)

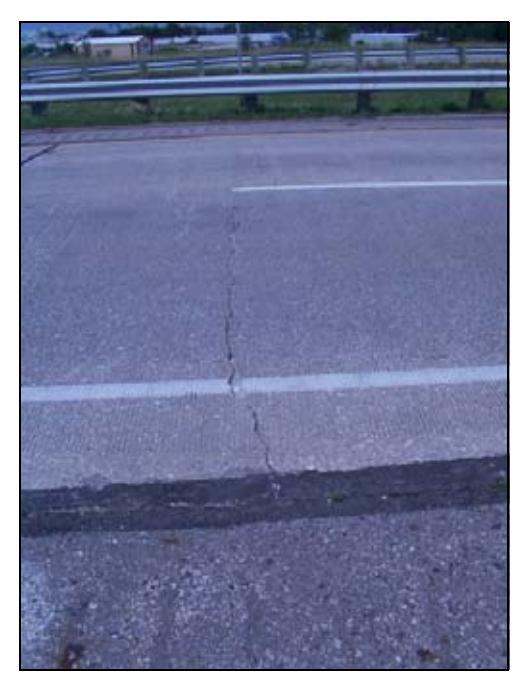
Figure 319. Transverse cracking at the bridge approach (North end of SBL)

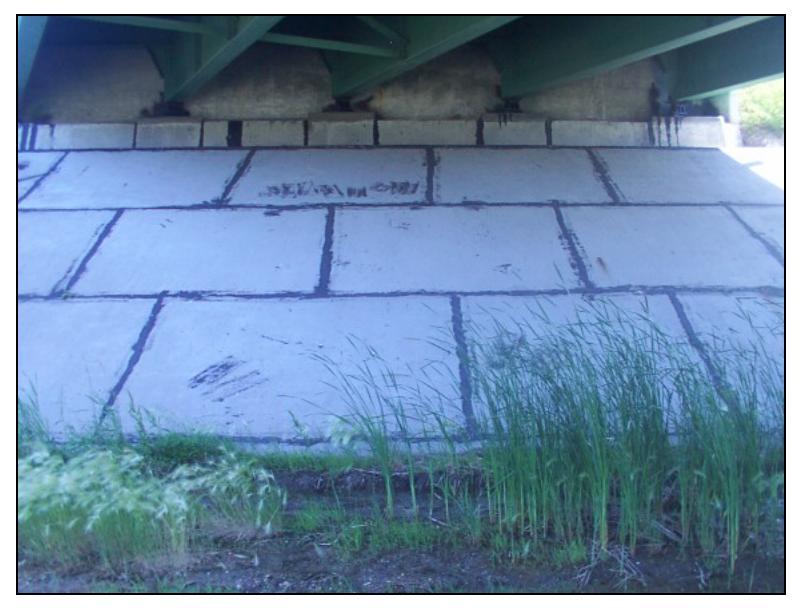
At the south end of the southbound lanes approach slab settlement was observed as shown in Figure 320. The strip seal was filled with soil particles, but the overall condition of the expansion joint was satisfactory. The concrete slope protection was in good condition with no observed settlement (Figure 321).

Figure 321. Bridge embankment in a satisfactory condition

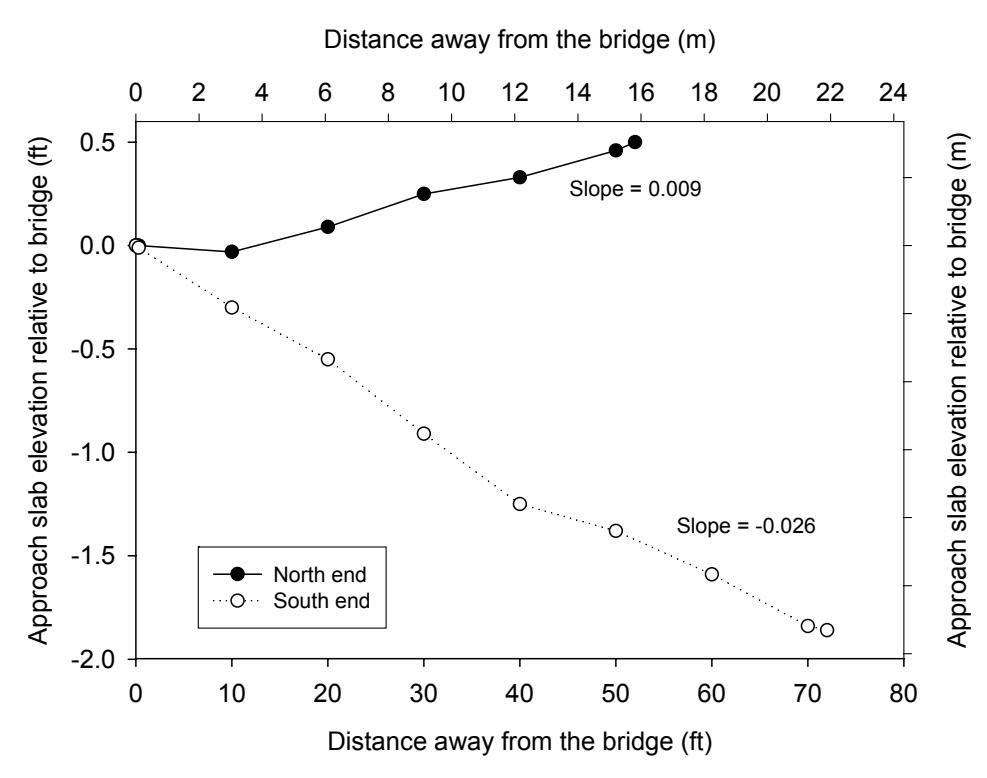
Profiles of both approaches at the edge line of southbound lane are shown in Figure 322. The maximum settlement of the north end approach slab relative to the original profile was 1.2 inches at 10 feet from the bridge abutment. The maximum settlement of the south end approach slab relative to the original profile was about 3 inches at 40 feet from the bridge abutment. The slope of the north and south end approach slabs are 0.009 and -0.026, respectively.

Figure 322. Profile of the bridge approach relative to bridge slab (SBL)

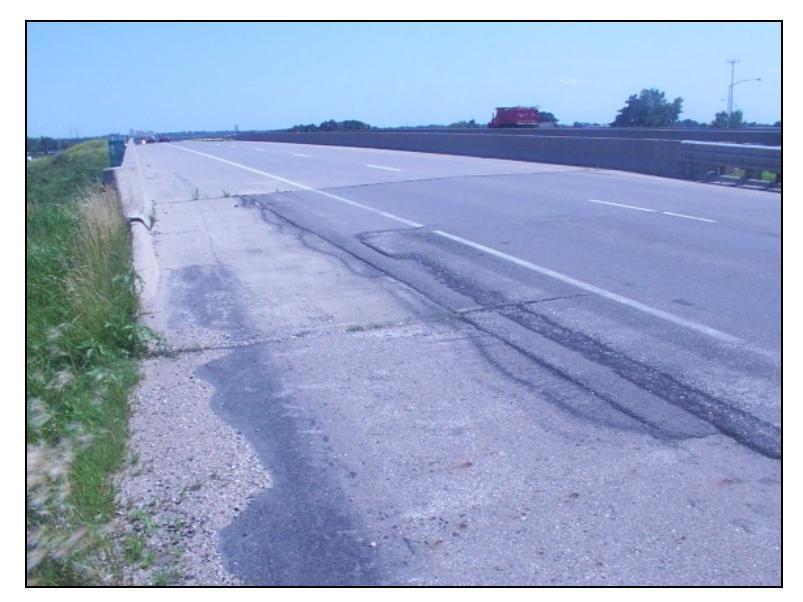
This bridge is a four-span bridge with concrete girders and integral abutments. Although the north end of the northbound lane was overlaid with asphalt, differential settlement of 2 inches was measured at the end of the wingwall (Figure 323). A 2-inch gap between the bridge approach and the wingwall developed due to settlement of the approach slab relative to the wingwall (Figure 324). Recycled tire chips were used as joint filler in the expansion joint. The embankment had settled about 4 inches and a 2-inch horizontal gap had formed between the abutment and embankment, as shown in Figure 325. The slope protection, however, was still in a satisfactory condition.

Figure 323. Asphalt overlay placed to compensate for the differential settlement (North of end NBL)

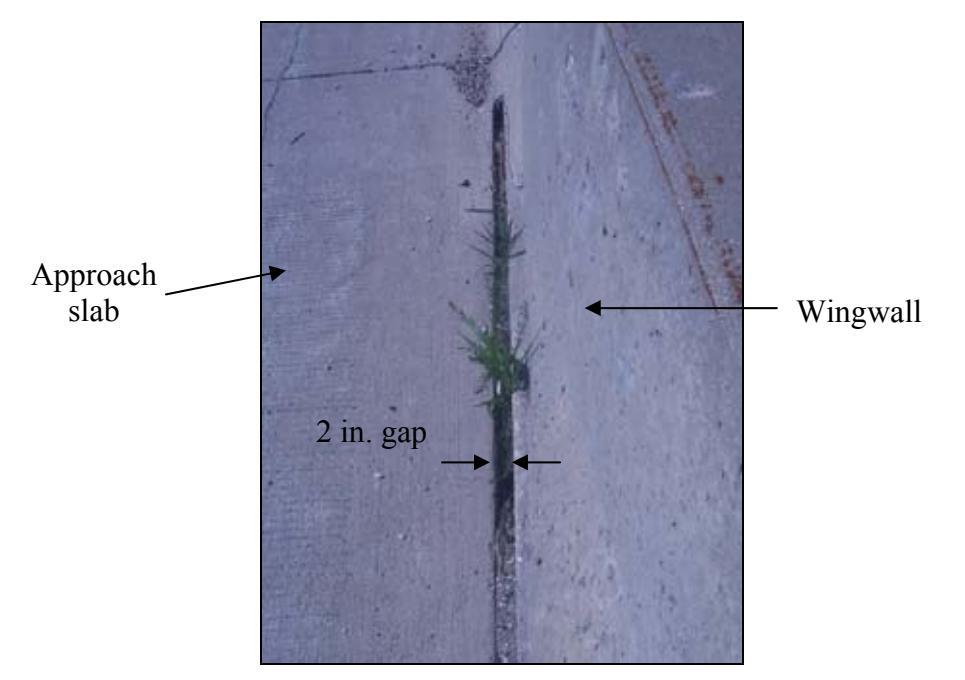
Figure 324. A 2-inch gap formed between the approach slab and the wingwall due to settlement of the approach slab (North end of NBL)
