IDENTIFICATION OF THE BEST PRACTICES FOR DESIGN, CONSTRUCTION, AND REPAIR OF BRIDGE APPROACHES

Iowa DOT Project TR-481 CTRE Project 02-118

Final Report

January 2005

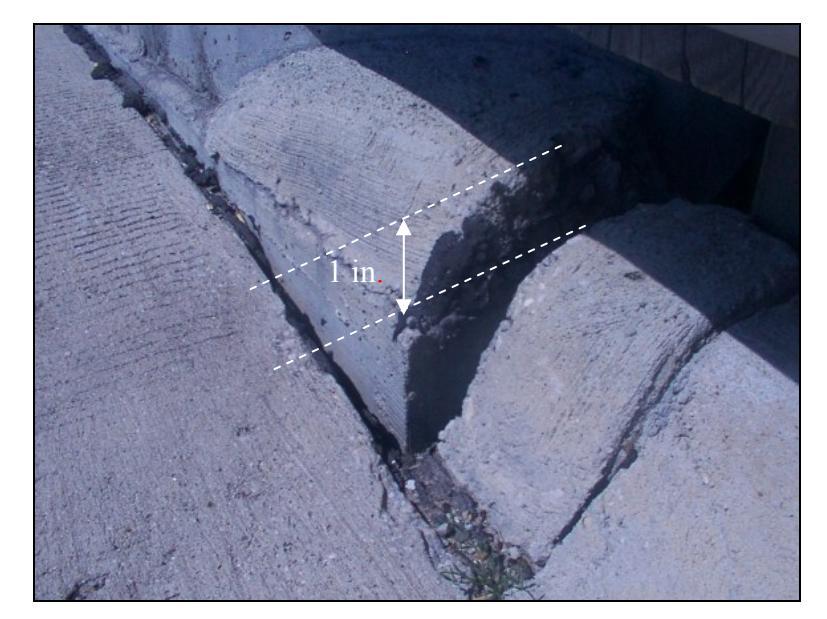
At the south end of the northbound lanes, differential settlement of 1 inch was measured at the end of the wingwall (Figure 326). The width of the expansion joint was about 5 inches. Recycled tire chips were used as joint filler and did not seal the joint. Settlement of the embankment was 4 inches. The end drain was observed to be damaged and not functioning.

Figure 326. Differential settlement at the bridge approach (South end of NBL)

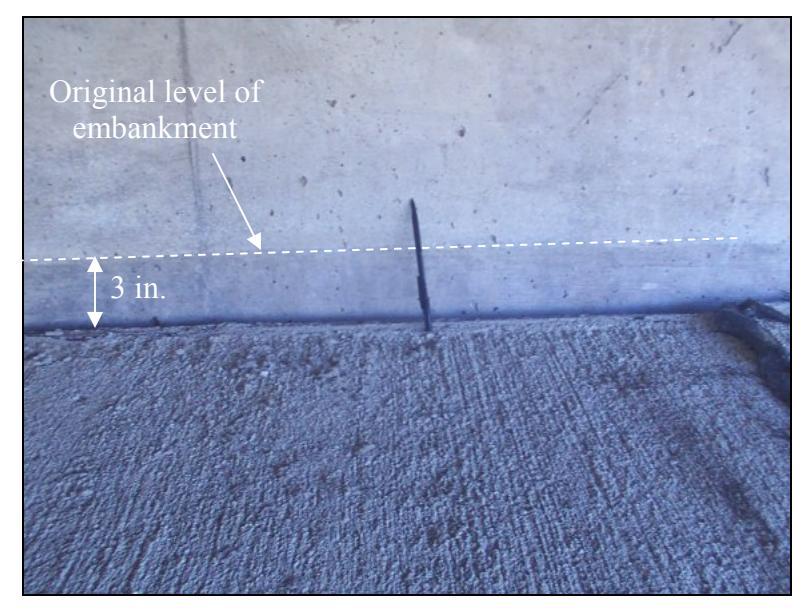
At the north end of the southbound lanes, differential settlement was about 2 inches. Moderate erosion along the sides of the abutment was observed. The concrete slope protection of the embankment under the bridge was in a good condition; however, the embankment settled 3 inches, and a 2-inch gap had developed between the embankment and the abutment (Figure 327).

Figure 327. Settlement of embankment at distance of 3 inches

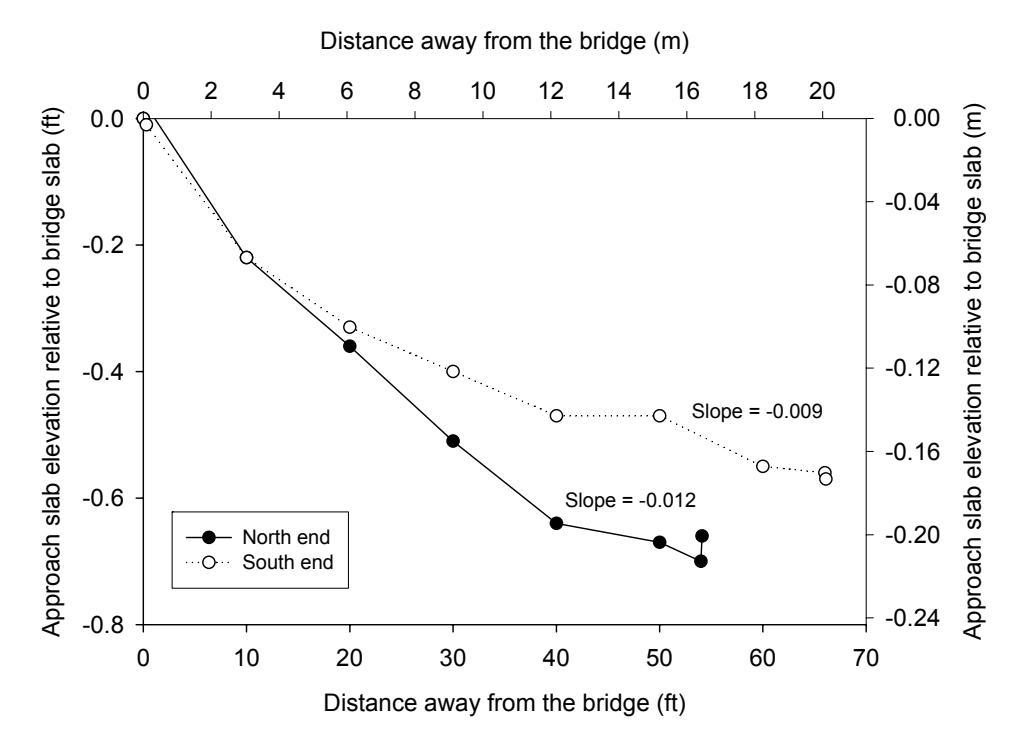
Elevation profiles for all four approaches were obtained from the edge line of the right lane and are shown in Figures 328 and 329. At the northbound lanes, differential settlement between the north end approach slab and the roadway was approximately 0.5 inches and the maximum settlement relative to the original profile was 1.5 inches at 40 feet from the bridge abutment. At the south end, the maximum settlement relative to the original profile was about 1 inch at 40 feet from the bridge abutment. The slopes of the north and south end approach slabs are -0.012 and - 0.009, respectively.

Figure 328. Elevation of the bridge approach relative to the bridge slab (NBL)

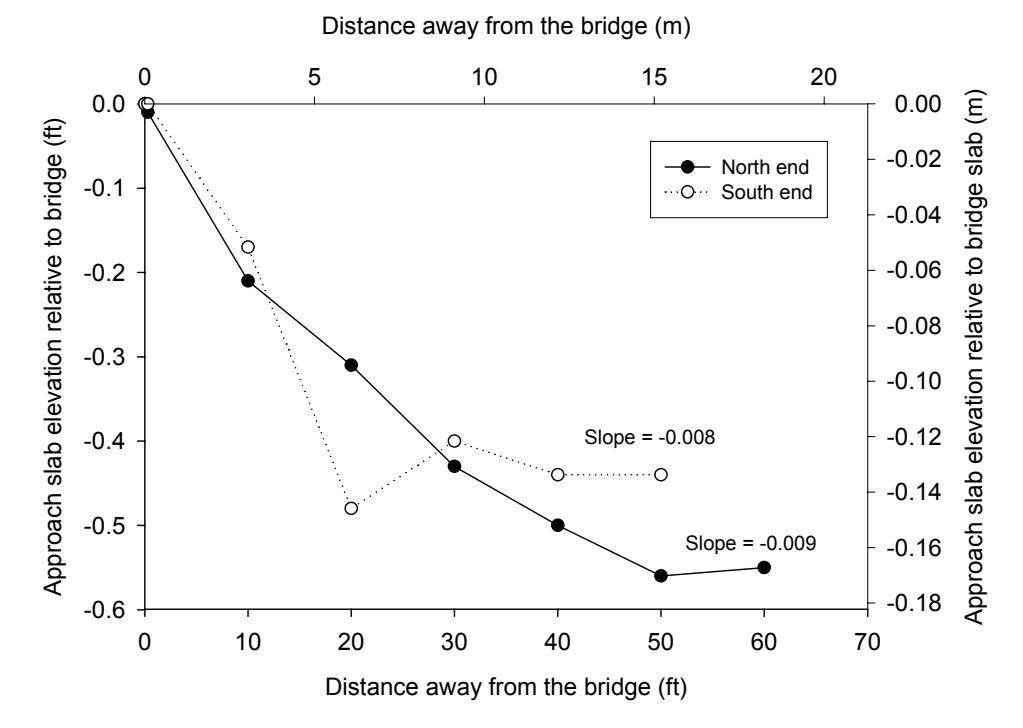
At the south bound, the maximum differential settlement at the north end approach slab relative to the original profile was 1.5 inches at 30 feet from the bridge, while at the south end approach slab, the maximum settlement was 3 inches at 20 feet from the bridge abutment. The slopes of the north and south end approach slabs are -0.009 and -0.008, respectively. All four approach slabs at this bridge slope away from the bridge, which may indicate compression of the embankment soil or settlement of the foundation soil.

Figure 329. Elevation of the bridge approach relative to the bridge slab (SBL)

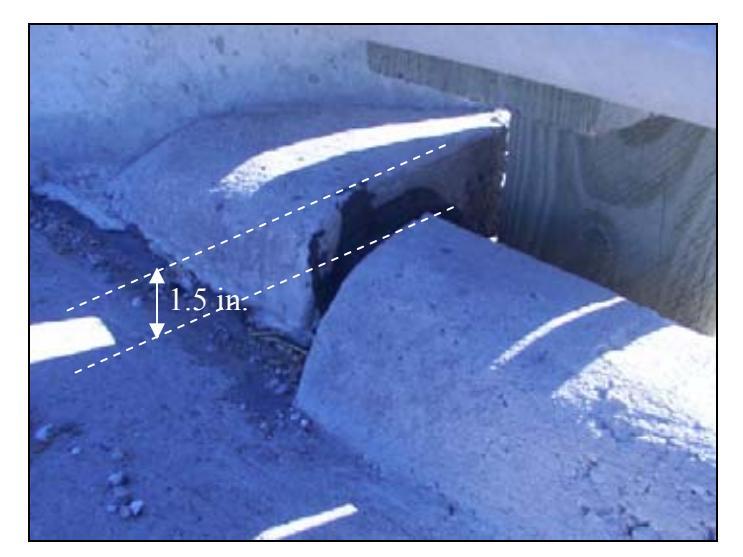
At the west end of the eastbound lane, differential settlement between the bridge approach and the bridge deck at the wingwall was approximately 1.5 inches (Figure 330). Furthermore, the expansion joint sealer was deteriorated exposing the flexible foam filler material, which was poorly sealing the expansion joint leaving a gap for water to flow around the bridge, as shown in Figure 331. The bridge embankment has a slope protection, which was in good condition; however, the embankment settled 3.5 inches, as shown in Figure 332. A 1-inch gap between the bridge embankment and the bridge abutment was measured (Figure 333).

Figure 330. Differential settlement between the bridge approach and the approach slab (West end of EBL)

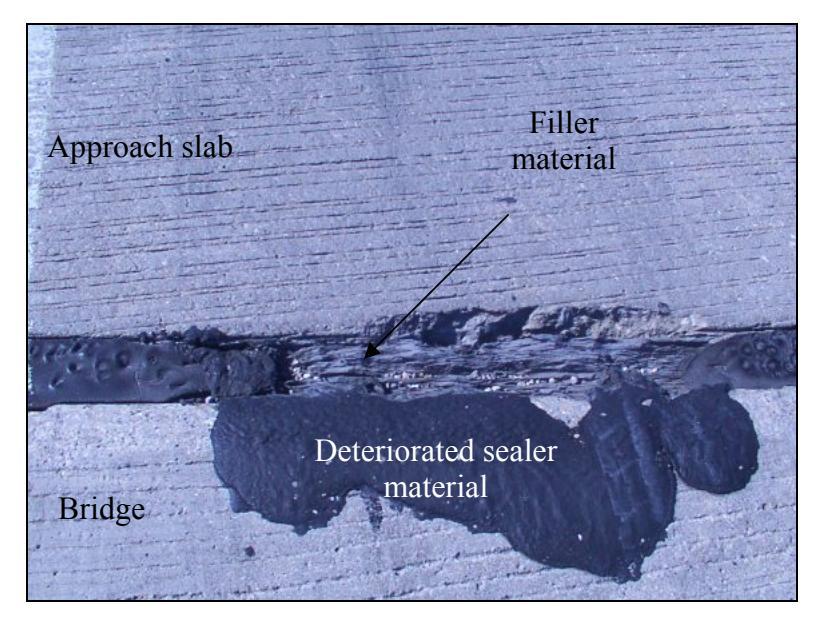
Figure 331. Deterioration of the expansion joint sealer (West end of EBL)

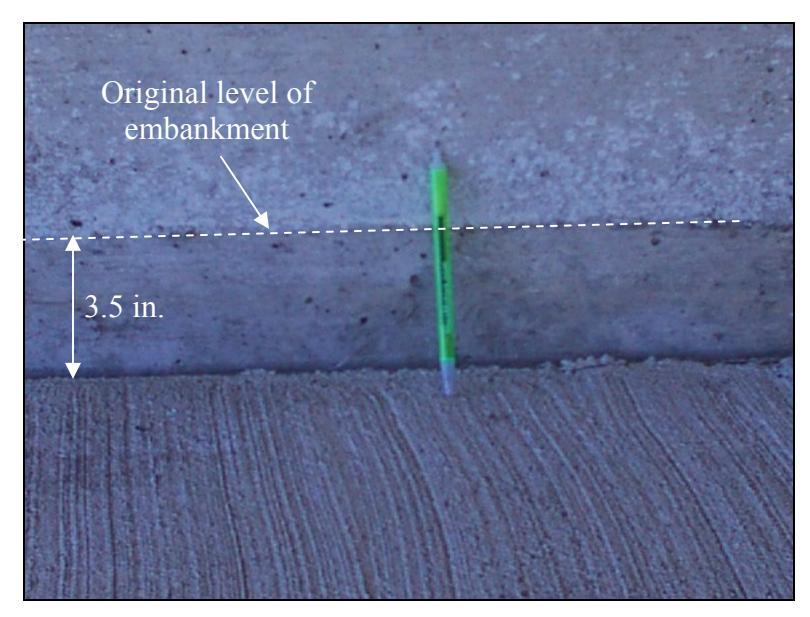
Figure 332. Settlement of the bridge embankment (West end of EBL)

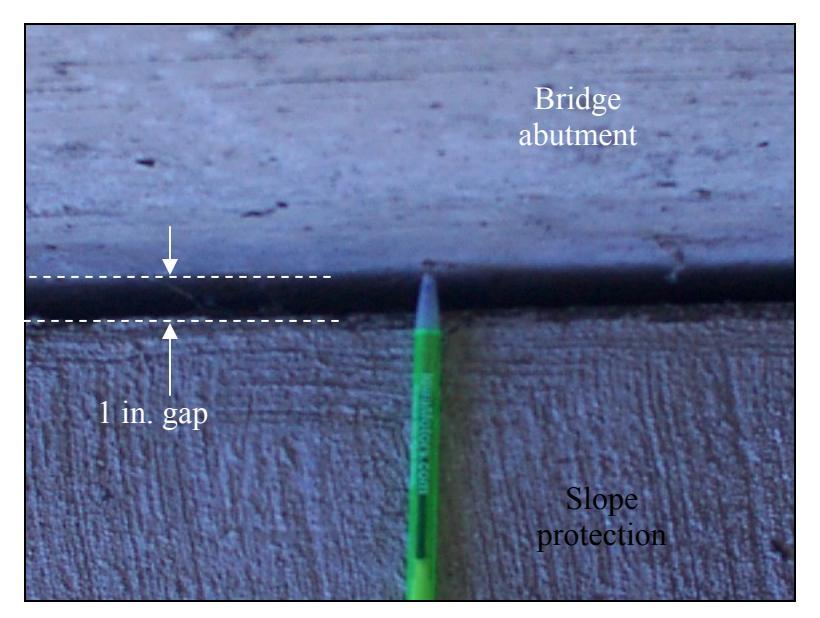
Figure 333. Top view showing a gap between the bridge embankment and the bridge abutment (West end of EBL)

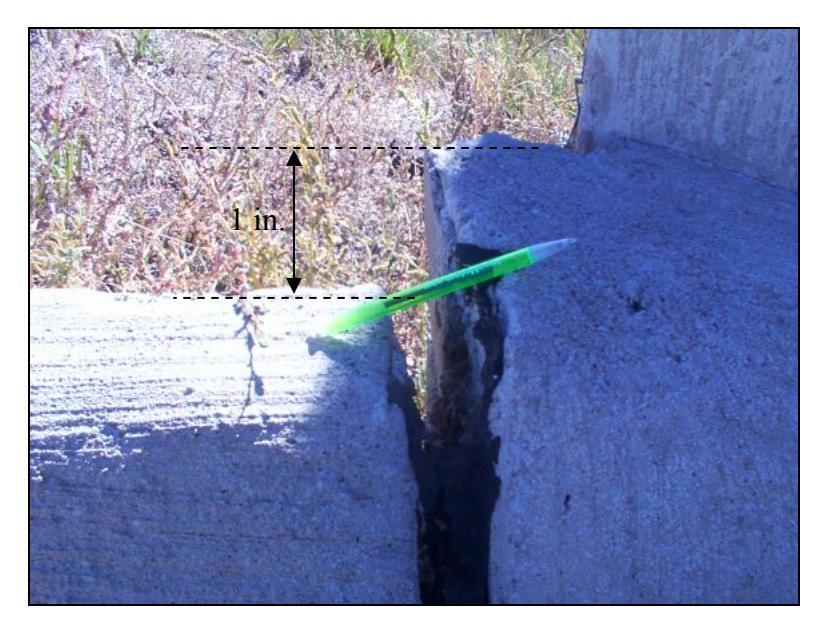
At the east end of the eastbound lane, differential settlement at the wingwall was 1 inch (Figure 334). Similar to the west end, the sealer material at the expansion joint was deteriorated exposing the flexible foam material, which poorly sealed the expansion joint. In addition, concrete spalling near the expansion joint was observed (See Figure 335).

Figure 334. Differential settlement between the bridge approach and the approach slab (East end of EBL)

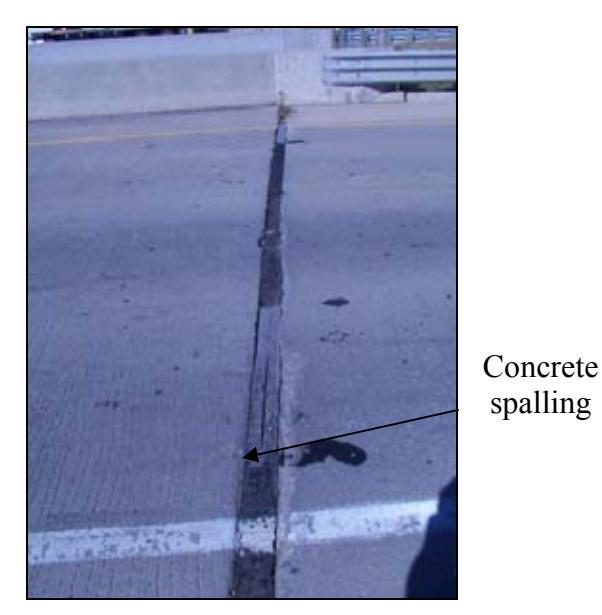
Figure 335. Poorly sealed expansion joint with concrete spalling (East end of EBL)

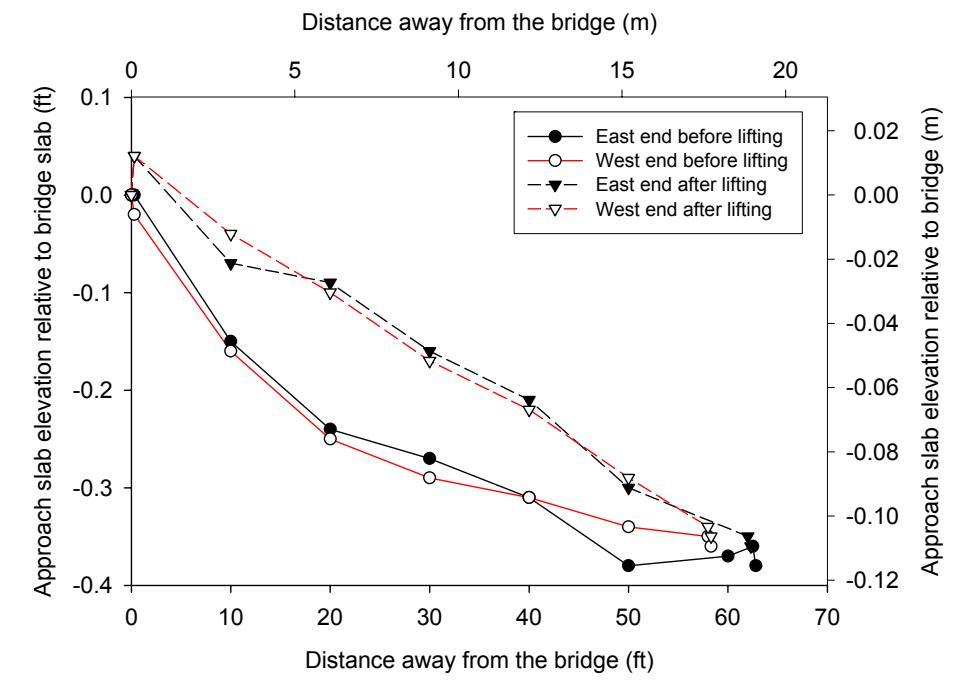
Figure 336. Approach slabs elevations before and after injecting the expansive polyurethane (EBL)

URETEK, Inc., injected polyurethane material under both approach slabs at the eastbound lane to alleviate the bump caused by excessive settlement. The profiles of the approach slabs before and after injecting the expansive polyurethane were measured. Both approaches were lifted approximately 1.8 inches at 20 feet away from the bridge; however, both approach slabs were lifted approximately 0.5 inch higher than the bridge deck level, creating a bump.

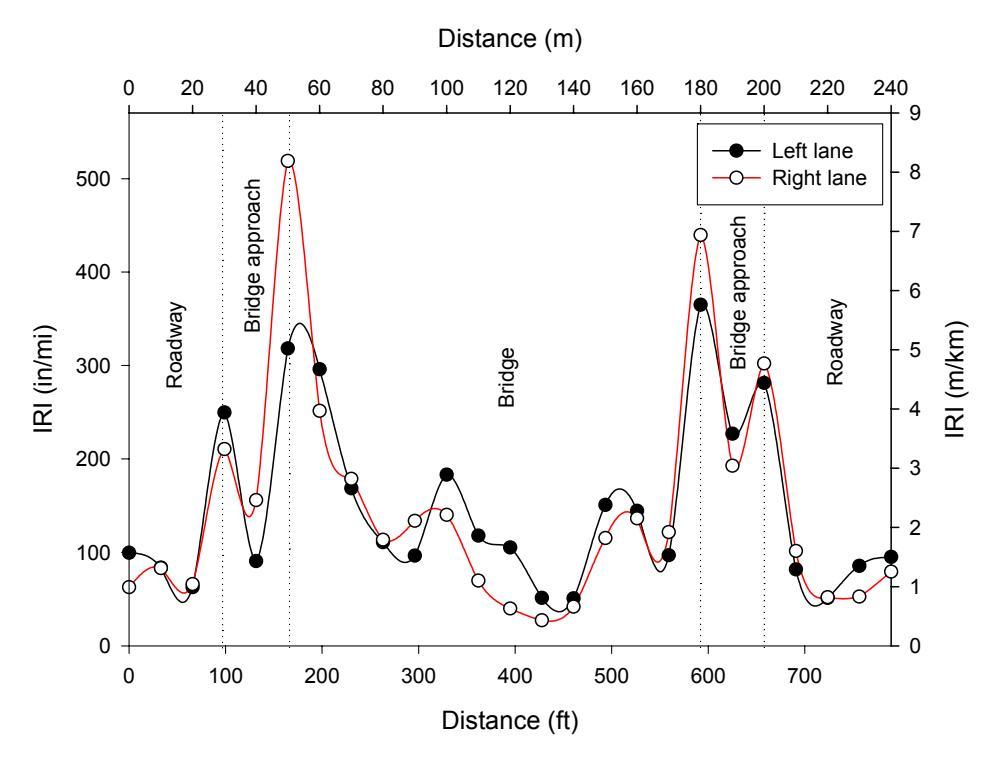
IRI results obtained from the Center for Transportation Research and Education (CTRE) at Iowa State University were from measurements made between 2001 and 2003. The IRI data was provided for 10 bridges and 27 bridge approaches (see Appendix D for all profiles). A sample of IRI profiles is shown in Figure 337. The transition between the roadway and the approach slab, and the transition between the approach slab and the bridge have significantly higher IRI values. These values ranged from 3.9 to 11.8 m/km.

Figure 337. IRI graph; Bridge no. 7777.0065 SBL

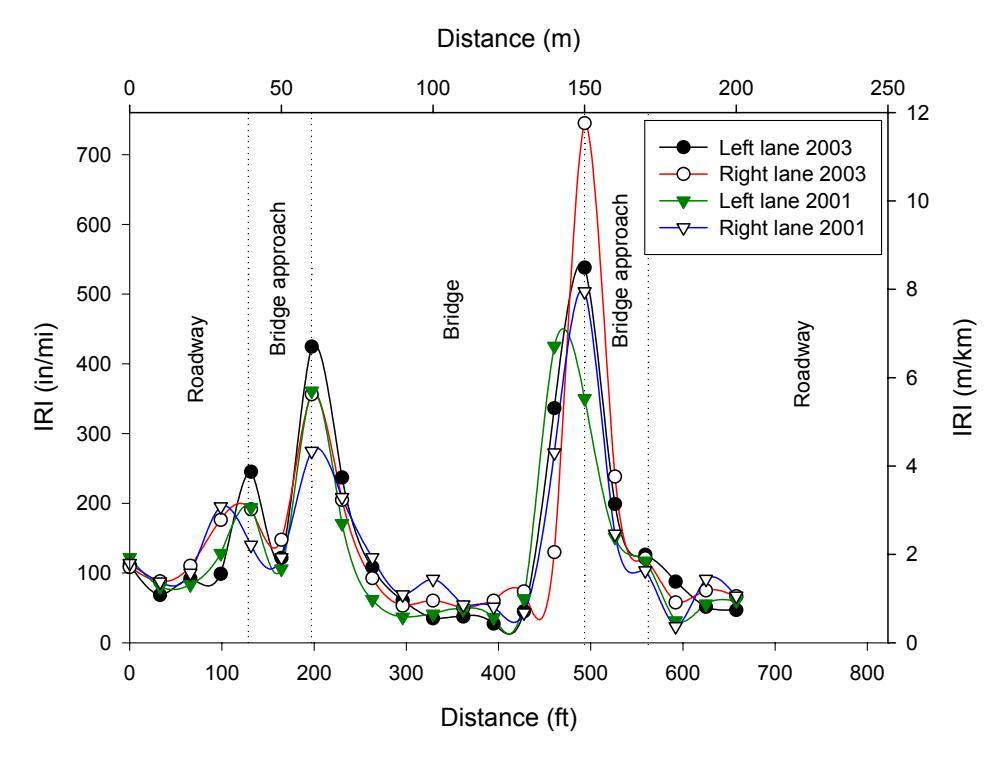
The 2001 IRI values of the bridges on U.S. 65 were compared to the 2003 data. A sample of this comparison is shown in Figure 338. Results show that the high IRI values at the two transition locations (i.e., the transition between the road and the approach slab and the transition between the approach slab and the bridge) increase with time, which indicates approach slab deterioration with time. It was determined that IRI values could provide useful information for characterizing bridge approach performance.

Figure 338. Increase of International Roughness Index with time; Bridge no. 7773.0065 NBL

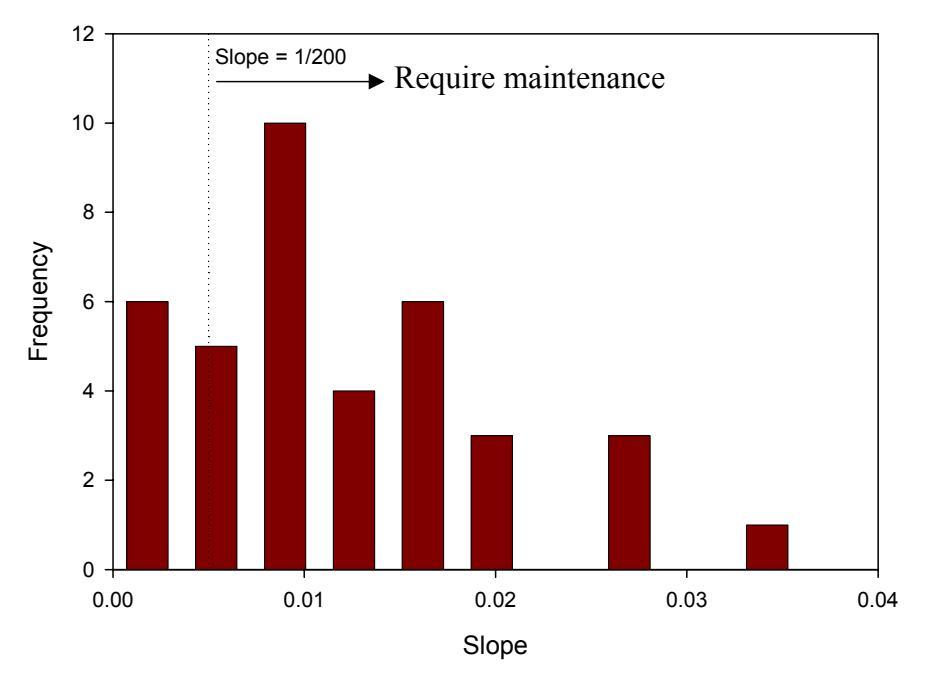
Figure 339. A frequency plot for slopes calculated from approach slab profiles

The elevation profiles of 38 bridge approaches were measured relative to the bridge deck. All profiles were measured at the edge line of the right lane. The slopes of the bridge approach slabs were calculated using the elevations of the first and last points on the bridge approach profile. Figure 339 shows that the majority of the slopes are higher that 1/200 suggested by Wahls (1990) as a maximum slope for bridge approaches. According to this criterion, bridge approaches with slopes higher than 1/200 require maintenance. To further characterize the performance of bridge approaches, the Bridge Approach Index (BI) was developed. The BI is calculated as the area between the original profile and the existing profile of the original profile, which is assumed to be a straight line connecting the bridge slab to the pavement elevation just past the CF joint, and the existing profile over the length of the approach slab. In general, the higher the calculated BI, the worse the approach slab condition.

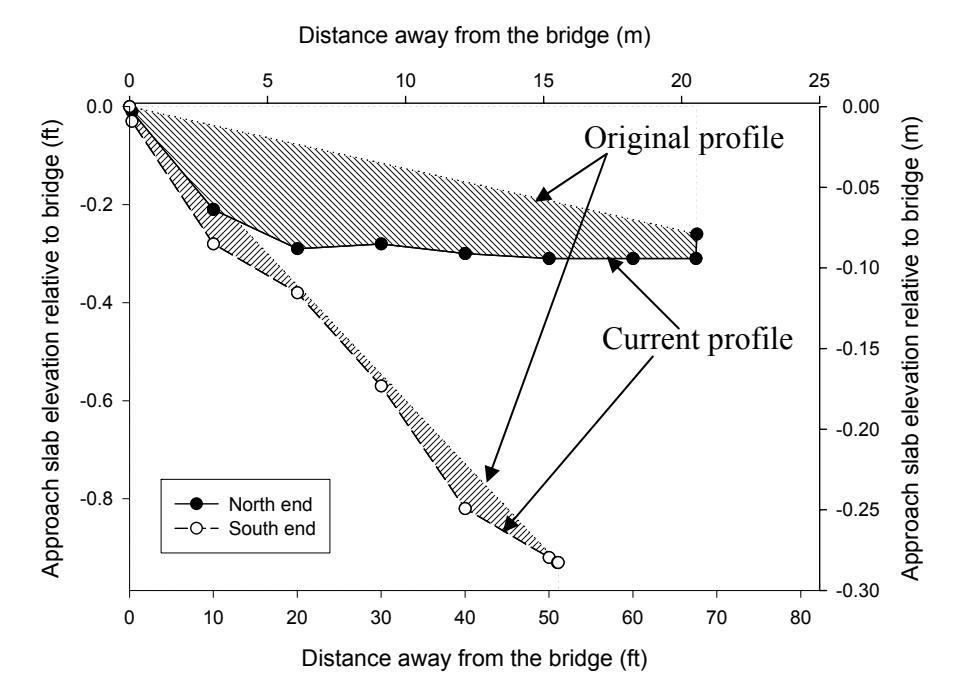
Figure 340. Elevation of two approach slabs relative to bridge; Bridge no. 7777.0065 NBL

Figure 340 shows the profiles of two approach slabs relative to the original profile. A shown, the north end settled more than the south end, which is reflected in the higher area calculation between the original and existing profile. The area calculated for the north end was 50.2 ft^2 (4.7 m²), while the area calculated for the south end was 28.4 ft² (2.6 m²). After dividing by the length, the BI values for these two approaches were 0.822 and 0.557, respectively.

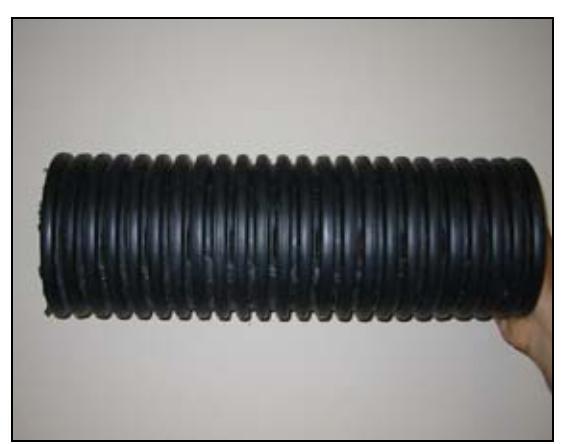
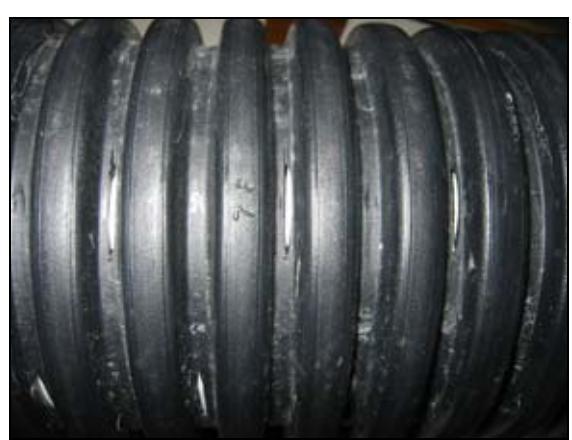
Even though it was specified, at many bridge sites it was observed that no porous backfill was placed around the subdrain. Generally, granular backfill was used in lieu of porous backfill. Iowa DOT specifies that granular backfill material must have 20% to 100% passing the No. 8 sieve and up to 10% passing the No. 200 sieve. Figure 342 shows a typical perforated drainage pipe used for subdrain construction. The width of ten random pipe perforations was measured to compare to the size of granular backfill particles. The largest measured pipe opening was 0.09 in. (2.3 mm) and the average pipe opening was 0.07 in. (2.0 mm), which is similar to the No. 8 sieve opening (2.36 mm). Further, it was found that the majority of granular backfill soil particles are smaller than the subdrain perforation size, which possibly lead to plugged drains. Table 24 shows that the percentage of granular backfill soil particles smaller than the average subdrain perforation size, which possibly lead to plugged drains. Table 24 shows that the percentage of granular backfill soil particles smaller than the average subdrain perforation size, which possibly lead to plugged drains. Table 24 shows that the percentage of granular backfill soil particles smaller than the average subdrain perforation is about 80%.

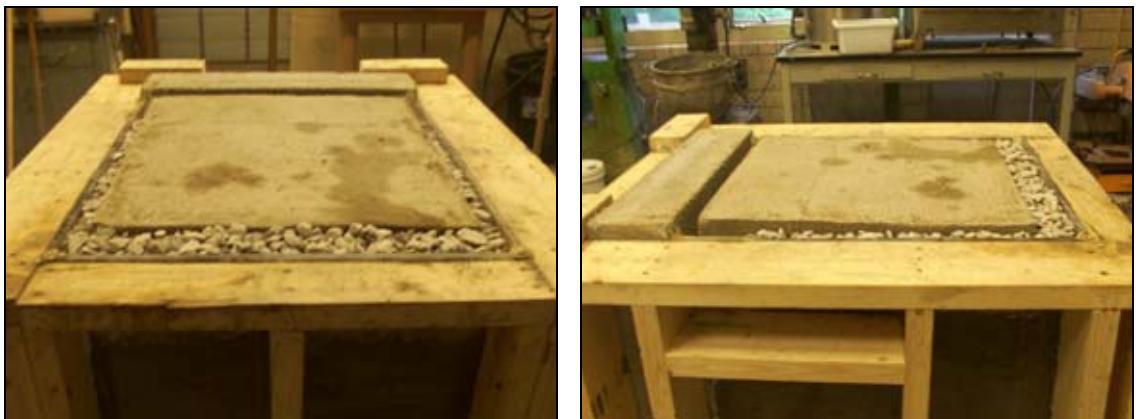
Figure 360. Level of bridge approach before the test

Water began to flow out of the subdrain after 10 minutes of introducing water through the expansion joint. Initially, fine soil particles were observed in the water. After 15 minutes, the water became clear. Table 25 summarizes the results of this test. The maximum achieved steady state flow was 32cm^3 /sec. A void developed at the abutment that measured 4.5 inches deep and extended through the full width of the approach slab. The maximum differential settlement was 2 inches (Figures 360 and 361). An interesting observation is that water only entered the drain tile from the bottom perforations. One might expect water to enter from the top and bottom perforations. A possible explanation of why water only entered from the bottom is that the soil particles plugged the voids of the porous backfill and/or the pipe openings.

-
Backfill type	Granular backfill with porous fill around subdrain and special backfill under the approach slab
Moisture content	3.0 %
Compaction	By tamper every 2 in. lift
	Left side: 2.0 in.
Settlement (III)	Right side: 1.5 in.
Void (in)	Left side: 4.5 in. deep at the abutment face and extending 8.5 in. under the approach slab
void (in)	Right side: 3.5 in. deep at the abutment face and extending 9.0 in. under the approach slab
Maximum steady state flow (cm ³ /sec)	32.0
Time for water to drain (min)	10

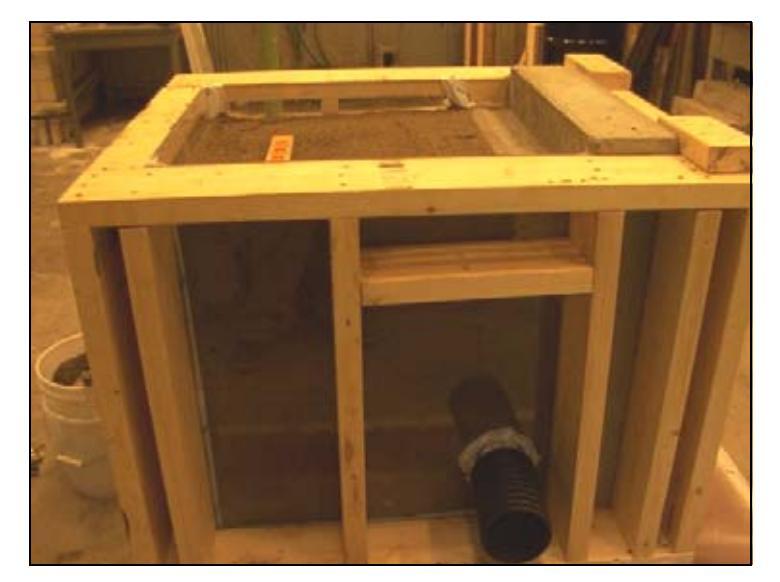
Figure 365. Granular backfill placed behind the abutment

The purpose of this test was to recreate the construction practices observed during field visits made to several newly constructed bridges. The backfill was placed at an average moisture content of about 3% and compacted by its own weight to simulate dumping. Furthermore, no porous backfill was placed around the subdrain (Figure 365).

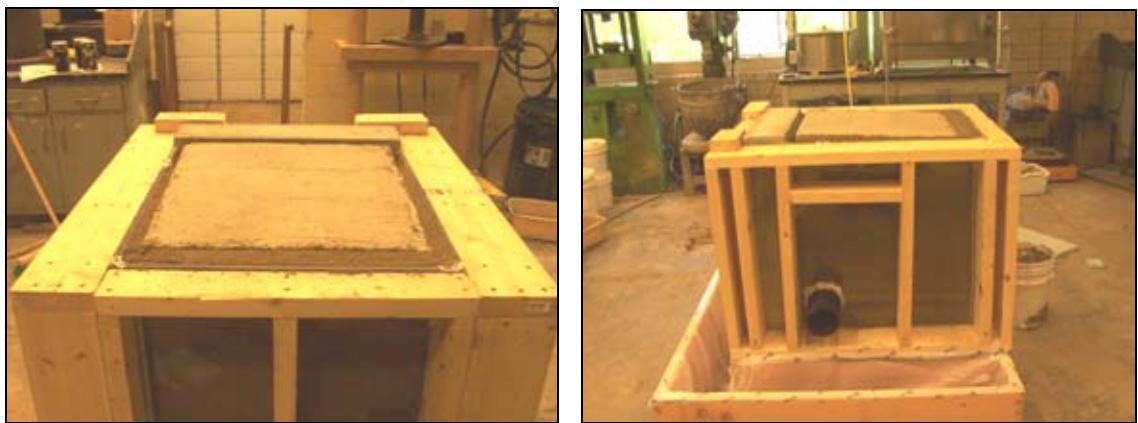
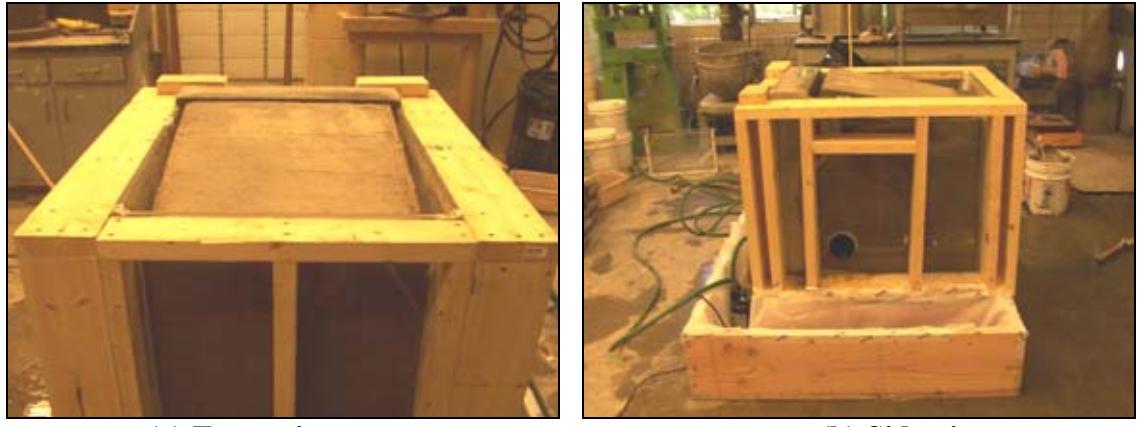
Figure 366. Level of bridge approach before the test

The water began to flow out of the subdrain after 10 minutes. Fine soil particles were washed out of the subdrain at the beginning of the test. After 20 minutes, the water became clear. Table 27 summarizes the results of this test. The void formed under the approach slab extended through the full width of the model. The maximum void depth was 4 inches at the abutment and extended 4.5 inches under the approach slab away from the abutment. The highest soil collapse occurred directly above the subdrain. The maximum measured settlement of the approach slab was 2.3 inches (Figures 366 and 367). Water was again observed seeping into the subdrain from the bottom.

Backfill type	Granular
Moisture content	3.0 %
Compaction	By own weight
Sattlamont (in)	Left side: 1.75 in.
Settlement (In)	Right side: 2.25 in.
Void (in)	Left side: 4 in. deep at the abutment face and extending 4.5 in. under the approach slab
void (iii) —	Right side: 3.25 in. deep at the abutment face and extending 4.5 in. under the approach slab
Maximum steady state flow (cm ³ /sec)	33.5
Time for water to drain (min)	10

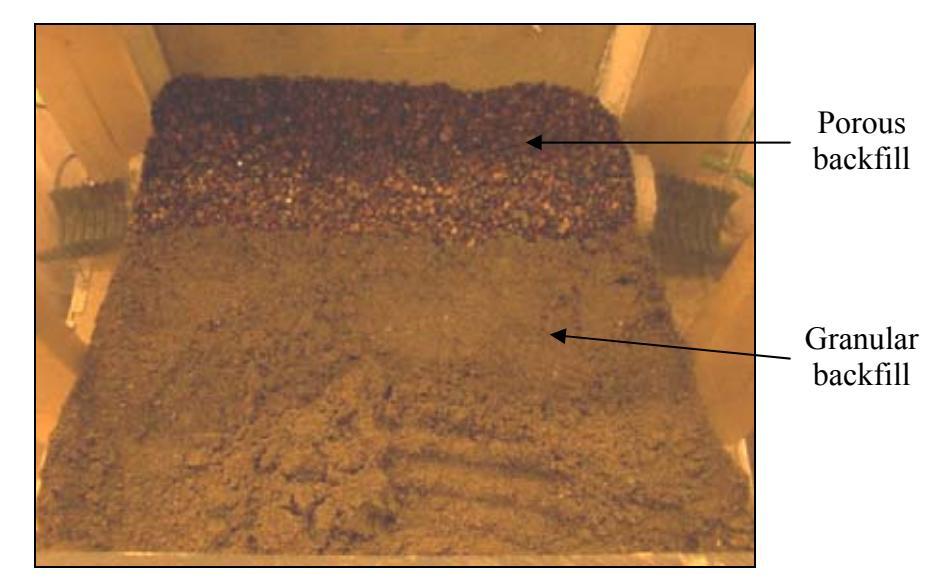
Figure 368. Porous fill placed around the subdrain

The purpose of this test was to simulate field practice observed at two different newly constructed bridges. In both cases, porous backfill was used around the subdrain, but the granular backfill was placed at the bulking moisture content. The porous backfill was placed to a height of 1 inch above the drainage pipe and extended 6.5 inches away from the abutment (Figure 368). Granular backfill was placed at a moisture content of 5.5 %. The backfill material was compacted by its own weight to simulate dumping the backfill behind the abutment.

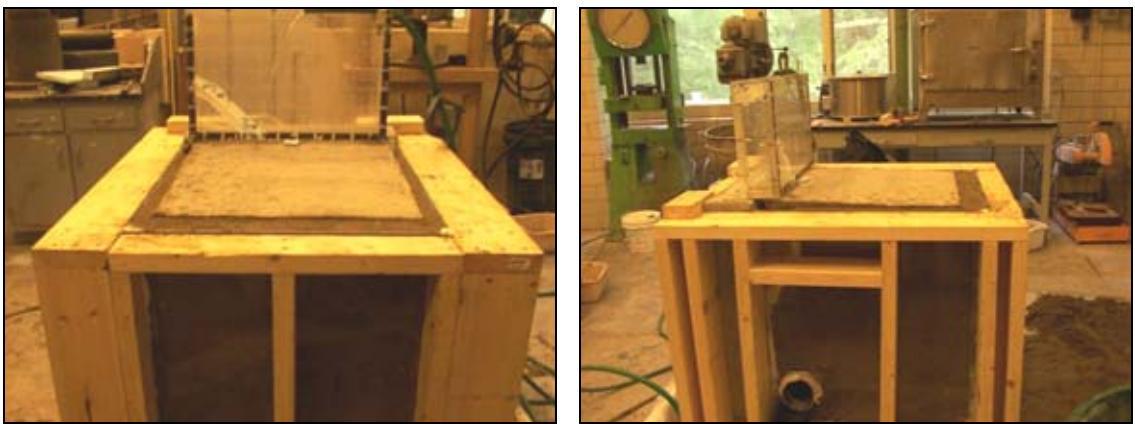
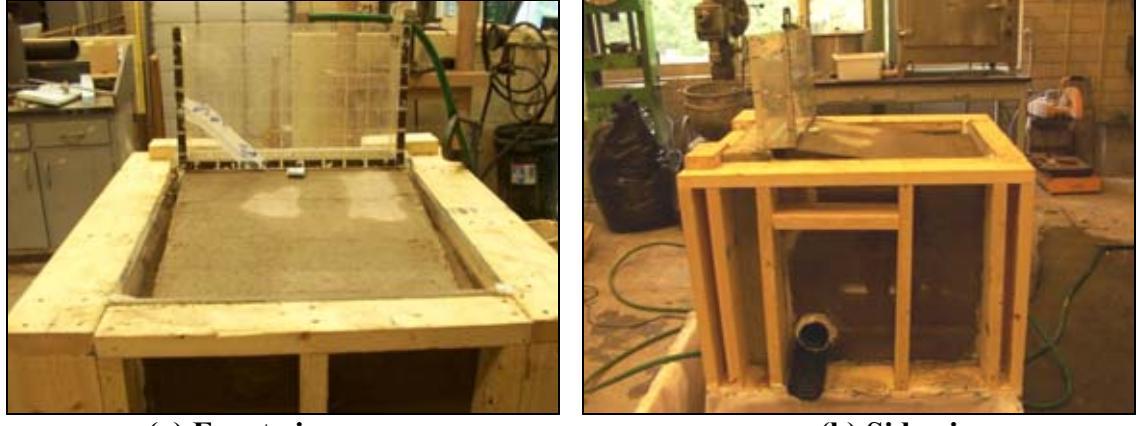
Figure 369. Level of approach slab before the test

Similar to Test 1, water started to flow out of the subdrain after 11 minutes. The maximum steady state flow rate, however, was increased to 67 cm³/sec. The porous backfill seemed to reduce the soil fines entering the subdrain, compared to Test 3. The water became clear after 14 minutes. Drainage out of the subdrain occurred as water rose from the bottom and filled the subdrain. Water was observed draining from the bottom of the drainage pipe. Table 28 summarizes the results of this test. The void was 2 inches deep at the abutment that extended 10 inches away from the abutment and extended the full width of the abutment. Maximum soil collapse occurred above the subdrain, and the maximum measured settlement was 2.3 inches (Figures 369 and 370).

Backfill type	Granular with porous fill around subdrain
Moisture content	5.45 %
Compaction	By own weight
Sottlamont (in)	Left side: 2.0 in.
Settlement (III) -	Right side: 2.25 in.
Void (in)	Left side: 2 in. deep at the abutment face and extending 10 in. under the approach slab
	Right side: 2 in. deep at the abutment face and extending 3 in. under the approach slab
Maximum steady state flow (cm ³ /sec)	67.0
Time for water to drain (min)	11

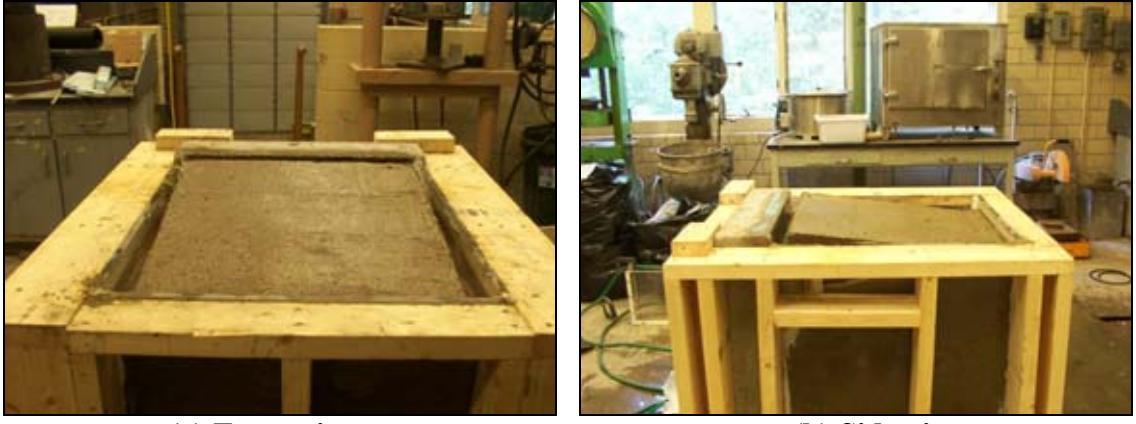
Figure 373. Level of approach after the test

Water started to flow out of the subdrain, with some fines, after 10 minutes similar to tests 3 and 4. The water became clear after about 12 minutes. The small amount of washed out fines may be the roughly 5% of the granular backfill particles, which are smaller than the size of the opening of the geotextile. The maximum achieved steady state flow was 82 cm³/sec, which represents a 22% increase compared to Test 4 (Table 29). The maximum measured settlement was 2 inches (Figures 372 and 373) and the developed void was 2.5 inches deep and extended the full width of the approach slab and 9 inches away from the abutment (Figure 374). When compared to Test 4, void size was reduced 16% and the approach slab settlement was reduced 11%. The maximum soil collapse occurred above the subdrain.

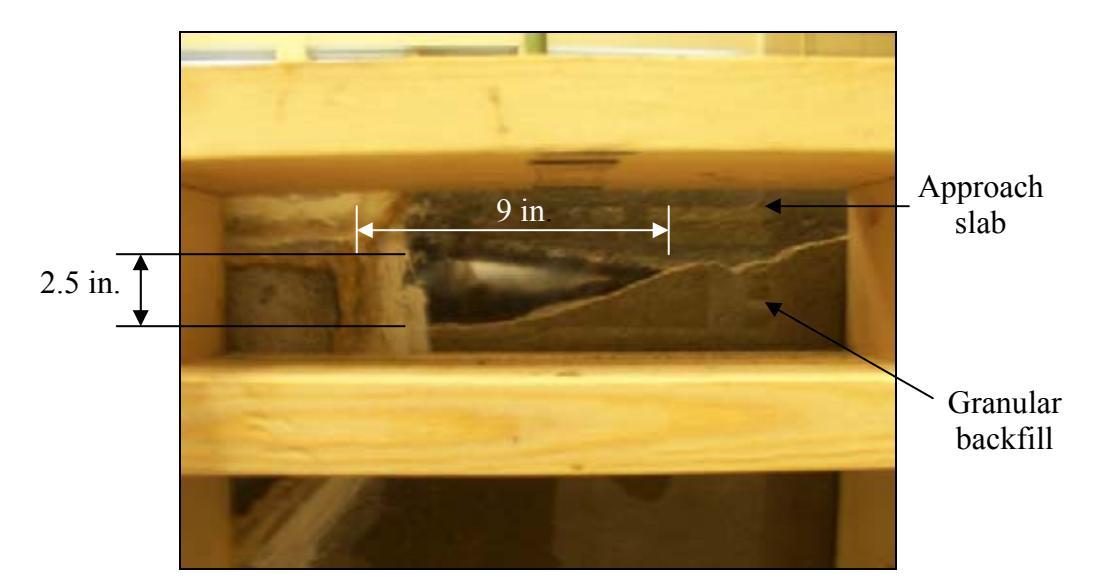
Figure 374. A void 2.5 in. deep and 9 in. long developed under the approach slab

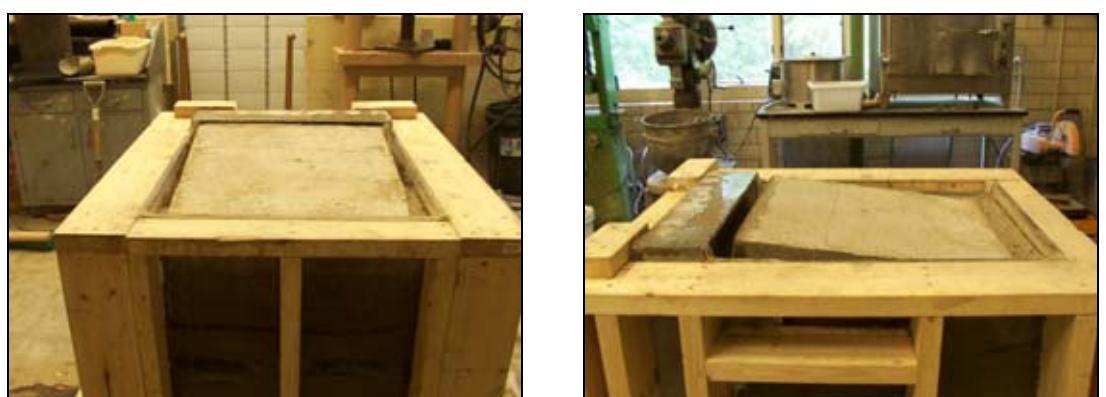
Figure 382. Level of approach slab after the test

Water began flowing out of the subdrain after 4 minutes from starting the test. Initially, no soil fines were washed out with the flowing water. After 30 minutes, however, the granular backfill started passing through the Plexiglas vertical drain interface, and as a result, some fines were washed out. This problem is not expected to occur in the field because the vertical drain will be covering the wingwalls as well. Once the maximum steady state capacity of the vertical geocomposite drainage was exceeded, the water passed through the vertical drain fabric to the reinforced backfill which lead to the formation of a void and settlement. Table 31 summarizes the results of this test. The maximum measured settlement was 2.1 inches (Figures 381 and 382). The maximum void developed was 5.5 inches at the abutment and extended 6.5 inches away from the abutment. Figure 383 shows the void after removing the approach slab. By using this vertical drain system, the maximum steady flow rate was increased 350% compared to Test 6.

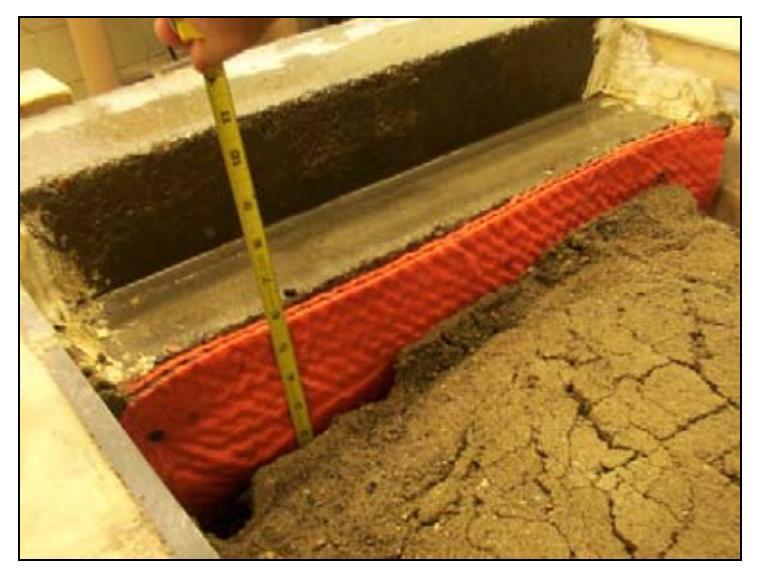
Figure 383. Void developed under the approach slab

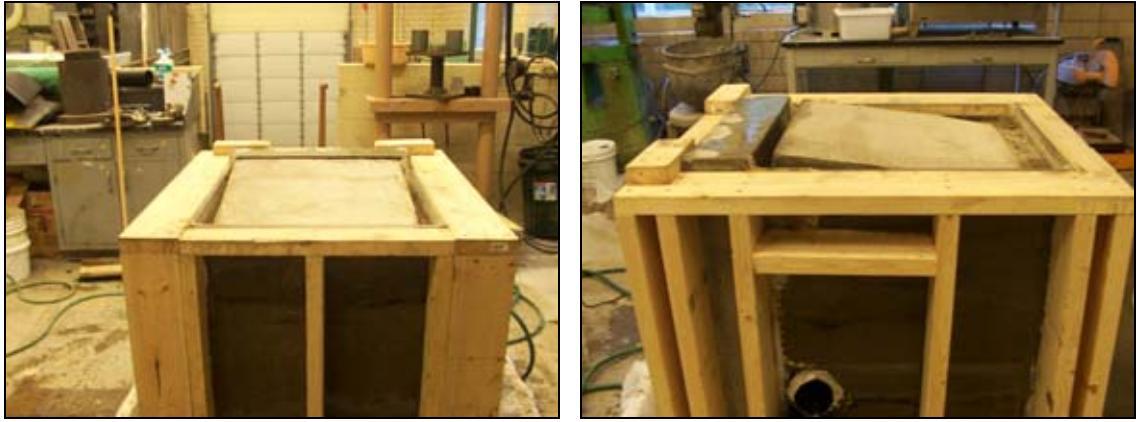
Figure 386. Level of approach slab after the test

Water began flowing out of the subdrain after 1 minute from starting the test. No fines were washed out during the test. Similar to Test 7, once the maximum steady state flow (383 cm³/sec) of the geocomposite drain was exceeded, water started to overflow saturating the backfill, and as a result, settlement and void development were observed. The maximum approach slab settlement was 2.5 inches (Table 32), which is similar to the settlement observed in Test 7 (Figures 385 and 386). The void was 1.5 inches deep at the abutment and extended 4 inches away from the abutment. The void extended to the full width of the approach slab (Figure 387). The maximum steady state flow was 72% higher than the maximum steady state of the product used in Test 7, and the void was approximately 70% smaller. Similar to other tests, water was observed draining from the bottom of the drainage pipe.

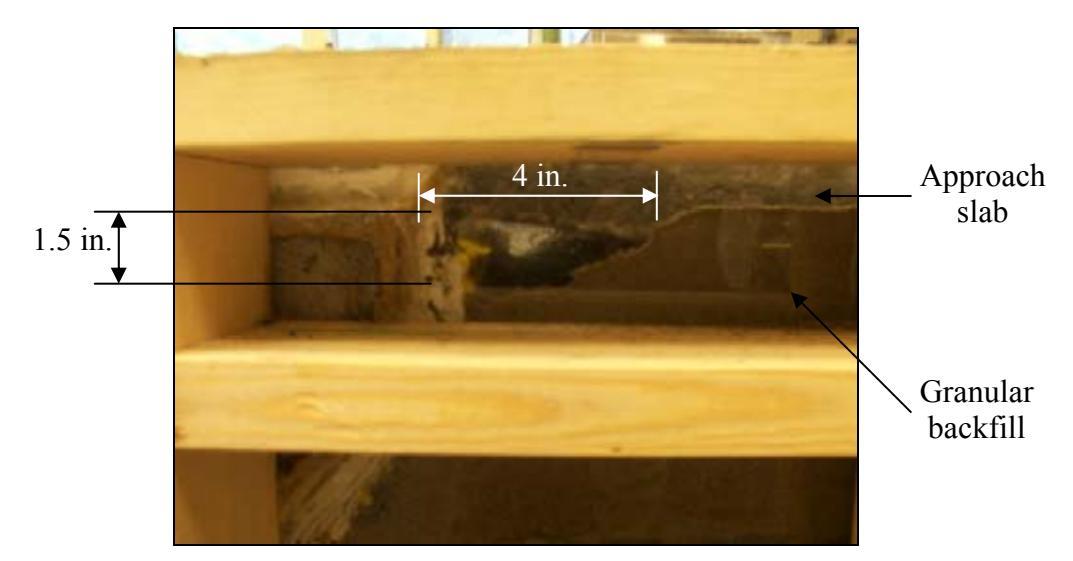
Figure 387. Void developed under the approach slab

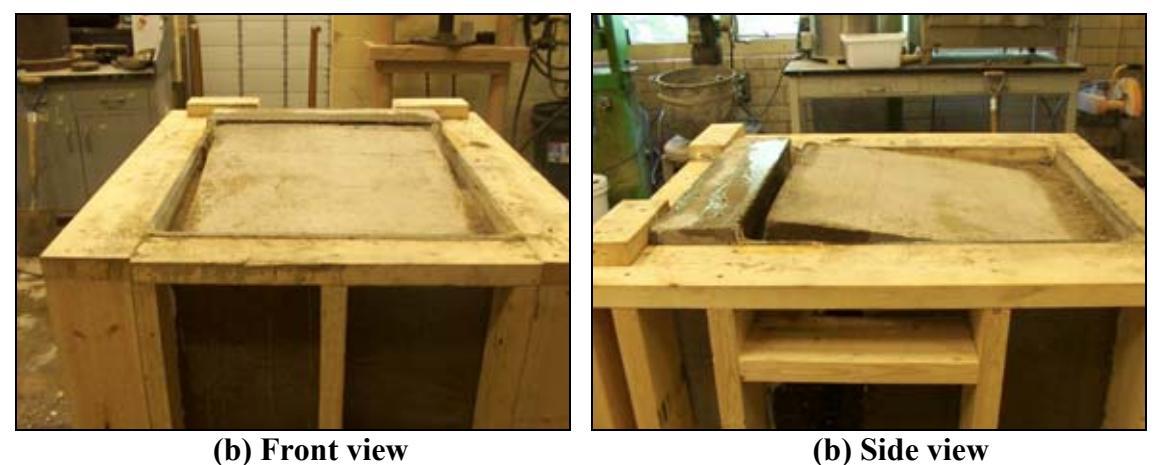
Figure 391. Level of approach slab after the test

Water began to flow out of the subdrain after one minute from starting the test. The use of tire chips minimized settlement and void size but did not completely prevent them from occurring (Table 33). The maximum void formed was 2 inches deep at the abutment face and extended 3 inches away from the abutment. The void was discontinuous (i.e., did not extend the full width of the approach slab) and was formed in the granular backfill beyond the foam board. The maximum measured settlement was 1.9 inches, which is 25% less than for Test 8 (Figures 390 and 391). The steady state flow was 43% higher than for Test 8 (383 cm³/sec). In addition, water was drained from the top and bottom portions of the subdrain, which suggests that the tire chips did not block the top drainage pipe openings. Although 30% of the tire chips are smaller than the subdrain openings, none of the tire chips were washed out.

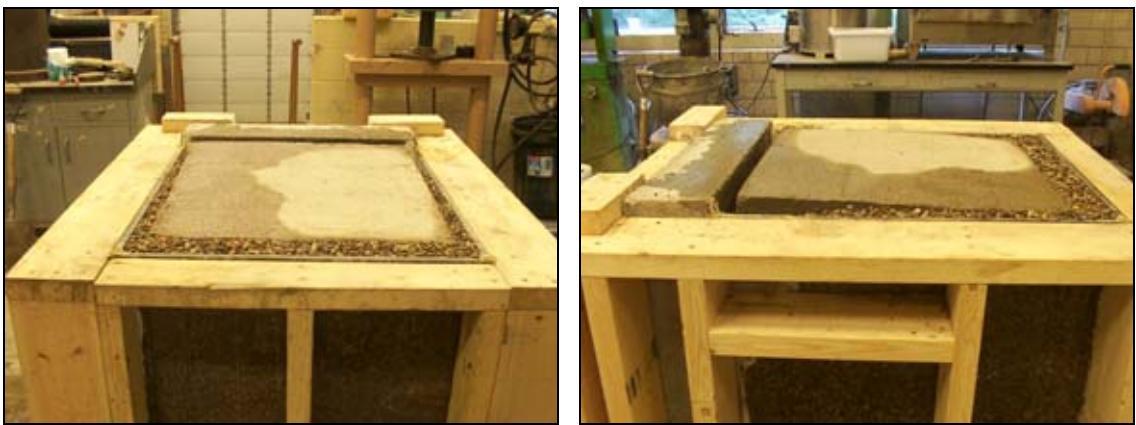
Water began flowing out of the subdrain after 4 minutes from starting the test. The pea gravel included some fines which were washed out. The water started to clear after 18 minutes. Table 35 summarizes the results of this test. The porous backfill prevented the void formation and approach slab settlement completely (Figures 398 and 399). The maximum steady state flow was 92 cm³/sec, which was approximately 3 times higher than the maximum steady state flow

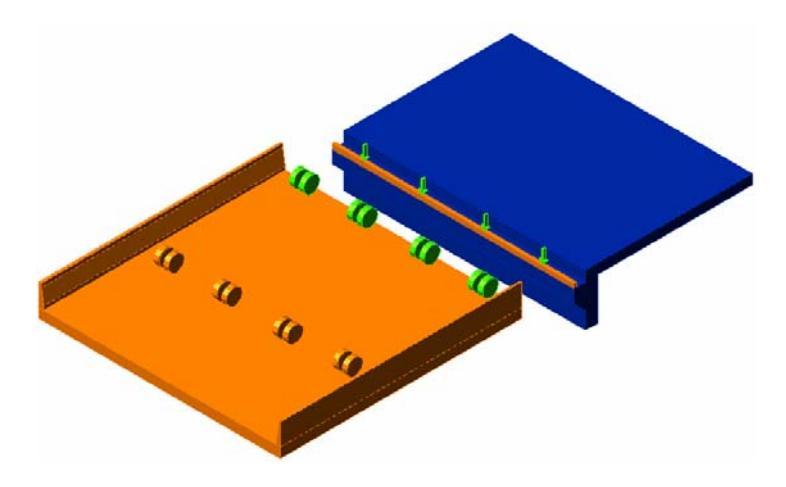
The dead load, which included the weight of the approach slab, future wearing surface, and guardrails, and the 32 kip live load due to the axles positioned at 14 ft away from the notch, were uniformly distributed over the entire length of the pavement notch, as shown in Figure 404(b). An additional live load acting on a 32-inch length of the notch was considered. This load was a result of a wheel load applied over a one-foot wide contact area between the wheel and the approach slab, as shown in Figure 405. Accordingly, a wheel load of 16 kip was uniformly distributed over a 32 in. (2 ft 8 in.) length of the notch and the corresponding total factored load was obtained as

(b) Load case 2 Figure 404. Static load cases

For the pavement notch analysis, Static Load Case 2 generally controlled by producing the most severe loading conditions. However, as detailed in the next section, Static Load Case 1 was found to be more critical for one of the direct shear failure modes by giving a smaller capacity to demand ratio. In addition to the critical static load cases, two dynamic load cases were included in the analysis as detailed below.
