IDENTIFICATION OF THE BEST PRACTICES FOR DESIGN, CONSTRUCTION, AND REPAIR OF BRIDGE APPROACHES

Iowa DOT Project TR-481 CTRE Project 02-118

Final Report

January 2005

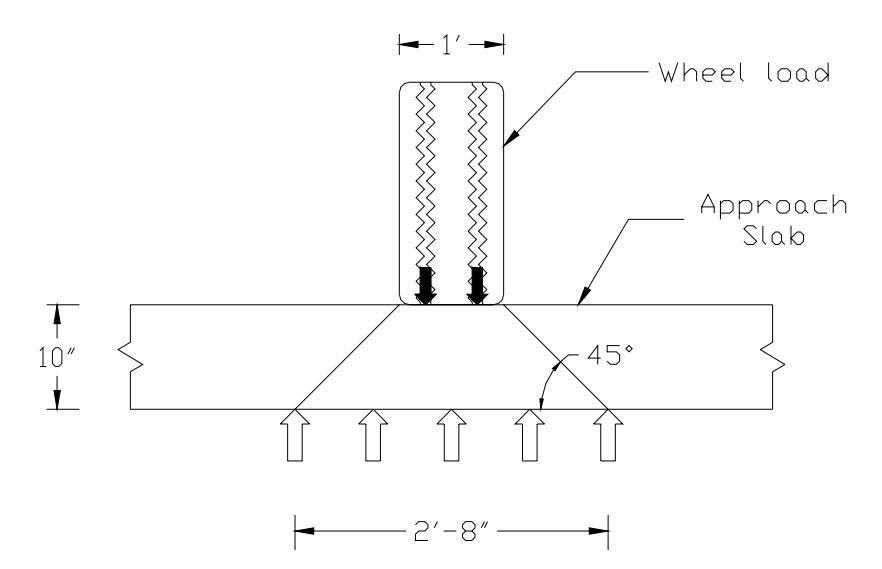
Figure 405. Dispersion of a wheel load through the approach slab

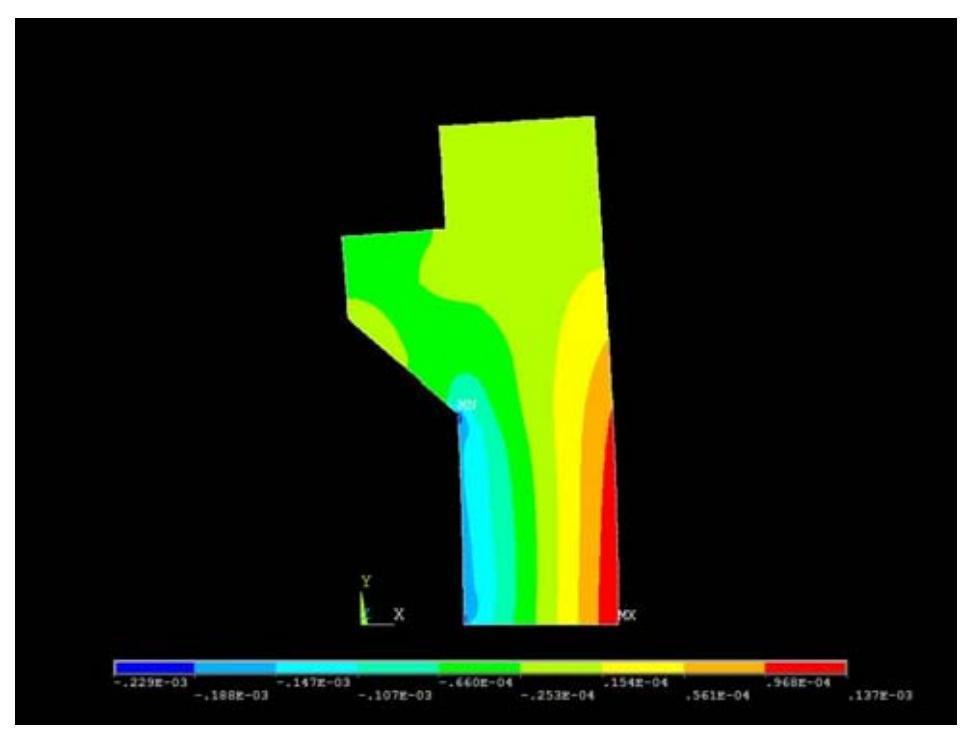
The finite element analysis plots showing the strain in the vertical direction, principal stresses, and the corresponding vector plot delineating the direction and magnitude of principal stresses are presented in Figures 406, 407 and 408, respectively. These figures illustrate the typical force flow path through the pavement notch to the abutment wall induced by SLC2 and the corresponding horizontal force (N_{cu}). Based on these plots, suitable nodes for the strut-and-tie model were identified. As previously noted, the steel reinforcements were not included in the finite element model and the concrete was assumed to carry tension. The resultant tensile force in the cross-section of the abutment wall was located assuming a linear stress variation with zero stress at the neutral axis position and the maximum stress at the location of the abutment wall was found to be approximately at 2 inches. Recognizing the actual position of the steel reinforcement in the abutment wall, the tie was fixed at 2 in. from the edge of the concrete.

Figure 406 Vertical direction strains in the pavement notch region corresponding to Static Load Case 2

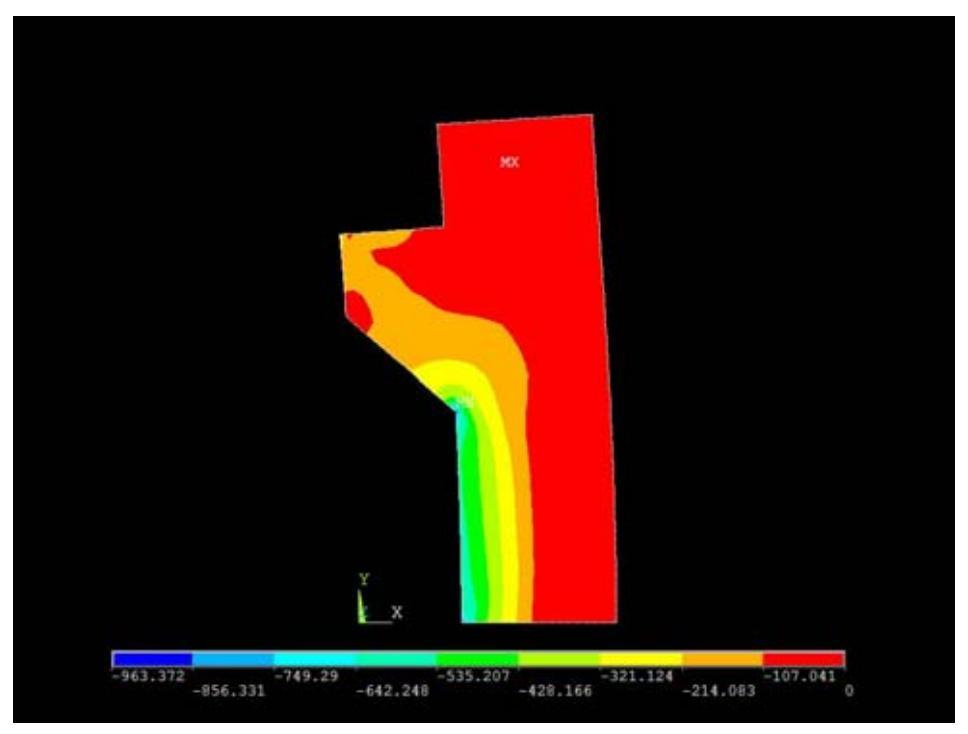
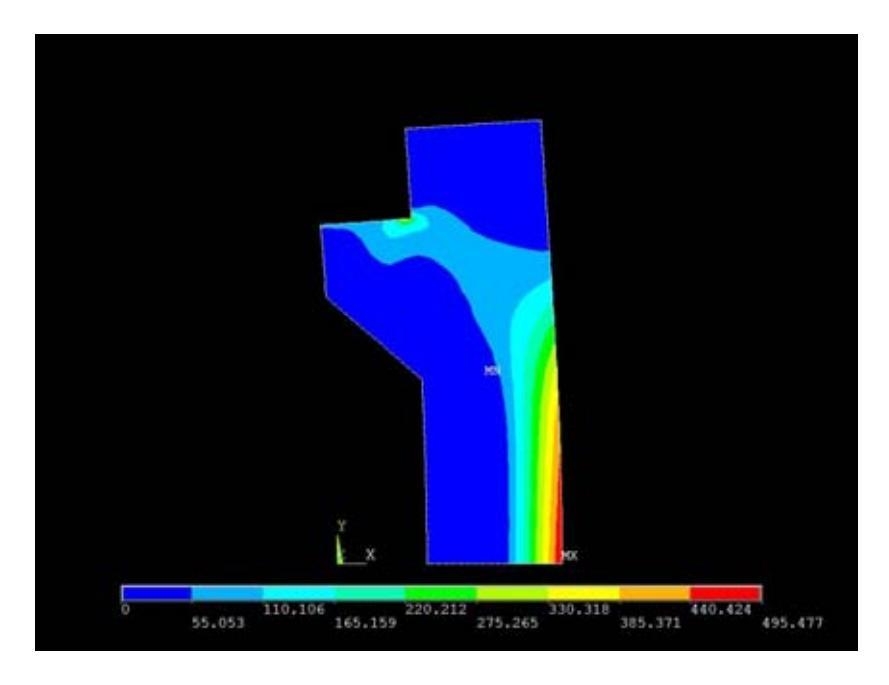
(a) Principal compressive stresses in psi unit

(b) Principal tensile stresses in psi unit

Figure 407. Principal stresses in the pavement notch region corresponding to Static Load Case 2

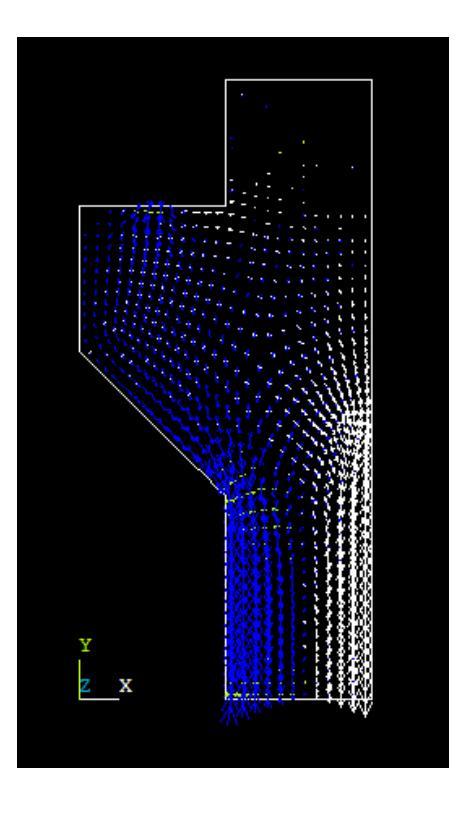
Figure 408. Vector plot showing the direction of the principal compressive and tensile stresses corresponding to Static Load Case 2

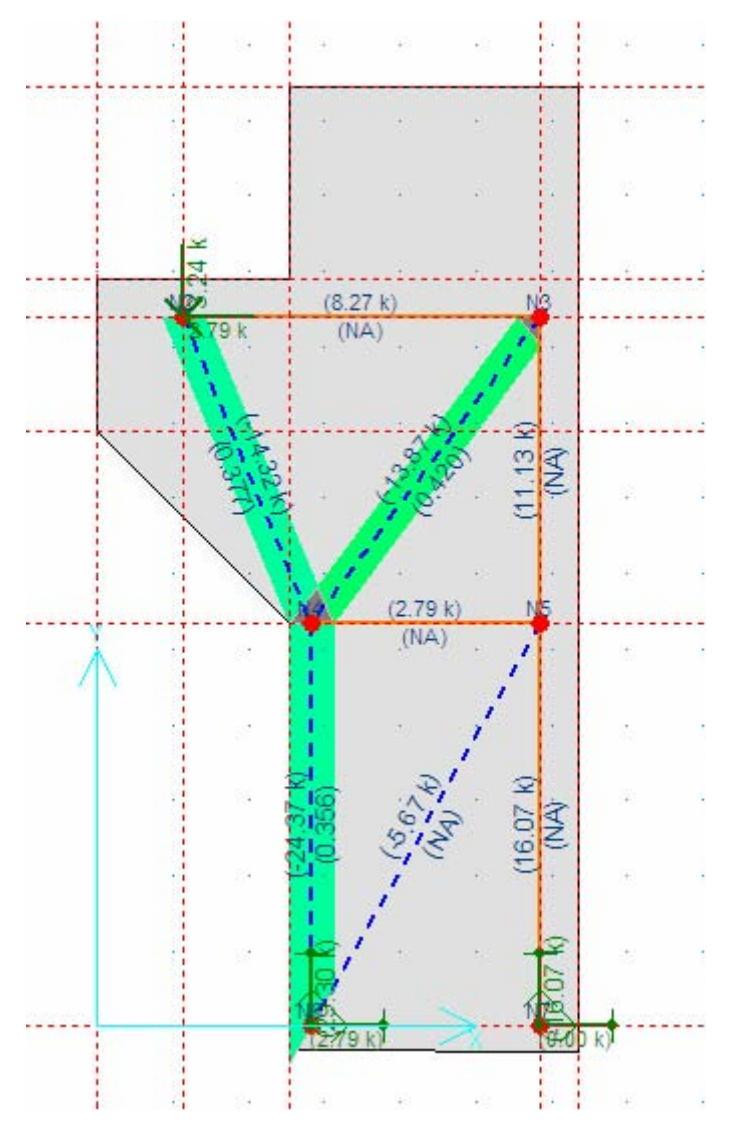
Figure 409 and Table 36 list the calculated strut and tie forces for the loads corresponding to SLC2. The output from CAST is produced in Figure 410, which shows the strut and tie demands and stress ratios for the critical struts. The stress ratio of a strut is defined in CAST as the ratio of stress demand to the permissible stress limit. Hence, a stress ratio greater than one would indicate failure of that strut. For the CAST model in Figure 410, DD' was the most critical strut and a width of 2.24 in. was accurately modeled for this strut. For the other struts (i.e., BD, and CD), smaller strut widths were used conservatively to keep the nodal boundaries within the geometry of the abutment and pavement notch modeled in Figure 410.

Figure 410. Strut and tie forces and the corresponding stress ratios obtained from CAST for the load condition in shown in Figure 408

where b_w is the width of strut extending in the outer plane direction, and d is the depth of strut in the plane of loading perpendicular to the direction of the compressive force. The value of b_w was 12 in., while d varied between struts. As represented in Figure 410, the strut depths for BD and CD were taken as 1.80 in. and 2.07 in., respectively, while the d value for strut DD' was estimated to be 2.24 inches. With a strength reduction factor of 0.75, the capacities of the struts were computed using Eq. 7, and the values are reported in Table 39.

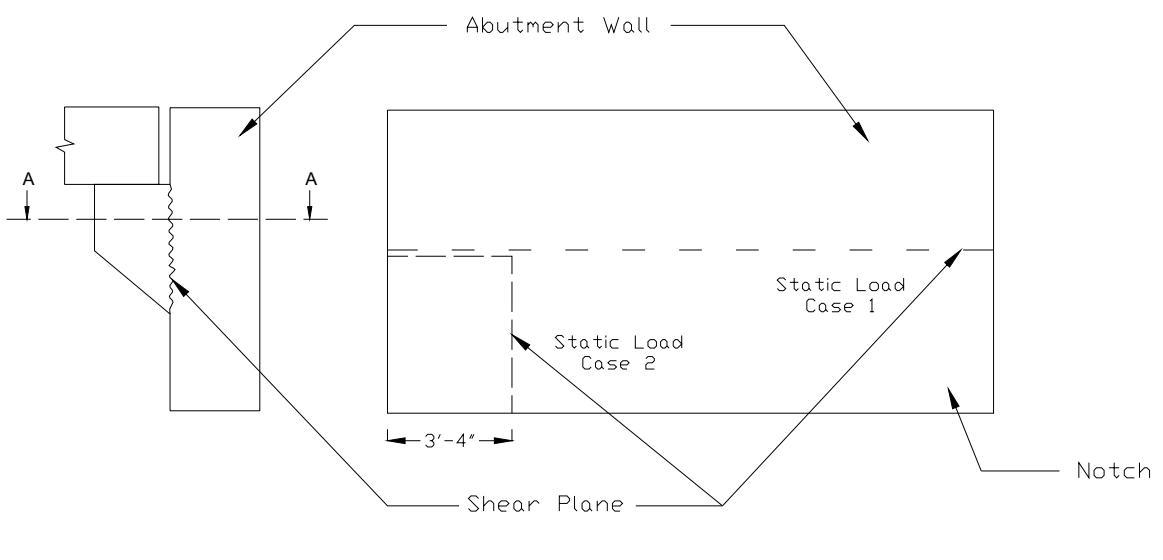
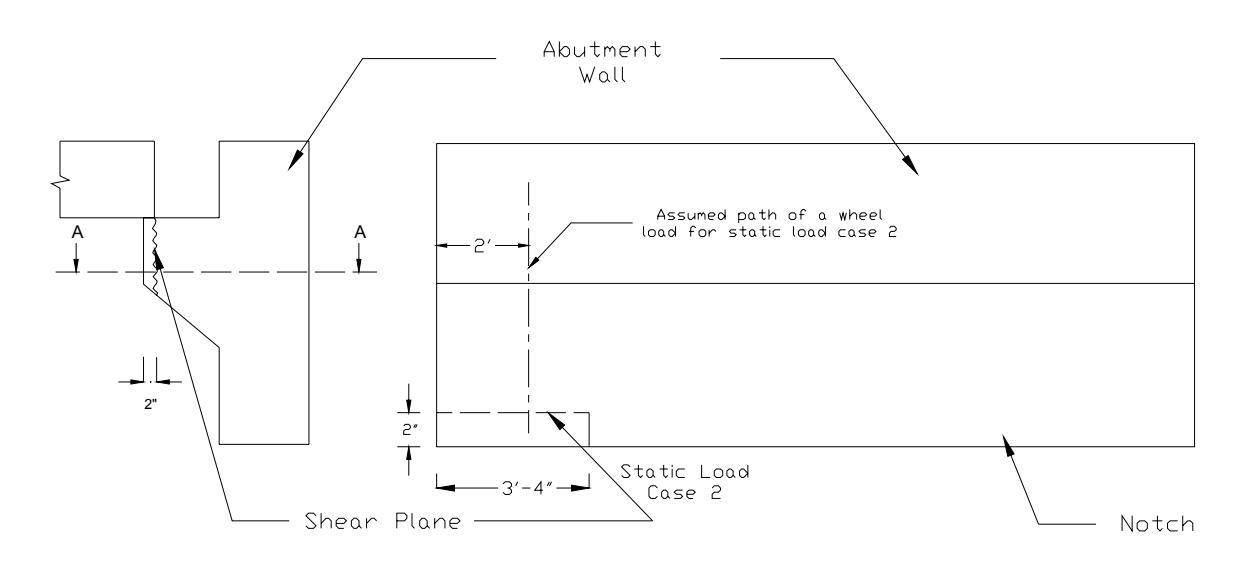
In this failure case, it was assumed that the approach slab was supported over a reduced width on the notch, as shown in Figure 412. This condition can be attributed to poor construction practice, thermal effects, or a combination thereof (see an example of this condition in Figure 276 – HW65 bridge). The width of the failure segment was conservatively taken as 2 in. from the free edge of the pavement notch. This small segment of the notch was assumed to have no steel reinforcement. Because the shear plane runs in the direction of the bridge is very small, SLC2 governs this failure case by producing a lower capacity to demand ratio.

Figure 412. Direct shear failure – Case 2

For the second direct shear failure case, the capacity may not be found from the above equation because no mild steel reinforcement was assumed to cross the shear failure planes and the shear failure was considered to occur within an unreinforced segment of concrete. In the absence of a procedure to compute the capacity across an unreinforced direct shear failure plane in Article 11.7.4, the shear capacity for Case 2 was determined using Eq. 5, according to Article 11.3.1 of ACI 318-02. This equation is intended for computing shear strength provided by concrete in members subjected to shear and flexure.

Therefore, from Eq. 5, $V_c = 2* \ 0.0633 * 42 * 10 = 53.17$ kips, and $\Phi*V_c = 39.88$ kips For the static load condition, the critical factored live and dead loads, including a wheel load, acting on the pavement notch were obtained using the loads acting on the 3 ft - 4 in. segment identified in Figure 412.

The procedure used for Case 2 of the direct shear failure mode in the pavement notch was followed for the failure investigation at the approach slab end. Using depth of 10 in. for the approach slab and a shear failure plane identical to that shown in Figure 412, the shear capacity from Eq. 5 is:

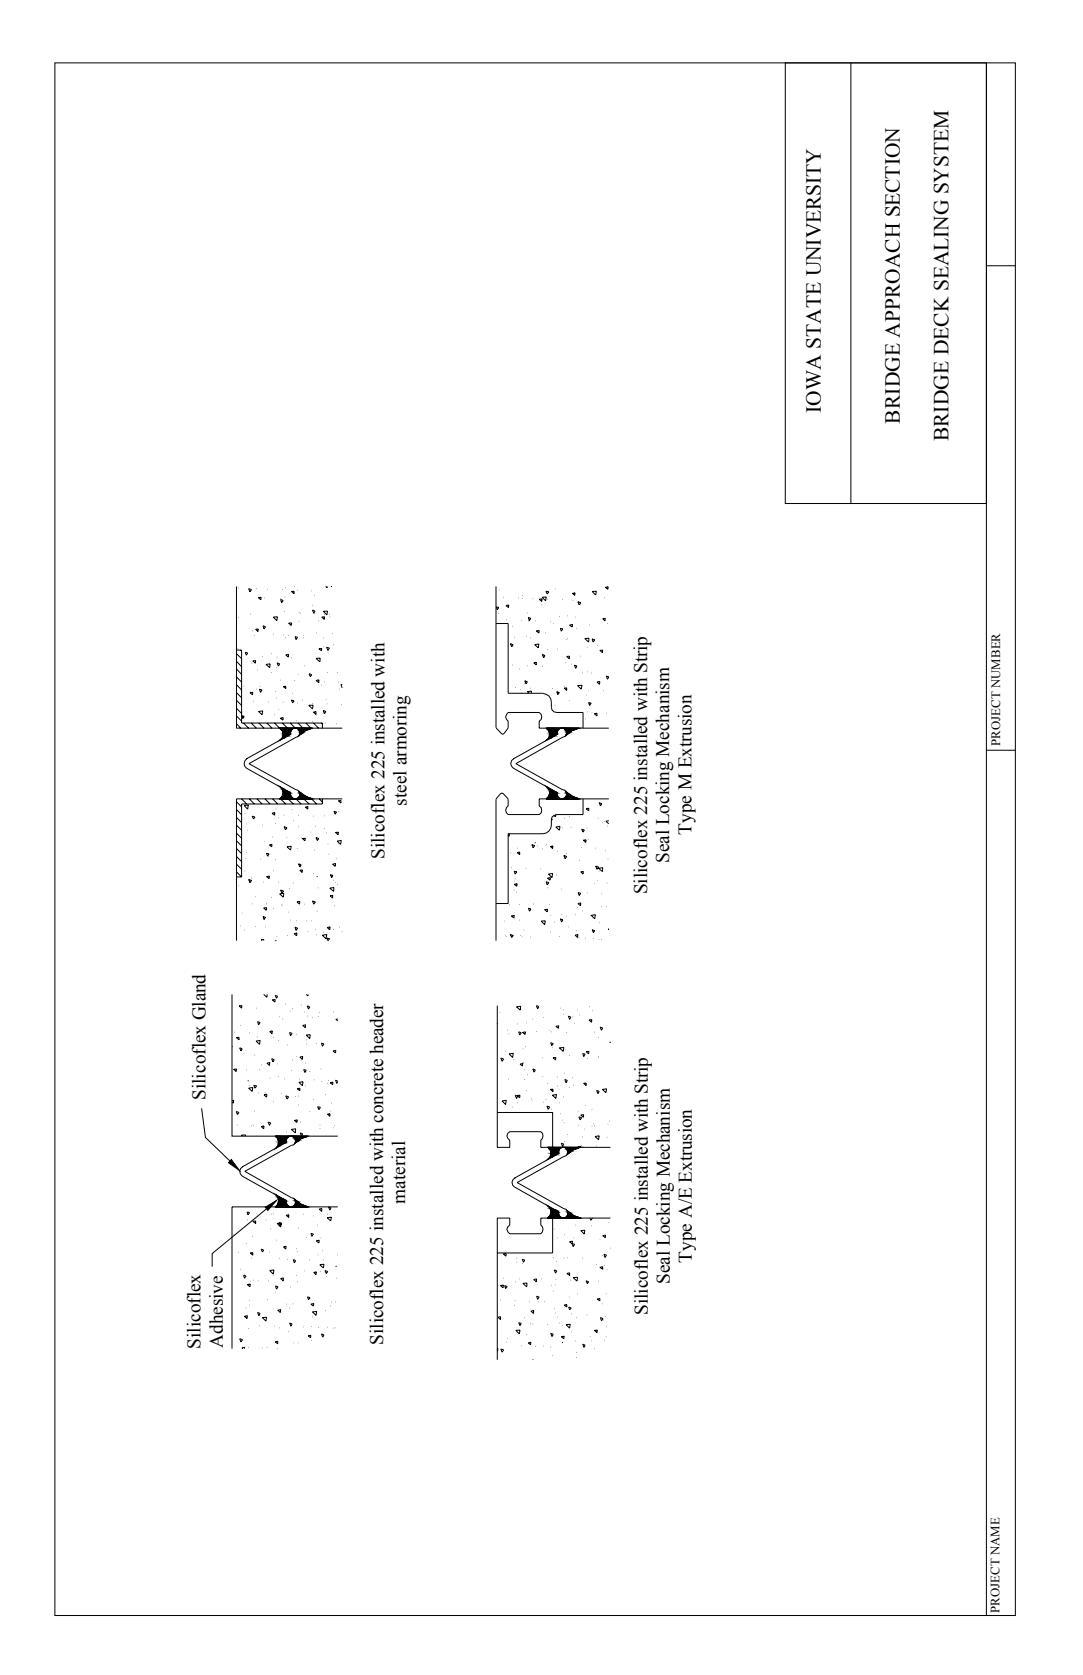
Figure 414. Proposed bridge joint sealing system

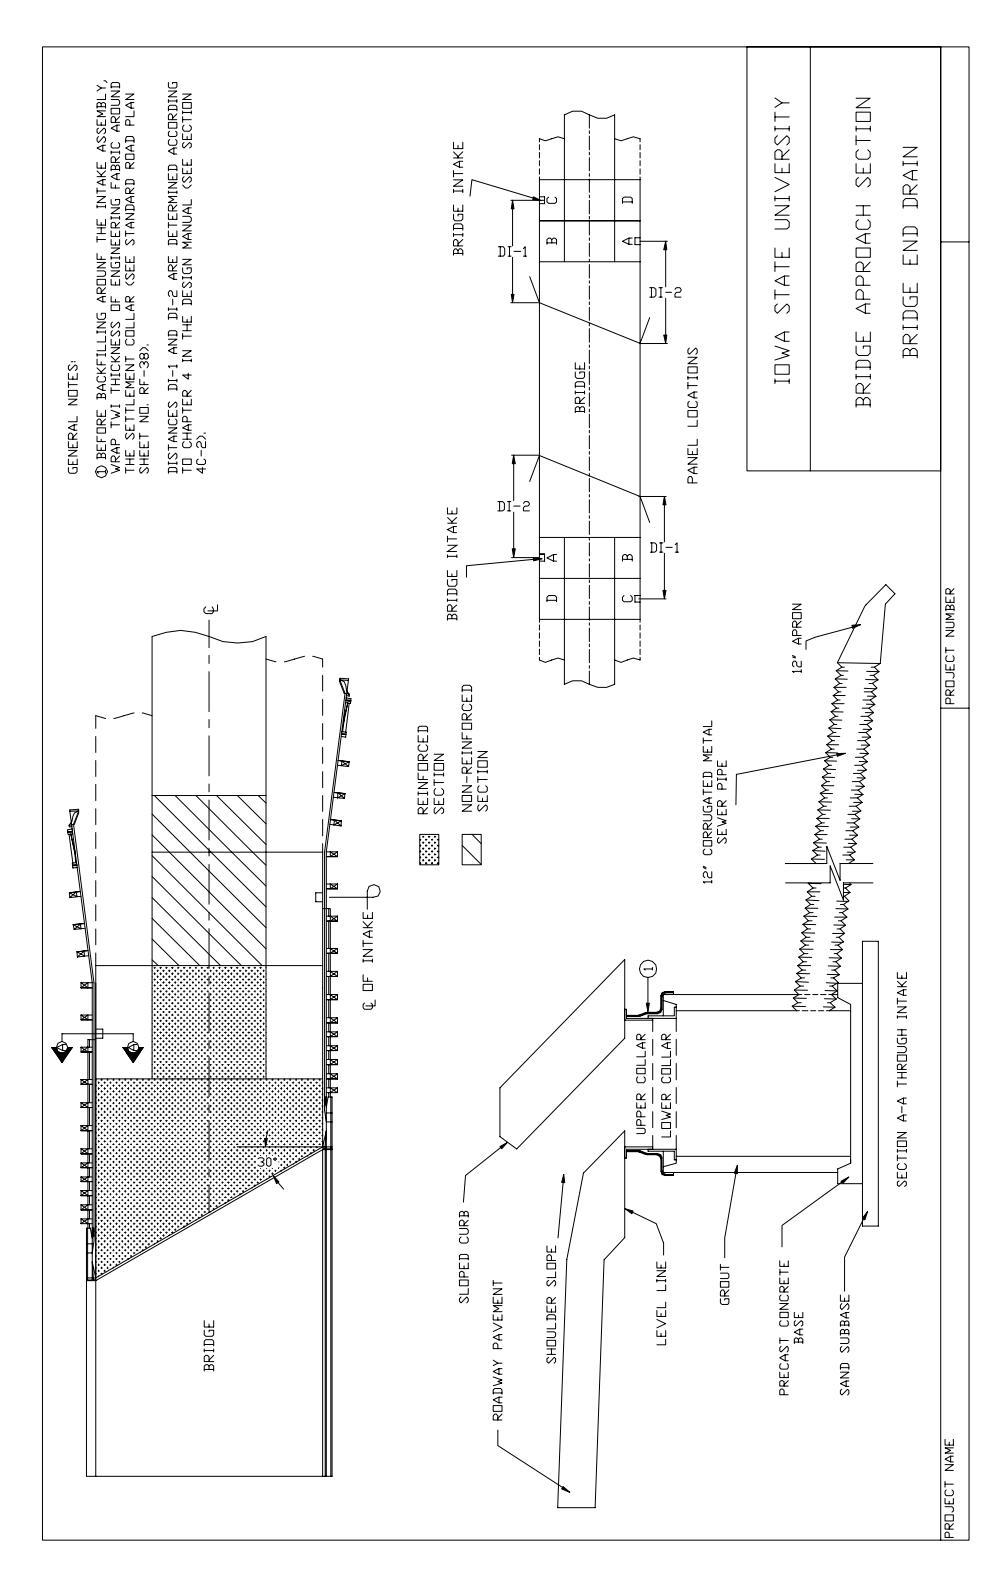
Figure 415. Proposed surface drainage detail

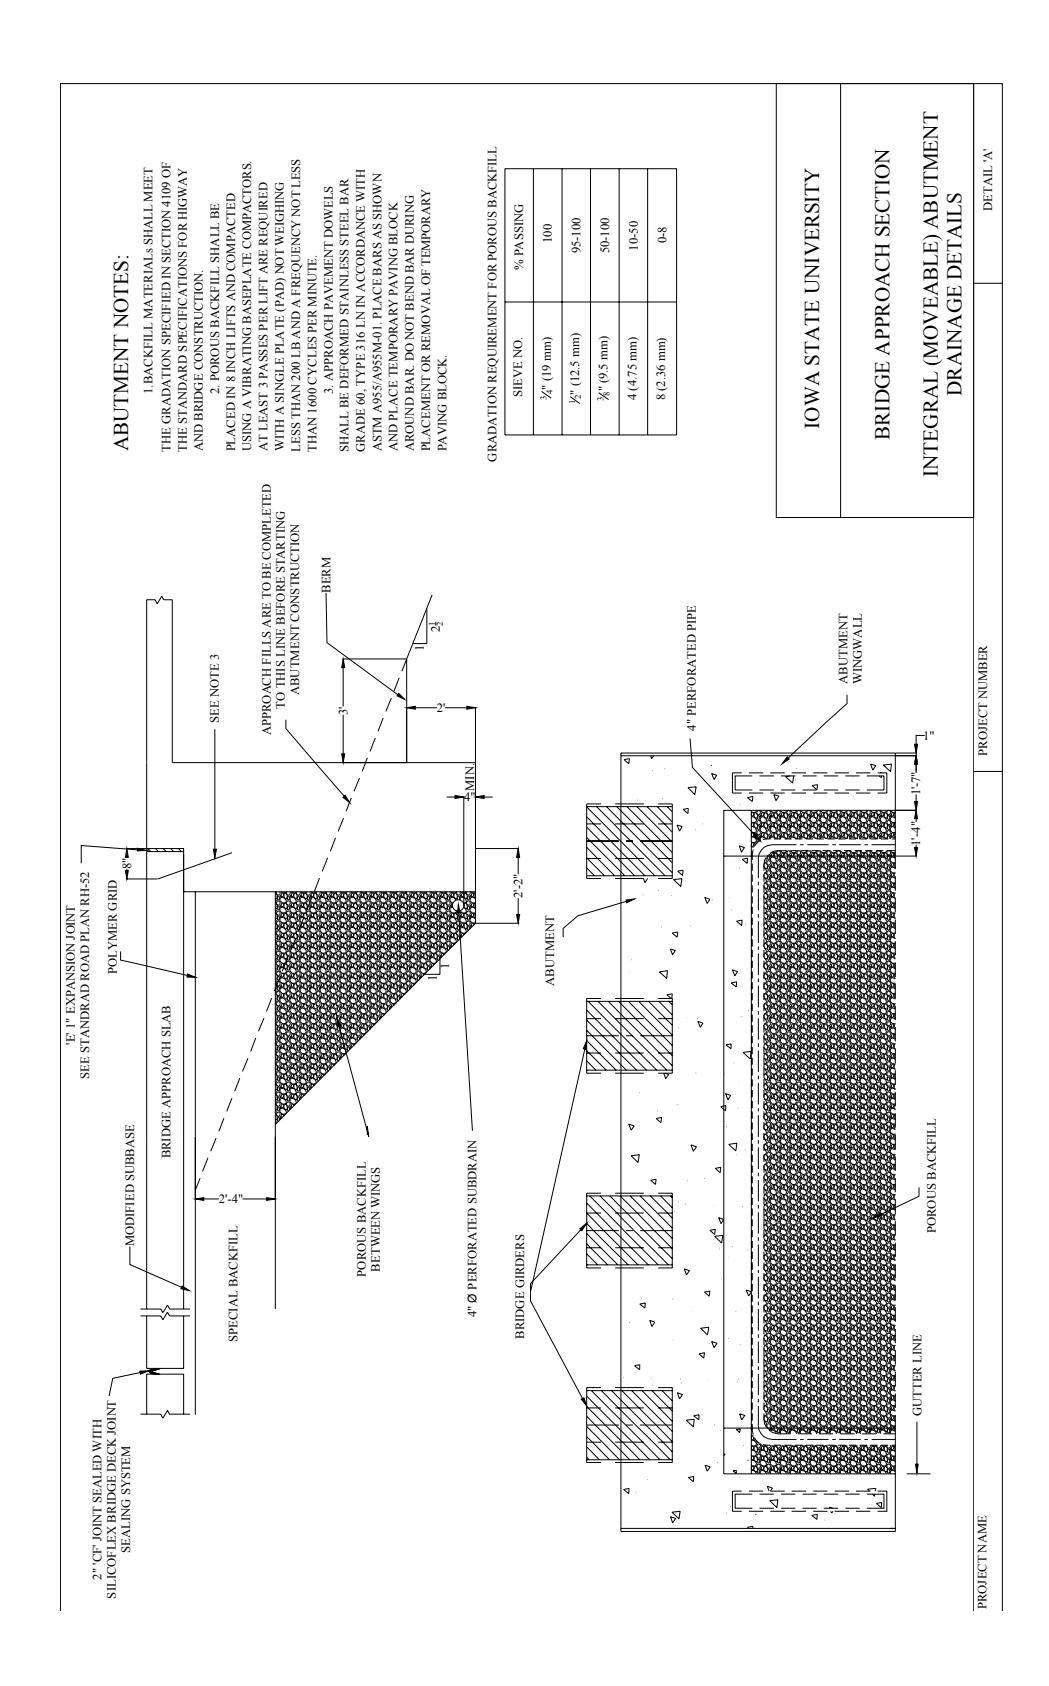
Figure 416. Proposed integral bridge approach drainage detail with porous backfill

- 1. Use porous backfill behind the abutment in lieu of granular backfill (Figure 416). This design option is simple to construct, increases the drainage capacity, and prevents settlement and void formation from collapse.

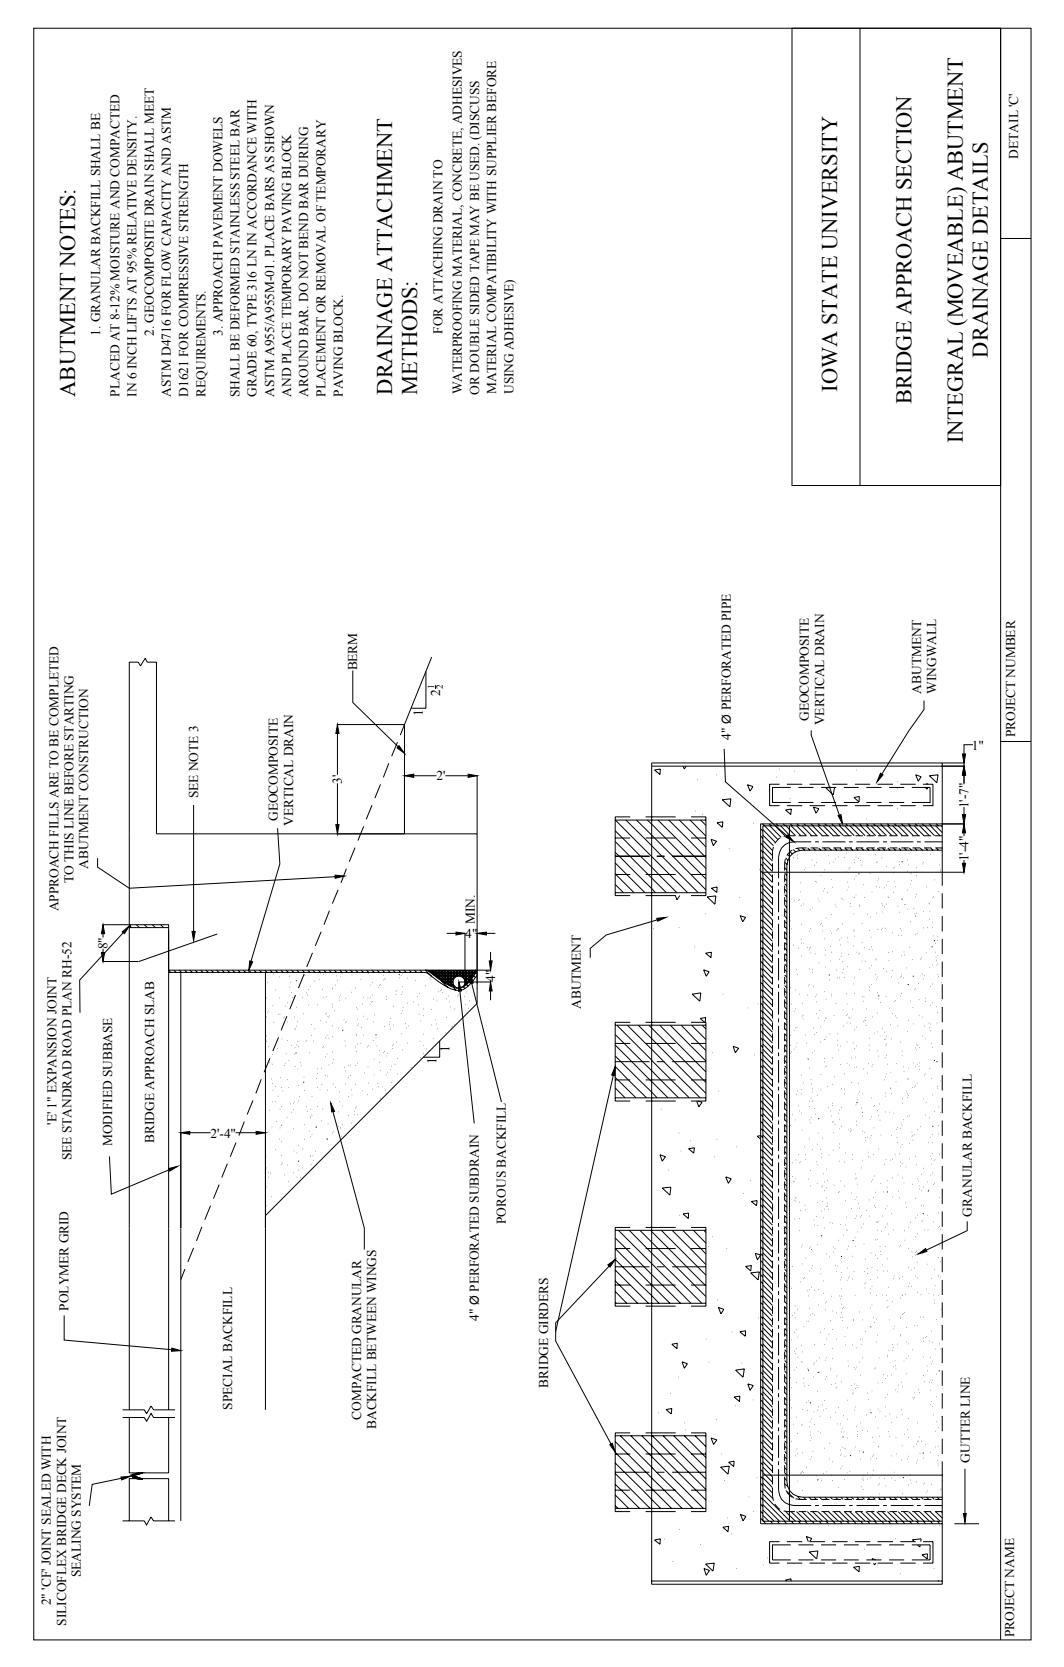
Figure 417. Proposed integral bridge approach drainage detail with geocomposite

- 3. Use a geocomposite vertical drainage system behind the abutment (Figure 418). This drainage option has a simple construction sequence, increases the drainage capacity, and helps to reduce the void size and differential settlement. This drainage option could be combined with a square abutment face for easier installation.

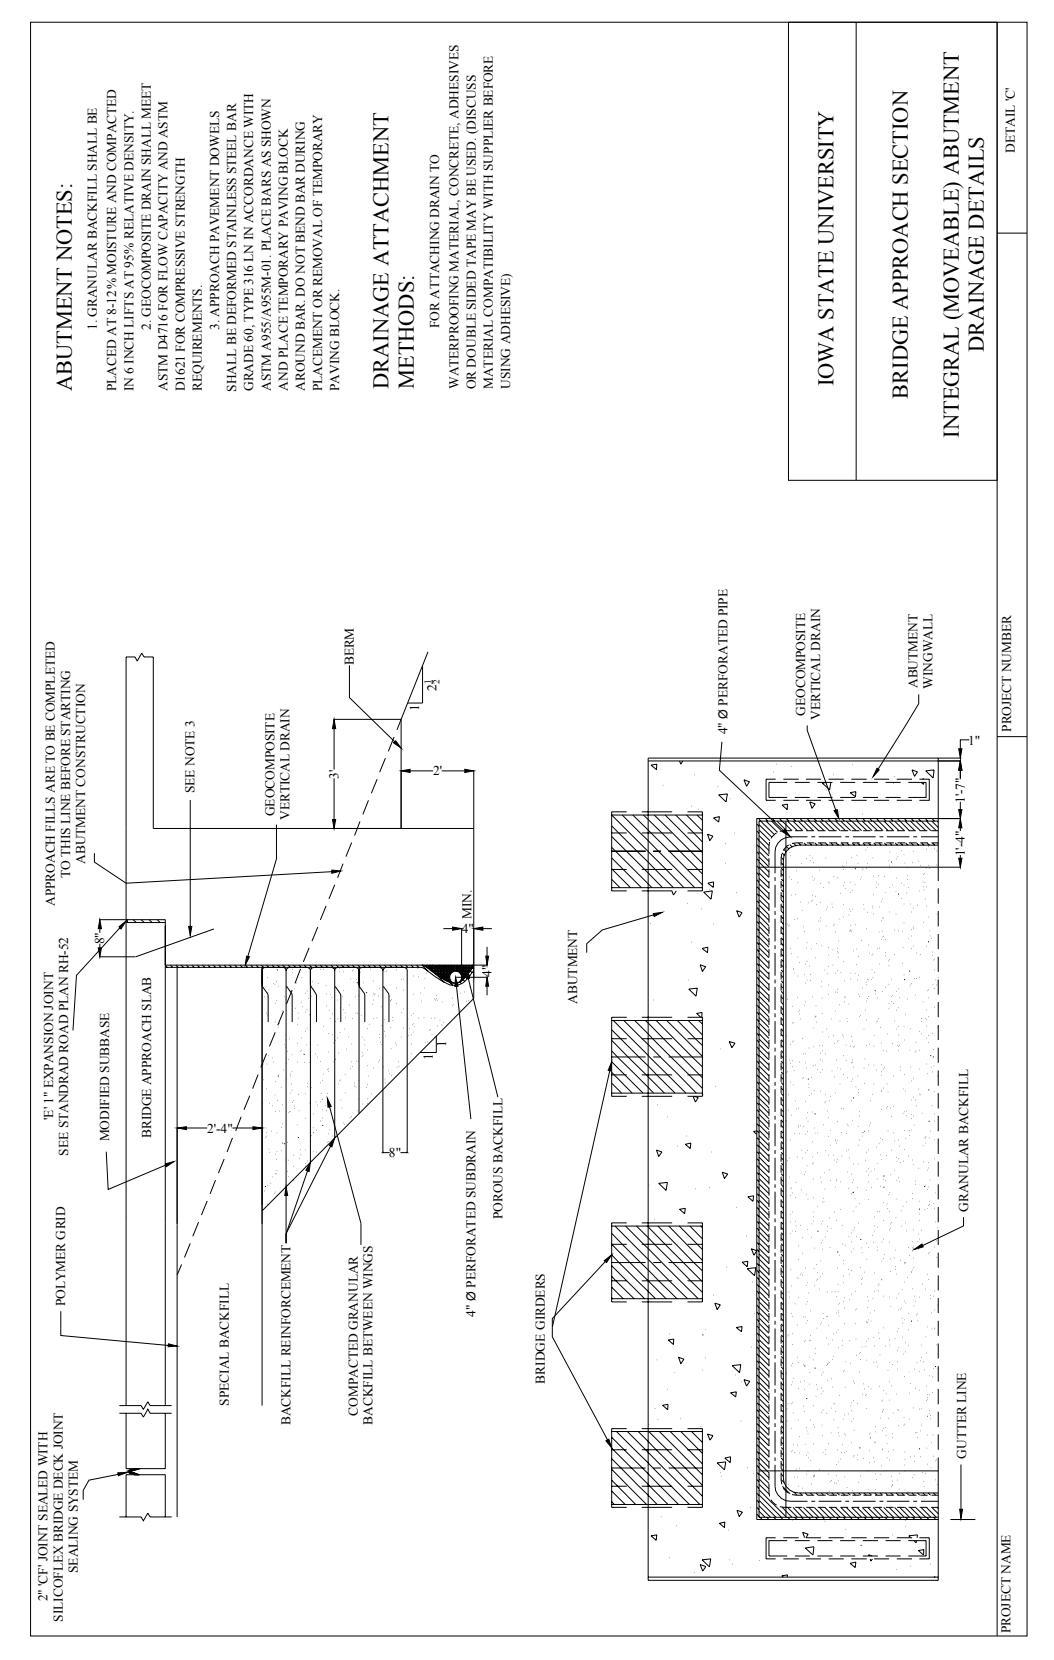
Figure 418. Proposed integral bridge approach drainage detail with geotextile reinforcement

- 2. Use the current Iowa DOT design approach and materials, but add geotextiles reinforcing layers to the granular backfill (Figure 417). Based on the model tests conducted in this study, this design reduces the void size and differential settlement.

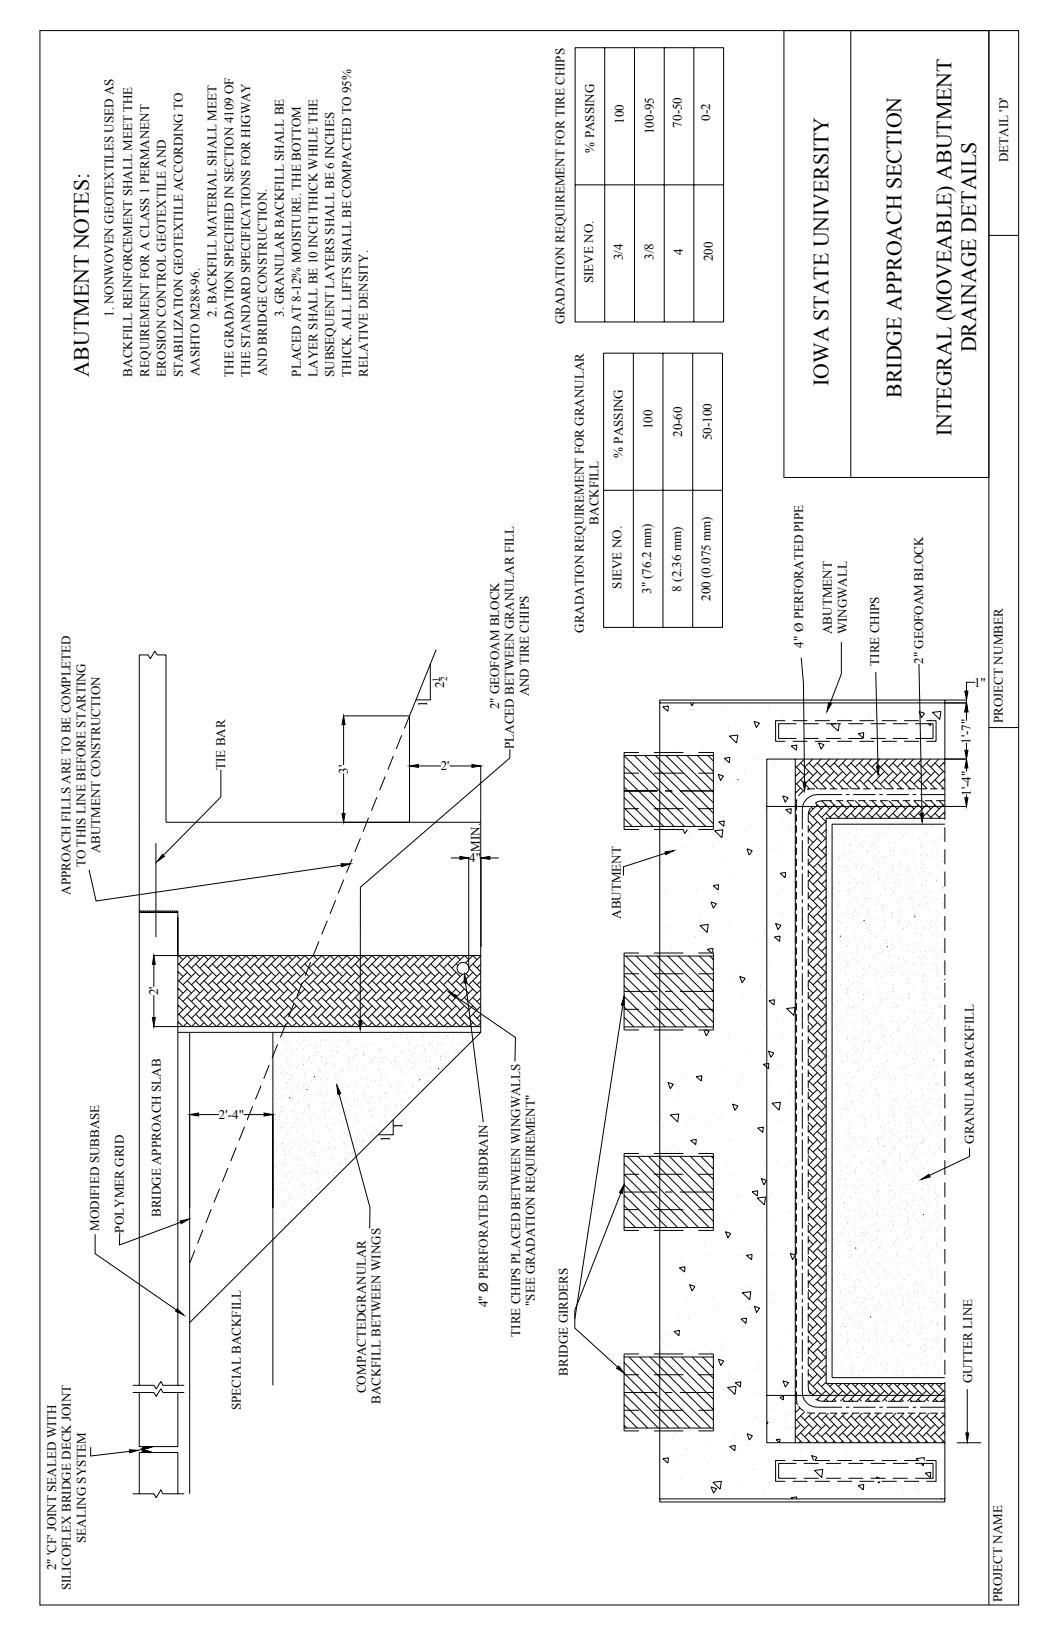
Figure 419. Proposed integral bridge approach drainage detail with tire chip backfill

- 4. Use a 1 to 2 ft. thick layer of tire chips behind the abutment as an elastic and drainage fill material (Figure 418). This design option provides an elastic zone behind the abutment which allows for lateral abutment movement with temperature changes. Furthermore, it has a very high drainage capacity. The tire chips should be protected with a geotextile filter fabric.

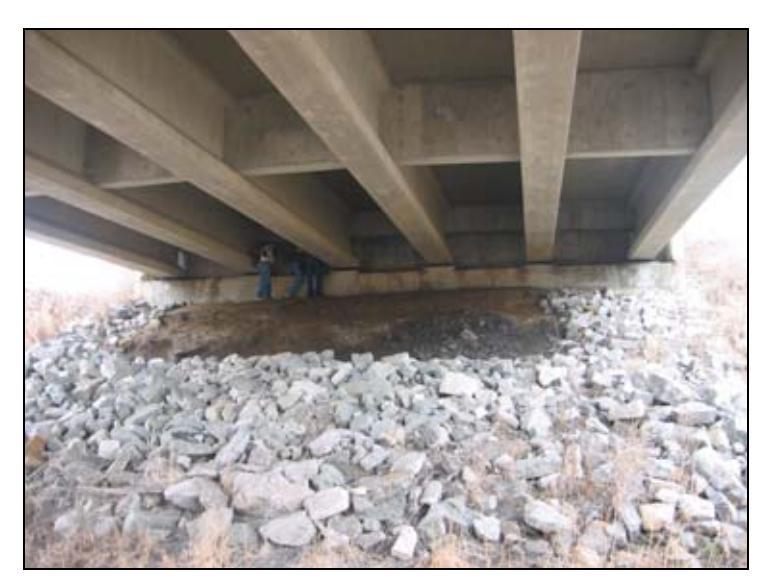
Bridge at US 65 over South Skunk river (Mile: 92)

Figure A1. Rocks used to decrease erosion at the embankment

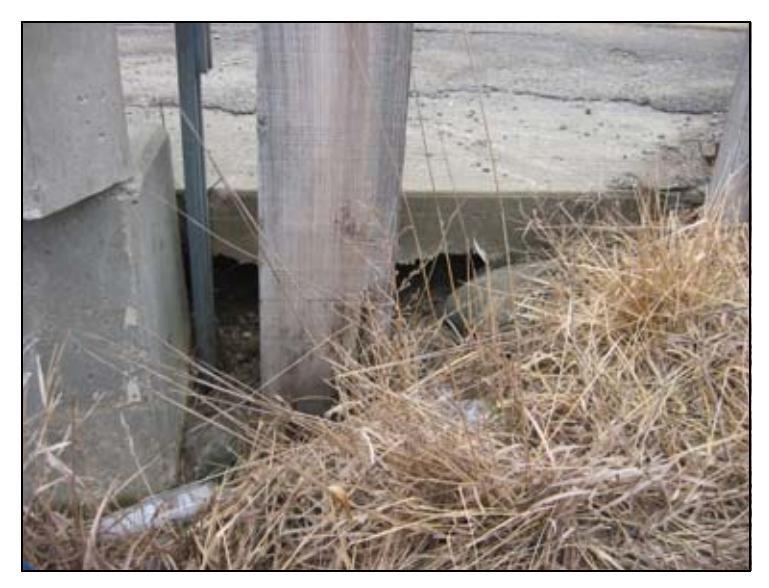
Bridge at US 65 over Rail Road (Mile: 89)

Figure A2. Void developed under approach slab

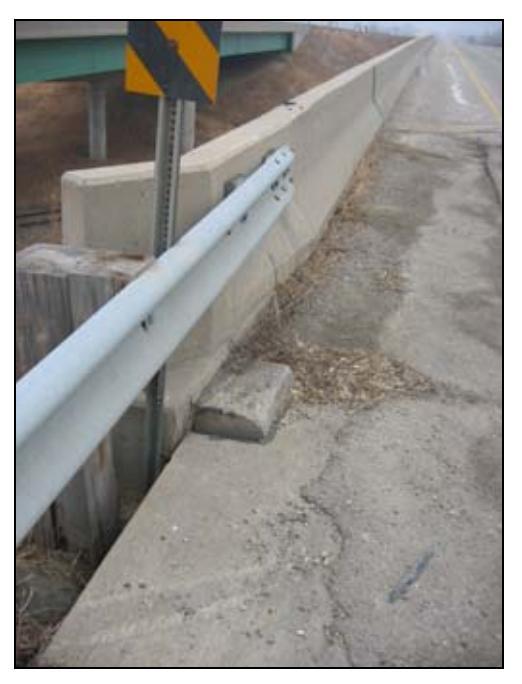
Figure A3. Differential settlement

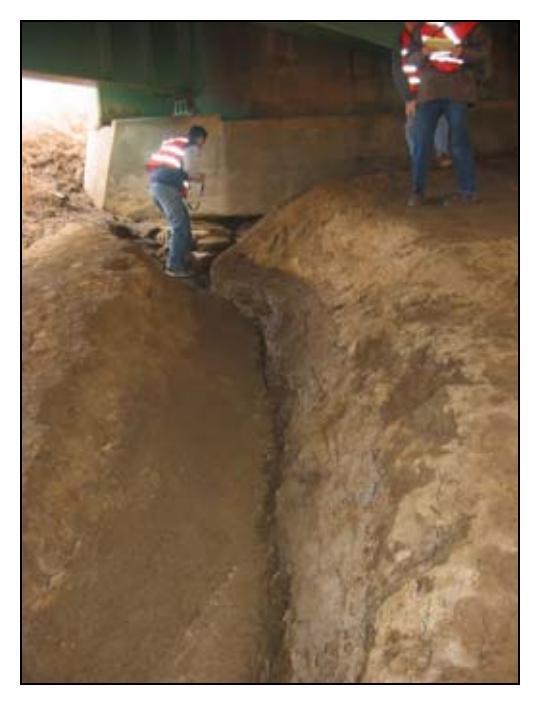
Figure A4. Soil erosion at the bridge embankment

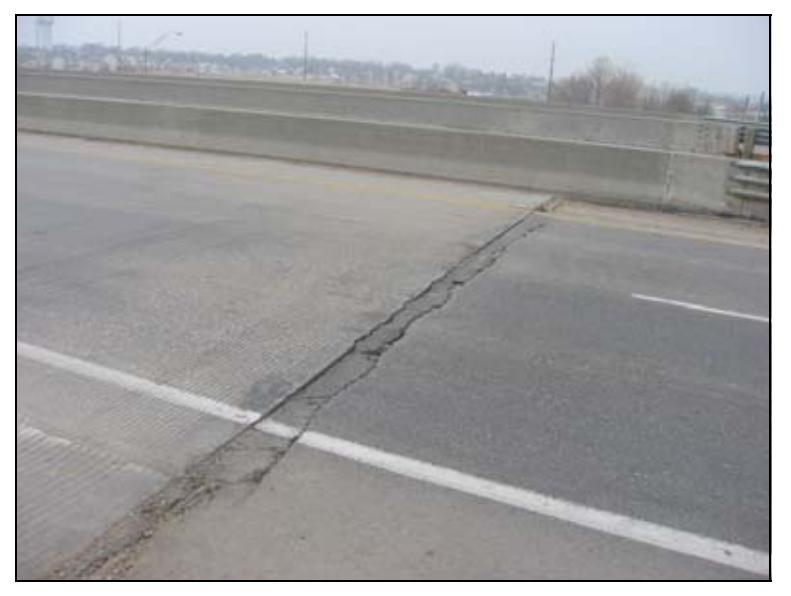
Bridge at US 65 over 163

Figure A5. Cracks near the expansion joint

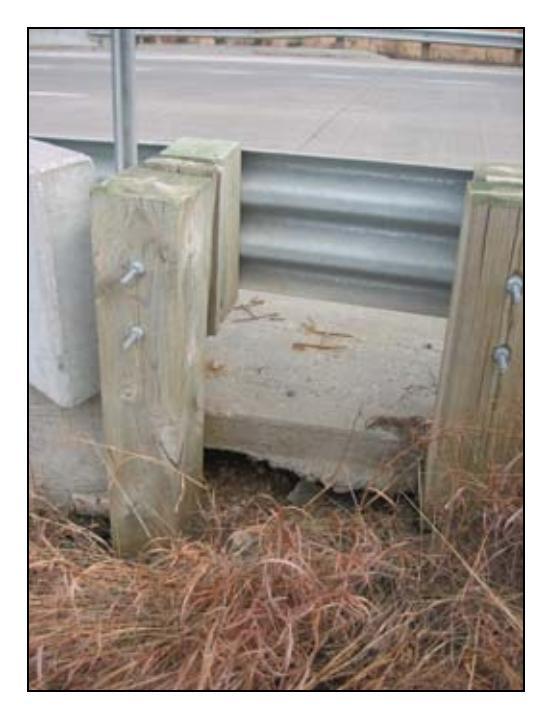
Bridge at US 65 over Pleasant Hill Road

Figure A6. Void developed under the approach slab

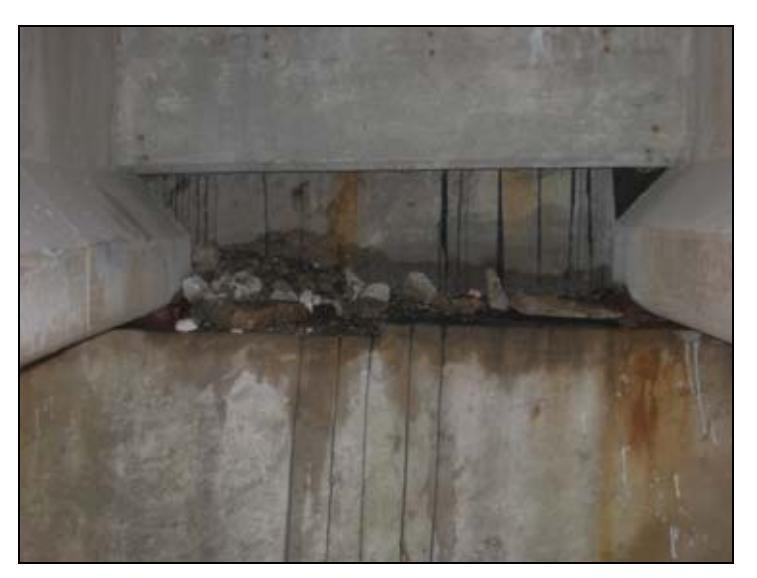
Bridge at Highway 30 over Duff Ave

Figure A7. Water flowing down the bridge abutment
