Investigation of Steel-Stringer Bridges: Superstructures and Substructures, Volume II

Final Report
October 2007

Sponsored by
the Iowa Highway Research Board (Project TR-522)
and the Iowa Department of Transportation (CTRE Project 04-184).

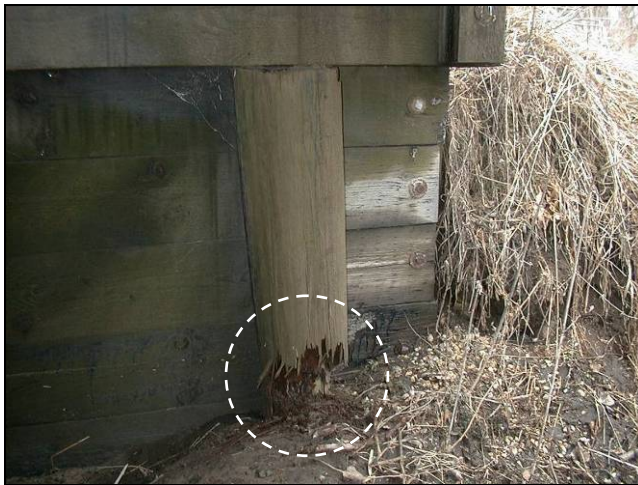
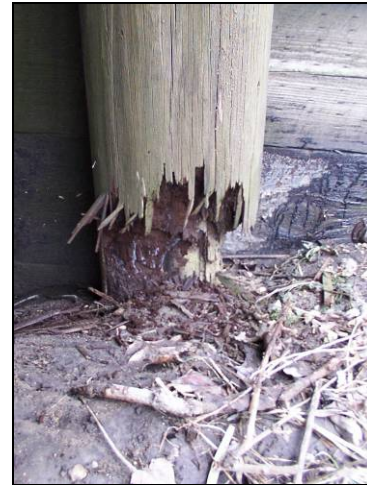
Biological deterioration of timber piles caused by bacteria and fungi attack was frequently observed. In all cases, deterioration originated near the ground or water level due to optimum moisture and oxygen conditions needed for biological activity. At initial stages, deterioration can be difficult to detect by conventional methods such as hammer sounding. If allowed to progress, fungi and bacteria attack can result in significant reduction in the pile cross section decreasing its load carrying capacity (Figure 4.1a). In extreme cases, biological deterioration can result in complete failure of the pile section (Figure 4.1b).

(a) Reduction of pile cross section (Bridge No. 13-42-06 Buchanan County – February 16 2005)

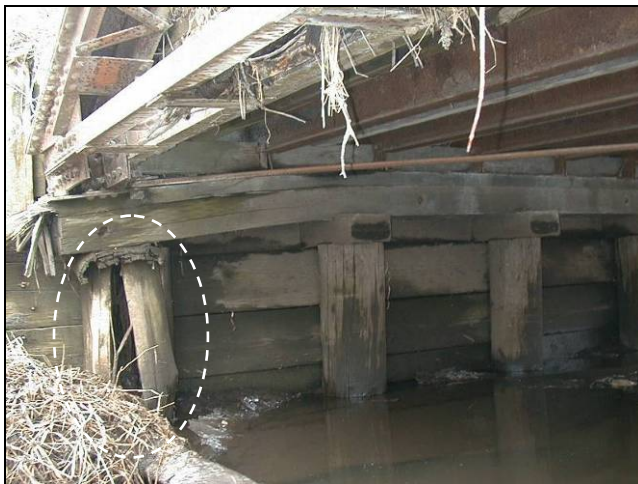
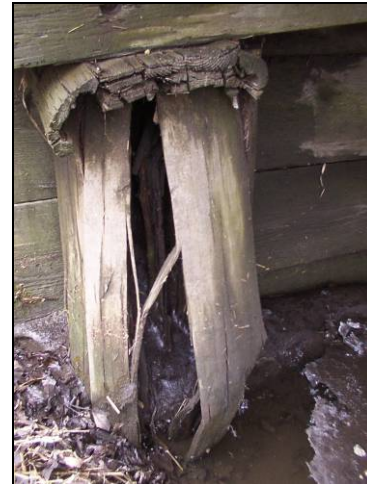
(b) Complete deterioration of pile section (Bridge No. 27-42-00 Buchanan County – February 16 2005)

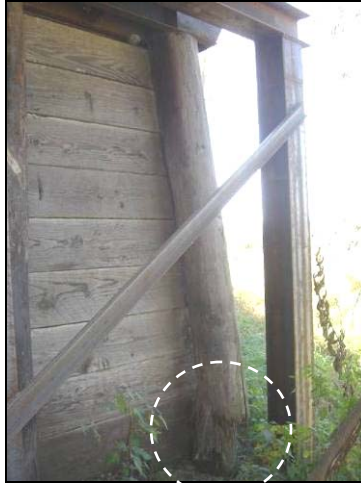
(a) Separation of pile section (Bridge No. 23-70-00 Mahaska County – July 8 2005)

Figure 4.4. Compression failure of pile section caused by overloading

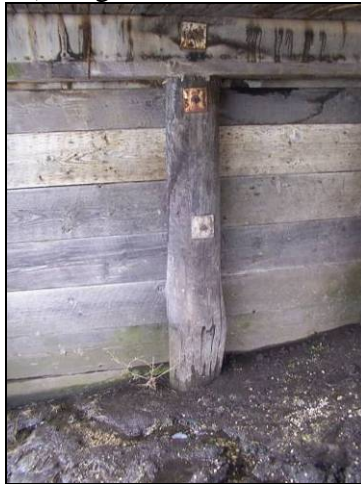
Physical deterioration, which can exist in many forms such as severe cracks and splits, reduction of pile cross section by abrasion, broken piles, and brooming of the pile was also apparent at many sites. Cracks and splits near the pile top can occur while driving the pile, and can result in exposing the untreated pile core to insects and bacteria. An example of commonly observed pile cracks is shown in Figure 4.2. Flowing debris and ice are other factors that contribute to pile physical deterioration, and can result in reduction of pile cross section by abrasion as shown in Figure 4.3. Overloading the piles was observed at 20% of the inspected substructures. Overloading, which is mostly caused by failure of adjacent pile(s), can result in compression failure of the pile and separation of the top portion of the pile as shown in Figure 4.4a. Compression failure can also be in the form of bulging of wood fibers or “mushrooming” at a hollow pile section (See Figure 4.4b and c).

(b) Bulging of timber fibers (Bridge No. 35-87-00 Buchanan County – February 15 2005)

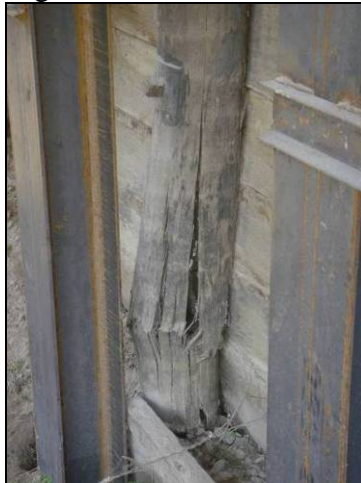
(c) “Mushrooming” of fibers at a hollow section (Bridge No. 23-70-00 Mahaska County – July 8 2005)

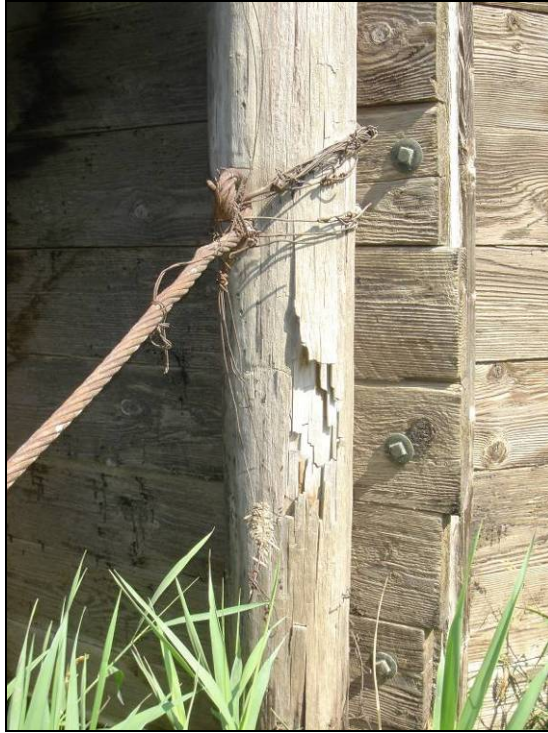
From the field reconnaissance, other causes of pile deterioration that were less frequent and less threatening to the pile integrity were observed. These causes include UV degradation, misalignment of the pile and pile cap deterioration. UV rays break down the lignin, the natural glue which holds wood fibers together, at the surface causing fraying of wood and leaving it with a gray color (USDA 1999). Figure 4.5 shows a timber pile with advanced UV degradation; as a result, the wood at the surface can be peeled off.

Figure 4.5. Ultraviolet degradation of a timber pile (Bridge No. 23-73-50 Mahaska County – July 8 2005)

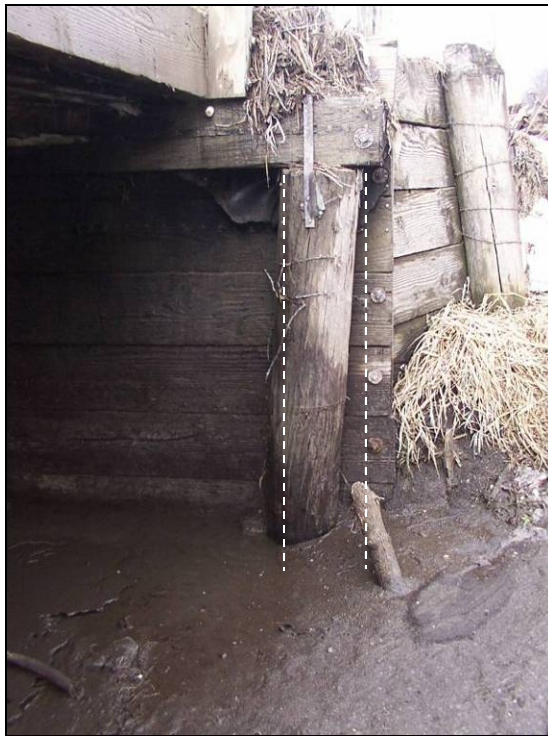
Misalignment of timber piles is another factor contributing to poor substructure performance. Misalignment can result from failure of the connection between the pile cap and the pile due to corrosion. This results in movement of the pile away from the abutment. Further, misalignment can also occur during pile driving, which causes non-uniform bearing between the pile cap and the pile and in turn poor load transfer (See Figure 4.6).

Figure 4.6. Misalignment of a timber pile (Bridge No. 22-00-44 Buchanan County – February 15 2005)

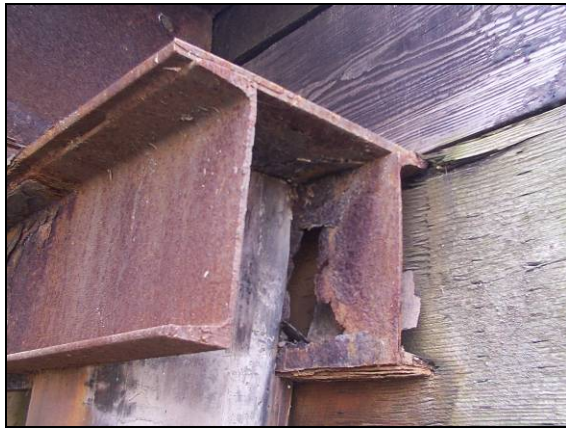
Another observed form of substructure degradation was deterioration of pile caps. A corroded steel cap is presented in Figure 4.7a, while a biologically deteriorated timber cap is shown in Figure 4.7b. Deteriorated pile caps can result in poor load-bearing characteristics and overloading of adjacent piles.

(a) Corroded steel
(Bridge No. 1045 Black Hawk County
– April 2 2005)

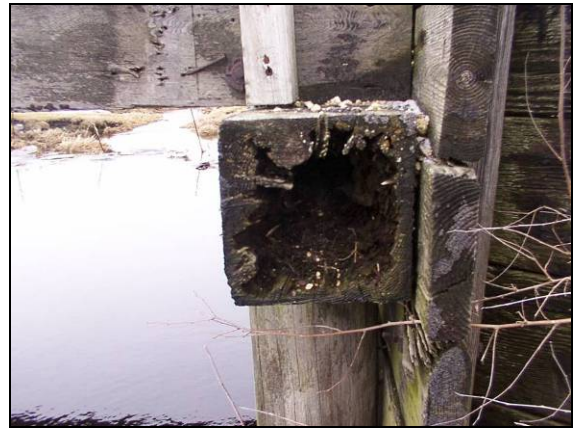
(b) Biologically degraded timber cap
(Bridge No. 15-00-62 Buchanan County
– February 15 2005)

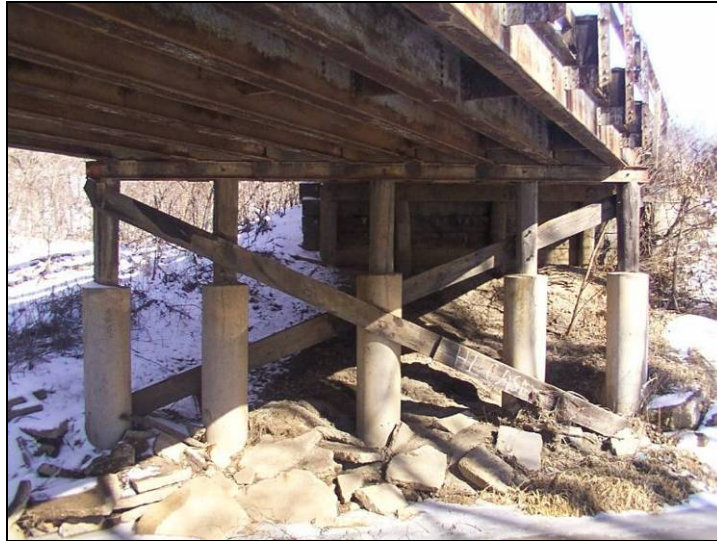
Figure 4.8. Encasing the center piers with concrete for pile restoration (Bridge No. 149 Boone County – February 11 2005)

As mentioned in the pile maintenance section, concrete casing, which can be used to restore timber, concrete or steel piles, is typically used when the pile cross sectional area is reduced by 10 to 50%. At one bridge, the center piers were encased with concrete as shown in Figure 4.8. Inspection at this site showed that longitudinal cracks and concrete spalling were present in all concrete casings, which may have resulted from corrosion of reinforcement and freeze-thaw degradation (See Figure 4.9). Another maintenance practice observed is the addition of a new pile adjacent to a defective pile. In the case of progressive deterioration at one pile, a new pile (timber or steel) is driven next to the faulty pile as shown in Figure 4.10. The final maintenance practice observed is the complete replacement of the existing abutment system, which mainly occurred when advanced deterioration is widespread in more than one pile threatening the integrity of the bridge.

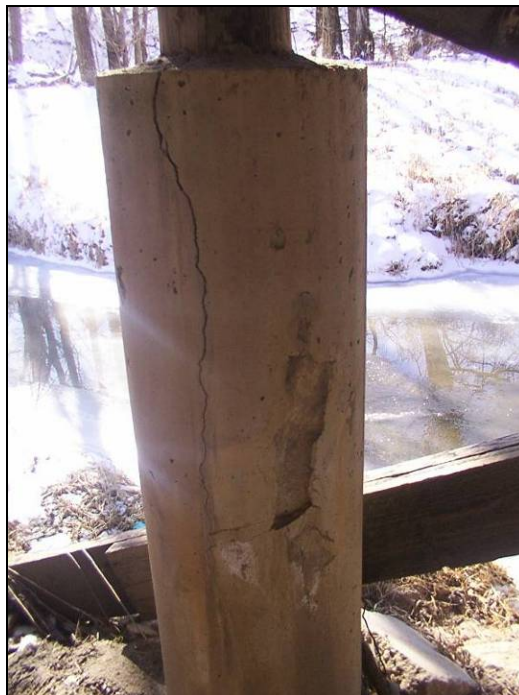
Figure 4.9. Spalling and cracking of concrete casing (Bridge No. 149 Boone County – February 11 2005)

- Longitudinal cracks and concrete spalling are common distresses associated with concrete casing.
- A new timber or steel pile is driven next to the faulty pile when deterioration is excessive and is localized in one pile.

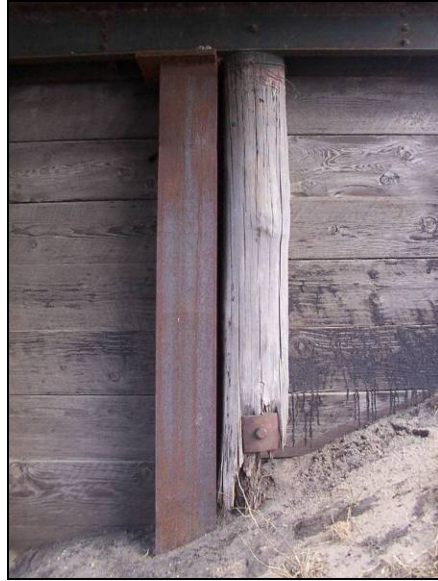
Figure 4.10. New steel pile driven adjacent to defective pile (Bridge on Indian Creek Road Black Hawk County – April 2 2005)

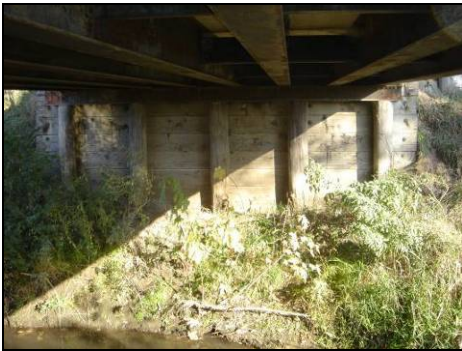
(a) Overview of the north abutment before replacement

Figure 4.11. Bridge No. 31-72-50 Tama County – October 27 2005

In one bridge in Tama County, IA, complete replacement of an existing timber abutment with a new timber abutment system was documented. Replacement was conducted because of severe deterioration at both the north and south abutments. Several deterioration problems were identified at the north abutment such as brooming of the pile section due to overloading, soft section near the ground level with high moisture content, and hollow pile section caused by biological decay (See Figure 4.11). To drive new piles, a section of the concrete deck was removed and about 20 ft of the gravel road near the backwall was excavated (Figure 4.12). Four temporary timber piles (two on each side) were driven adjacent to the sides of the bridge and steel beams were placed on top of them under the existing girder to support the bridge as the

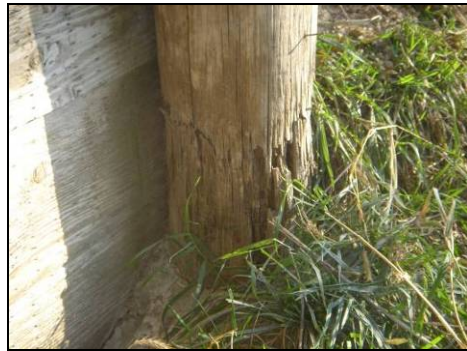
(b) Brooming of pile at the east end of the north abutment

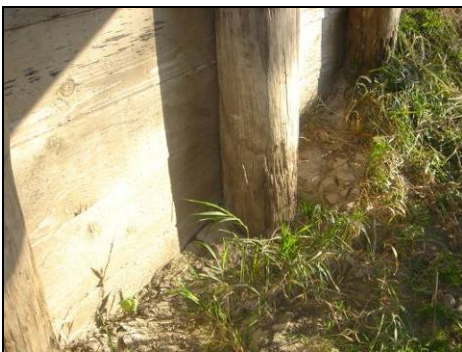
(c) Soft pile section with high moisture near the ground level

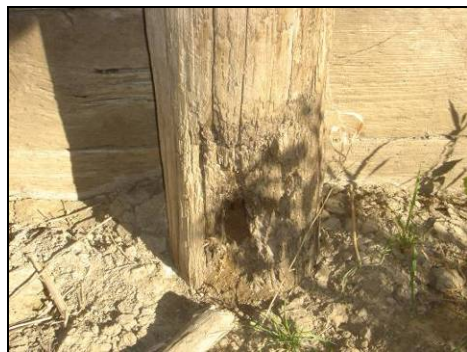
(d) hollow pile section near the ground level

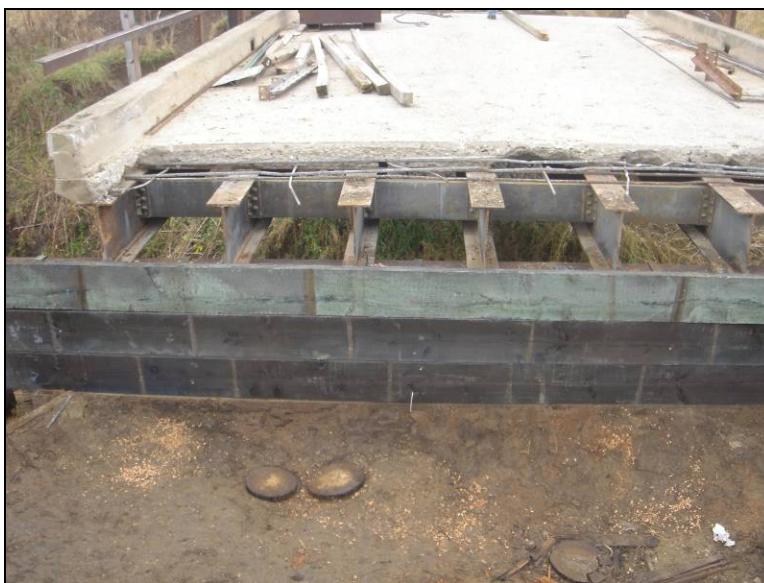
Figure 4.12. A section from the concrete deck is removed for driving timber piles (Bridge No. 31-72-50 Tama County – September 8 2005)

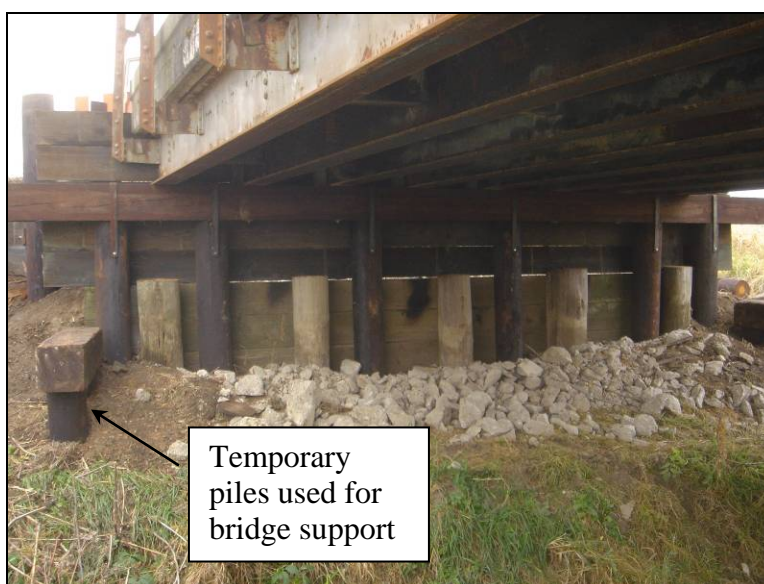
Figure 4.13. New timber abutment system constructed at the north side (Bridge No. 31-72-50 Tama County – September 8 2005)

deteriorated piles were cut short. The new timber piles were driven next to the existing ones and a new timber pile cap was placed under the girders and connected to the new piles. The supporting beams were removed and the old and temporary piles were left in place (Figure 4.13). Leaving the deteriorated piles in place diverts the biological decay away from the new piles, however, it is still recommended to treat the causes of biological decay if the new piles are timber. As an alternative, steel piles can be used for maintenance as shown in Figure 4.14.

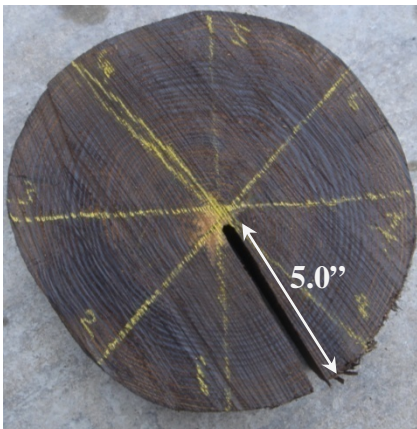
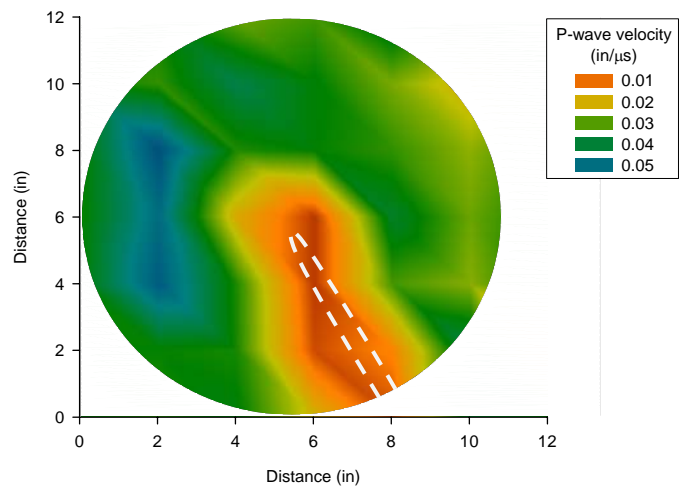
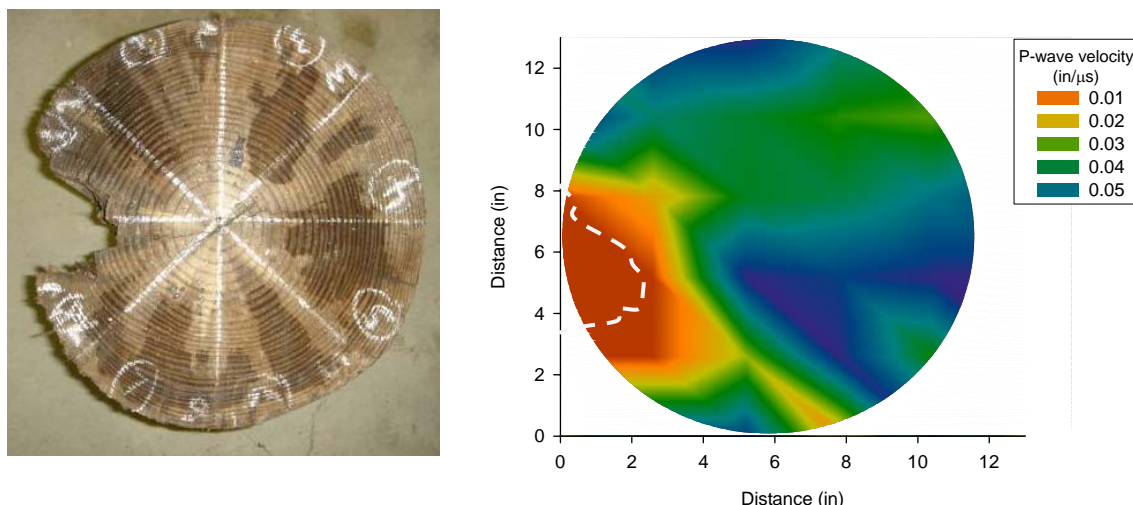
Figure 5.6. Comparison of tomography and digital images generated for damaged piles

To verify that the selected imaging reconstruction technique and test procedure produce reliable results, tomographic images generated at the surface of several piles were compared to digital images. Four pile sections were damaged by creating a cavity near the pile core as shown in Figure 5.6 to simulate biological deterioration, which would not necessarily be visible from the outside of an in-service pile. A radial cut was made in one pile section to simulate pile cracking, which typically develops due to wet-dry cycles or during pile driving (See Figure 5.6e). The height and diameter of these pile sections were about 5 inches and 11.5 inches, respectively. Another pile section used in this study was obtained from a bridge abutment replaced in August 2005. The pile had considerable outer damage as depicted in Figure 5.6f. The pile height and diameter were approximately 22 inches and 12 inches, respectively. The results, demonstrated by the tomography images shown below, indicate that the selected test procedure and image reconstruction technique were successful in capturing the approximate shape and location of the internal damage. Results also show that the velocities in the hollow areas are lower than the velocities in the intact parts of the pile sections. Velocities in hollow areas were generally less than 0.02 inches/ μ s.

(d) Squared cavity; 3"x3"

(e) Radial crack

(f) Irregular outer cavity

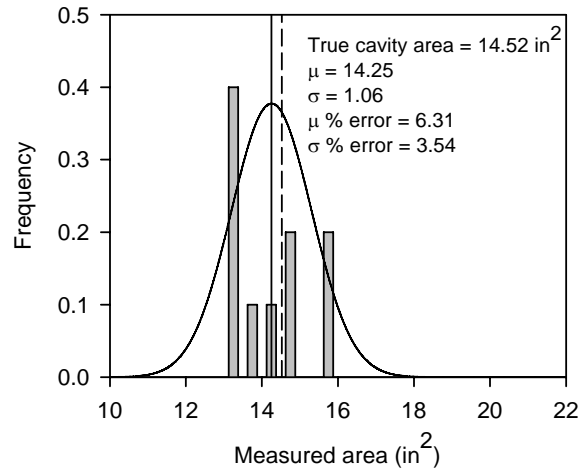
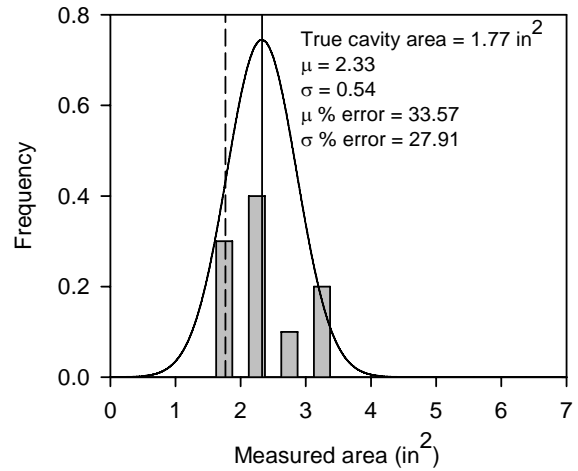
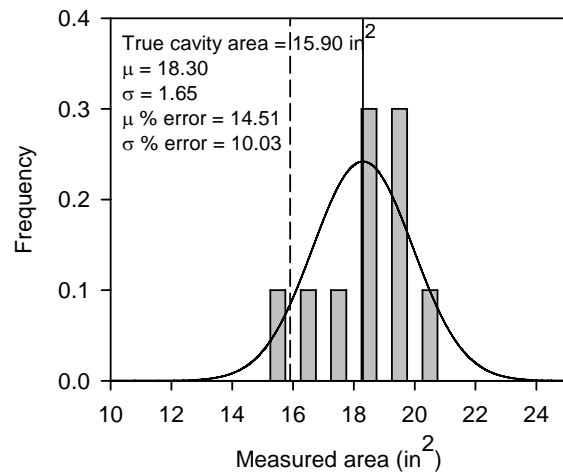
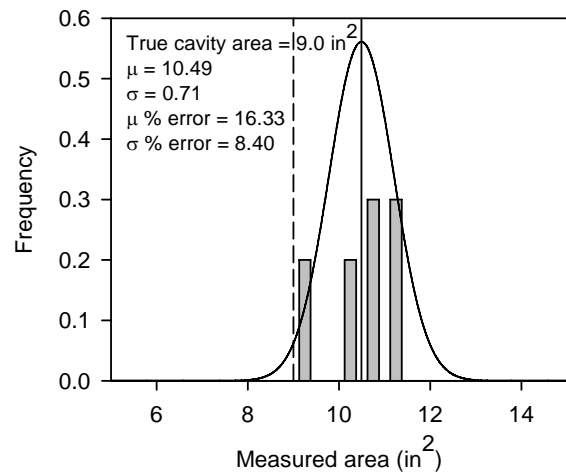
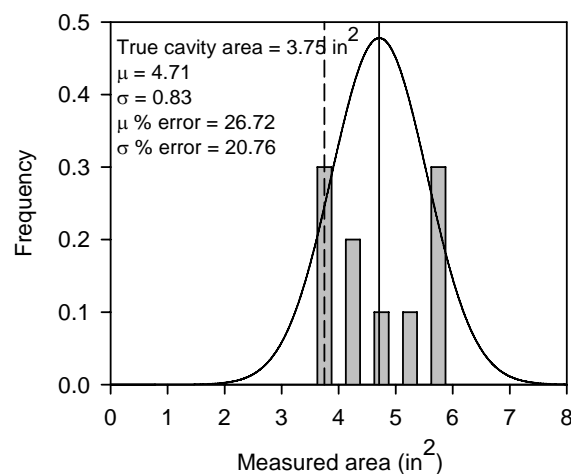
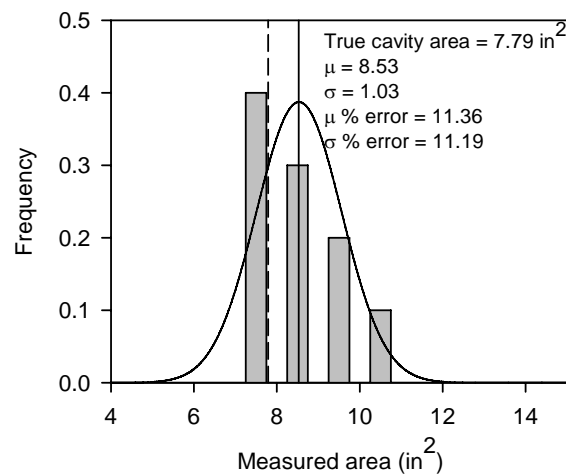
Figure 5.7. Normal distribution plots of the damaged pile sections evaluating accuracy and precision of the ultrasonic stress wave test procedure

The accuracy and repeatability of the test procedure was evaluated by repeating the ultrasonic stress wave test 10 times for each pile section. At each test, the locations of the 8 test points, where the transmitting and receiving transducers were positioned, were shifted and a tomography image was generated (i.e. for each pile, 10 tomograms were created). From each image, the region enclosed by velocities less than 0.02 inches/ μ s was measured to estimate the hollow area of the pile, which was then compared to the true area. The difference between the true cavity area and mean measured area for each pile section gave an indication of the accuracy of the test procedure, while the difference between the measured areas gave an indication of the test procedure repeatability (precision). Normal distribution plots of the measured areas for the 6 pile sections are presented in Figure 5.7. The dashed lines depicted in the figure represent the true cavity areas. Apart from the results shown in Figure 5.7a, where the damage comprised of a square cavity with an area of 14.52 in² and the measured area was 14.25 in², the results demonstrate that the test procedure and/or the image reconstruction process have a “biased” tendency to over predict the cavity area. The range of over prediction, as evidenced by the mean of the percent error, ranged from 6 to 34% of the true cavity area. The results also show that the pile sections have different standard deviation of the percent error values. Due to this difference, it was concluded that the orientation of transducers influence the precision of the test procedure. This can be explained by the anisotropy of acoustic propagating velocities in wood (i.e. the elastic properties and the associated acoustical properties are very different in the radial, tangential, and longitudinal directions). The results also show that the size and shape of the internal defect can influence the precision of the test procedure. Small defects, relative to the pile diameter, such as the 1.5 inch circular cavity or the radial crack have higher mean and standard deviation percent error. This may be attributed to the number of measurements, which can only identify defects with limited precision. Increasing the number of measurements may decrease the influence of the internal defect size and shape on the test procedure precision.

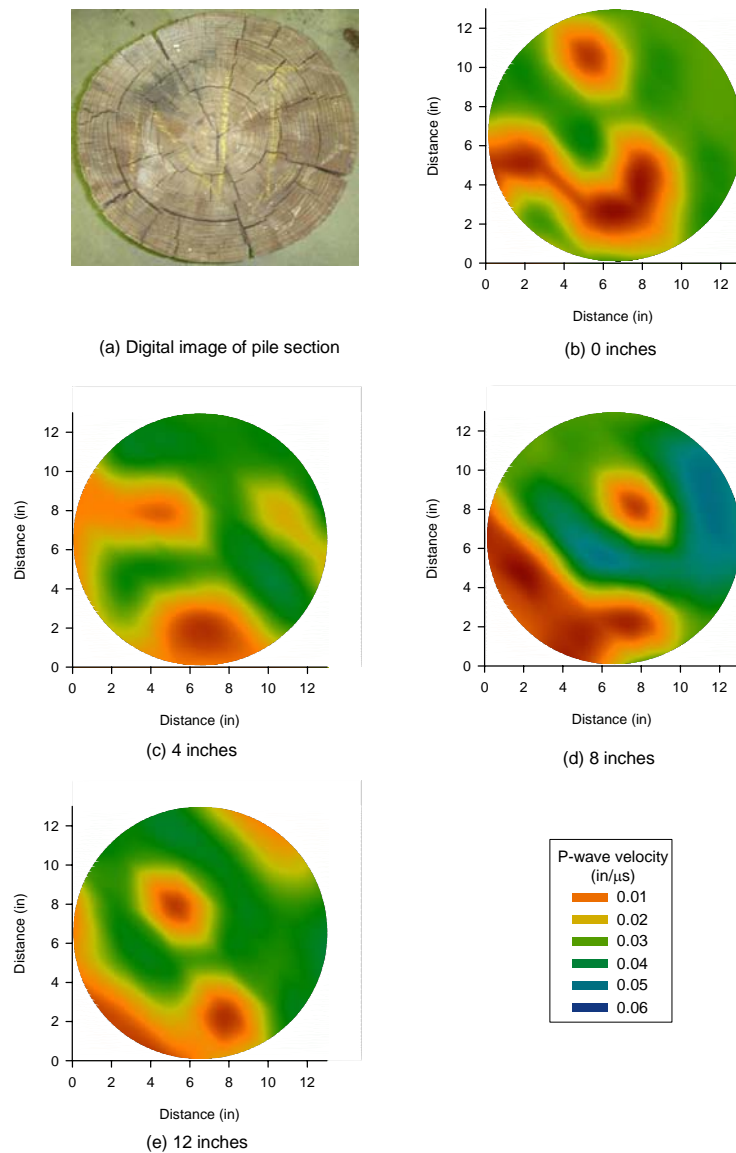
The ultrasonic stress wave test was performed on 12 timber pile specimens for multiple cross sections for a given pile. Multiple measurements, using the transducers arrangement outlined earlier, were performed at each cross section to obtain a tomographic image every 4 inches revealing the pile internal condition. Out of the 12 specimens, 9 were previously in-service and 3 were new. An example of the output generated for each pile specimen is presented in Figure 5.8. This figure was generated for a pile obtained from the north abutment of a bridge in Marshall County, Iowa. Additional images of other timber specimens tested are presented in Appendix B.

Figure 5.8. Generated tomography images of a timber pile specimen (Pile 1 North Abutment Marshall County Bridge)

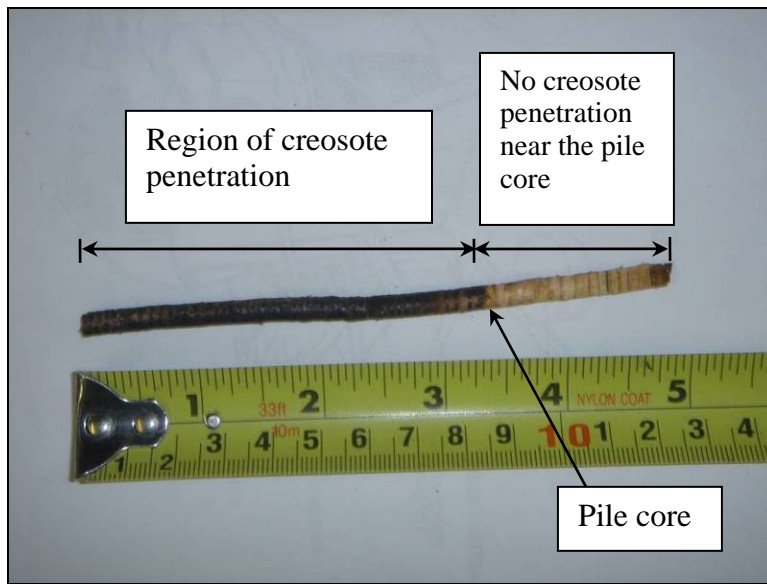
An increment borer was used to obtain a pile core from each pile (See Figure 6.10). The increment borer, which has a diameter of 0.203 inches, was used to determine if the pile was hollow near its core, and to obtain a specimen for determining the wood density. For some piles, more than one core was obtained to determine the density profile along the pile. The extracted cores were also used to visually assess the level of creosote penetration in the piles. It was noted that the creosote diffusion in most piles was not high enough to reach the pile core. A core obtained from a pile in Bridge no. 094680 Carroll County is shown in Figure 6.11. The total length of the core was about 4.9 inches. The creosote penetrated a distance of about 3.3 inches into the pile. The typical penetration distance for creosote in the piles supporting the six bridges investigated ranged from 2 to 4 inches.

Figure 6.11. Pile core showing level of creosote penetration

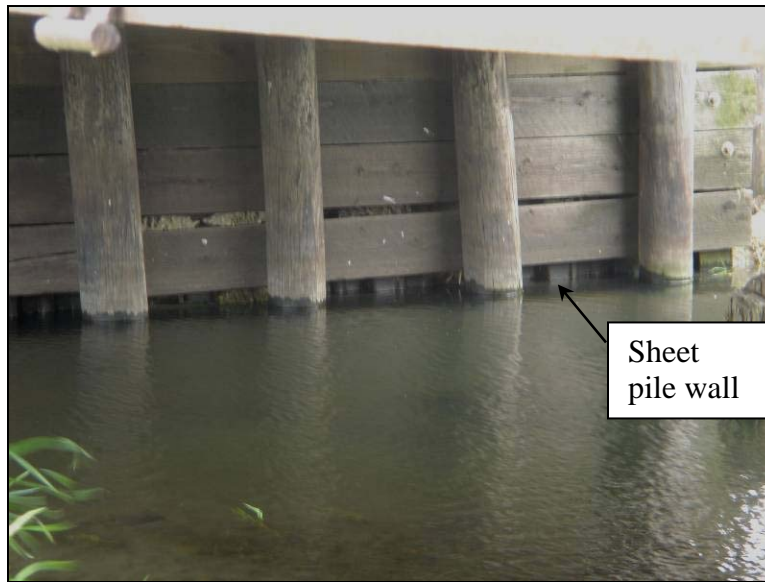
Each abutment is comprised of seven timber piles about 7 inches in diameter, a timber backwall, and a double c-channel cap (See Figure 7.2). The average exposed length of the piles above the water table was about 50 inches. The pile length below ground level is unknown since no bridge plans were available. The piles at the north abutment were denoted as no. 1 located at the northwest edge of the bridge, through no. 7 as shown in Figure 7.3. The dimensions of the north abutment are shown in Figure 7.4. A schematic diagram of the abutment, shown in Figure 7.5, indicates that the bridge does not have a conventional stub-abutment detail; the girder ends are integrally connected to a concrete diaphragm, which rests directly on top of the pile cap. This integral connection complicates the substructure analysis due to the difficulty in quantitatively, isolating, and understanding its effect on load distribution through the substructure components. Inspection of the north abutment revealed decay at pile no. 1 about 32 inches above the water level (See Figure 7.6). Also, a soft pile section right above the water table was observed at pile no. 7 as shown in Figure 7.7. The soft section may be a result of high levels of moisture due to the variation of the water table, which in turn triggers biological activity. Excessive scour occurred near the south abutment undermining the timber backwall. This led to exposure and erosion of the backfill material creating a void behind the backwall. In 1993, as shown in Figure 7.8, a sheet pile wall was driven behind the south abutment to prevent further erosion; the erosion-induced void was filled with concrete.

Figure 7.8. Sheet pile wall driven behind the south abutment to prevent backfill erosion (Bridge No. 7710 Boone County – June 1 2005)

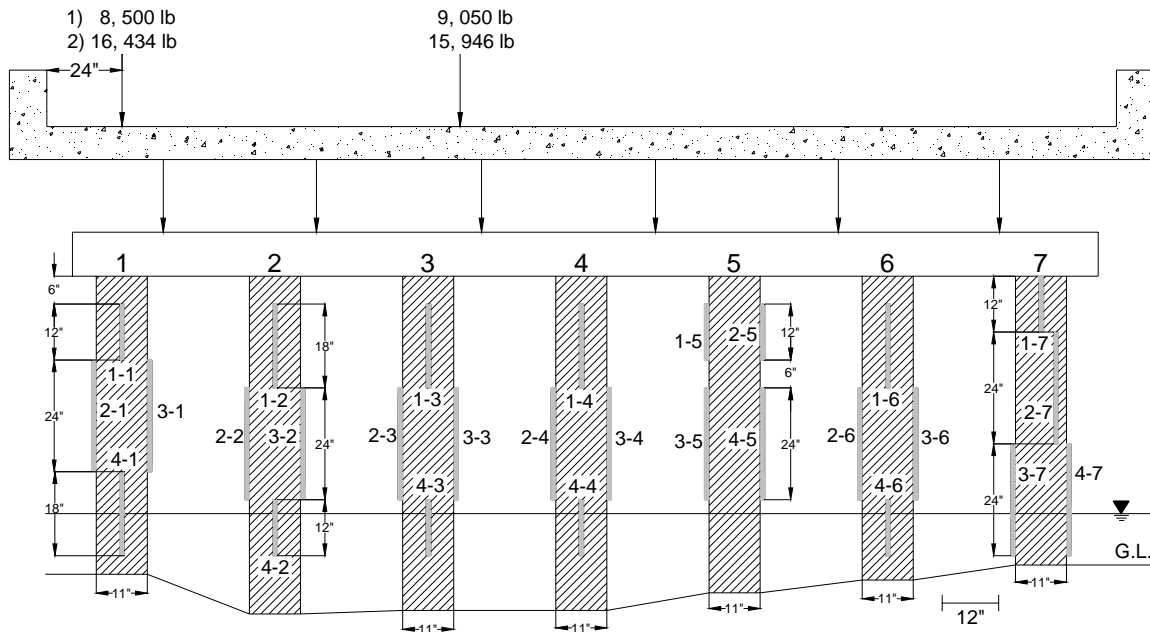
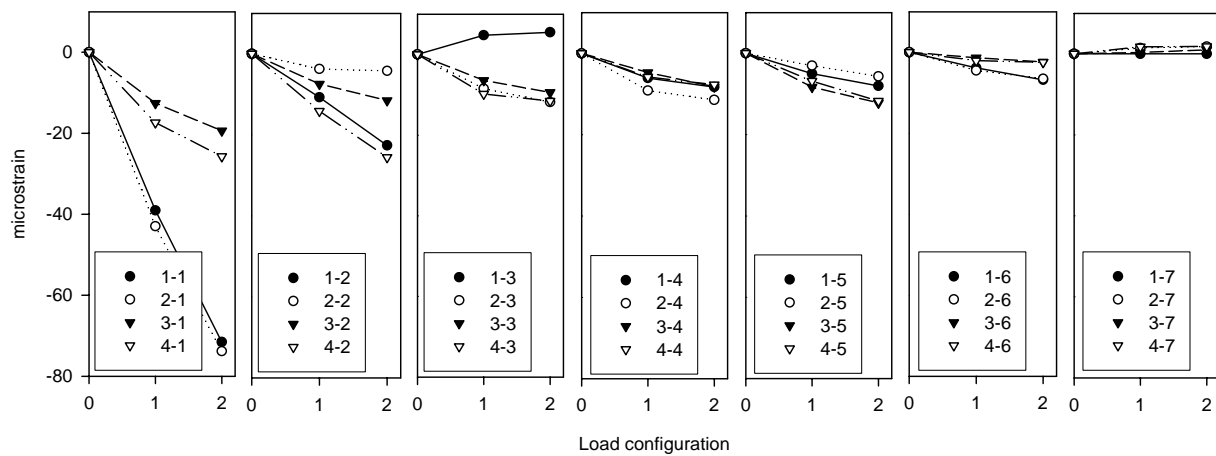
Figure 7.10. Pile strains for north abutment – West edge (Bridge No. 7710 – Boone County)

The north abutment was loaded at the west edge of the bridge. Summarized in Figure 7.10 are the strains measured in each pile and the locations of the applied loads. Load configurations 1 and 2 correspond to positioning the rear wheel then the front wheel of the tandem axle over the centerline of the piles, respectively (Refer to Figure 6.4 for loading pattern). The highest strains measured, which occurred in pile no. 1, were about -40 and -78 microstrains at both load configurations. Without knowing the pile modulus, it is not possible to determine whether the high strains are a result of higher load or higher pile compression caused by internal decay. The field data revealed that strain values decreased with increasing distance from the applied load so that there was essentially no strain in pile no. 7. The difference in strain values between piles is an indication of the flexible behavior of the pile cap. The strain transducer 1-3 on pile no. 3 showed positive strains (top 18 inches). This may be caused by pile bending due to eccentric axial load and/or mobilization of lateral earth pressure. Below this region, however, strain measurements for pile no. 3 were negative. At each pile and for a specific load configuration, the strains varied both longitudinally and transversally along the exposed portion of the pile. This finding, which is attributed to the anisotropic behavior of timber and to localized degraded regions along the pile, further increased the difficulty in characterizing the pile's condition.

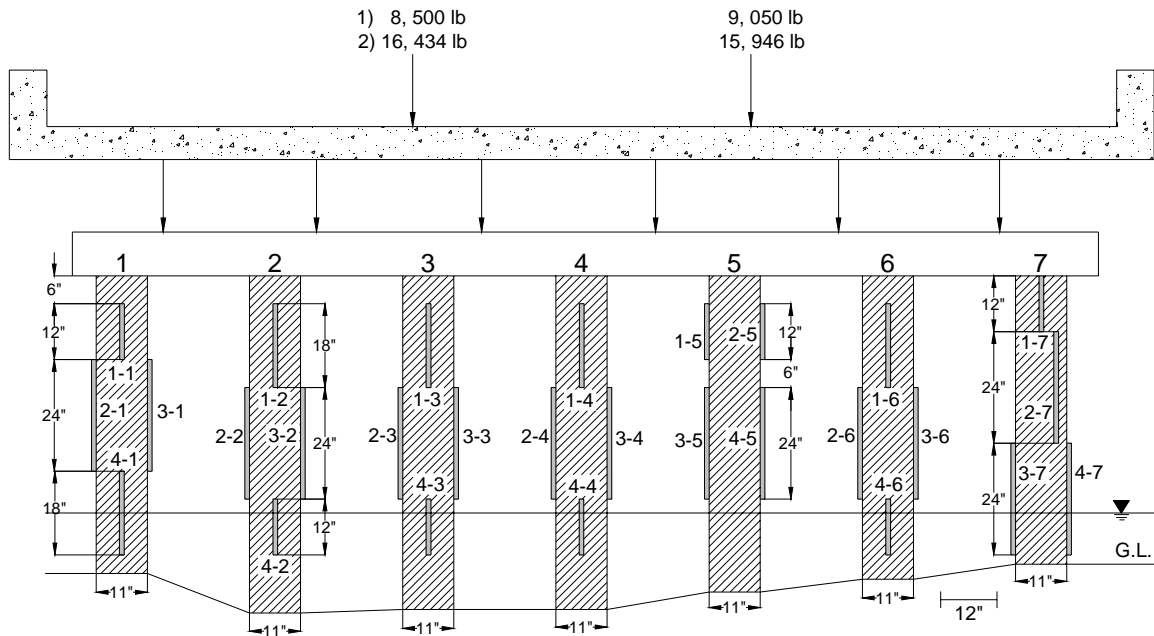
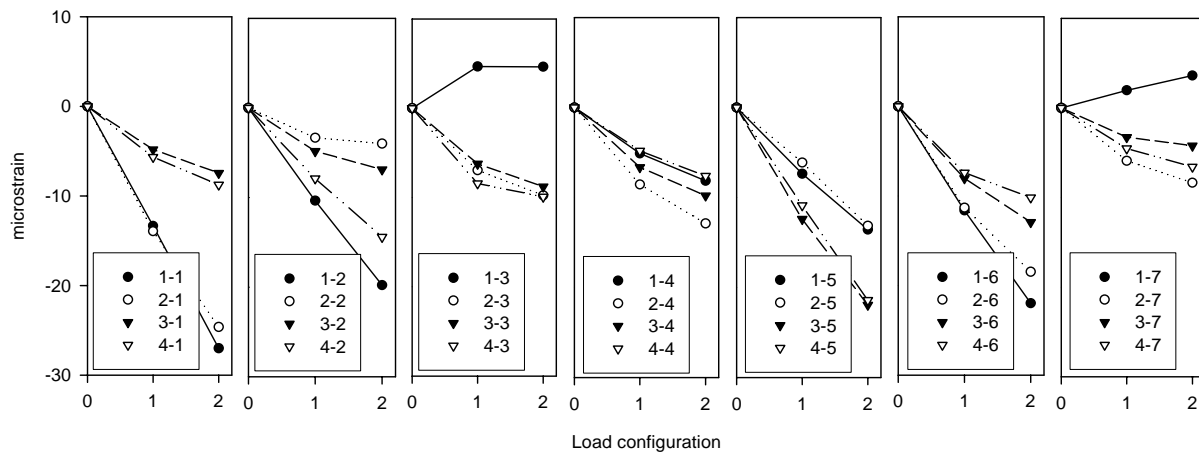
Figure 7.11. Pile strains at north abutment – Centerline (Bridge No. 7710 – Boone County)

The second loading location was at the centerline of the bridge. Pile strains and the locations of the applied static loads for this load case is shown in Figure 7.11. For the first and second loading configurations, strain transducers 1-1 and 2-1, which were attached to pile no. 1, measured the highest strain. Since high strains were measured at pile no. 1 during loading both the west end and centerline lanes, it is surmised that pile no. 1 was compressing more than adjacent piles due to its degraded condition (Refer to Figure 7.6) assuming reduced stiffness. Also, pile nos. 2, 5, and 6 measured high strains. Similar to the previous test, strain transducer 1-3 measured positive strains in the upper portion of the pile.

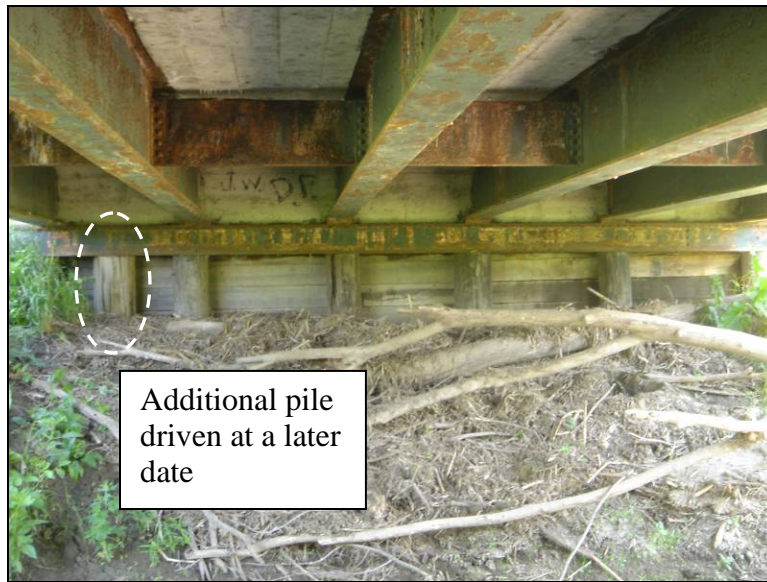
According to maintenance records, the substructure was inspected in spring of 1998. Pile no. 2 (added at a later date) and pile no. 4 at the north abutment were identified as having about 50% section loss. Prior to 1998, substructure rating varied between good and satisfactory. The bridge was inspected again by a consultant in December 2003. The bridge substructure was given a poor condition rating with seven piles undergoing decay. These piles, however, were not identified in the inspection report.

Figure 8.3. North abutment (Bridge No. 243470 Marshall County – July 22 2005)

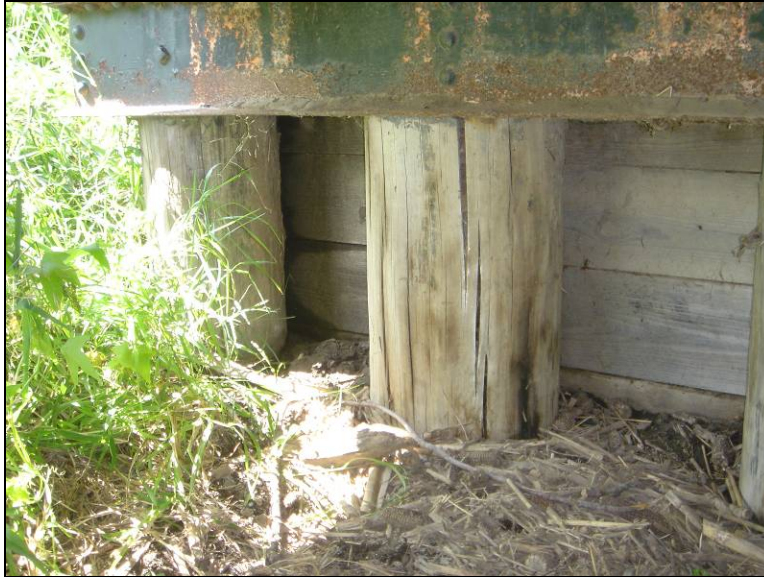
Visual inspection revealed that both abutments showed signs deterioration. At the north abutment, hammer sounding and probing indicated that pile no. 2 had a hollow core. Considerable pile cracking was also noted (See Figure 8.6). Also, advanced biological deterioration was observed at pile no. 4; the intact pile diameter was about 3 inches as shown in Figure 8.7. The intact pile was surrounded by timber powder, which was reddish brown in color, possibly caused by brown-rot fungi. At the south abutment, high moisture content was observed at the ground level resulting in a rotted section in piles nos. 1 and 4 (See Figure 8.8).

Figure 8.6. Hammer sounding and probing revealed a hollow core at pile no. 2 at the north abutment (Bridge No. 243470 Marshall County – June 22 2005)

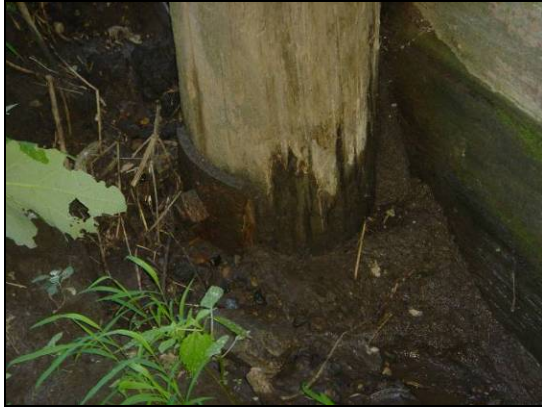
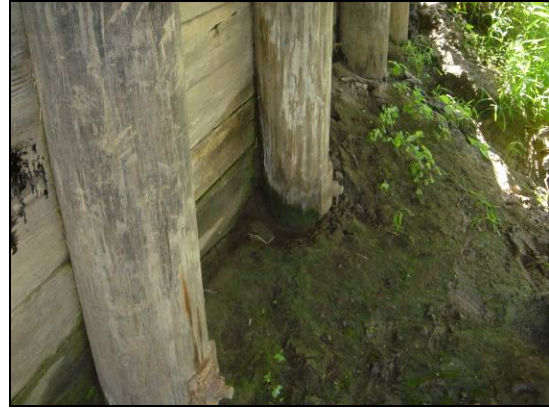
Figure 8.8. Rotting pile sections at the south abutment caused by high moisture content near the ground level (Bridge No. 243470 Marshall County – July 22 2005)

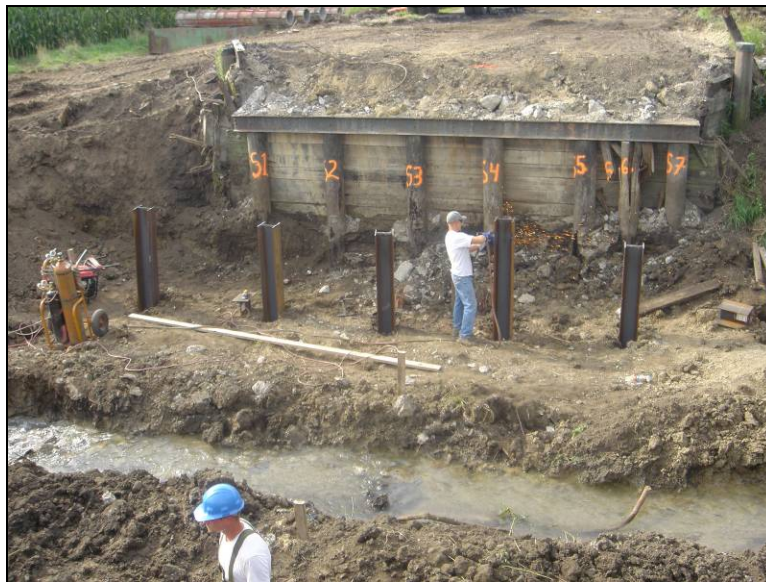
Two weeks after load testing the bridge, and due to the poor conditions of the superstructure and substructure, the bridge was demolished and replaced with a new bridge. Figure 8.9 shows the location of the old south abutment and the construction of the new bridge foundation. The exposed part of some timber piles from both abutments were obtained and were tested in the laboratory to measure their strength properties.

Figure 8.9. Construction of the new bridge foundation (Bridge No. 243470 Marshall County – August 19 2005)

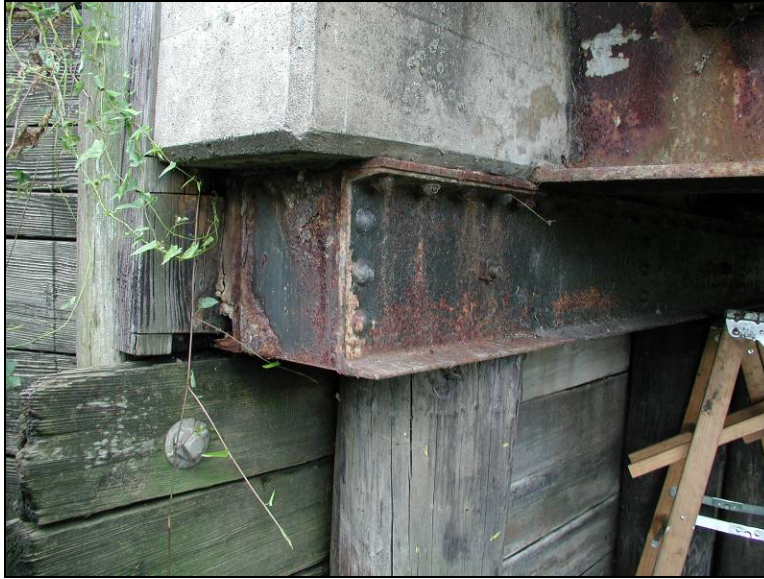
Similar to the pile strains, the backwall strains were higher directly under the live load and decreased with increasing distance from the load location. Figure 8.18 shows the pile cap partially resting on the top of the timber backwall; therefore, the measured negative strains may be a result of axial compression of the backwall.

Figure 8.18. Pile cap partially resting on the timber backwall (Bridge No. 243470 – Marshall County – July 28 2005)

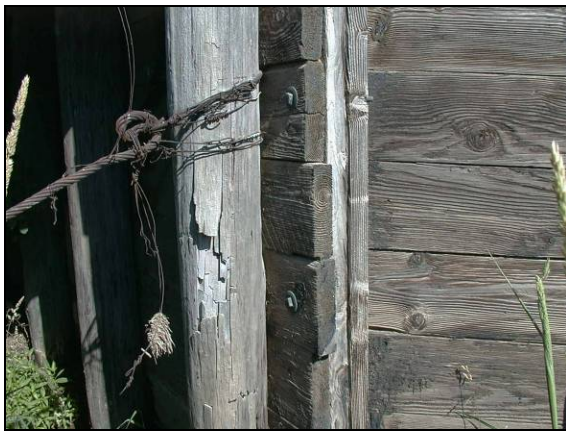
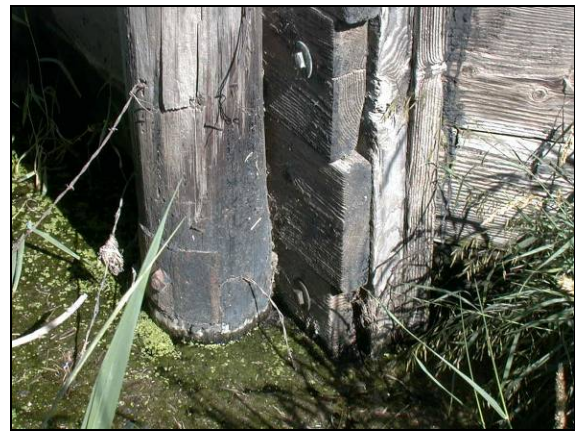
Figure 9.5. Deterioration observed at pile No. 5 (Bridge No. 237350 Mahaska County – October 25 2005)

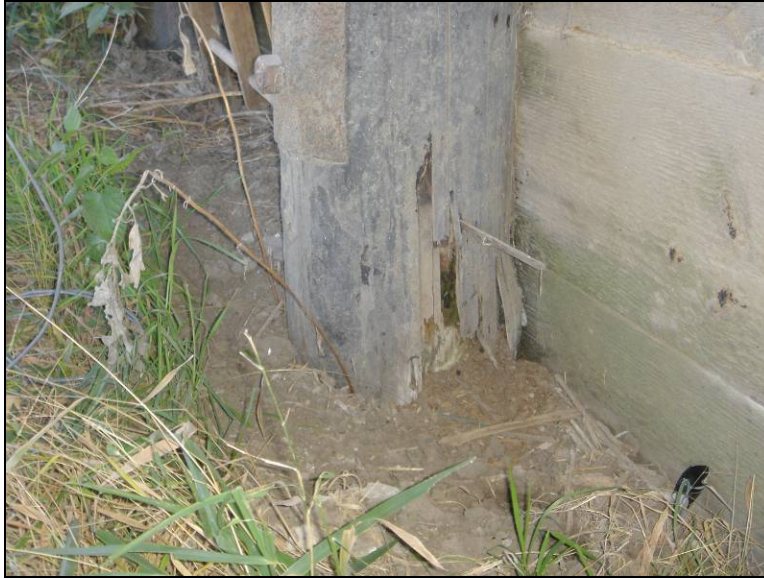
The south abutment, shown in Figure 9.6, has an average exposed pile length of about 94 inches and an average pile spacing of 49 inches. The tie back rods are about 6.5 ft from the pile heads. Figure 9.7 is a schematic diagram of the south abutment illustrating the exposed pile lengths and spacing. Visual observation revealed brooming in pile no. 2 near the ground level as shown in Figure 9.8. For pile no. 5, rotting near the ground level was observed (See Figure 9.9).

Figure 9.8. Brooming of pile No. 2 near the ground level (Bridge No. 237350 Mahaska County – October 25 2005)

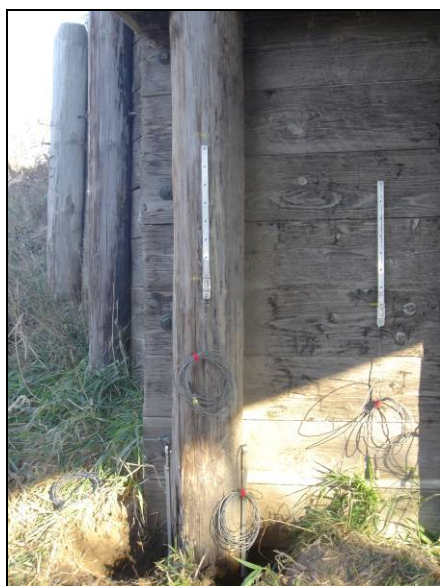
(a) Pile no. 1 at the north abutment

Figure 9.11. Soil excavated around piles to allow for strain transducer installation across deteriorated regions (Bridge No. 237350 Mahaska County – October 28 2005)

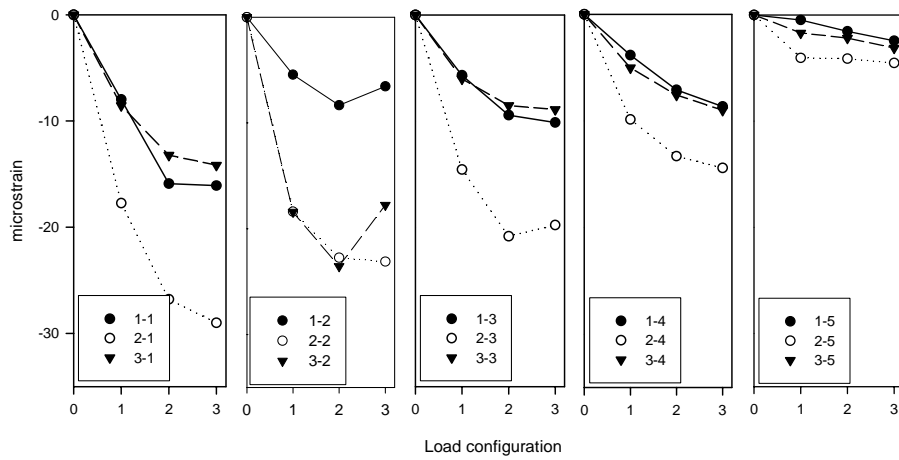
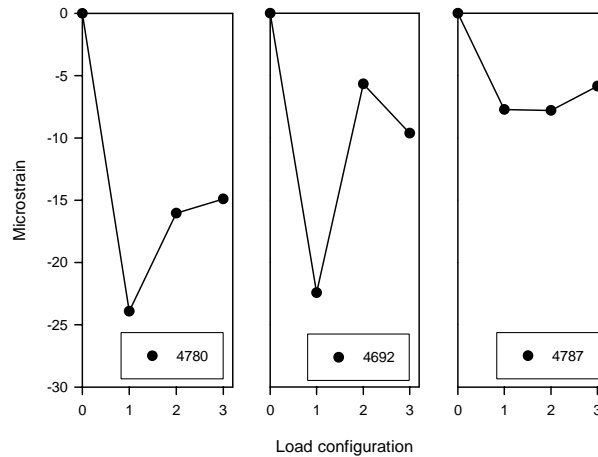
Figure 9.12. Static load test at the west edge (Bridge No. 237350 – Mahaska County)

The first load test was performed with the load at the west edge of the bridge. The load was offset about 2 ft from the curb. Figure 9.12 shows the location and magnitude of the loads, pile strains, and backwall strains. The highest strain measured was in pile no. 1 and was about -29 microstrains during load configuration 3. The measured strain decreased with increasing distance from the location of the applied loads. Strain transducer 2-1, which was attached to a biologically deteriorated section, indicated a higher strain measurement when compared to other strain measurements in pile no. 1.

The backwall strains were highest near the applied load, and decreased with increasing distance from the location of the loads. For load configurations 2 and 3, the recorded strain decreased due to reduction in axial load. Negative strains were recorded at load configuration 3 because of the partial bearing of the pile cap on the backwall (See Figure 9.13).
