Investigation of Steel-Stringer Bridges: Superstructures and Substructures, Volume II

Final Report
October 2007

Sponsored by
the Iowa Highway Research Board (Project TR-522)
and the Iowa Department of Transportation (CTRE Project 04-184).

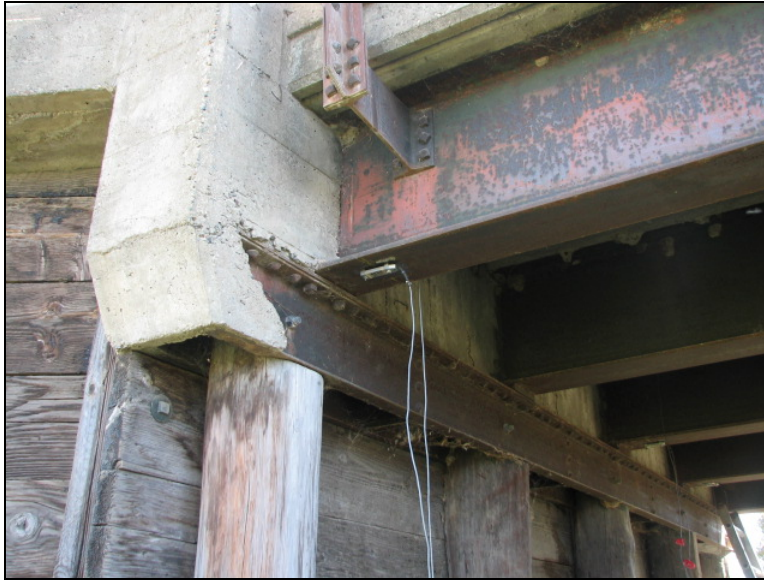
The backwall strains were highest near the applied load, and decreased with increasing distance from the location of the loads. For load configurations 2 and 3, the recorded strain decreased due to reduction in axial load. Negative strains were recorded at load configuration 3 because of the partial bearing of the pile cap on the backwall (See Figure 9.13).

Figure 9.13. Pile cap partially resting on the timber backwall (Bridge No. 237350 Mahaska County – October 28 2005)

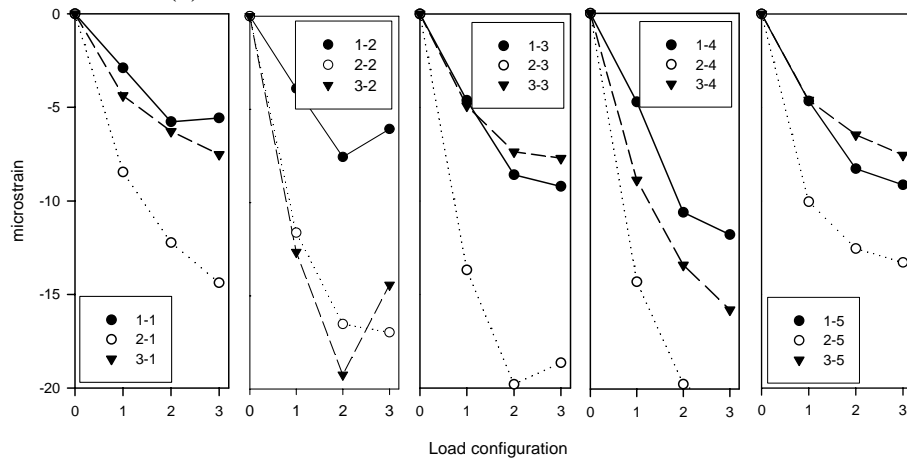
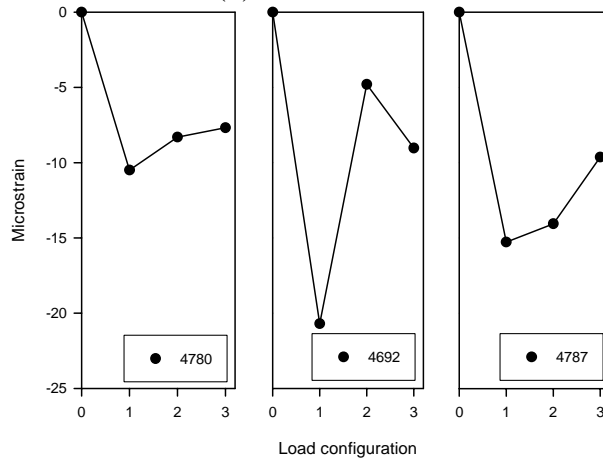
Figure 9.14. Static load test at the centerline (Bridge No. 237350 – Mahaska County)

The second load test was performed with the load in the centerline lane. The location and magnitude of the applied axial loads, pile strains, and backwall strains are shown in Figure 9.14. The recorded strains were highest in pile nos. 2, 3, and 4 and decreased with increasing distance from the location of the applied load. The highest strain occurred in pile no. 4 and was about -20 microstrains in load configuration 3. Strain transducer 2-1 continued to show higher strain compared to other strains measured in pile no. 1. Similarly, the backwall strains were highest directly under the applied load (i.e. between pile nos. 2 and 3). In load configuration 1, the highest strain measured was about -21 microstrains between pile nos. 2 and 3.

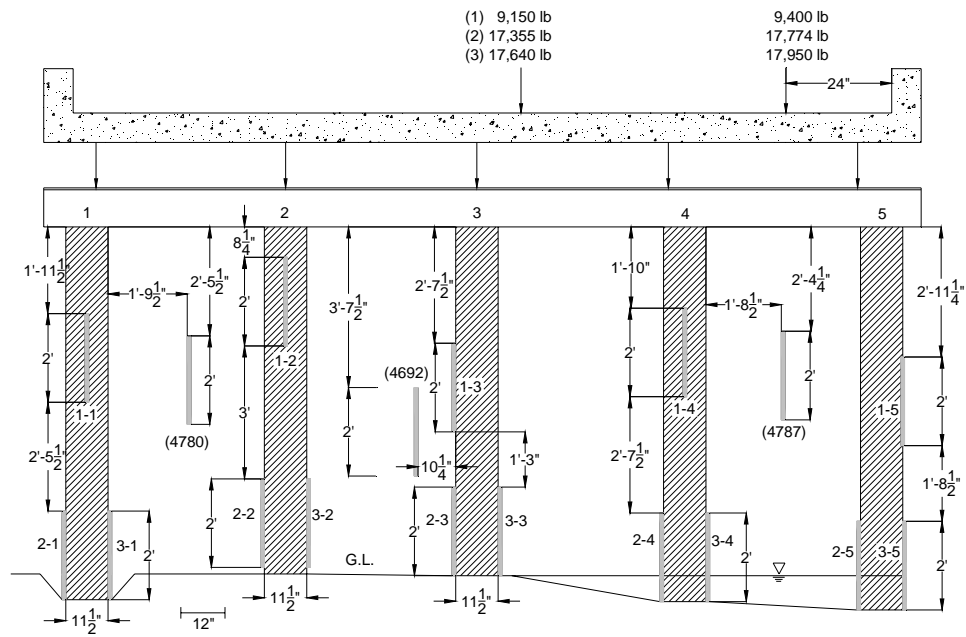
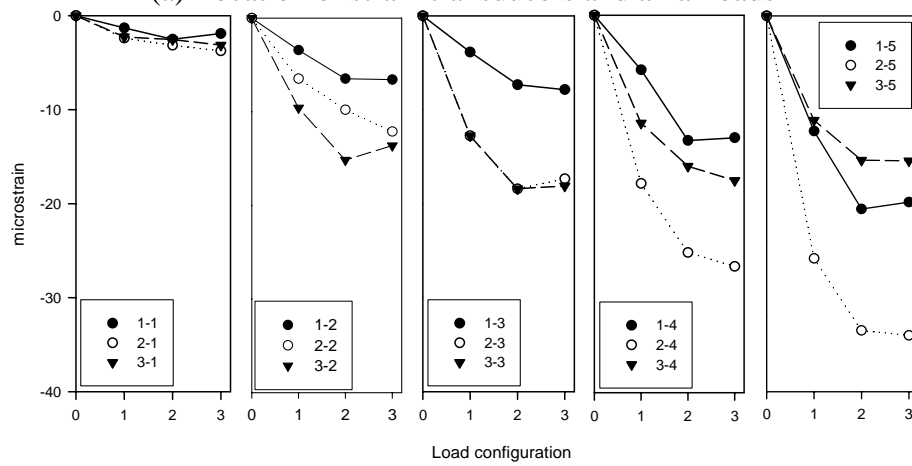
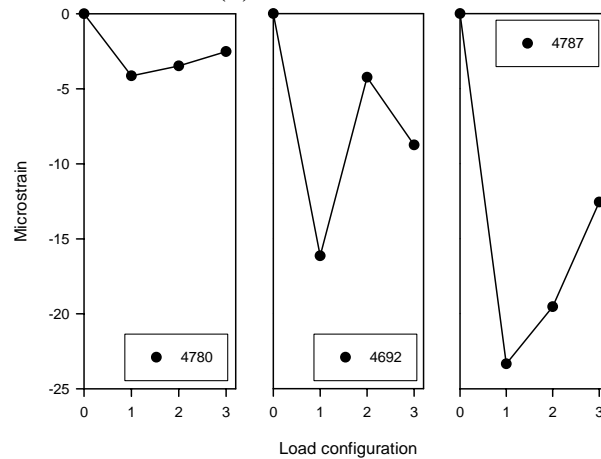
Figure 9.15. Static load test at the east edge (Bridge No. 237350 – Mahaska County)

The third load test was performed with the load at the east edge of the bridge. The load was offset about 2 ft from the curb. The location and magnitude of the applied axial loads, piles strains, and backwall strains are shown in Figure 9.15. The highest strain was measured in pile no. 5 and was about -21 microstrains in load configuration 3. The measured strain decreased with increasing distance from the location of the applied loads. The backwall strains were highest near the applied load (i.e. between pile nos. 4 and 5), and decreased with increasing distance from the location of the axial loads. In load configuration 1, the highest strain measured was about -23 microstrains.

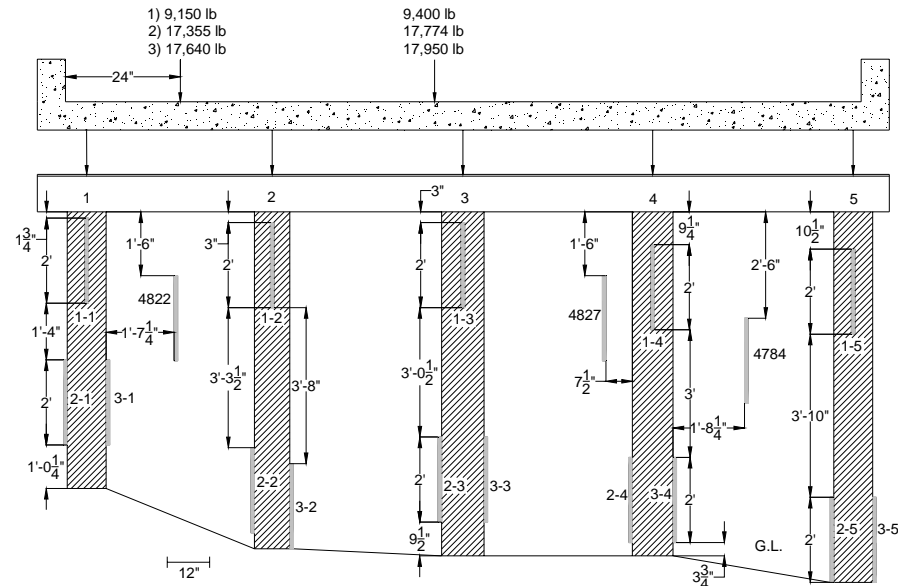
Figure 9.16. Static load test at the west edge (Bridge No. 237350 – Mahaska County)

At the south abutment, the first static load test was performed with the load at the west edge of the bridge. The load was offset about 2 ft from the curb. The location and magnitude of the applied axial loads, piles strains, and backwall strains are presented in Figure 9.16. The highest strain was measured in pile no. 5 and was about -34 microstrains at load configuration 3. The measured strain decreased with increasing distance from the location of the applied loads. Strain transducers 3-2 and 2-5, which were attached to soft sections near the ground level, displayed higher strains compared to other strain measurements in pile nos. 2 and 5.

The highest backwall strain was between pile nos. 3 and 4 directly under the applied load and was about -20 microstrains. Backwall strains decreased with increasing distance from the location of the axial loads. In load configurations 2 and 3, the backwall showed positive strain values.

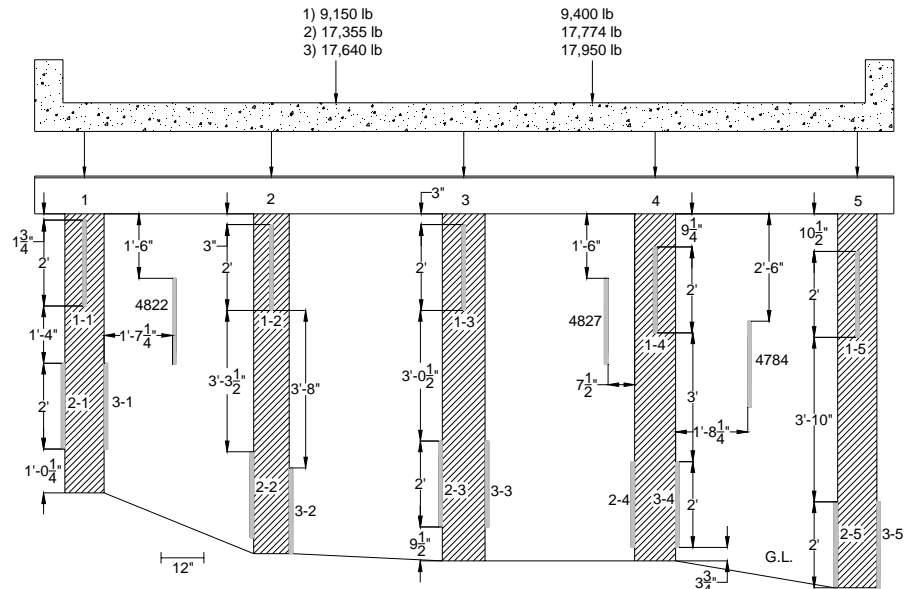
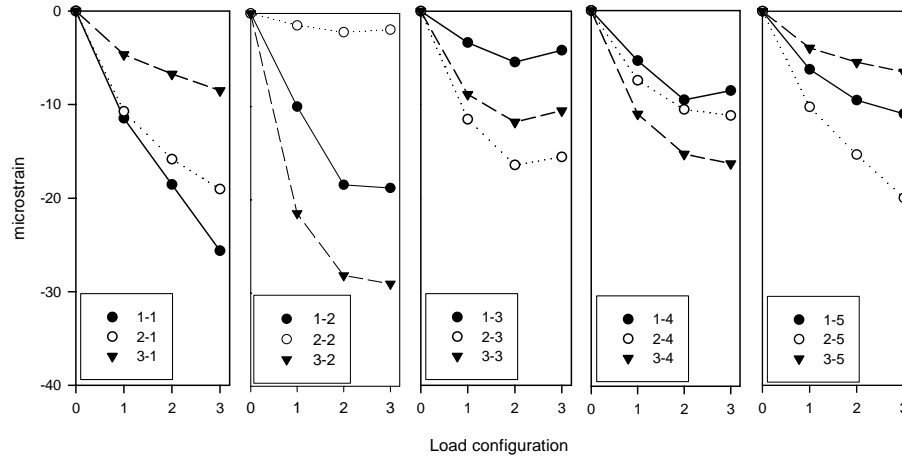
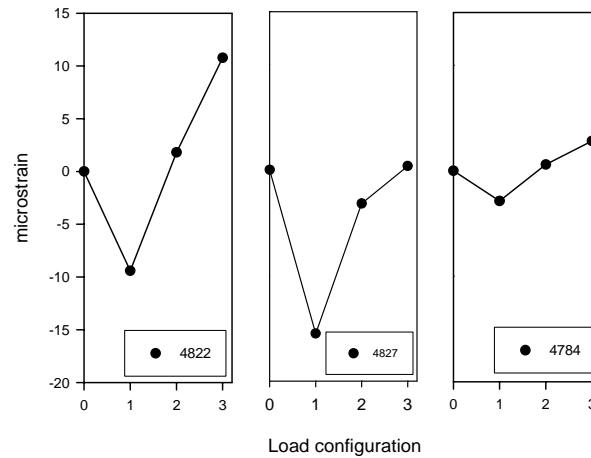
Figure 9.17. Static load test at the centerline (Bridge No. 237350 – Mahaska County)

The second load test was performed with the load at the centerline of the bridge deck. The location and magnitude of the applied axial loads, pile strains, and backwall strains are presented in Figure 9.17. The results indicate a more uniform strain distribution, compared to the west edge test, through the substructure components. The highest strain was measured in pile no. 2 and was about -29 microstrains in the third load configuration. Strain transducers 3-2 and 2-5 indicated higher strains since they were attached to softer pile sections. Backwall strains continued to show negative values in load configuration 1, and positive values in load configurations 2 and 3.

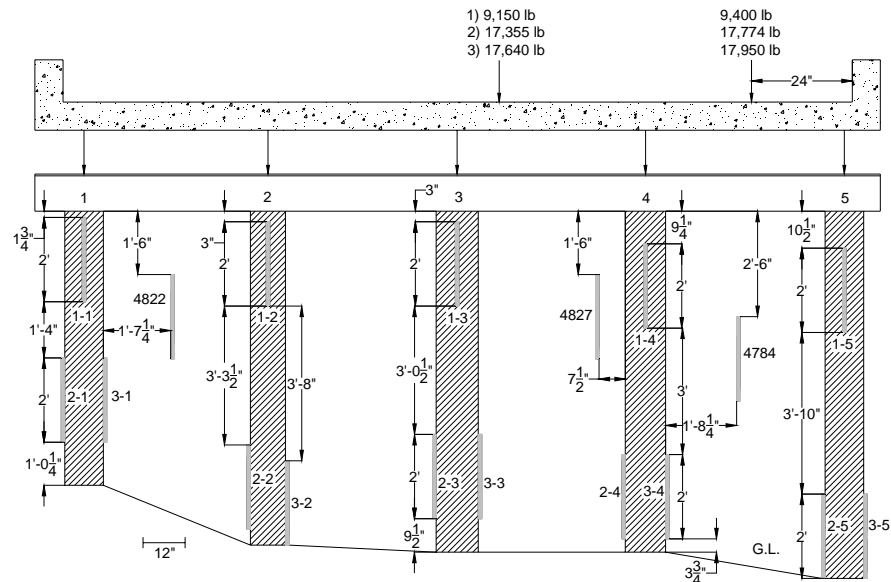
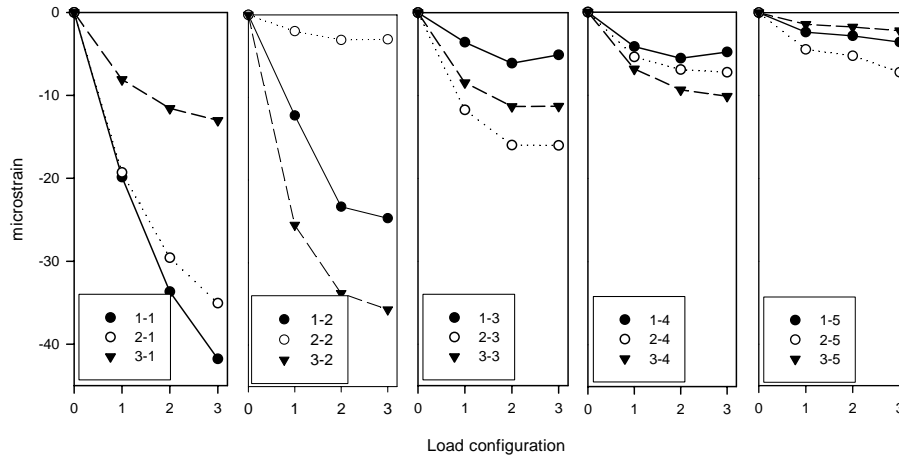
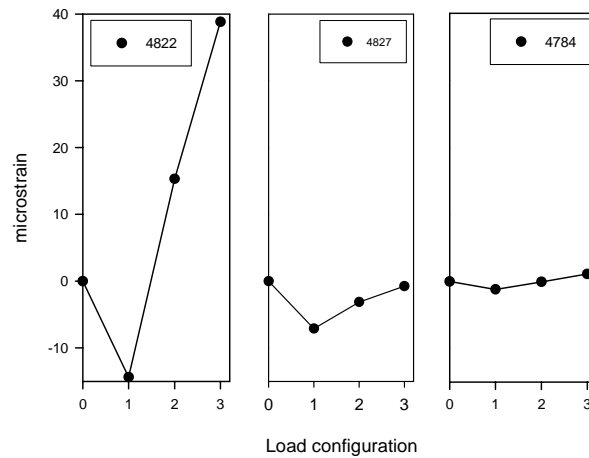
Figure 9.18. Static load test at the east edge (Bridge No. 237350 – Mahaska County)

The third load test was performed with the load at the east edge of the bridge. The load was offset about 2 ft from the curb. The location and magnitude of the applied axial loads, piles strains, and backwall strains are presented in Figure 9.18. The highest strain was measured in pile no. 1 and was about -42 microstrains in load configuration 3. The measured strain decreased with increasing distance from the location of the applied loads. The strain transducers attached to the deteriorated pile section (i.e. strain transducers 3-2 and 2-5) recorded higher strains compared to other strains measured in pile nos. 2 and 5.

The backwall strain was highest under the applied load (i.e. between pile nos. 1 and 2) and was about -14.4 microstrains in the first load configuration. The strains decreased with increasing distance from the location of the axial loads. In load configurations 2 and 3, the strain transducer between pile nos. 1 and 2 (transducer no. 4822) recorded high positive values, which may be a result of bending in the timber backwall.

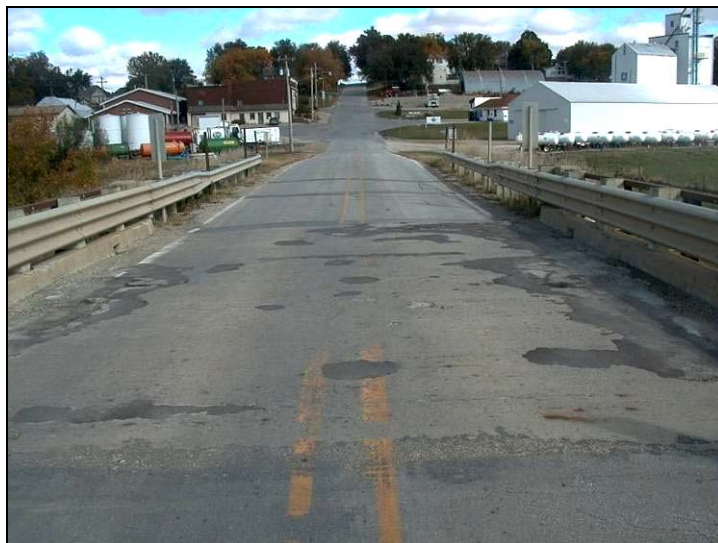
The fourth bridge tested was in Carroll County, Iowa. The bridge, which was 33.5 ft long, 22 ft wide, and has a 0° skew, was located on 245th St. south of Halbur, Iowa crossing a creek (See Figure 10.1). The superstructure consisted of a non-composite concrete deck supported by a four girder system. Due to deterioration in the concrete deck, as may be seen in Figure 10.2, there were numerous asphalt patches.

Figure 10.2. Concrete deck patched with asphalt (Bridge No. 094680 Carroll County – May 16 2006)

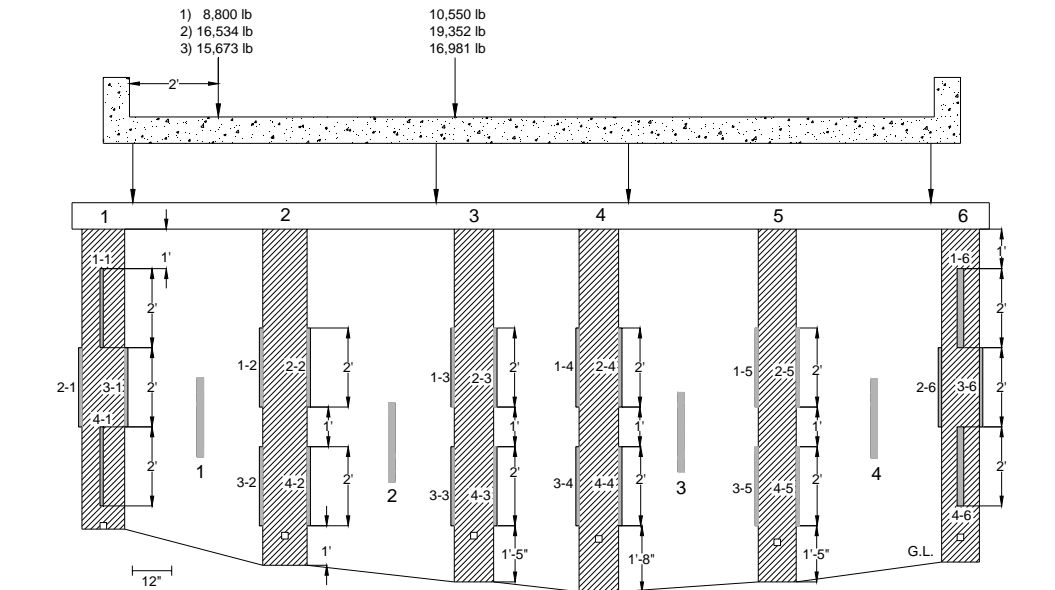
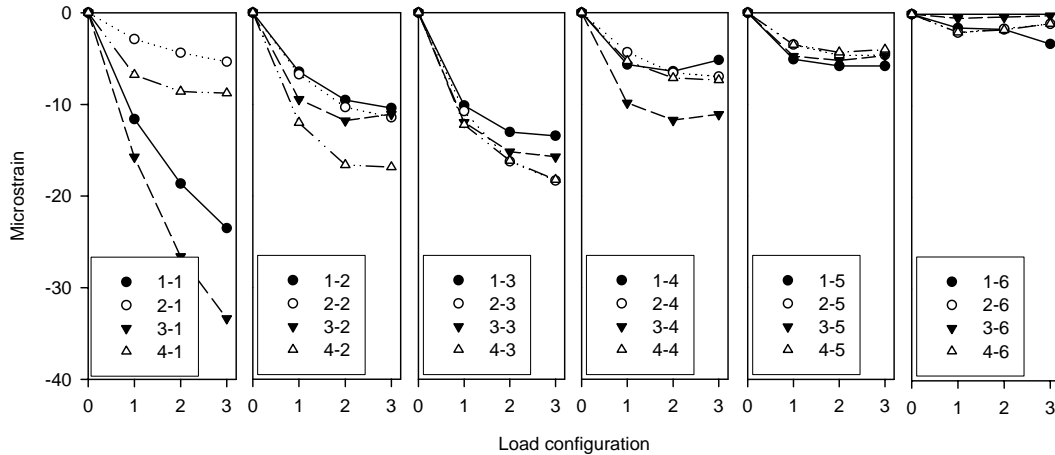
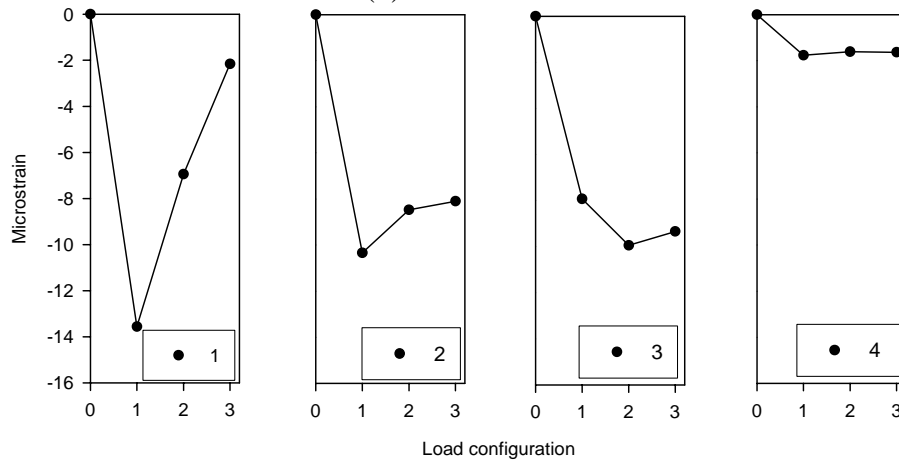
Figure 10.13. Static load test at the west edge (Bridge No. 094680 – Carroll County)

The north abutment was first loaded at the west edge of the bridge. The location of the applied loads, pile strains, and backwall strains are shown in Figure 10.13. The applied loads were offset 2 ft from the curb. The highest strain was measured in pile no. 1 and was about -33 microstrains at load configuration 3. The strain recorded at pile no. 1 varied considerably along the exposed pile length. This may be due to the localized hollow pile sections, which were detected using the increment borer. The measured strain values decreased with increasing distance from the location of the applied loads; as may be seen in Figure 10.13b, almost no strain was recorded in pile no. 6.

Similar to pile strains, backwall strains were highest directly under the applied load, and decreased with increasing distance from the location of the axial loads. The highest strain measured was about -13.6 microstrains between pile nos. 1 and 2 (See Figure 10.13c). Partial bearing between the pile cap and the timber backwall can be seen in Figure 10.14. Therefore, the recorded backwall strains are a combination of axial and lateral loads.

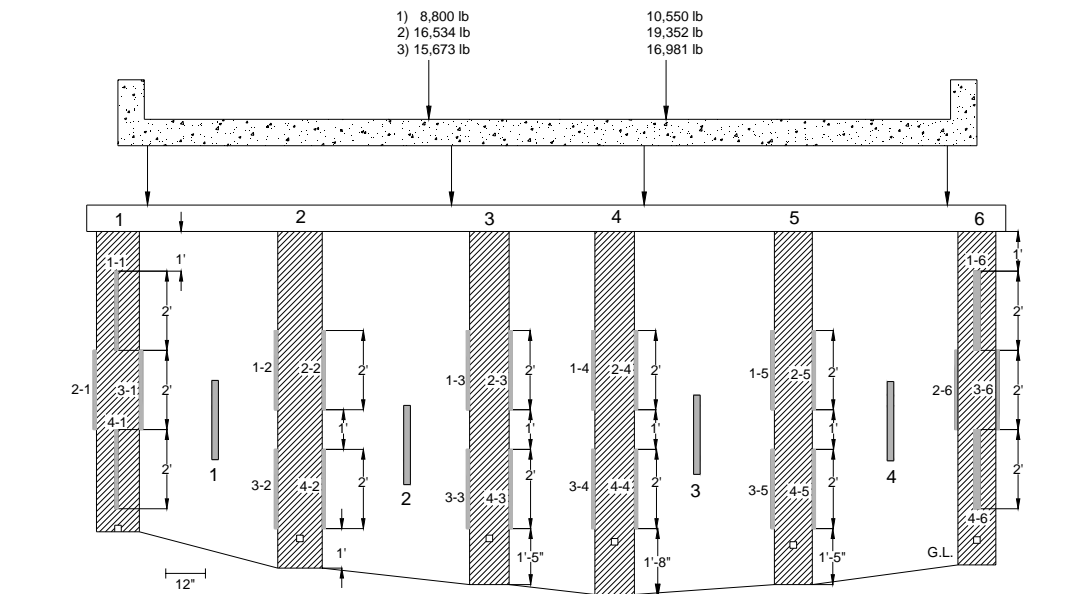
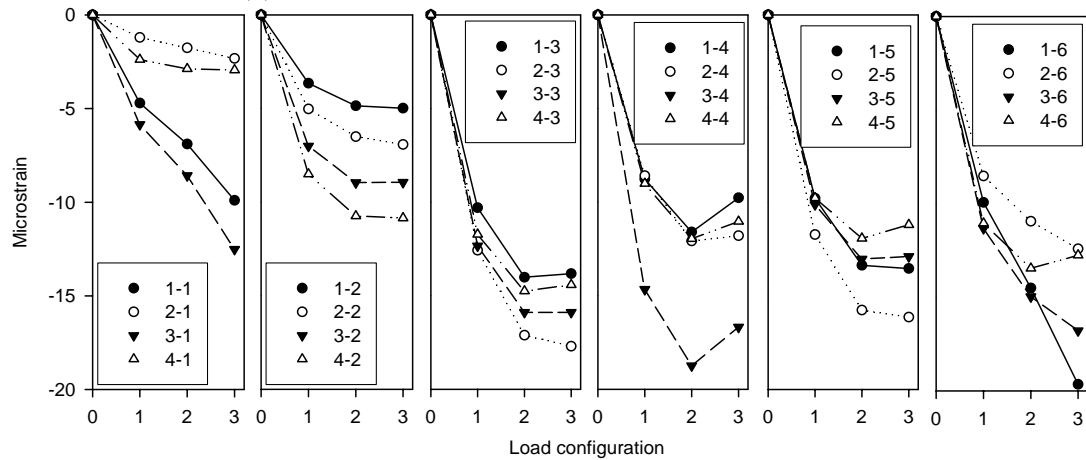
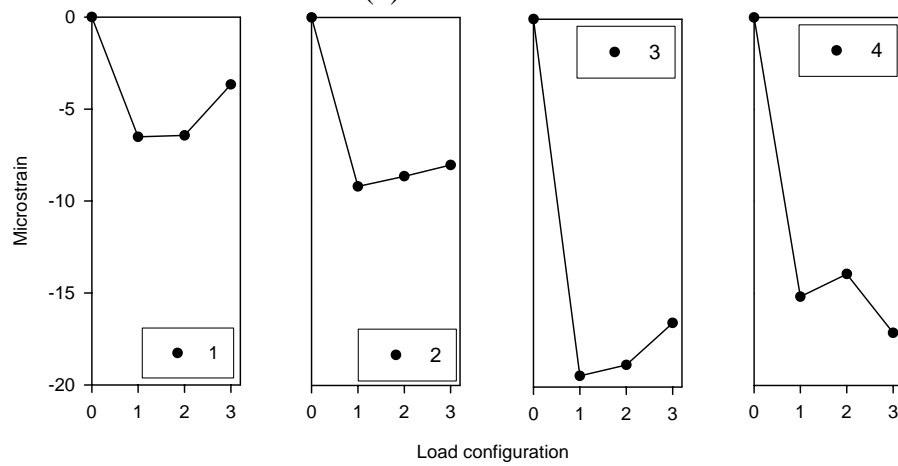
Figure 10.15. Static load test at the centerline (Bridge No. 094680 – Carroll County)

The north abutment was loaded at the centerline of the bridge deck as shown in Figure 10.15a. The recorded strains were higher at pile nos. 3, 4, 5, and 6 (See Figure 10.15b). The E_s of these piles are unknown; therefore, it was not determined whether the high strain values are due to higher axial loads or softer pile sections. In load configuration 3, pile no. 6 had the highest strain value, which was about -20 microstrains. Pile nos. 1 and 2 experienced lower strains compared to the other piles. Backwall strains were also higher on the east edge of the bridge (See Figure 10.15c). The backwall strains were highest between pile nos. 4 and 5. Generally, the strains were highest in load configuration 1 since the front axle and the front wheels of the tandem axle were still on the roadway, and were lowest in load configuration 3, where the backwall strains are induced by axial compression only.

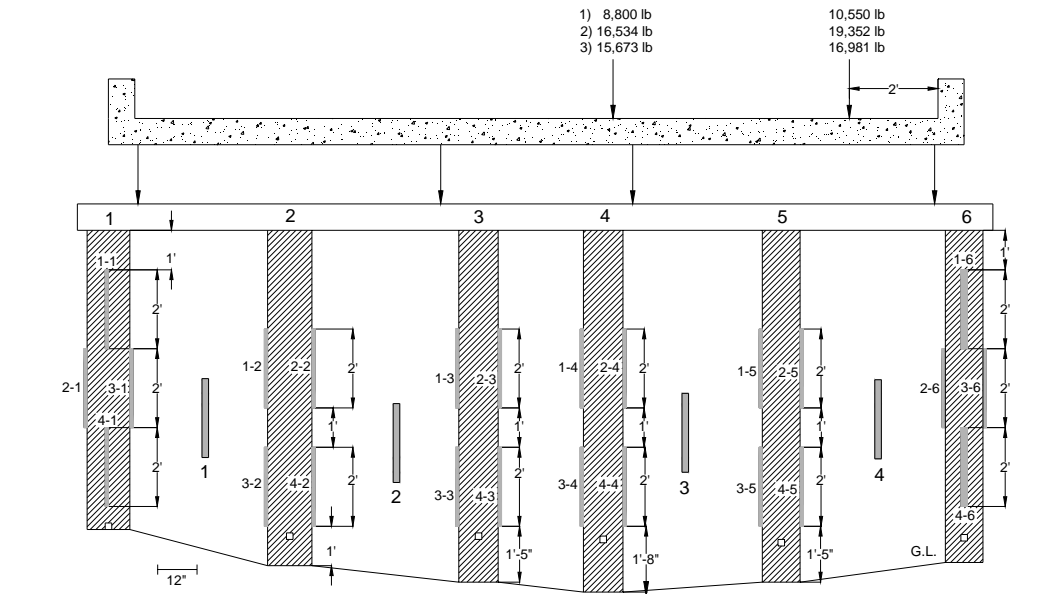
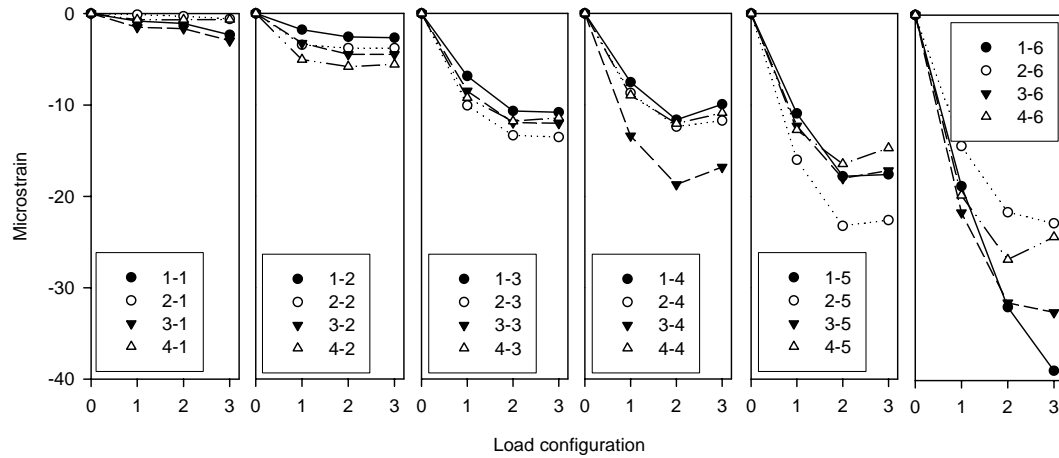
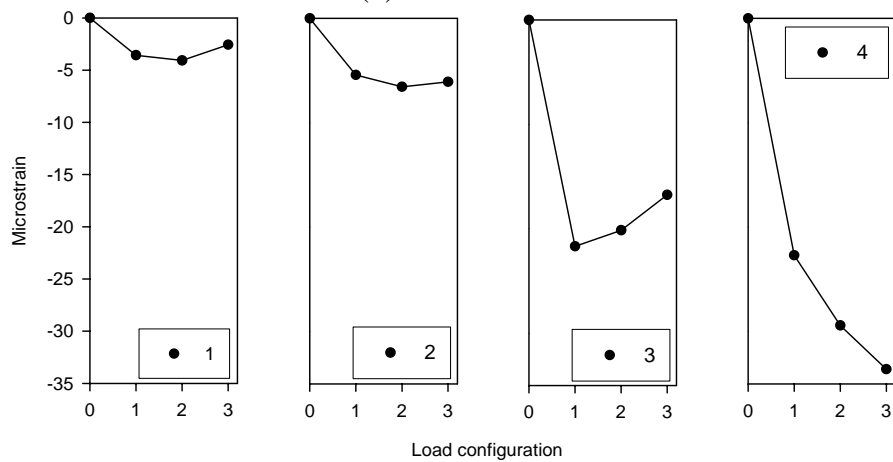
Figure 10.16. Static load test at the east edge (Bridge No. 094680 – Carroll County)

The third load test conducted at the north abutment was with the loading at the west edge of the bridge. The location of the applied loads, pile strains, and backwall strains are shown in Figure 10.16. The highest strain was measured was in pile no. 6 and was about -39 microstrains in load configuration 3. The strains decreased with increasing distance from the location of the applied loads. Backwall strains were highest at the east side of the bridge under the applied load, and decreased with increasing distance from the location of the load. This highest strain measured was about -34 microstrains between pile nos. 5 and 6. Similar to the previous tests, the backwall strains in load configuration 3 are caused by the partial bearing between the pile cap and the backwall, which transferred axial loads from the front axle.

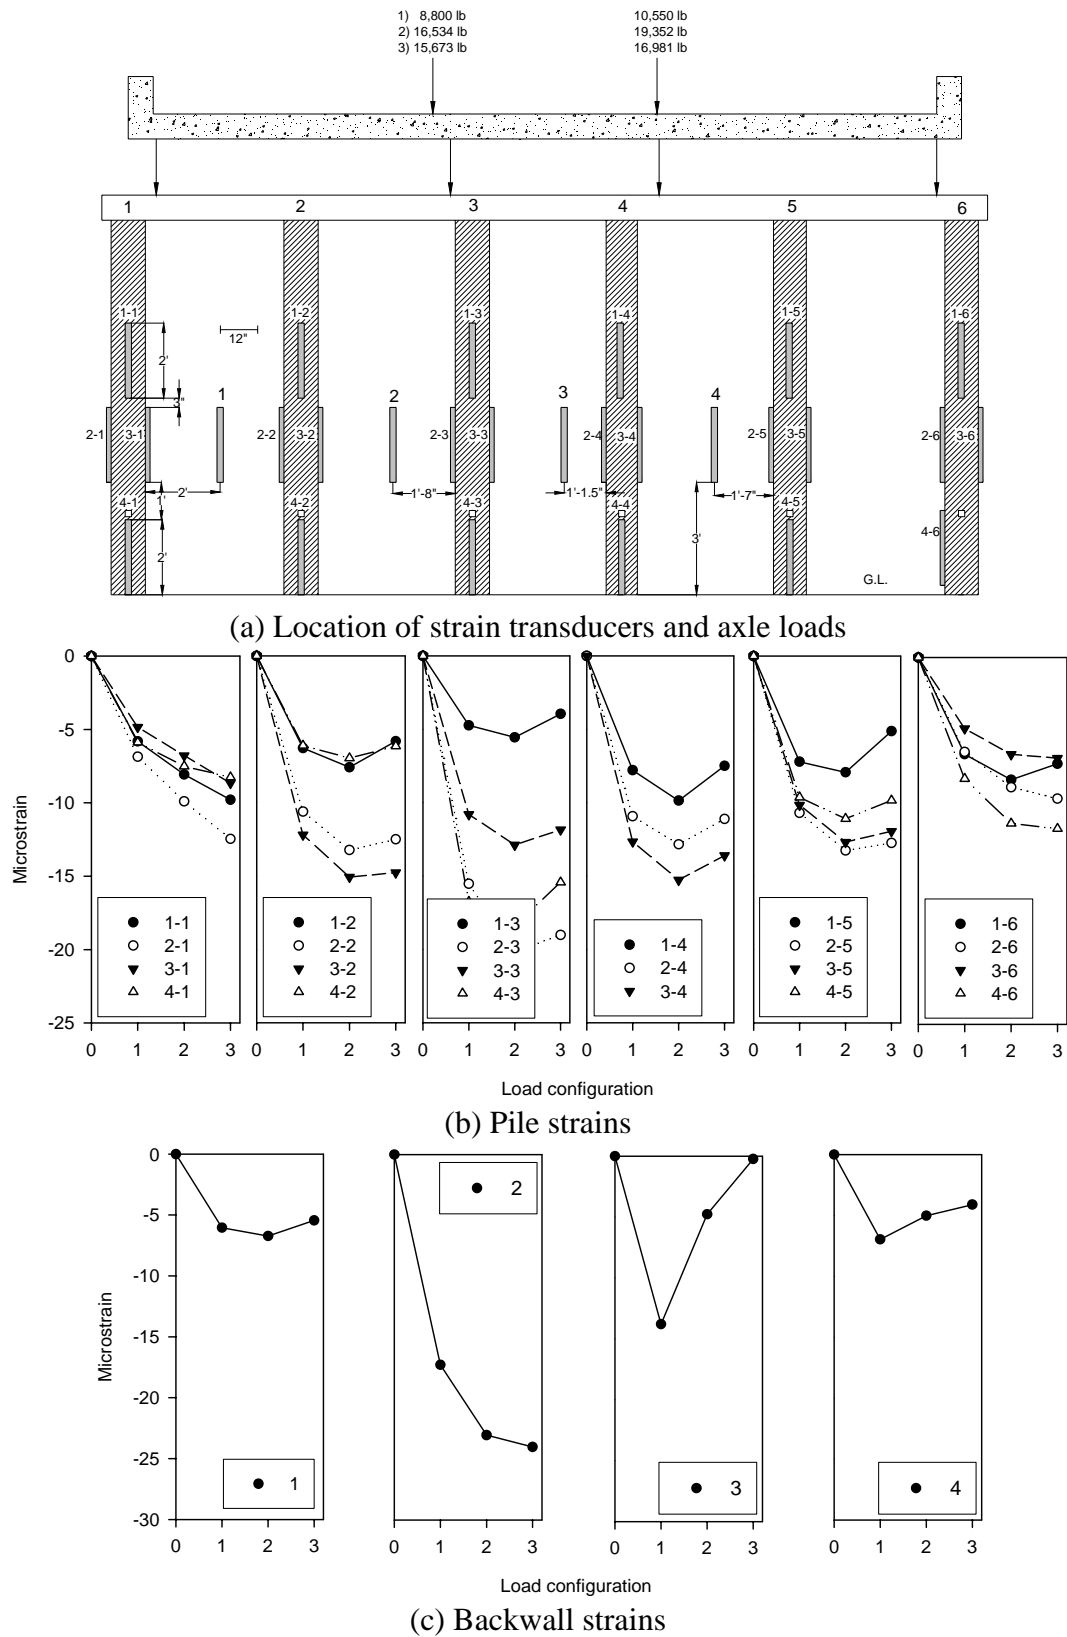
Figure 10.18. Static load test at the centerline (Bridge No. 094680 – Carroll County)

In the second load test, loading was applied along the centerline of the bridge. Figure 10.18 illustrates the locations of the applied loads, pile strains, and backwall strains. Loading the bridge at the centerline resulted in a more uniform strain distribution as may be seen in Figure 10.18b. Pile no. 3, however, displayed higher strain compared to the other piles. In the third load configuration, 63% of the load applied by the back wheel of the tandem axle was carried by the north abutment piles. This explains why the strains for most piles were reduced in the third load configuration.

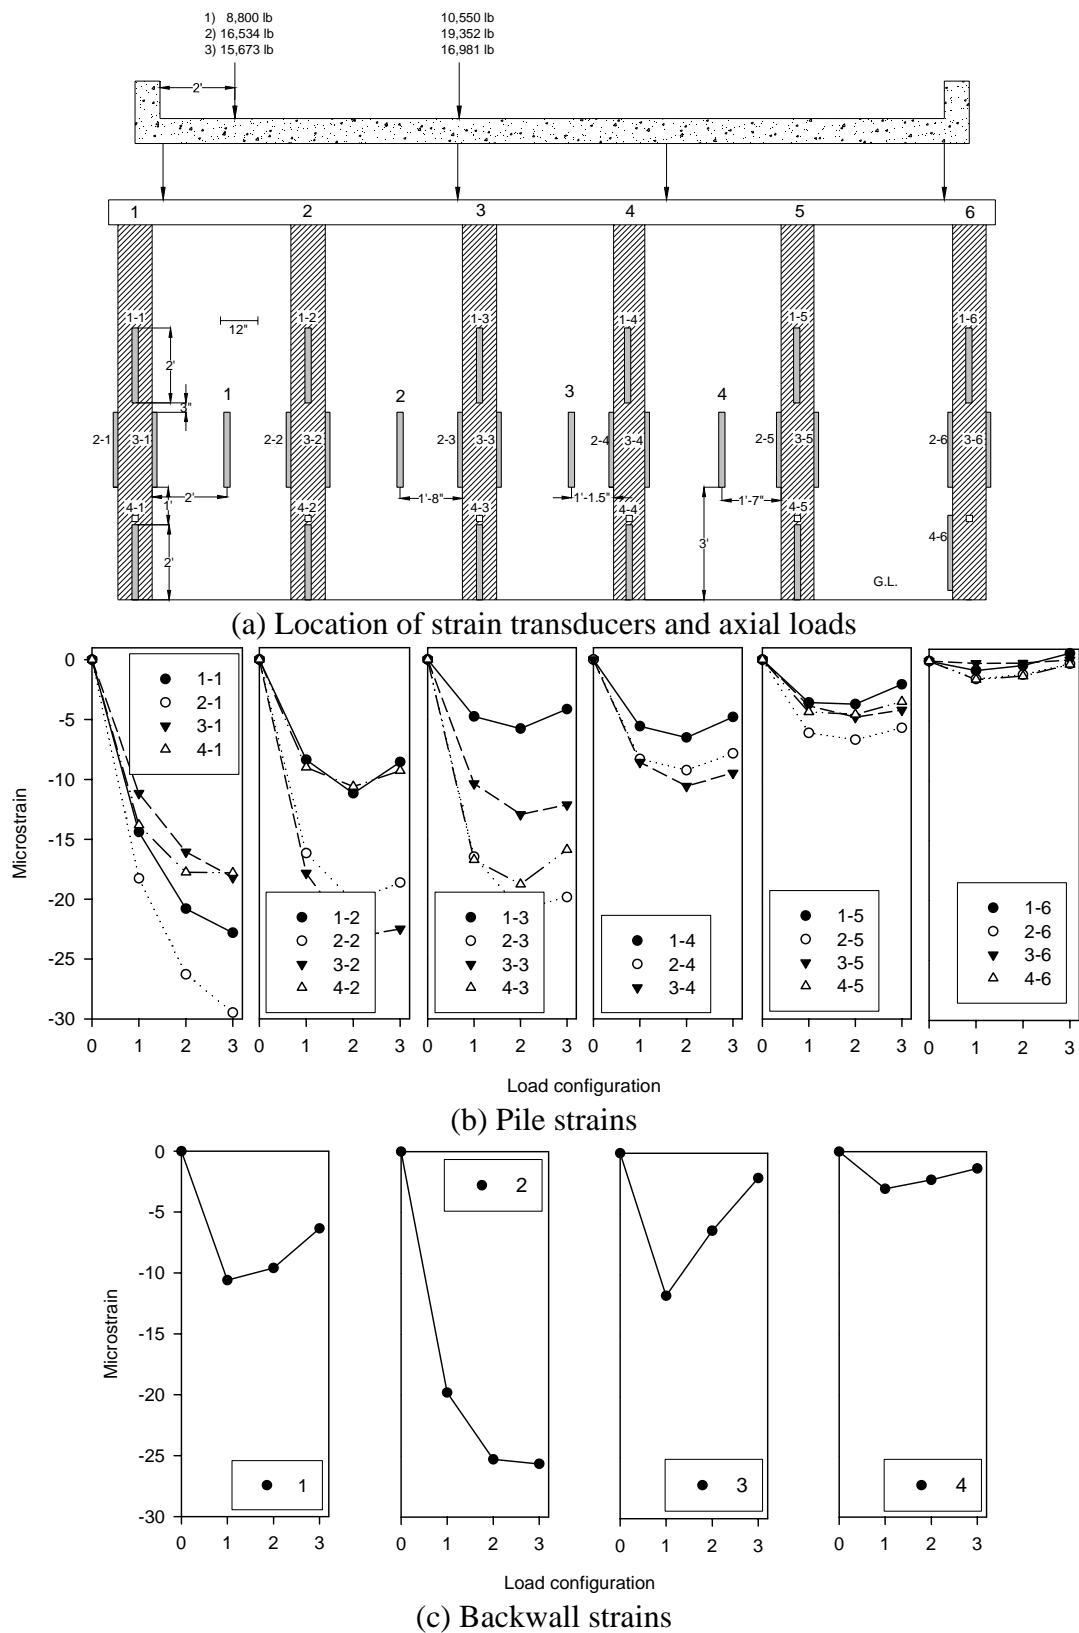
Figure 10.19. Static load test at the east edge (Bridge No. 094680 – Carroll County)

In the third load test, loading was applied at the east edge of the bridge. The locations of the applied loads, pile strains, and backwall strains are shown in Figure 10.19. The applied load was offset 2 ft from the curb. The pile strain was highest near the applied loads and decreased with increasing distance from the location of the applied loads. Almost no strain was measured in pile no. 6. The highest strain was measured in pile no. 1 and was about -30 microstrains in load configuration 3.

Similar to the two previous load tests, backwall strains measured between pile nos. 2 and 3 were higher than strains measured at other locations across the backwall. Unlike the other locations, the strains at this location continued to increase with higher load configurations.

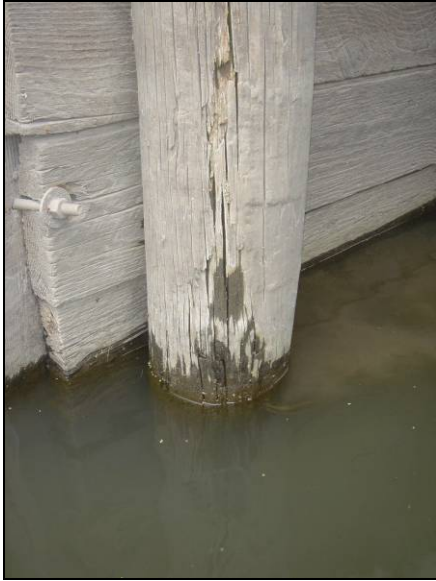
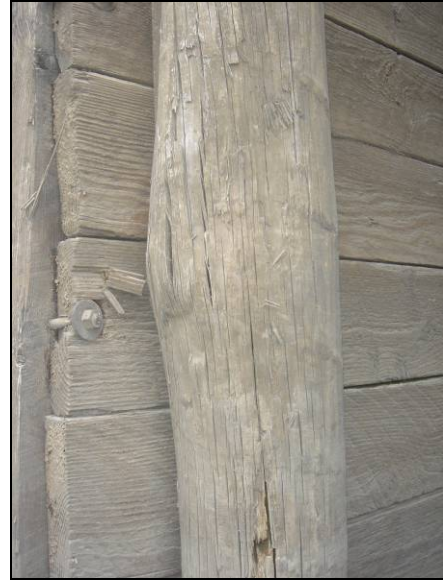
Figure 11.4. Deterioration of pile no. 1 (Bridge No. 237380 Mahaska County – April 16 2006)

(a) Biological deterioration near the water level

(b) Bulging of timber fibers

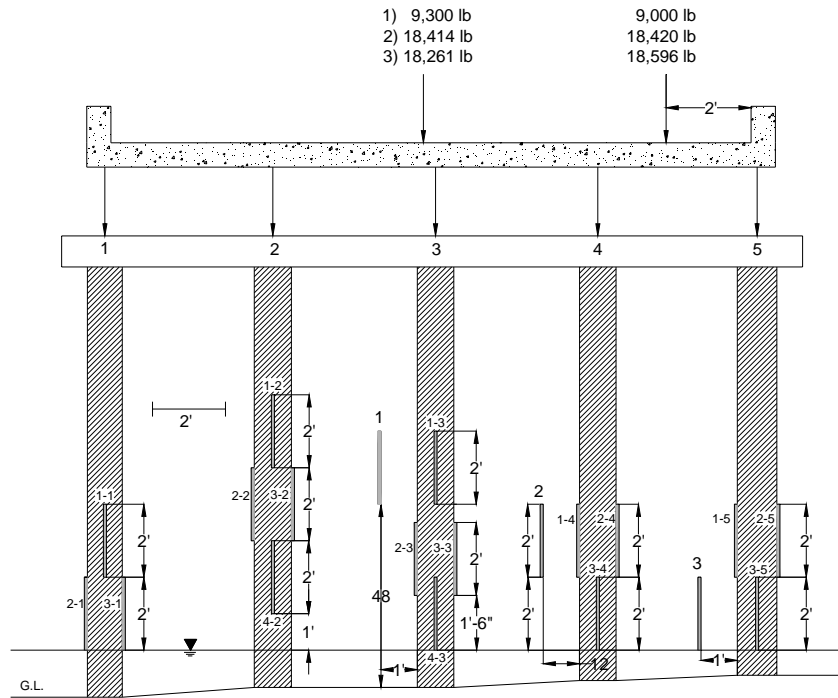
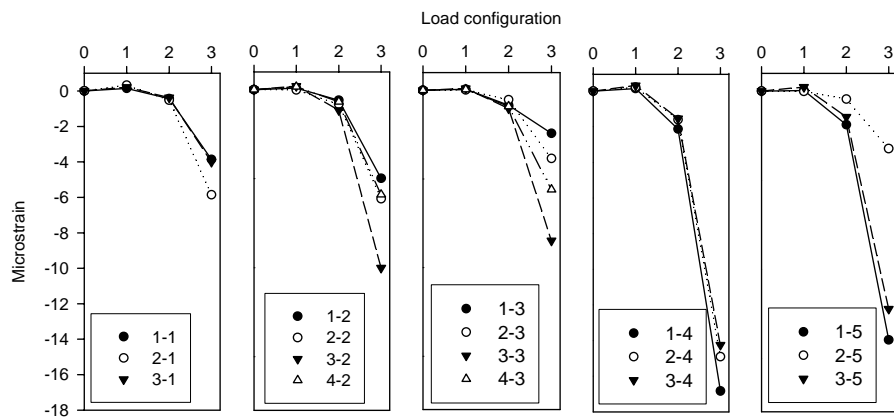
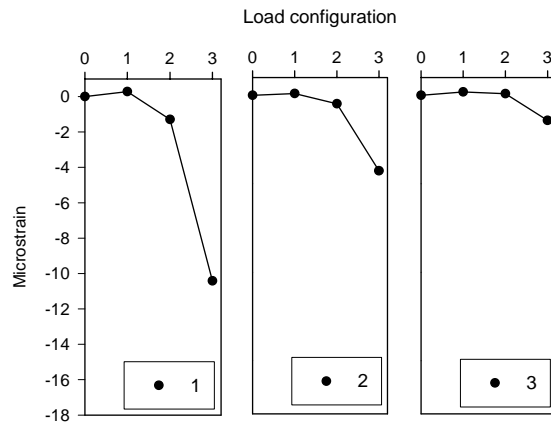
Figure 11.9. Static load test at the north edge (Bridge No. 237380 – Mahaska County)

The first load test was conducted with the loading at the north edge of the bridge. The location of the applied loads, pile strains, and backwall strains are shown in Figure 11.9. Most of the strains were observed in piles nos. 4 and 5. The highest strain was measured in pile no. 4 and was about -17 microstrains. The highest strain measured in pile no. 3, which was directly under the applied load, in load configuration 3 was about -9 microstrains. Pile no. 2 experienced higher strain even though it was located at a greater distance from the location of the axial load. The highest strain in pile no. 2 in load configuration 3 was about -10 microstrains. The backwall strains were highest between pile nos. 2 and 3 where the strain transducer was placed at a higher elevation (48 inches above the water level). At the lower elevation (closer to the water level), the strains decreased

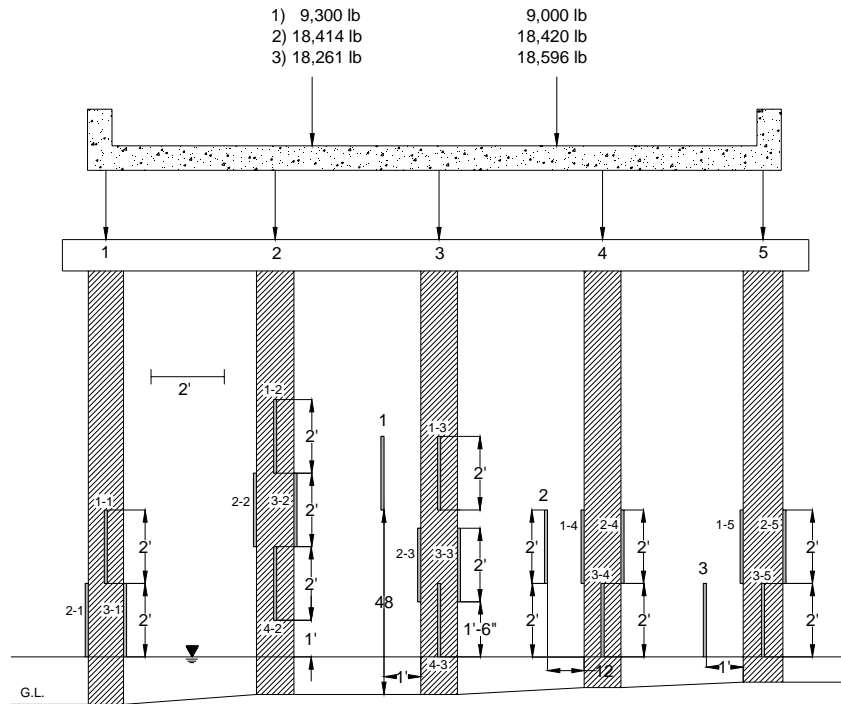
Figure 11.10. Static load test at the centerline (Bridge No. 237380 – Mahaska County)

The test was repeated with the loading at the centerline of the bridge. The location of the applied loads, pile strains, and backwall strains are shown in Figure 11.10. The results indicate that pile nos. 1, 2, and 4 are carrying most of the load since they displayed the highest strain measurement. The strain measured in pile no. 3 was about -9 microstrains similar to the previous test. This confirms the visual observation that the pile was deteriorated. Pile nos. 1 and 2 experienced similar strains even though pile no. 1 is further away from the location of the applied axial loads. The strains measured in pile nos. 1 and 2 were about -14 microstrains. This demonstrates that part of the load carried by pile no. 2 was transferred to adjacent pile no. 1. Similar to the previous test, backwall strains were highest at high elevation close to the applied load and decreased with increasing depth.

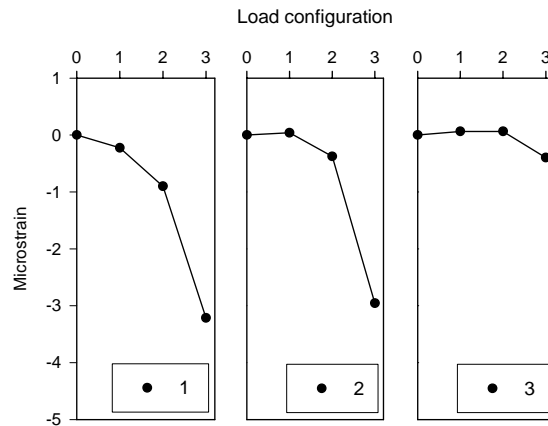
Figure 11.11. Static load test at the south edge (Bridge No. 237380 – Mahaska County)

The northwest abutment was tested with the loading at the south edge of the bridge. The location of the applied loads, which were offset 2 ft from the curb, pile strains, and backwall strains are shown in Figure 11.11. As shown in Figure 11.11a, one wheel load was directly above pile no. 3. However, the strains did not increase compared to the previous two tests. The highest strain value measured in load configuration 3 was still about -8 microstrains (See Figure 11.11b). The results also demonstrate that the load was mostly carried by pile no. 1 as evidenced by the higher strain.

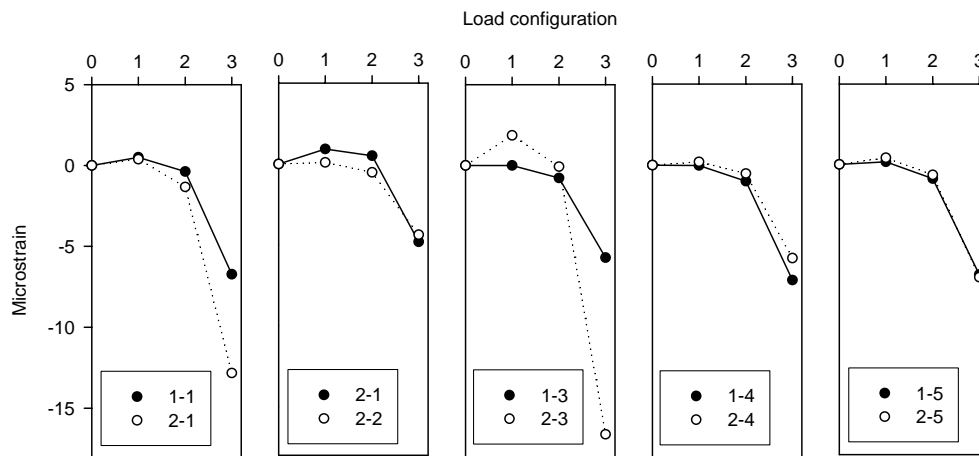
When the loading was applied at the centerline of the bridge deck, the load was carried primarily by pile nos. 1 and 3 (See Figure 11.13). The strain measured in pile nos. 1 and 3 in load configuration 3 were -13 and -17 microstrains, respectively. Lower strain measurements were recorded at pile no. 2 during the centerline and north edge load tests.

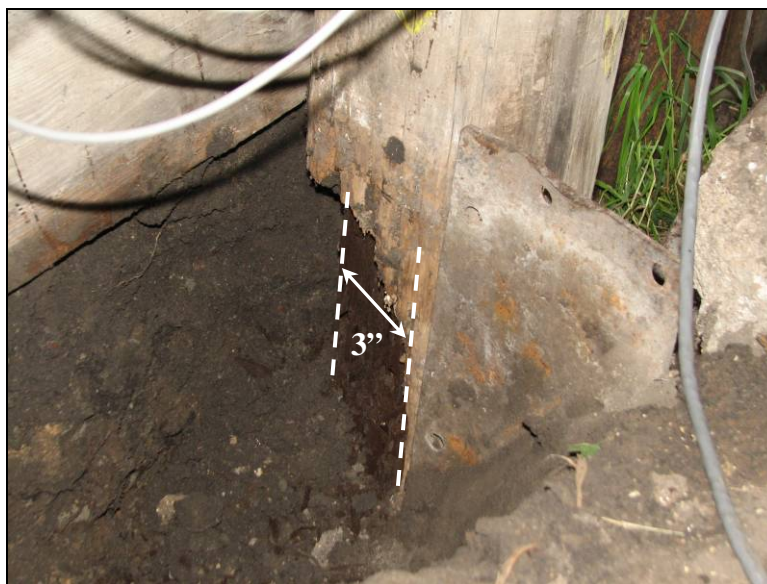
Figure 12.9. Advanced section loss at pile No. 6 at the east abutment (Bridge No. 029070 Humboldt County – July 12 2006)

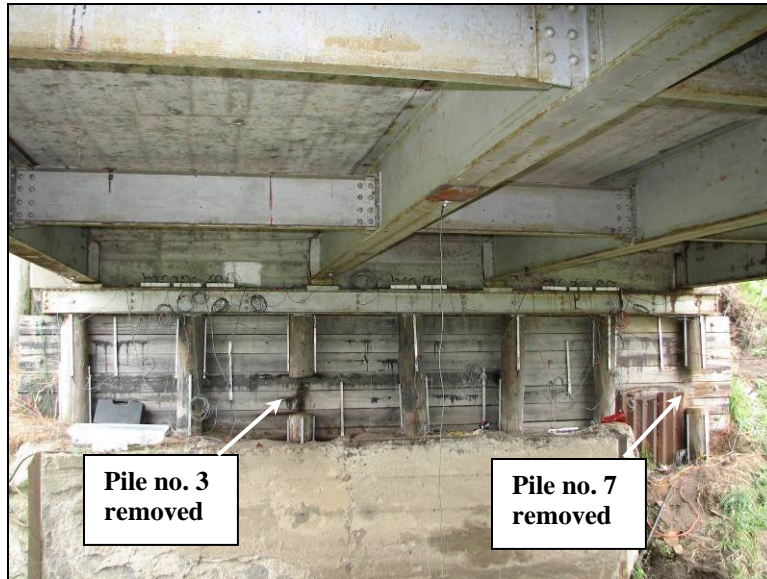
The destructive load test was carried out at the east abutment by consecutively removing a 16 inch section from three of the seven supporting piles to simulate pile deterioration (See Figure 12.17). Pile nos. 7, 3, and 6 were removed consecutively. After removing each pile, the bridge was load tested and strains in the intact piles were measured. The east abutment with pile nos. 3 and 7 removed is shown in Figure 12.18. To measure the load carried by the removed piles, a load cell and a mechanical jack were installed as shown in Figure 12.19. Before statically loading the abutment, the mechanical jack was used to apply load on the pile. The load was gradually increased in order to restore the dead load, which was initially carried by the pile before removing the section. This was accomplished by monitoring the pile strain before and after removing the pile section and restoring the pile strain to its initial value. Once the initial strain was restored, the load carried by the pile was recorded using a readout attached to the load cell. This procedure was carried out for pile nos. 3 and 7. The section from Pile no. 6 that was removed near the ground level was not restored (See Figure 12.20).

Figure 12.18. Pile nos. 3 and 7 removed at the east abutment (Bridge No. 029070 Humboldt County – July 12 2006)

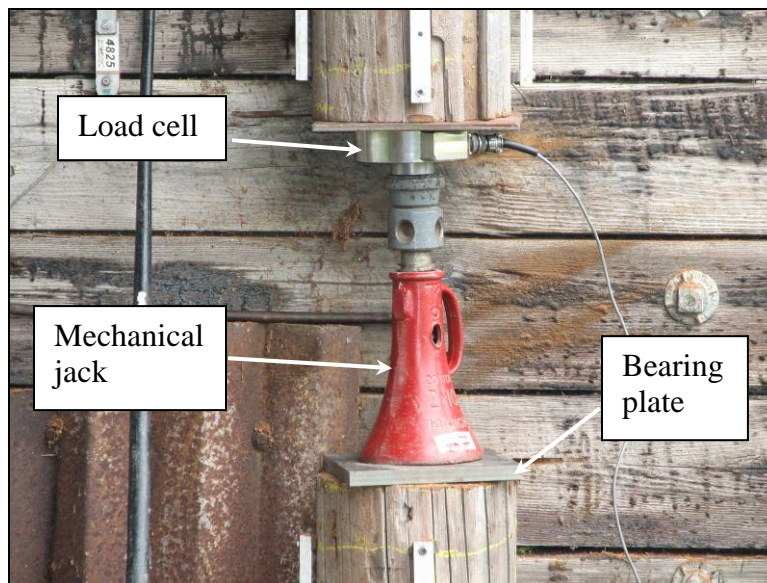
Figure 12.19. Mechanical jack and load cell used to restore and record the load carried by pile no. 7 (Bridge No. 029070 Humboldt County – July 12 2006)

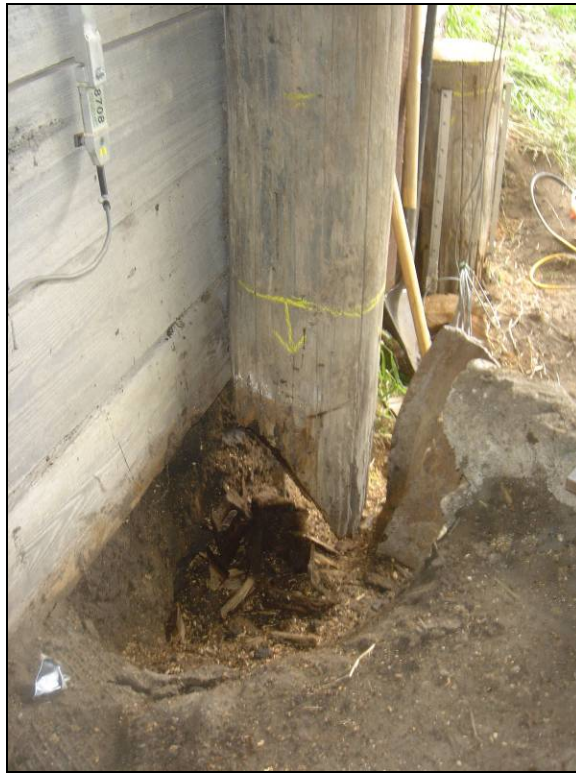
Figure 12.20. A section of Pile no. 6 removed near the ground level (Bridge No. 029070 Humboldt County – July 12 2006)
