Investigation of Steel-Stringer Bridges: Superstructures and Substructures, Volume II

Final Report
October 2007

Sponsored by
the Iowa Highway Research Board (Project TR-522)
and the Iowa Department of Transportation (CTRE Project 04-184).

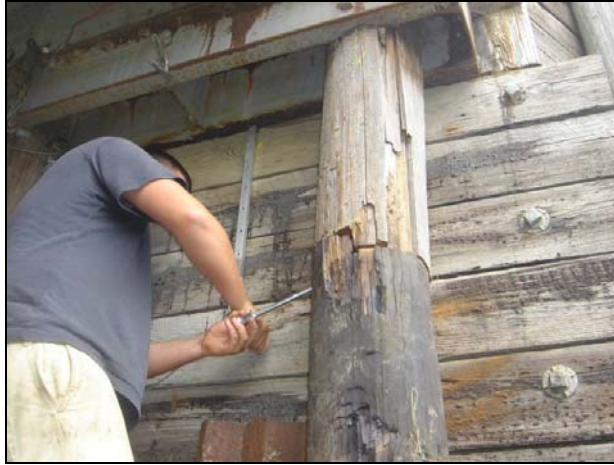
Figure 12.22. Metal screws used to connect the new section to the existing timber pile (Bridge No. 029070 Humboldt County – July 12 2006)

To determine the feasibility of repairing localized deteriorated sections in timber piles, pile no. 7 was repaired using a splicing technique in which the percent restoration of pile capacity was measured. A new timber section was spliced and placed instead of the removed section as shown in Figure 12.21. The existing and new pile sections were connected by installing two metal screws at an angle as demonstrated in Figure 12.22. Once repaired, the bridge was load tested and the percentage of the restored capacity was evaluated.

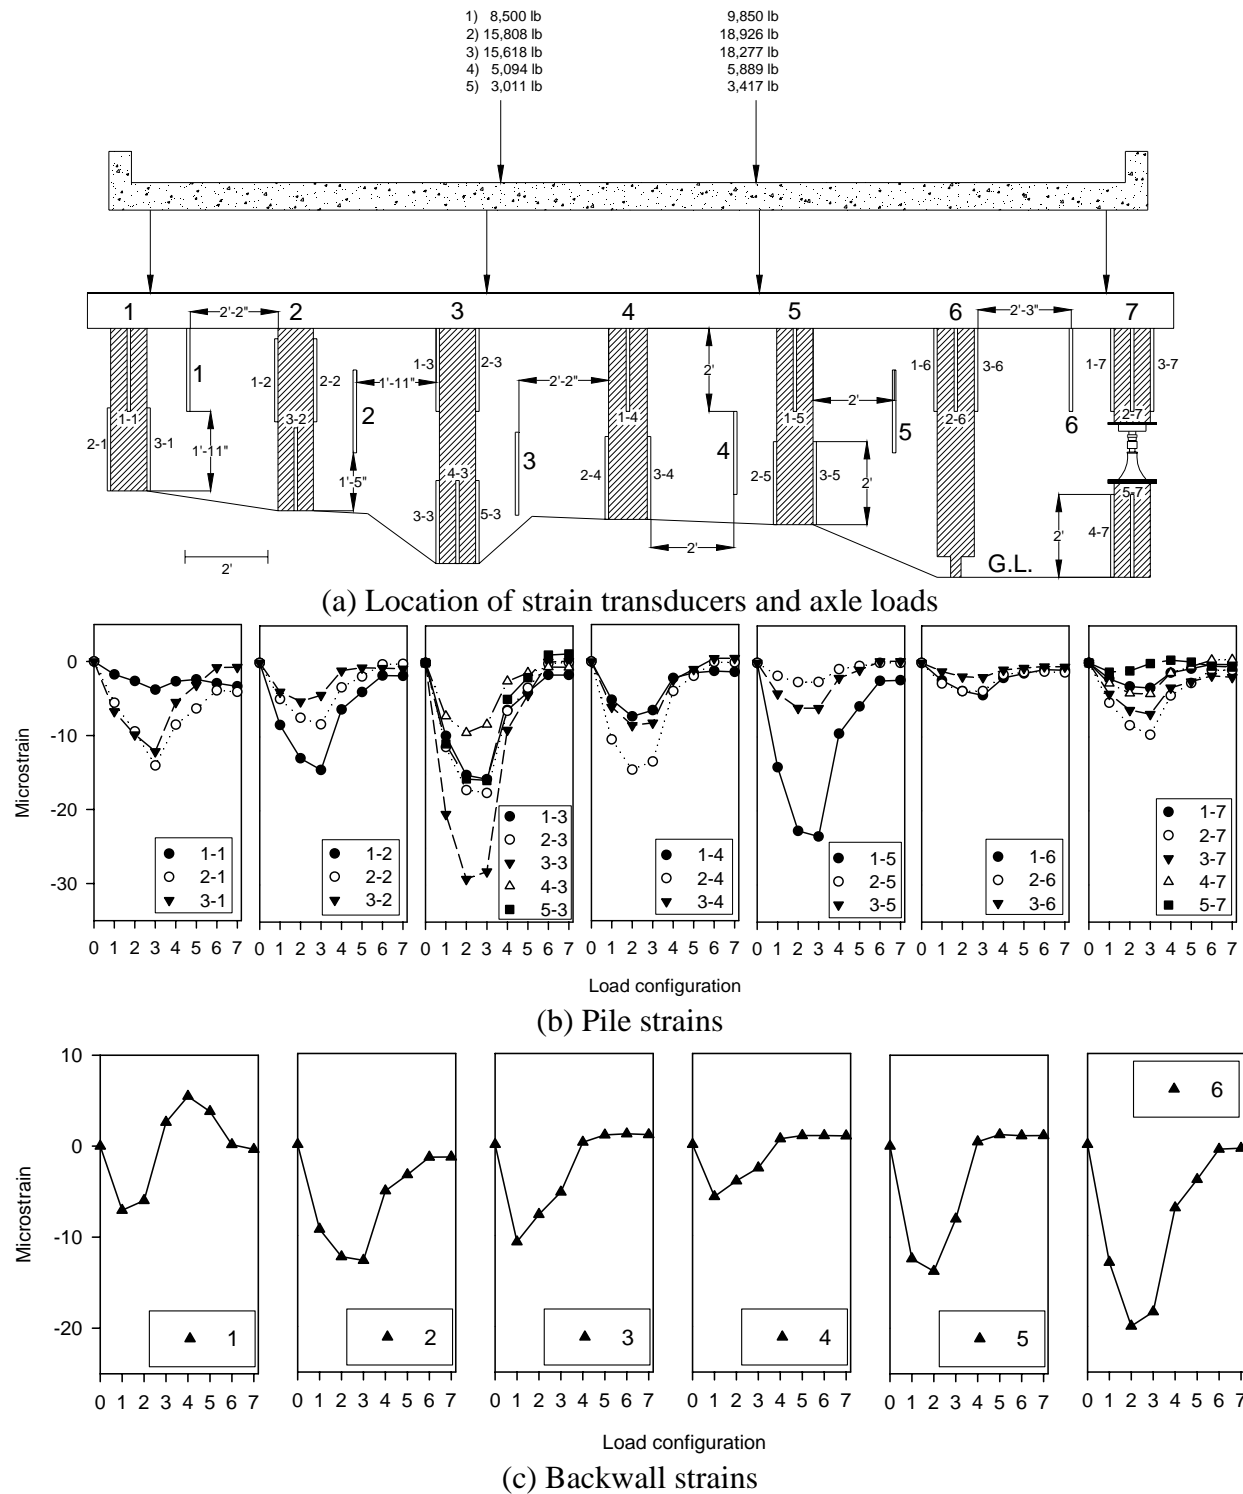
The results of loading the east abutment along the centerline of the bridge deck are shown in Figure 12.29. The strain data were essentially the same strain data obtained in the nondestructive load test at the centerline that was previously conducted (Refer to Figure 12.27). This indicates that the procedure of jacking pile no. 7 was successful in restoring the abutment initial loading condition. Using the load cell, the load carried by pile no. 7 (minus the dead load) was recorded and the stresses in the pile were determined. The stresses varied laterally and longitudinally through the pile section illustrating the non-homogeneity of wood. The results also demonstrate that the load carried by pile no. 7 was about 8% of the total applied axial load.

Figure 12.29. Static load test at the centerline with pile No. 7 jacked (Bridge No. 029070 – Humboldt County)

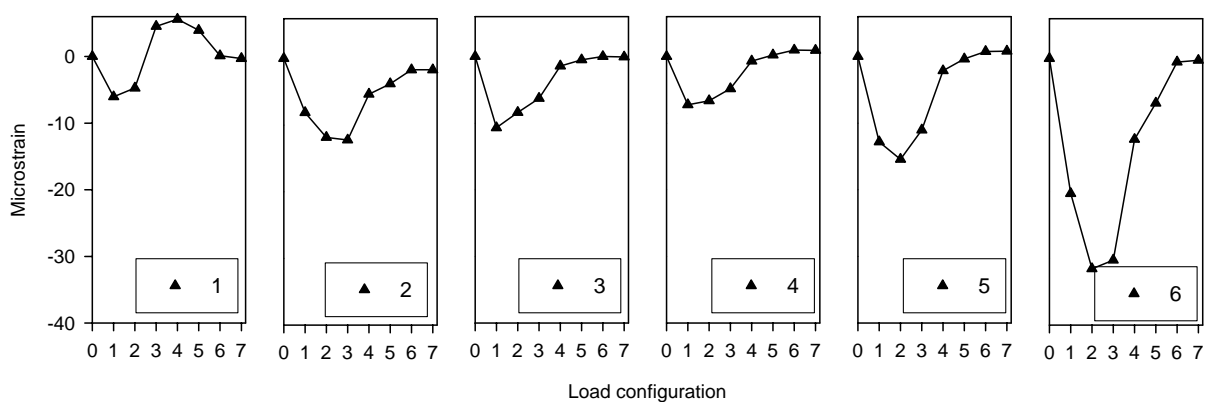
The east abutment was then loaded at the centerline of the bridge deck. The location of loads, pile strain measurements, and backwall strains are presented in Figure 12.32. The results reveal a 25% increase in strain in pile no. 5 and about a 3% increase in the measured strains in pile nos. 3 and 4 compared to the nondestructive test at the same location. Most of the load carried by pile no. 7 was transferred to the next adjacent sound pile. The backwall strains also increased in the areas between pile Nos. 4 and 5, 5 and 6, and 6 and 7. About 63% strain was measured between pile nos. 6 and 7. Due to the partial bearing of the pile cap on the backwall, and due to the removal of pile no. 7, the backwall resisted a higher load as evidenced by the increase in negative strain at this location.

Figure 12.32. Static load test at the centerline with pile No. 7 removed (Bridge No. 029070 – Humboldt County)

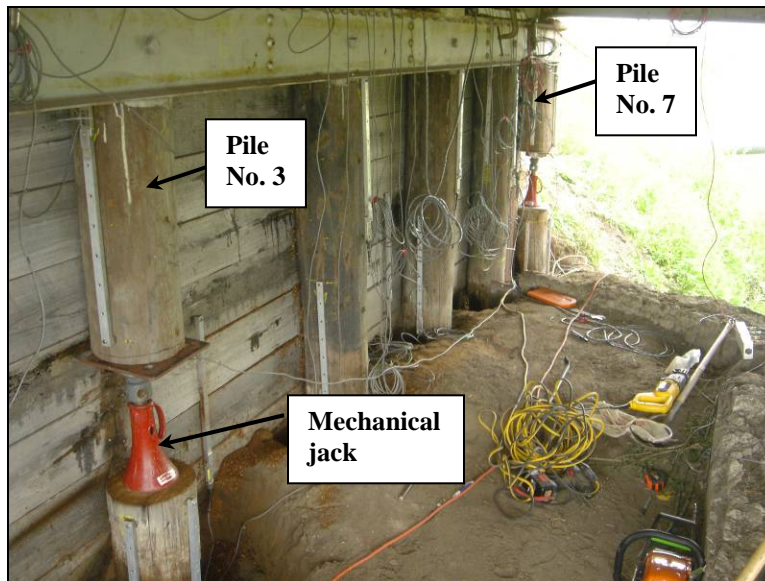
In this destructive test, a section was removed from pile no. 3 after which both pile nos. 3 and 7 were jacked to their initial measured strain values (See Figure 12.34). A load cell was placed above each mechanical jack to measure the load carried by each pile due to live load. Three load tests were conducted with the load being applied at the north, centerline, and south edges.

Figure 12.34. Pile Nos. 3 and 7 jacked (Bridge No. 029070 Humboldt County – July 12 2006)

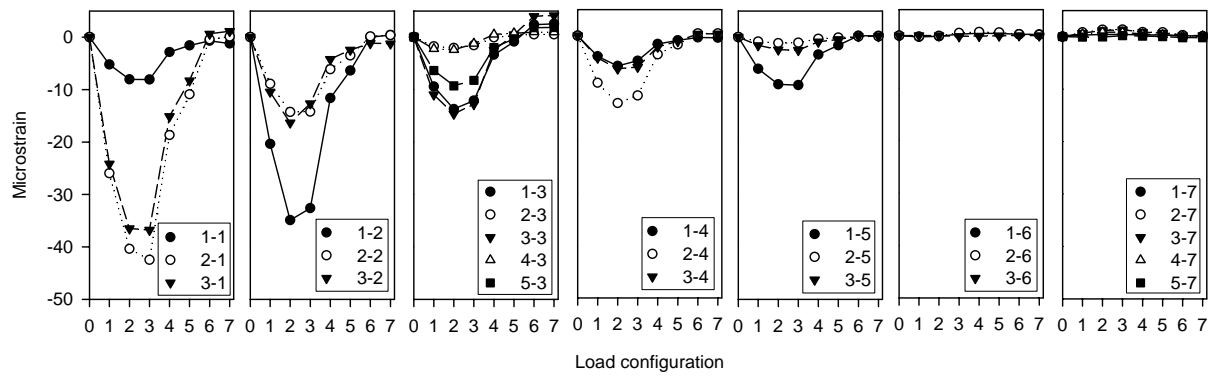
The east abutment was first loaded at the north edge of the bridge. The location of the loads, which were offset 2 ft from the curb, the pile strain measurements, and the backwall strains are presented in Figure 12.35. The results illustrate that the strains in pile no. 3 decreased by about 45% compared to those measured during the nondestructive test at this location. As a result, the strains in the adjacent pile nos. 2 and 4 increased by about 39 and 6%, respectively. The results show that the load carried by pile no. 3 was about 10% of the total load when the abutment was loaded at the north edge.

No significant change was observed in the backwall strains compared to the strains that occurred in the nondestructive test except in the strain between pile nos. 3 and 4. The strains measured in this location increased by approximately 60%. A possible explanation for this increase is that the mechanical jack did not fully restore the timber pile to its initial condition as evidenced by the strain reduction in the pile compared to the nondestructive test strains; therefore, the backwall at this location was resisting more axial load due to the partial bearing of the pile cap on the backwall resulting in higher deflections.

Figure 12.35. Static load test at the north edge with pile Nos. 7 and 3 jacked (Bridge No. 029070 – Humboldt County)

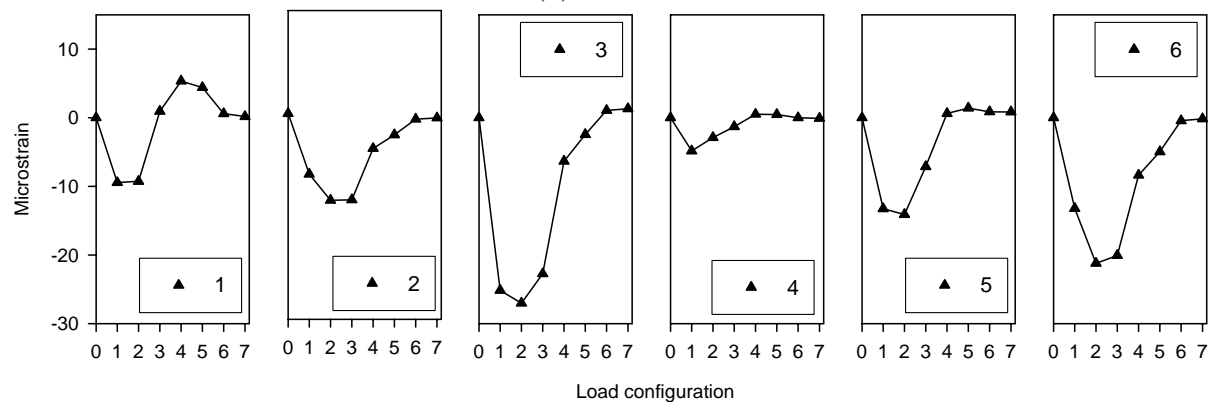
Loading the abutment at the centerline of the bridge deck resulted in an increase in strain at pile nos. 2 and 4 by 50 and 12%, respectively, compared to the strains that occurred in destructive test no. 3 (See Figure 12.39b). Furthermore, a 40% increase in the backwall strain between pile nos. 3 and 4 was measured (See Figure 12.39c). The percent load carried by pile no. 7 was 9%, which is equal to that measured during test no. 3.

Figure 12.39. Static load test at the centerline pile No. 3 removed and pile No. 7 jacked (Bridge No. 029070 – Humboldt County)

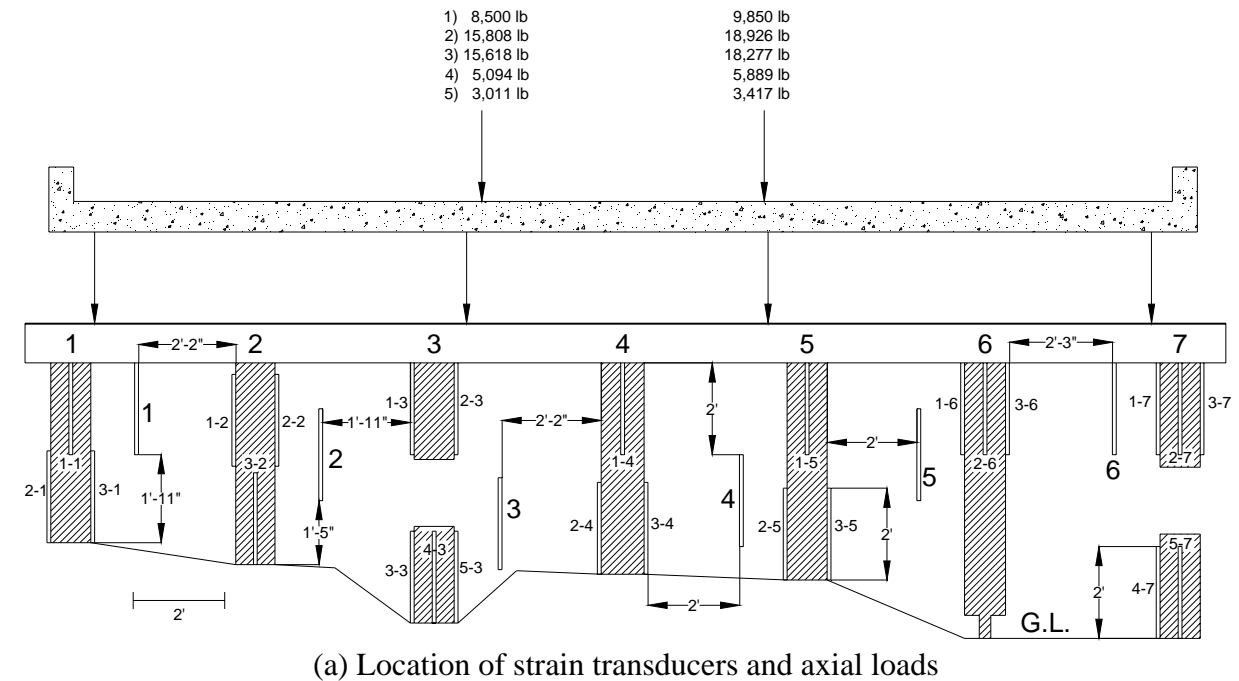
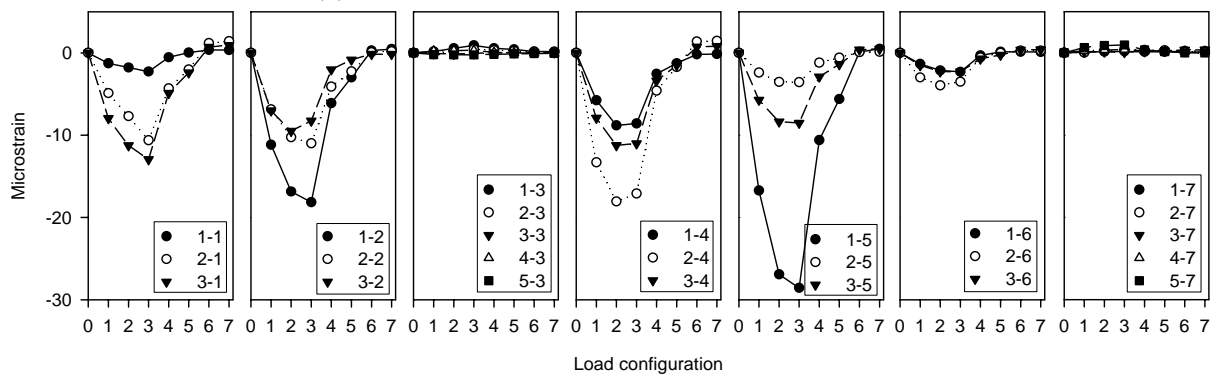
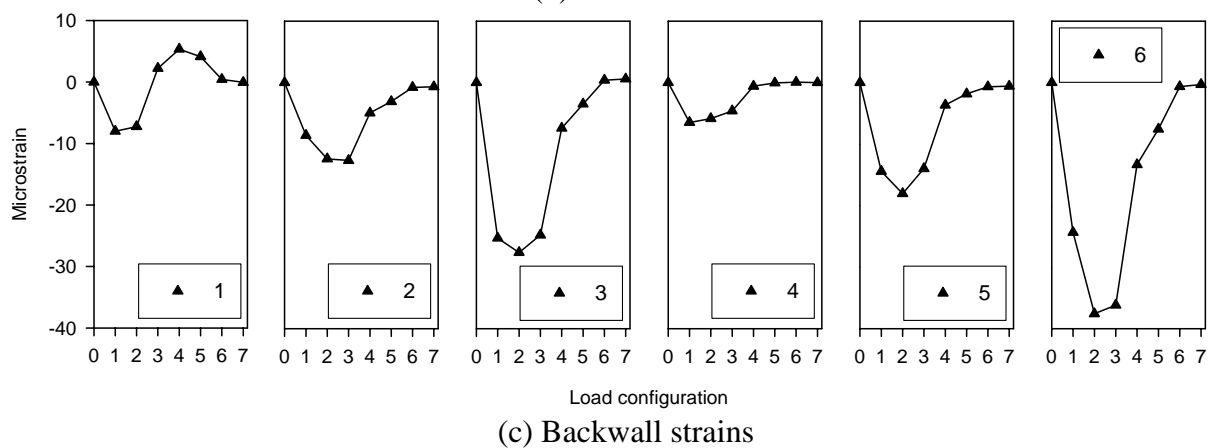
When the abutment was loaded at the centerline, the influence of the exterior pile no. 7 became more apparent (See Figure 12.41). This was determined by comparing the strains in load configuration 3 for pile no. 5 during test nos. 3, 4, and 5. The strain in test no. 3 was about -23 microstrains. When pile no. 3 was removed, the strain increased to -24 microstrains (about 4% increase), however, when pile no. 7 was removed the strain increased to -28 microstrains (20% increase). The exterior pile no. 7 does not appear to have any influence on pile nos. 1 through 4 since the strains did not change compared to test no. 4.

Figure 12.41. Static load test at the centerline with pile Nos. 3 and 7 removed (Bridge No. 029070 – Humboldt County)

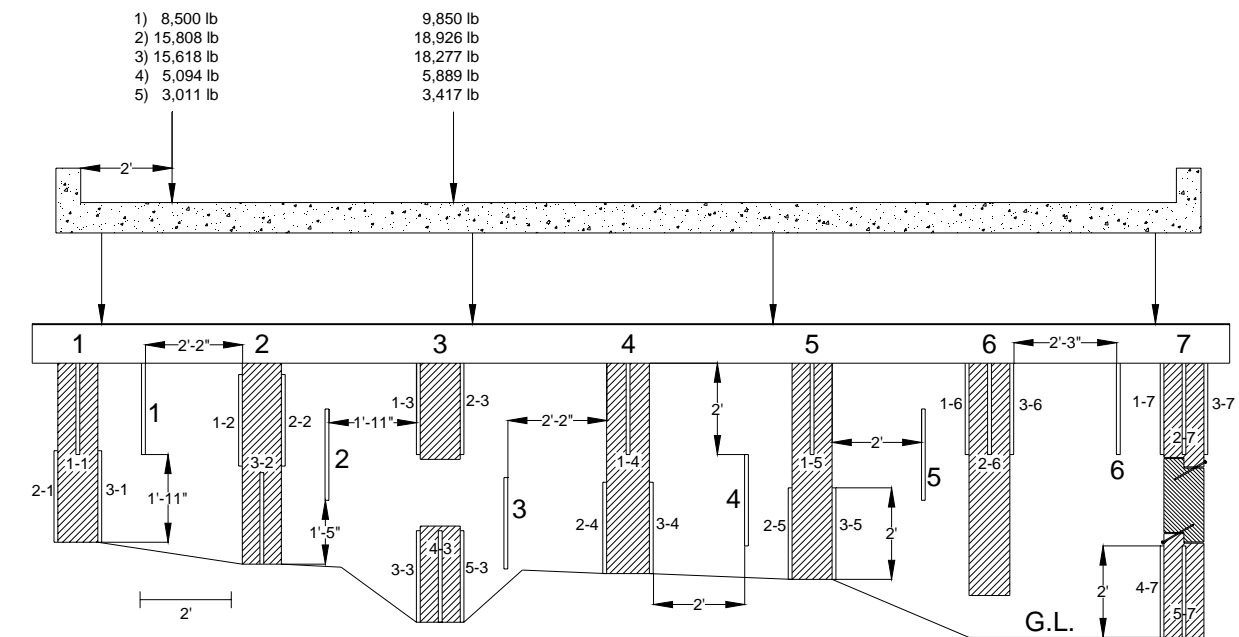
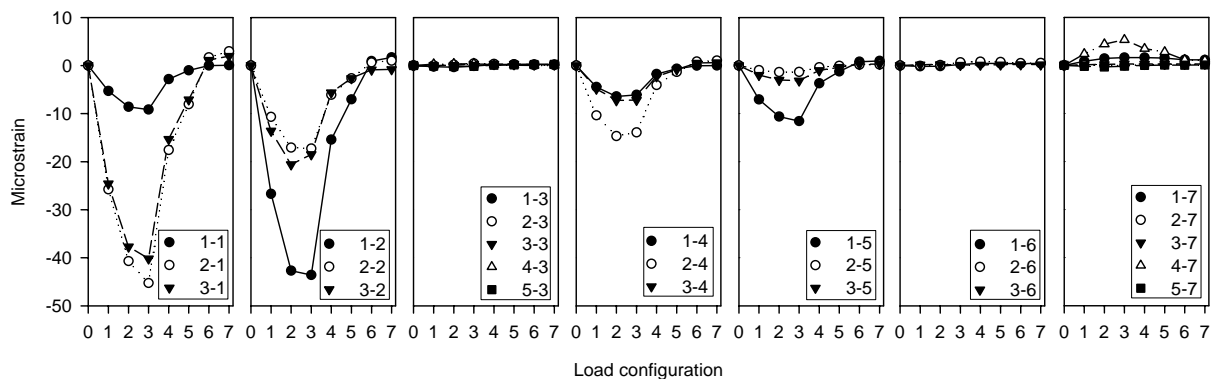
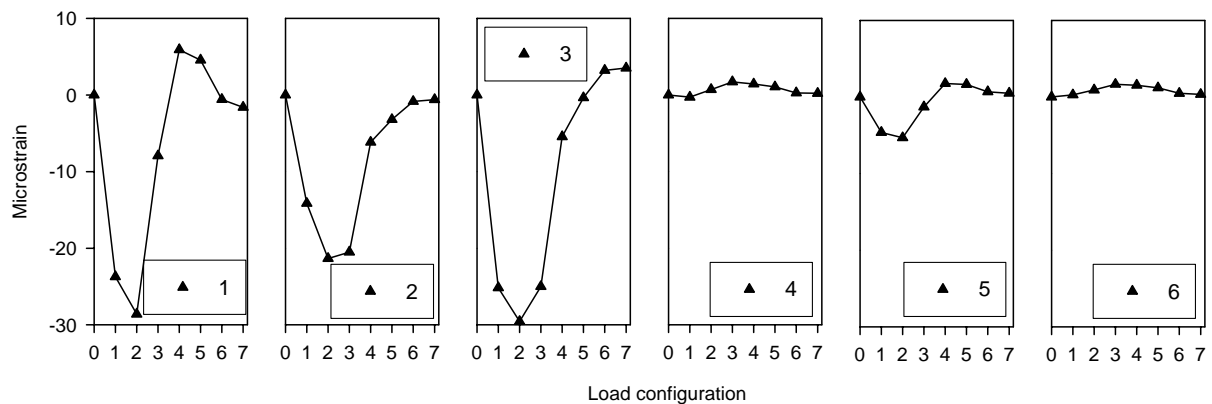
The first load test was carried out with the loading at the north edge of the bridge (See Figure 12.46). The pile and backwall strain measurements were similar to those measured during test nos. 5 and 6. When the abutment is loaded at the north edge of the bridge, almost no load is resisted by pile no. 7, which is reflected by the negligible pile strain.

Figure 12.46. Static load test at the north edge with pile nos. 3 and 6 removed and pile no. 7 repaired (Bridge No. 029070 – Humboldt County)

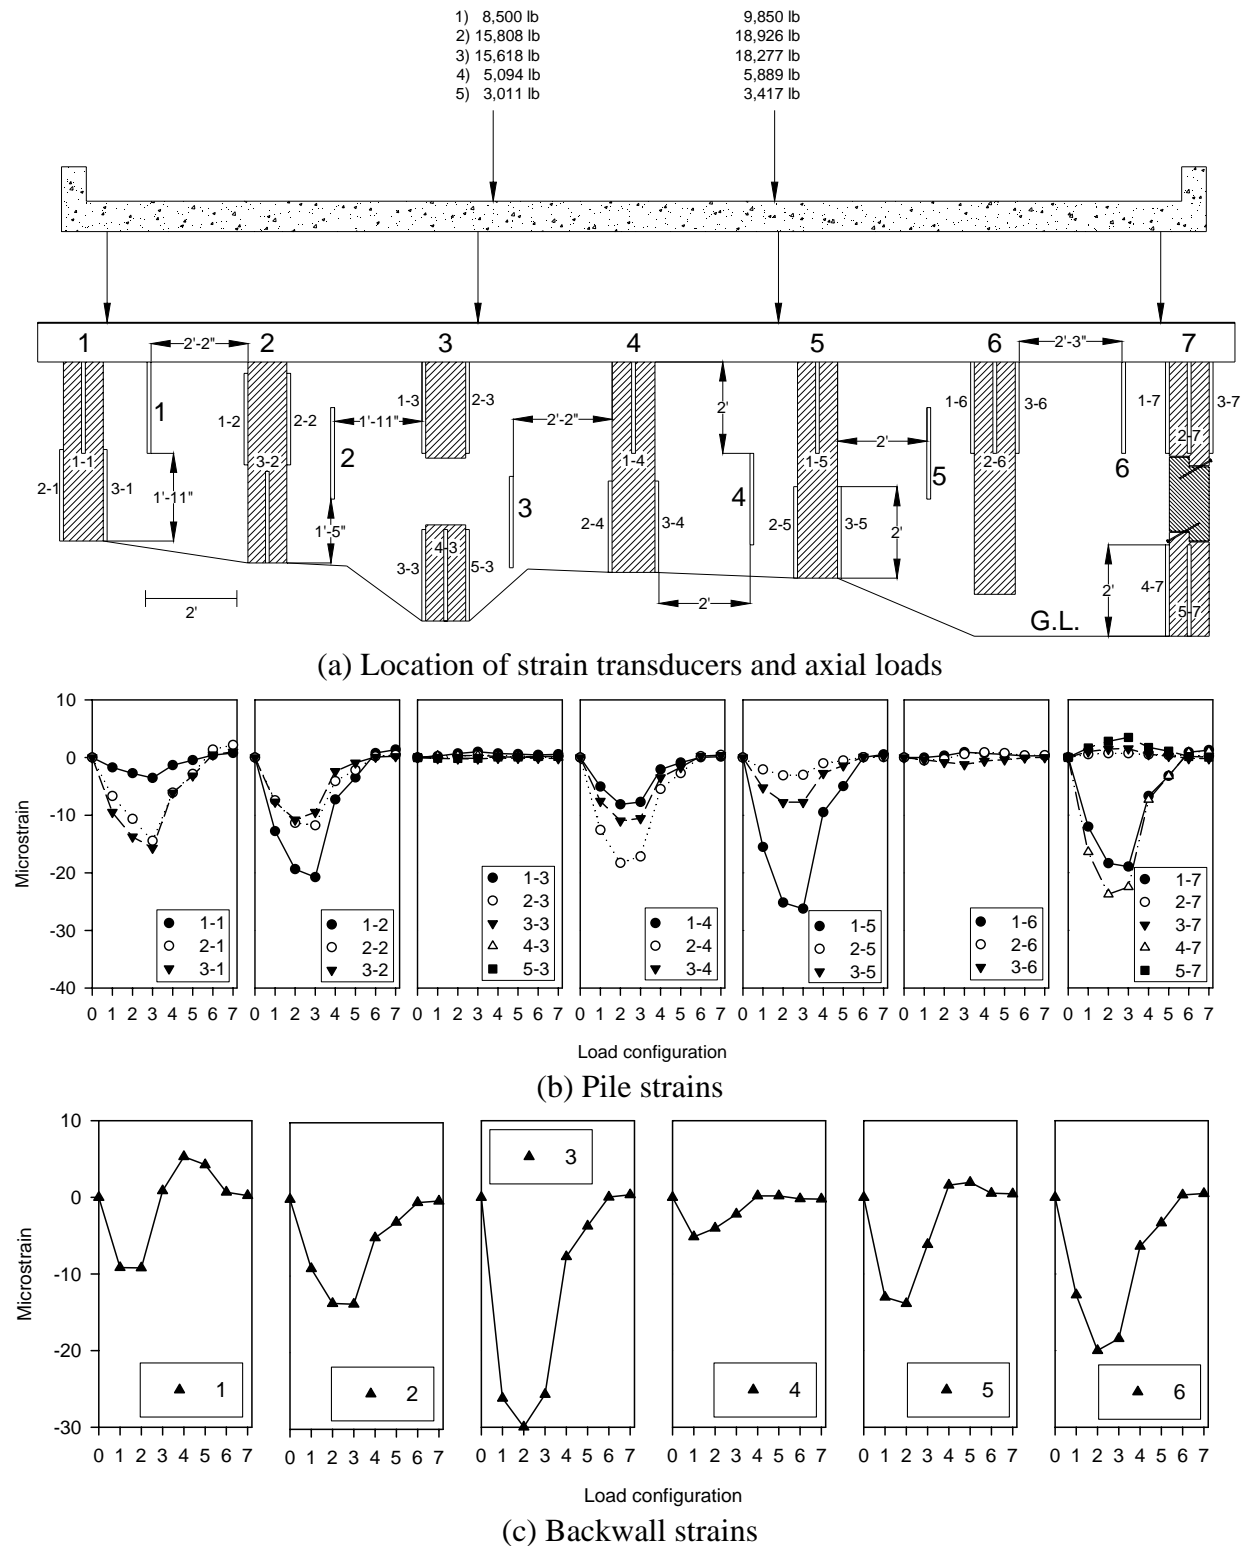
The pile and backwall strain measurements resulting from loading the abutment at the centerline of the bridge deck are shown in Figure 12.47. The results indicate the success of the pile repair method in restoring part of the capacity of pile no. 7 as evidenced by the pile strain measurement, which was about -24 microstrains in load configuration 2. The pile repair resulted also in a reduction of the strain measured in pile no. 5 by about 15% compared to test no. 5. The backwall strain between pile nos. 6 and 7 was also reduced by 45%. The strain measured in pile no. 7 was 3 times higher than that measured during destructive test no. 4 (pile no. 3 removed and pile no. 7 jacked). The pile strains, however, were only recorded by strain transducers 1-7 and 4-7 (See Figure 12.47b).

Figure 12.47. Static load test at the centerline with pile Nos. 3 and 6 removed and pile No. 7 repaired (Bridge No. 029070 – Humboldt County)

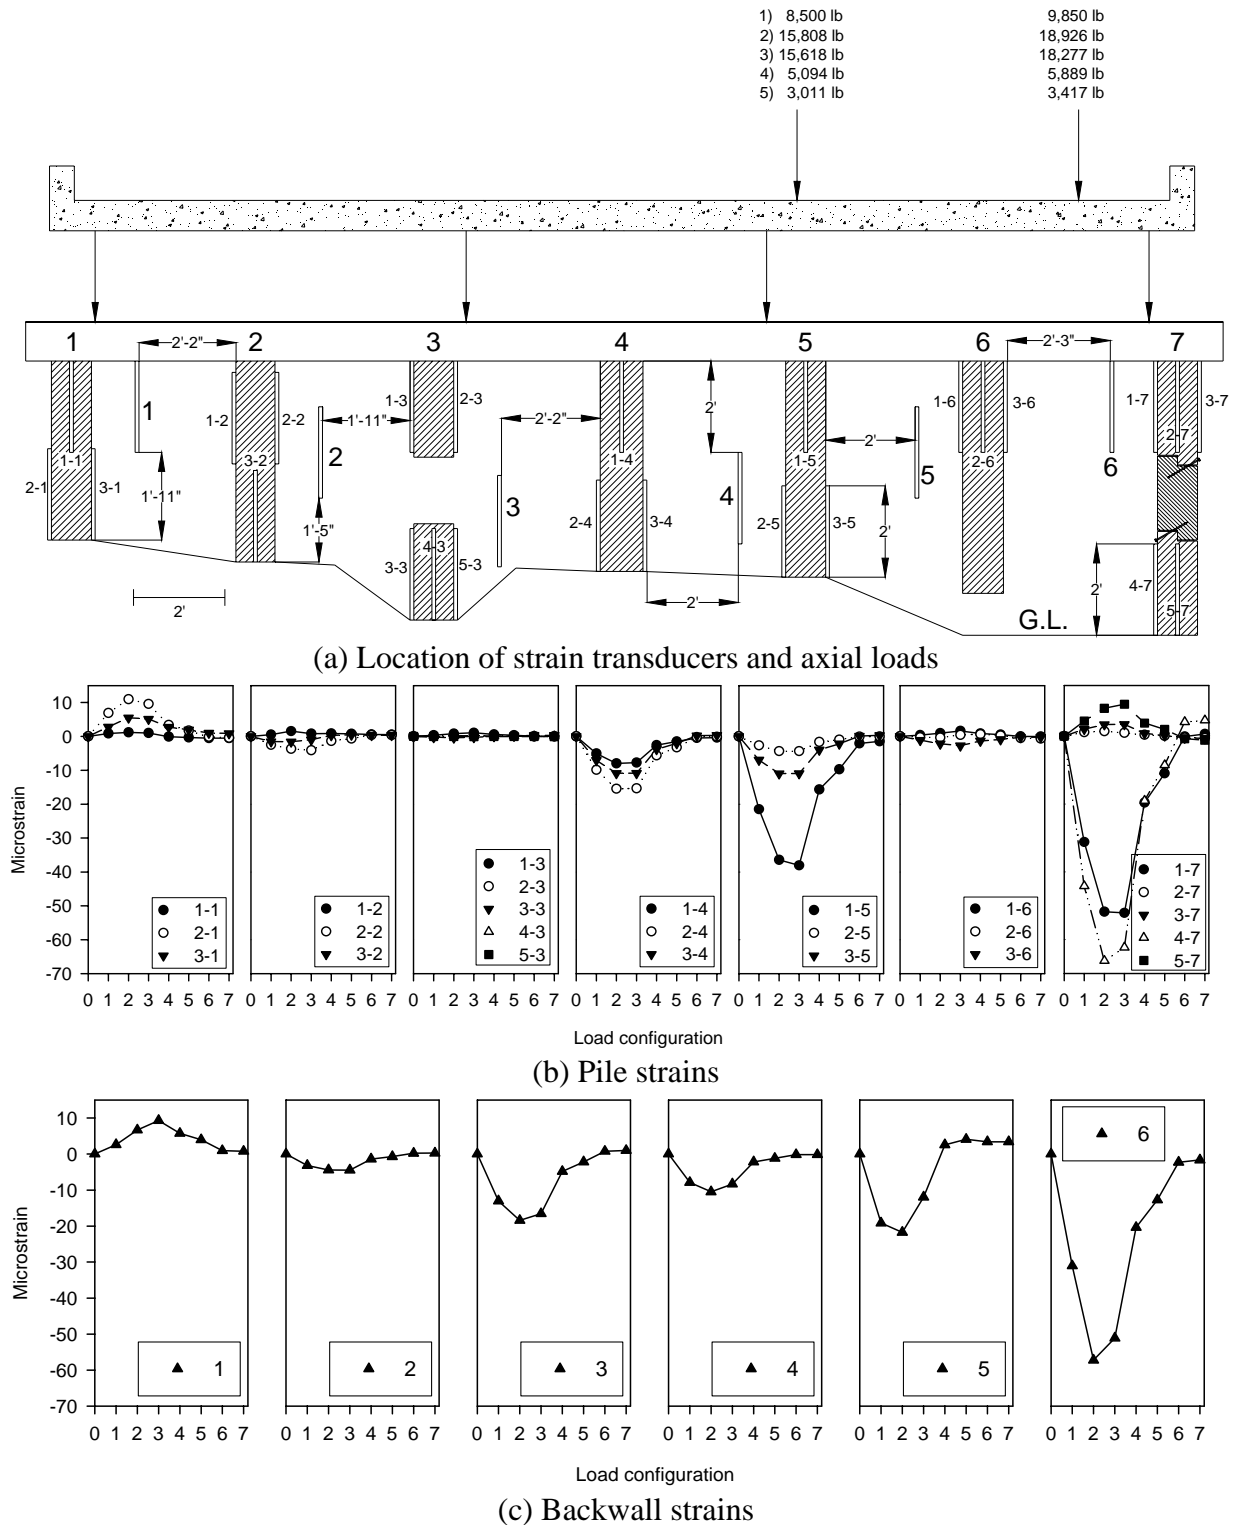
The east abutment was finally loaded with the loading at the south edge of the bridge. The pile and backwall strains are shown in Figure 12.48. Similar to the centerline load test, repairing pile no. 7 reduced the strain in the adjacent pile no. 5 by 25%. Furthermore, the backwall strain between pile nos. 6 and 7 was reduced by 40%. The strain in pile no. 7 was about 3.5 times higher than that recorded during destructive test no. 4 (pile no. 3 removed and pile no. 7 jacked). Repairing pile no. 7 also resulted in reducing the positive strains in pile nos. 1 and 2 during test no. 5 (pile nos. 3, 6, and 7 removed) by about 40 and 15%, respectively.

Figure 12.48. Static load test at the south edge with pile nos. 3 and 6 removed and pile no. 7 repaired (Bridge No. 029070 – Humboldt County)

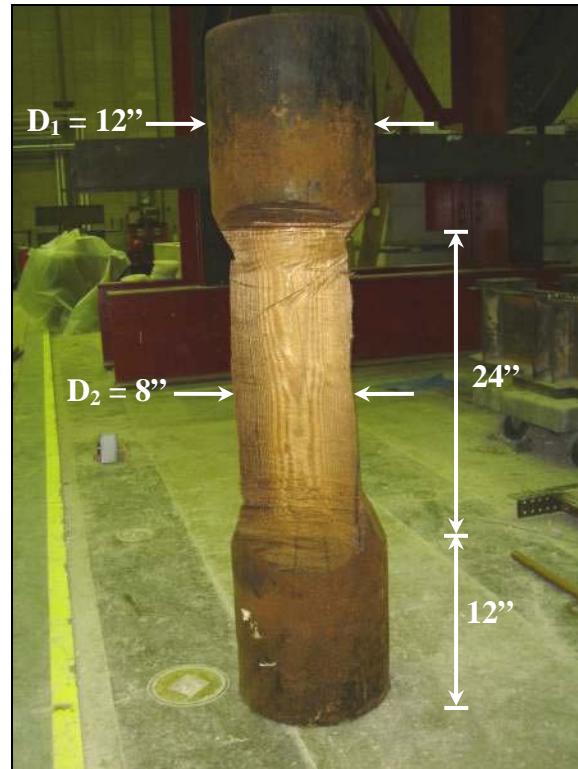
The cross sectional area of two new 4 ft timber sections was reduced by approximately 50% to simulate pile deterioration. The pile diameter was reduced from about 12 inches to about 8 inches as shown in Figure 13.4.

Figure 13.4. Reduced cross sectional area of control timber pile section

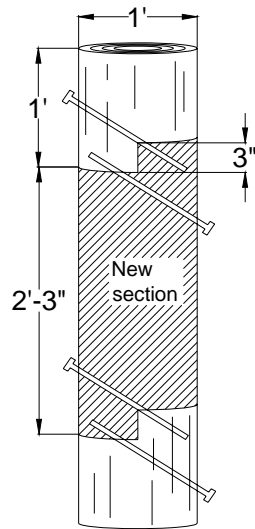
(a) Schematic diagram of the repair method

The first repair method was mechanical splicing. After testing the piles one in compression and one in bending, the pile mid section was removed and replaced with a new section, which was about 27 inches long, as shown in Figure 13.5a. The new section was connected to the pile using four metal screws installed at an angle to go through both pile sections (See Figure 13.5b). The metal screws were 0.5 inches in diameter and 12 inches long. A pile section repaired using the mechanical splicing method may be seen Figure 13.6.

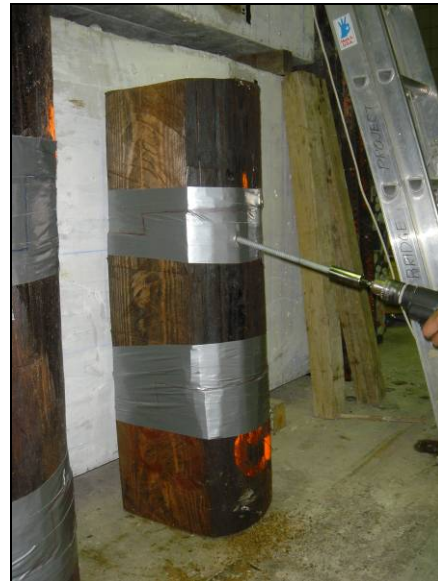
Figure 13.5. Repair method A

(b) Connecting the pile sections using a metal screw

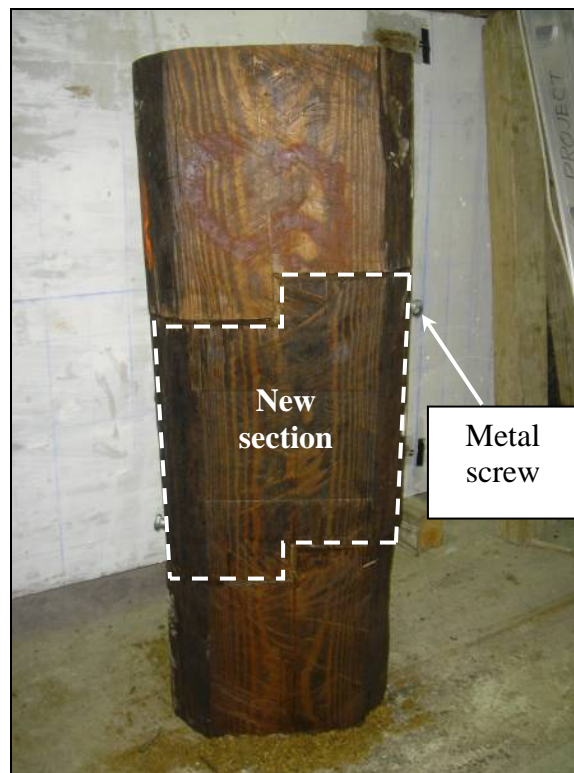
Figure 13.6. Pile section repaired using a mechanical splicing techniques

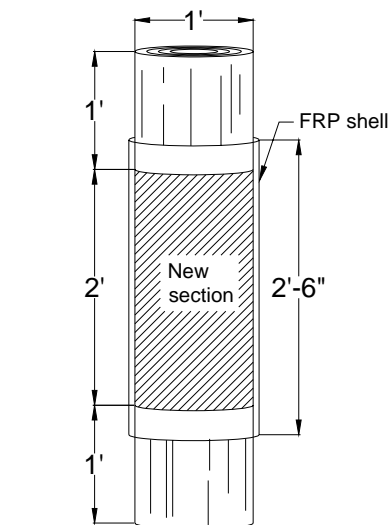
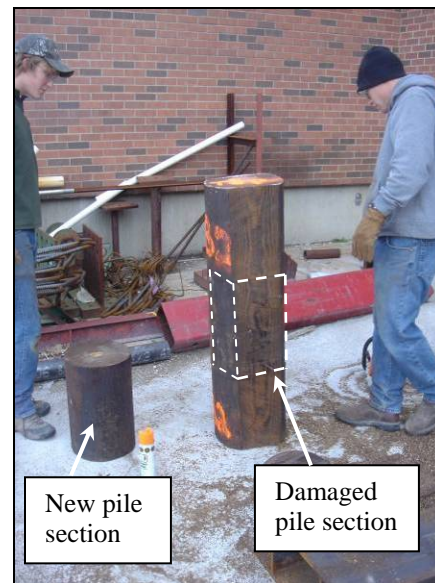
Figure 13.7. Repair method B

(b) Replacing old timber section with new one

Repair method B comprised of cutting the damaged mid sections for the axial compression and bending, which was about 2 ft long, and replacing it with a new timber section (See Figure 13.7). The timber pile was then wrapped with 5 unidirectional glass fabric sheets (Tyfo[®] SHE-51A Composite), each 30 inches x 45 inches, which allowed for about 7 inches overlap for each sheet. The overlap for each sheet was staggered to avoid lines of weakness along the entire shell. Prior to wrapping the FRP sheets, a special epoxy (Tyfo[®] S Saturant Epoxy), used typically for bonding applications, was prepared and applied to the FRP sheets. The epoxy was prepared by mixing 100 parts of component A to 42 parts of component B by volume. The two components were mixed using a gear driven mixer for about five minutes until uniformly blended. A paint roller was used to apply the bonding epoxy as shown in Figure 13.8. The epoxy was always applied in the direction of the fibers until the FRP sheet is fully saturated. The FRP sheet was wrapped around the timber pile as shown in Figure 13.9. The paint roller was used to press the FRP sheet against the pile for better bonding and to remove entrapped air. This process was repeated until all five sheets were wrapped around the pile. Wire cords were used to secure the FRP in place until it cured (See Figure 13.10). The material was allowed to cure for three days at 70° F before testing.

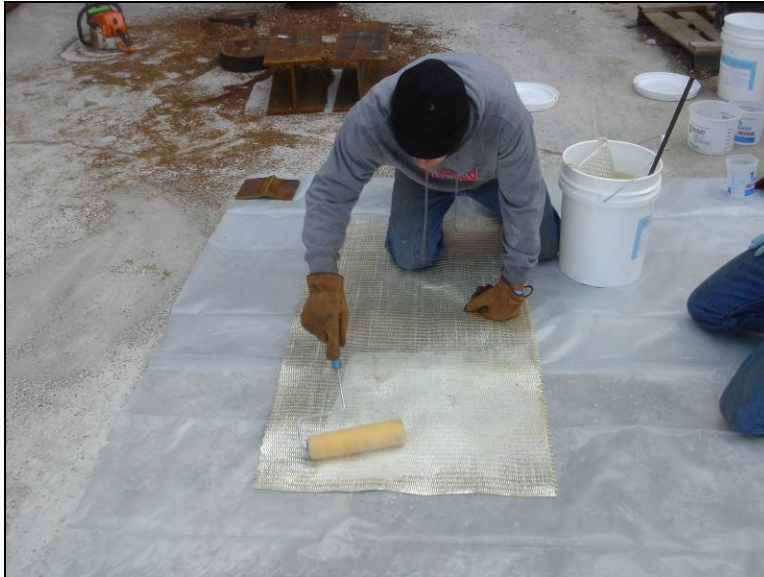
Figure 13.8. Applying the bonding epoxy using a paint roller

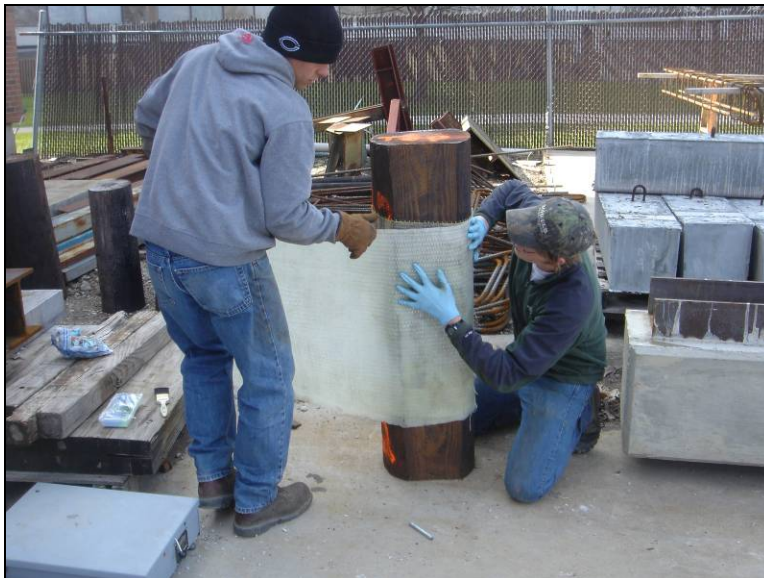
Figure 13.9. Wrapping the FRP sheet around the timber pile

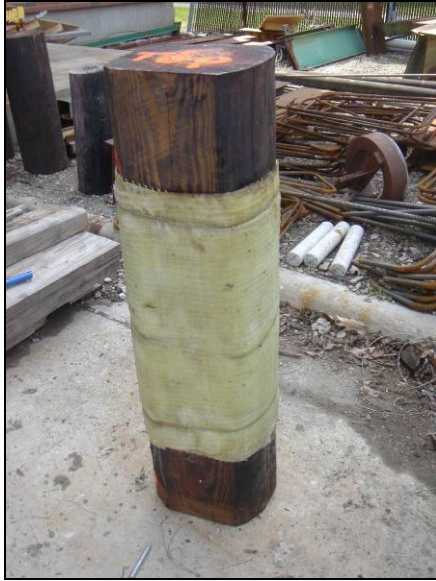
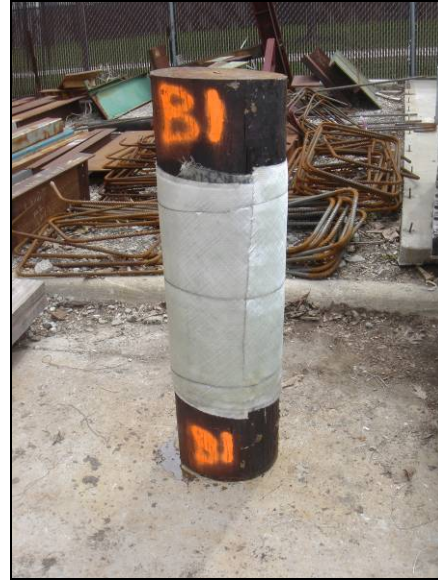
Figure 13.10. Two piles repaired using repair method B

(a) Pile subjected to flexural loading

(b) Pile subjected to axial loading

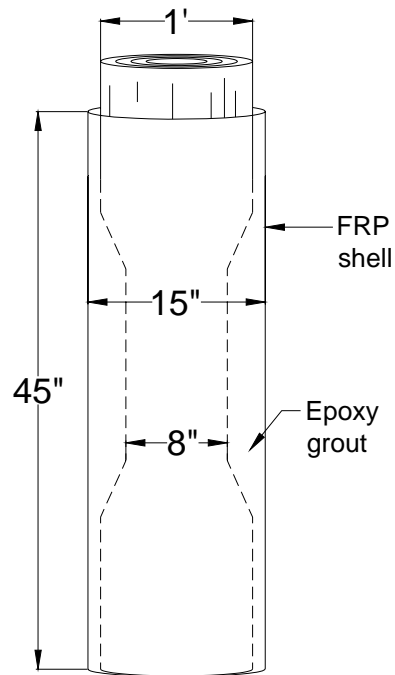
Figure 13.11. Schematic diagram of repair method C

Repair method C comprised of removing 50% of the cross sectional area of the damaged pile similar to the control section, wrapping the pile with a FRP shell, and filling the void between the pile and the shell with a wood filler epoxy resin (Tyfo[®] WHF). Two piles were tested; one in axial compression and one in bending. A schematic of this repair method is shown in Figure 13.11. The diameter of the FRP shell was about 15 inches, whereas the diameter of the pile section was about 12 inches. The diameter of the reduced pile cross section was a nominal 8 inches. A PVC pipe with an 15 inch diameter was used to mold the FRP shell (See Figure 13.12a). The pipe was covered with plastic sheets to prevent bonding the FRP shell to the pipe. Three FRP sheets, each 45 inches x 56 inches, were used to form the FRP shell. Bonding epoxy was applied to each sheet, similar to Repair Method C, which was then wrapped around the PVC pipe (See Figure 13.12b). The longitudinal slit of each sheet was staggered to prevent weak lines along the FRP shell. The shell was held in place using wire cords until the bonding epoxy hardened. After curing for 3 days at 70° F, the shell was detached from the PVC pipe and the plastic sheet as shown in Figure 13.13. The FRP shell was placed around the pile section with approximately 1.5 inch gap to allow for placing the wood filler epoxy. According to the procedure recommended by the manufacturer, the wood filler epoxy was prepared by mixing 14% by weight of moist sawdust to Component A. Two parts of Component A were then mixed to one part Component B by volume. A gear driven mixer was used to mix the two components for about 5 minutes until uniformly blended. Once mixed, the wood filler epoxy was applied immediately, since this material cures rapidly, to fill the void (See Figure 13.14). This material produces an exothermic reaction upon curing, expands rapidly after approximately one minute from application, and produces fumes.

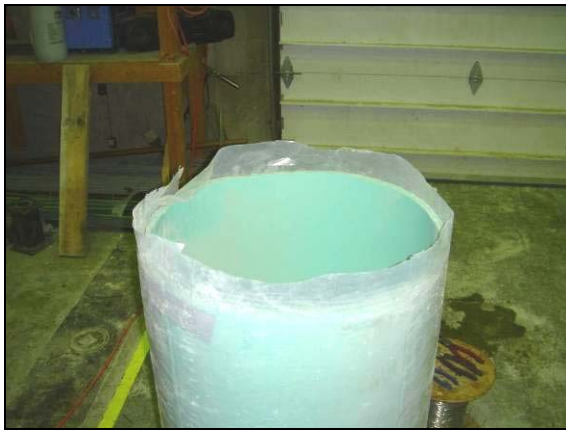
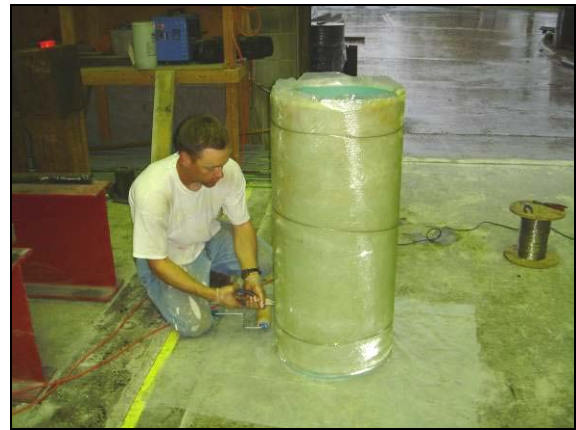
Figure 13.12. Forming the FRP shell

(a) PVC pipe used as a shell mold

(b) FRP sheets wrapped around the pipe

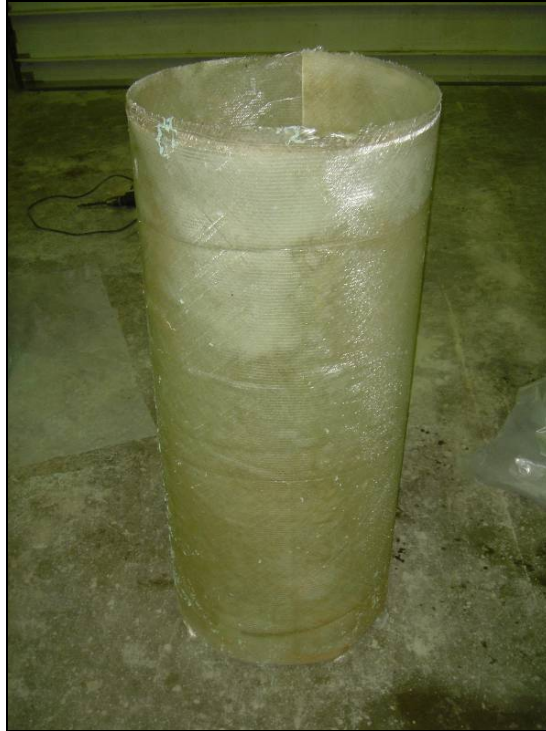
Figure 13.13. FRP shell detached from PVC pipe after curing for three days

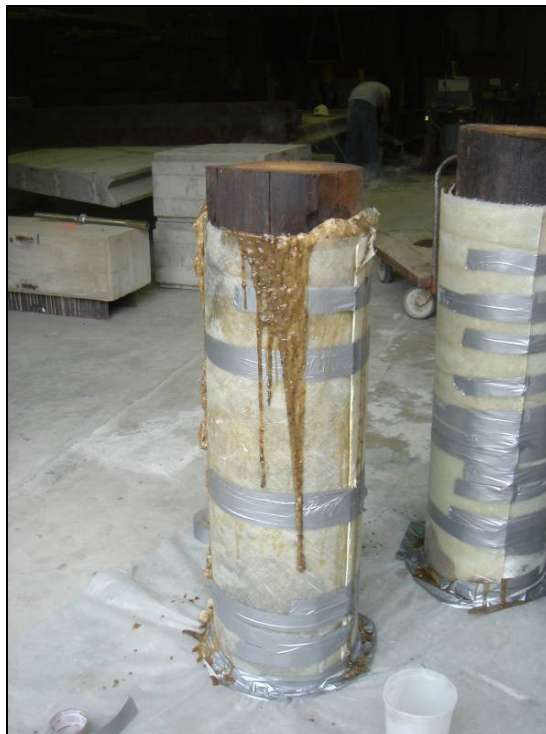
Figure 13.14. Expandable wood filler epoxy applied to fill the void between the pile and the FRP shell

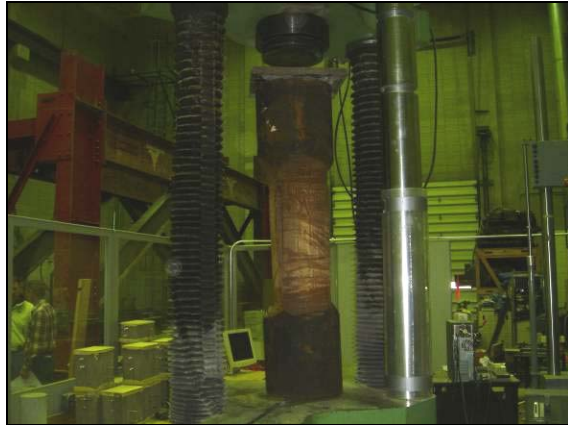
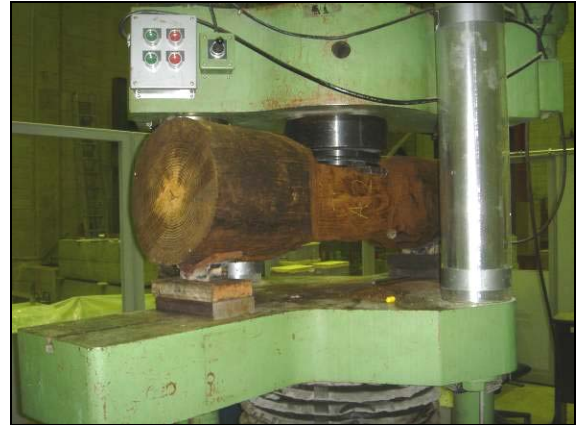
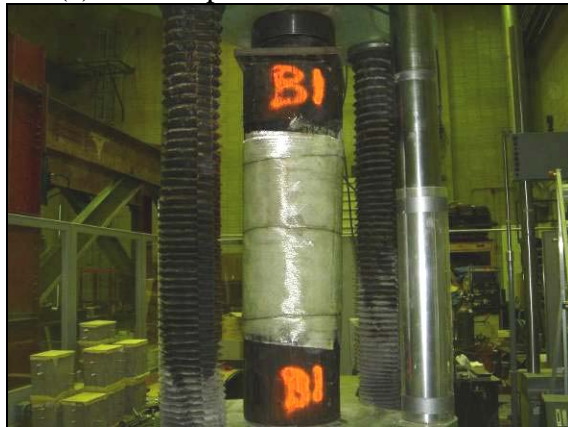
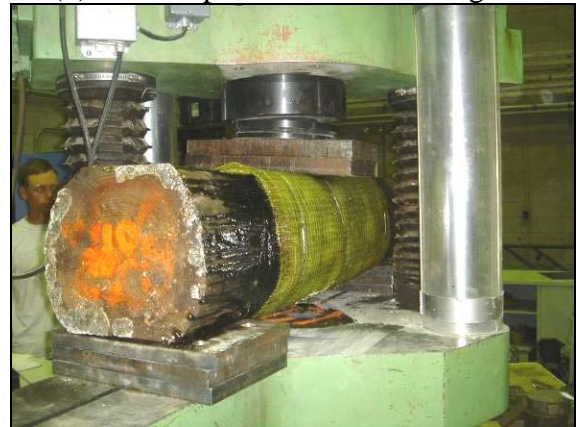
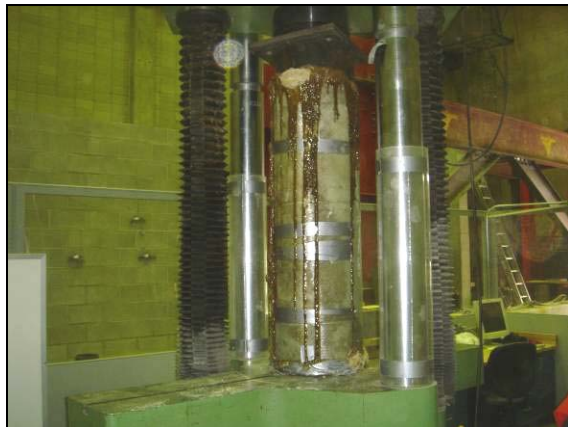
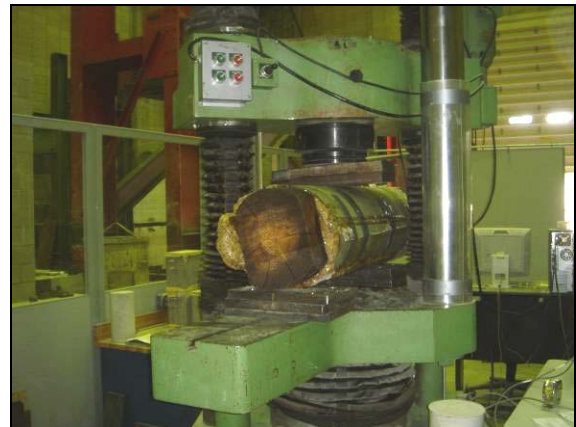
Figure 13.15. Axial and bending load tests

For each repair method, two pile sections were tested in axial compression and in bending. Figure 13.15 shows the axial compression and bending tests for the control piles and the piles repaired using methods B and C. The results of the axial compression and bending tests are shown in Figure 13.16 and Figure 13.17, respectively. Also, Table 13.3 summarizes the ultimate load measured during axial compression tests and the percent load restored for each repair method. Table 13.4 summarizes the ultimate load and deflection at failure measured during the bending tests and the percent load restored after repair. The results of the axial compression tests show that repair method A restored about 100% of the axial capacity; however, the deflection was about 10% higher. Repair methods B and C restored about 70 and 50% of their corresponding axial capacity, respectively. Compared to the control section, repair methods A, B, and C restored about 120, 102, and 88% of the load, respectively. The selected repair methods, therefore, have the potential of restoring the axial capacity of partially deteriorated timber piles. The results of the bending tests illustrate that repair method C restored about 70% of the intact pile ultimate load, which is the highest percent restoration observed. Repair methods A and B restored about 50 and 20% of the ultimate load, respectively. Repair method B showed high deflection prior to failure. Compared to the control section, repair methods A, B, and C restored about 80, 40, and 175% of the ultimate load, respectively.

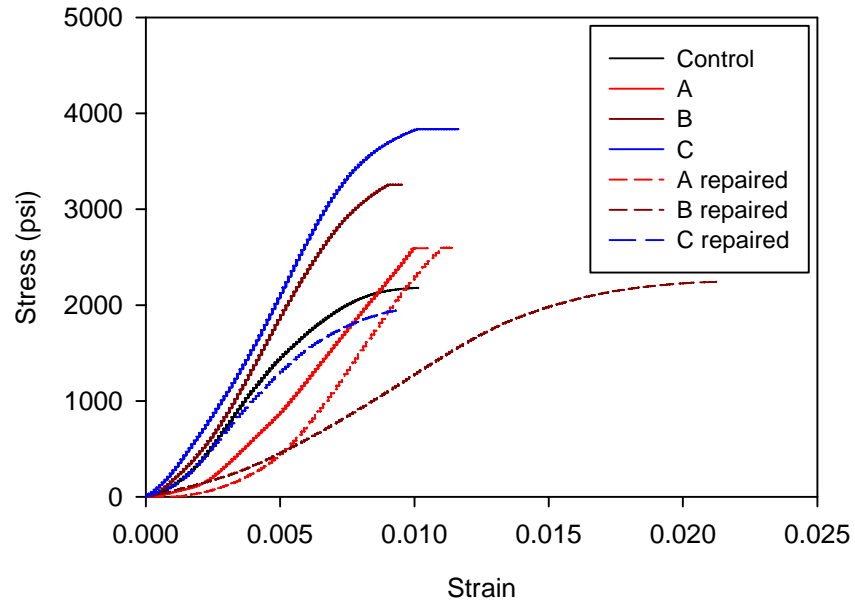
Figure 13.16. Summary of axial compression test results

Pile	Diameter (in)	Length (in)	Repair method	Compressive stress at failure (intact), psi	Compressive stress at failure (repaired), psi	% compressive strength restored
1	12	48	Control	2,177	-	-
2	14	47	A	2,590	2,600	100
3	13	48	B	3,260	2,240	70
4	12	48	C	3,830	1,930	50

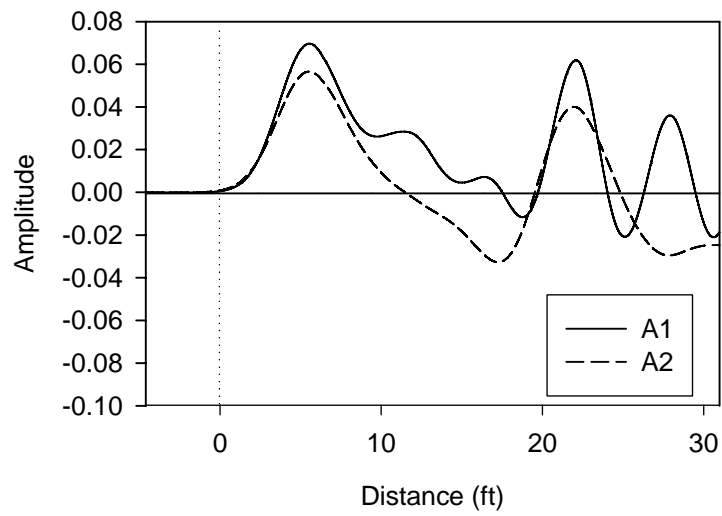
Figure C6. Pile integrity test results at pile no. 5 at the south abutment (distance between A1 and A2 = 5 ft)
