Investigation of Steel-Stringer Bridges: Superstructures and Substructures, Volume II

Final Report
October 2007

Sponsored by
the Iowa Highway Research Board (Project TR-522)
and the Iowa Department of Transportation (CTRE Project 04-184).

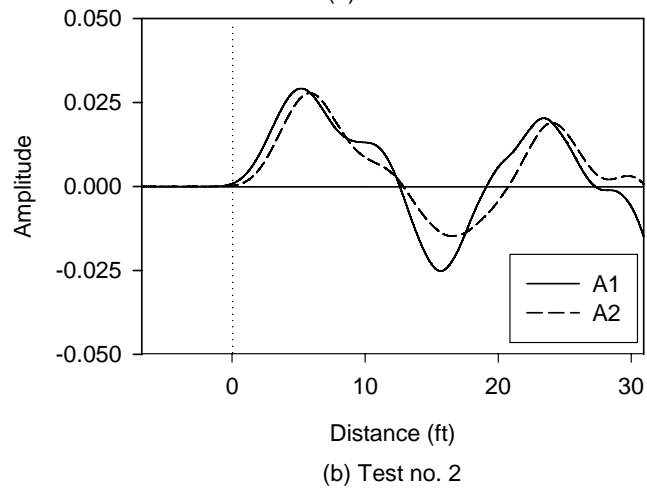
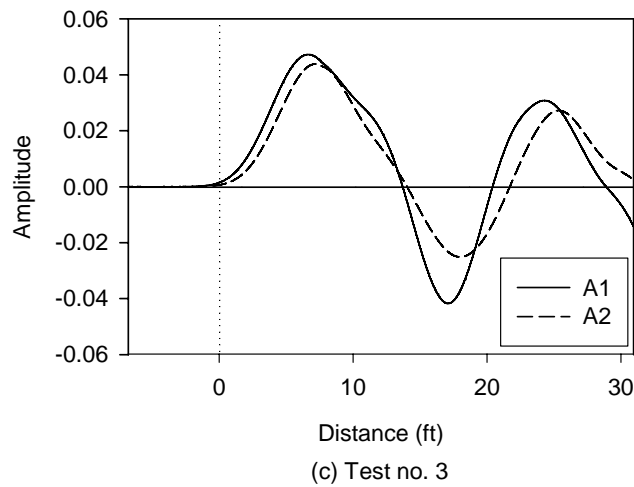
Figure C7. Pile integrity test results at pile no. 3 at the south abutment (distance between A1 and A2 = 2 ft)

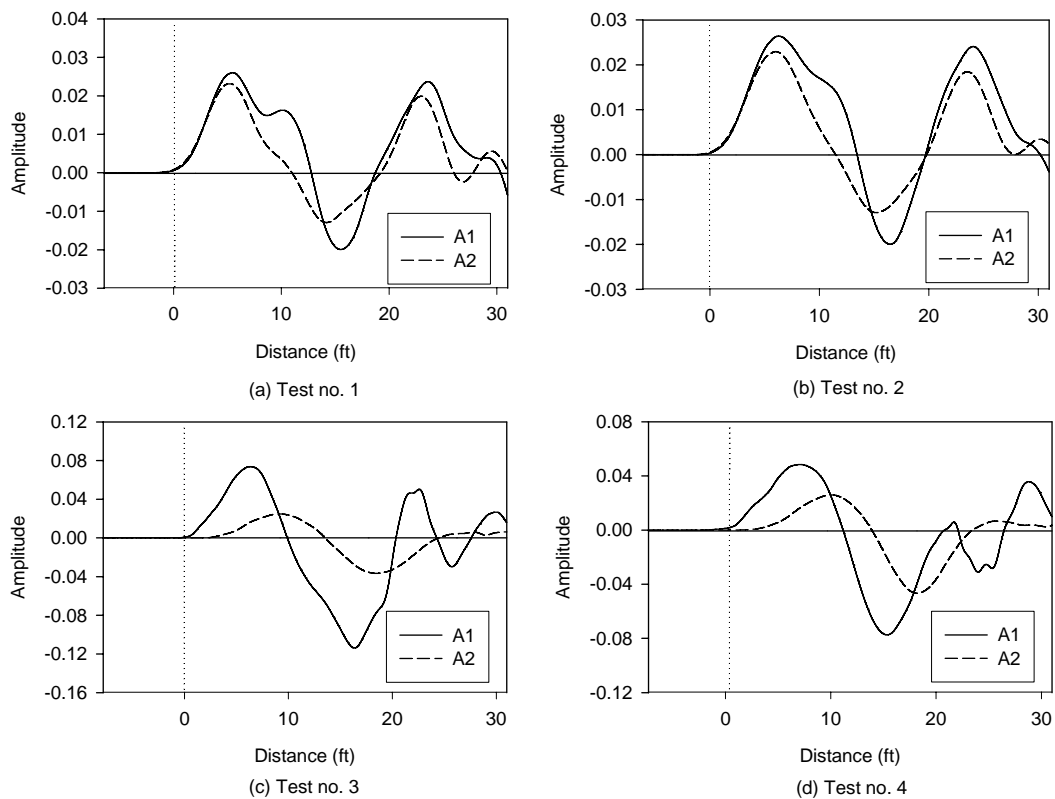
Figure C8. Pile integrity test results at pile no. 3 at the south abutment (distance between A1 and A2 = 4.5 ft)

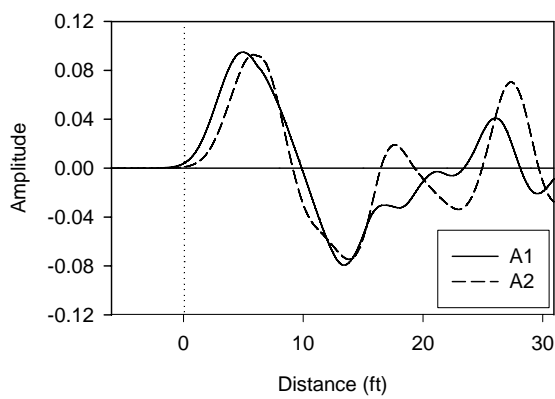
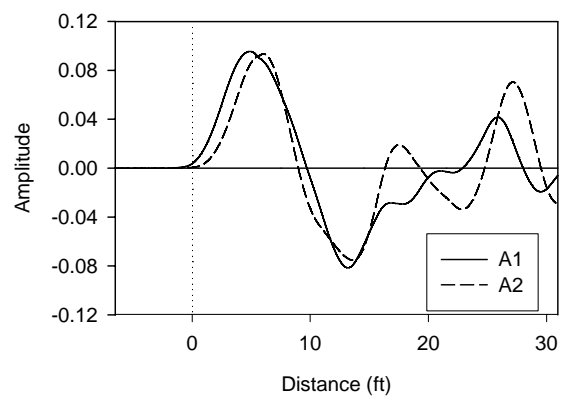
Figure C10. Pile integrity test results at pile no. 2 at the south abutment (distance between A1 and A2 = 2 ft)
