Field Testing and Evaluation of a Demonstration Timber Bridge

Final Report
February 2012

Sponsored by
Iowa Highway Research Board
(IHRB Project TR-604)
Iowa Department of Transportation
(InTrans Project 08-343)

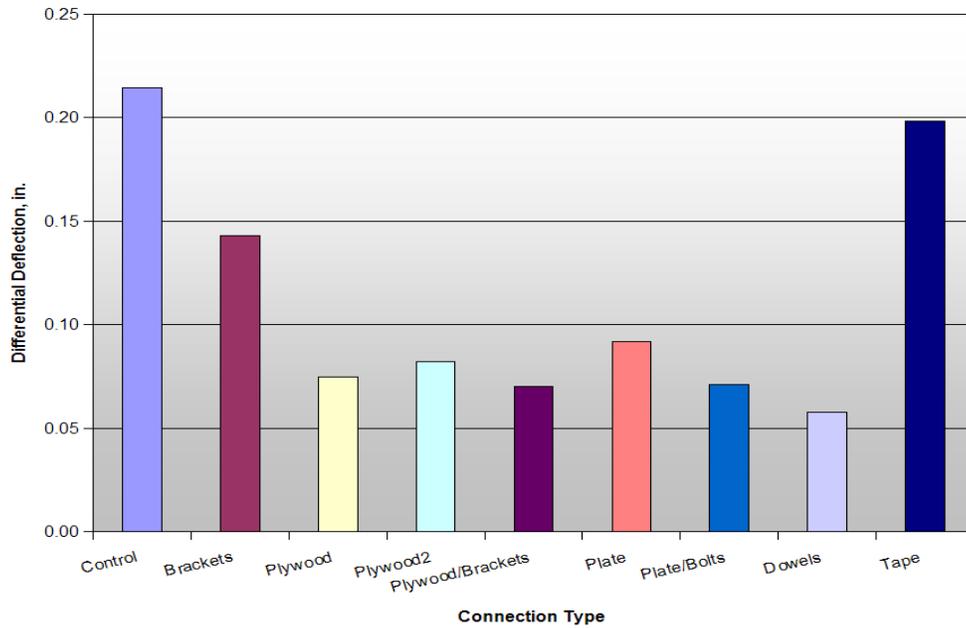
Figure 2.3. Maximum differential panel deflection for the laboratory bridge alternatives

Differential panel deflection data from the plywood overlay alternative is presented in Figure 2.3 as the data bar labeled Plywood. Compared to the control, the plywood overlay alternative reduced the differential panel deflections by more than 50 percent. In addition, this alternative is less expensive and a more construction-friendly alternative compared to the dowels alternative.

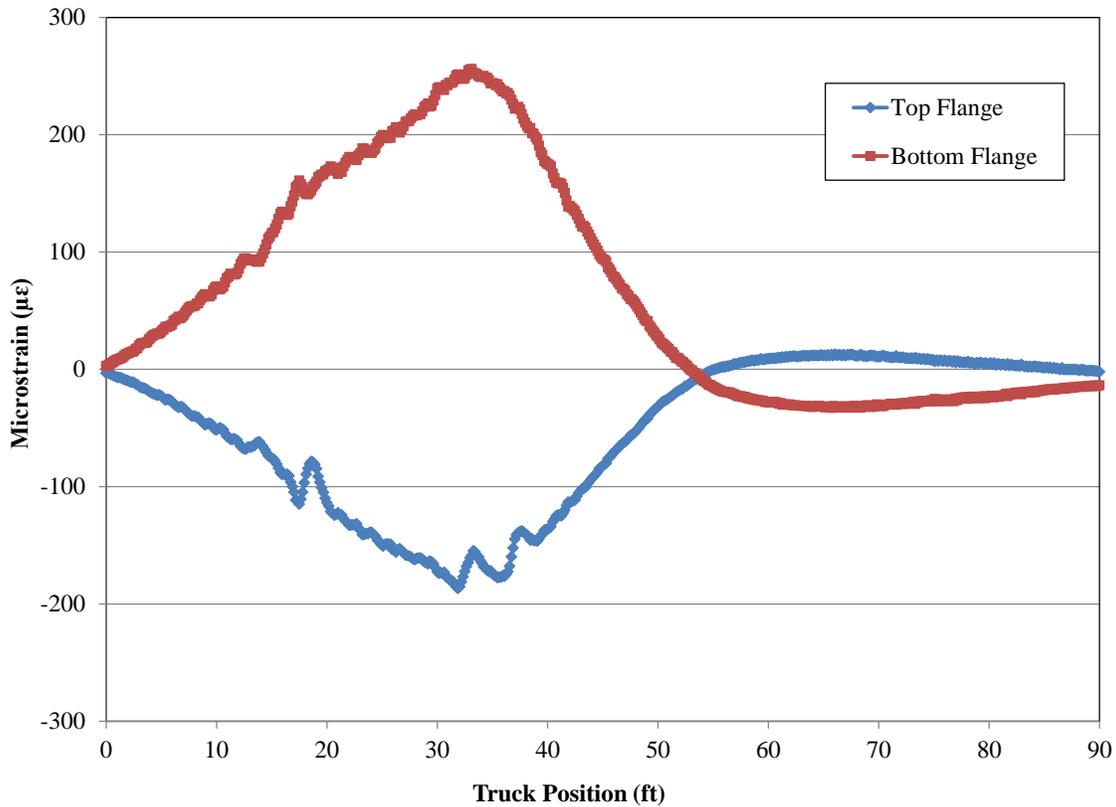
Figure 5.7. Top and bottom girder strains, Span 1, G6, 2010

A comparison of the top and bottom strain from a girder under the load truck for any given load case indicates that the transverse deck panels and the girders did not act compositely as expected; see Figure 5.7 for a typical strain plot from 2010.

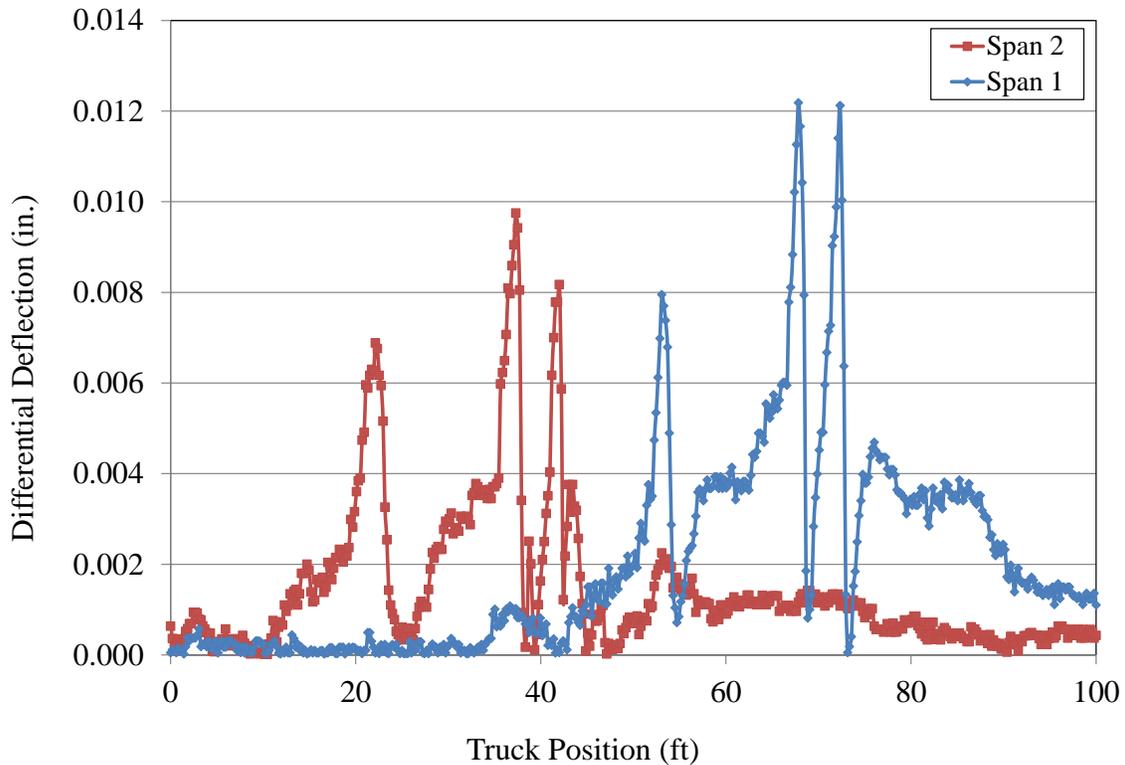
Figure 5.8. Comparison of differential panel deflections for Span 1 and Span 2, 2009 data

The data in Figure 5.8 indicate larger differential panel deflections on Span 1, the span with plywood, compared to Span 2, the span without plywood. This same observed behavior is evident in the other load cases, as well, and may be a result of the following factors: 1) the difference in the location of the measurement of the relative deflection longitudinally with respect to load direction on the two spans, 2) changes made to the plywood orientation, or 3) other factors or a combination of these factors.

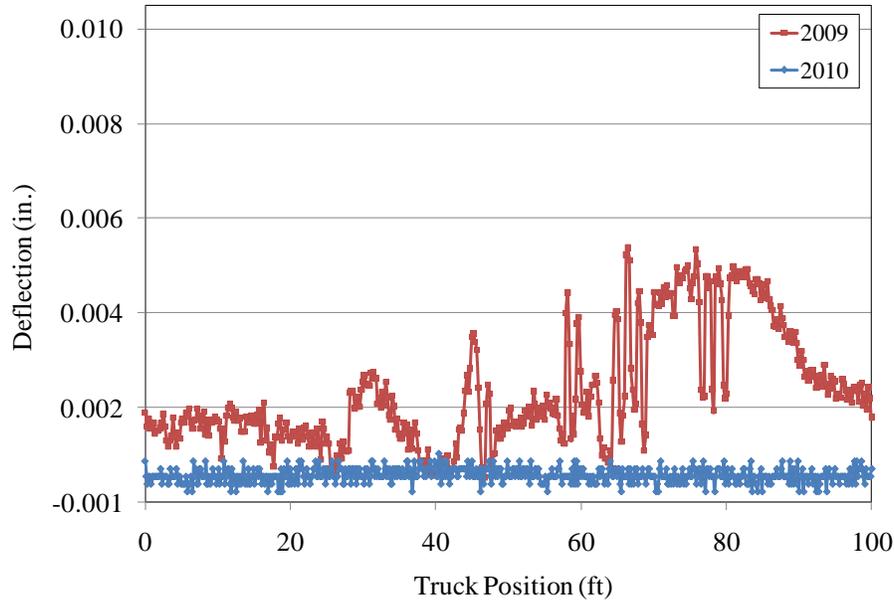
Figure 5.9. PJ6 differential panel deflection comparison, 2009-2010

Figure 5.9 shows the differential panel deflection data from 2009 and 2010 for location PJ6 (which was midway between the middle girders). The data suggest that some reduction in the differential panel deflection magnitude has taken place over the one-year time period. However, with the cracking of the asphalt wearing surface still prevalent, the significance of this decrease is unknown.

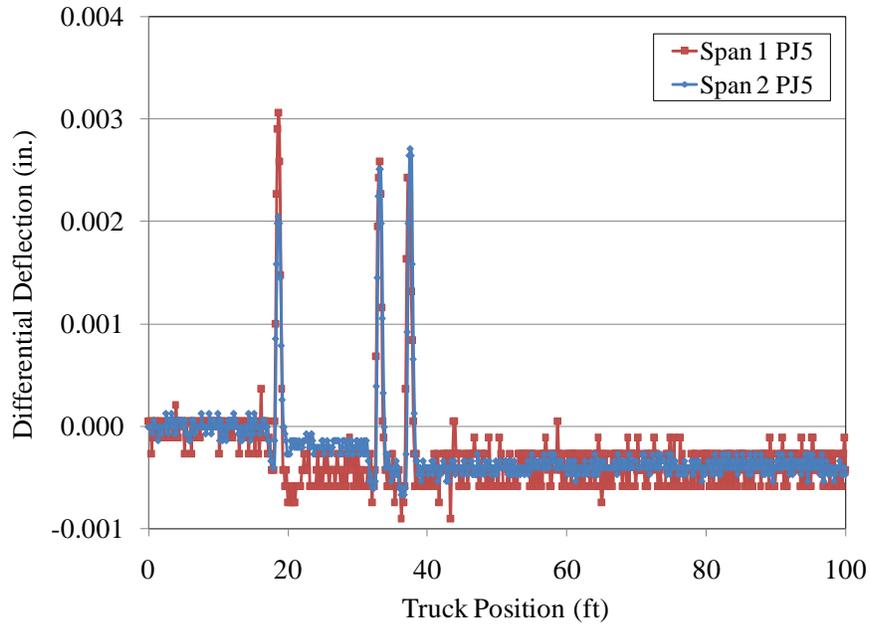
Figure 5.10. PJ5, LC 6, differential panel deflections between G3 and G4

Figure 5.10 shows the differential panel deflections between G3 and G4 at PJ5 for LC 6 and indicates that the differential panel deflections for the demonstration bridge are well below the suggested limit of 0.10 in. However, with the deflection magnitudes of Span 1 and Span 2 being so similar, it also suggests that the plywood on Span 1 has little influence on the magnitude of the differential panel deflections. Similar findings were found at panel joint PJ4, as shown Figure 5.11.

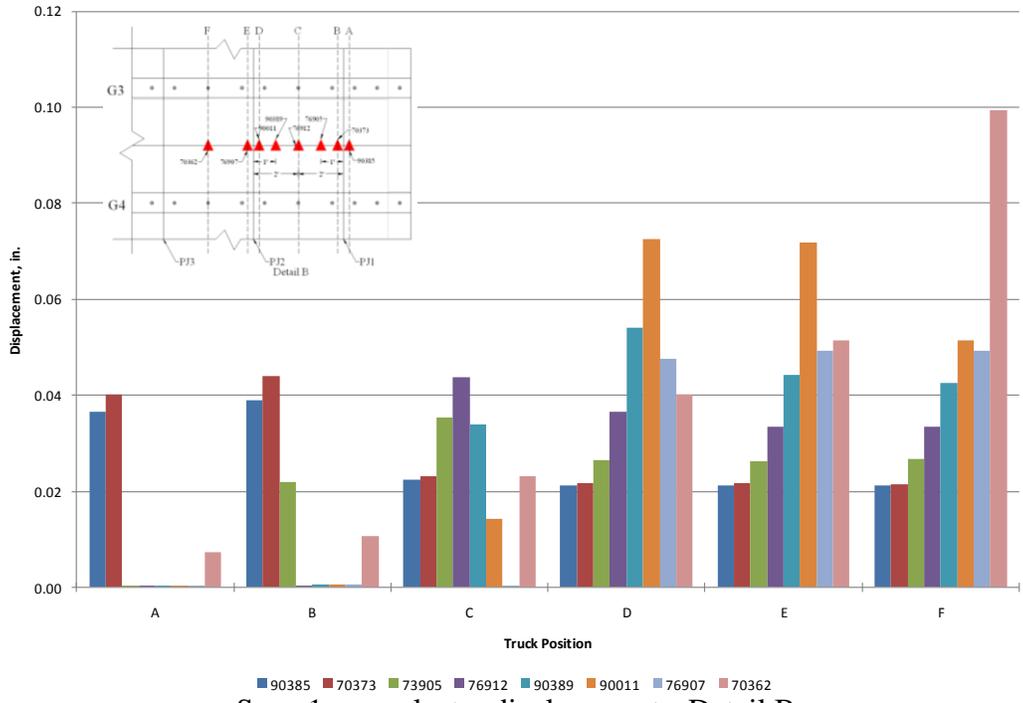
a. Span 1 gage cluster displacements, Detail B

Figure 5.12 shows the global displacements measured at each gage in the cluster for each of the six locations (A-F) detailed in Figure 4.4. Figure 5.12a represents Span 1 and Figure 5.12b represents Span 2.

Moving left to right across both graphs in Figure 5.12 provides a snapshot of the displacement of the cluster of gages as the load truck travels across the section. Not only is the pattern of the displacements similar for both spans at each location of the truck, but the magnitudes are similar as well. There appears to be little to no influence on the global panel deflection or the differential panel joint deflections from the presence of the plywood.
