Western Iowa Missouri River Flooding— Geo-Infrastructure Damage Assessment, Repair, and Mitigation Strategies

SEPTEMBER 2013

Final Report

Federal Highway Administration
Iowa Highway Research Board
(IHRB Project TR-638)
Iowa Department of Transportation
(InTrans Project 11-419)

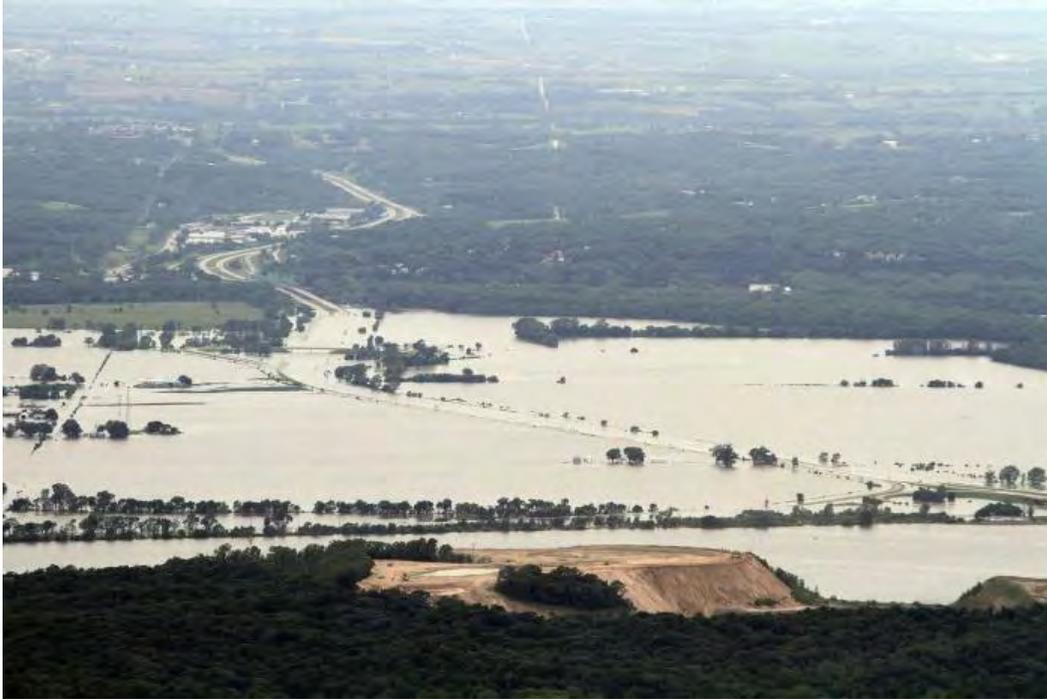
Figure 10. Aerial photo of the flooding on I-29 between Council Bluffs and Hamburg, Iowa on June 16, 2011 (Image Courtesy of Rodney White, The Register)

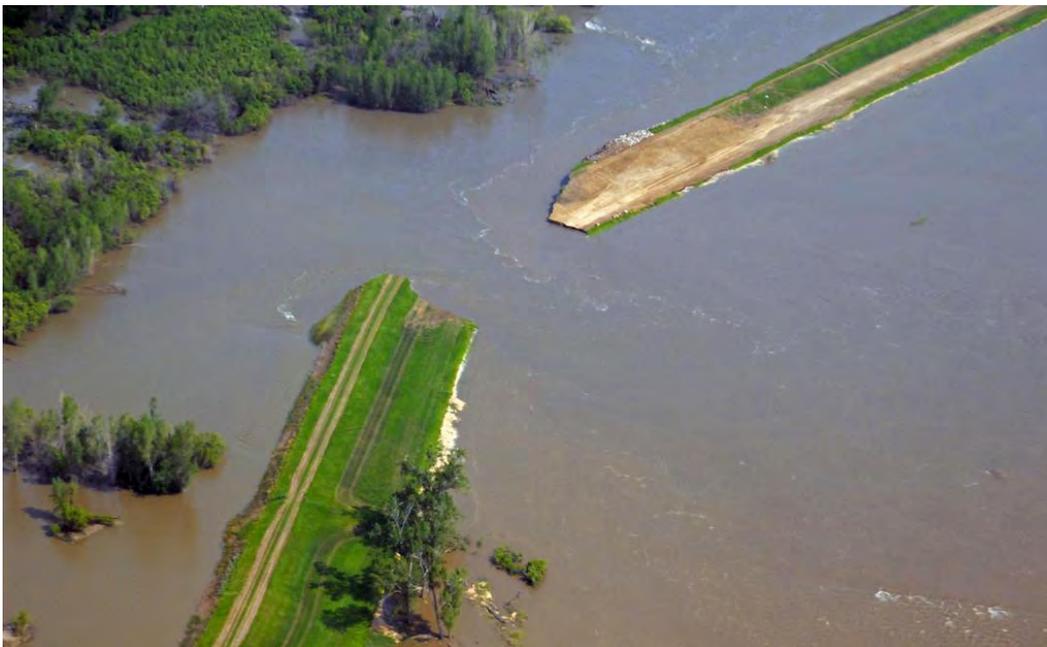
Figure 11. Aerial photo of the full breach at Federal levee 575 near Hamburg, Iowa, on June 14, 2011 (Image Courtesy of USACE <http://www.flickr.com/photos/usacehq/5837117182/in/photostream/>)

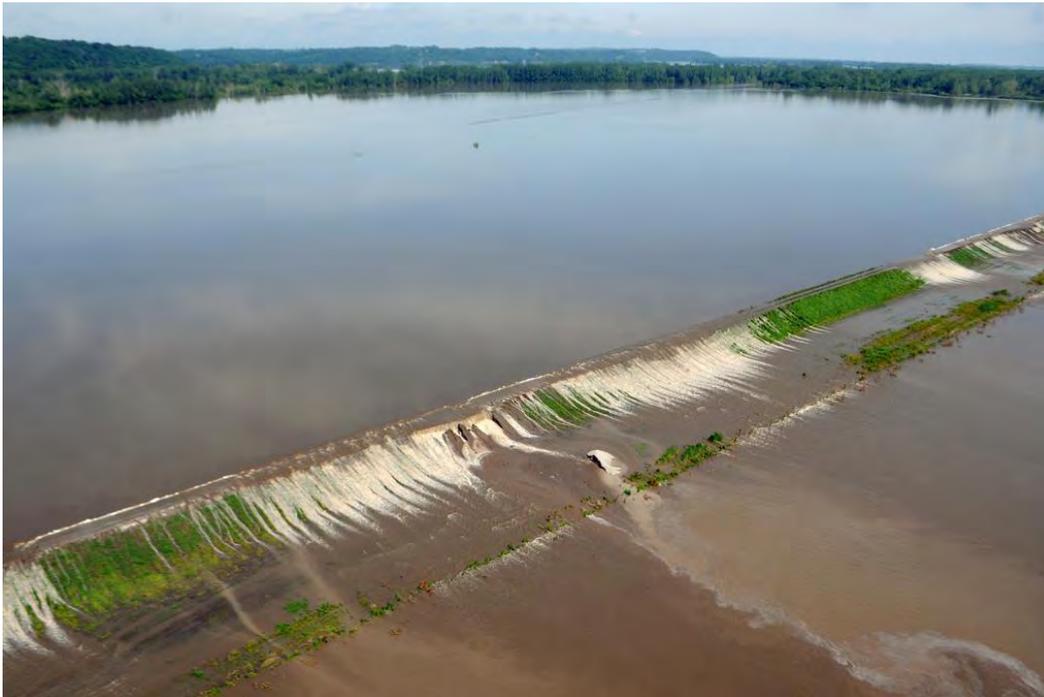
Figure 13. Aerial photo of the overtopping of Federal levee 550 near Highway 136 in Atchison County, Missouri, on June 19, 2011 (Image Courtesy of USACE <http://www.flickr.com/photos/usacehq/5849817627/in/photostream/>)

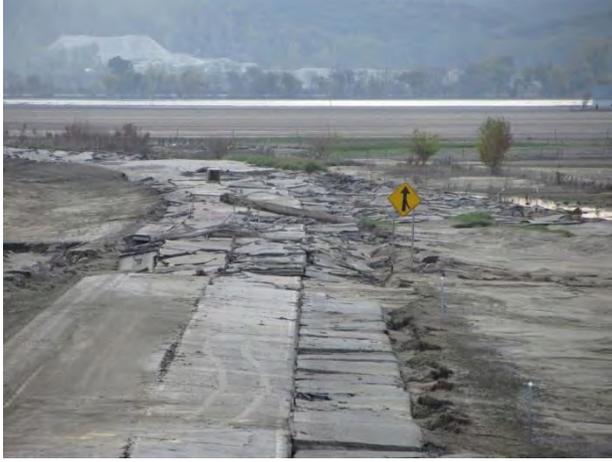
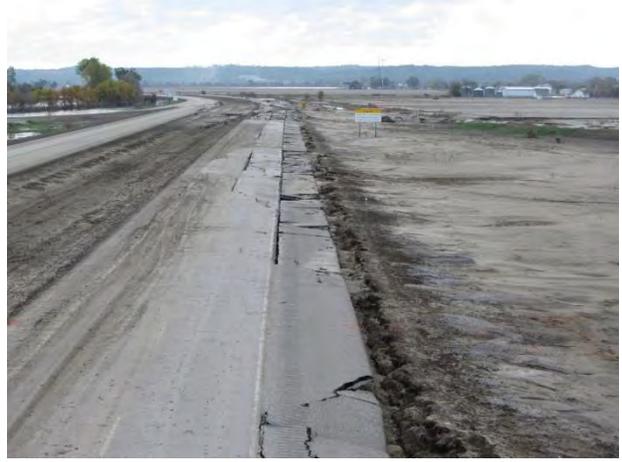
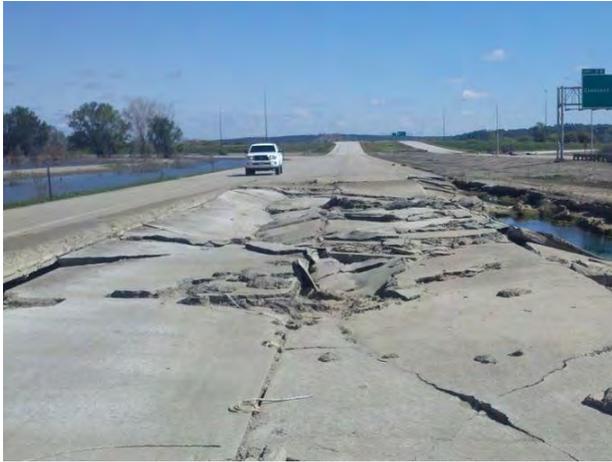
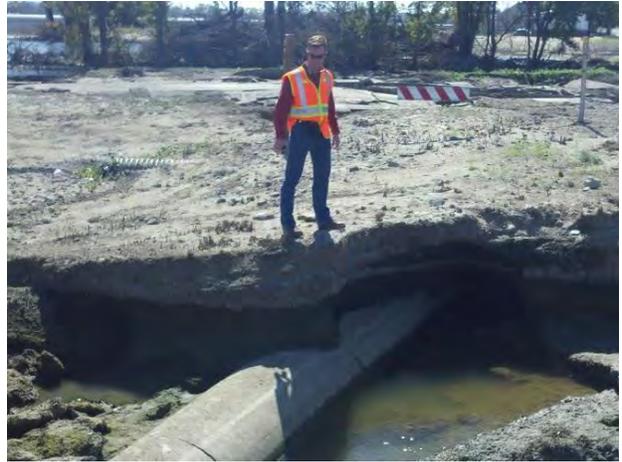
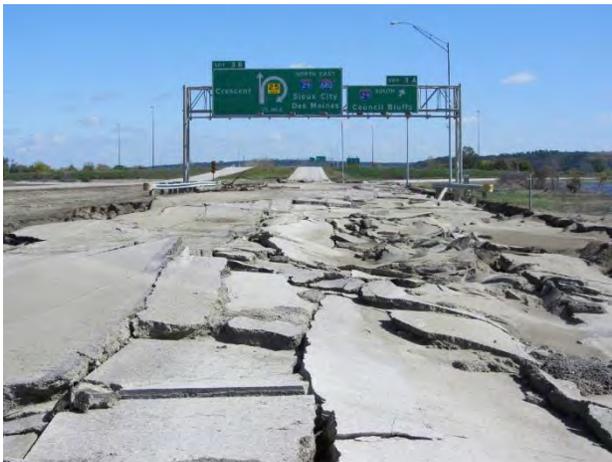
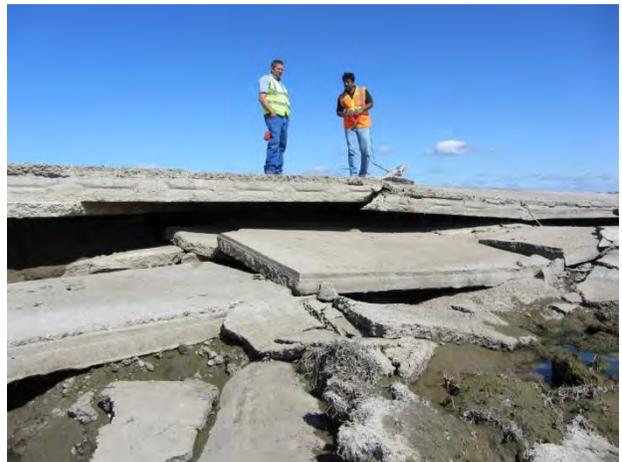
Figure 27. Pictures taken near I-29 and I-680 intersection north of Council Bluffs on 9/21/2013

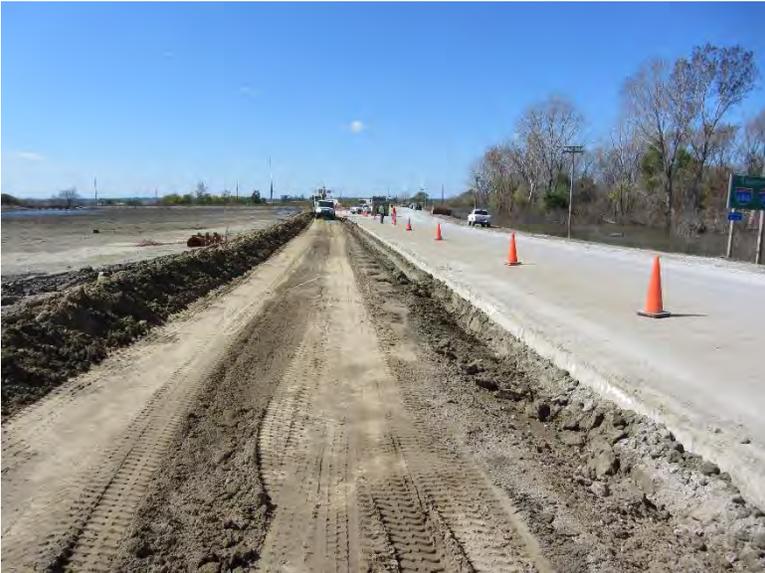
Figure 40. Delaminated HMA overlay over PCC pavement and eroded shoulders refilled with crushed limestone – Old Mormon Road (looking east), Pottawatamie County (Photos taken on 9/21/11)

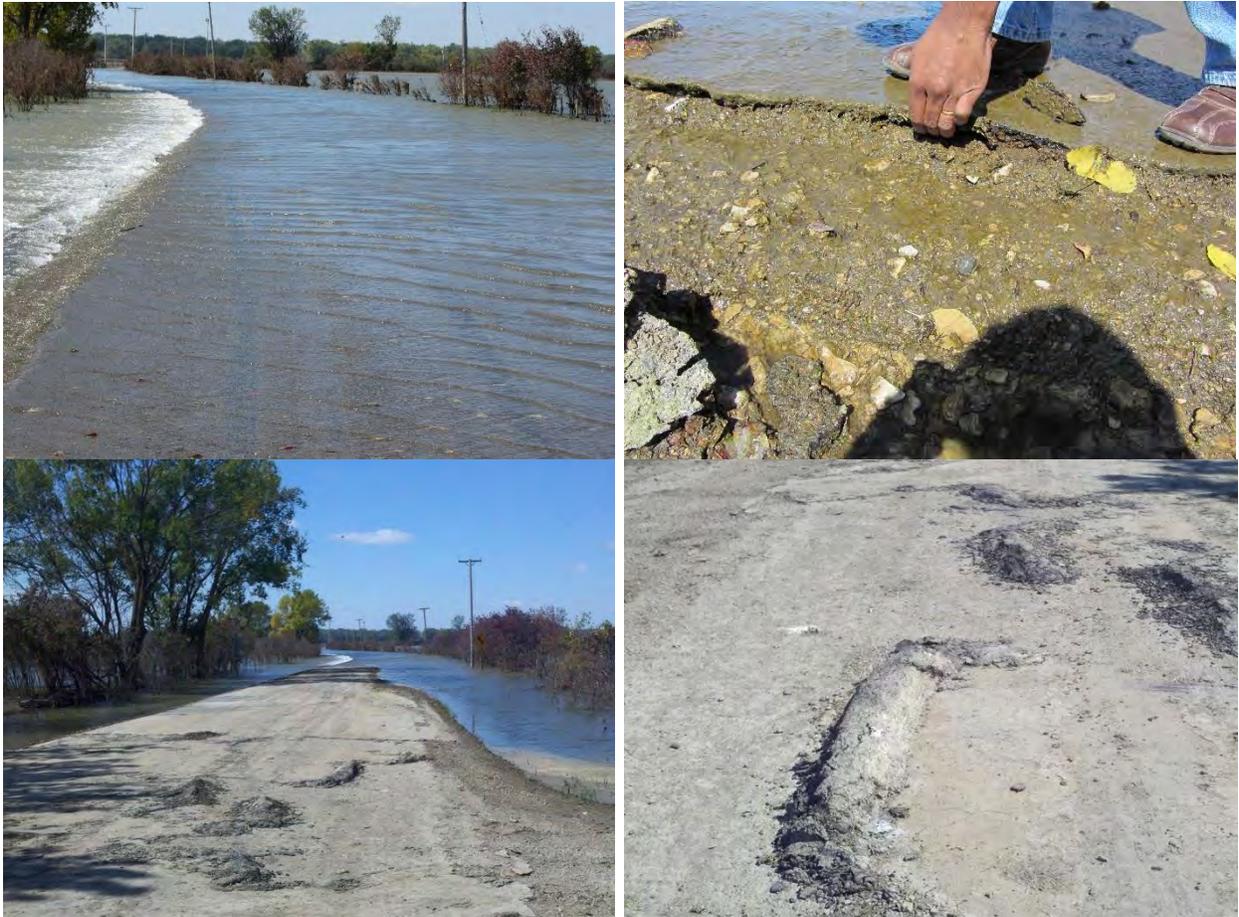
Figure 41. Eroded shoulder next to PCC pavement being reconstructed on 9/21/11 – Old Mormon Road (looking west towards I-680 and I-29 intersection), Pottawatamie County (Photos taken on 9/21/11)

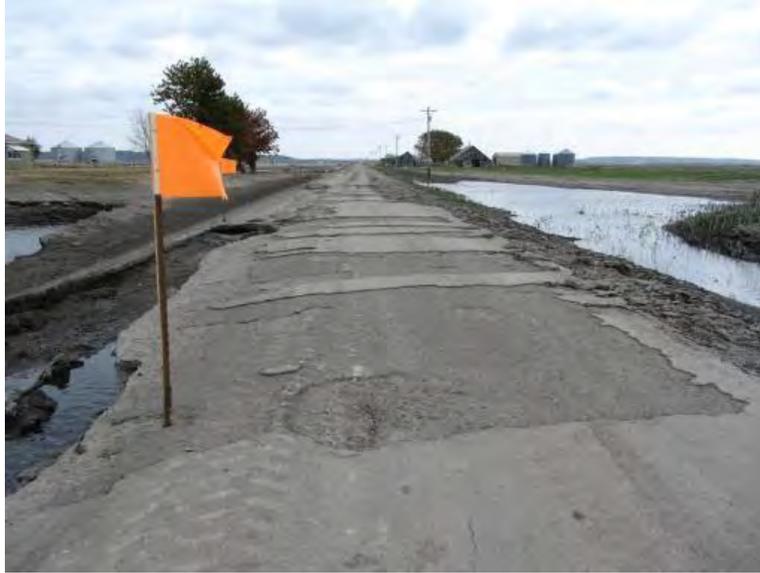
Figure 49. Erosion of shoulder and roadbed on a chip seal surfaced gravel road – Fremont County (Photo taken on 10/26/11)

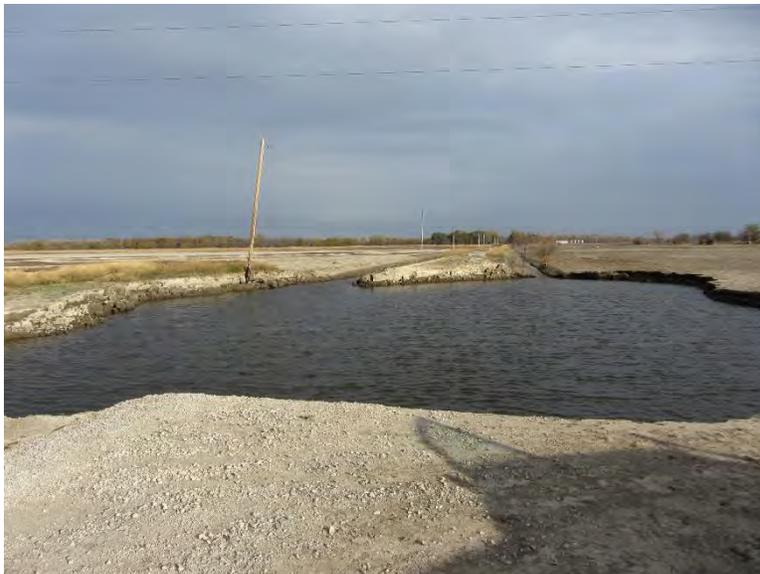
Figure 50. Delaminated or stripped chipseal surfacing – Fremont County (Photo taken on 10/26/11)

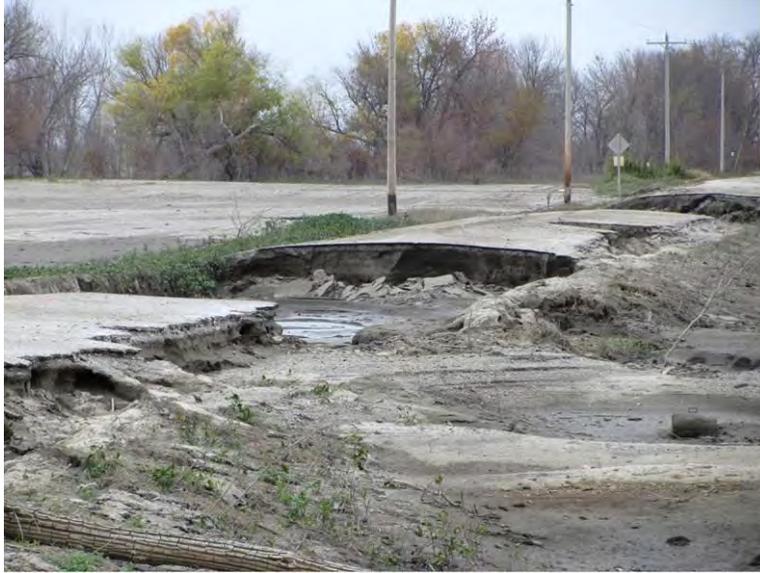
Figure 51. Full breach of a gravel road (about 100 m (330 ft) long) – Fremont County (Photo taken on 10/26/11)

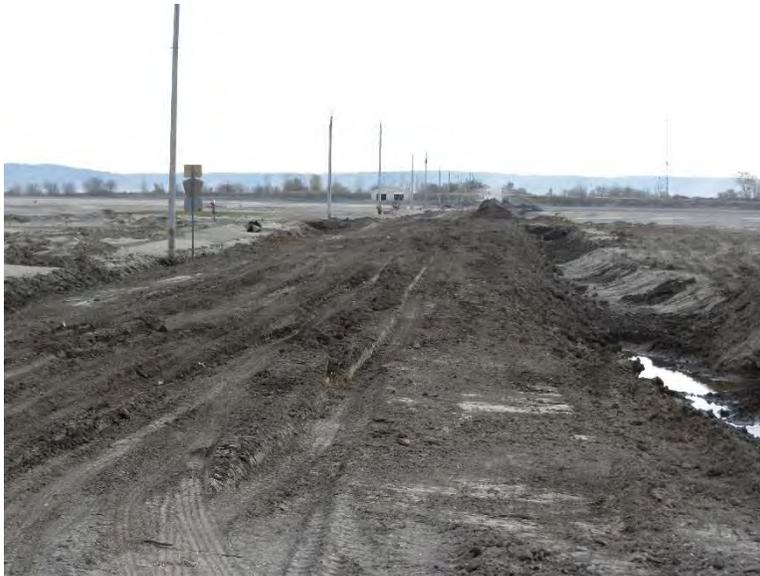
Figure 52. Gravel road segments washed away during floods – Fremont County (Photo taken on 10/26/11)

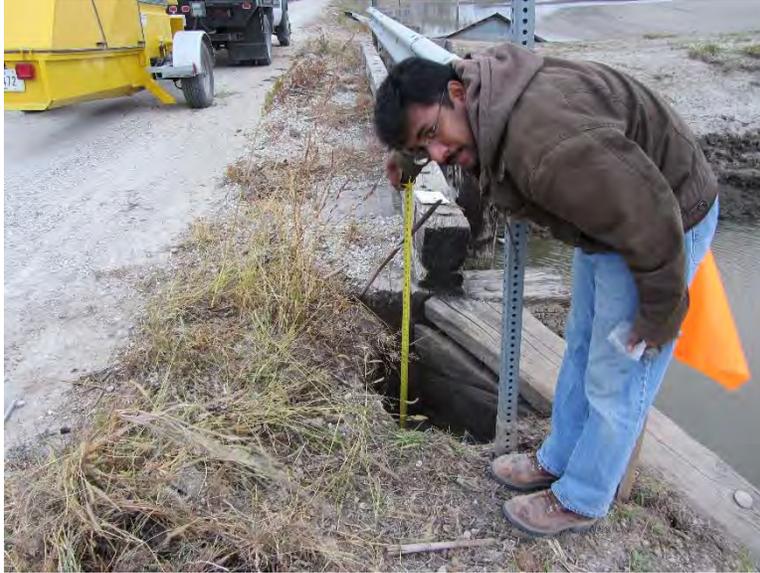
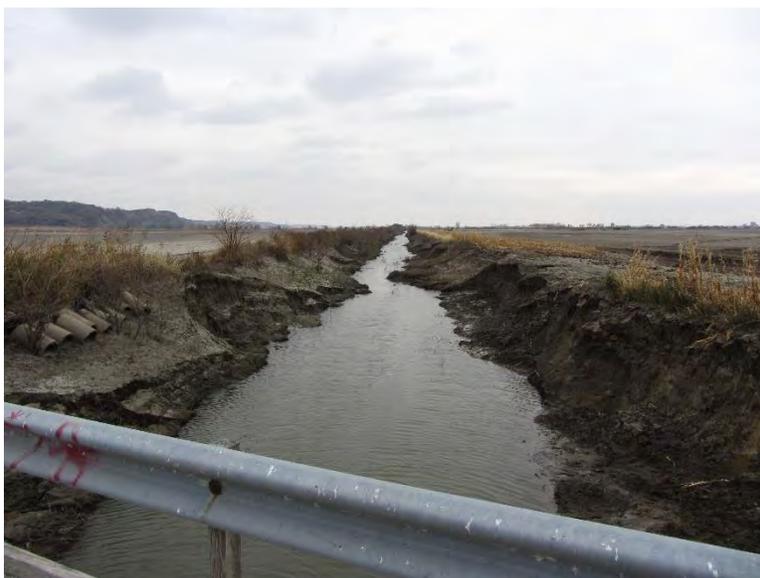
Figure 53. Reconstruction of a gravel road washed away during floods and deposited with silt and sand– Fremont County (Photo taken on 10/26/11)

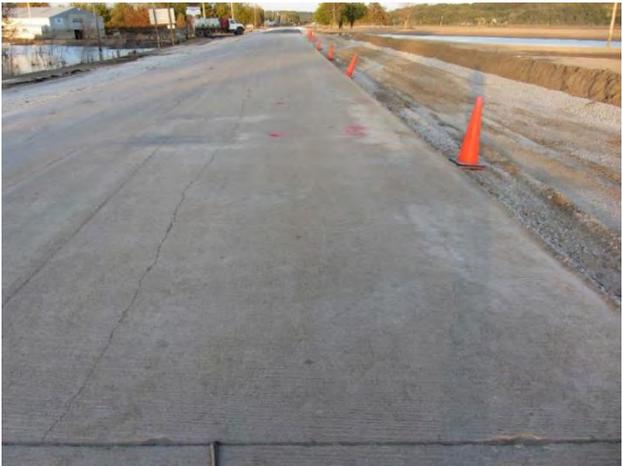
During the 2011 flood event, the test segment was fully submerged for about two months (Figure 62). Reportedly, the flood waters receded in the area on 9/1/11. The TS reportedly experienced heavy water currents as the water levels fluctuated during the flood event. The granular shoulders were completely eroded, a portion of the pavement was washed away, and subbase layer under the pavement was eroded in a portion of the TS (Figure 63). The section where the pavement was washed away was replaced with a new 230 mm (9 in.) thick PCC pavement placed directly over the subgrade. Flowable cement grout was used to fill the voids formed due to subbase layer erosion. Pictures taken two days after cement grout was placed are shown in Figure 63. The grout was very soft and did not setup even two days after placement. Field engineers indicated that there could have been water beneath pavement during grouting. Longitudinal cracks were observed on a few panels where the subbase layer was eroded (Figure 64).

Figure 64. Longitudinal cracks on PCC pavement with undermined base material on TS2 (Photo taken on 9/21/11) – Pottawattamie County

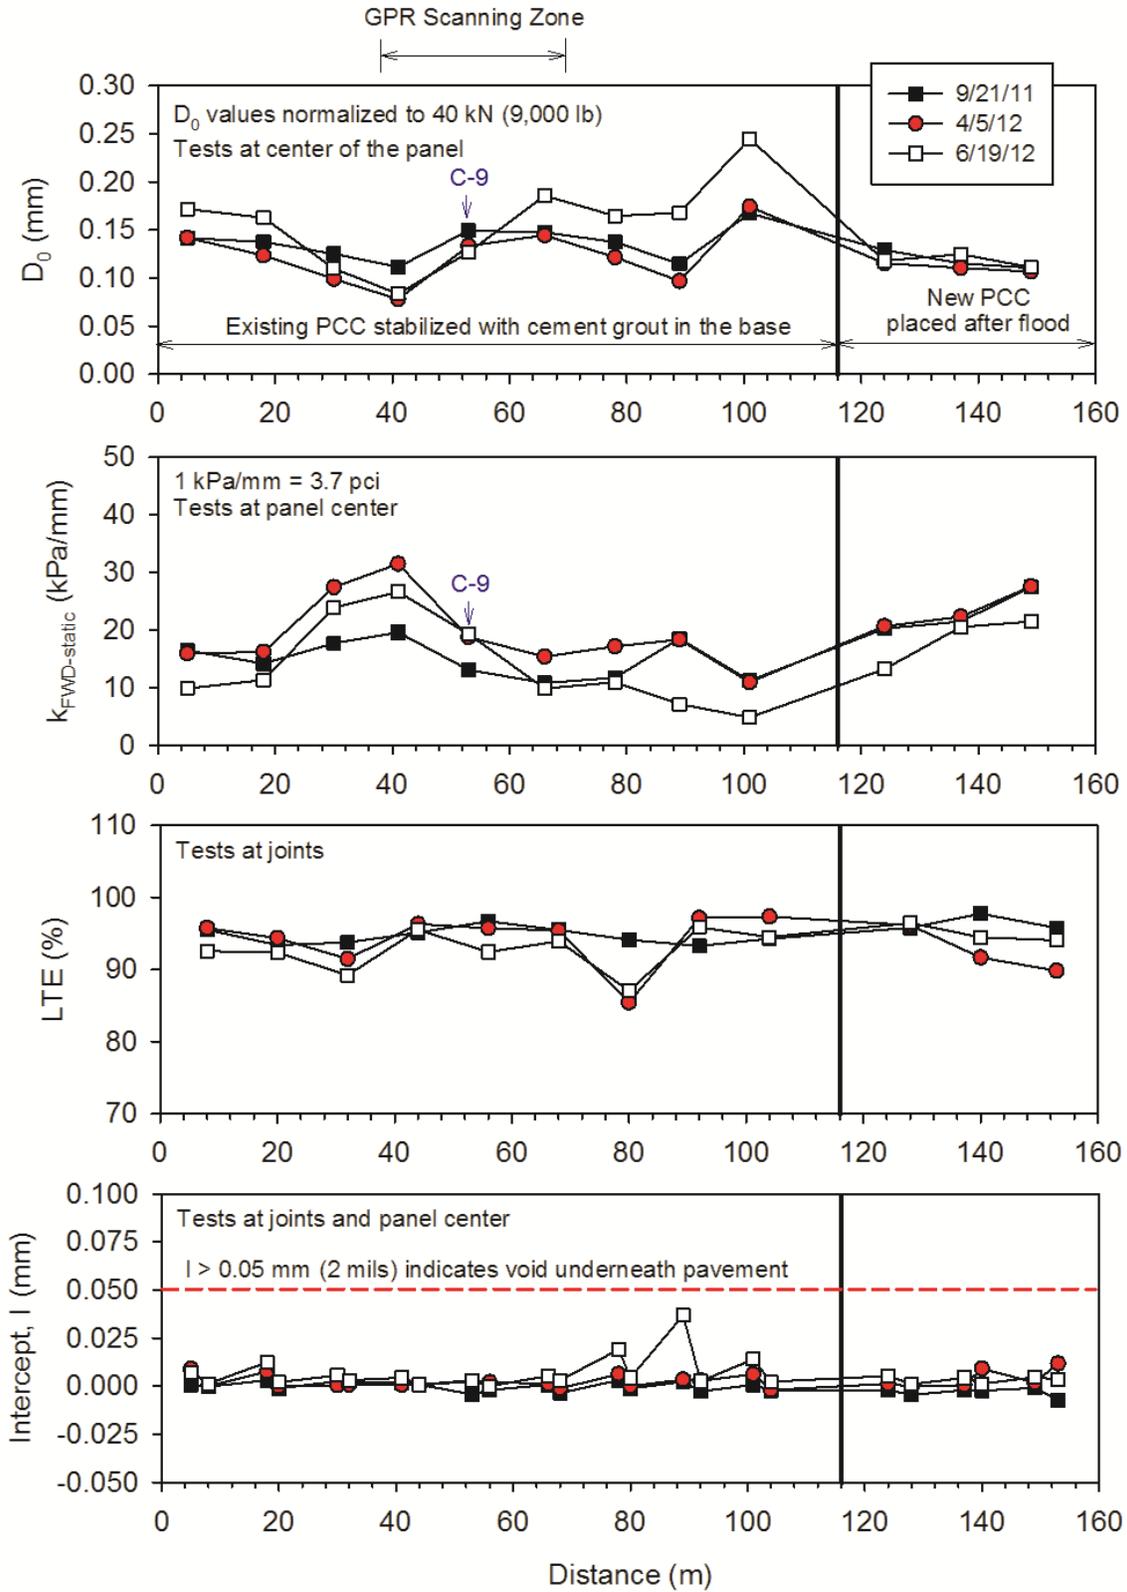
FWD test results from three different testing times along the TS are shown in Figure 65. DCP-CBR profiles at the two test locations from two different testing times are shown in Figure 66. Some key findings from these in situ testing are as follows:

Figure 65. FWD results from three different testing times after flooding on TS2 – Pottawattamie County

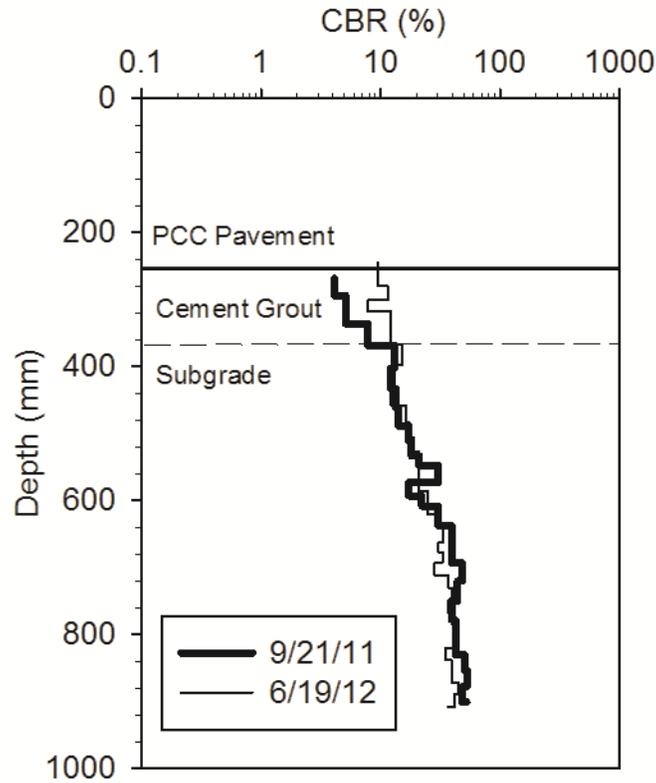
Figure 66. DCP-CBR profiles at one test locations at two different times after flooding on TS2 – Pottawattamie County

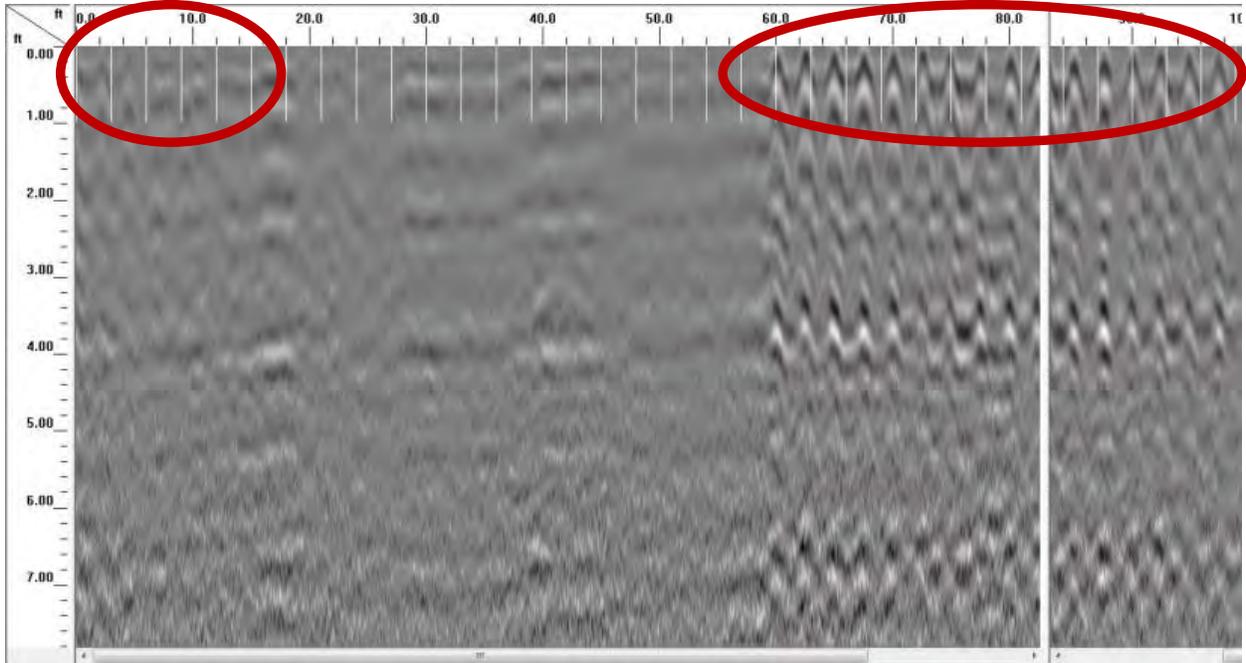
Figure 68. GPR scan using 400 MHz antenna along the north side of the east bound lane on TS2 (note 0 ft on the figure represents the 38 m station and the 100 ft on the figure represents the 68 m station of the TS) – areas circled in red denote rebars in pavement – Pottawattamie County

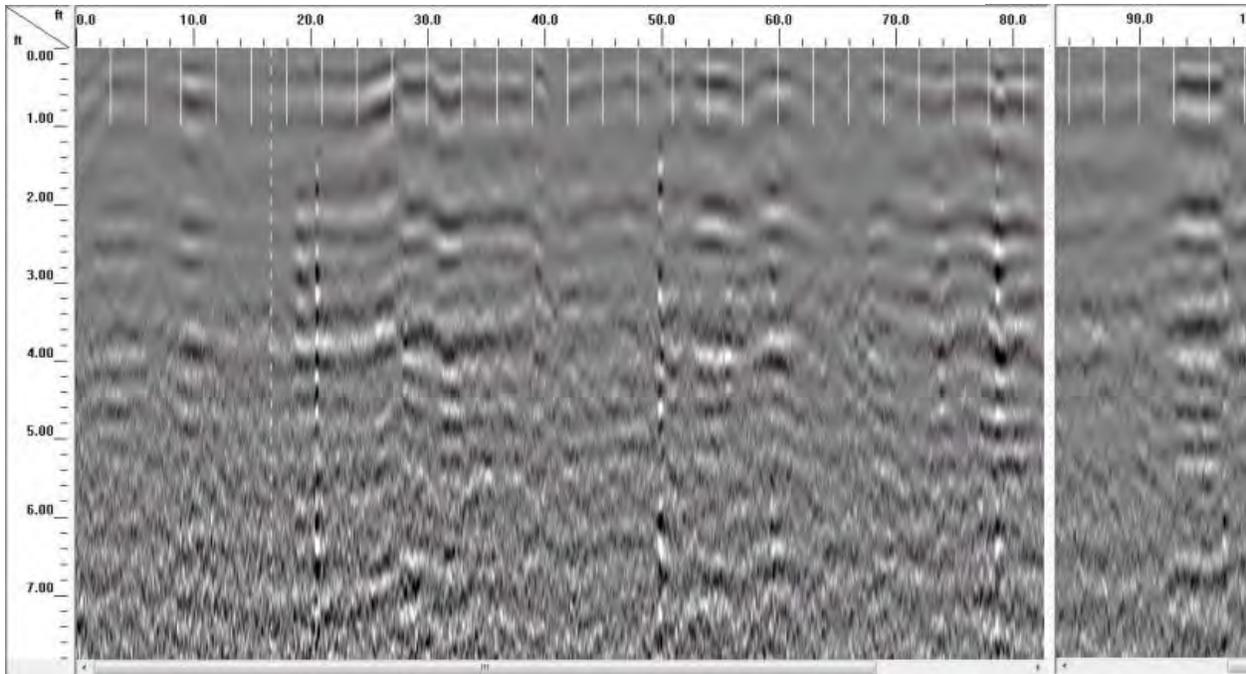
Figure 69. GPR scan using 400 MHz antenna along the middle of the east bound lane on TS2 (note 0 ft on the figure represents the 38 m station and the 100 ft on the figure represents the 68 m station of the TS) – Pottawattamie County

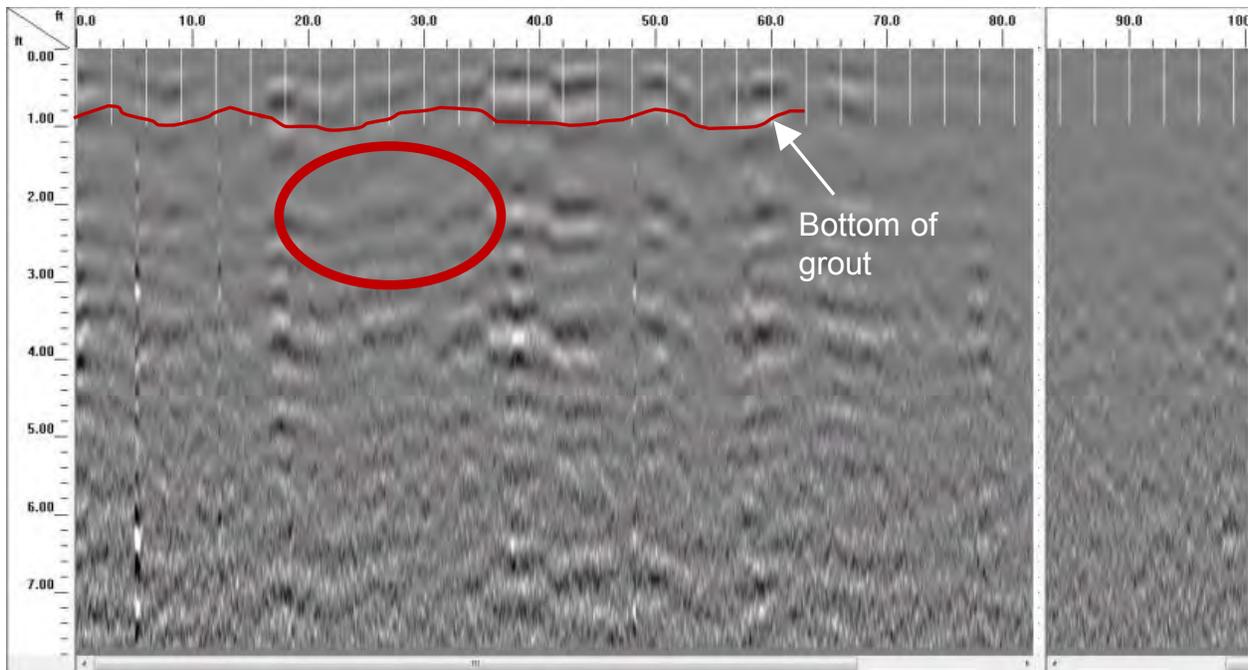
Figure 70. GPR scan using 400 MHz antenna along the south side of the east bound lane on TS2 (note 0 ft on the figure represents the 38 m station and the 100 ft on the figure represents the 68 m station of the TS) – area circled in red denote a potential void zone beneath pavement – Pottawattamie County

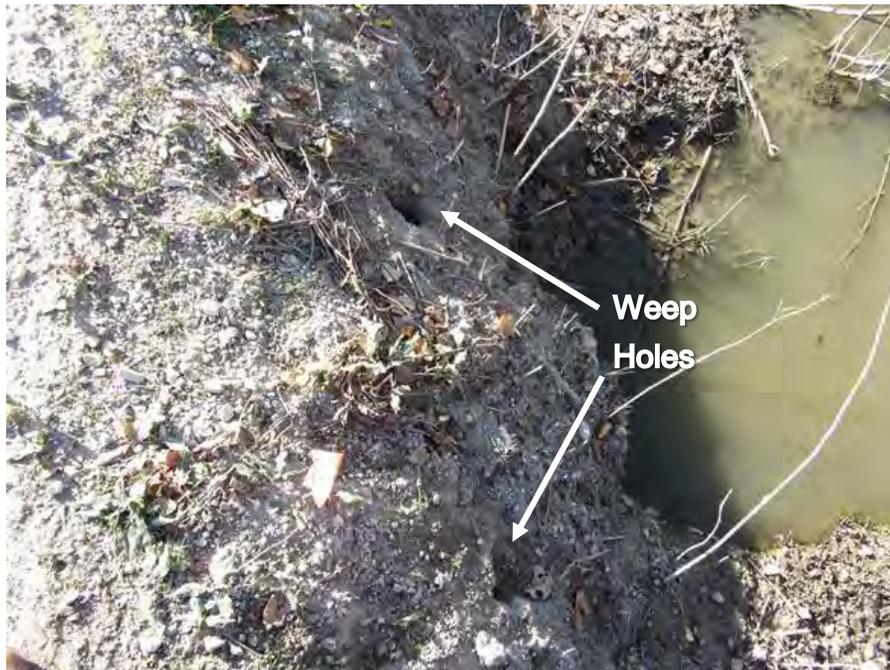
- Ground water level was located at about 1.27 m below surface under the roadway, while the water level in the ditches was about 0.15 m below the gravel surface during 9/22/11 testing (about 21 days after flooding). Moisture contents varied from about 18 to 22% above the water table. During field visit on 10/25/11, some subsurface weep holes were observed around the culvert (Figure 73), indicating erosion of material around the culvert.

Figure 73. Weep holes near culvert on TS3 (Photo taken on 10/25/2011) – Pottawattamie County

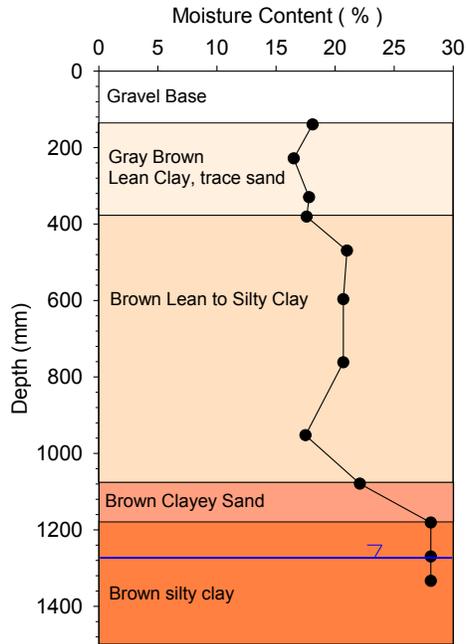
Figure 74. Soil moisture content profile with depth to water table at G-14 on 9/22/11 – Pottawattamie County

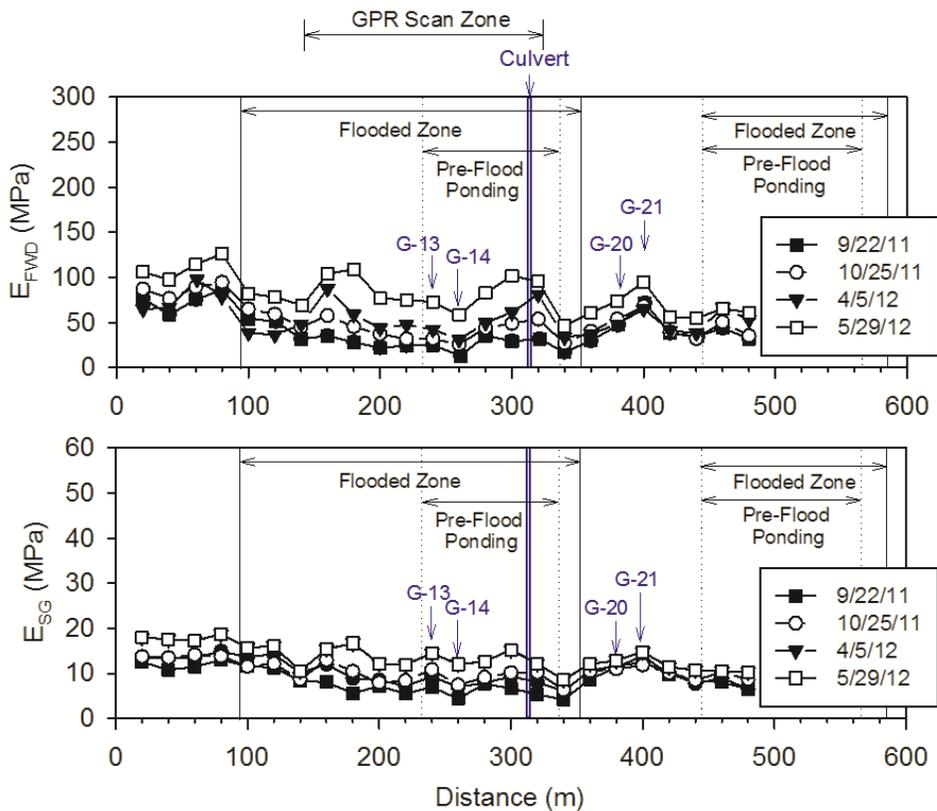
- The DCP and FWD test results on this test segment illustrate that both subgrade and the surface gravel layers gained strength with time, likely because of subgrade material drying over time.

Figure 75. Surface FWD modulus and subgrade modulus at four different times after flooding on TS3 – Pottawattamie County

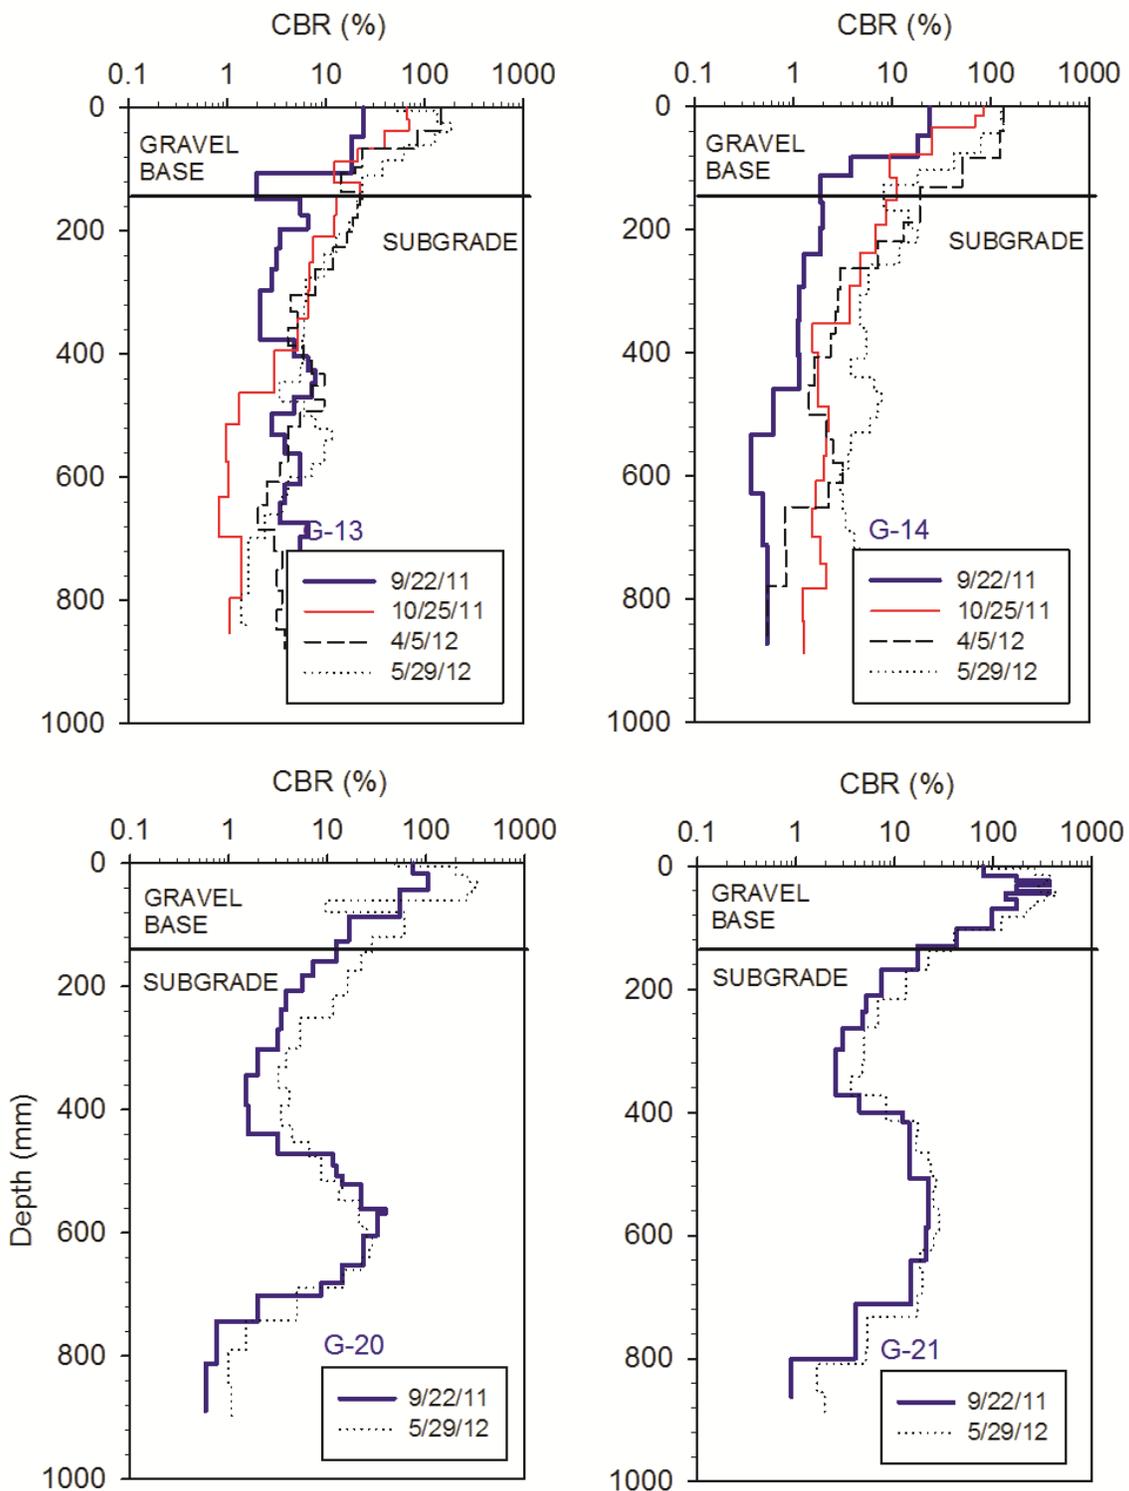
- The subgrade CBR values (averaged over the top 300 mm) in the flooded zone increased (from 1.7 to 6.4 and 4.0 to 8.5 at the two locations) from 21 to 54 days after flooding. At 21 days after flooding, subgrade CBR values in the non-flooded zone were higher (4.5 and 8.2) than the values in flooded zone (1.7 and 4.0), but they were about the same (10 to 12) at 8 months after flooding.

Figure 76. DCP-CBR profiles at four test locations from four different testing times on TS3 – Pottawattamie County

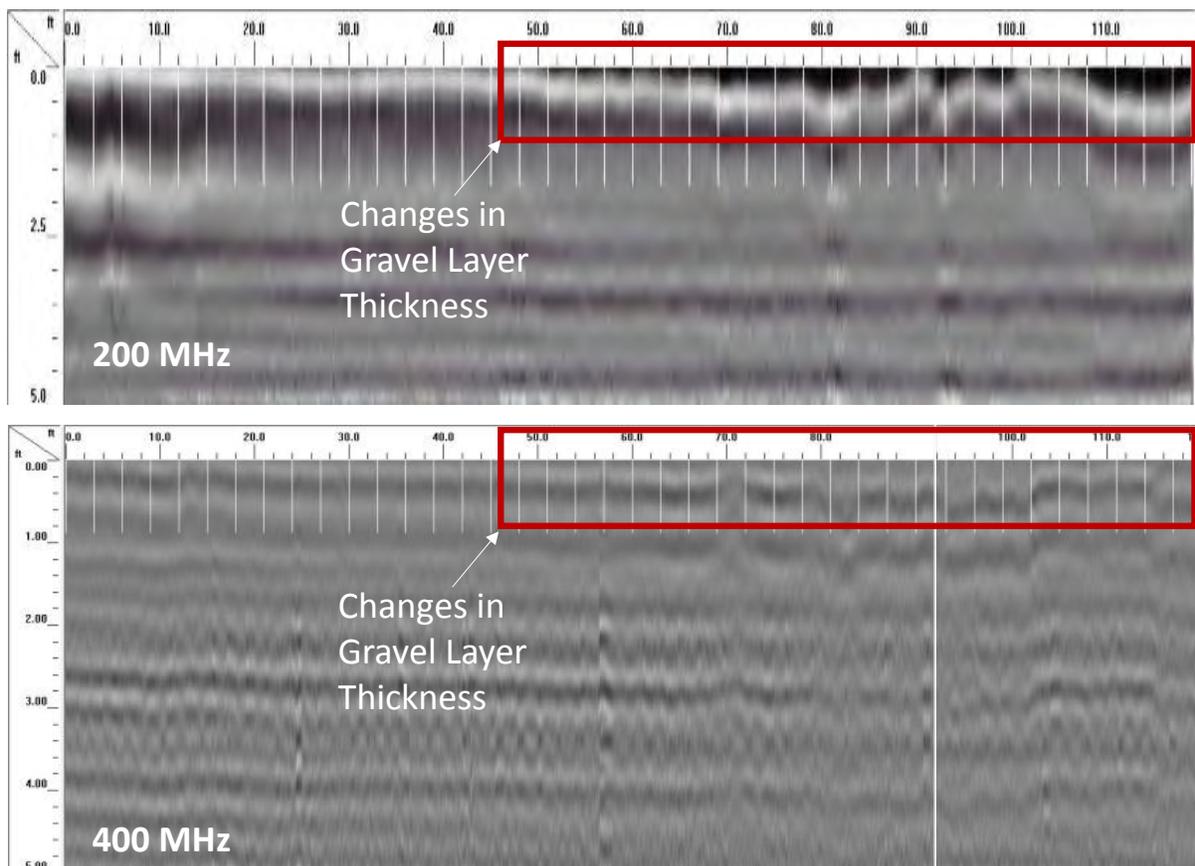
- Changes in gravel layer thickness along the roadway were identified in both 200 MHz and 400 MHz antenna scans (Figure 68). Note that the depths on the vertical scale were not calibrated with the actual depth measurements and they must be considered approximate. However, if calibrated (i.e., if verified with a known feature at known depth in situ), gravel layer thickness can be obtained accurately.

Figure 79. GPR scans using 200 and 400 MHz antennas on TS3 (note 0 ft on the figure represents the 130 m station of the TS) – Pottawattamie County

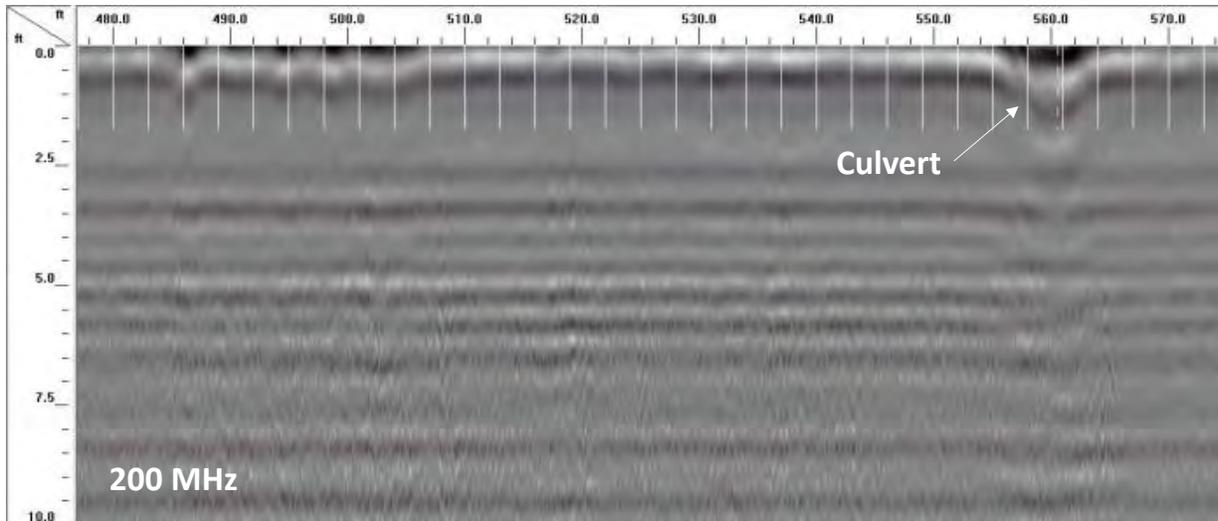
- Culvert location was identified in the scans as shown in Figure 80.
- No weep holes were noted in the scans. Although they were visible near the culvert during 10/25/11 field visit, they were not seen at the time of scanning on 6/19/12.

Figure 80. GPR scan using 200 MHz antenna on TS3 (note that 560 ft on the figure represents the 310 m station (at culvert) of the TS) – Pottawattamie County

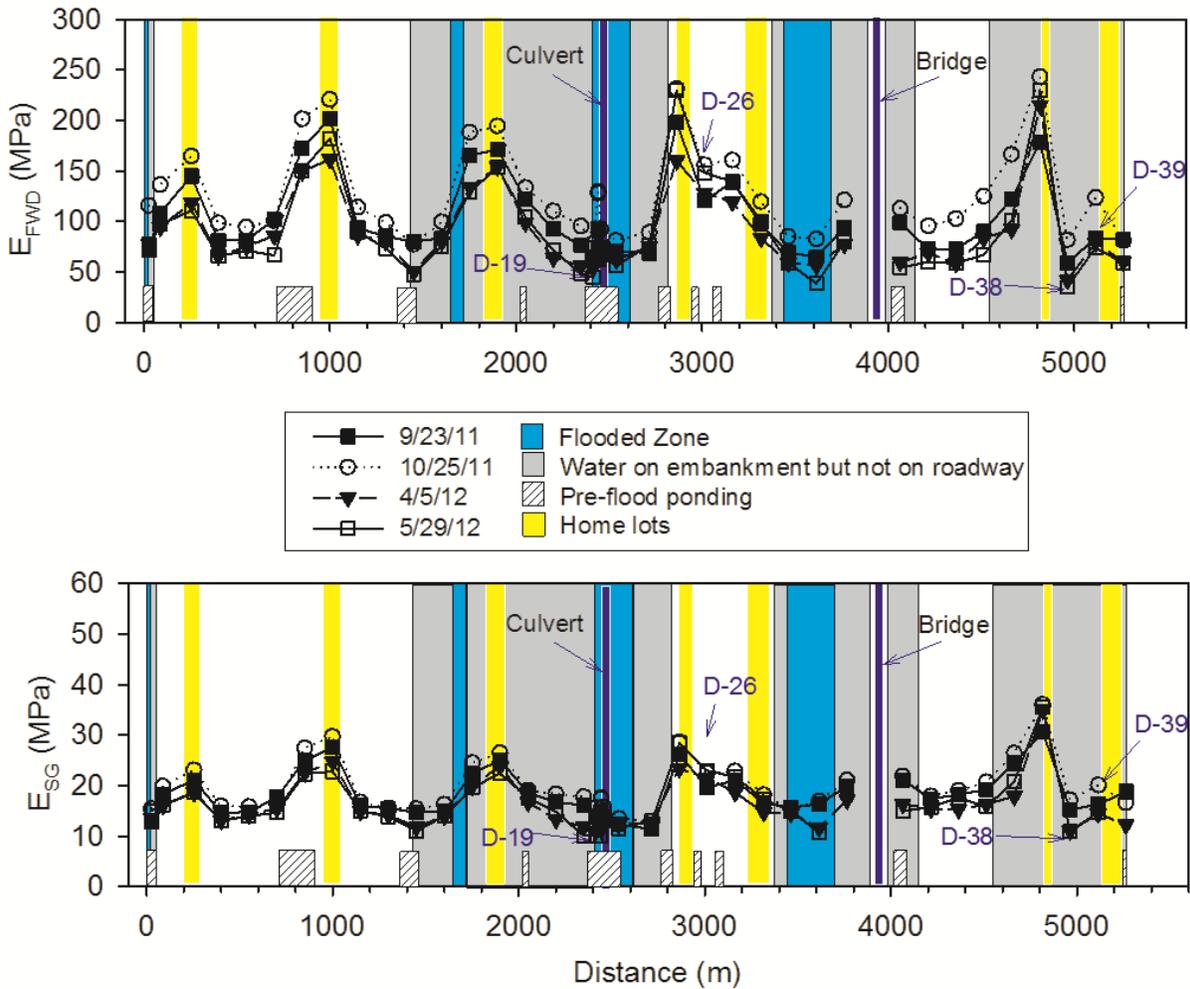
- The DCP and FWD test results on this TS illustrate that flooded areas were comparatively softer than the non-flooded areas and remained the same even at 8 months after flooding.

Figure 83. Surface FWD modulus and subgrade modulus at four different times after flooding on TS4 (highlighted in color are drainage, flooding, and home lot features observed from aerial maps) – Pottawattamie County

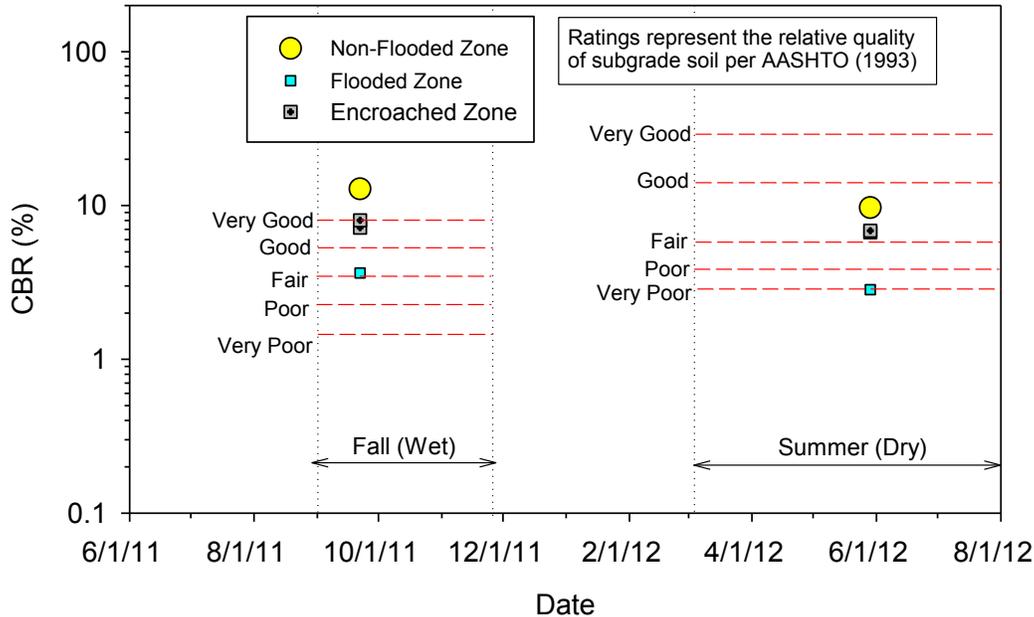
- The CBR of the stabilized gravel layer was about the same in flooded and non-flooded zones (>50), but the CBR of the subgrade layer (in the top 300 mm) was not. At 22 days after flooding, the subgrade CBR was about 3.7 in the flooded zone, 7.7 in the encroached zone, and about 14 in the non-flooded zone. This trend remained the same but the values decreased slightly during testing at 8 months after flooding (see Figure 86).

Figure 86. Comparison of subgrade CBR values in flooded and non-flooded zones with relative quality ratings on TS4 – Pottawattamie County

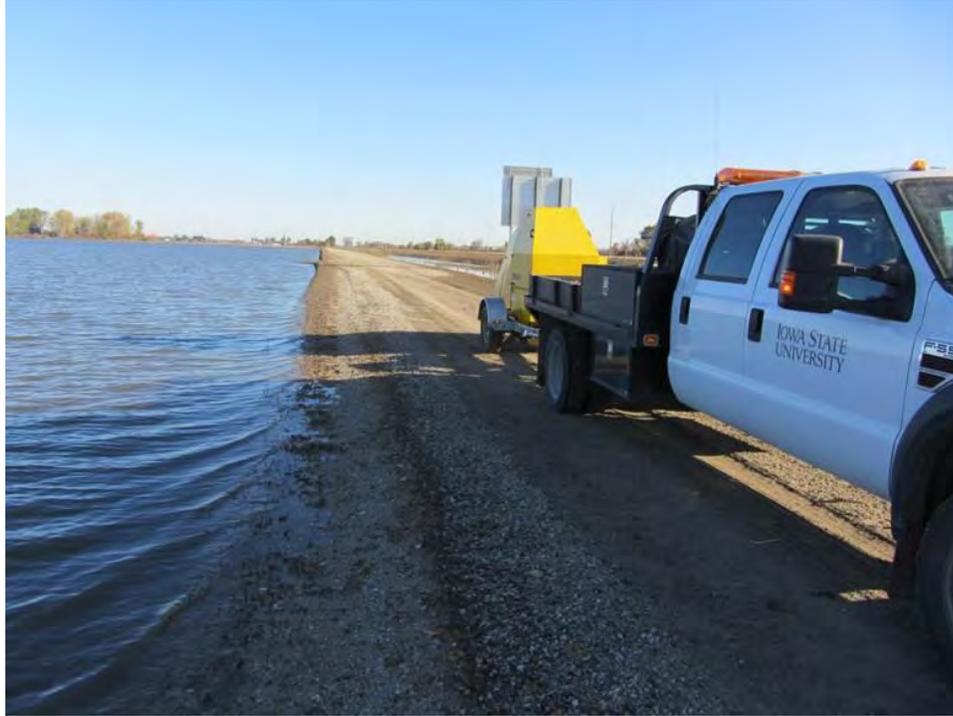
Figure 90. FWD testing on TS5 with floodwater up to the edge of the road (Photo taken 9/23/11) – Pottawattamie County
