Western Iowa Missouri River Flooding— Geo-Infrastructure Damage Assessment, Repair, and Mitigation Strategies

SEPTEMBER 2013

Final Report

Federal Highway Administration
Iowa Highway Research Board
(IHRB Project TR-638)
Iowa Department of Transportation
(InTrans Project 11-419)

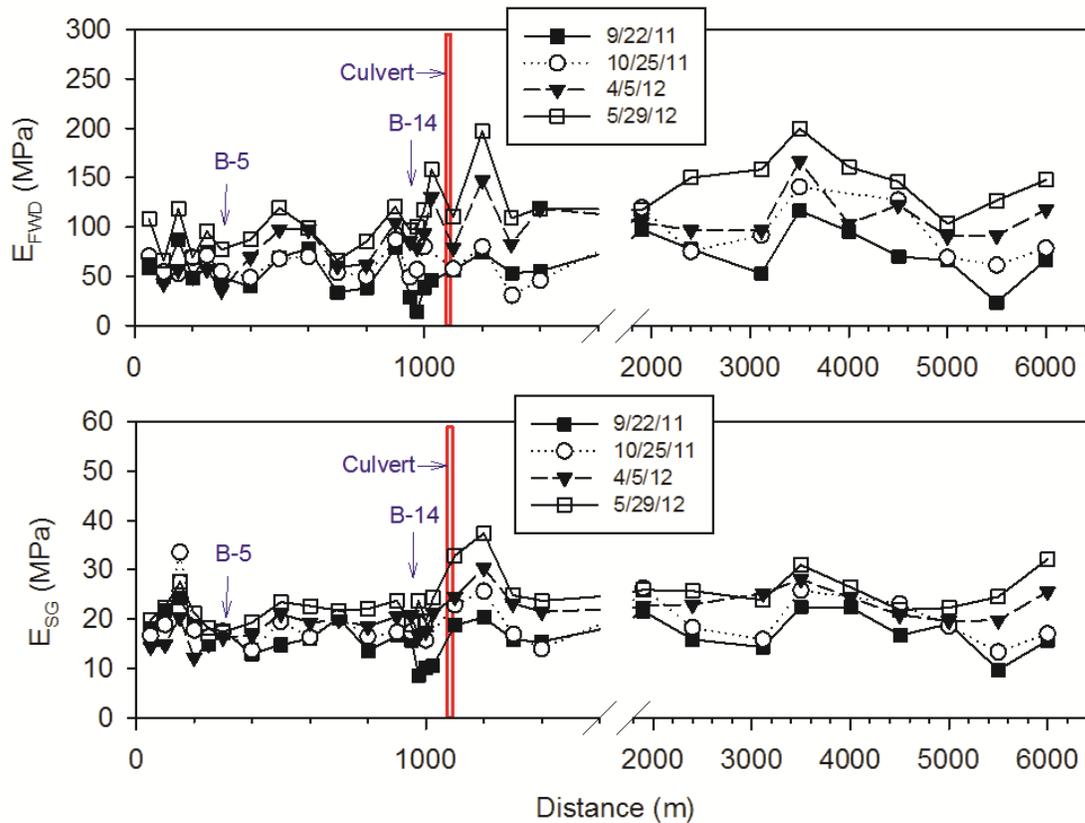
Figure 93. Surface FWD modulus and subgrade modulus at four different times after flooding on TS5 – Pottawattamie County

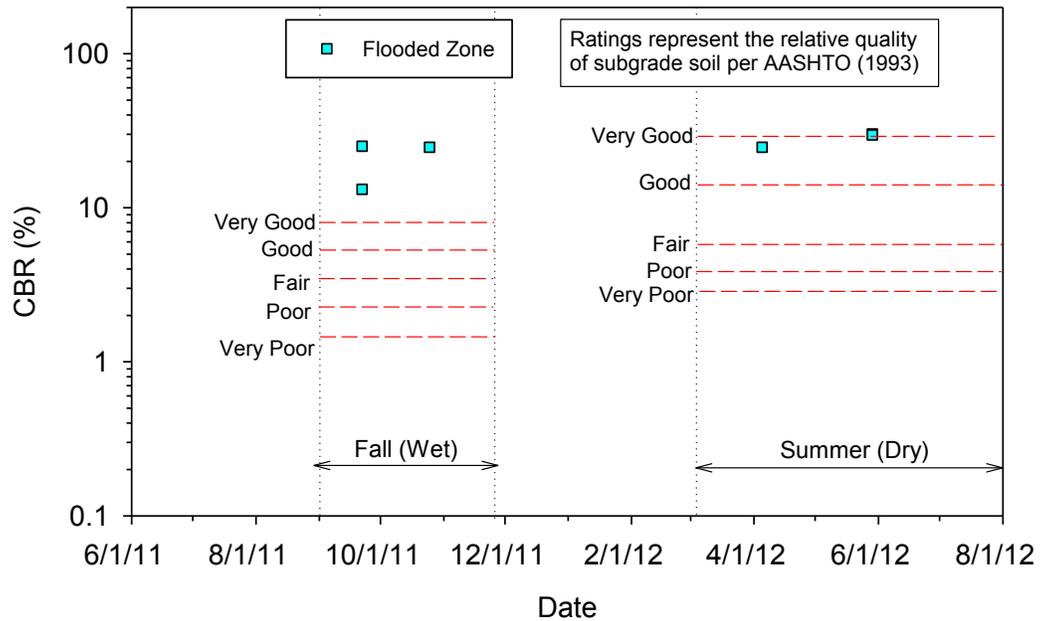
- Ground water level was located at about 0.58 m below surface under the roadway, while the water level in the ditches was close to the gravel surface during 9/23/11 testing (about 21 days after flooding). Moisture contents varied from about 12 to 18% above the water table and the material consisted of clayey to fine sand material.
- On average, the E_{SG} values in the whole TS were low and the quality is rated as “very poor” to “poor,” per AASHTO (1993). The E_{SG} values improved slightly over time (on average from about 17 to 23 MPa), likely because of subgrade material drying.
- Although limited, DCP-CBR results were in contrast with the E_{SG} values. Subgrade CBR values at two locations were > 10 on 9/23/11, which is rated as “very good,” per AASHTO (1993). Results increased over time to about 30 on 5/29/12 (Figure 96).

Figure 96. Subgrade CBR values at different testing times with relative quality ratings on TS5 – Pottawattamie County

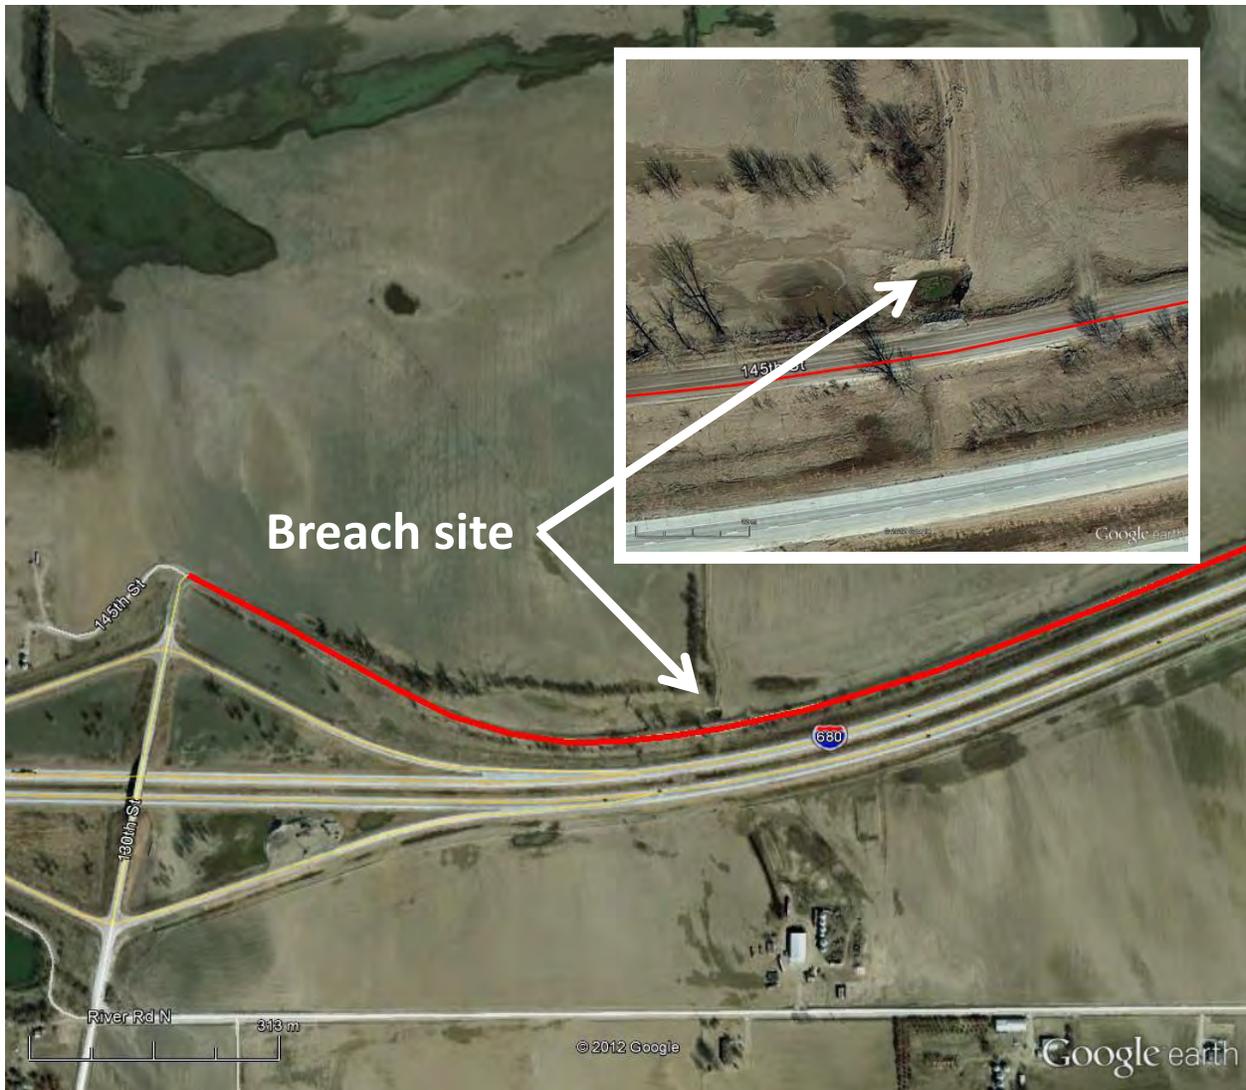
Figure 97. Aerial imagery of the breach site located next to TS5 145th St. (Google image from 3/7/12) – Pottawattamie County

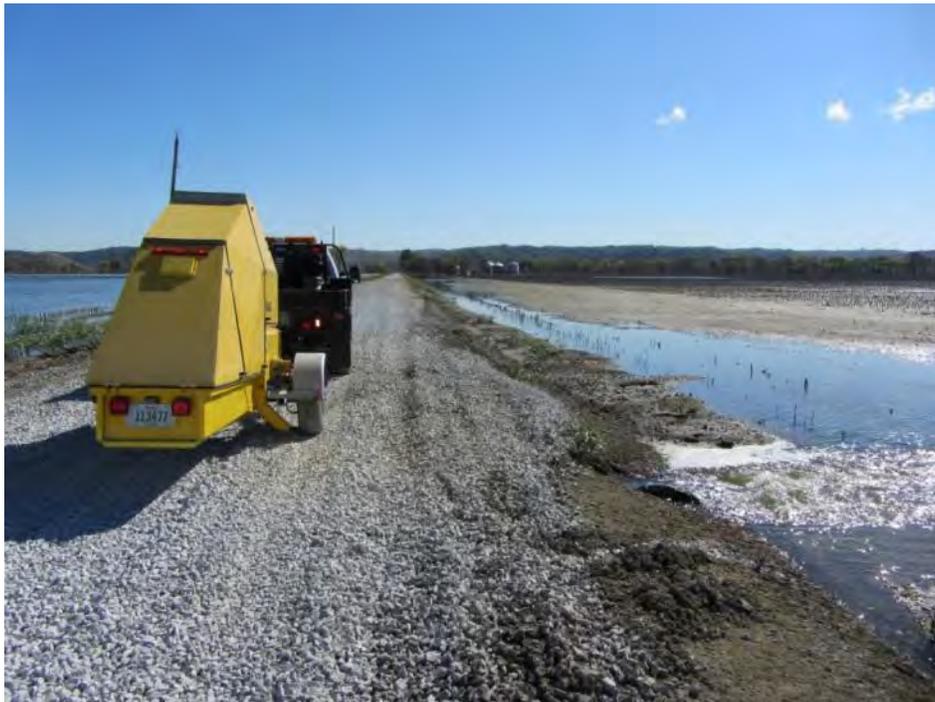
- The FWD test results showed soft conditions ($E_{SG} \leq 10$ MPa) in areas close to culverts, where the gravel was washed away and new gravel was placed, at all times of testing.

- DCP-CBR results also indicated “very poor” subgrade conditions (with $CBR < 2$ within the top 200 mm of subgrade) at 23 days after flooding, at a test location that showed the lowest E_{SG} value (9 MPa). The test area was located near a culvert, where gravel was washed away and new gravel was placed. The subgrade CBR values improved to “fair” to “good” conditions (with $CBR = 6.0$ and 8.8) at 6 and 8 months after testing (Figure 117).

Figure 111. Newly placed gravel showing rutting near culvert (Picture taken on 9/23/2011) – Pottawattamie County

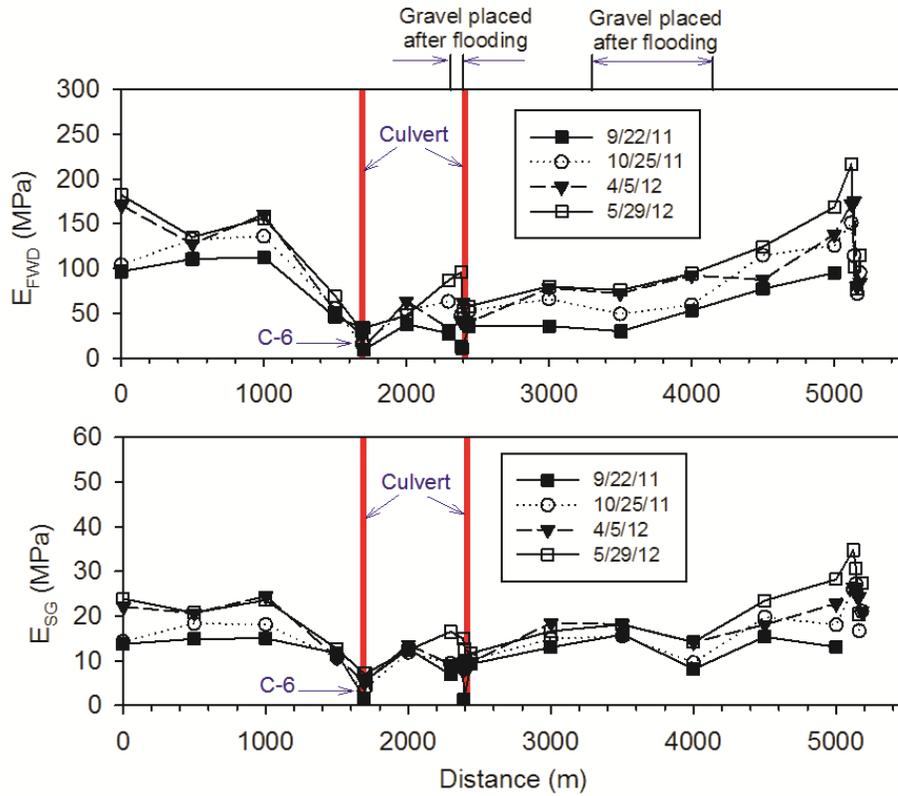
Figure 114. Surface FWD modulus and subgrade modulus at four different times after flooding on TS6 – Pottawattamie County

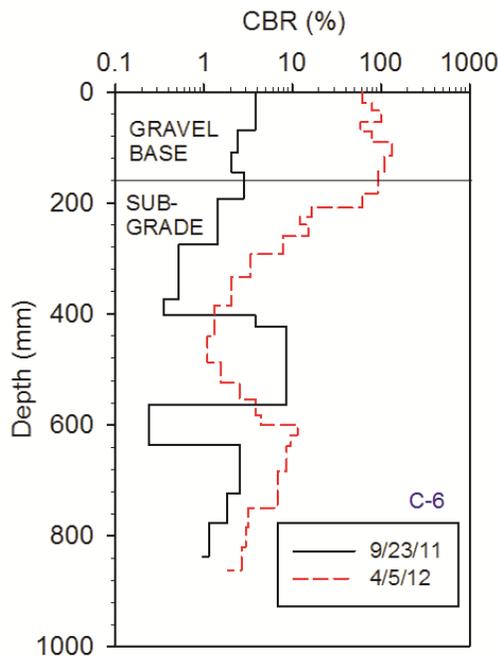
Figure 115. DCP-CBR profiles from two different testing times at C-6 test location on TS6 – Pottawattamie County

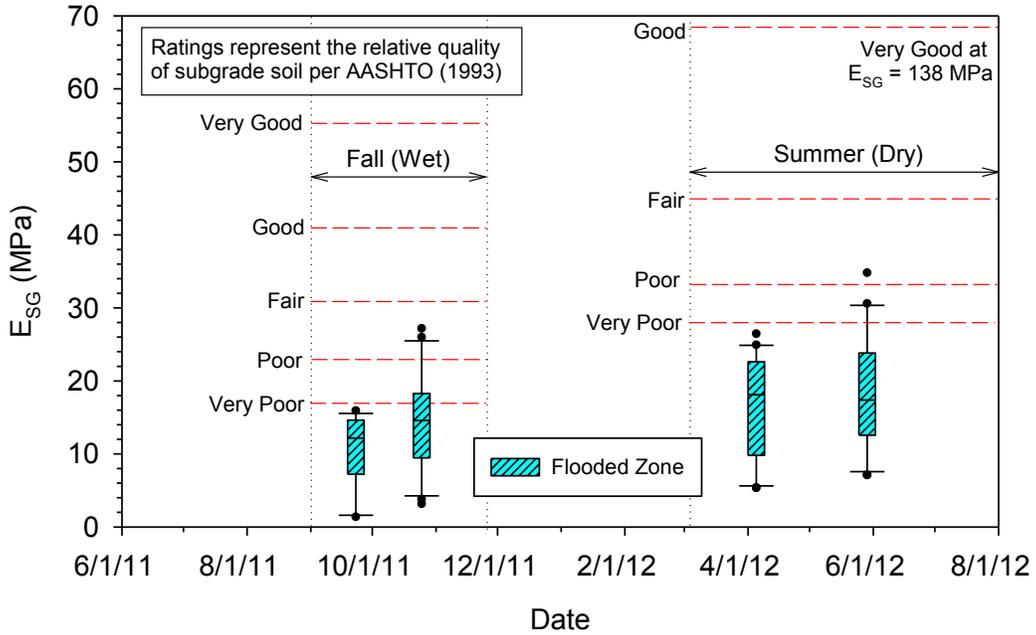
Figure 116. Box plots of subgrade modulus values in comparison with relative quality ratings on TS6 – Pottawattamie County

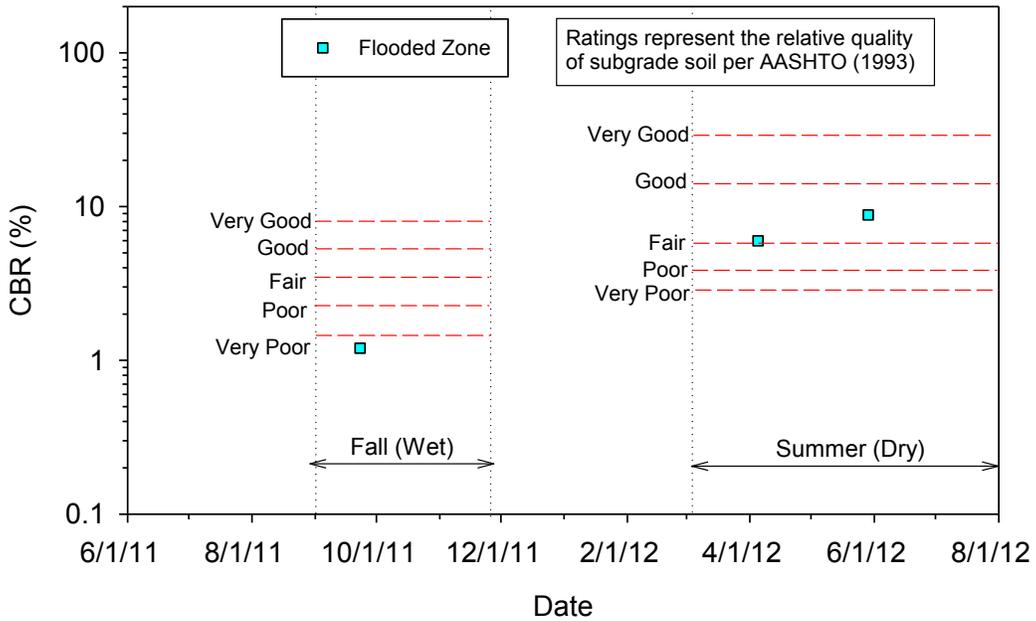
Figure 117. Subgrade CBR values at different testing times with relative quality ratings on TS6 – Pottawattamie County

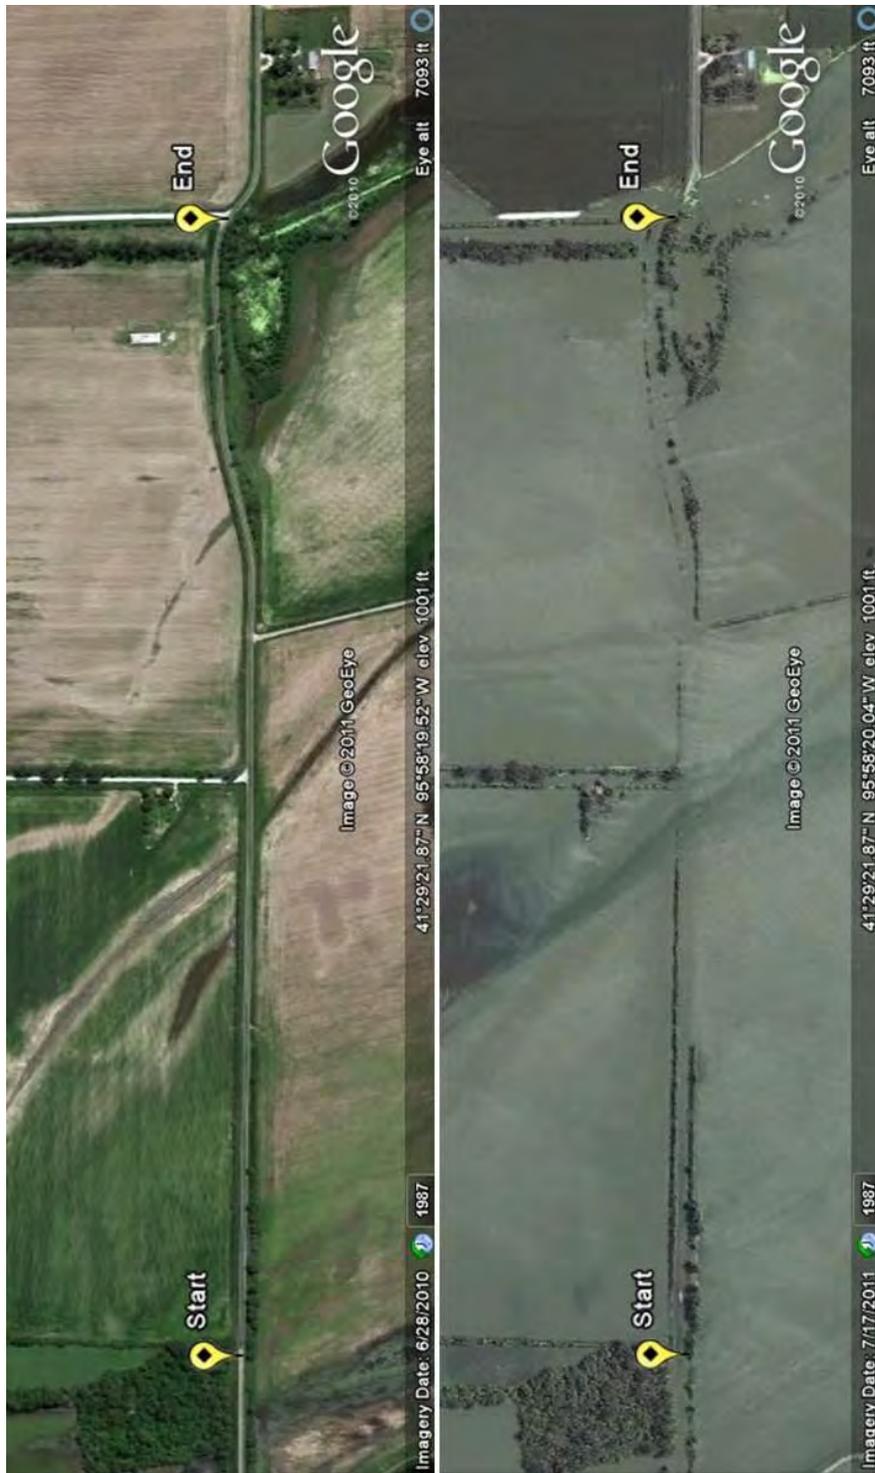
Figure 118. Aerial imagery before flooding (from 6/28/10) and during flooding (from 7/17/11) on TS7 – Pottawattamie County

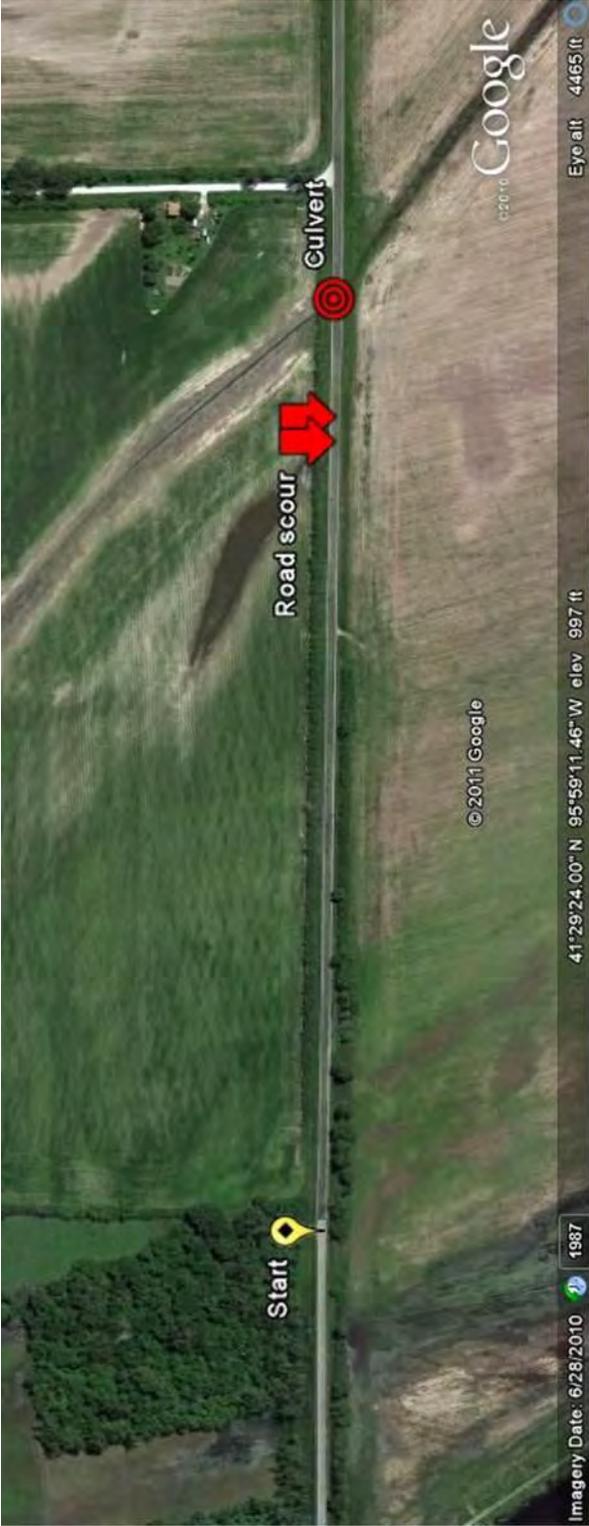
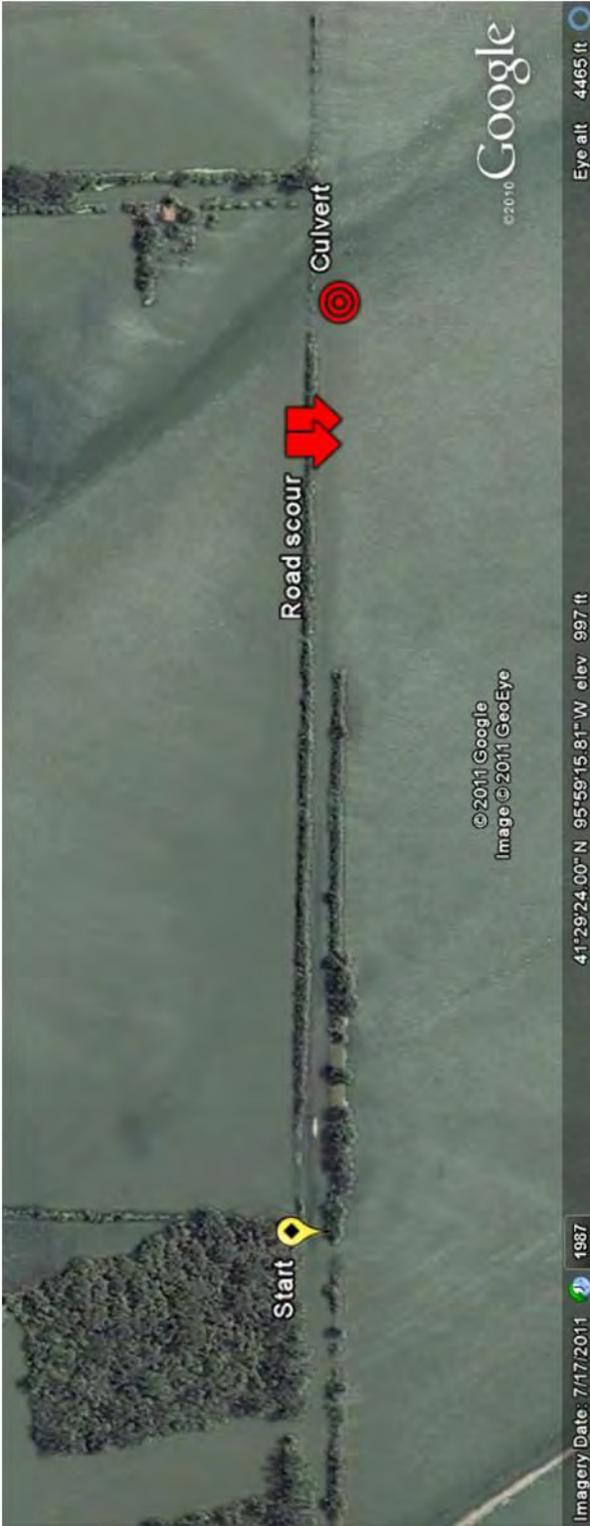
Figure 119. Aerial imagery before flooding (from 6/28/10) and during flooding (from 7/17/11) showing road scour and culvert locations on TS7 – Pottawattamie County

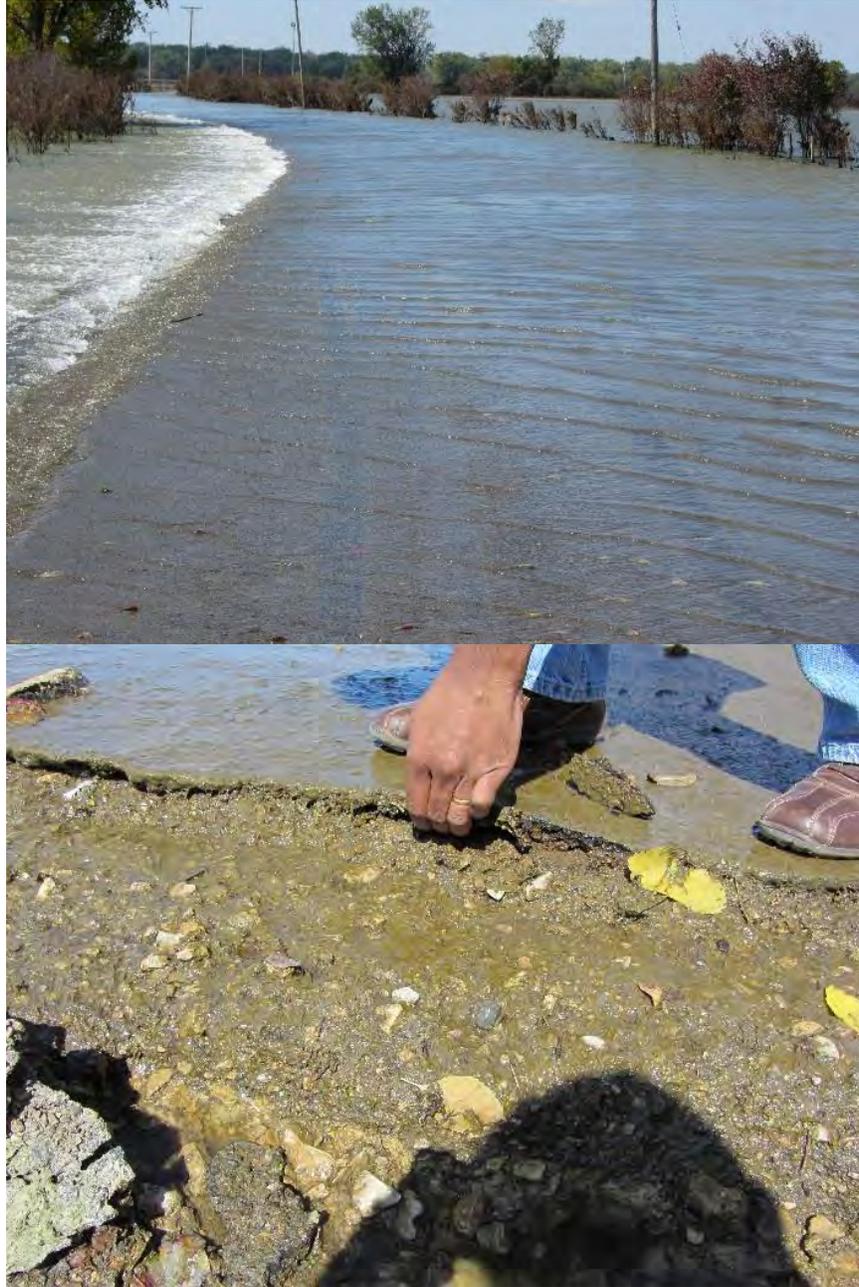
During the 2011 flood event, this TS was fully submerged under water for nearly one to three months (Figure 118 and Figure 119). The flood waters receded in a portion of this TS on 9/1/11, but in some areas flood waters overtopped the roadway till 9/31/11. During the flood event, chipseal coat was stripped off (delaminated) at a few locations and granular shoulder material was eroded at isolated locations (shown as road scour in Figure 119). Weep holes were observed around culverts along the TS. Photos taken during field testing are shown in Figure 120 and Figure 122.

Figure 120. Water overtopping Desoto Avenue on 9/21/11 and delamination of chipseal coat at the surface (Pictures taken on 9/21/11) – Pottawattamie County

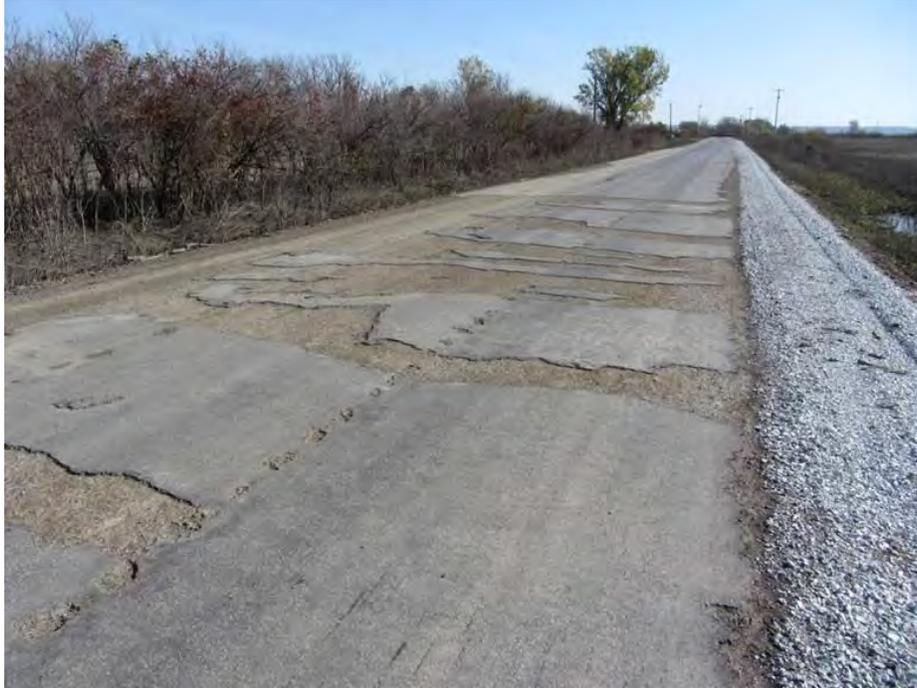
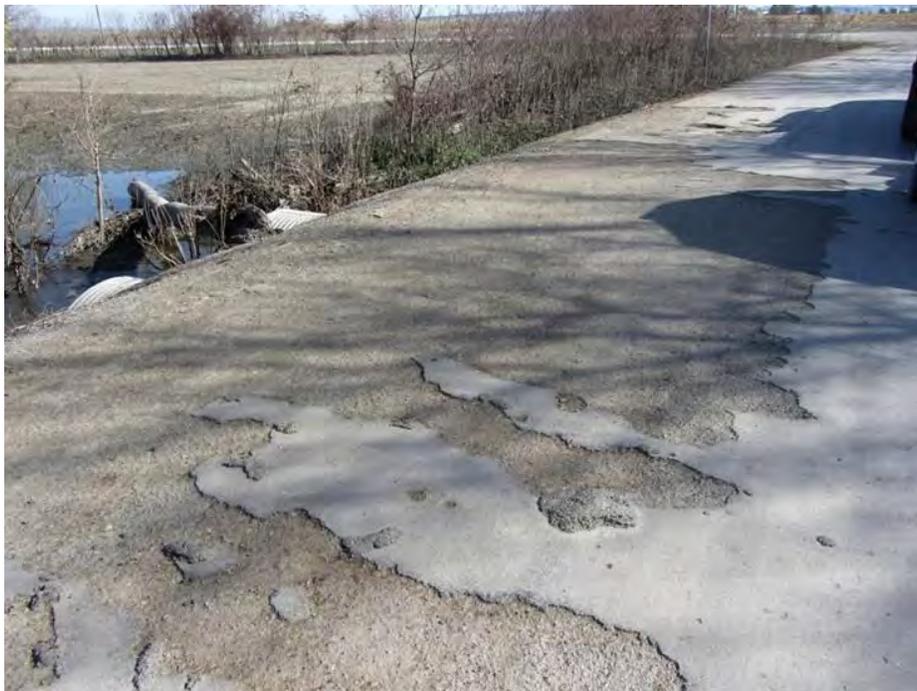
Figure 121. Delaminated surface chipseal on Desoto Avenue due to flood waters overtopping the roadway (Pictures taken on 10/25/11) – Pottawattamie County

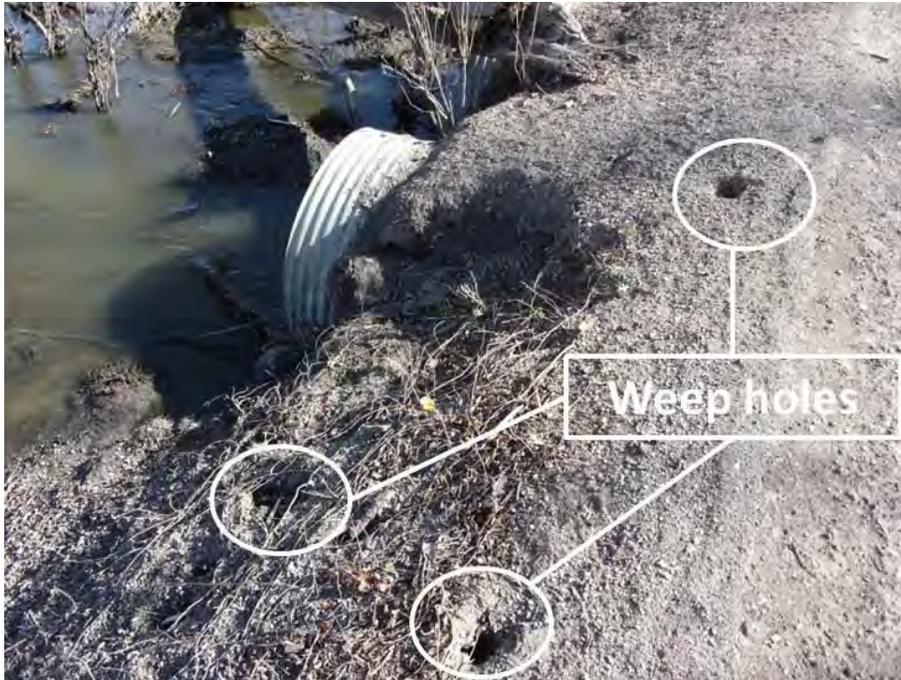
- The E_{SG} values in the whole TS were low and the quality is rated as “very poor” to “poor,” per AASHTO (1993). The E_{SG} values did not change over time (varied on average from 16 to 17 MPa).
- With the exception of granular shoulder loss at a few locations, which was replaced shortly after the flood event, no significant distresses or damages were noted on this roadway. Some weep holes were observed around culvert locations and were also found in GPR scans as discussed below.

Figure 122. Weep holes around culvert inlets on TS7 (Picture taken on 10/25/11) – Pottawattamie County

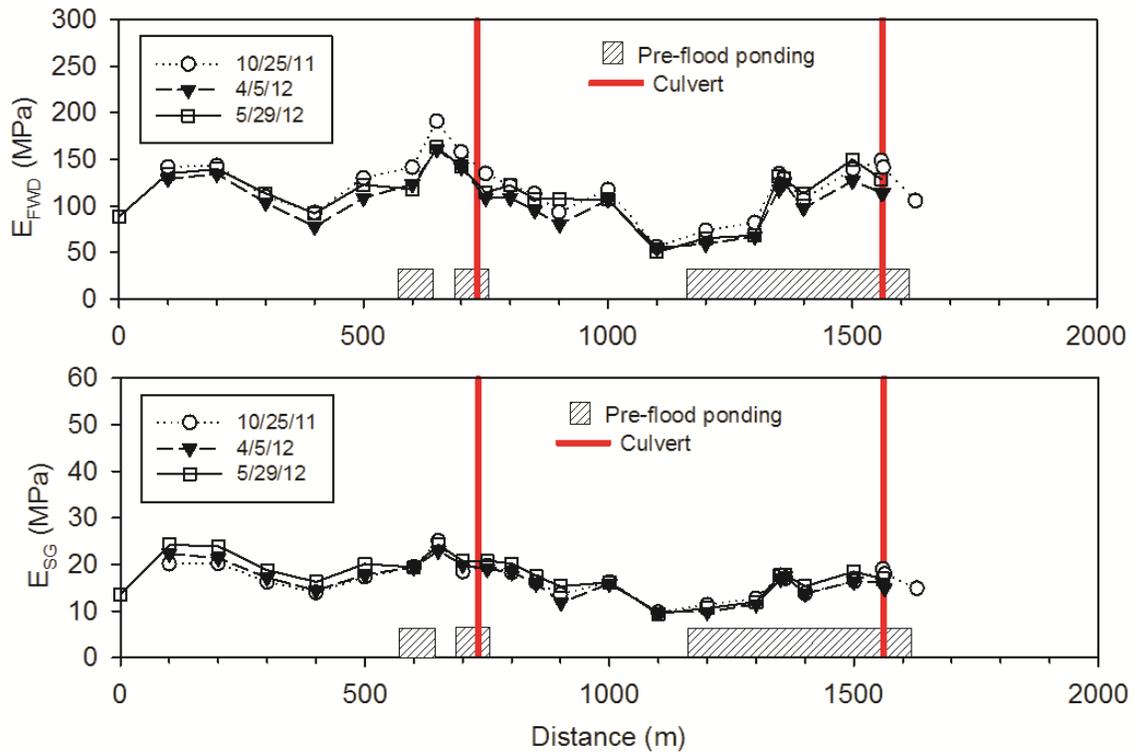
Figure 123. Surface FWD modulus and subgrade modulus at three different times after flooding on TS7 (entire TS was flooded and pre-flood ponding zones identified from aerial maps) – Pottawattamie County

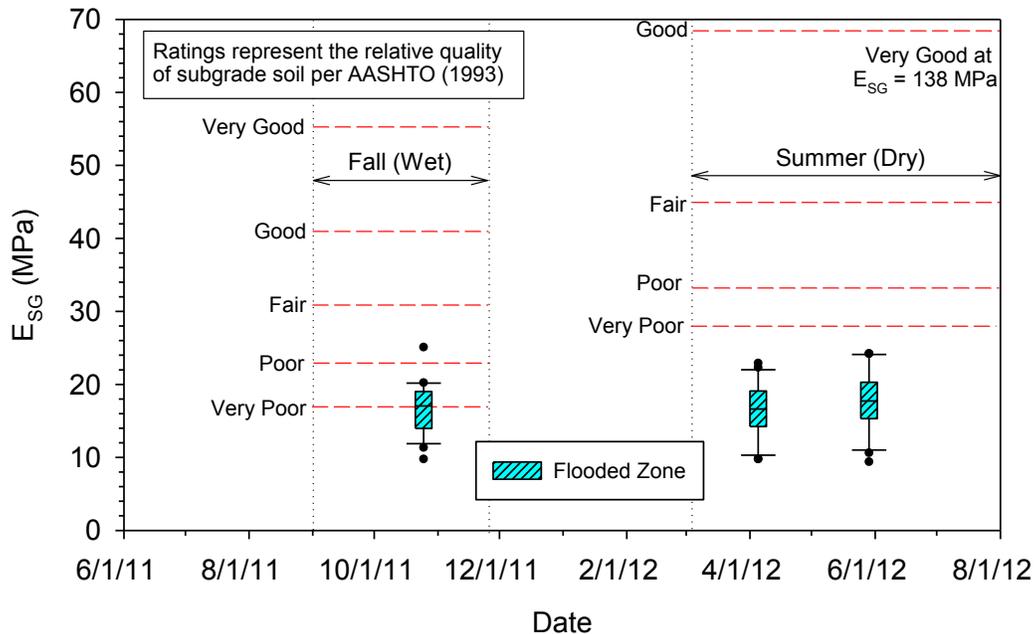
Figure 124. Box plots of subgrade modulus values in comparison with relative quality ratings on TS7 – Pottawattamie County

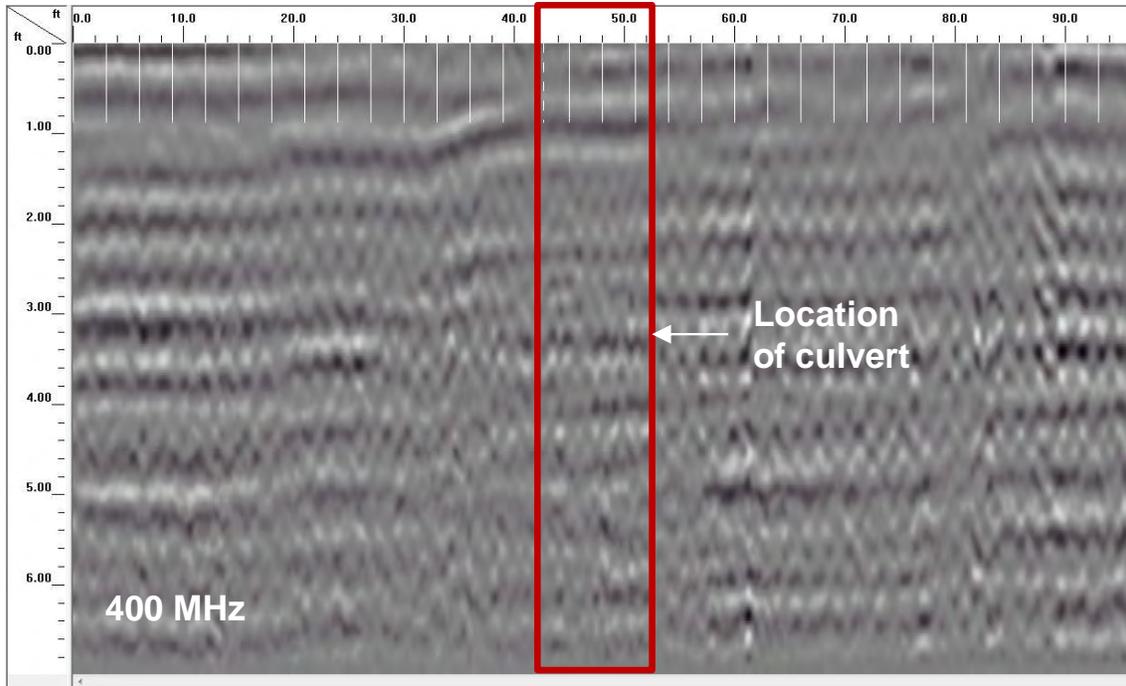
- Culvert location was not clearly identified in the scans shown in Figure 125.
- Weep holes were noted at several locations in the scans as shown in Figure 126 and Figure 127.

Figure 125. GPR scan using 400 MHz antennas on TS7 showing location of culvert (at station 724 m) – Pottawattamie County

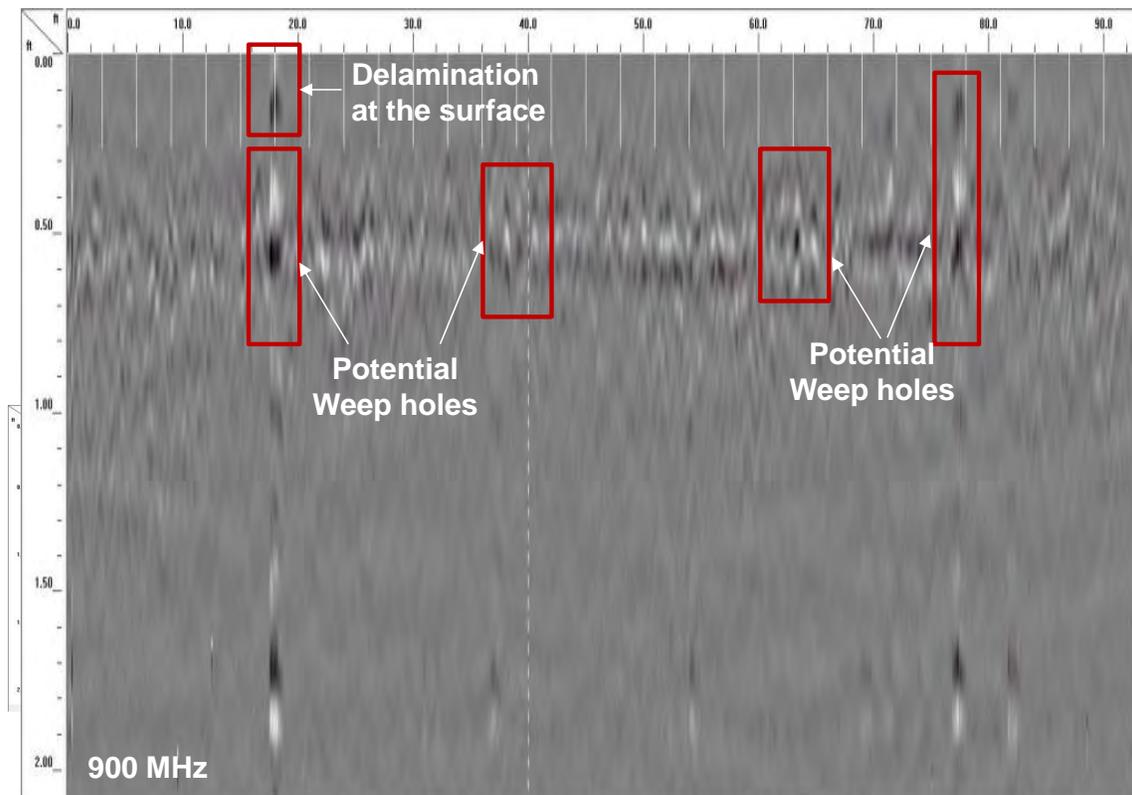
Figure 126. GPR scan using 900 MHz antenna on TS7 showing potential weep holes in the subgrade (between 720 m and 750 m stations on east bound lane) – Pottawattamie County

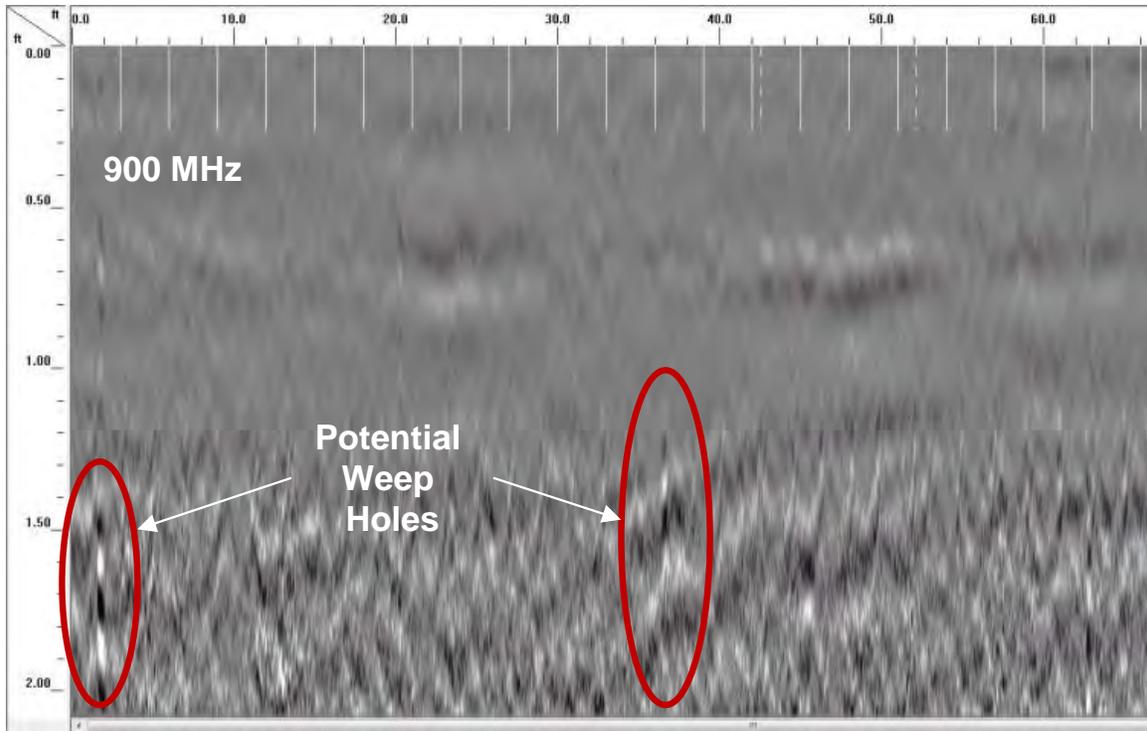
Figure 127. GPR scan using 900 MHz antenna on TS7 showing potential weep holes in the subgrade (between 1550 m and 1580 m stations on east bound lane) – Pottawattamie County

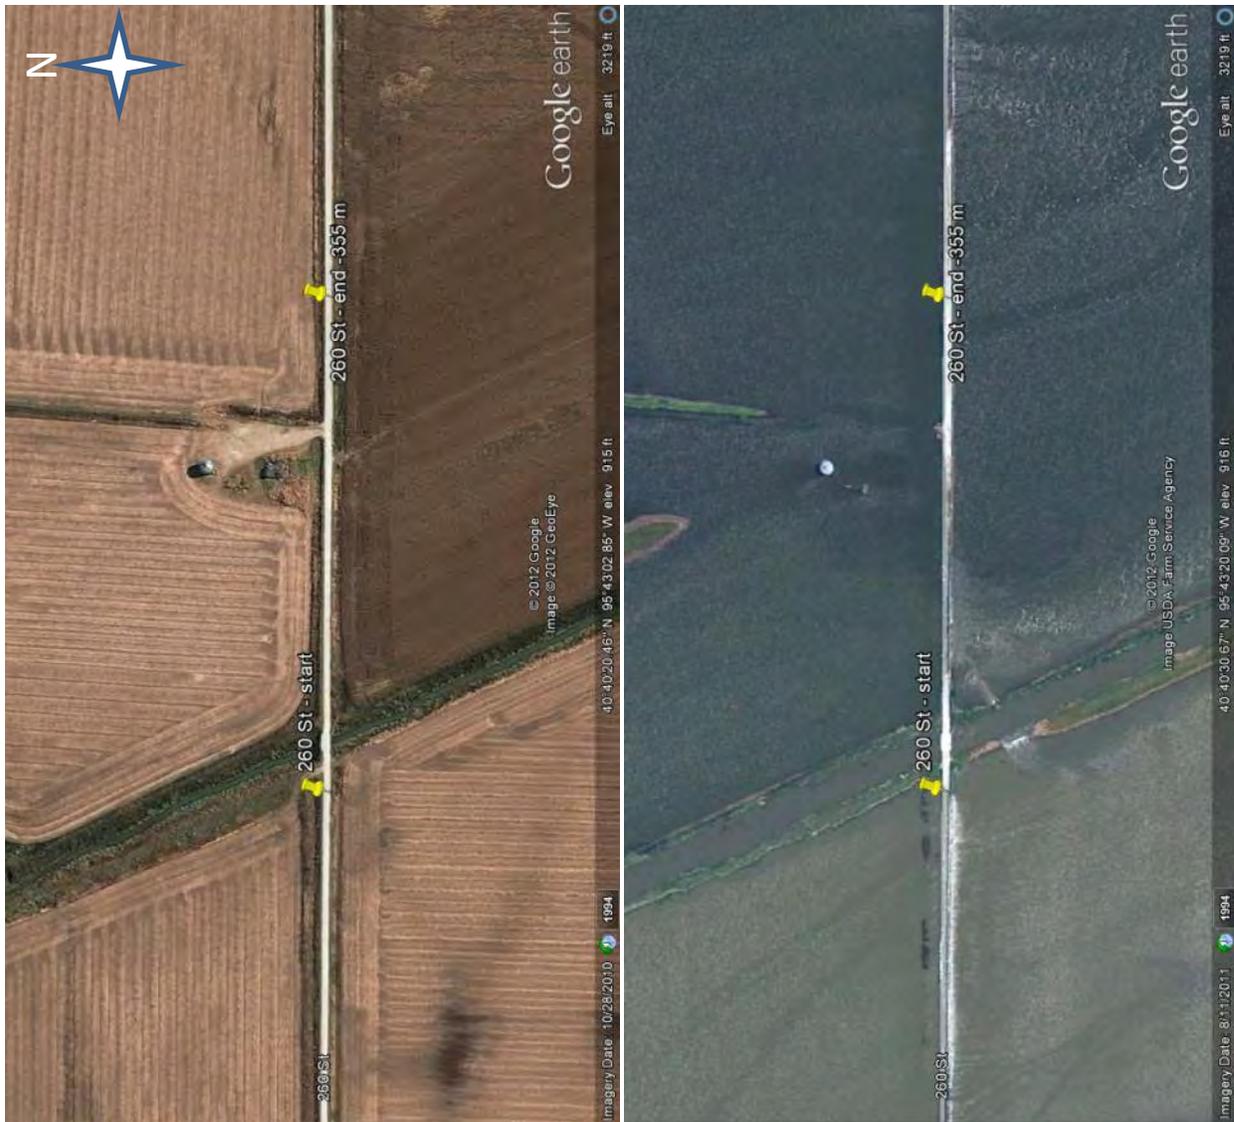
Figure 129. Aerial imagery before flooding on left (from 10/28/10) and during flooding on right (from 8/11/11) on TS1 – Fremont County

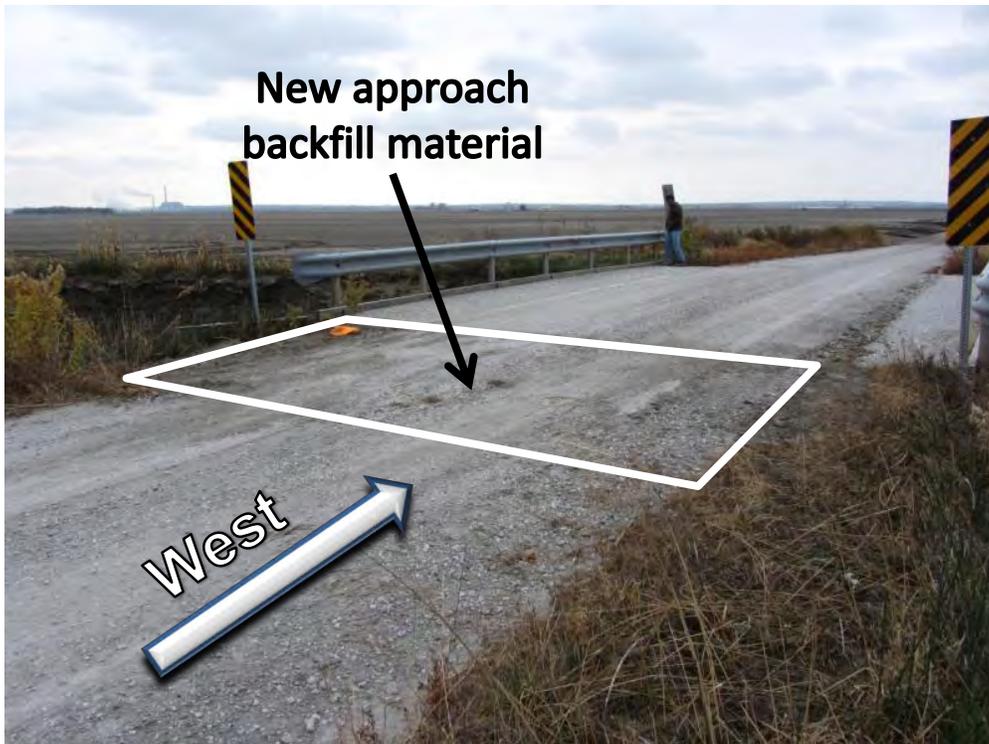
During the 2011 flood event, the TS was partially submerged for about two to three months (Figure 129). Reportedly, the flood waters receded in the area during mid-September 2011. During the flood event, backfill material behind the east bridge approach was eroded away and new fill was placed prior to testing (Figure 130). The bridge crosses a drainage ditch. The drainage ditch embankment slopes (close to the bridge abutments) were scoured during the flood event (see pictures from 10/25/11 in Figure 131 to Figure 133). Field observations during 4/4/12 indicated continued erosion of backfill materials abutment, and scoured embankments (Figure 134). The scoured embankment slopes and bridge abutments were repaired by 6/19/12 using on-site clay fill material (Figure 135).

Figure 130. New bridge approach backfill material placed along the east approach on TS1 (Picture taken on 10/26/11) – Fremont County

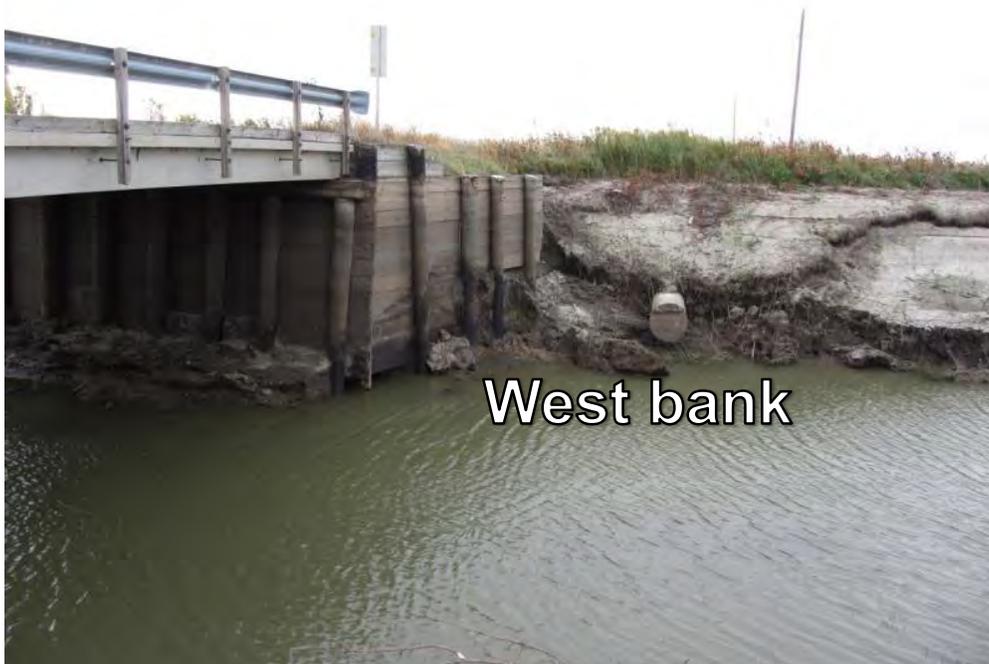
Figure 131. Erosion of embankment material along the west bank on TS1 (Picture taken on 10/26/11) – Fremont County

- Field observations indicated that clay fill material was used to stabilize the bridge abutments and block erosion of the backfill materials through the abutment walls. However, this material can be scoured away easily during a future flood event. Use of rip rap material as scour protection for the abutment wall would be a better repair and mitigation alternative.

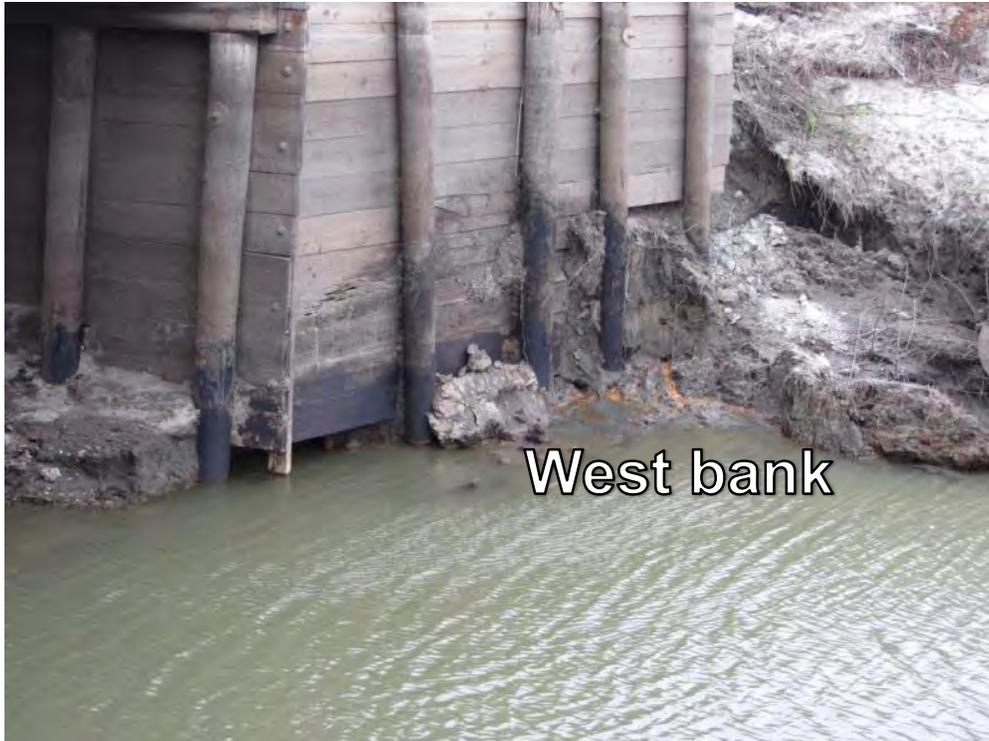
Figure 132. Erosion of embankment material along the west bank near abutment wing walls on TS1 (Picture taken on 10/26/11) – Fremont County

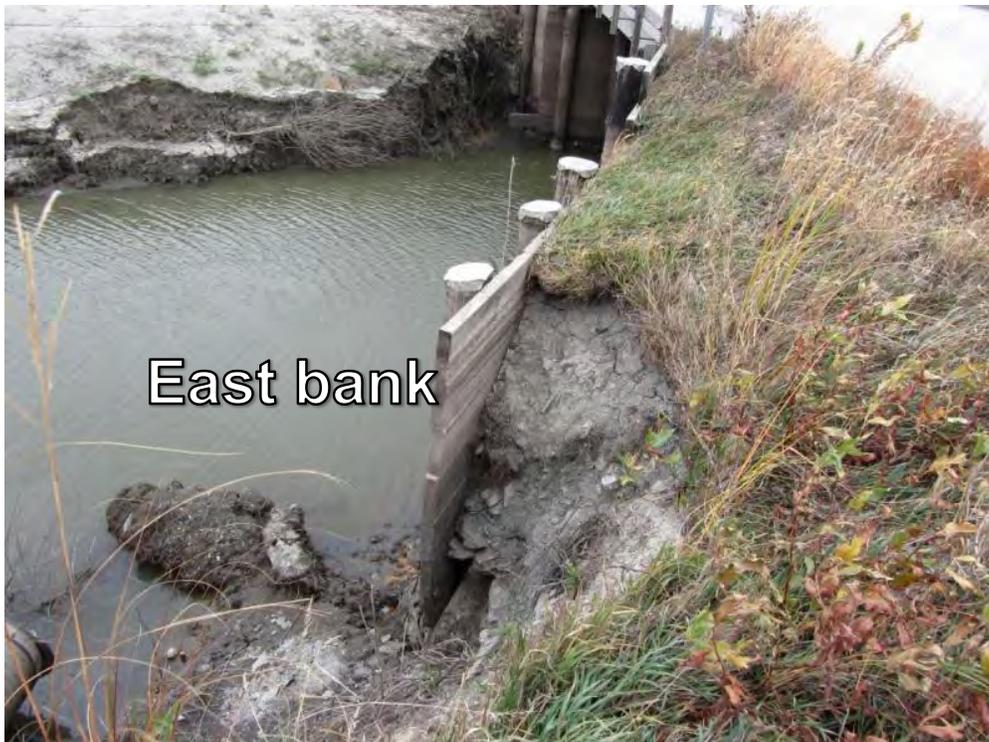
Figure 133. Erosion of backfill material behind the wing wall on TS1 (Picture taken on 10/26/11) – Fremont County

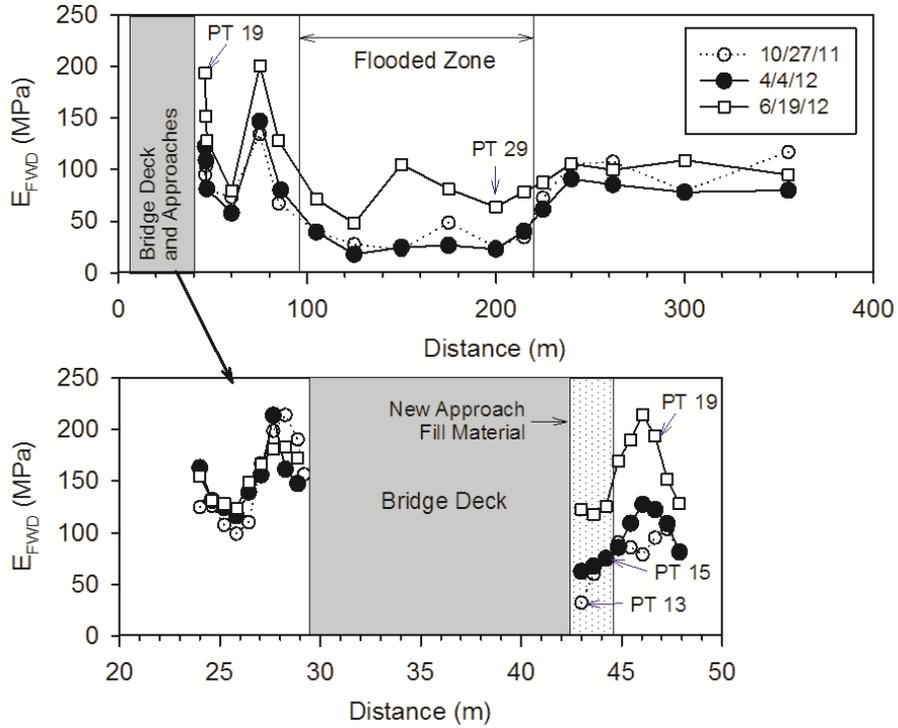
Figure 136. Surface FWD modulus at three different times after flooding on TS1 – Fremont County
